## **Bugley Farm, Warminster Proposed Residential Development Supplementary Foundation Assessment**

Report Reference: ESP.8917.4133

## Bugley Farm, Warminster Proposed Residential Development Supplementary Foundation Assessment

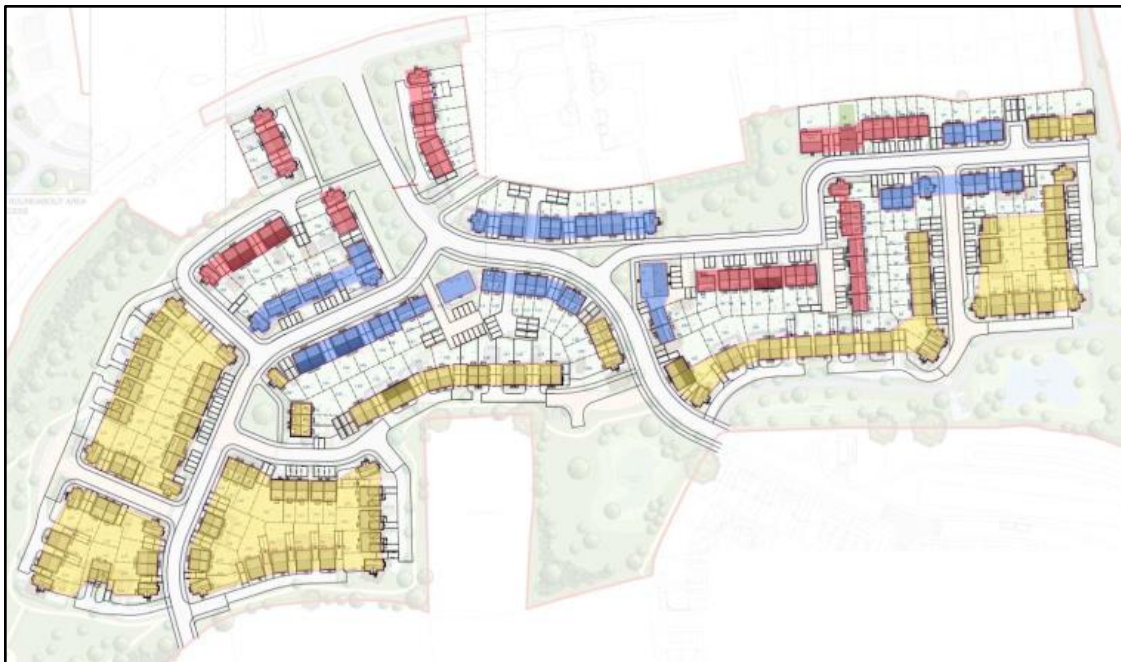
Insert 2 – Proposed Development Layout (after PPDS, document ref: STD001-PRO-X-XX-SP-DT-0122)

The proposed development comprises 227no. private and affordable residential units of varying size, with associated areas of private gardens, landscaping and hardstanding. A proposed site layout is shown as Insert 2 below.

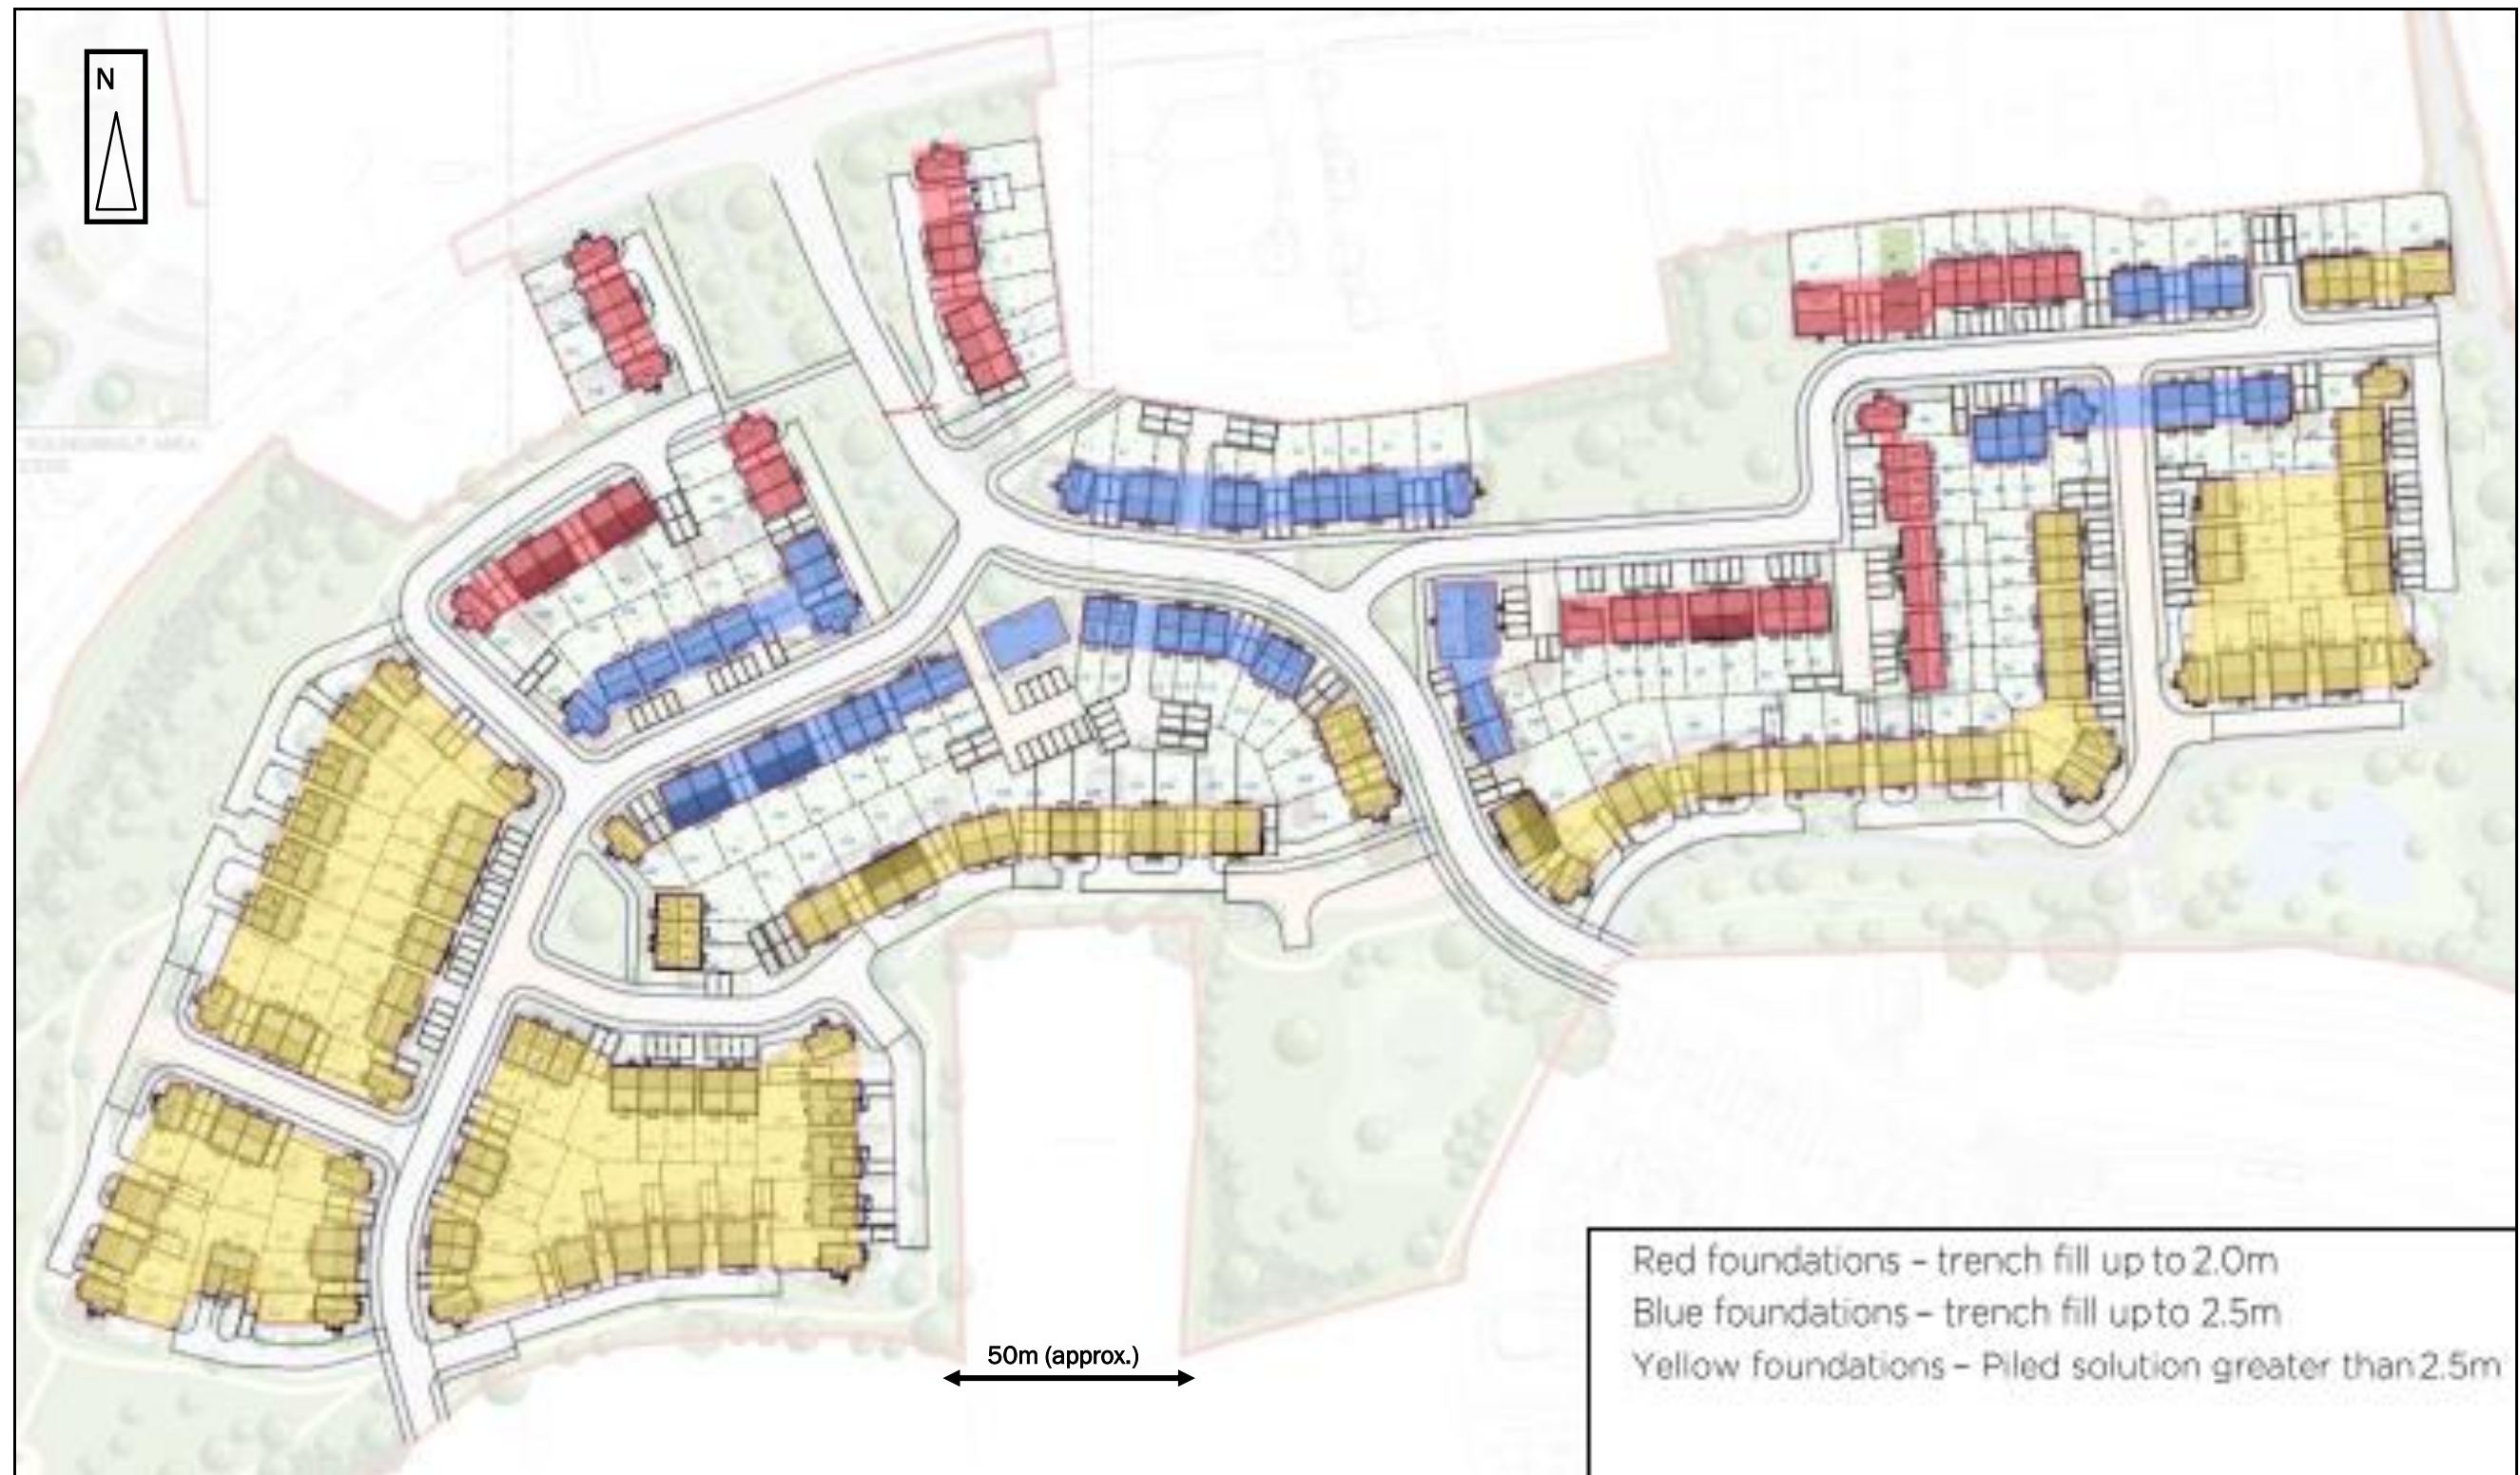
Based on the Due Diligence Report (ref: STD001-PRO-X-XX-SP-DT-0122), there are three proposed foundation solutions selected for the site development. These comprise:

Drawing after Protech-PDS Limited (PPDS) – Document reference: STD001-PRO-X-XX-SP-DT-0122

A proposed foundation layout, prepared by PDDS is presented as Figure 4.
