Sir Audley Arms,  
Chippenham

Protected Species Report & BNG Assessment  
Report Reference KE25/011/01

27<sup>th</sup> January 2025

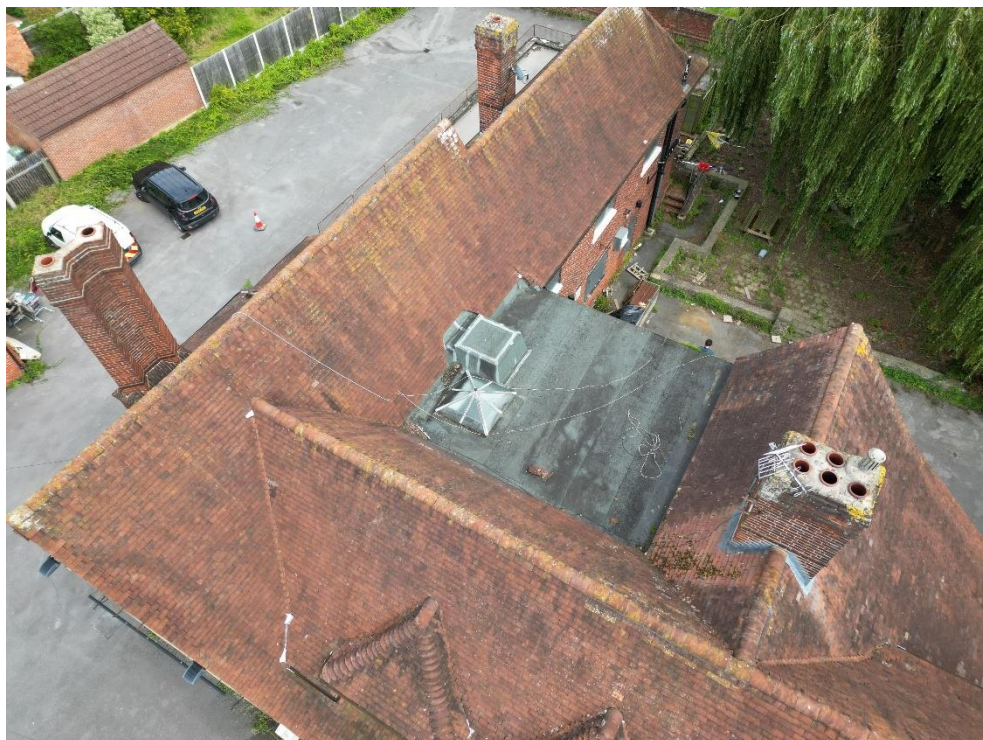
*Photograph 4- View of roof of pub*

Externally, the building is largely in good condition with intact brickwork, well mortared ridge and hip tiles, and intact verge mortar. However, some potential bat roosting features were identified in association with the building's roof. These features included crevices running beneath the eaves, a large hole at the west facing gable plus gaps around fascia boarding (see Table 2 below).

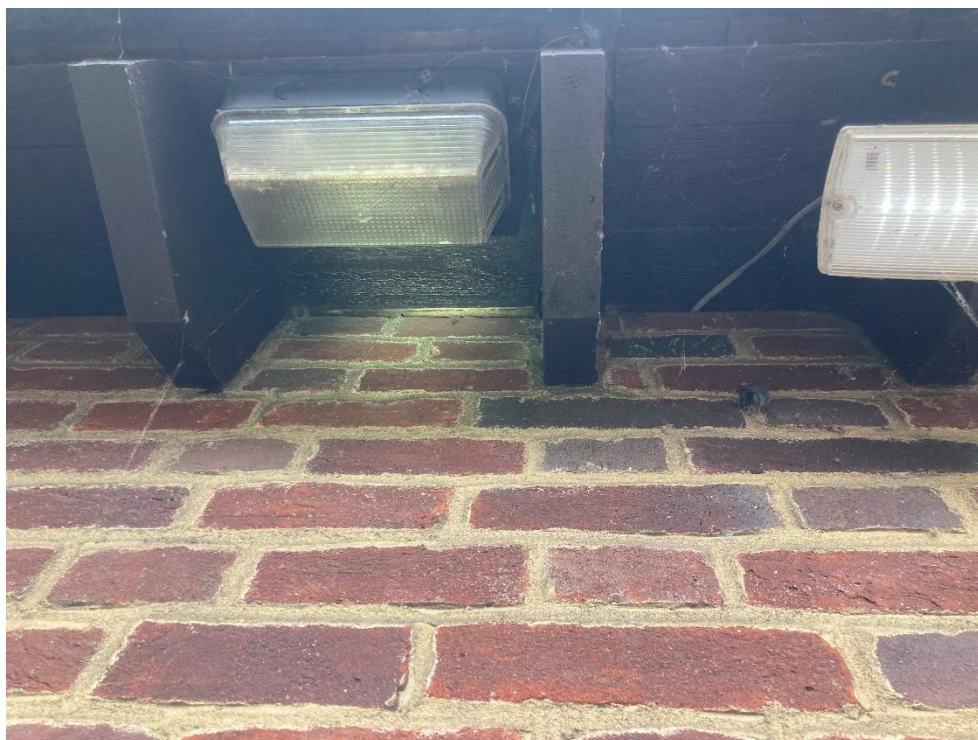
| Target Note | Description |
|---|---|
| 1 | Crevices located at the eaves between tops of the outer walls and the wooden boarding on the internal face of the roof. |

*Photograph 5- View of crevice at eaves*

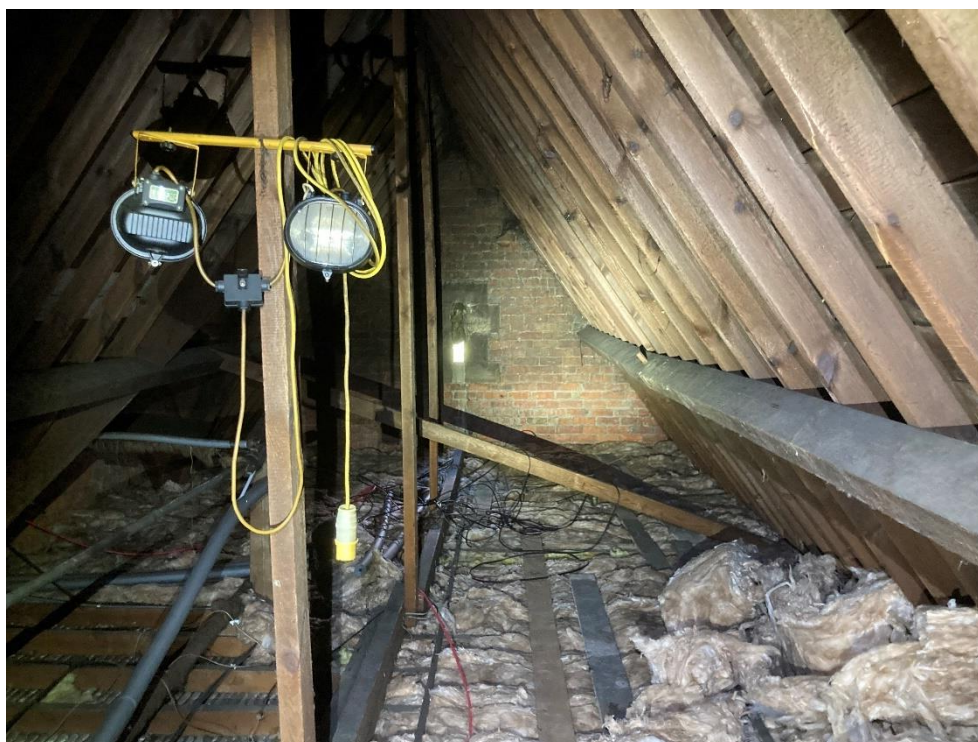
There is an opening/owl hole at the west facing gable of the loft space. The opening is approximately 10 cm x 20 cm in size and has been partially blocked with rock wall. The opening offers potential access for bats and birds into the loft space.

| Target Note | Description |
|---|---|
| 3 | Opening leading into loft space at West facing gable of building. The opening is approximately 10 cm x 20 cm in size and has been partially blocked with rock wall. The opening offers potential access for bats and birds into the loft space. |

*Photograph 6- View of loft space looking towards crevice at Target Note 3*

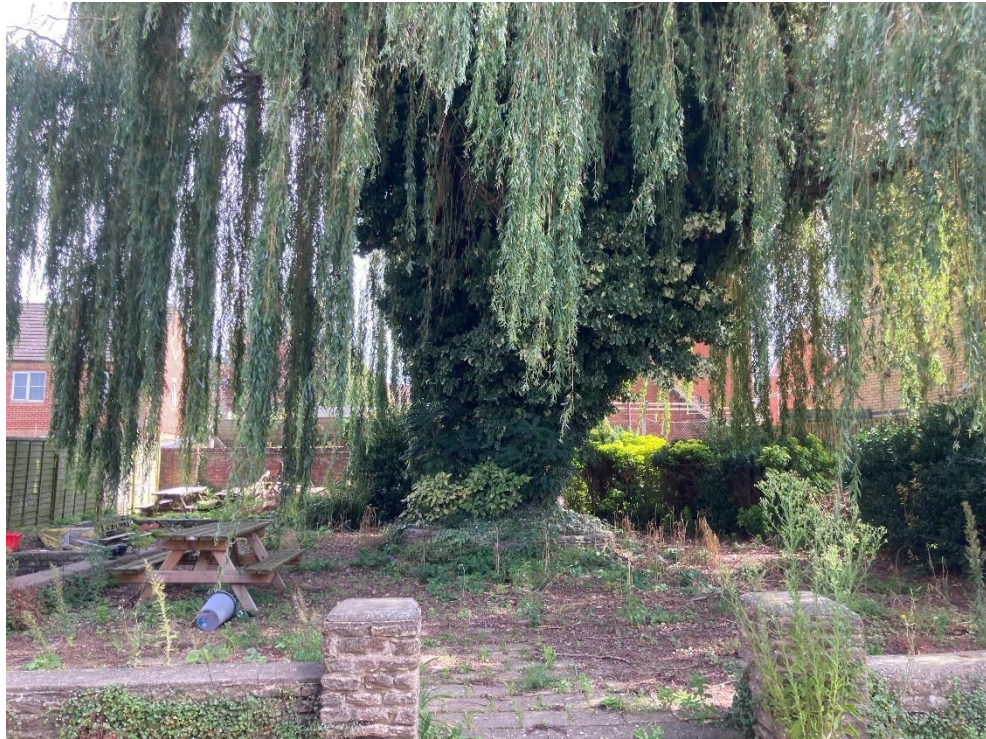
There is a single large, mature weeping willow tree located to the rear of the main public building (Target Note 6 on Figure 2). The tree is overgrown with ivy offering some low value potential bats roosting habitat behind ivy stems. The tree would be retained as part of development proposals. The tree is located within a raised planter, over an area of paved patio. With regards to the biodiversity net gain assessment, the tree was assessed as being 'very large', and considered to be in a 'moderate' condition. Relevant habitat condition sheets are provided in the Appendix.

*Photograph 7- Weeping willow in rear of pub*

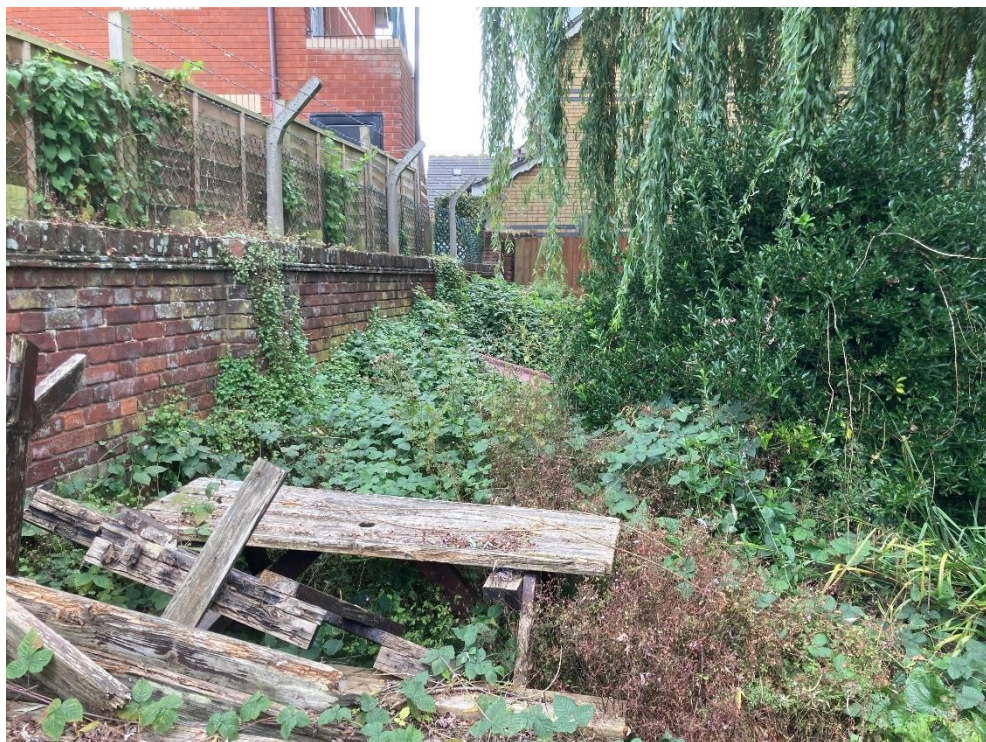
There is a further narrow fringe of ruderal vegetation running around the perimeter of the site (Targets Note 8) which includes smooth sowthistle, dandelion, Canadian fleabane, nettle, field horsetail, and hedge bindweed. With regards to the biodiversity net gain assessment, this habitat is classified as 'ruderal/ephemeral' in a 'moderate' condition. Condition sheets provided in the Appendix.

*Photograph 8- Ruderal habitat at southeast corner of site*

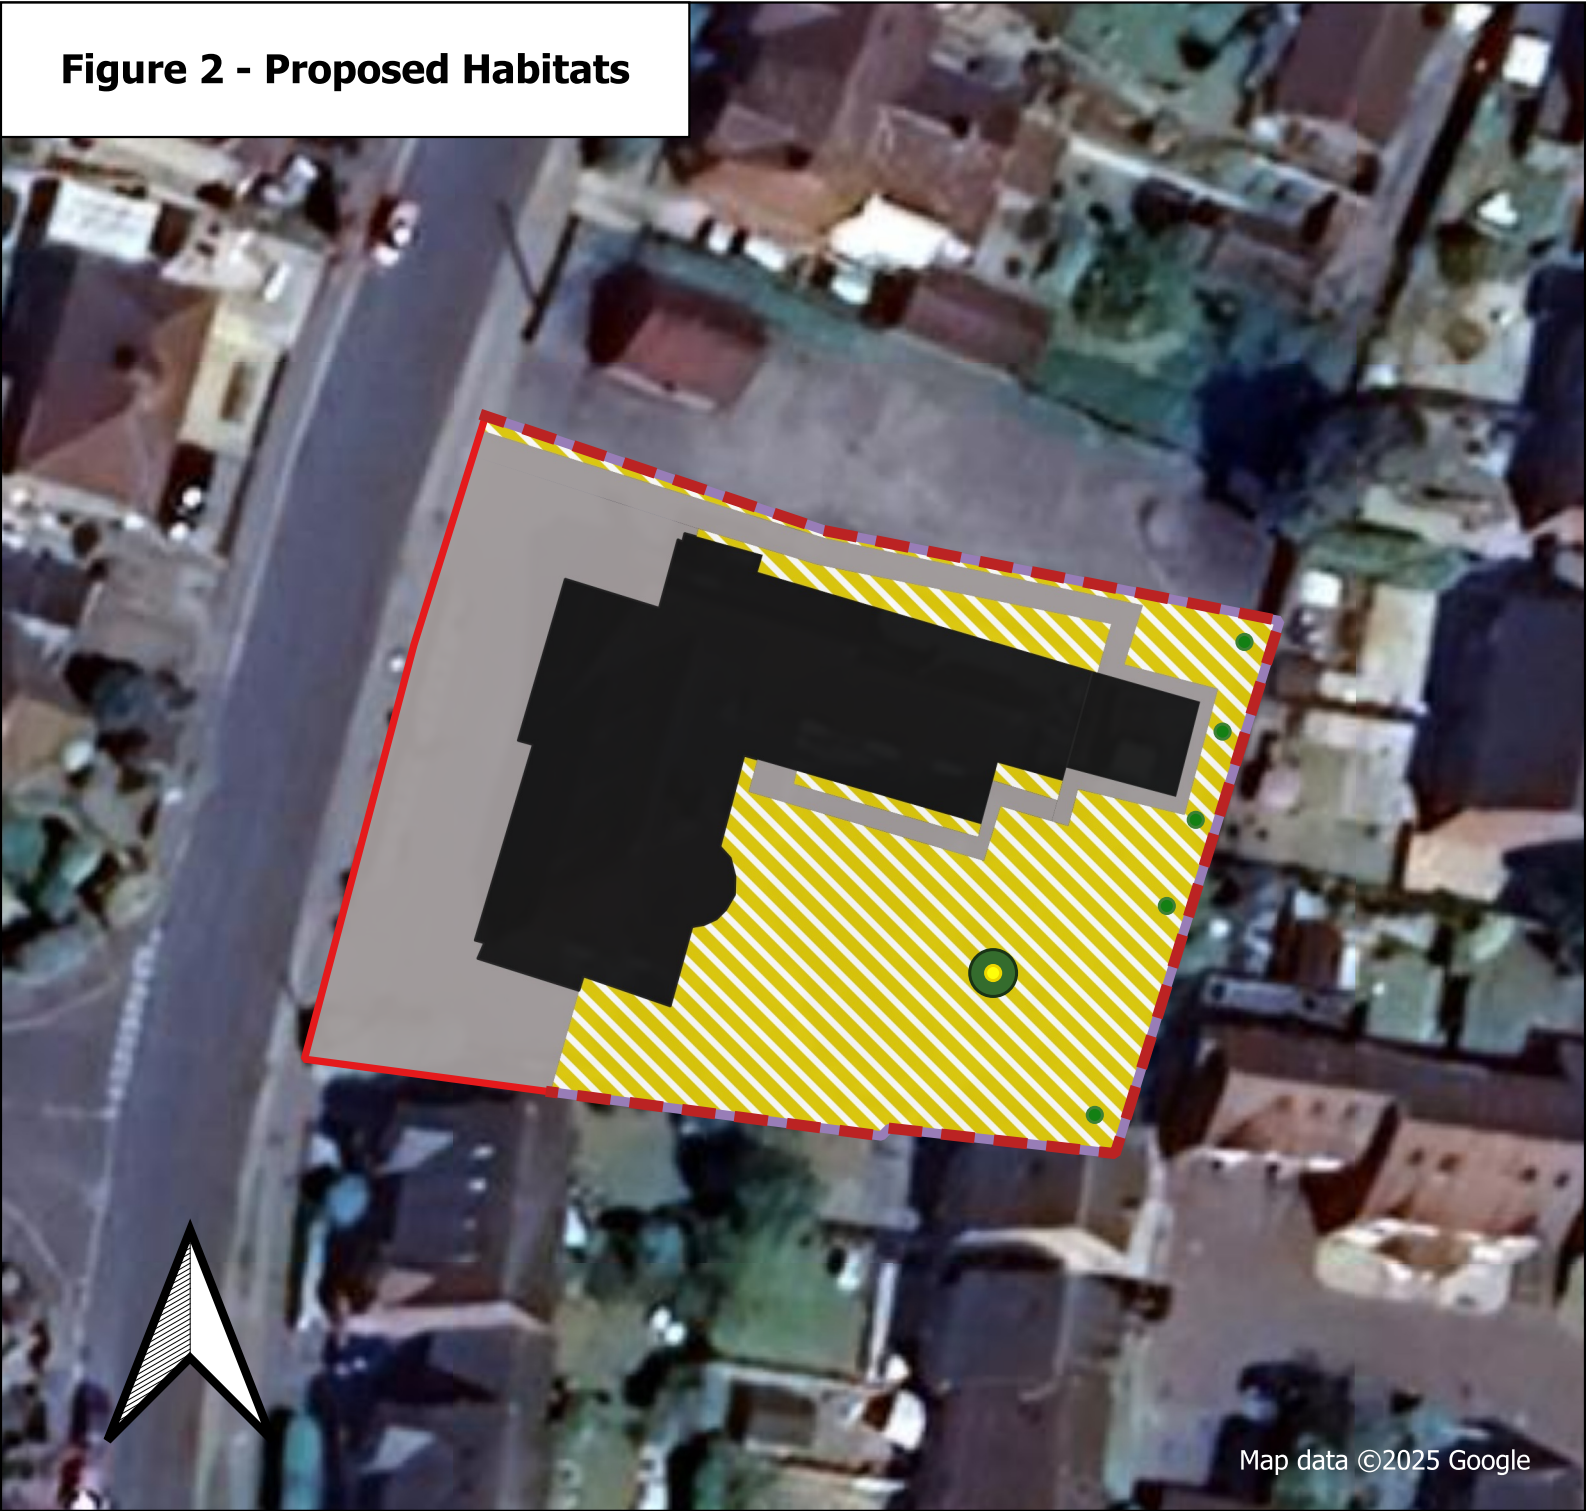
Figure 2 - Proposed Habitats

The proposed development works are shown on Figure 2. Development proposals are to convert the main pub building to provide a new block of eight apartments. The apartments will have gardens to the rear and the existing weeping willow tree would be retained.

The development will include the planting of 5 x new, native trees as well as new areas of hedgerow and vegetated garden. It is envisaged that the new trees will achieve a 'moderate' target condition.
