Hill Cottage, 7 Reybridge, Lacock  
Preliminary Roost Assessment (PRA)  
*For Artel31*

30<sup>th</sup> October 2025

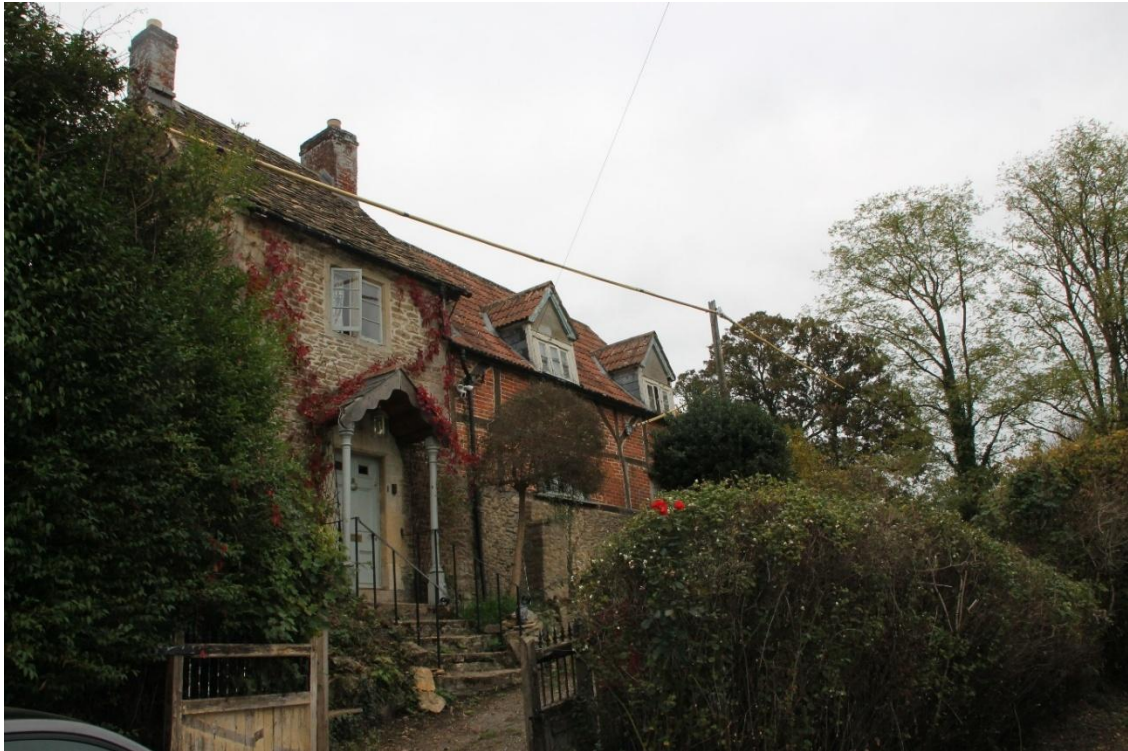
Externally the walls of the building were found to be in a good condition with no gaps or crevices in which bats could gain access for roosting. The walls were found to be smooth and no evidence of bat activity, such as droppings or feeding remains, was found.

The windows and doors of the building were found to be in good condition with no gaps where bats could gain access to the internal spaces for roosting. No evidence of bat activity, such as droppings or feeding remains, was found around the doors or windows, and there was no evidence of bat activity within the main living areas of the building.

*Photograph 1: showing a view of the target building (front elevation of the house)*

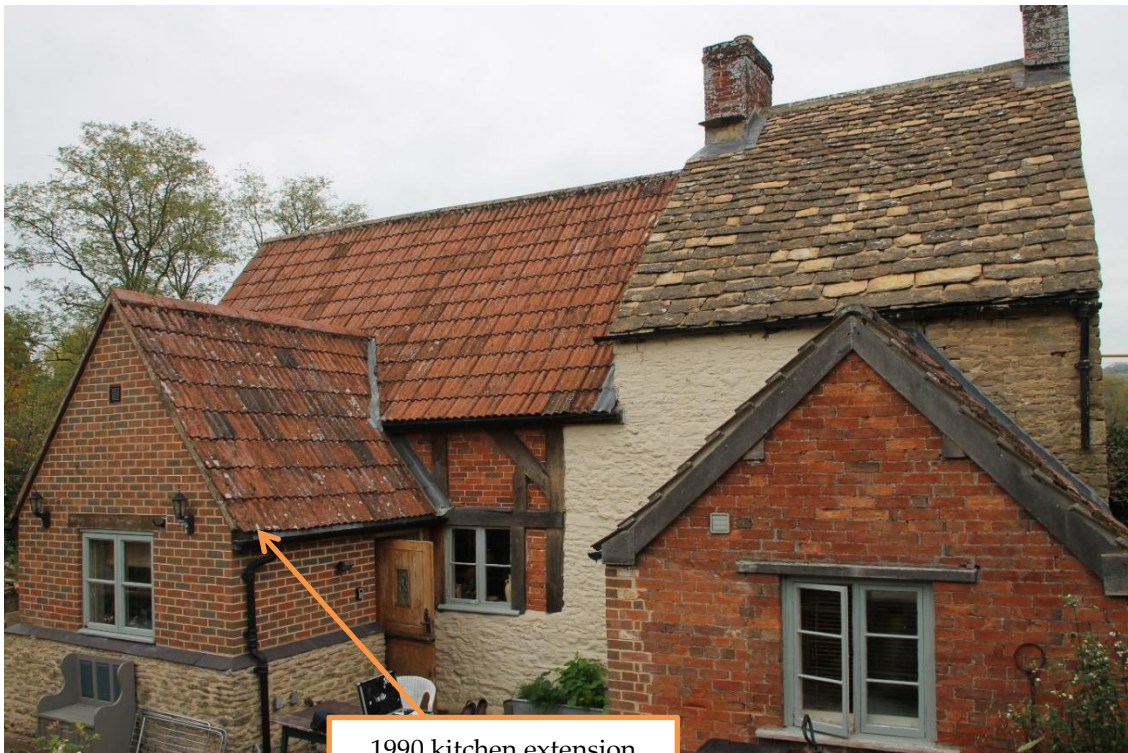
*Photograph 2: showing a view of the rear of the building*

The external roof structure of the building was found to be in a good condition with no loose, lifted or missing tiles that would allow bats to access the internal spaces. It is understood that much of the roof has been previously replaced and repaired, approximately 10 years ago. No evidence of bat activity, such as staining, was found on the external roof of the building.

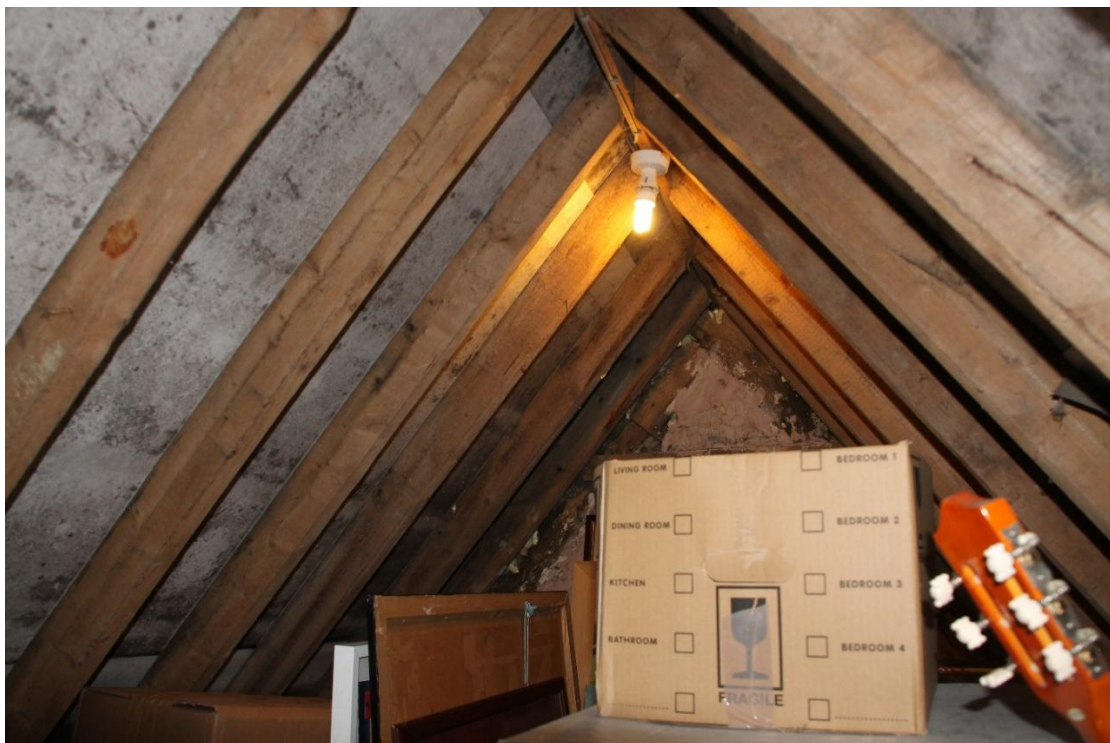
The accessible loft spaces were inspected and were found to be in a good condition with modern breathable membrane present from previous works to the roof structure. No rips were found where bats could gain access to the internal space of the loft and no evidence of bat activity, such as droppings of feeding remains, was found during the inspection.

*Photograph 3: showing a view of loft space above the original cottage to the north of the building*

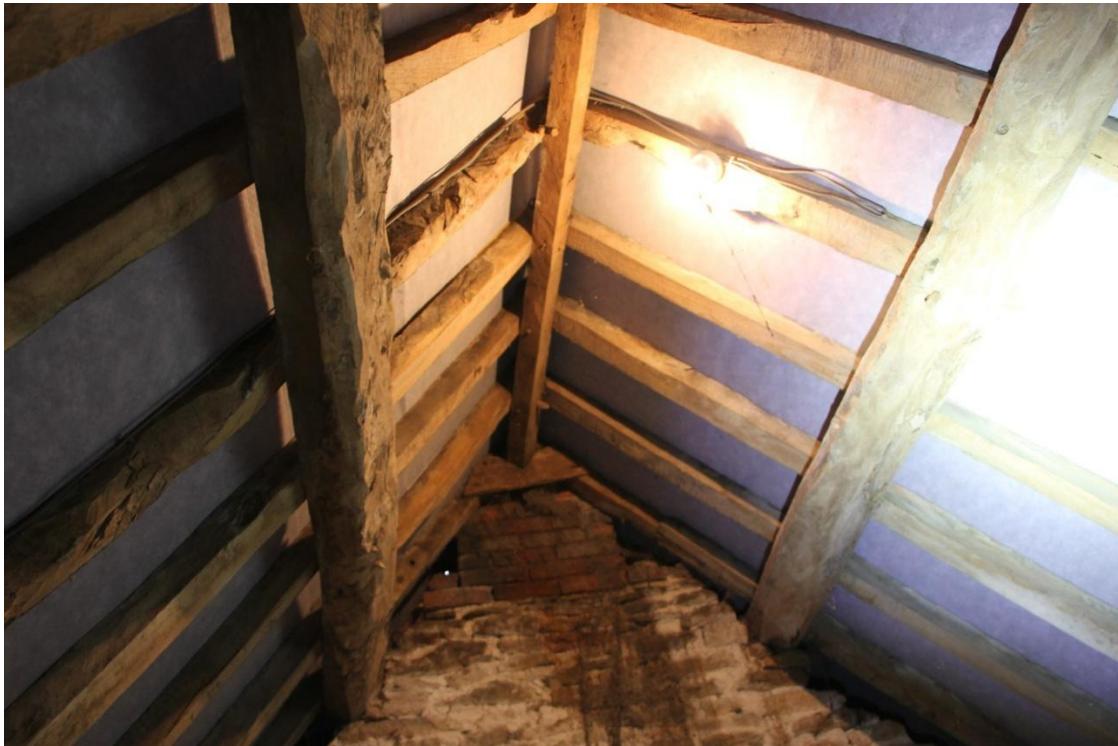
*Photograph 4: showing a view of loft space above the south of the building*

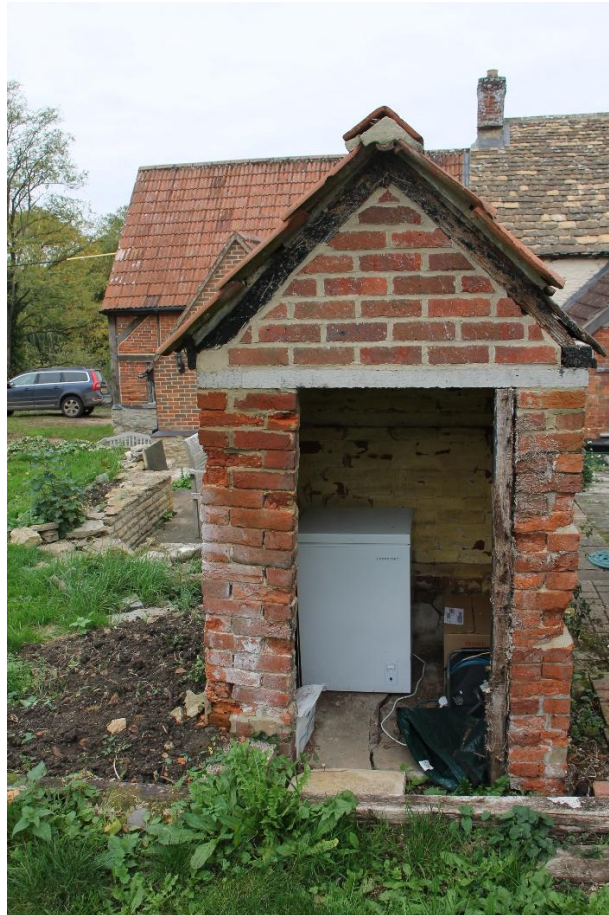
A small outhouse is located to the west of the main house and is constructed from red brick with a pitched roof covered with tiles. The building is approximately 1.25m long by 1.25m wide and 2m tall. The building was open on the western side with no door present on the structure making the internal space cold and damp. The building is currently used for storage.

No evidence of bat activity was found within the outbuilding to indicate that it is being used by bats for roosting or as a feeding perch. Bats are therefore not considered to be present.

*Photograph 5: showing a view of the outhouse (looking east)*

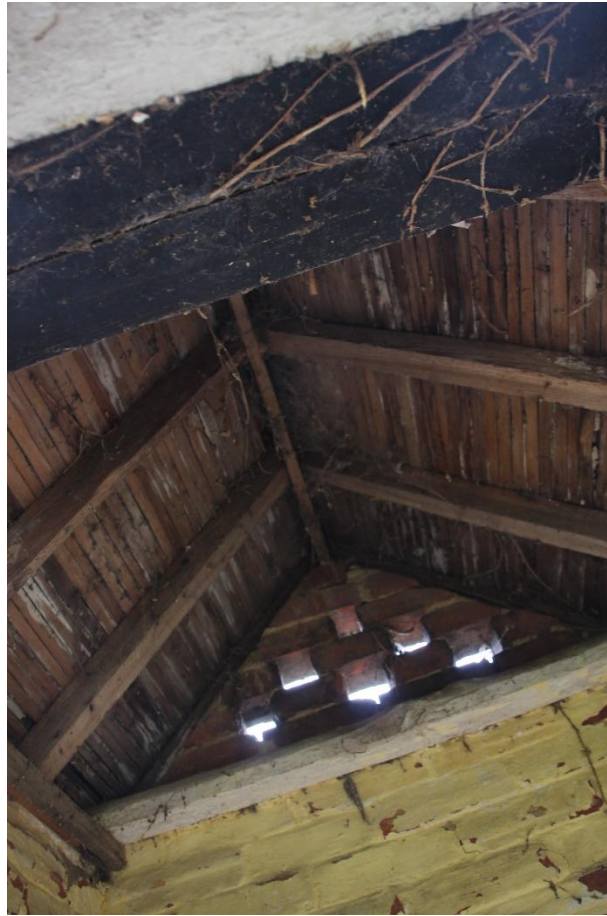
*Photograph 6: showing a view inside of the outhouse*

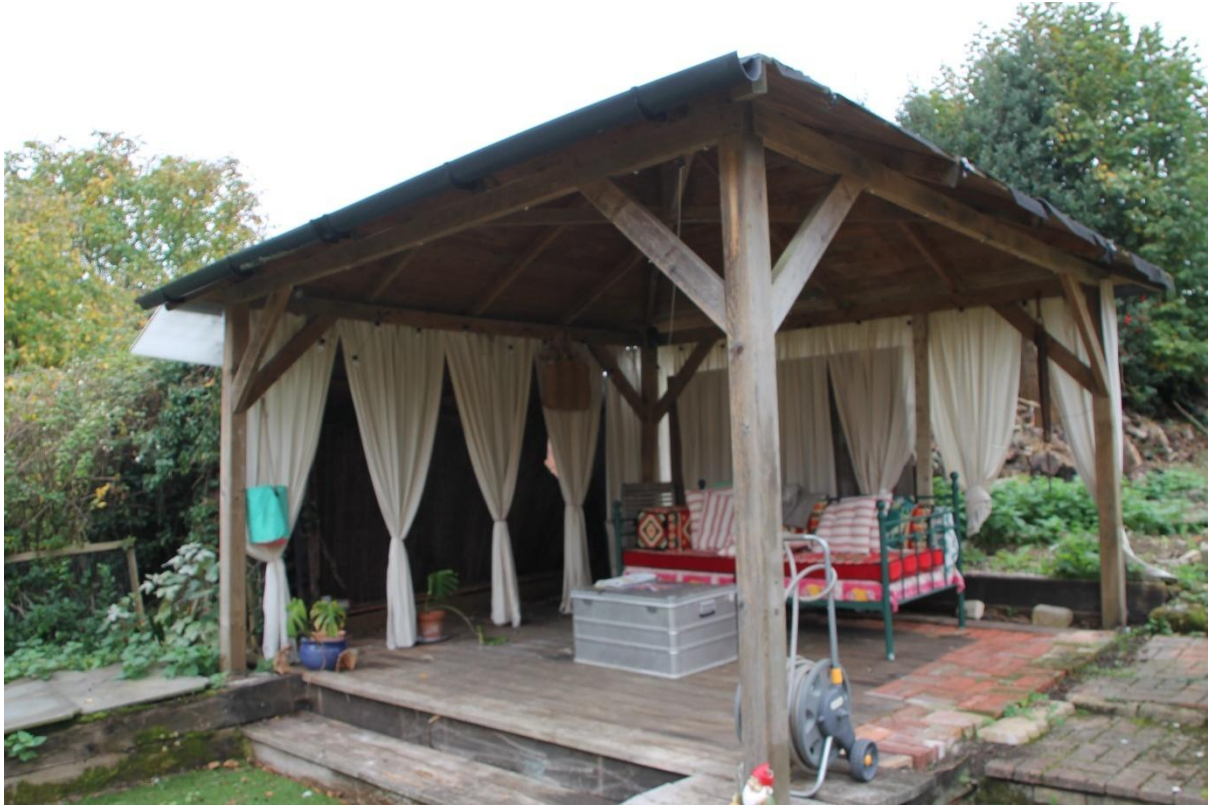
A wooden pergola is present adjacent to the outhouse. It is approximately 3m long by 3m wide and 2m tall with a pitched roof. The structure is open on all sides and has bitumen tiles on the roof which were found to be in a declining condition. No evidence of bat activity was found within the pergola to indicate that it is being used by bats for roosting or as a feeding perch. Bats are therefore not considered to be present.

*Photograph 7: showing a view of the wooden pergola*
