# **Grove Cottage Wardour**

## **Arboricultural Impact Assessment, Tree Protection Plan and Arboricultural Method Statement**

**9th December 2025**

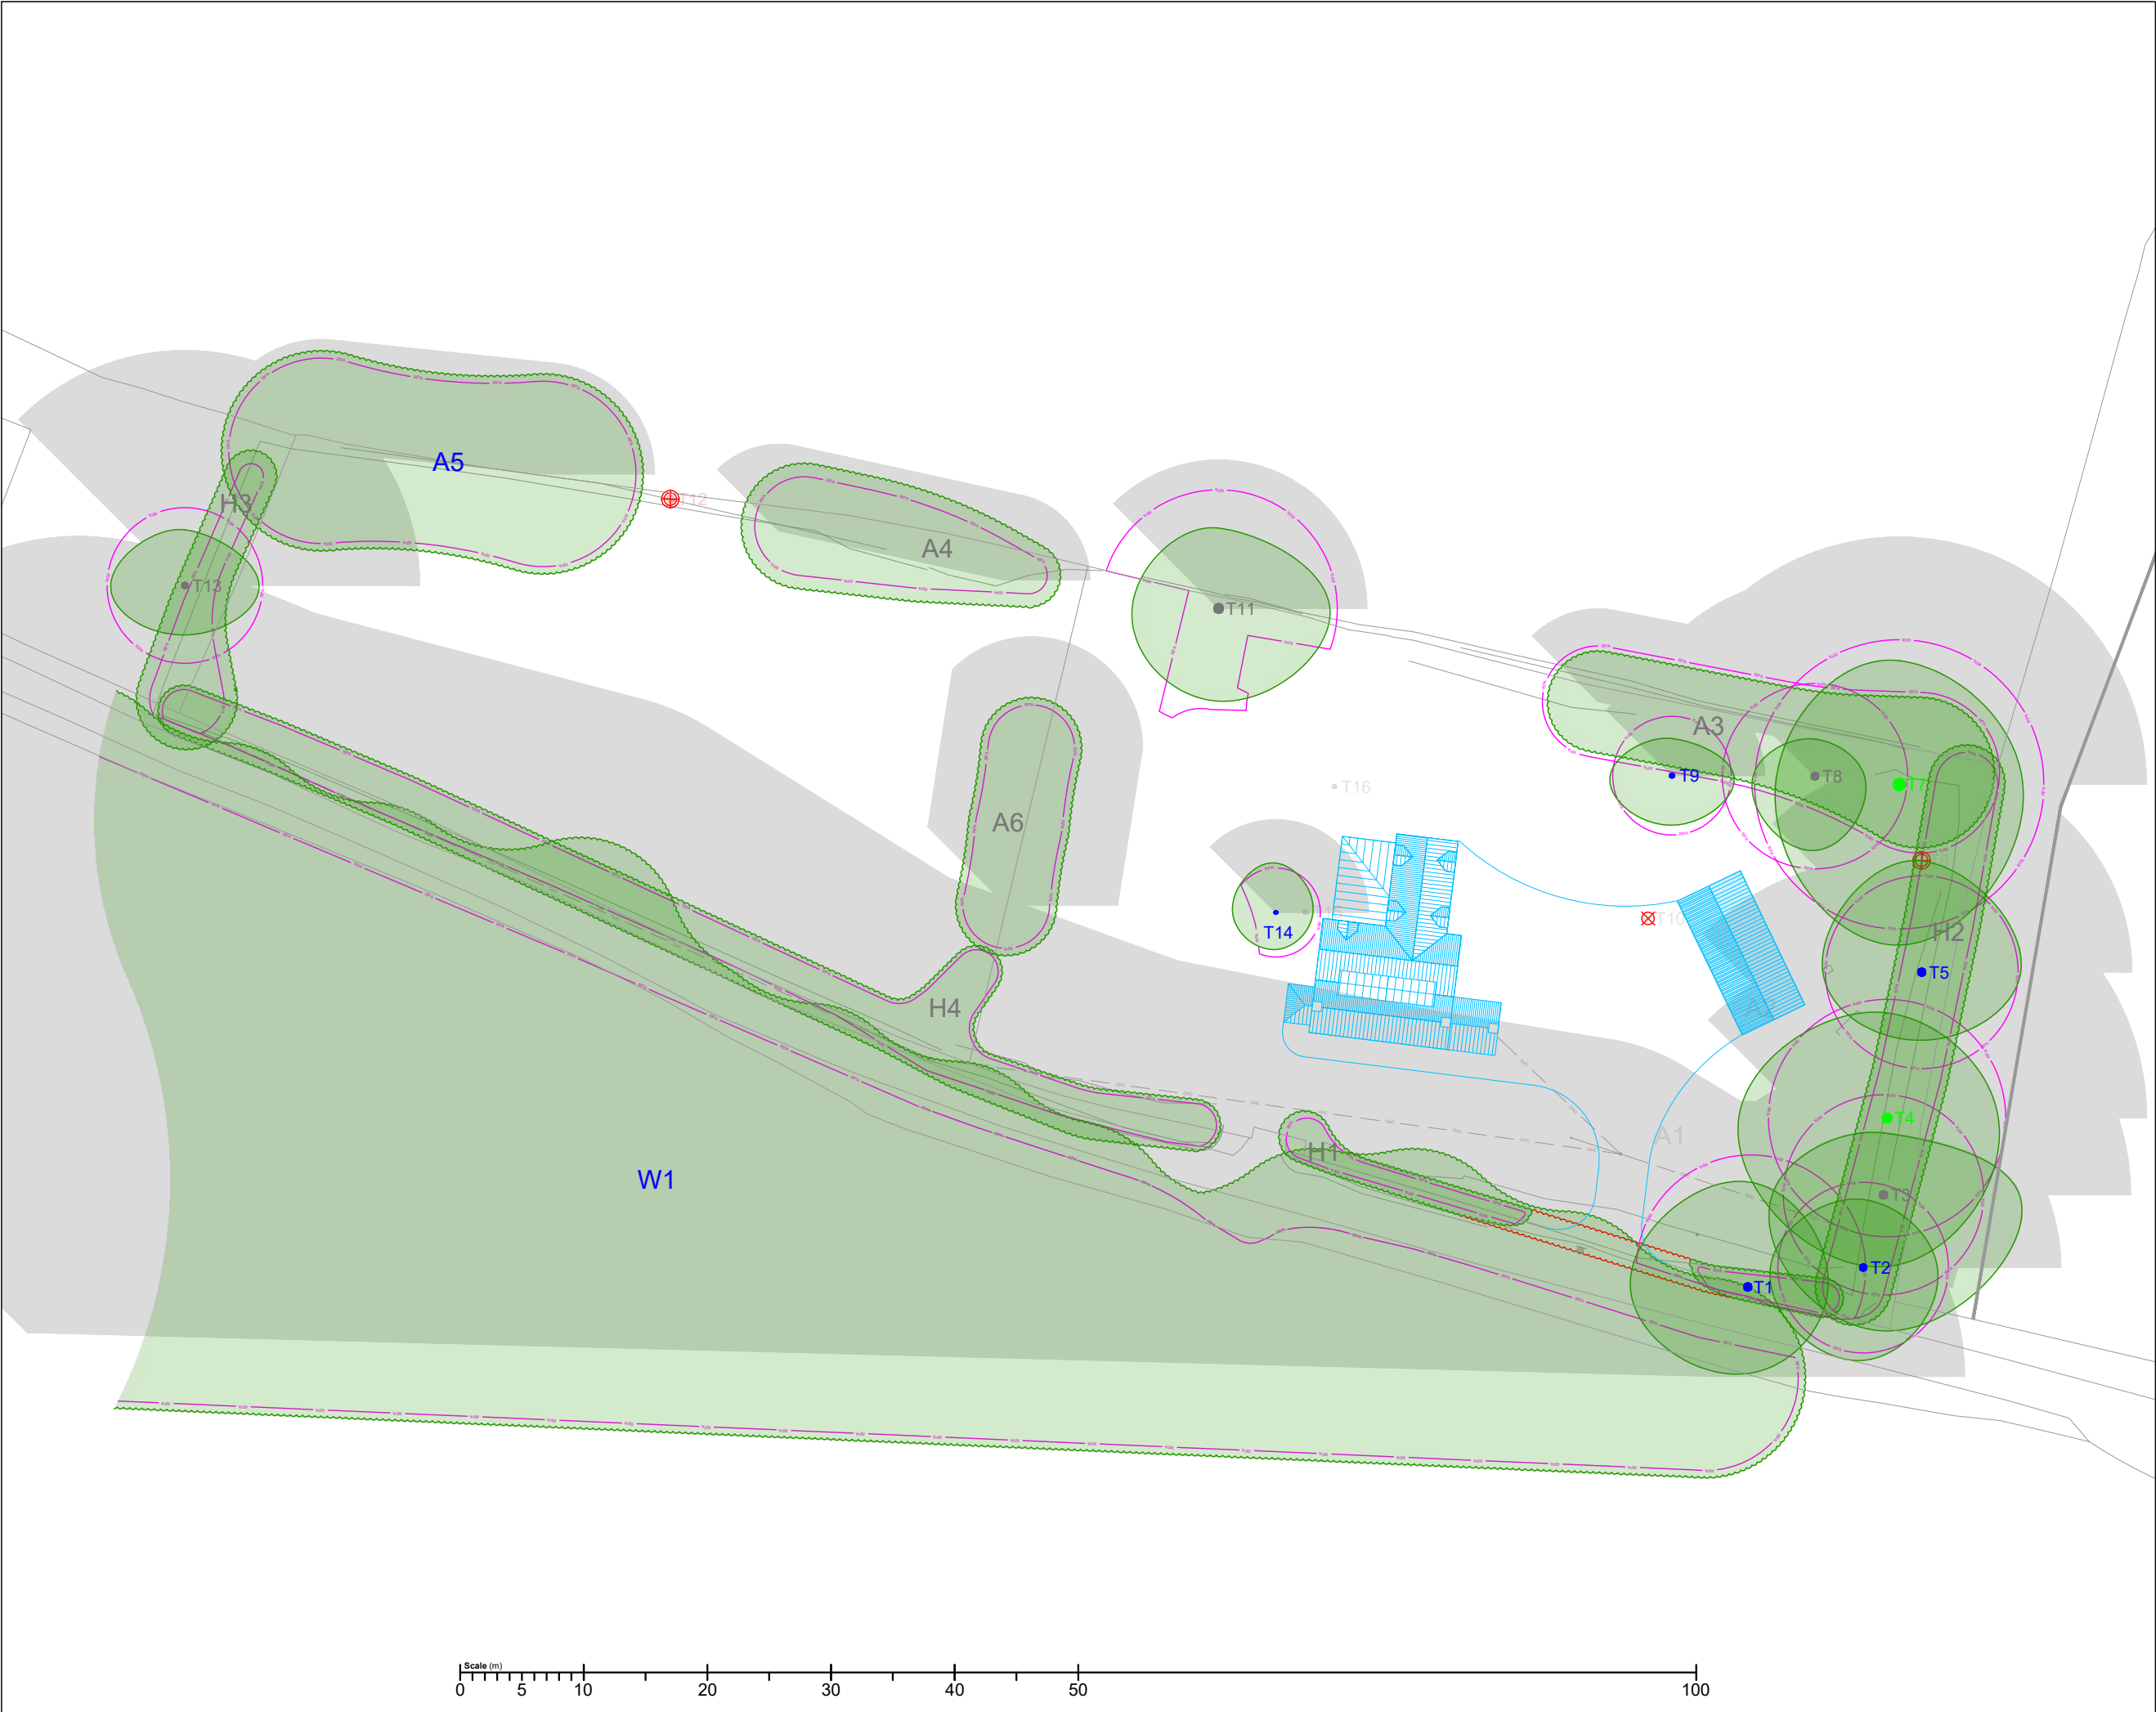
Note: The original of this drawing was produced in colour - a monochrome copy should not be relied upon. All drawings © Advanced Arboriculture.

A total of 33 metres of high visibility fencing (see Arboricultural Guidance Sheet AGS105) is also shown on the Tree Protection Plan. The purpose of this is to act as a visual demarcation of the construction exclusion zones where there is considered to be a low risk of damage to retained trees from plant, materials or personnel.

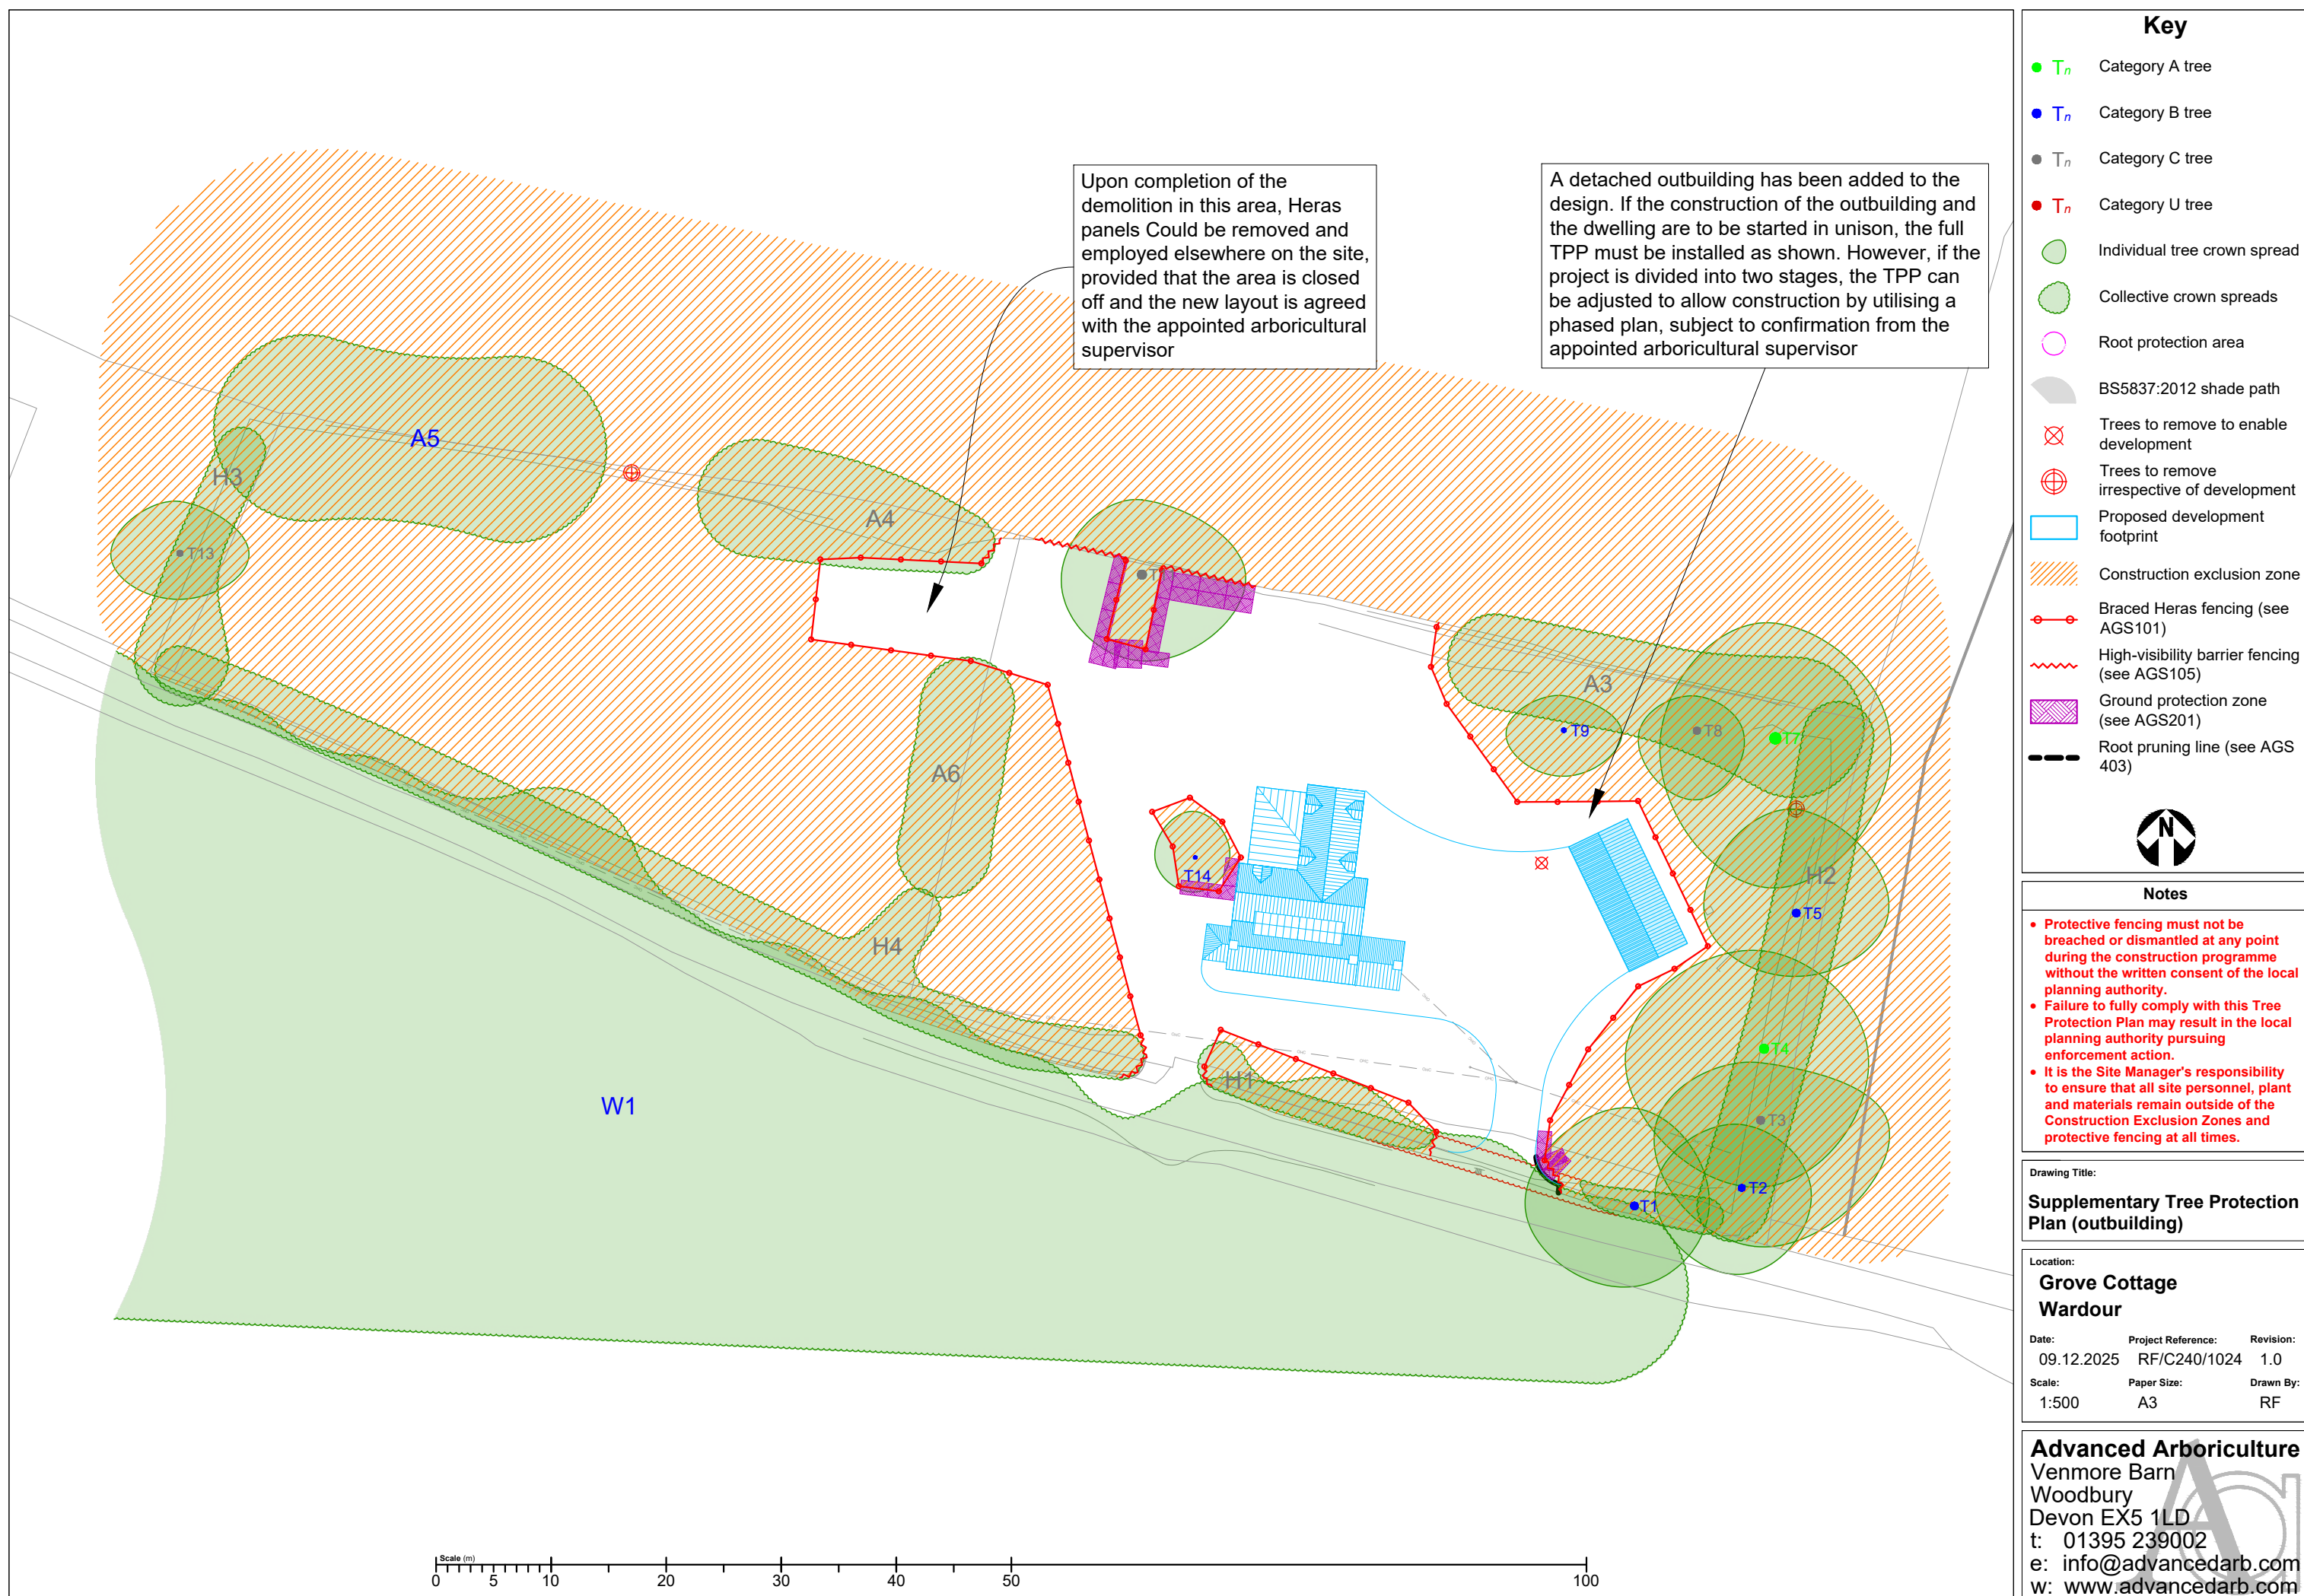
Arboricultural Method Statement

9. Any accidental damage to trees to be reported immediately to Advanced Arboriculture with any necessary remedial works to be agreed with the local planning authority.

10. Fencing to be dismantled only on completion of all construction works and to allow for soft landscaping.
11. Signed copy of this drawing and Arboricultural Supervision Inspection Record to be held on project files on completion of all construction works.

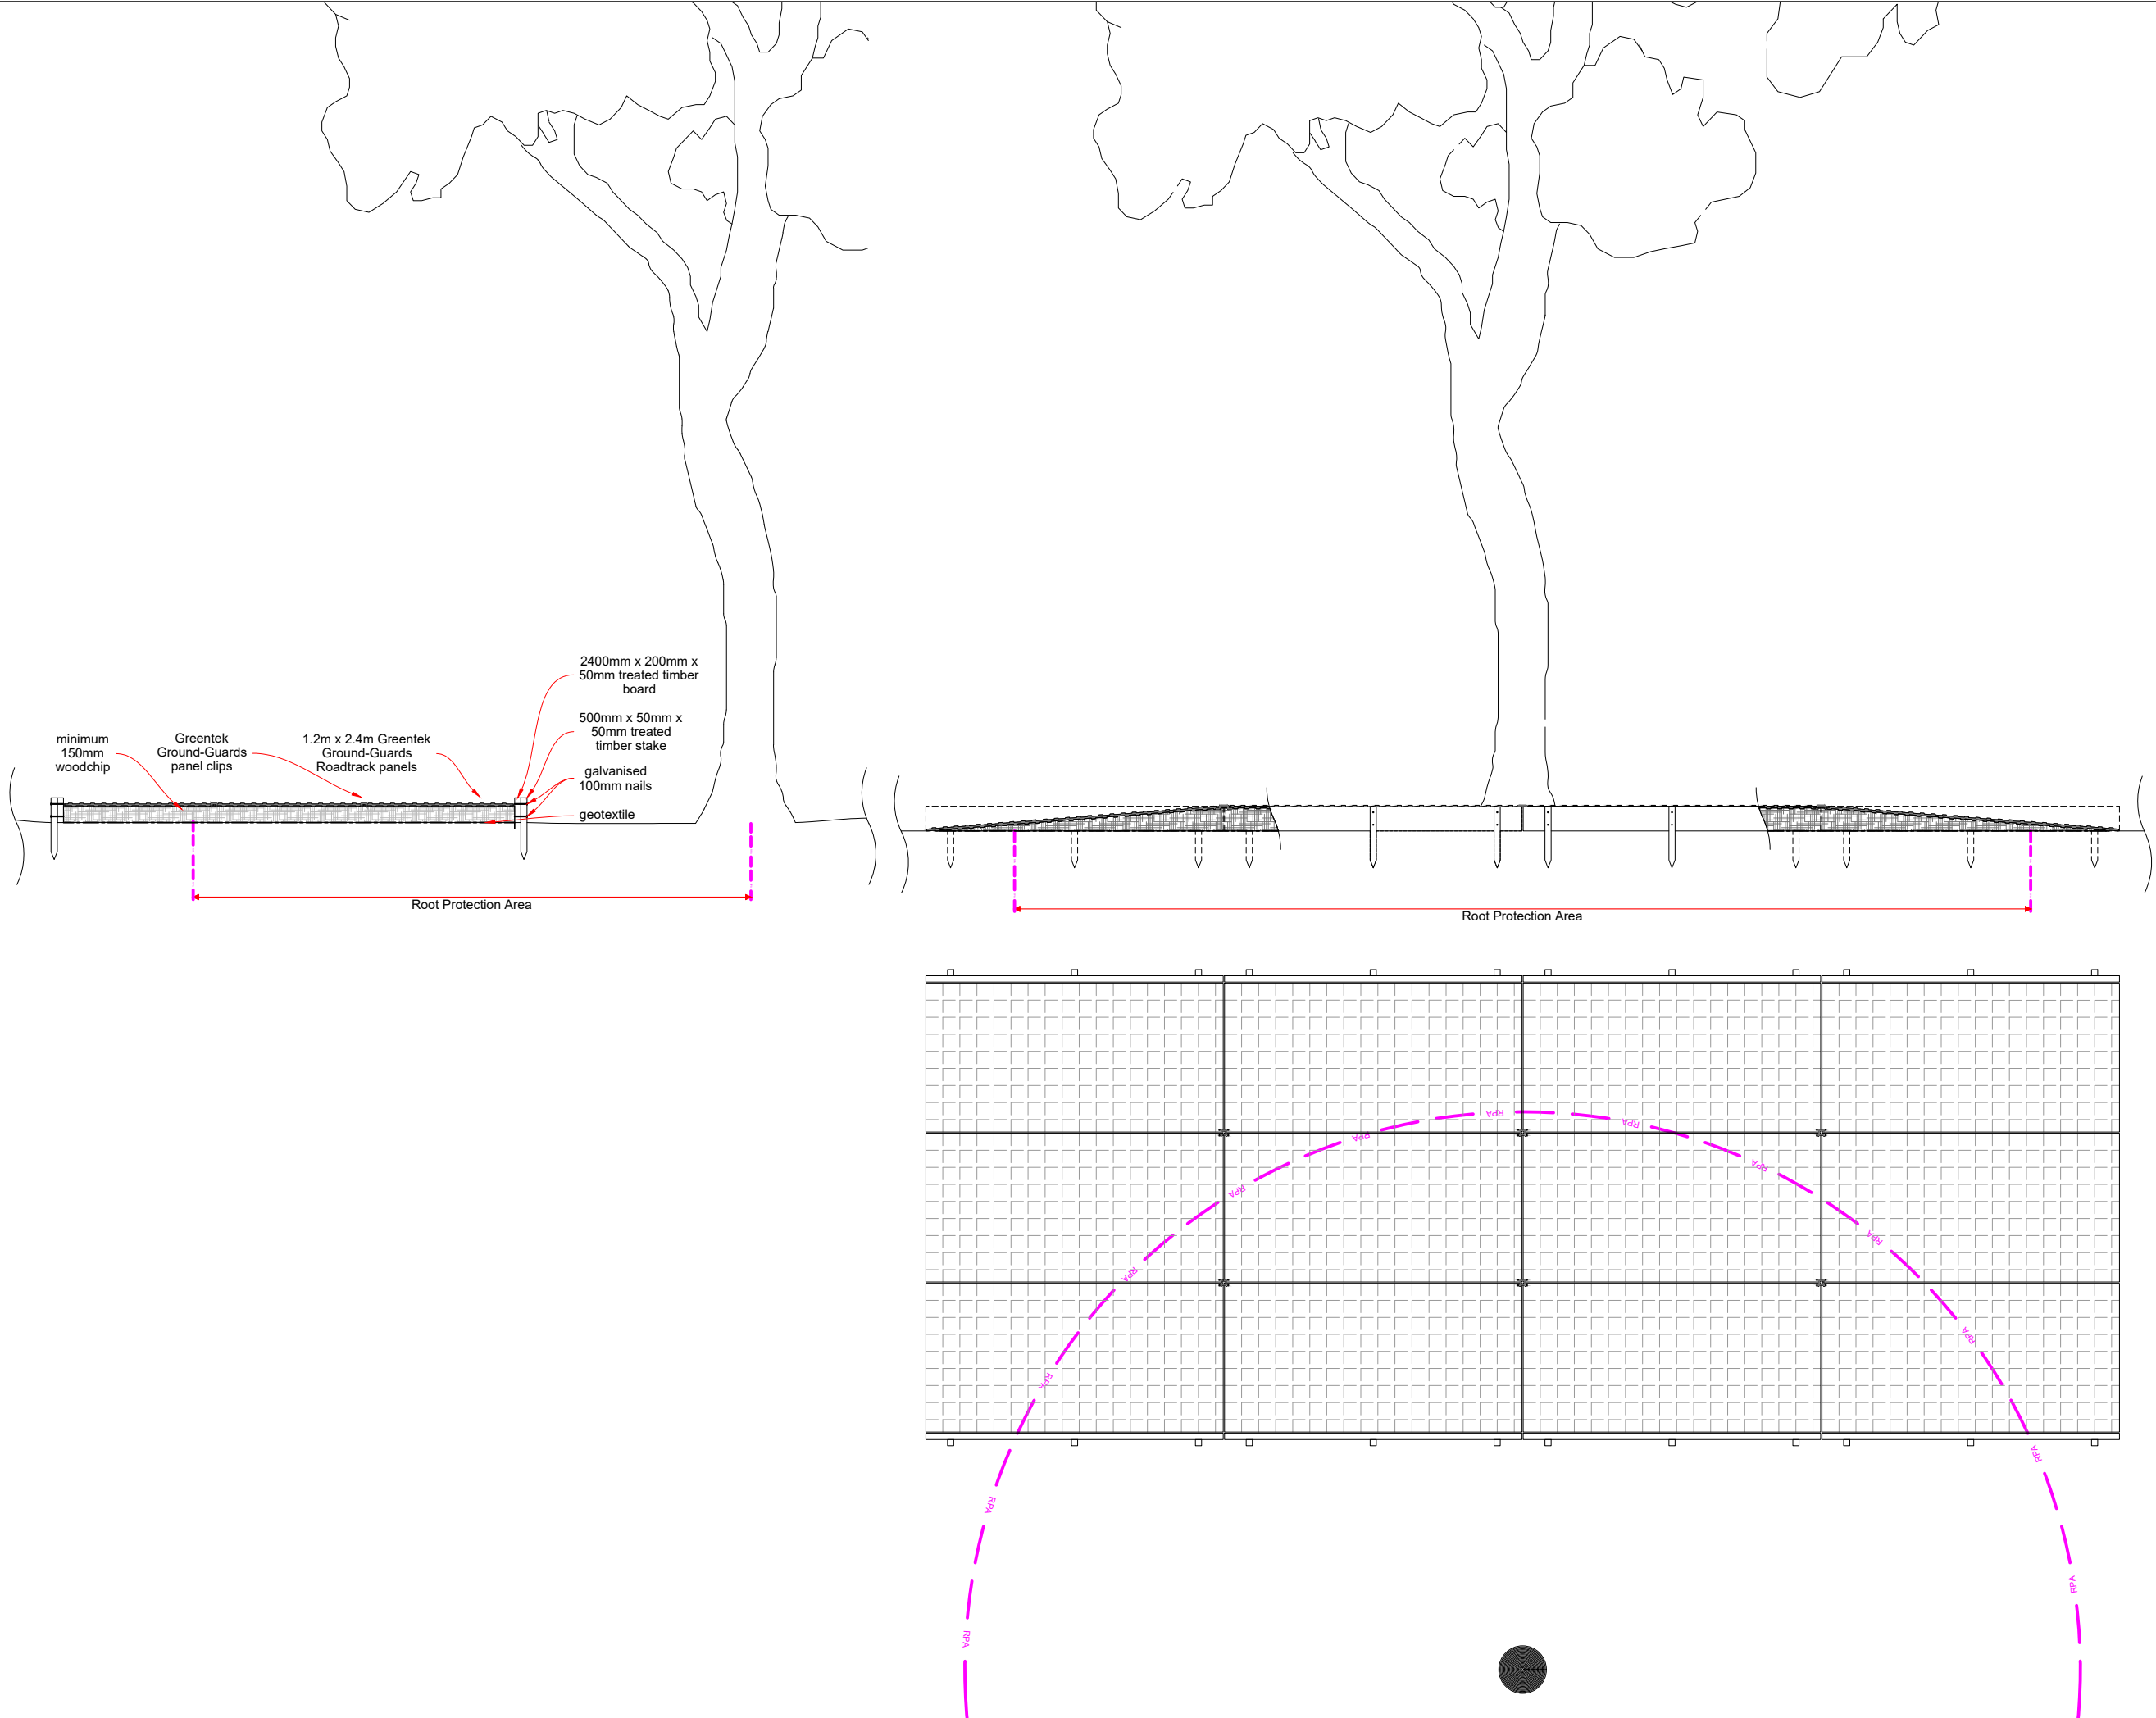
**Drawing Title:**  
**Ground Protection**

- Notes**
- These specifications are for guidance only.
  - This information must accompany all tender documents to enable contractors to include tree protection measures in their costings.
  - Local planning authority consent for these specifications cannot be assumed and must be sought prior to commencement of any construction works.

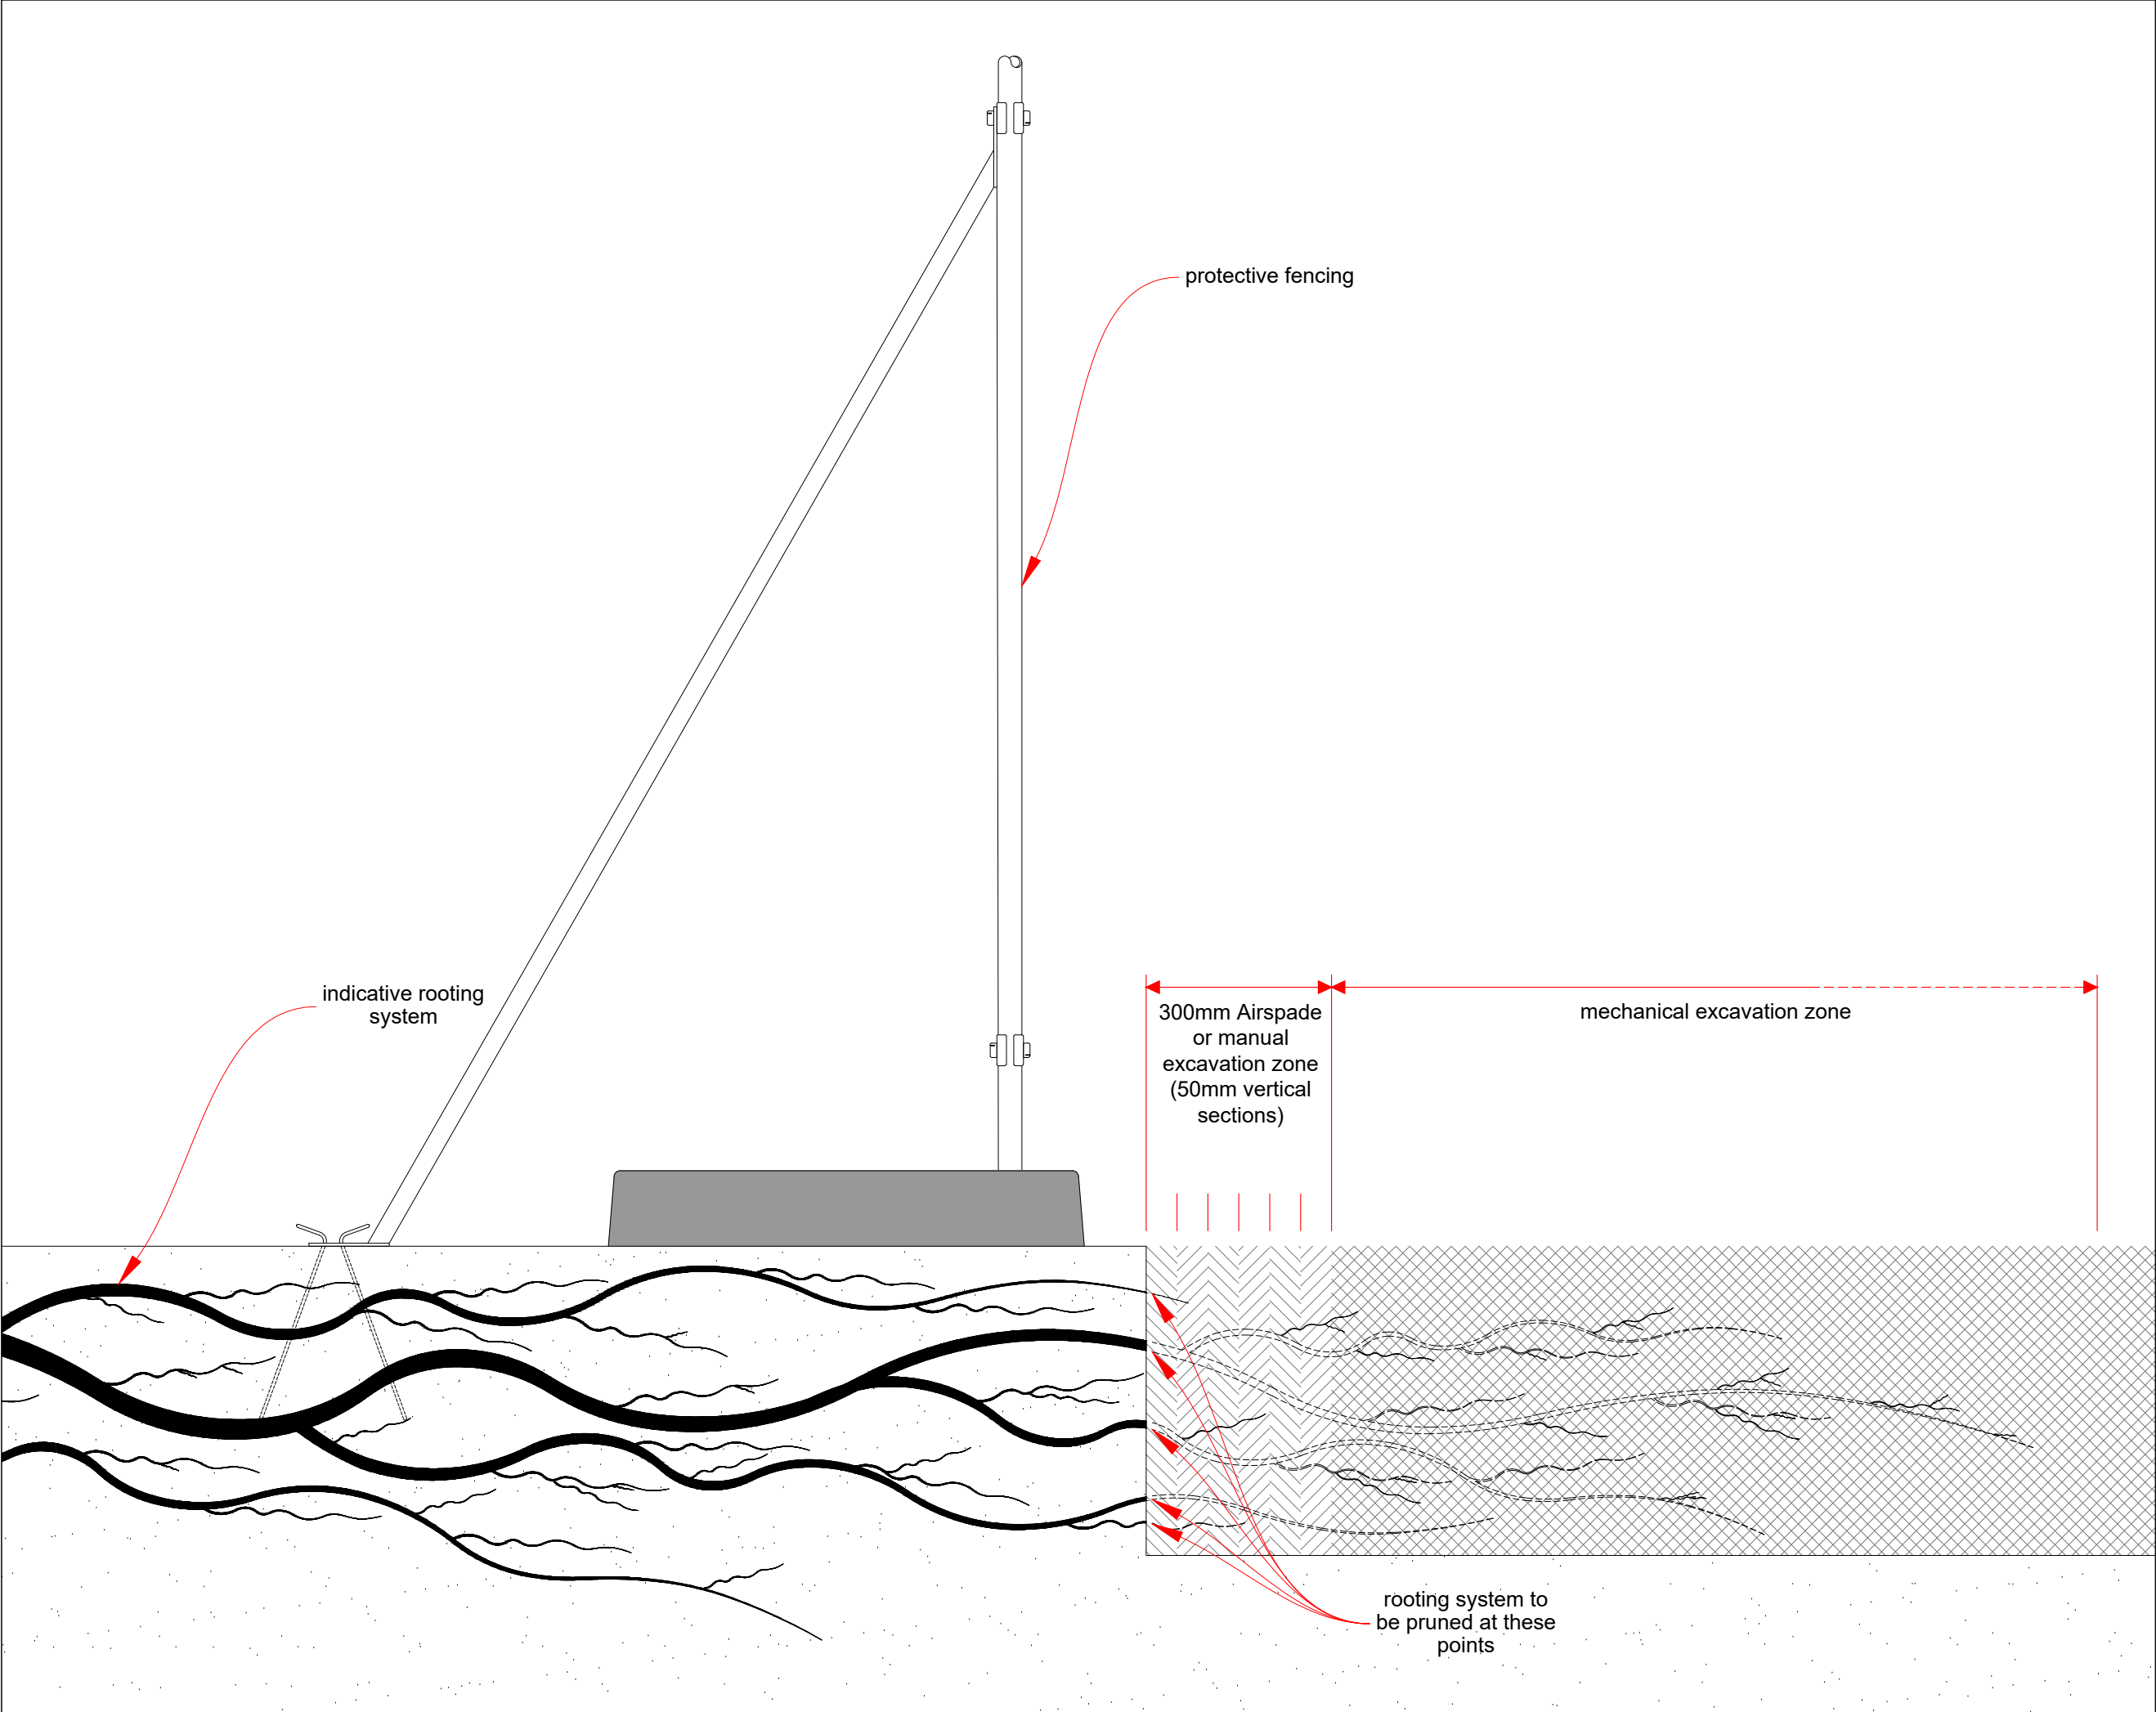
- Arboricultural Method Statement**
1. Full details of excavation to be discussed between Project Manager and Arboricultural Supervisor. Review alternative solutions to excavation and adopt where practicable (impact tunneling, re-routing, etc.)

5. For excavations in excess of 300mm width, the final 300mm strip of excavation to be completed manually using an Airspade operated by an experienced arborist. Where soil is too wet or clay-rich for effective Airspade use, the bank must be loosened back in 50mm sections using a fork to ease back soil, taking care to minimise root scuffing and fracturing.

Where excavation is required on the outer sections of the root protection area, it will be necessary to undertake controlled excavation and root pruning. It is recommended that this be undertaken by a suitably qualified arboricultural contractor in accordance with the method statement detailed within Arboricultural Guidance Sheet AGS403. We are able to arrange these works on request.

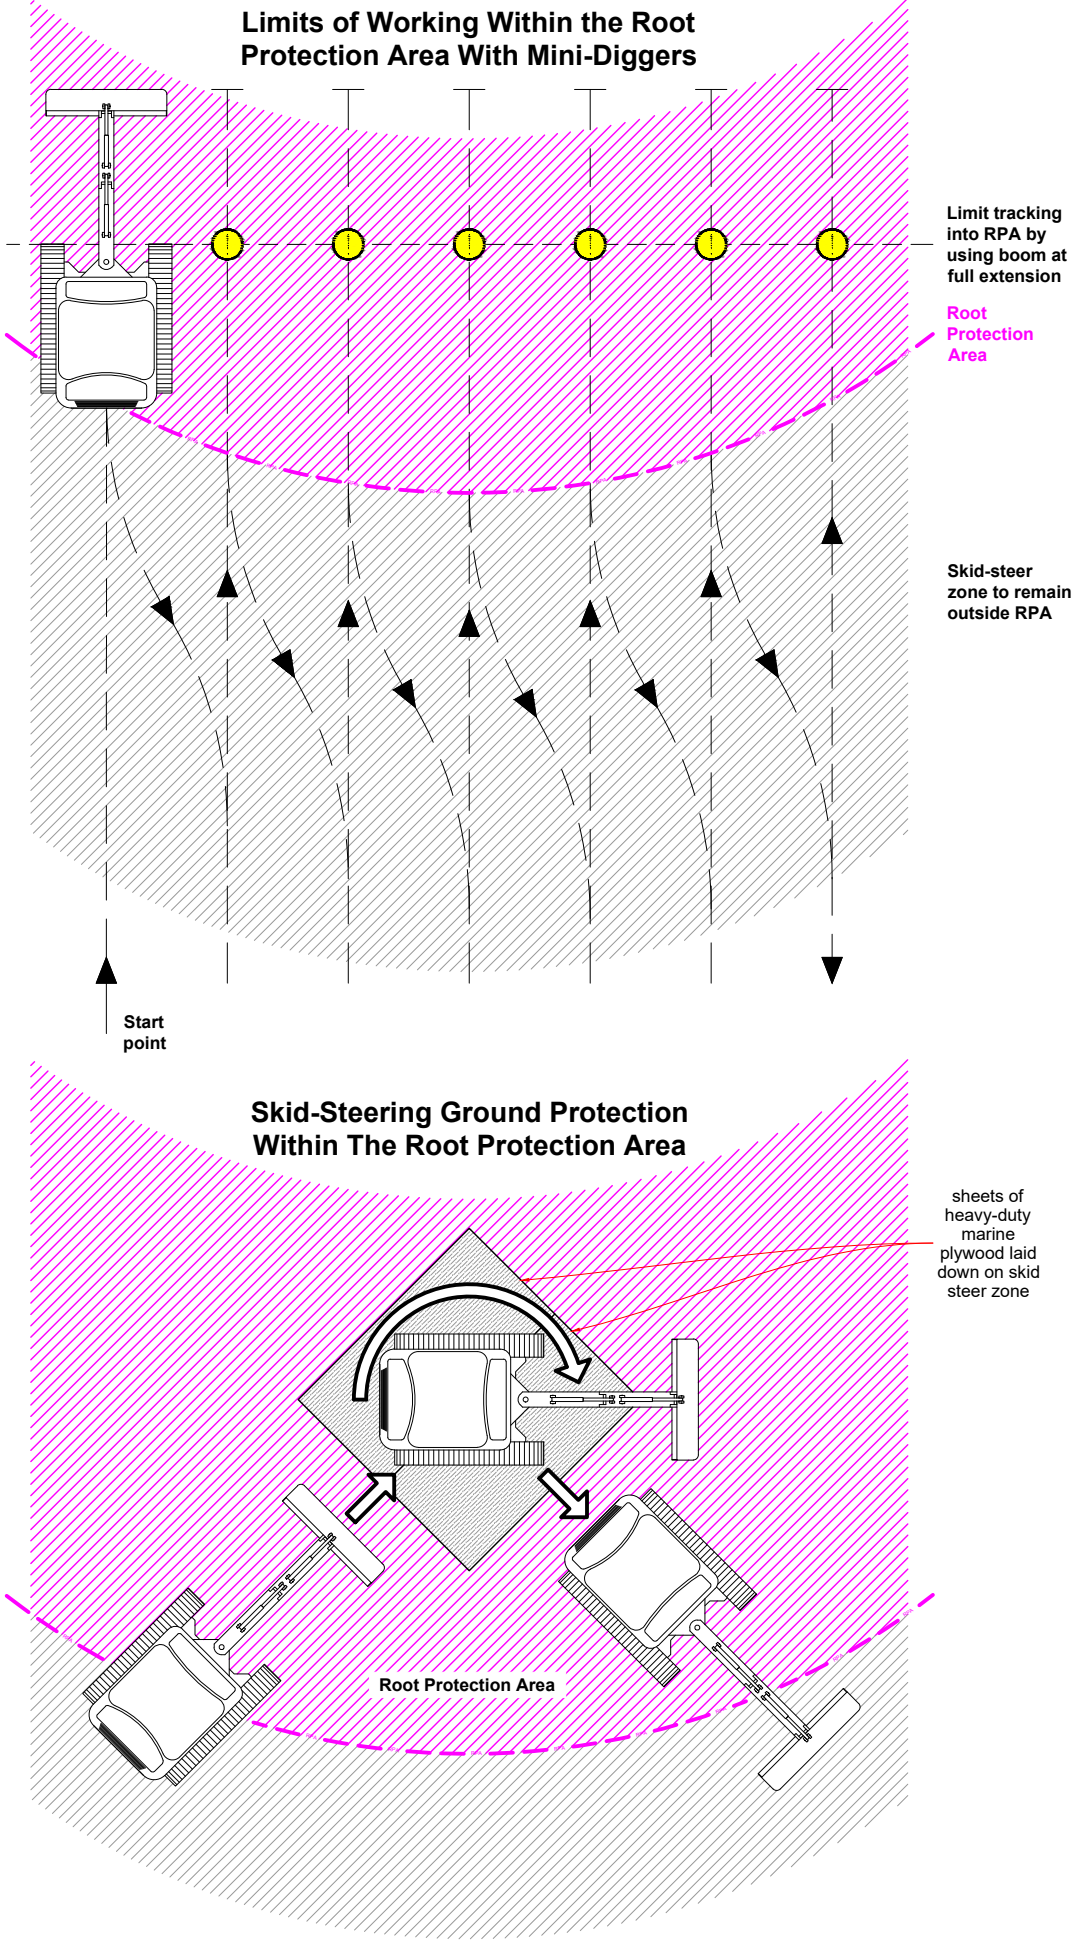
Mechanical Plant Operations Near Trees

| Notes |
|---|
| <ul style="list-style-type: none"><li>• These specifications are for guidance only and must be reviewed by the Project Manager, Demolition Contractor and Arboricultural Supervisor prior to commencement of any works on site.</li><li>• This information must accompany all tender documents to enable contractors to include for specific working requirements in their costings.</li><li>• Local planning authority consent for these specifications cannot be assumed and may need to be sought prior to commencement of any demolition works.</li></ul> |
