PRELIMINARY ECOLOGICAL APPRAISAL AND  
BAT SURVEY REPORT

BARN AT NORTH STREET, MERE, WILTSHIRE

DECEMBER 2025

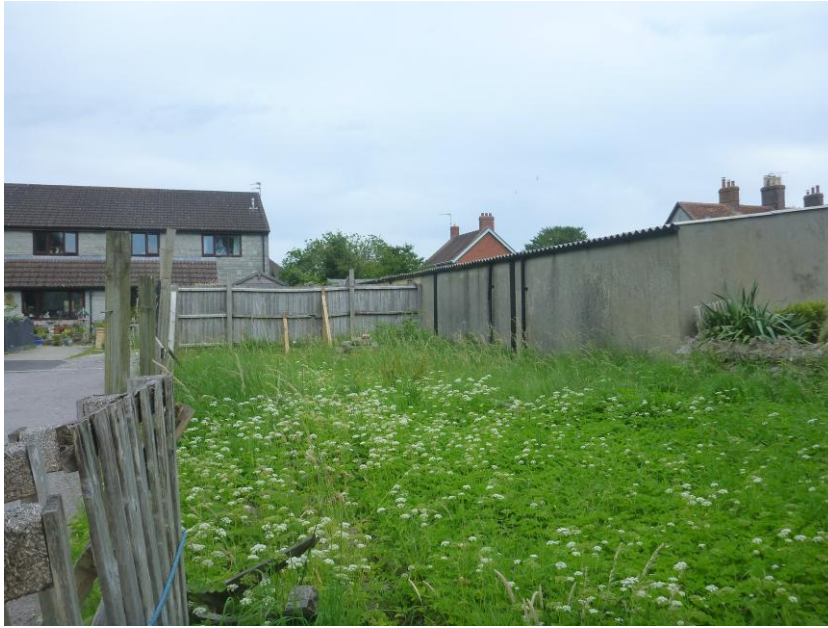
**Fig 2:** The northern part of the site is a vegetated garden

The northern part of the site is a garden which comprises ground elder *Aegopodium podagraria*, false oat grass *Arrhenatherum elatius*, ribwort plantain *Plantago lanceolata* and dock *Rumex obtusifolius* with some scattered bramble *Rubus fruticosus* agg.

This photo taken facing north on 20<sup>th</sup> June 2025.

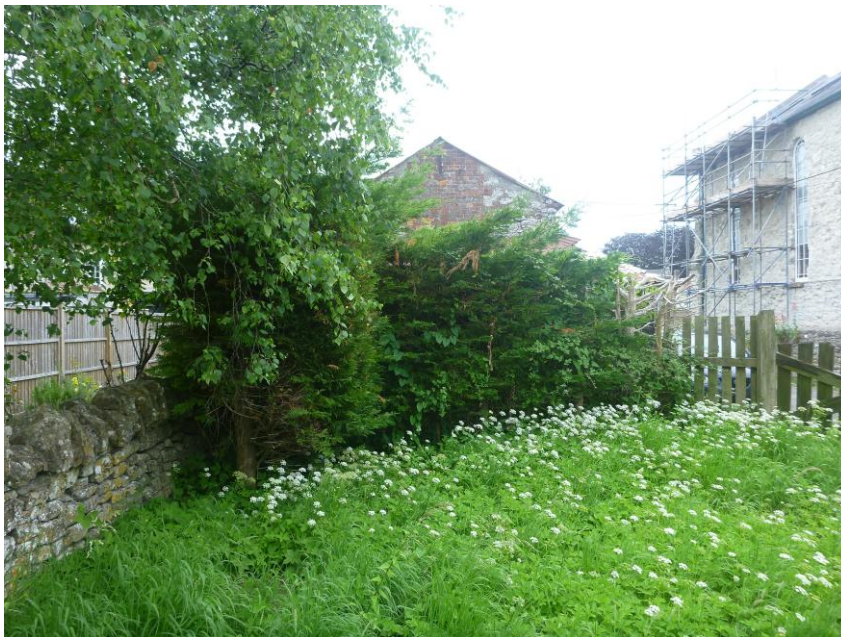
**Fig 3:** A small area of yew planting.

This part of the site also includes a small area of yew *Taxus baccata* planting.

This photo taken facing south on 20<sup>th</sup> June 2025.

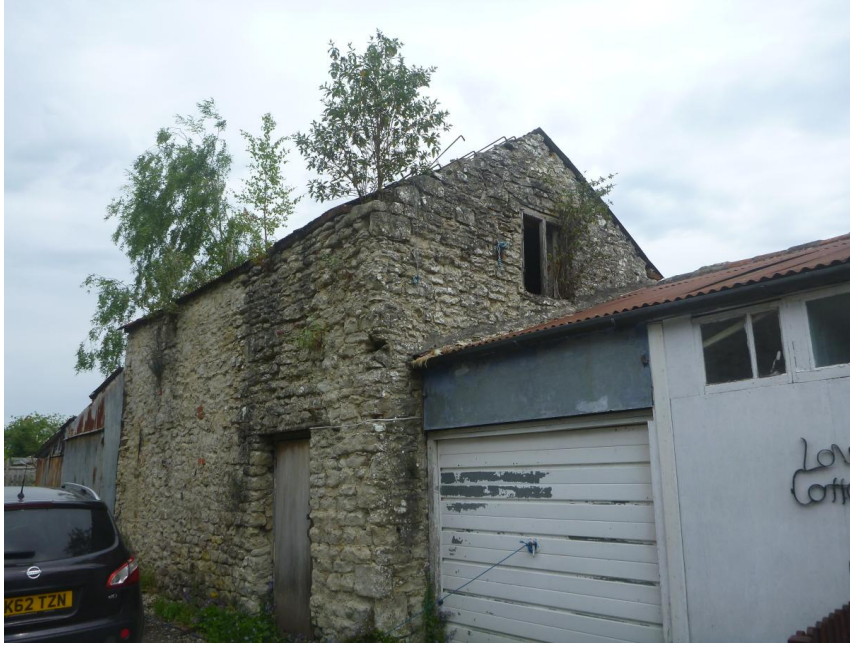
The barn is 1.5 storeys and has stone walls. The roof is unlined corrugated metal, part of which was missing at the time of this survey, allowing daylight to penetrate many areas of the barn. There is an intermediate floor which protects parts of the ground floor from light spill and the worst of the weather.

**Fig 4:** The stone barn is 1.5 storeys.

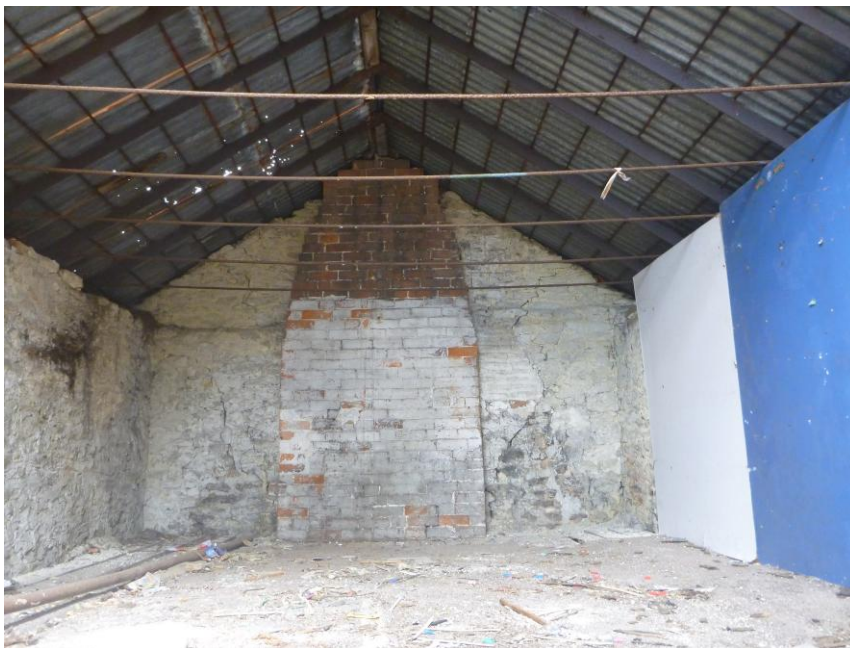
**Fig 5:** The roof is unlined corrugated metal.

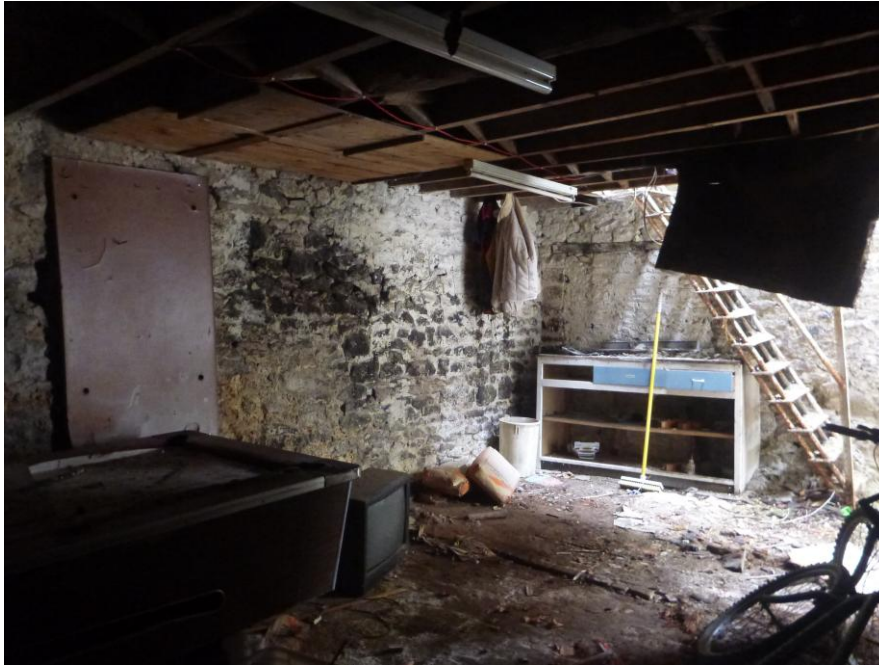
**Fig 6:** Part of the roof has blown off, allowing daylight to penetrate the upper floor of the barn. The intermediate floor prevents light spill into the ground floor.

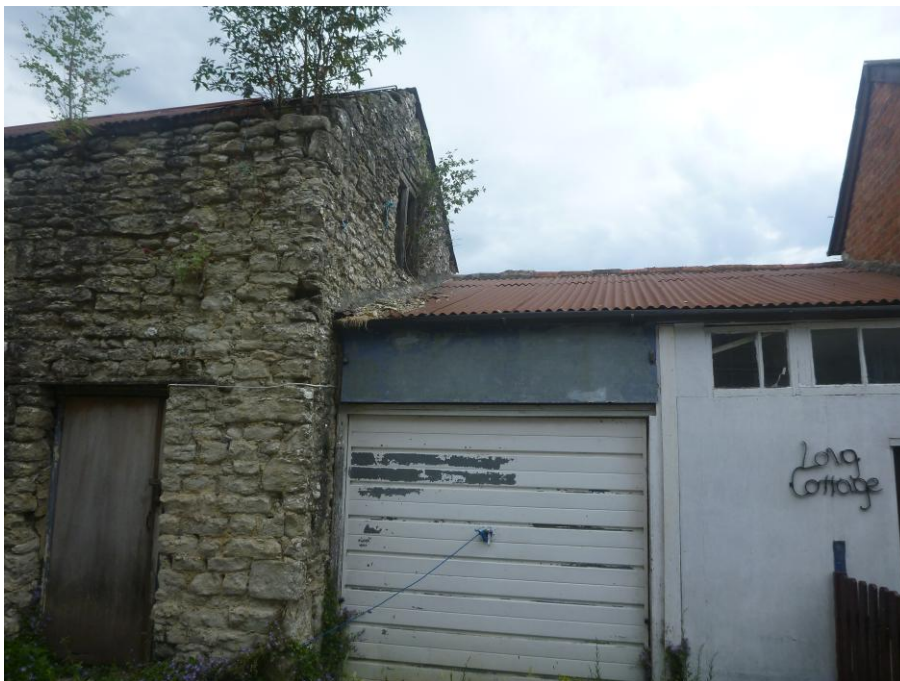
**Fig 7:** There is a single storey garage which links the barn to Long Cottage.

There was no internal access to the garage building but it was found to be well sealed externally.

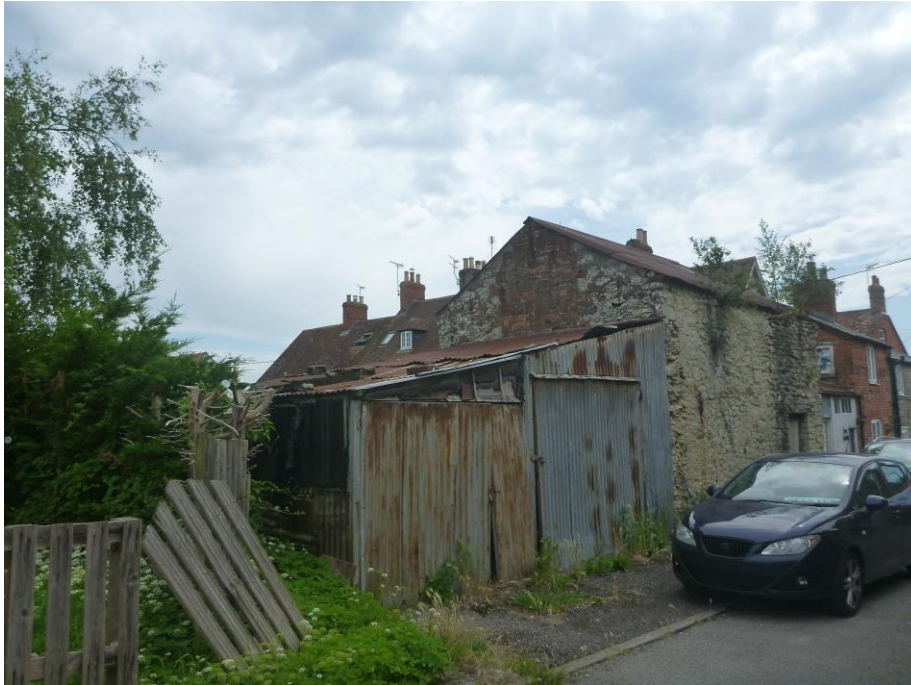
At the northern end of the stone barn is a single storey corrugated metal lean-to which has a mono-pitch roof. In this part of the building the corrugated metal roof is lined with bitumen felt.

**Fig 8:** There is a single storey corrugated metal lean-to at the northern end of the barn.

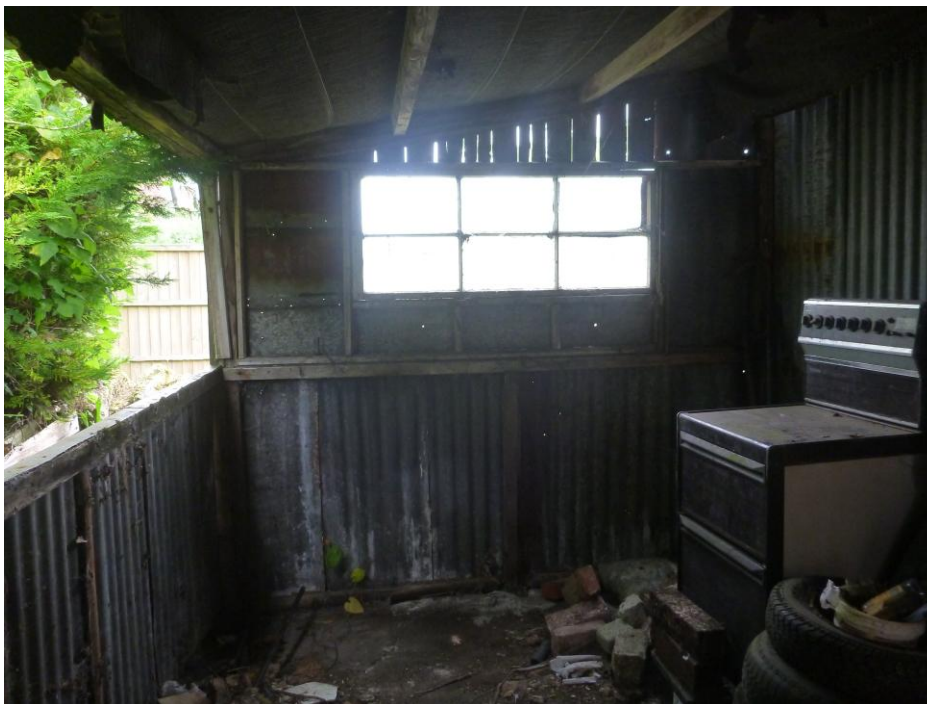
This part of the building is open along its north face where a window is missing.

**Fig 9:** A missing window on the north face of the single storey lean-to.

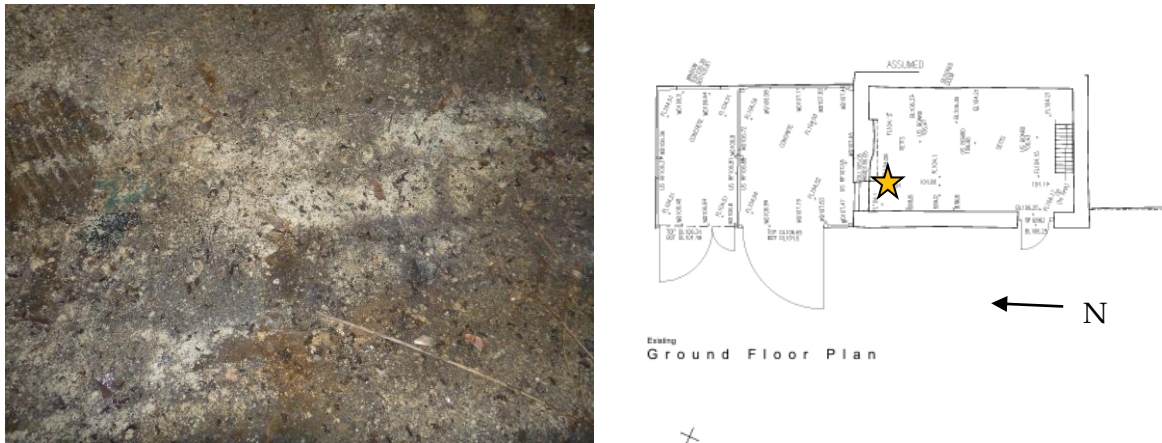
Internally an accumulation of c.50 bat droppings was found on the ground floor of the barn. A sample of the droppings was collected and sent for DNA analysis, which confirmed the presence of brown long-eared *Plecotus auritus* bats.

**Fig 10:** Approximately 50 brown long-eared bat droppings were found on the ground floor of the barn on 20<sup>th</sup> June 2025.

A building inspection survey and emergence surveys of the barn at North Street have confirmed a night roost of low numbers of brown long-eared bats in the ground floor of the barn.

The roost will be destroyed when the barn is converted and in order to proceed lawfully, initial conversion work will require a licence from Natural England. An application to Natural England for a licence can be made once full planning permission has been granted and all conditions relating to wildlife discharged. Under the terms of the licence, and to maintain the Favourable Conservation Status of bats at the site, works to strip roof materials, intermediate floor and any other areas of the building where bats could be seeking shelter will need to be carried out by hand under ecological supervision. Materials will be carefully removed by hand and will be lifted, not rolled, to prevent crushing any bats which may be present beneath. All materials will then be checked on all surfaces for bats before stacking or throwing.

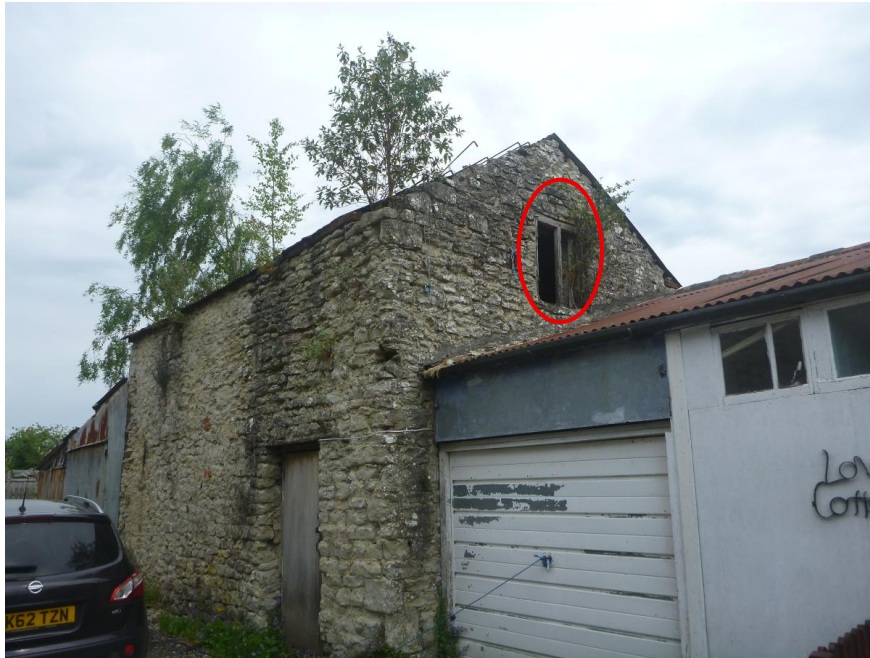
During this survey one brown long-eared bat was recorded entering the barn through a window in the south facing gable end wall at 2135. The bat was then seen flying within the barn for several minutes.

**Fig 11:** One brown long-eared bat was recorded entering the barn through this window on 20<sup>th</sup> August 2025.
