# ABSOLUTE ARCHAEOLOGY 2025

An Interim Report for Archaeological test pitting carried out  
within the confines of Lacock Abbey, Wiltshire

Document Title: An interim report for Archaeological test pitting carried out within the confines of Lacock Abbey, Wiltshire

Document Type: Excavation/Evaluation Report

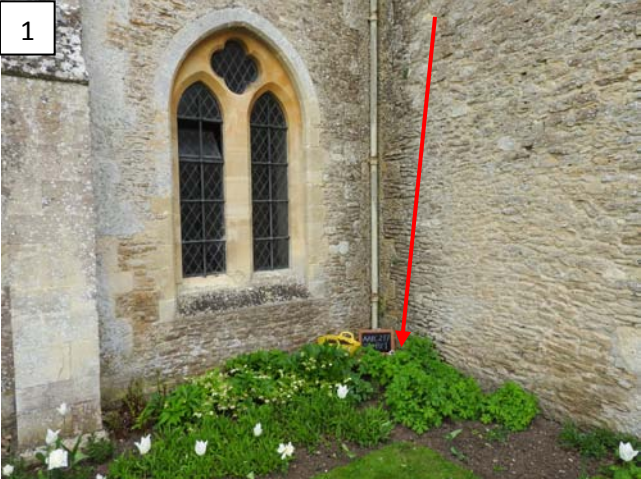
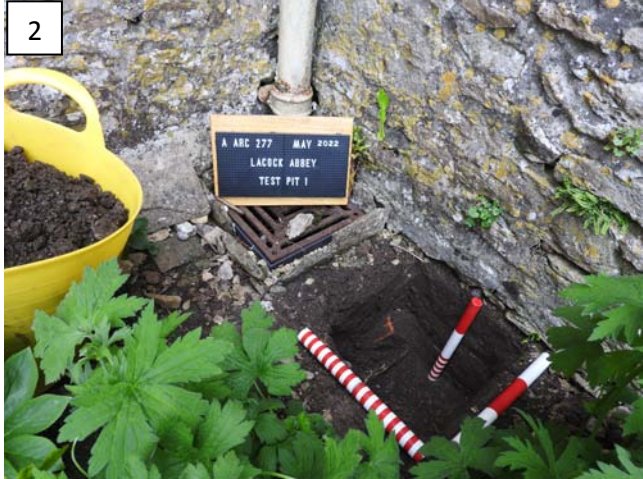
4.1. TEST PIT 1. Grid Ref No. ST 91970 68422.

Located in the corner of the 'Warming Room'/ East annexe outer wall and adjacent to a roof water drain and metal pipe. The 0.3m cubed test pit was excavated down through 0.3m of humic calcareous border topsoil (100) residing above a subsoil (101). Only residual finds of post- medieval broken slate and tile were found. The positioning of the test pit (20cm east of drain surround) was positive ready for accommodating the earthing pit mechanism.

Test pit 1 in the outer corner of the 'Warming Room' and Eastern entrance

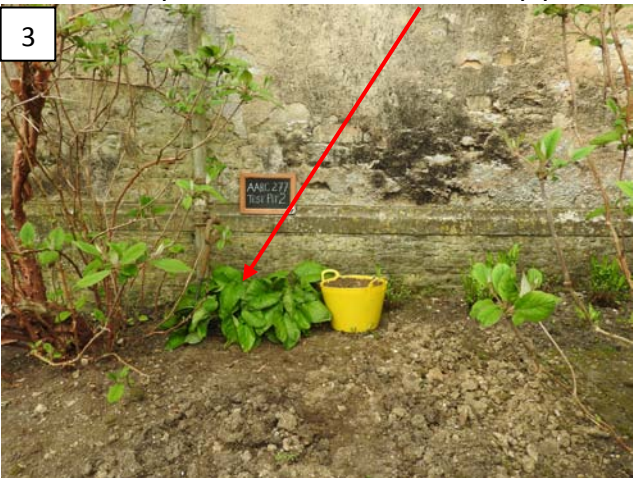
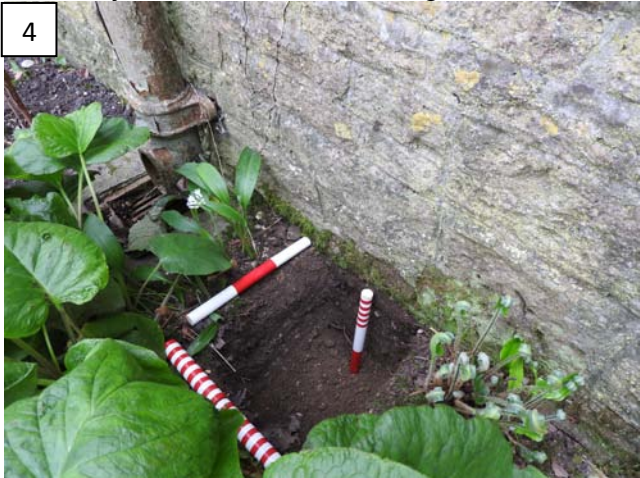
4.2. TEST PIT 2. Grid Ref No ST 91972 68434.

Located in the along the North facing wall of the Eastern annexe and next to a drain and a metal downpipe. The 0.3m cubed test pit was excavated down through 0.3m of humic border topsoil (200) residing above a clay subsoil (201). Only residual finds of post- medieval broken slate and tile were found. The positioning of the test pit (20cm to the east of the drain surround) was positive ready for accommodating the earthing pit mechanism.

Test pit 2 next to the metal downpipe and drain and adjacent to the North facing wall

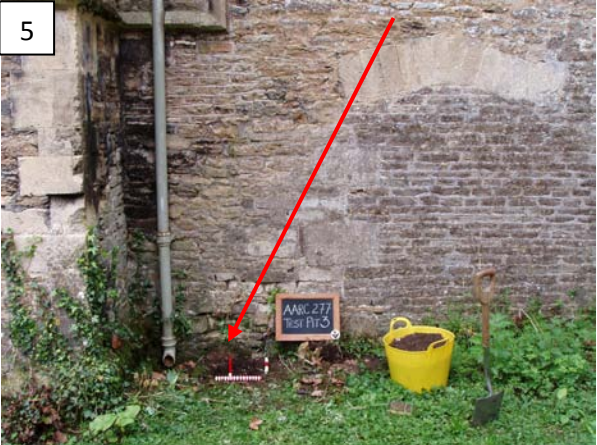
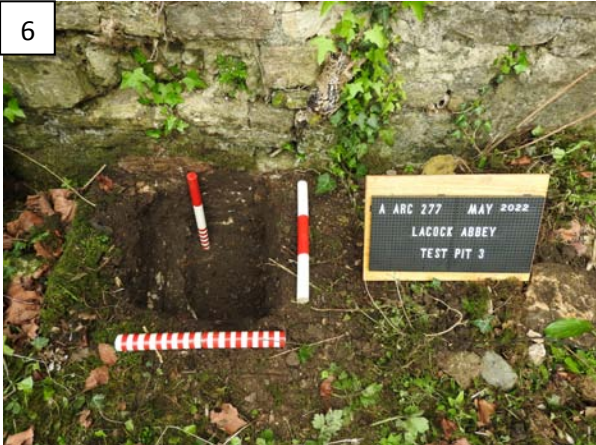
4.3. TEST PIT 3. Grid Ref No ST 91940 68474. 41.28m aOD

Located in the along the North facing wall and next to a drain and a metal downpipe. The 0.3m cubed test pit was excavated down through 0.3m of humic border topsoil (300) residing above a subsoil (301). Only residual finds of post- medieval broken glass, slate and tile were found. The positioning of the test pit was positive (25cm to the west of the drain surround) ready for accommodating the earthing pit mechanism.

Test pit 3 next to the metal downpipe and drain and adjacent to the North facing wall

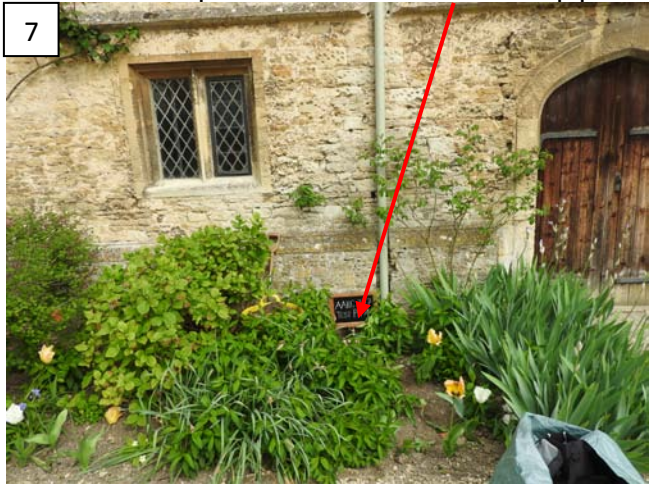
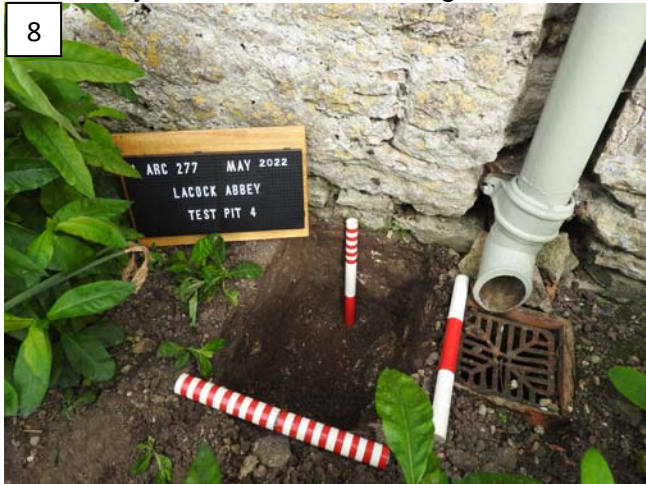
4.4. TEST PIT 4. Grid Ref No ST 91961 68448. 40.68m aOD

Located in the along the West facing wall in the Courtyard and next to a drain and a metal downpipe. The 0.3m cubed test pit was excavated down through a humic topsoil (400). Only residual finds of post-medieval tile were found. The positioning of the test pit was positive (20cm to the north of the drain surround) ready for accommodating the earthing pit mechanism.

Test pit 4 next to the metal downpipe and drain and adjacent to the West facing wall

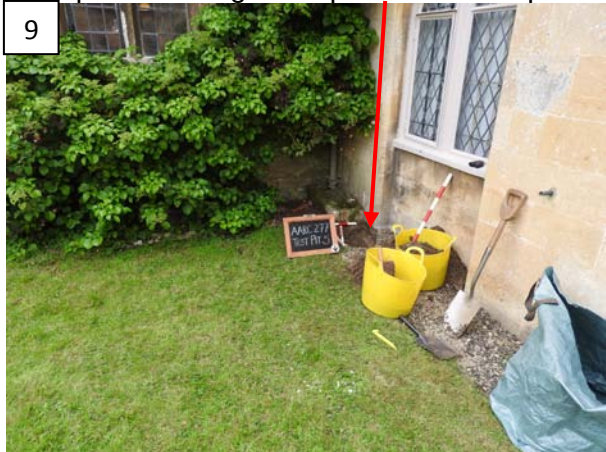
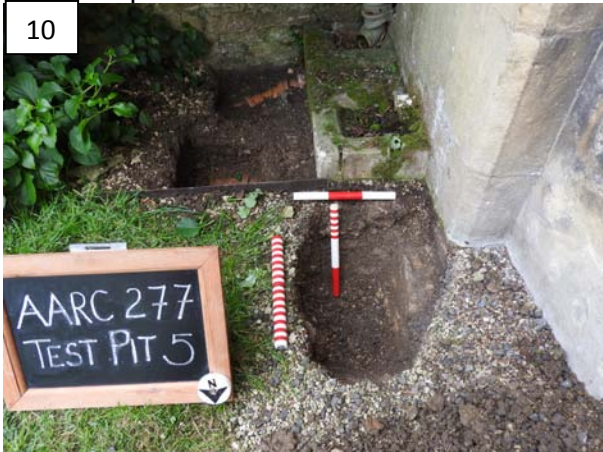
4.5. TEST PIT 5. Grid Ref No ST 91933 68435. 40.78m aOD

Located in the along the West facing wall in the Courtyard and next to a double drain and a metal downpipe. Two test holes were excavated only to find modern plastic drain pipes in both test pits. The plastic pipes continued through the border. A new positioning (20 cm from drain surround and 20cm East of the wall) was found for accommodating the earthing pit mechanism, North and adjacent to the drain and border surround. No features or finds were found within the buried topsoil (503).

Test pit 5 showing the repositioned test pit. The two other test pits were deemed unsuitable

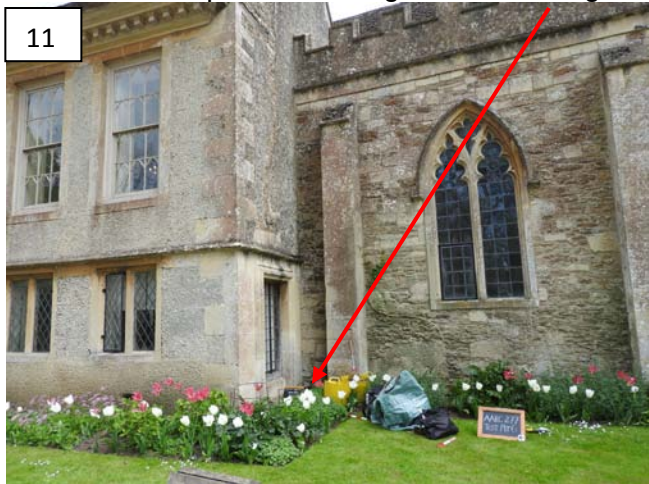
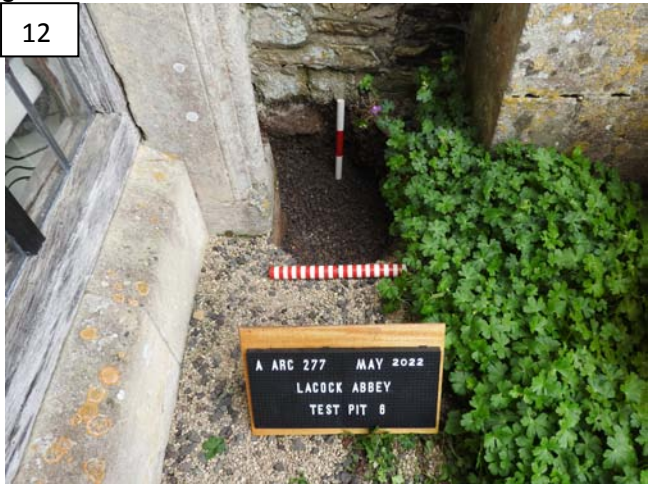
**4.6. TEST PIT 6.** Grid Ref No ST 91925 68426. 41.90m aOD

Located along the West facing wall and next to the outer kitchen lesene/butress. The 0.3m cubed test pit was excavated down through a deep deposit of drainage shingle (601). This was not bottomed at 0.5m. The positioning of the test pit would have to be considered for accommodating the earthing pit mechanism.

Test pit 6 cut through 0.3m of shingle/aggregate next to the outer kitchen

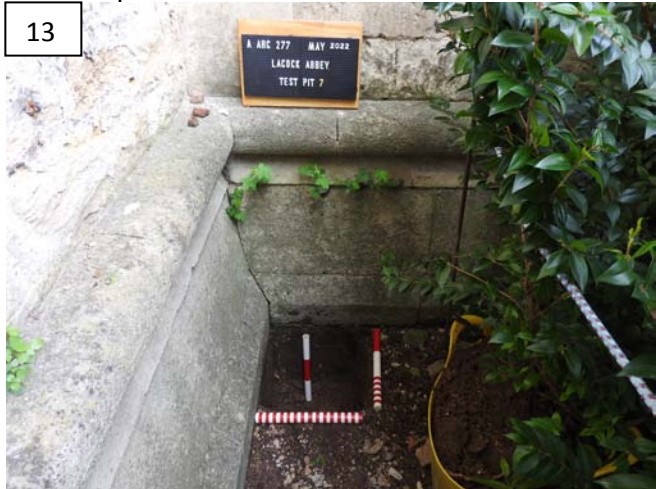
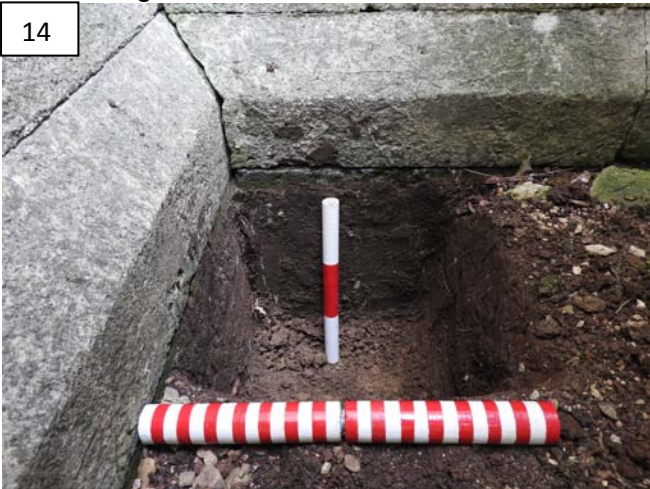
**4.7. TEST PIT 7.** Grid Ref No ST 91946 68385.

Located in the corner of the South outer 'Cloister' wall. The 0.3m cubed test pit was excavated down through 0.28m of humic border topsoil (700) residing above a natural alluvial clay (701). Only residual finds of post- medieval broken CBM were found. The positioning of the test pit was positive ready for accommodating the earthing pit mechanism.

Test pit 7 in the corner of the outer 'Cloister' wall and to the right of the main 'Cloister' entrance

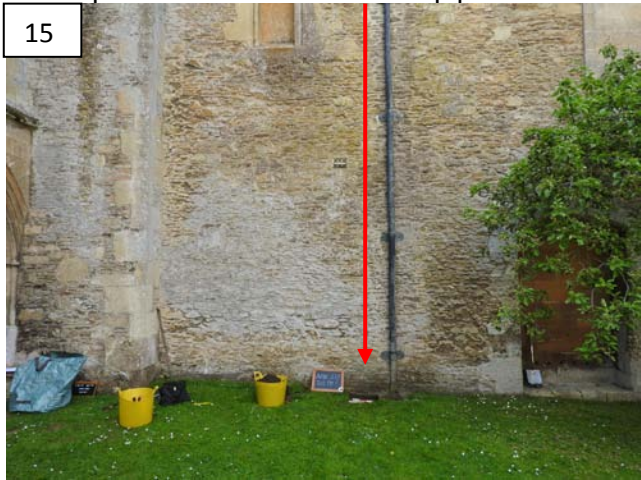
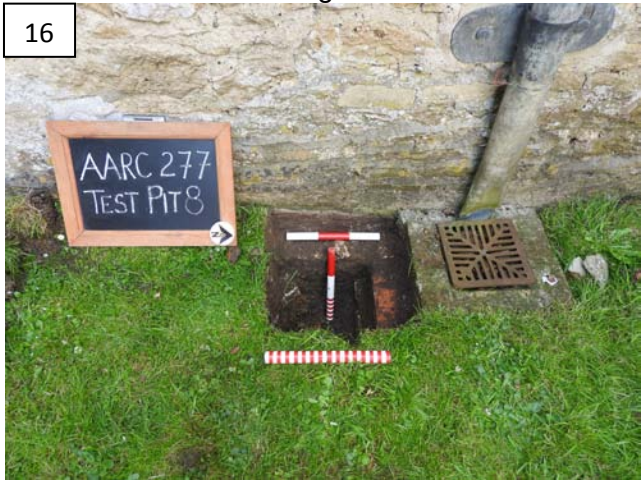
**4.8. TEST PIT 8.** Grid Ref No ST 91934 68396.

Located in the along the West facing wall in the Courtyard and next to a drain and a lead downpipe. The 0.3m cubed test pit was excavated down through 0.25m of humic border topsoil (800) residing above a natural clay (801). Only residual finds of post- medieval slate and tile were found. The positioning of the test pit (20 cm to the south of the drain surround and 20cm to the east of the Cloister wall) was positive ready for accommodating the earthing pit mechanism.

Test pit 8 next to the lead downpipe and drain. Located next to the East facing wall in the ‘Cloister’

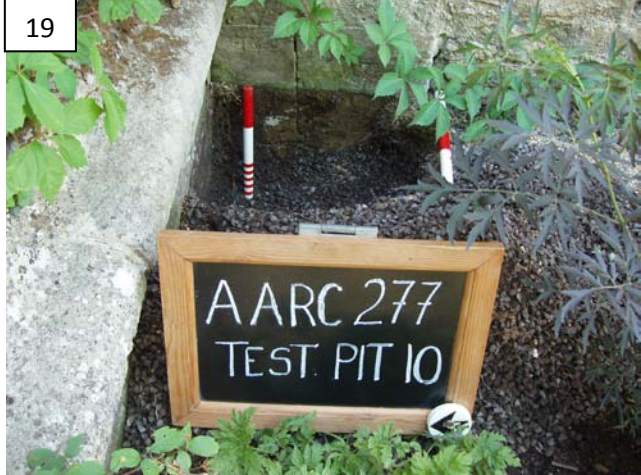
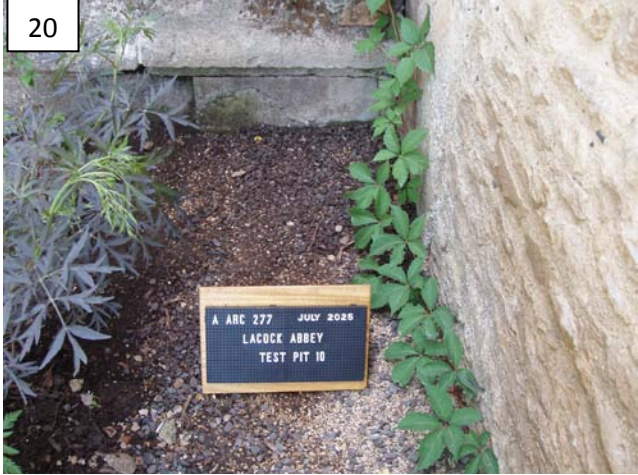
**4.10. TEST PIT 10.** Grid Ref No ST 91923 68436.

Located in the NW corner of the outer courtyard building. A 0.3m cubed test pit was excavated down through 0.3m of drainage gravel/scalping (1000) adjacent to the west facing wall. No finds. Would be difficult to place the earthing mechanism in such loose gravel/scalping.

Test Pit 10 showing the 0.3m cubed hole cut through drainage gravel/scalping, then after backfill

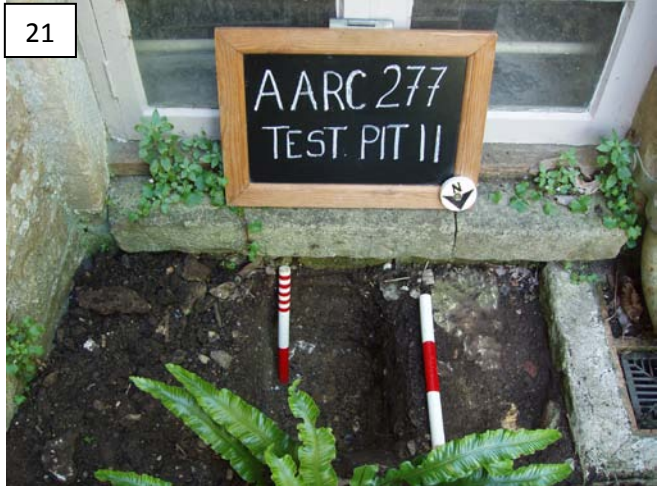
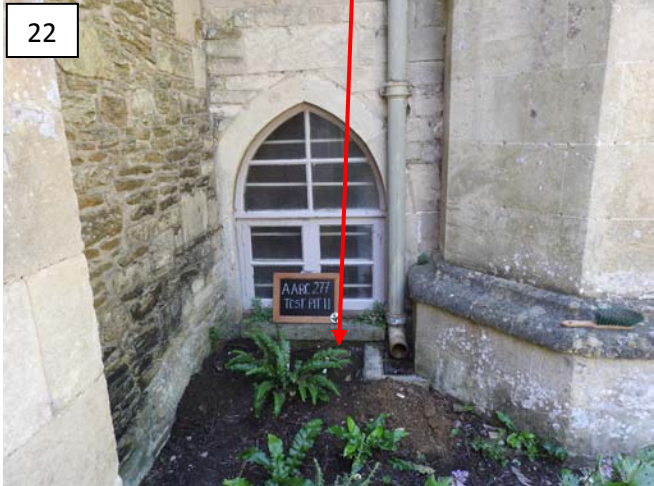
**4.11. TEST PIT 11.** Grid Ref No ST 91923 68414.

Located in the SW corner of the outer 'Kitchen' wall and the NW corner of the 'Hallover' wall and central to the lancet window. A 0.3m cubed test pit was excavated down through 0.2m of topsoil (1100) and through 0.1m of natural clay. No finds. The test pit needs to be placed 0.3 metres to the left of the main drain and central to the lancet window to accommodate the earthing mechanism.

Test Pit 11 showing the 0.3m cubed hole cut through topsoil (1100) and natural clay (1101)

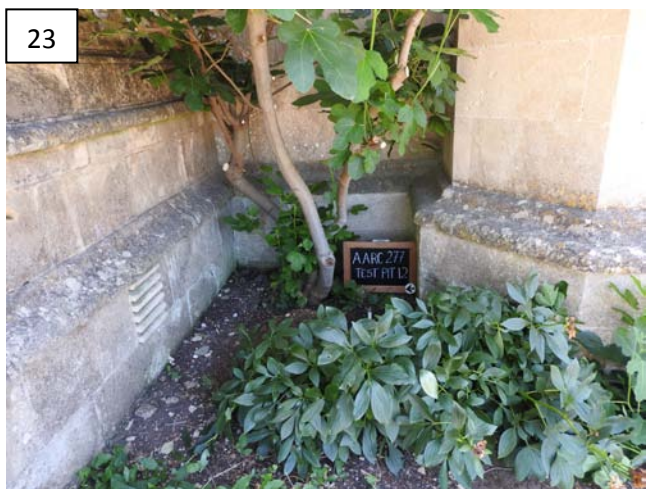
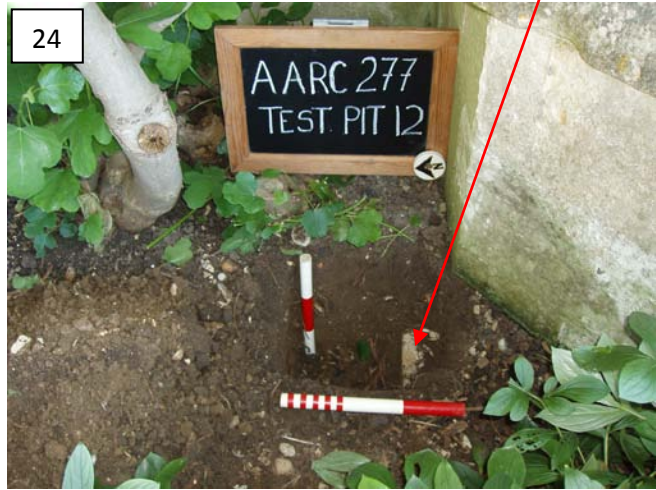
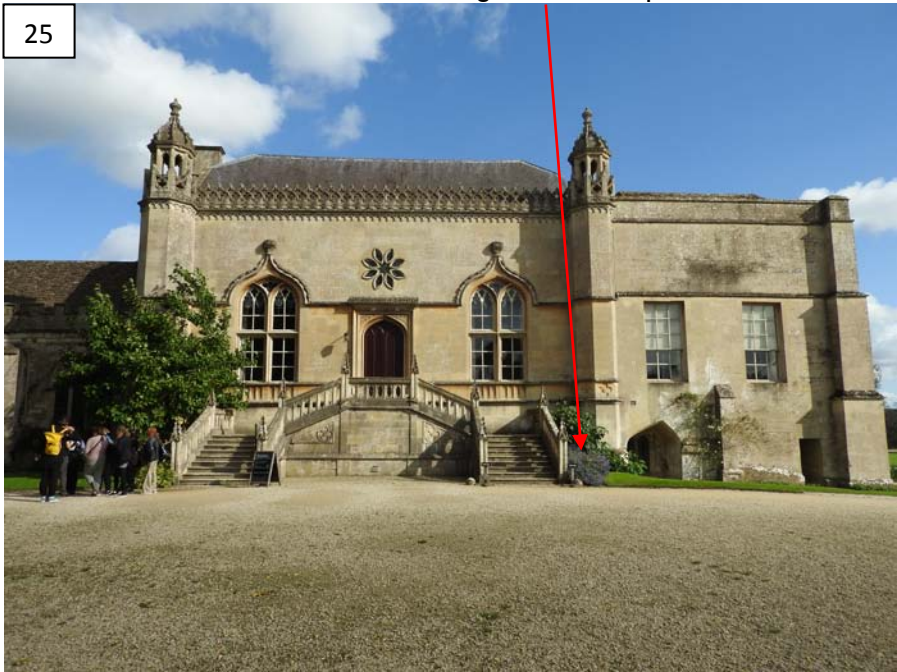
4.12. TEST PIT 12. Grid Ref No ST 91921 68400.

Located in the SW corner of the Outer Parlour' wall. A mature 'Fig' tree had to be pruned back to gain access to the area required. Due to a mass of roots it was decided to excavate test pit twelve 0.6 metres to the west of the west facing wall. A 0.3m cubed test pit was excavated down through 0.3m of topsoil (1200). The foundation stone [1201] to the angular alcove north facing wall would need to be avoided to accommodate the earthing pit mechanism. The fig tree in question due to its age and positioning could be removed after consultation with the Head Gardener

Test Pit 12 showing the 0.3m cubed hole cut through topsoil (1200) and the foundation stone [1201] and the fig tree within the alcove.

Test Pit 12 located to the right of the steps.

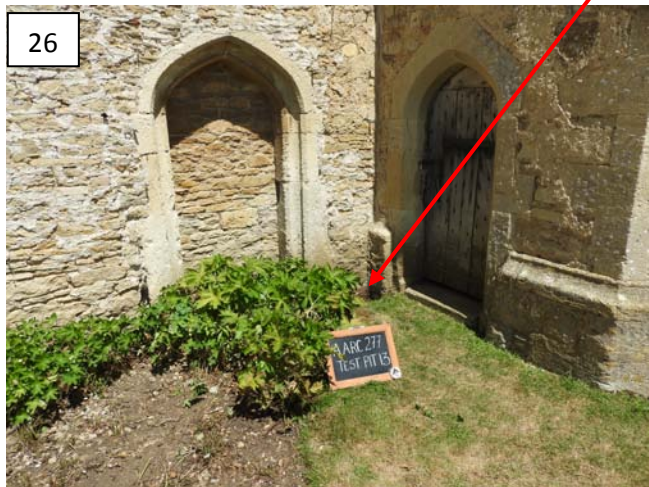
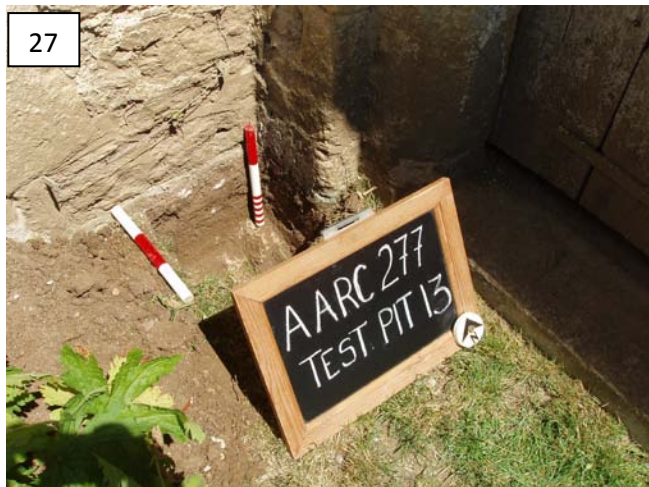
4.13. TEST PIT 13. Grid Ref No ST 91968 68382.

Located in the outer south corner of the ‘Church Sacristy’ filled in doorway and ‘Sharington ‘Tower’ doorway. Excavated through 0.28m-0.3m of topsoil. Foundation stones [1301] were located at 0.2m depth from the surface. The earthing pit mechanism will have to be moved slightly to avoid the foundations.

Test Pit 13 showing Test Pit 13 located in the corner of the filled in doorway and the corner of the ‘Sharington Tower’ doorway

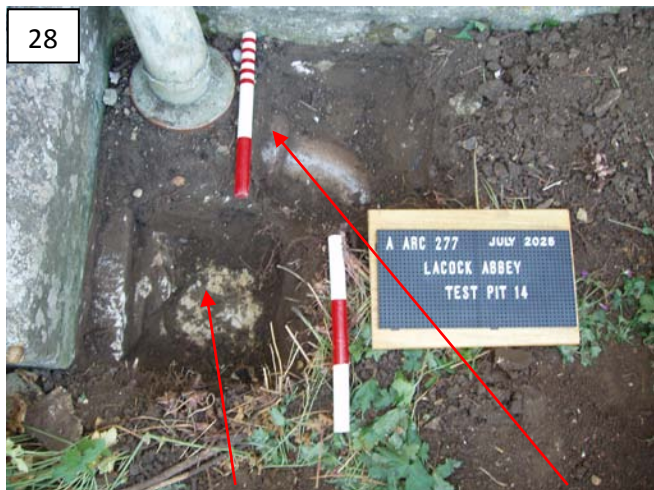
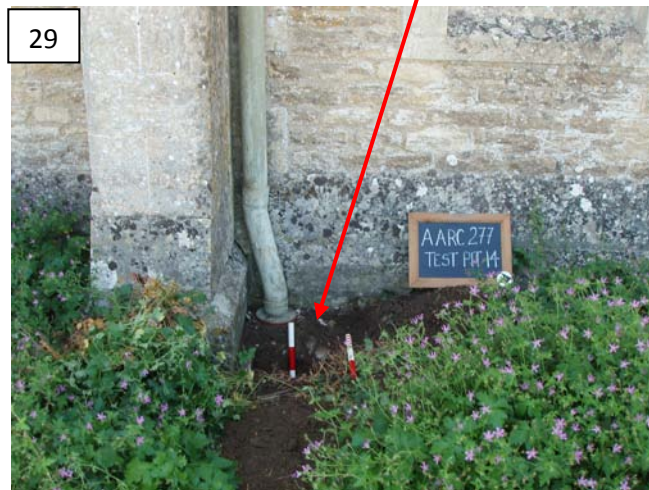
4.14. TEST PIT 14. Grid Ref No ST 91972 68387.

Located on the outer east facing wall of the ‘Chapel Sacristy’ and next and right to one of the external buttresses. Excavated through 0.25m of topsoil. Foundation stones to the buttress [1402] were located at 0.2m depth from the surface. A limestone slab [1403] was found at 0.25m from the surface. It is suggested that the earthing pit mechanism will have to be moved slightly to the north to avoid the buttress foundations [1402] and slightly raised above the limestone slab [1403]

Test Pit 14 showing the downpipe and glazed collared pipe [1401]. Measures 2x0.3m

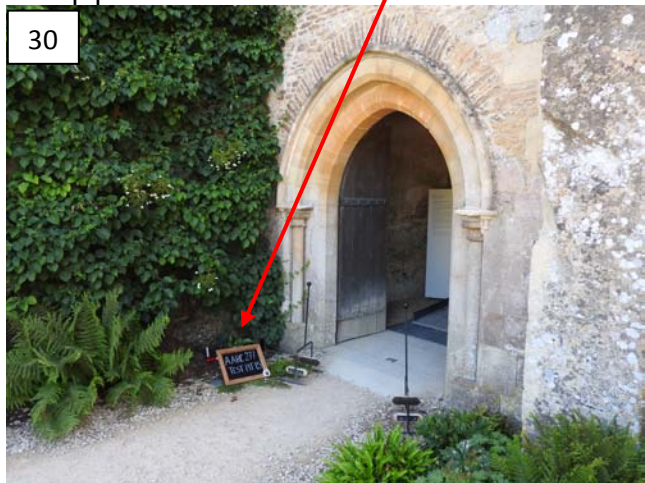
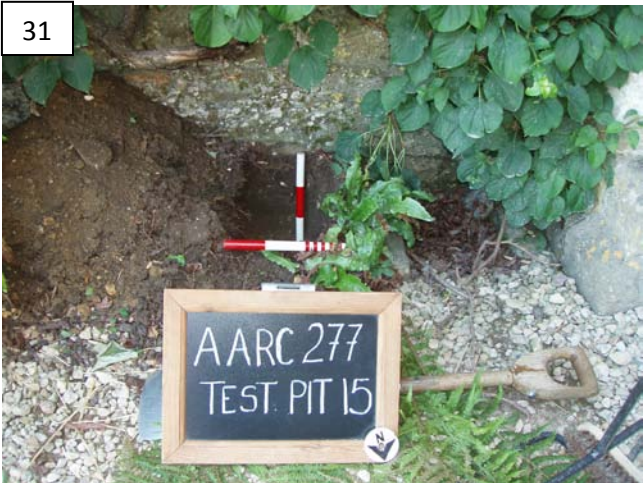
4.15. TEST PIT 15. Grid Ref No ST 91968 68403.

Test Pit 15 located to the left and corner of the 'Infirmary' passage entrance and adjacent and east of the drain and downpipe [1501]. The 0.3m cubed test pit was excavated through 0.3 metres of topsoil (1500). No archaeological features or finds located.

Test Pit 15 located to the left of the 'Infirmary' arched passage entrance and east of the drain and downpipe

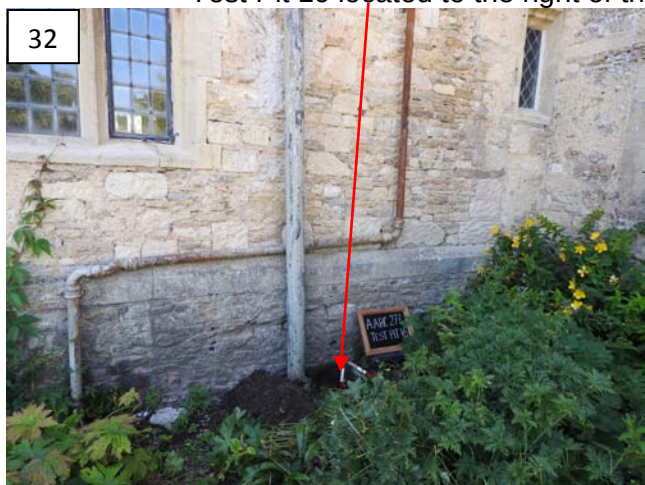
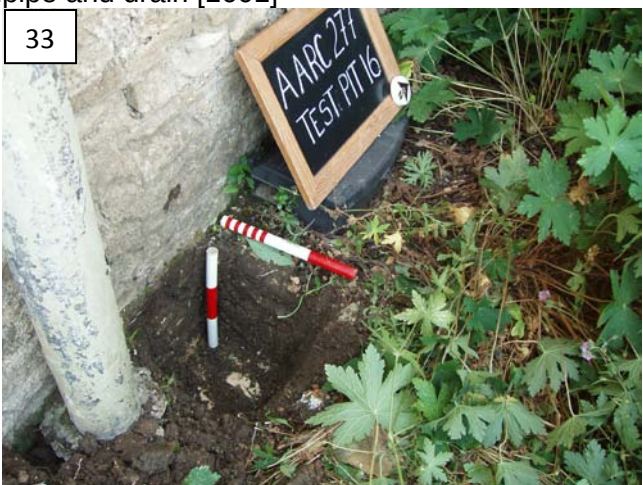
4.16. TEST PIT 16. Grid Ref No ST 91969 68456.

Test Pit 16 located to the outer east facing wall of the 'Courtyard' and right of the drain and downpipe [1601]. No archaeological features in the 0.3 metres of topsoil (1600). A limestone slab [1602] was located at 0.3m from the surface. There should be room to accommodate the earthing pit mechanism.

Test Pit 16 located to the right of the downpipe and drain [1601]

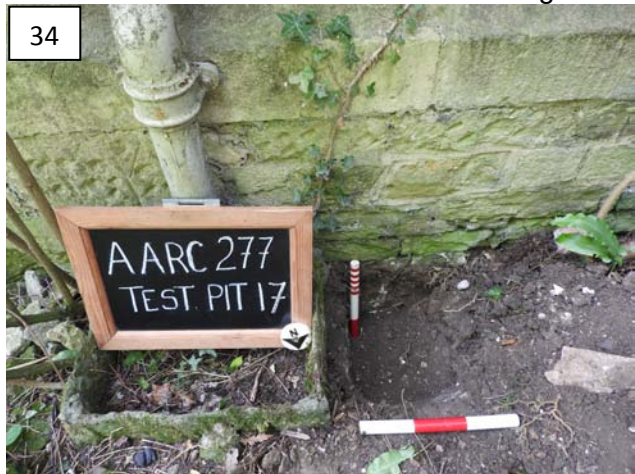
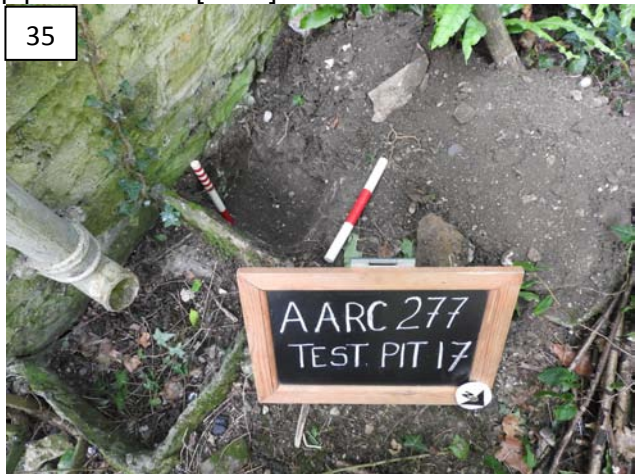
4.17. TEST PIT 17. Grid Ref No ST 91968 68470.

Test Pit 17 located near the NE corner of the Abbey and to the right of the downpipe and drain flaggy limestone surPround [1701]. Modern glass and broken limestone tiles found within the 0.3m of topsoil (1700). Plenty of room to accommodate the earthing pit mechanism.

Test Pit 17 located to the right of the downpipe and drain [1701]

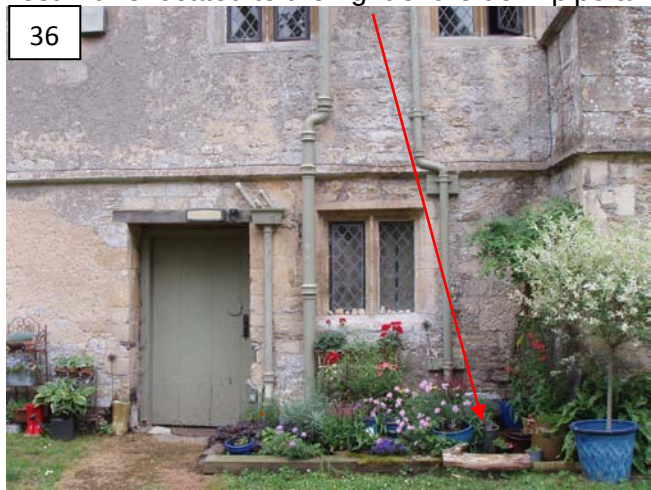
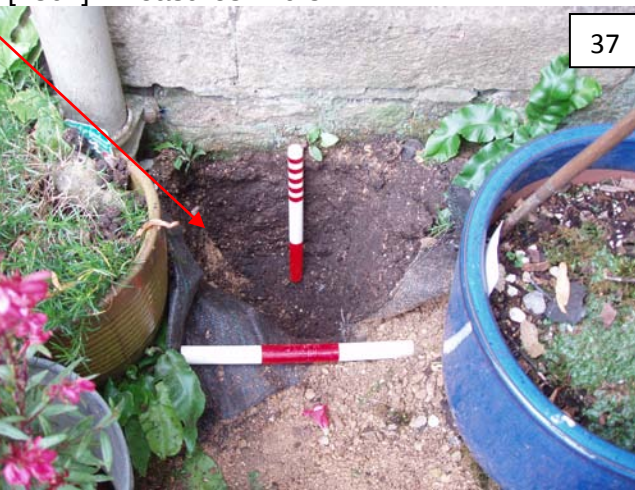
4.18. TEST PIT 18. Grid Ref No ST 91960 68470.

Test Pit 18 located near the NE corner of the Abbey and to the right of the downpipe and drain surround [1801]. The original positioning of the mechanism to the right of the doorway and downpipe had to be moved adjacent and right to the other downpipe due to a cast iron overflow pipe below the surface impeding any excavation. A number of container plants had to be removed plus a membrane to access the area. No finds within the 0.3m of topsoil (1800). There is sufficient room to accommodate the earthing pit mechanism.

Test Pit 18 located to the right of the downpipe and drain [1801]. Measures 2x0.3m

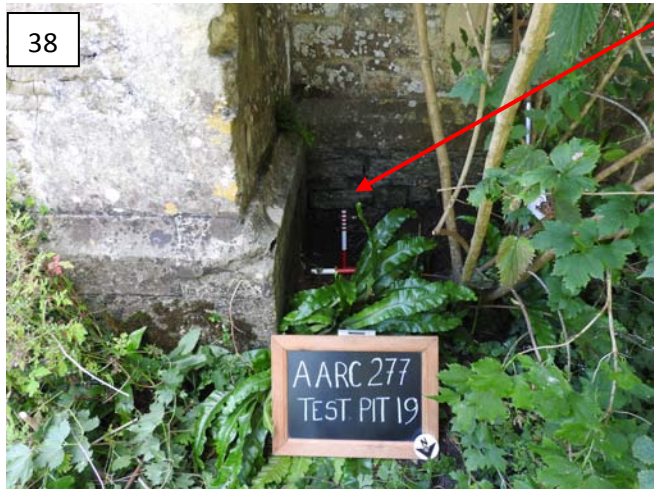
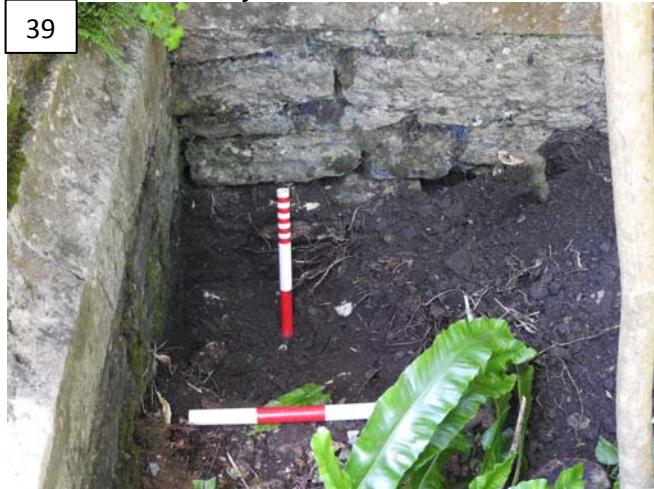
4.19. TEST PIT 19. Grid Ref No ST 91951 68472.

Test Pit 19 located central to the outer northern wall of the Abbey and to the right of the double chimney stack. Elder and a small maple had to be cut back to gain access. Modern window glass, broken flaggy limestone and slate were found within the 0.3m depth of topsoil (1900) There is sufficient room to accommodate the earthing pit mechanism without any obstacles

Test Pit 19 located to the right of the double chimney stack

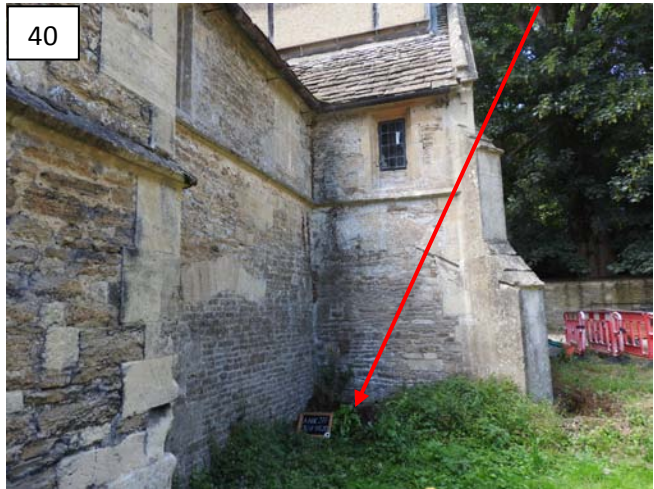
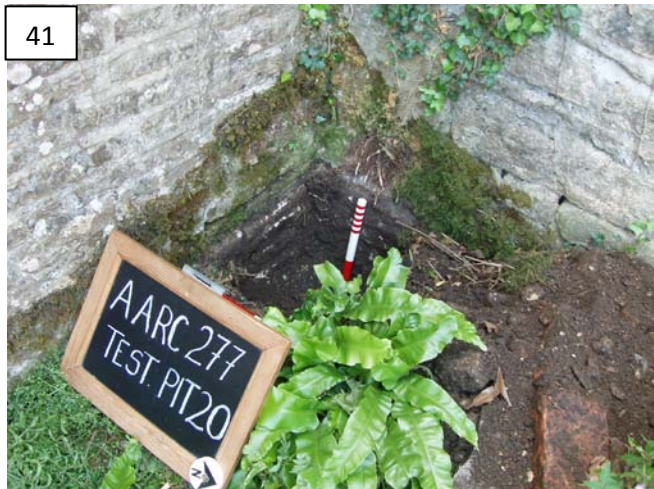
4.20. TEST PIT 20. Grid Ref No ST 91933 68473.

Test Pit 20 located on the outer wall corner of the 'Brew House'. No archaeological features or finds were made though the 0.3m cubed TEST pit was filled with discarded 20<sup>th</sup> century objects like broken bricks, paving slabs and a scaffolding plate. There is sufficient room to accommodate the earthing pit mechanism.

Test Pit 20 located in the outer wall corner of the 'Brew House'

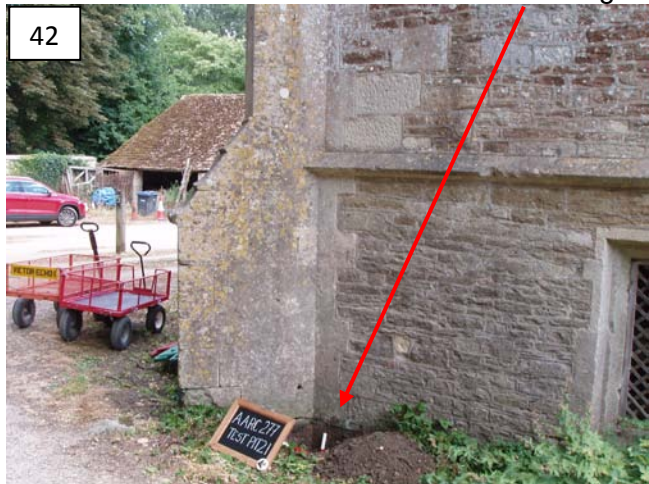
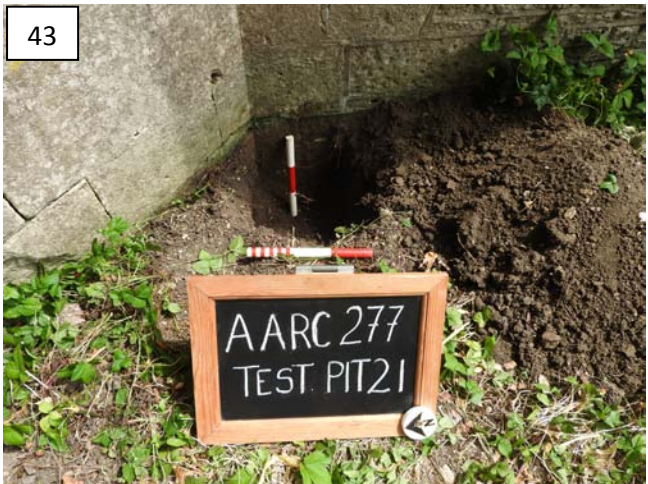
4.21. TEST PIT 21. Grid Ref No ST 91928 68473.

Test Pit 21 located to the right of the buttress in the NW corner of the Abbey and the outer wall of the 'Brew House'. No archaeological features or finds were made though the 0.3m cubed test pit. There is sufficient room to accommodate the earthing pit mechanism.

Test Pit 21 located next to the buttressing and outer wall corner of the 'Brew House'

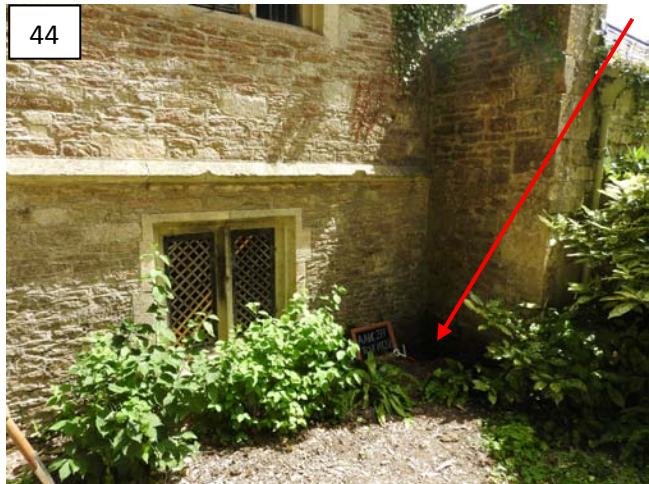
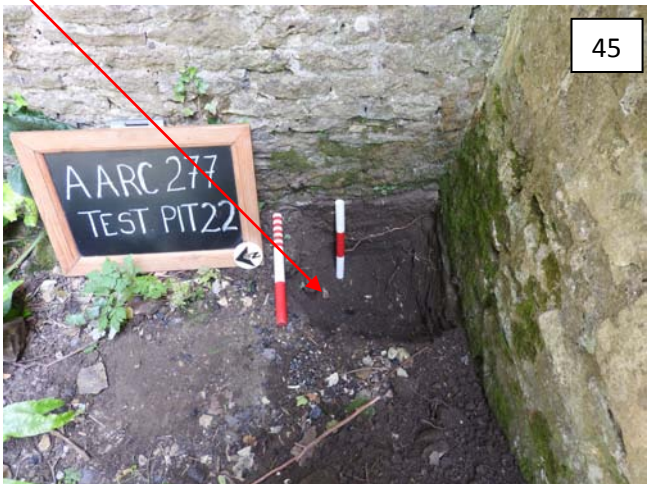
4.22. TEST PIT 22. Grid Ref No ST 91925 68465.

Test Pit 22 located to the SW outer corner of the 'Brew House'. Footings [2201] were located 0.3m down on the north facing wall. A metal rod, possibly an earthing rod was found to the north side of the test pit. No archaeological features or finds were made through the 0.3m cubed test pit of topsoil (2200). There is sufficient room to accommodate the earthing pit mechanism once the old earthing rod is removed.

Test Pit 22 located to the SW outer corner of the 'Brew House'

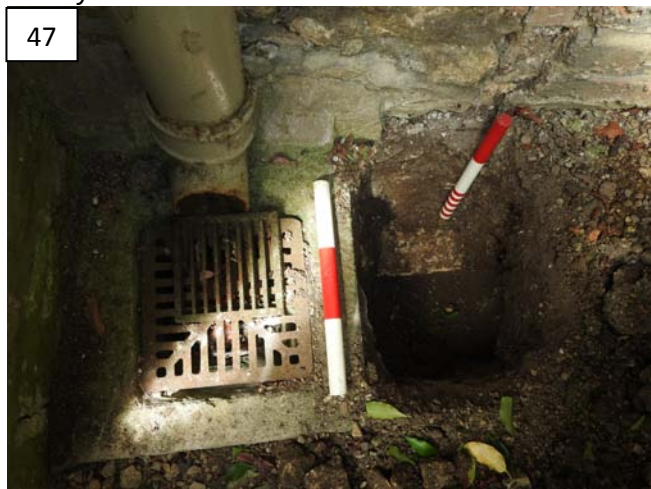
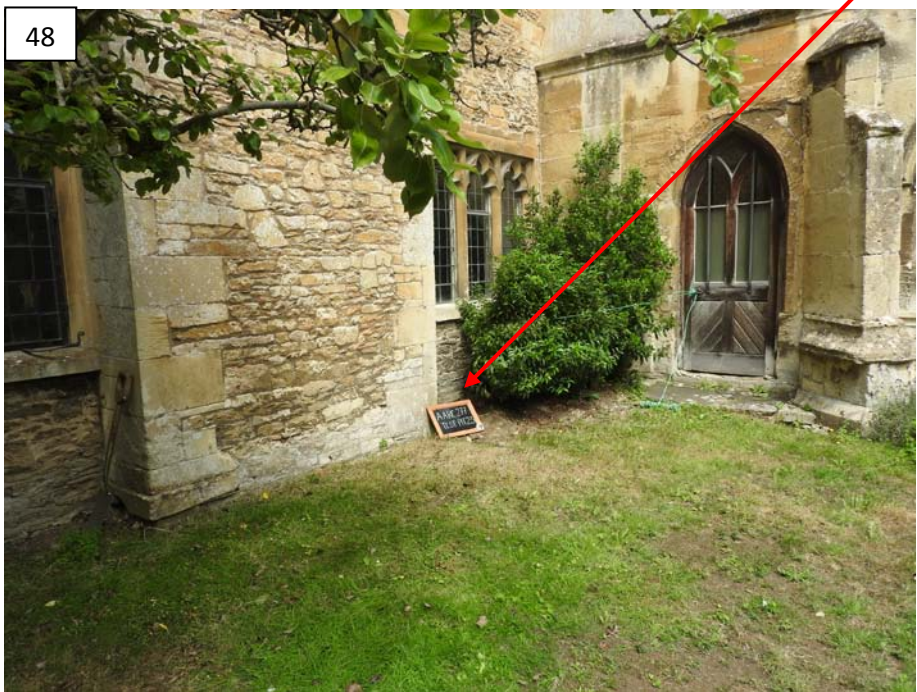
4.23. TEST PIT 23. Grid Ref No ST 91934 68403.

Test Pit 23 located towards the NW corner of the ‘Cloister Courtyard’ to the right of the chimney stack and behind a ‘Bay Leaf’ bush. Limestone footings [2303] were located 0.28m down along the east facing wall [2302] and protruding out 0.2m. The test pit was excavated to the north of drain [2301] to a depth of 0.3m through topsoil (2300). Natural alluvial clay (2304) was reached at 0.3m. There is sufficient room to accommodate the earthing pit mechanism east of the footings [2303] or to be placed adjacent to the drain [2301] within a raised area of soil.

Test Pit 23 located to the right of the chimney stack and drain

Test Pit 23 situated in the NW corner of the ‘Cloister Courtyard and behind the Bay leaf bush

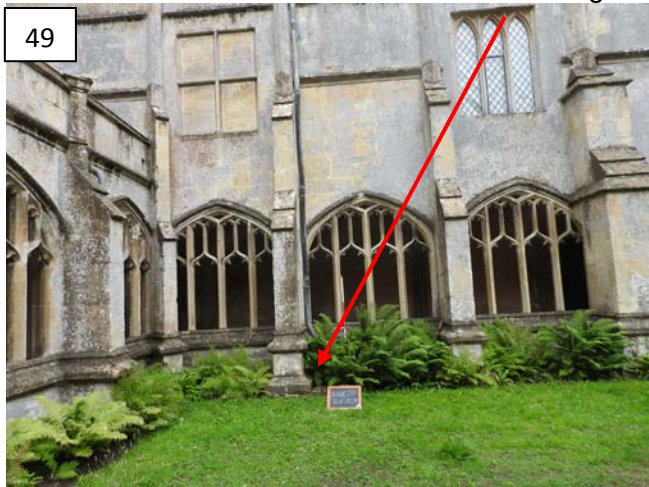
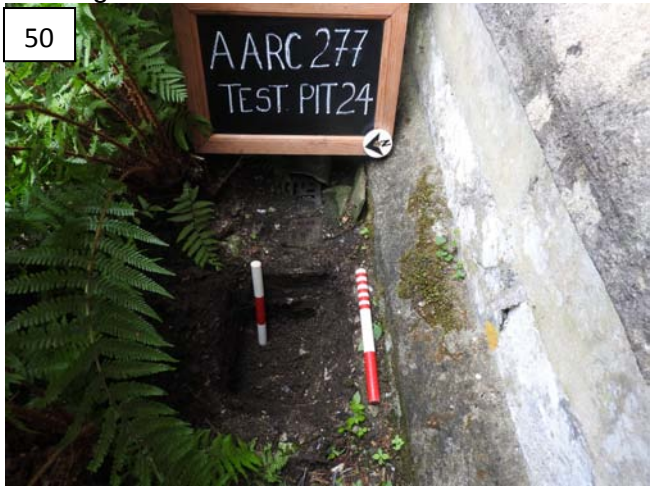
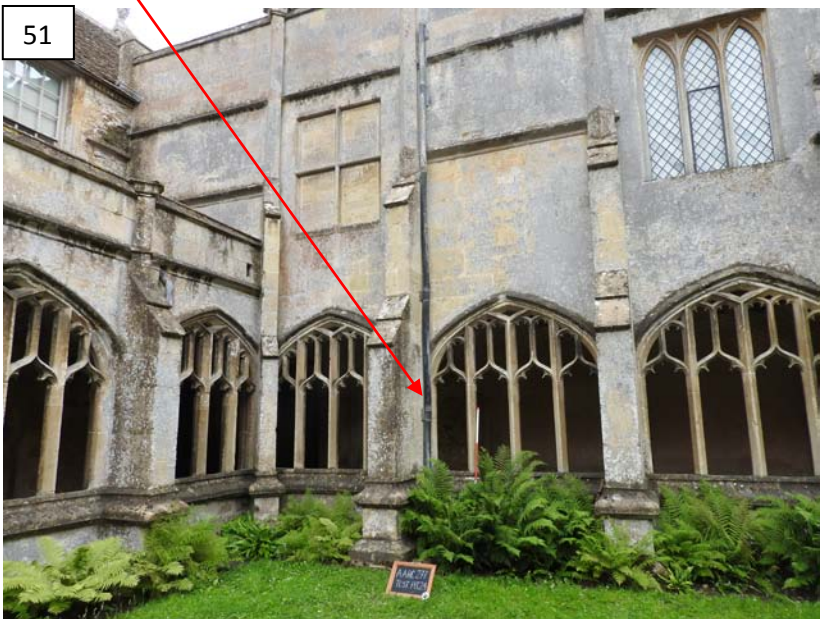
4.24. TEST PIT 24. Grid Ref No ST 91953 68390.

Test Pit 24 located towards the SW corner of the 'Cloister Courtyard' and to the right of one of the inner north facing buttresses. The test pit was excavated to the west and adjacent to drain [2401] to a depth of 0.3m through topsoil (2400) containing modern broken brick. Natural alluvial clay (2403) was reached at 0.3m. Foundations of the north facing cloister were [2402] were located just below the surface There is sufficient room to accommodate the earthing pit mechanism north of the footings [2402].

Test Pit 24 located to the right of the buttresing and drain

The original position of Test pit 24 was in the corner of the SE 'Cloister Courtyard' probably a mistake on the up to date plan. It was decided after consultation that the positioning should actually be to the right of the downpipe and triple buttressing

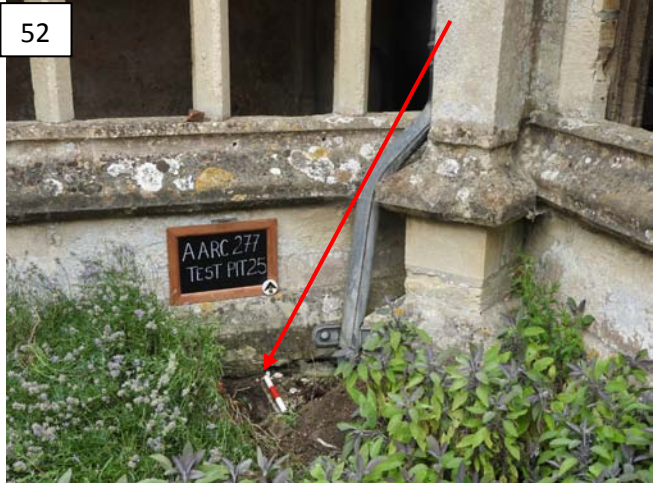
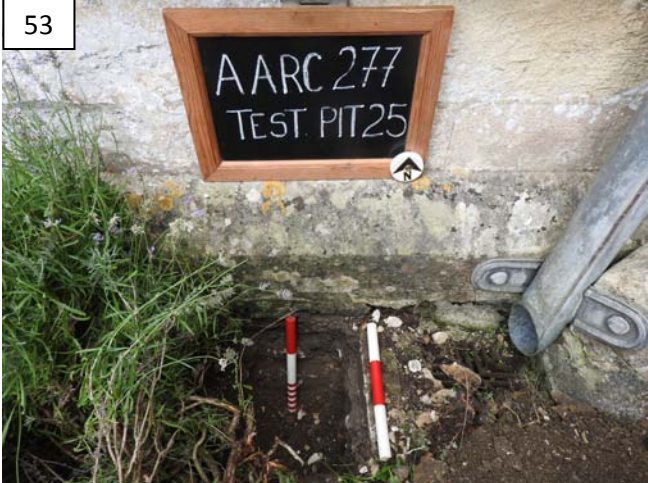
**4.25. TEST PIT 25.** Grid Ref No ST 91954 68404.

Test Pit 25 located in the NE corner of the ‘Cloister Courtyard’ and to the left of the drain and downpipe [2501] and angle buttress [2502]. The test pit was excavated to the west and adjacent to drain [2501] to a depth of 0.3m through topsoil (2500). There is sufficient room to accommodate the earthing pit mechanism.

Test Pit 25 located in the NE corner of the ‘Cloister Courtyard’

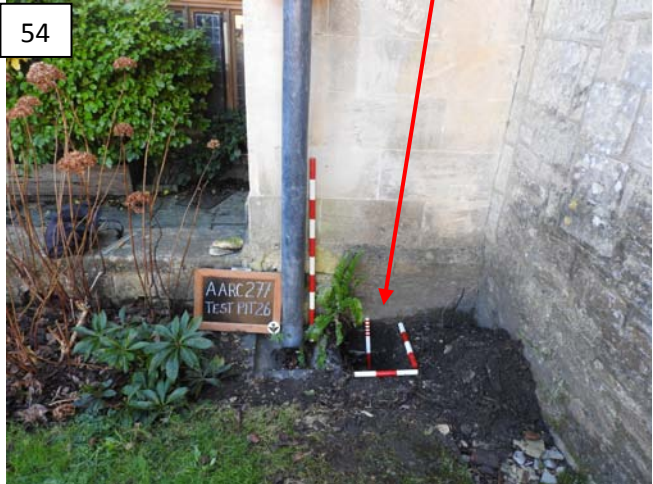
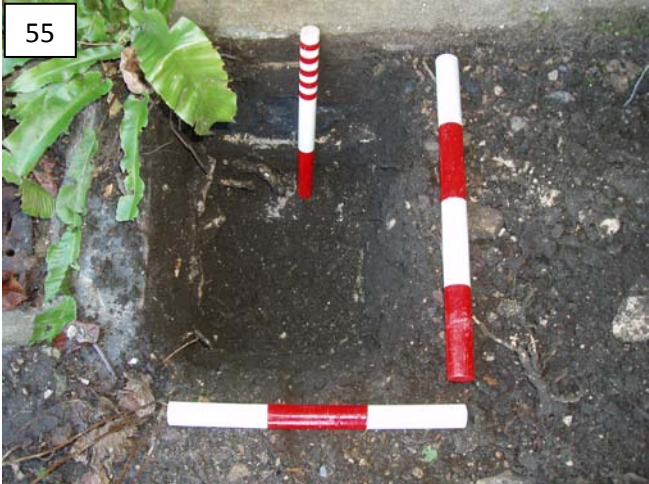
**4.26. TEST PIT 26.** Grid Ref No ST 91935 68426. To be excavated after Hydrangeas are removed.

Test Pit 26 located to the SW corner of the main Courtyard’ and to the right of the drain and downpipe [2601]. The test pit was excavated to the west and adjacent to drain [2601] to a depth of 0.3m through topsoil (2600). The test pit needs to move 0.25 metres to the North to avoid wall and slate damp course [2602]. There is sufficient room to accommodate the earthing pit mechanism at 0.3 metres depth.

Test Pit 26 located to the SW corner of the main ‘Courtyard’ showing downpipe, drain and surround [2601], slate damp course [2602] and foundations [2603]

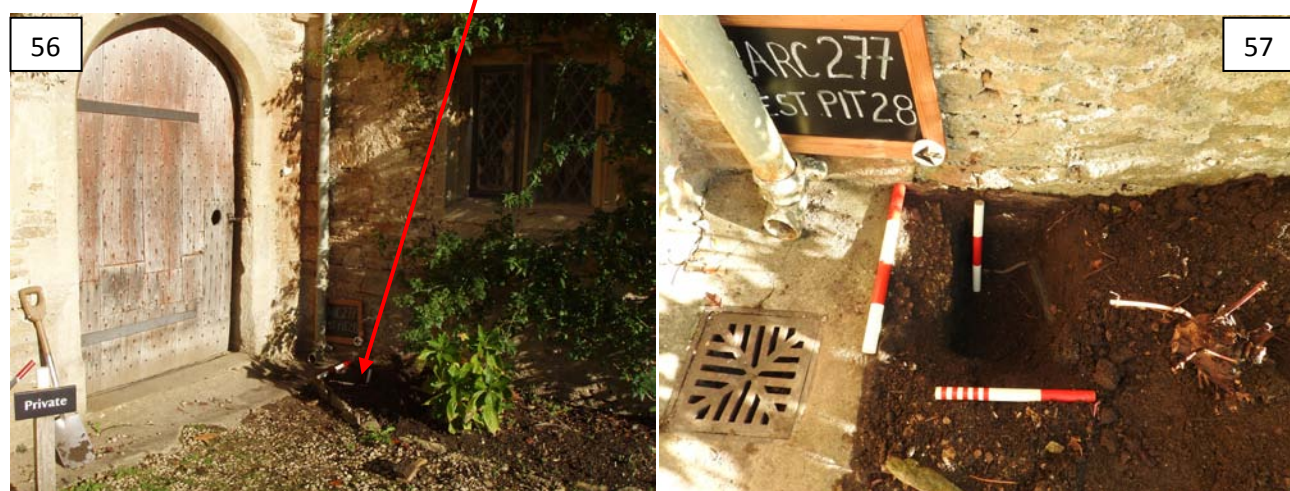
**4.28. TEST PIT 28.** Grid Ref No ST 91959 68460. To be excavated after climbing plant is removed.

Test Pit 28 located to the NE corner of the main Courtyard' and to the right of the drain and downpipe [2802]. The test pit was excavated to the south and adjacent to drain and footings [2802] to a depth of 0.3m through topsoil (2800). The test pit needs to move 0.3 metres to the West of wall [2803] to avoid an electrical conduit and cable [2802] located 0.25 metres down. There is sufficient room to accommodate the earthing pit mechanism at 0.3 metres depth.

Test Pit 28 located to the NE corner of the main 'Courtyard' showing downpipe, drain and surround [2802] and electrical conduit and cable [2801]

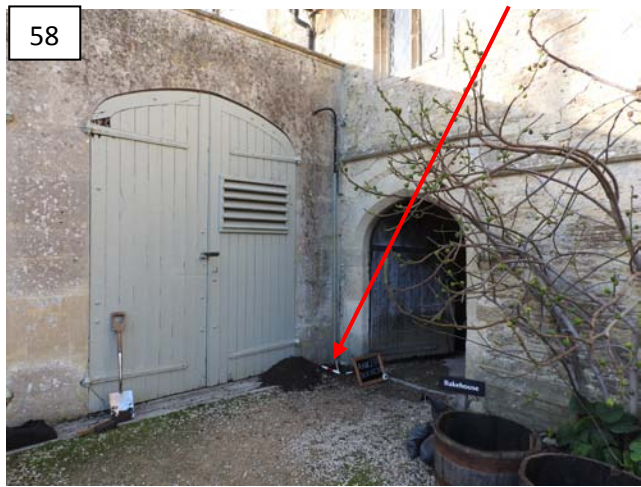
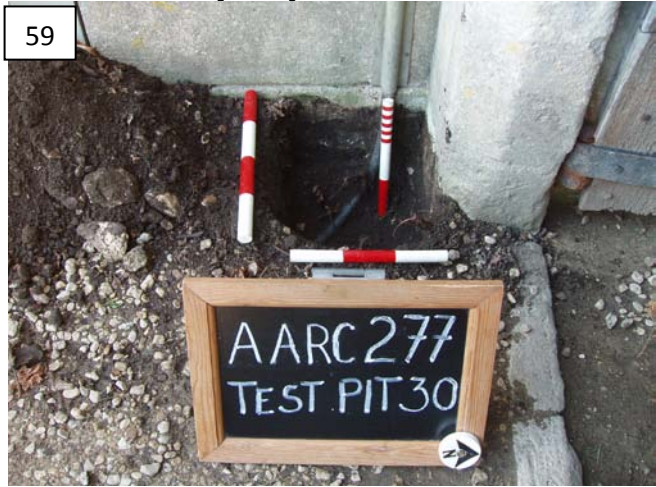
**4.30. TEST PIT 30.** Grid Ref No ST 91930 68464. To be excavated after Hop is removed.

Test Pit 30 located to the NW corner of the main Courtyard' and to the and to the left of the entrance into the 'Brewhouse'. The test pit was excavated through 0.3 metres of topsoil (3000). The test pit needs to move 0.15 metres away from wall [3002] to avoid an electrical conduit and cable [3001] located 0.28 metres down. Due to its positioning the earthing pit mechanism needs to be raised slightly to avoid the electrical conduit and cable.

Test Pit 30 and electrical conduit and cable [3001]
