# ABSOLUTE ARCHAEOLOGY 2025

An Interim Report for Archaeological test pitting carried out  
within the confines of Lacock Abbey, Wiltshire

Document Title: An interim report for Archaeological test pitting carried out within the confines of Lacock Abbey, Wiltshire

Document Type: Excavation/Evaluation Report

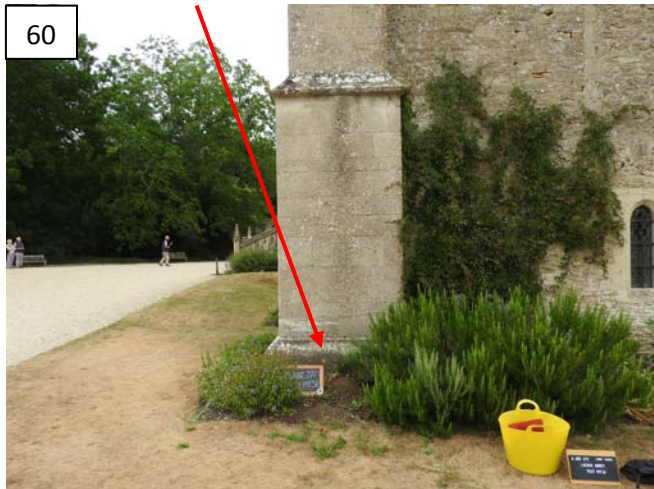
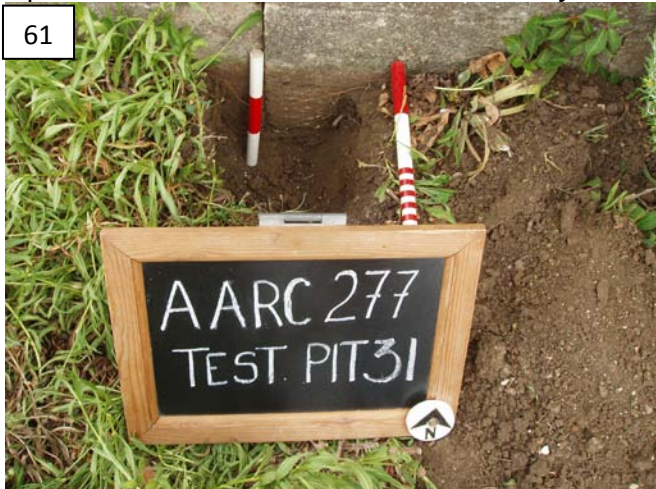
**4.31. TEST PIT 31.** Grid Ref No ST 91922 68386.

Test Pit 31 located in the SW outer corner of the 'Chaplains Room' and SW corner of the Abbey Courtyard'. The test pit was excavated through 0.3m cubed of topsoil (3100). There is sufficient room to accommodate the earthing mechanism.

Test Pit 31 located in the SW outer corner of the 'Chaplains Room' and SW corner of the Abbey
