# Ecological Impact Assessment

**Fives Court Mere**

**October 2024**

**Project:                            ETH24-049**

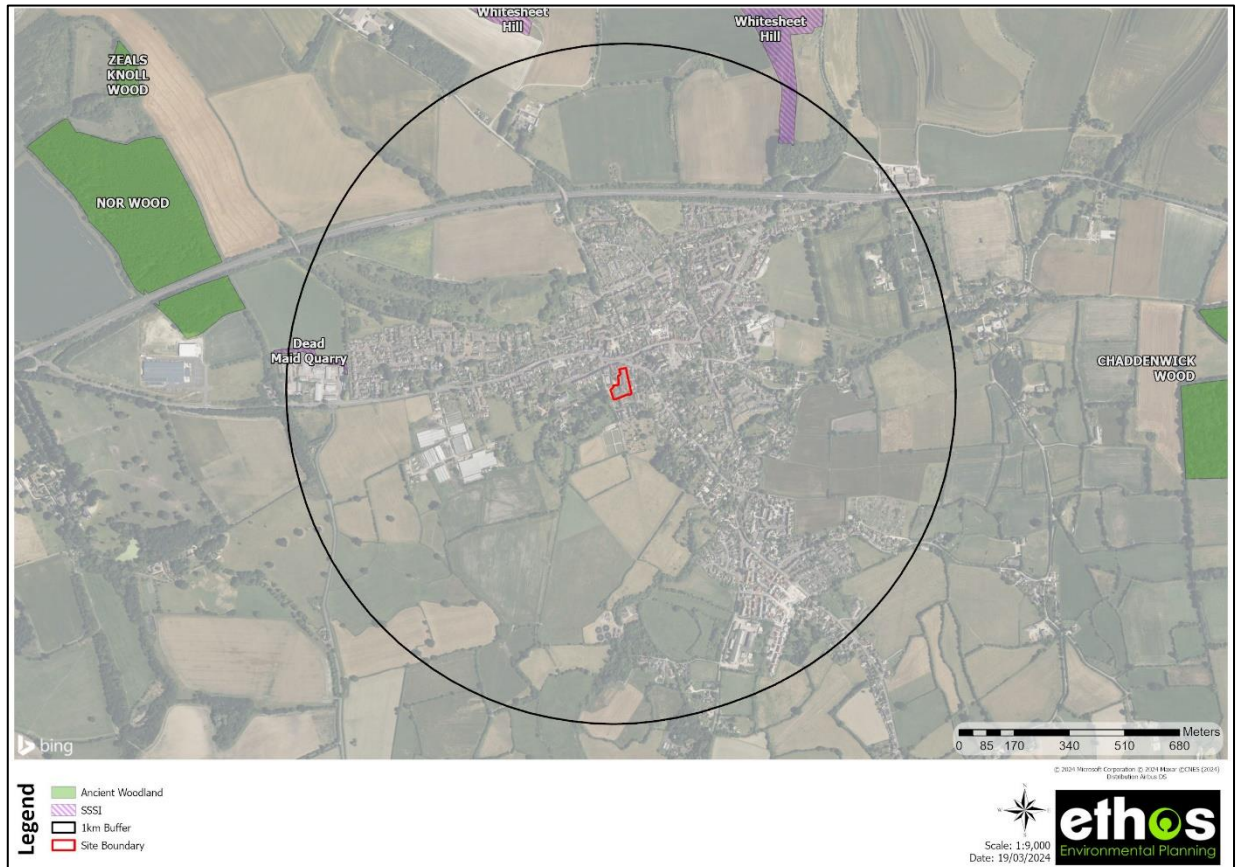
Figure 3 Statutory sites within 1km

- 4.1.1 Two statutory designated sites are present within 1km of the site, namely Dead Maid Quarry Site of Special Scientific Interest (SSSI) and Whitesheet Hill SSSI, as shown in Figure 3.

- 4.1.2 Dead Maid Quarry is located 840m west of the site and is important for the Chalk and Upper Grassland units of the Cretaceous.
- 4.1.3 Whitesheet Hill SSSI is located 900m north of the site and is designated for its extensive area of botanically rich chalk grassland predominantly on the west-facing slopes of the Middle Chalk. The site supports nationally restricted species of animals and plants and is one of the most westerly areas of downland in Britain.

- 4.1.4 The SSSI's are all of 'National' importance for nature conservation in line with their designations. Due to the small scale of the works proposed as well as distance between the proposed development site and the designated sites, no significant impacts are anticipated and these sites are therefore not considered further in this assessment.

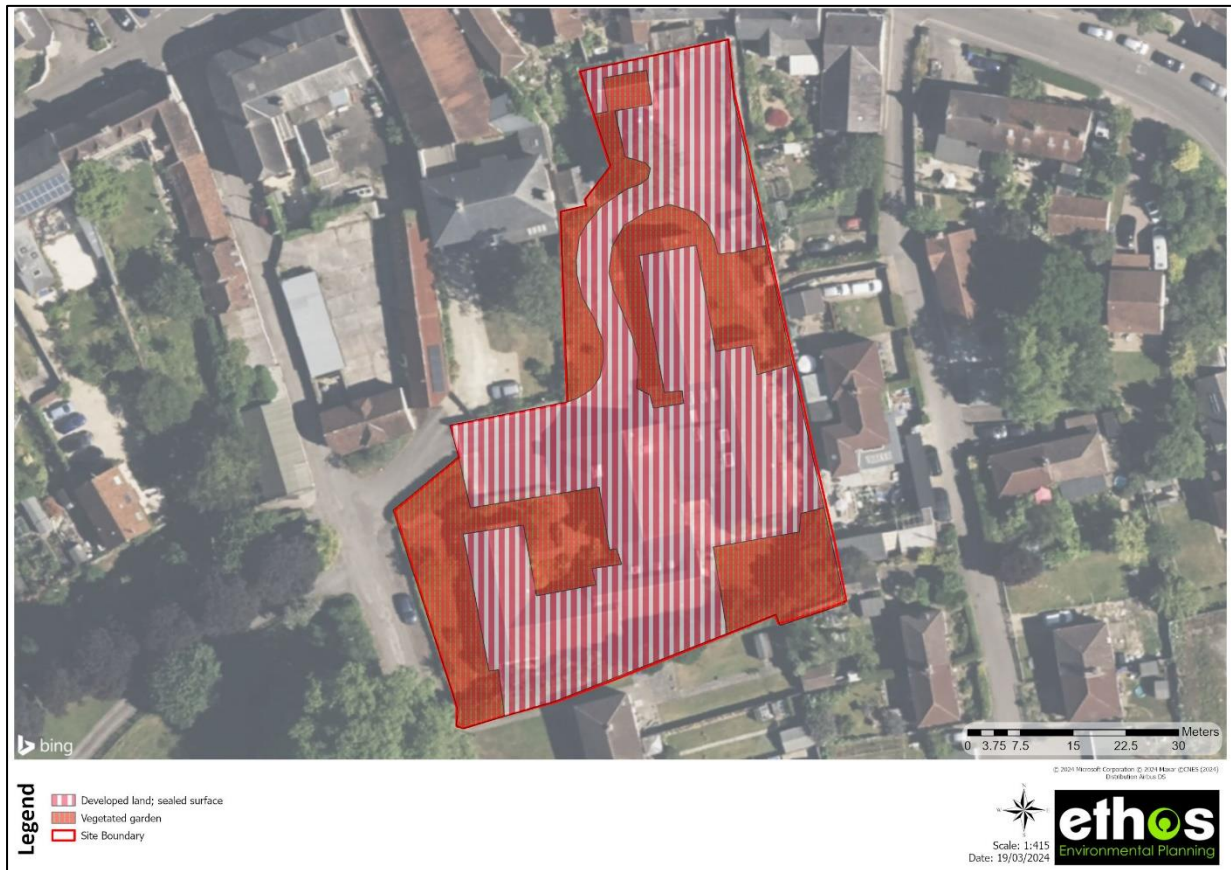
Figure 5 UK Habitat survey

- 4.2.2 Figure 3 displays the key habitats using the UK Habitat classifications. Descriptions of the habitats are provided in the following section and comprise:
- Urban – Developed land; sealed surface;
  - Urban – Vegetated garden; and
  - Urban tree.

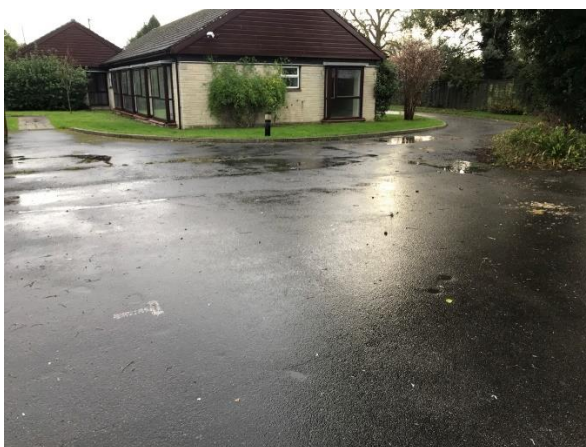
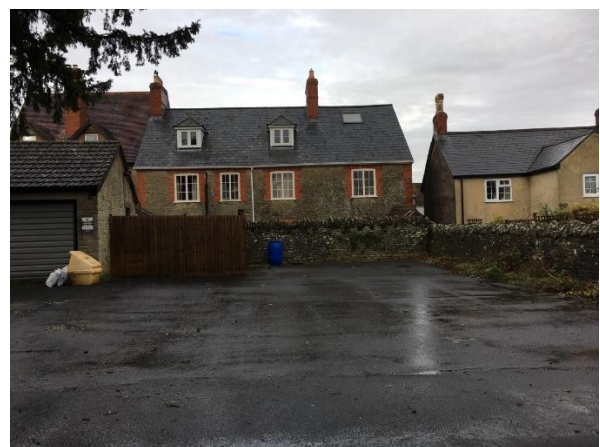
4.2.3 The site is dominated by developed land; sealed surface (Photo 7 and 8) in the form of two main structures, car parking and access on to the site. The hardstanding is in good structural condition and provides negligible potential for wildlife. This habitat is therefore not considered further in this assessment.

Photo 7 Developed land, sealed surface on site.

Photo 8 Developed land, sealed surface on site.

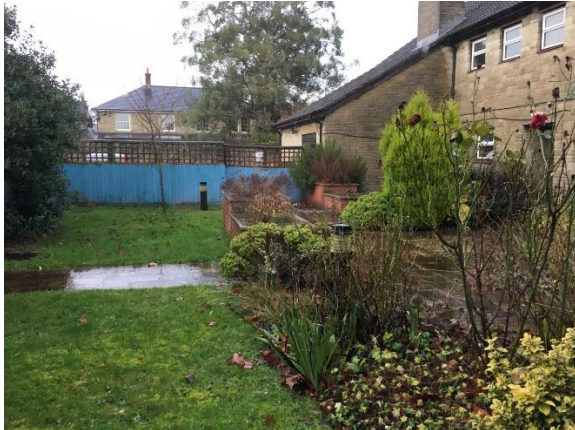
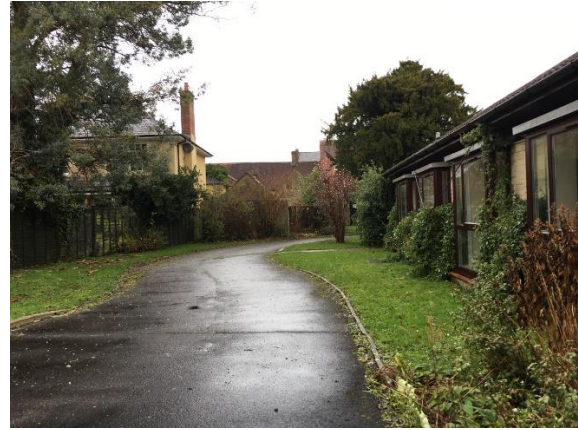
- 4.2.4 There are several sections of vegetated garden that include amenity grassland and introduced shrub that surrounded the main building on site (B1). The grassland was maintained to a short sward at the time of survey, as seen in Photo 9 and 10. Several sections of the garden are bordered by small, well-maintained ornamental beech hedgerows, as shown in Photo 11. There are also several young trees on site.

*Photo 9 Vegetated Garden*

*Photo 10 Vegetated Garden*

- 4.2.5 The vegetated garden is not assessed to be of particular importance for nature conservation and is not considered further in this assessment.

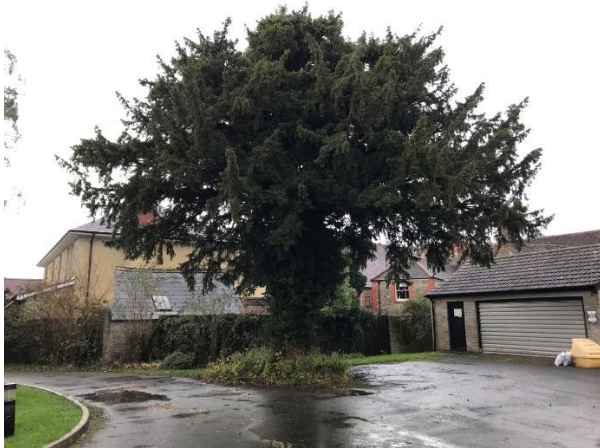
*Photo 12, Mature yew tree*

- 4.2.6 There is a single mature yew tree within the car parking area. This tree is covered around its trunk by ivy (*Hedera helix*) (Photo 12).
- 4.2.7 This yew tree is not assessed to be of particular importance for nature conservation and is only considered further in relation to its potential to support protected species.

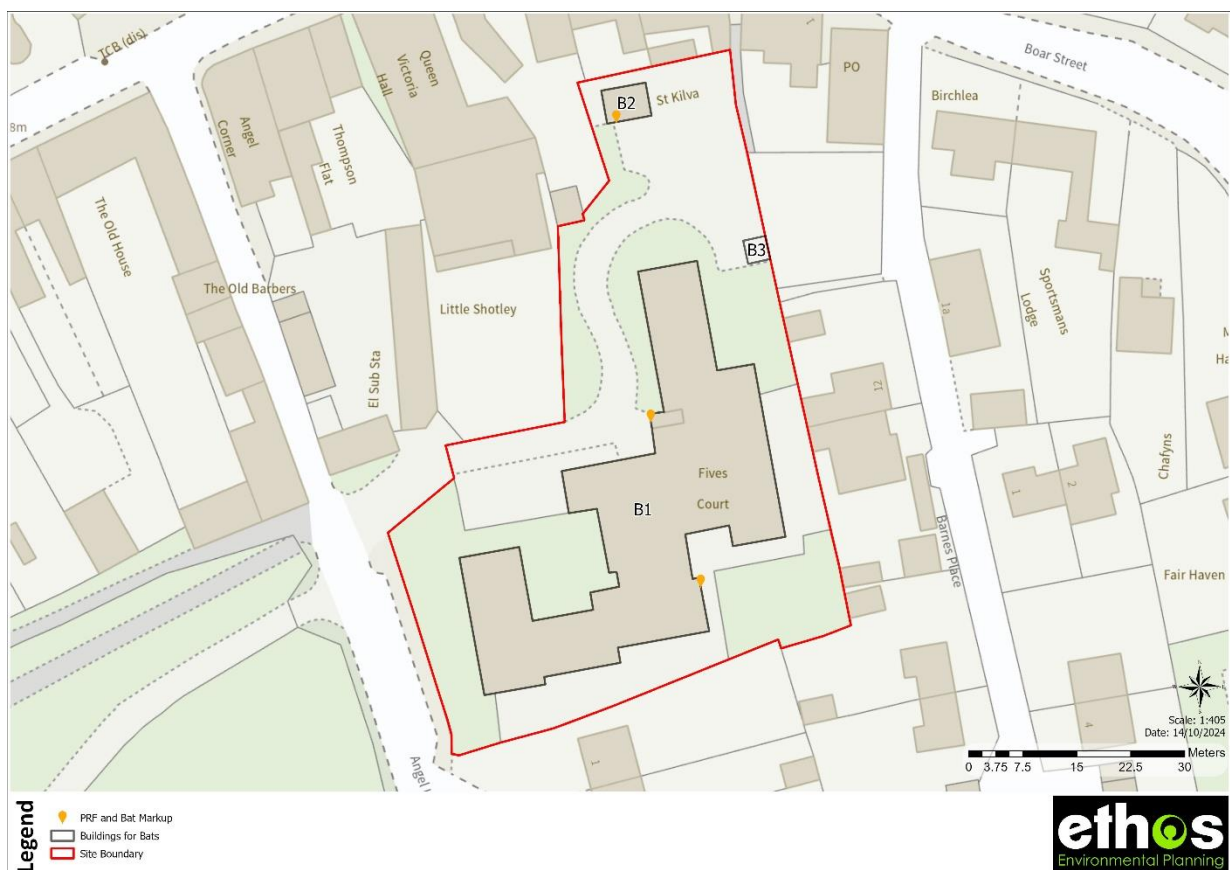
Figure 6 Structures on site

- 4.7.2 There are three structures on site; the main structure (B1) and a garage (B2) as shown in Figure 4, which are assessed for their potential to support roosting bats. There is also a small storage structure on the eastern boundary (B3).

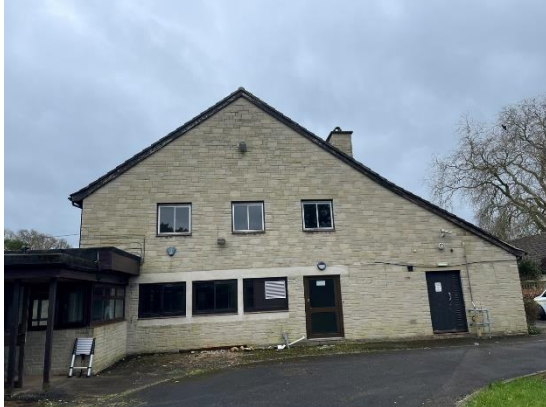
- 4.7.3 The building is an unoccupied assisted living home, constructed of stone walls with plastic cladding, all in good condition (Photos 13 and 14). The roof is a gable structure

with concrete tiles, chimneys and lead flashing that are all in good structural condition. There are sections of the roof that are pitched with interconnecting composite tiles. Soffit boxes are overall in good condition but damaged in isolated places (see Section 4.7.5). The walls are in good condition.

*Photo 13 Northern elevation of two storey section of B1*

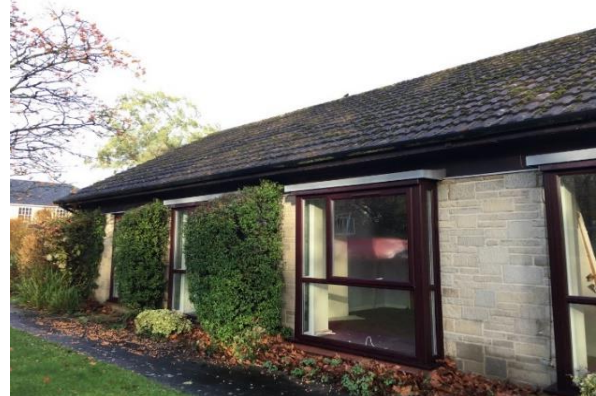
*Photo 14 Eastern elevation of northern wing B1*

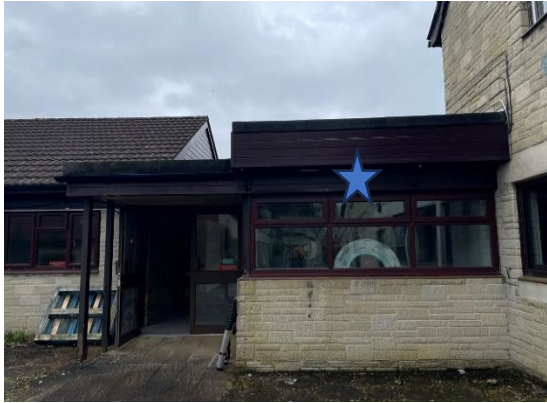
- 4.7.4 Two potential roost features have been identified in this building, which are described below.
- 4.7.5 The first is a flat roof void cavity above the entrance way and small front room of the building, located on the western elevation. In this location there is a potential exit/ re-entry gap created from damage to the soffit (shown in Photos 15 and 16). This feature was surveyed in part with an endoscope, which identified it was extensive and could not be fully investigated. No evidence of bats was observed within the accessible area of the void by the access gap.

*Photo 15 Western elevation of building with entry/ exit feature in the soffit (PRF – flat roof void over ground floor room)*

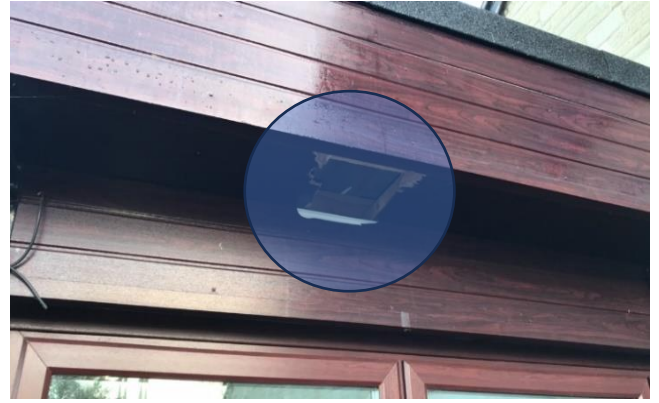
*Photo 16 Damage to soffit, creating potential access gap into PRF1*

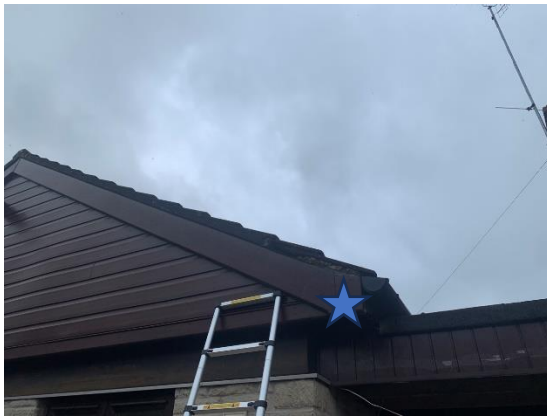
- 4.7.6 The second feature on the south east elevation is situated between the tiles and the main roof structure lining (Photos 17 and 18). The loft space extends approximately 2.5m across the roof and then upwards towards the apex of the roof. The void could be explored using the endoscope to view across the horizontal space, but not up into the space extending up the roof. No evidence of bats was found during the survey.

*Photo 17 Location of gap into PRF on east elevation of building*

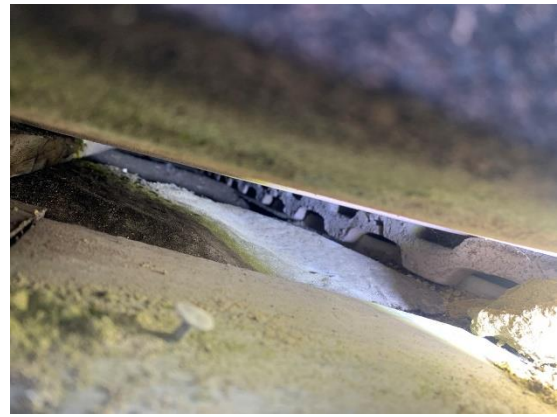
*Photo 18 Internal cavity of PRF2. Feature extends along the length of the lower eave*

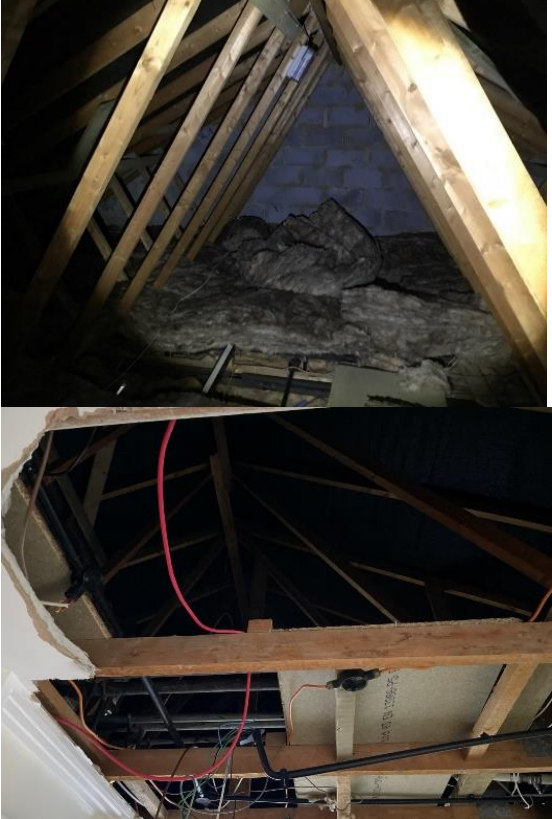
| Loft Void Number | Internal Structure Description | Photos |
|---|---|---|
| 2 | <p>Timber a-frame structure approximately 3m high, with bitumen felt sarking in rafters, in good condition. Part of the ceiling has been removed. <b>No evidence of bats</b> (or birds).</p> | |

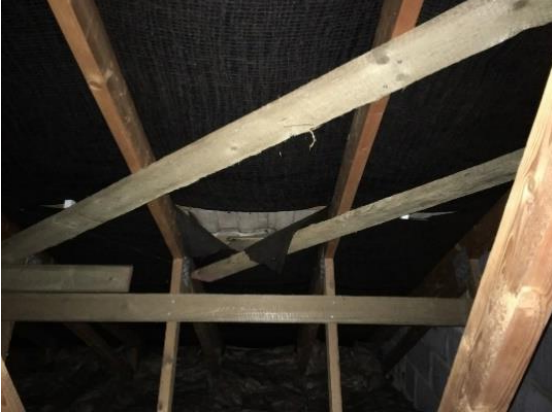
| Loft Void Number | Internal Structure Description | Photos |
|---|---|---|
| 3 | <p>Timber a-frame structure with bitumen felt sarking in rafters. Three small tears in sarking and some sarking sagging, with slight light ingress but the area behind comprises tight tiles. Adjoins larger loft area with the ceiling removed, however this still forms the internal of building, with no external access. <b>No evidence of bats</b> (or birds). A few scattered mouse droppings were present.</p> | |

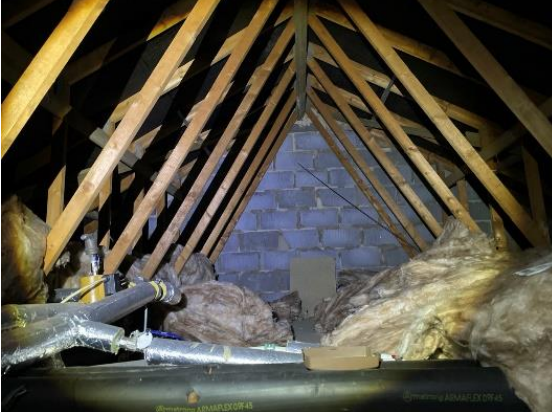
| Loft Void Number | Internal Structure Description | Photos |
|---|---|---|
| 4 | <p>Timber a-frame structure with bitumen felt sarking in rafters. Some sagging sarking present. There was no safe access into this loft and so, a full inspection could not be completed. The area is likely sealed under eaves similar to the other lofts, as thick insulation present would cover any gaps. Good condition bitumen felting present. In the areas able to be inspected there was <b>no evidence of bats</b>.</p> | |

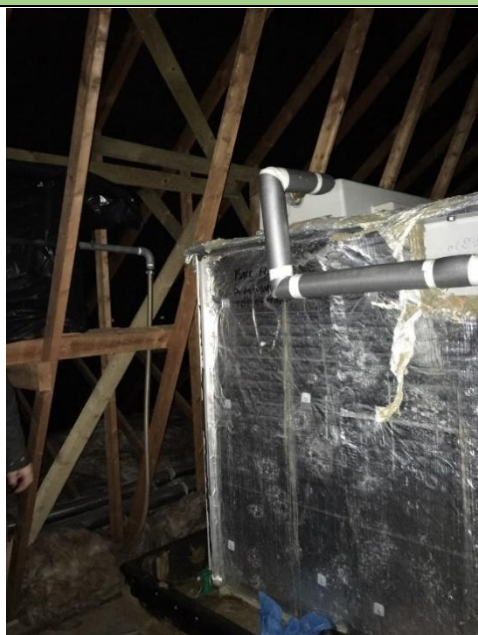
| Loft Void Number | Internal Structure Description | Photos |
|---|---|---|
| 5 | Timber a-frame structure with bitumen felt sarking with rafters in the two storey section. Good condition lining with one small tear, with tight tiles behind. The eaves are tightly sealed. There is a boiler and water tank present in the void. Breezeblocks walls are present on both ends of the void. <b>No evidence of bats</b> (or birds). | |

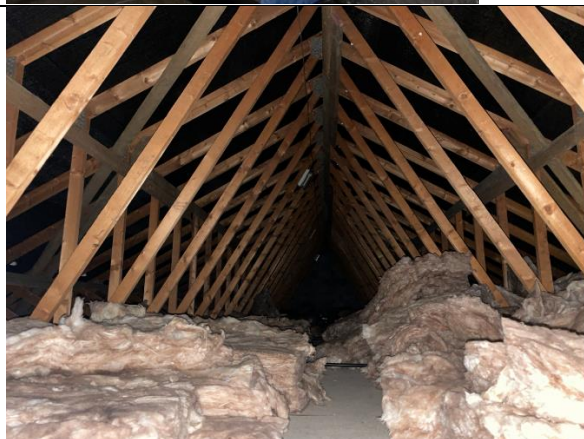
| Loft Void Number | Internal Structure Description | Photos |
|---|---|---|
| 6 | Internally connected with loft voids 3 and 4. Unsafe to enter (fragile ceiling joists). Bitumen felt sarking in good condition, tight no visible gaps or any ingress of light. In the areas able to be inspected there was <b>no evidence of bats</b> . | |

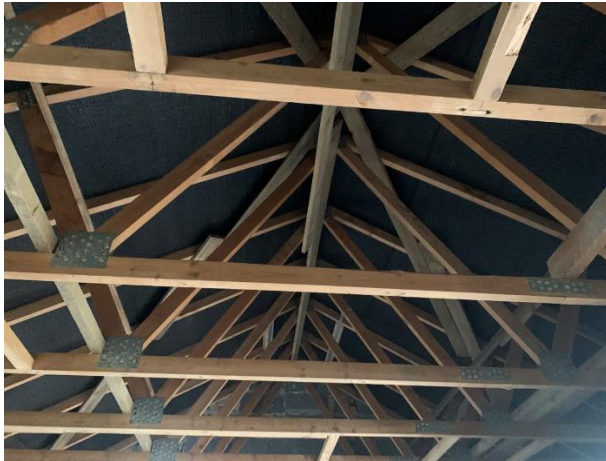
- 4.7.8 B2 is a disused garage, with one elevation having an up-and-over garage door. There is no longer a loft void as the ceiling has been removed between Ethos visits in 2022 and 2024 (Photo 19 and 20). The structure is comprised of modern brick walls and wooden beams. The structure is open and exposed, providing poor and unstable conditions for roosting bats. The soffit on the southwest elevation of the building is warped, allowing potential access for bats into this feature. The cavity extends along the length of the garage, approximately 7.5m x 10cm (see Photos 21 and 22).

*Photo 19 Garage void*

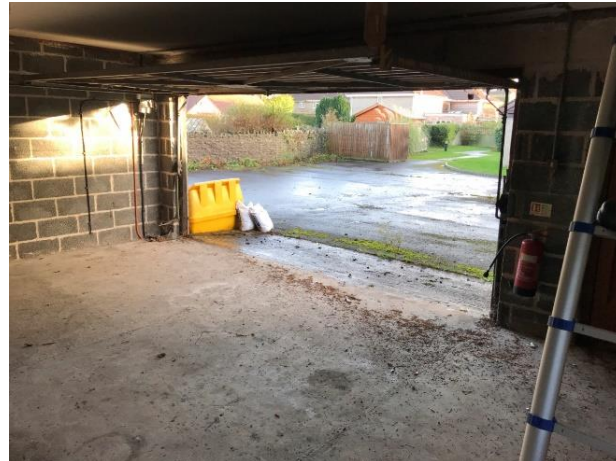
*Photo 20 Garage with up-and-over door*

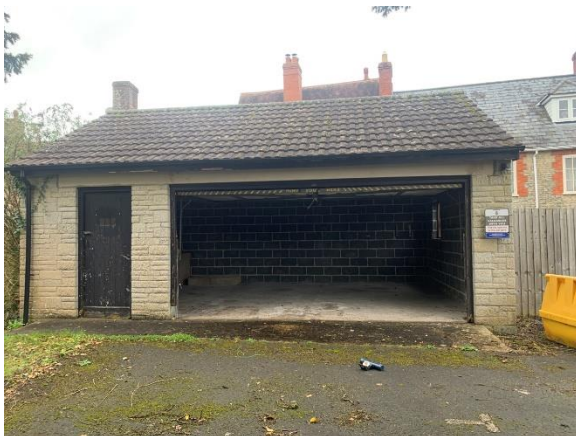
*Photo 21 Southern elevation of the garage*

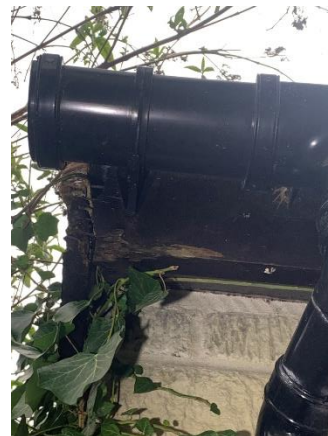
*Photo 22 Damage to soffit on south west elevation*

- 4.7.9 This building is assessed to have **moderate suitability** for bats, with the PRF limited to the soffit. This roost feature is again quite extensive but recently formed since the previous Ethos survey visit (Ethos, 2022) and the surrounding habitats do not provide particularly good foraging opportunities for bats and therefore, it is not considered likely to be of high suitability.

- 6.1.9 A controlled 'soft-strip' of any alarm boxes or barge boards on all elevations will be undertaken under direct supervision of the licensed bat worker. The materials will be removed by hand in areas of bat interest. Any animals found during the 'soft-strip' will be moved by the licensed bat ecologist into the temporary bat box.

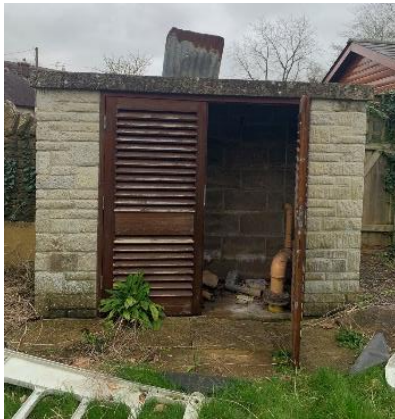
- 4.7.10 This structure (Photos 23 and 24) has a door with wooden slats which has gaps large enough for bats to access, however internally the building is light and exposed as well as damp, with **no evidence of bats** seen. There are no external crevice features suitable for bats. Therefore, the building is assessed to contain **negligible potential** for bats.

Photo 23 External of the gas building

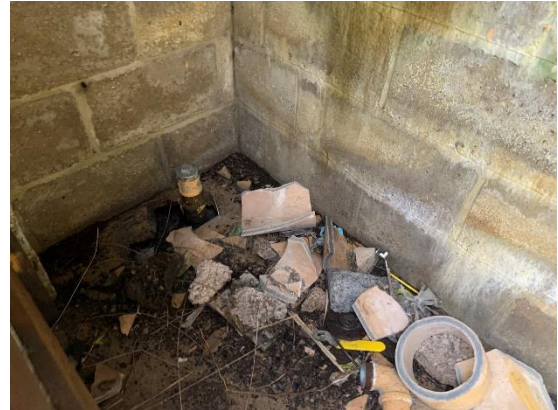
Photo 24 Internal of the gas building

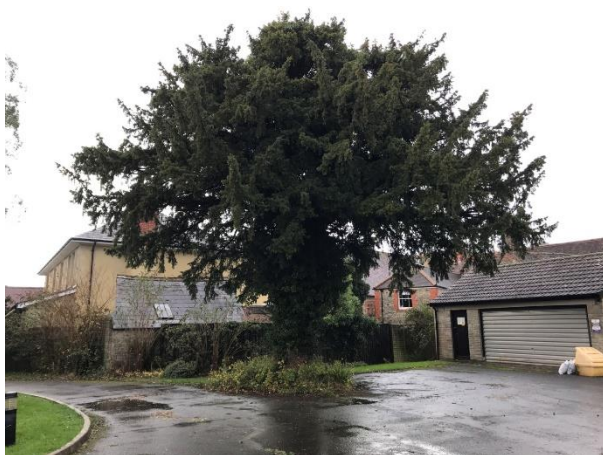
Photo 25 Mature yew tree

- 4.7.11 One mature yew (*Taxus baccata*) tree is on site (Photo 25), in the northern section by the car park. Ivy was growing up the stem, and the crown was not visible from ground level. Overall, the tree was assessed to be in good health. No evidence of roosting bats or roosting features were recorded during the survey from ground level. The ivy on the trunk was not thick or dense enough to be considered suitable as a potential bat roost as is assessed to have **negligible potential** for roosting bats.

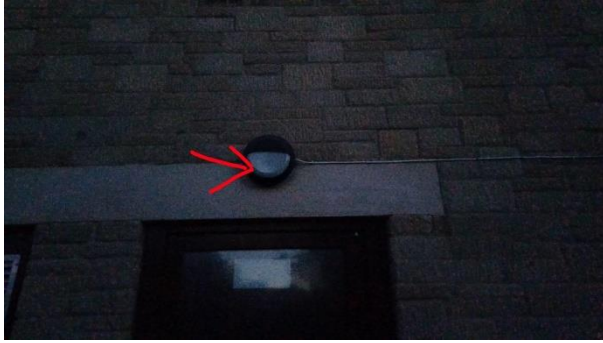
- Five emergence locations were identified during the emergence surveys (locations shown in Figure 7).
- These were single common pipistrelle bats from each location except the barge board on 27<sup>th</sup> July, where two common pipistrelle bats emerged.
- A single common pipistrelle emerged from under a security light on the northern elevation of the second story section of B1 (Photo 26)
- A single common pipistrelle emerged from behind the barge board on the apex of the roof on the northern side of B1 (Photo 27)
- A single common pipistrelle emerged from the apex of the second storey section on the southern side of B1 (Photo 28)
- Two common pipistrelles emerged from two location on the garage structure (B2) (Photo 29).
- The highest number of emergences were recorded on 30<sup>th</sup> July, when five bats emerged from four separate locations.

Photo 26, Emergence location behind security light June.

- 6.1.1 The plans will require new bat roosting features to be provided within the new roof. A lighting plan will be required to ensure the new roost features are not near security lights, or other lighting features and there are movement corridors for bats to these features.
- 6.1.2 Overall, with the implementation of works under bat licence, with suitable compensation features installed and managed as per the licence conditions, **no significant impacts** on roosting common pipistrelle bats are predicted as a result of the development.

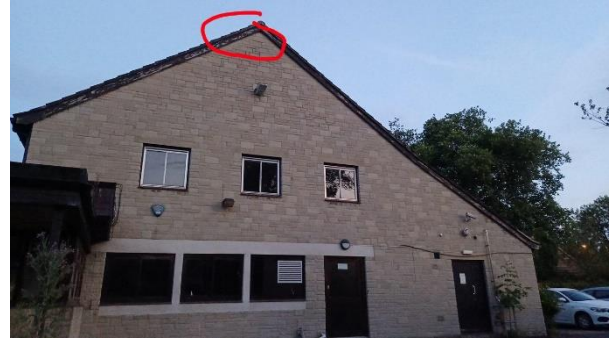
Photo 27, emergence location on northern elevation of two storey section - July.

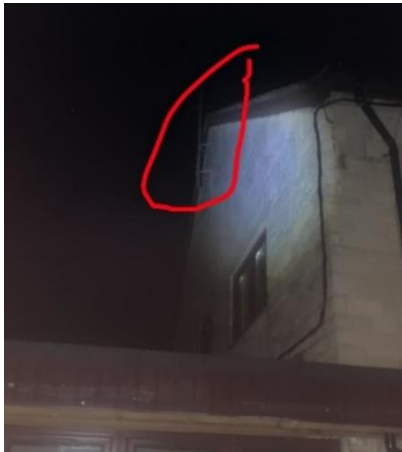
Photo 28, emergence location on southern elevation of two storey section - July.

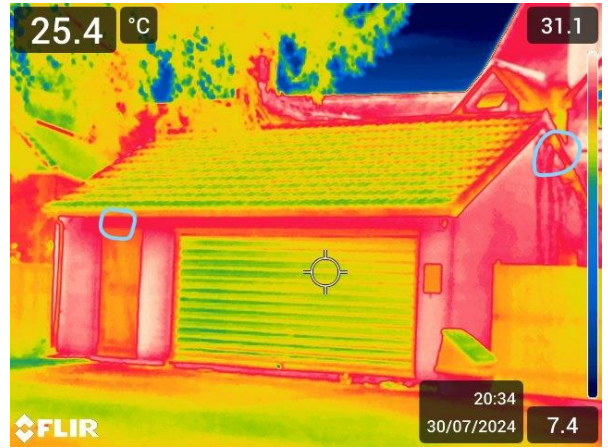
Photo 29, emergence positions on garage July.

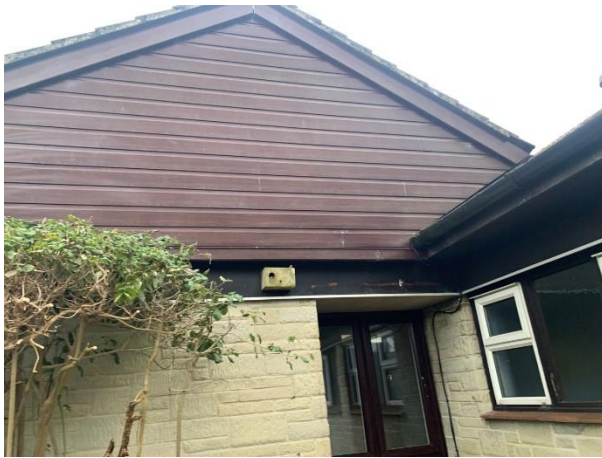
- 4.8.3 The hedgerows and trees on site are assessed as suitable nesting habitat for common and widespread species of bird. The remainder of the site comprises hard standing with amenity grassland that is maintained to a short sward, with introduced shrub and vegetated garden; these habitats are assessed to contain low value to common and widespread birds.
- 4.8.4 Wren, robins and house sparrows were observed during the ecological surveys. No evidence of breeding birds was identified during the internal structure inspection. On an outside wall, there is a bird box which appeared to have nesting material inside (Photos 30 and 31). Therefore, this is likely to be an active bird nest.

Photo 30, Bird box on western elevation of building.

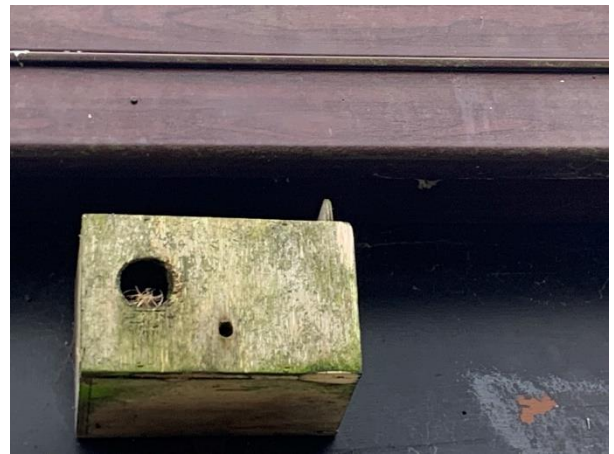
Photo 31, bird box showing nesting material.
