## **Blackmore Farm, Melksham**

### **Remediation Strategy**

P1418/CS-2957

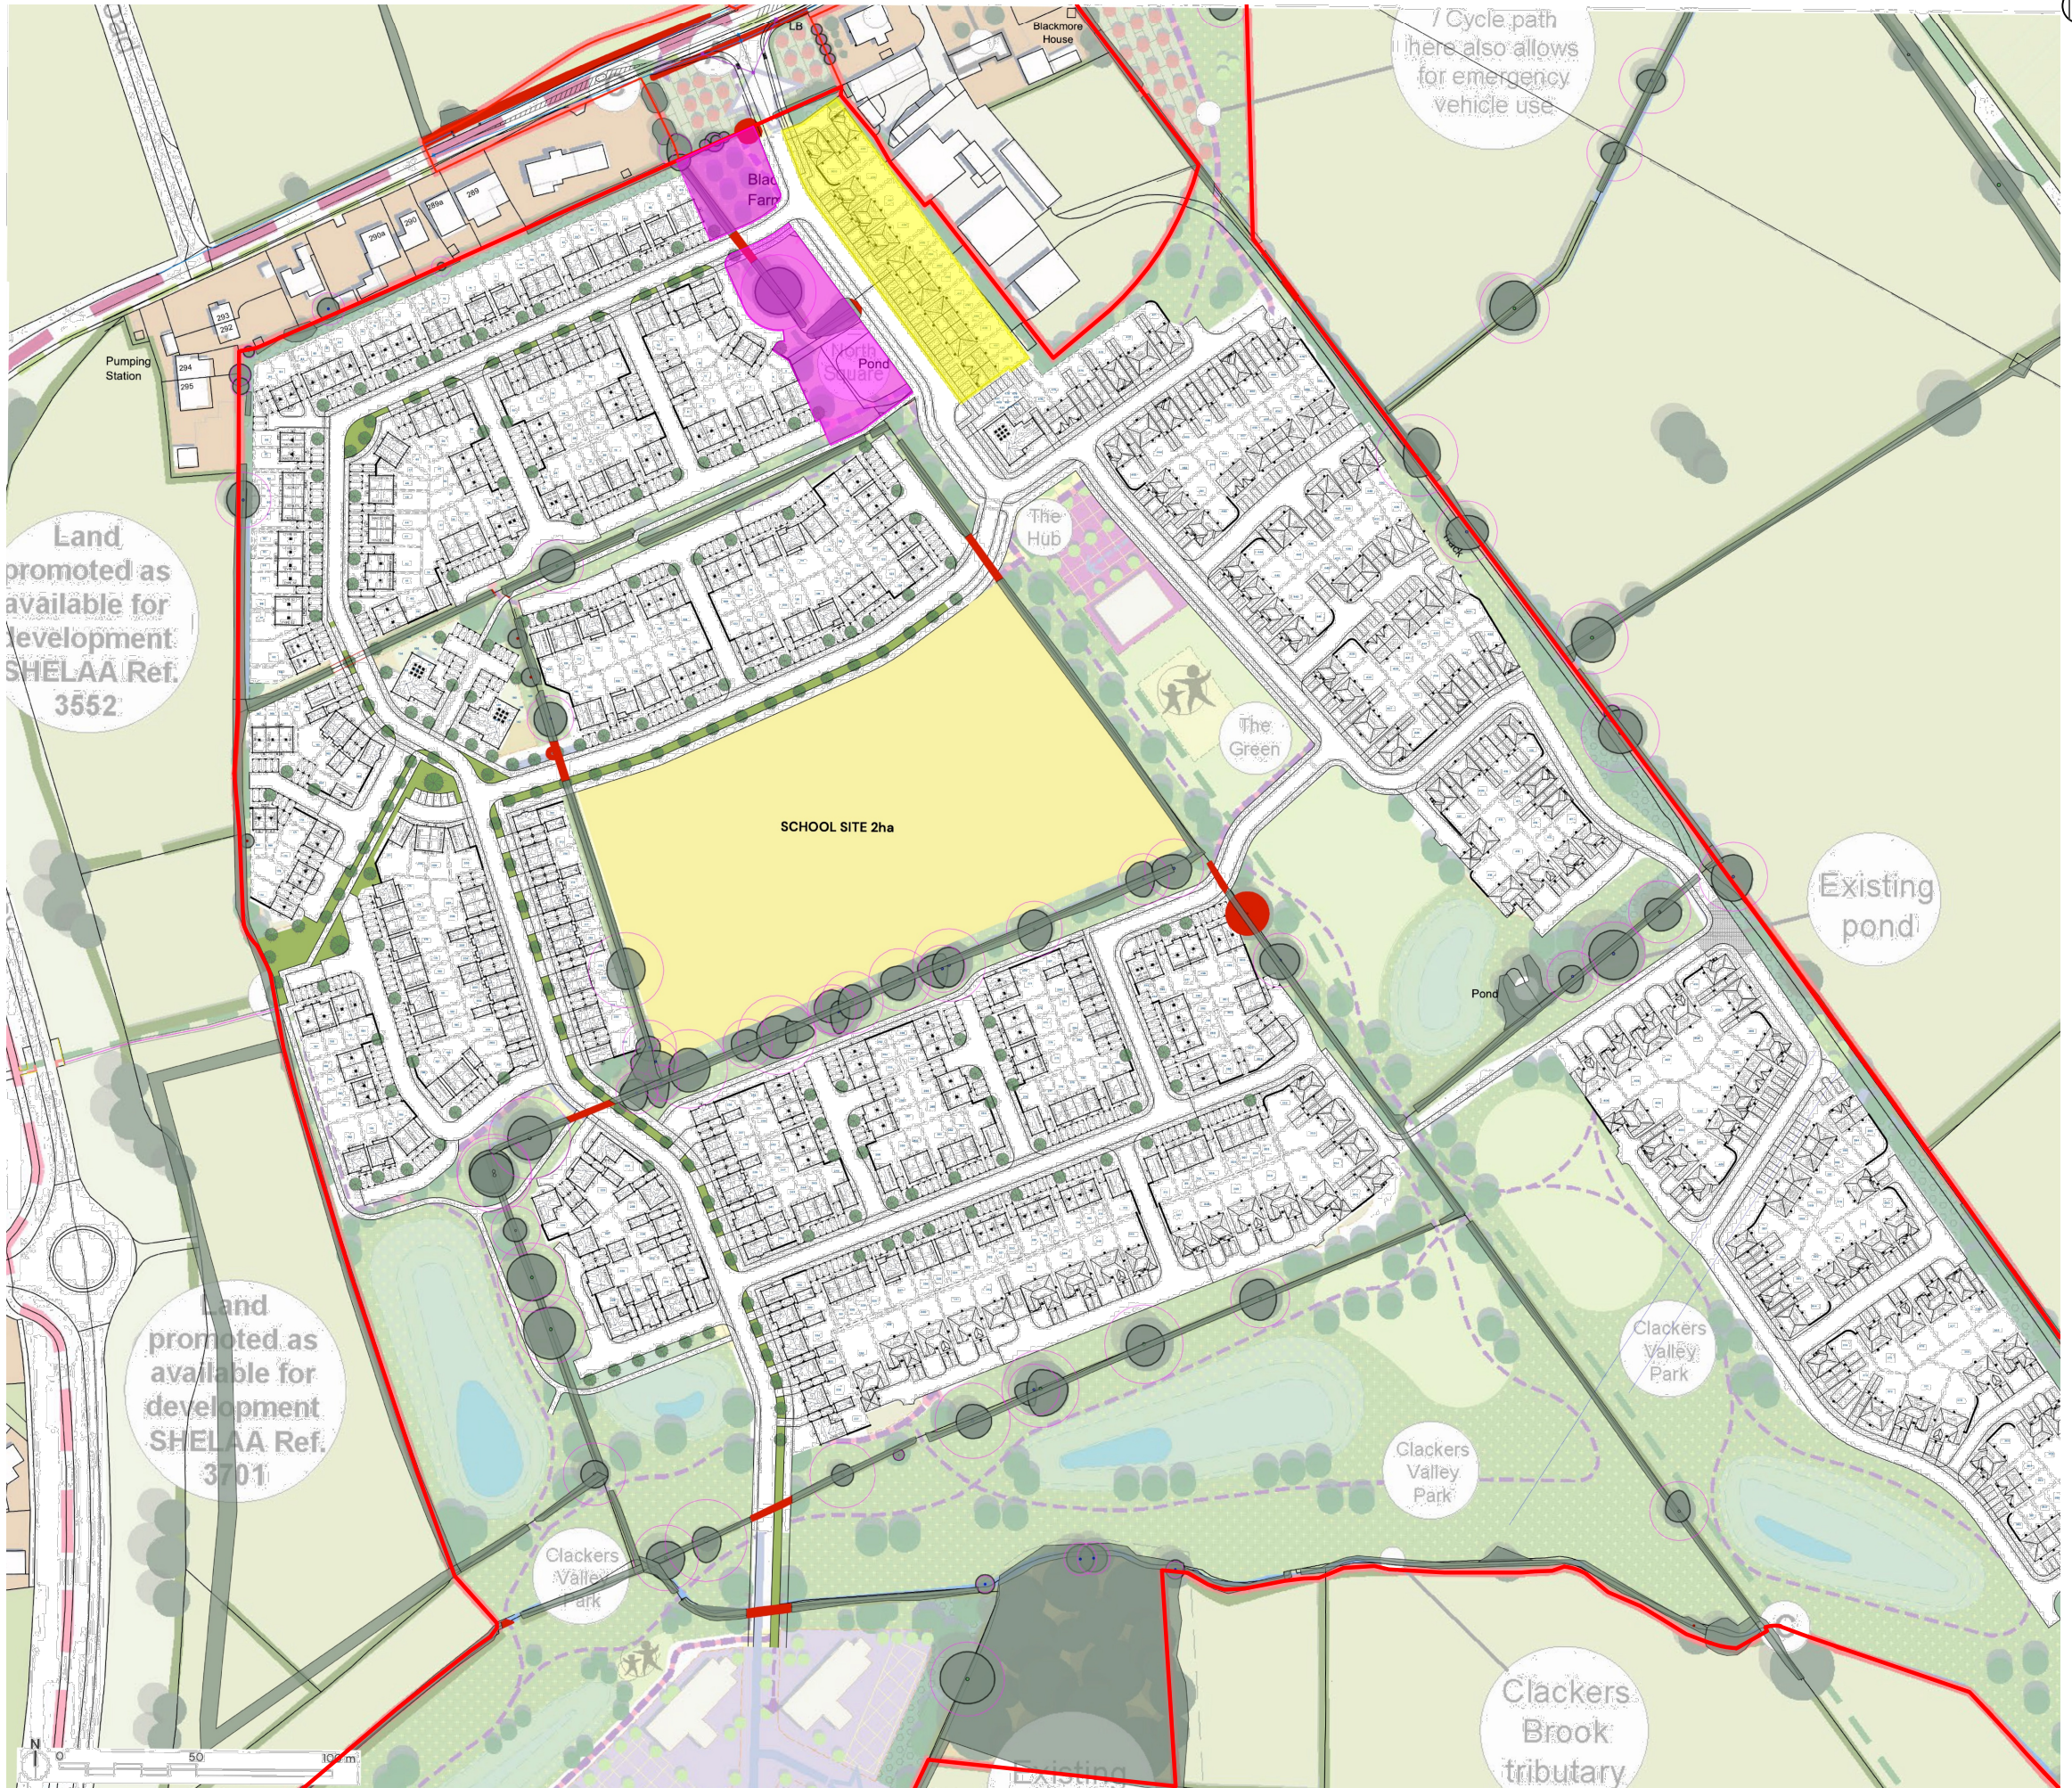
Base Map  
Company: - Pegasus Group  
DWG Title: - Combined Testing Layout  
DWG Number: - P24-2928\_DE\_07\_A\_01  
Date: - 17/09/2025

Areas of Soft Landscaping – Front and Rear Gardens Plots 486 – 500 (Farmyard Area):

General Recommendations

- The 'no dig' barrier shall comprise a minimum 150mm thickness of crushed aggregate with an underlying high visibility geotextile marker. For example, where private rear gardens are located in the vicinity of deep asbestos impacted soils, capping shall comprise a minimum 600mm of chemically and physically suitable soils, underlain by a minimum 150mm of aggregate, in turn underlain by a geotextile marker
- PE water supply pipework shall be used within the development.
- Any positively identified or suspected contaminated soils shall be stockpiled upon an impermeable barrier to mitigate the potential for cross contamination of underlying soils.

- In the defined areas of proposed private soft landscaping as shown on the plan within Appendix A, made ground shall be removed down to 600mm below finished level, with levels reinstated to reflect engineering requirements utilising chemically and physically suitable topsoil/sub-soil, as detailed within Section 6.1. A high visibility geotextile shall be provided at the base and sides of excavations as a marker layer.
- In addition to the remedial measures detailed within the preceding sections, a physical 'no-dig' barrier shall be provided below clean cover in areas where asbestos impacted soils have been positively identified and are to remain *in situ* > (0.6mbgl) at the base of the capping excavation.

- In the defined areas of communal soft landscaping as shown on the plan within Appendix A, made ground shall be removed down to 300mm below finished level, with levels reinstated to reflect engineering requirements utilising chemically and physically suitable topsoil/sub-soil, as detailed within Section 6.1. A high visibility geotextile shall be provided at the base and sides of excavations as a marker layer.

- In addition to the remedial measures detailed within the preceding sections, a physical 'no-dig' barrier shall be provided below clean cover in areas where asbestos impacted soils have been positively identified and are to remain *in situ* (>0.3mbgl) at the base of the capping excavation.

- The 'no dig' barrier shall comprise a minimum 150mm thickness of crushed aggregate with an underlying high visibility geotextile marker. For example, where private rear gardens are located in the vicinity of deep asbestos impacted soils, capping shall comprise a minimum 600mm of chemically and physically suitable soils, underlain by a minimum 150mm of aggregate, in turn underlain by a geotextile marker
