**RE: Letter report for the results of the Preliminary Ecological Appraisal and Preliminary Roost Assessment at 69-70 Silkhouse, Cote Lanes, Kilmington, Wiltshire, BA12 6QZ.**

Thank you for instructing LC Ecological Services Ltd to conduct a Preliminary Ecological Appraisal (PEA) and Preliminary Roost Assessment (PRA) in respect of your plans to repair and refurbish the cottage and storeroom at 69-70 Silkhouse, Cote Lanes, Kilmington, Wiltshire, BA12 6QZ.

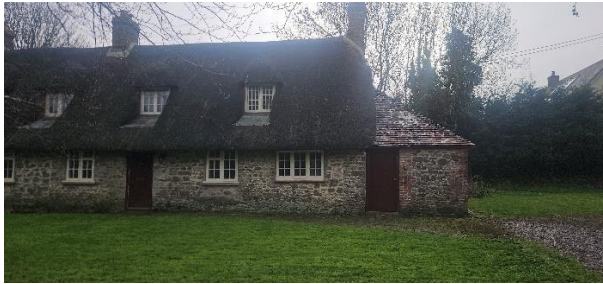
Photo 1: Northern elevation.

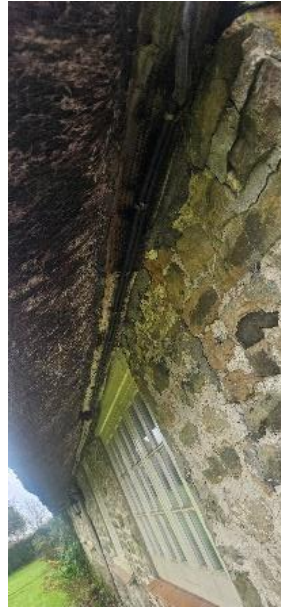
- Wooden fascias are present on the northern and southern elevations and appear well sealed.
- A small gap is present above the fascia on southern elevation.

Photo 2: Closed eaves/fascia on northern elevation.

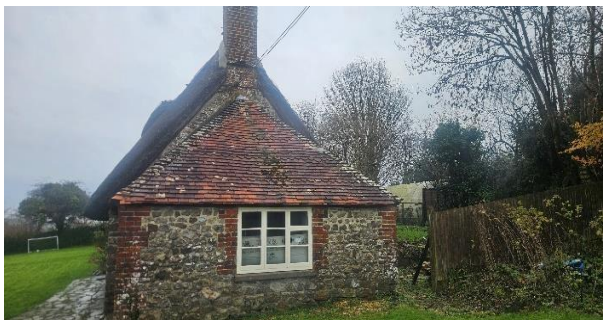
- The Storeroom is a one-storey brick and stone construction, with clay tiles on a hipped roof.
- There are several gaps underneath the tiles adjacent to the main cottage on the northern elevation. Gaps in the tiles were also recorded on the southern elevation and underneath bonnet tiles on the western elevation.
- Wooden beams are present internally, creating perching opportunities.
- Gaps in the tiles, located on the western and southern elevations, create access points into the storeroom.

Photo 3: Western elevation of the storeroom.

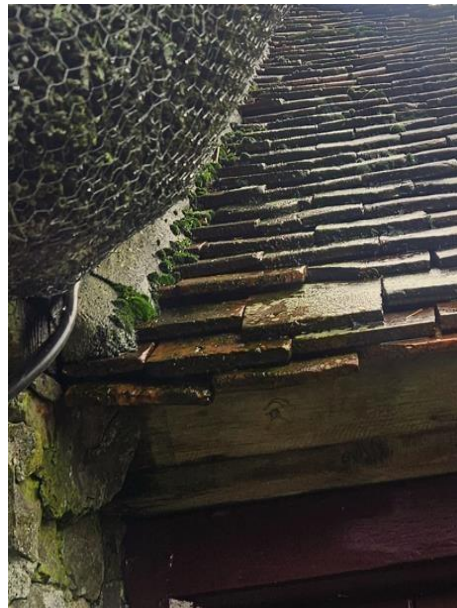
Photo 4: Gaps underneath tiles close to the cottage

In accordance with the Bat Conservation Trust (BCT) survey guidelines (Collins 2023), buildings with **low potential** require one dusk emergence between May and August and buildings with **moderate potential** require two dusk emergence surveys between May

and September, with at least one survey between May and August. Surveys must be spaced a minimum of three weeks apart.

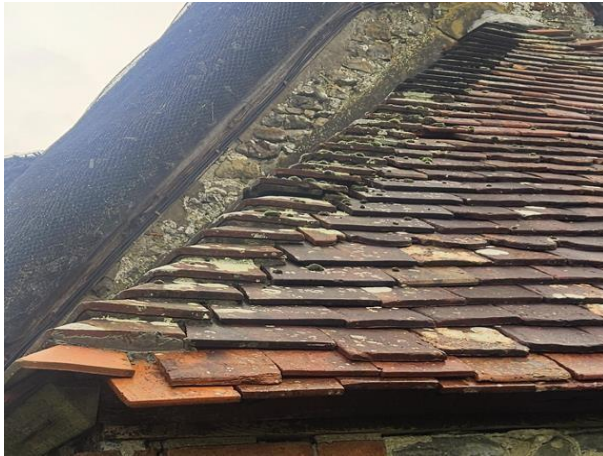
Photo 5: Gaps underneath bonnet tiles and raised main tiles on western elevation of the storeroom.

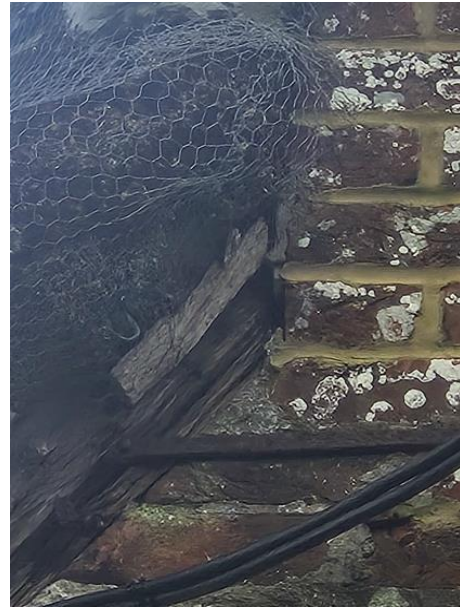
- Two internal chimney breasts are present. A gap is present on the western elevation of western-most chimney.
- No roof lining is present, with visible thatch between the rafters.

Photo 6: Gap on the western elevation of the cottage.

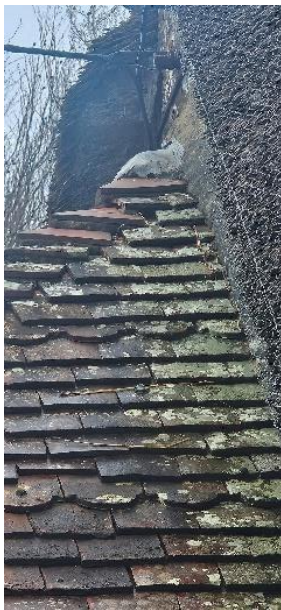
Photo 7: Gaps underneath tiles on the southern elevation of the storeroom.

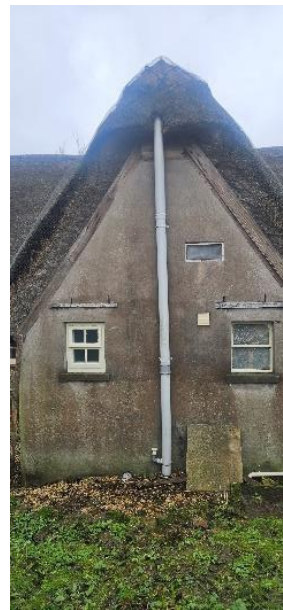
Photo 8: South elevation of the cottage.

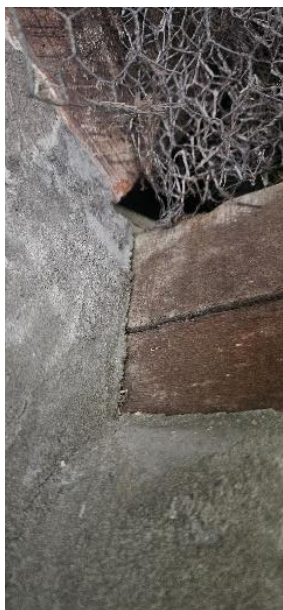
Photo 9: Small gap above fascia on southern elevation.

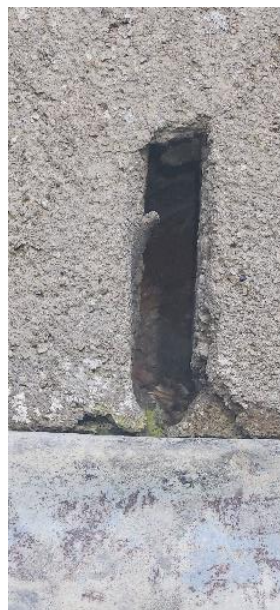
- Gaps are present in the render on the southern extension.
- A bird's nest was noted on the southern elevation in between the wiring and the thatch.
- There are two voids within the main cottage. Neither void was safe to fully enter as no boarding was present and therefore descriptions were taken from the hatch.

Photo 10: Close up of the gap in the brickwork/render on the southern elevation of the cottage.

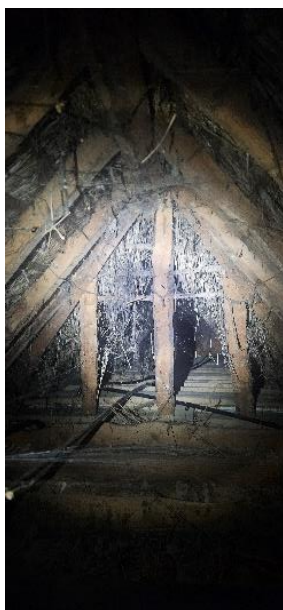
- The roof voids measured approximately 2 metres wide by 1 metre height at the apex.
- No light ingress was observed with the voids appearing very dark and well-sealed.

Photo 11: Looking west in the cottage void.

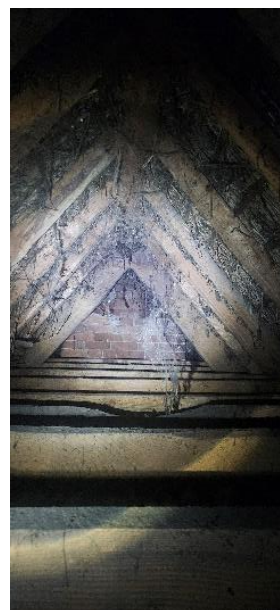
- The voids were heavily cobwebbed.
- No evidence of bat was observed.
- The cottage was assessed as holding **low** potential to support roosting bats, due to the limited access points.

Photo 12: Looking east along the cottage void, heavily cobwebbed.

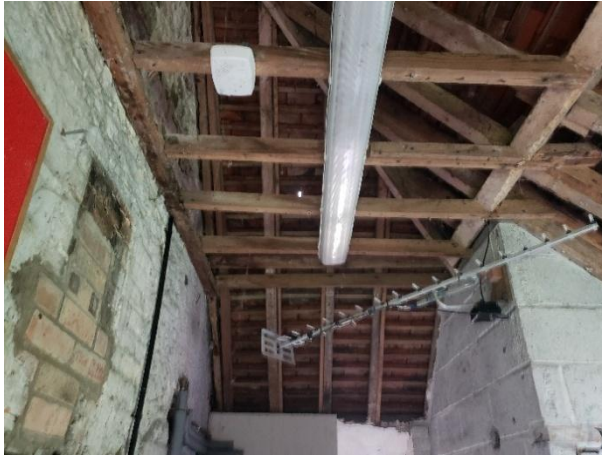
- Crevices between the wooden beams and wall provide roosting opportunities for crevice dwelling bats.
- The storeroom was assessed as holding **moderate** potential to support roosting bats due to the multiple access points and perching opportunities.

Photo 13: Internal south elevation of the storeroom.

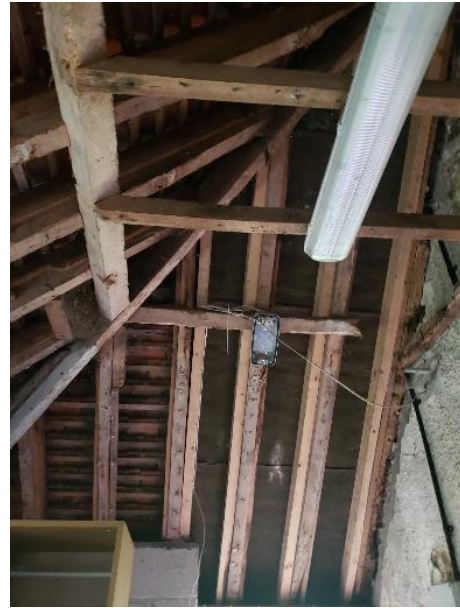
Photo 14: Internal north elevation of the storeroom.

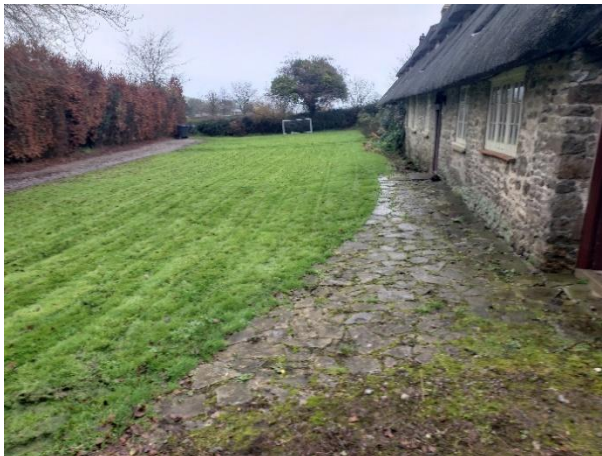
The front lawn comprises modified grassland with a few herbaceous species. It is well-managed with a sward height of proximately five centimetres at the time of survey. The front garden is comprised dominant creeping bent, with occasional red fescue (*Festuca rubra*), perennial ryegrass (*Lolium perenne*), oxeye daisy (*Leucanthemum vulgare*) and creeping buttercup (*Ranunculus repens*).

Photo 15: Front garden, on the northern side of the site.

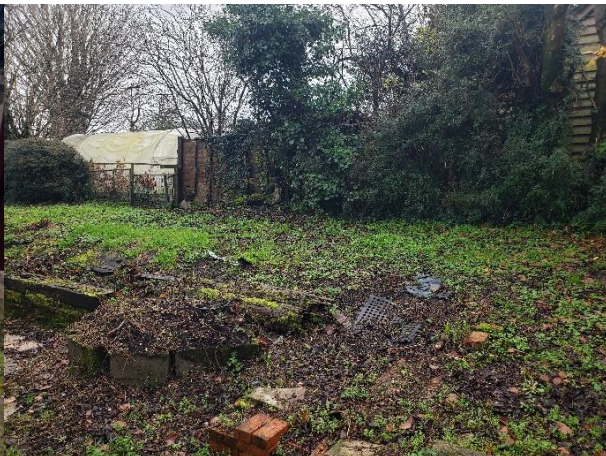
The lawn is sparse and disturbed in places with young grass and herbs growing through. The rear garden is managed with a sward height of proximately five centimetres at the time of survey. The rear comprised dominant creeping bent (*Agrostis stolonifera*), with abundant cleavers (*Galium aparine*), frequent and locally dominant ivy (*Hedera helix*), frequent cock's-foot (*Dactylis glomerata*), herb Robert (*Geranium robertianum*), wood avens (*Geum urbanum*) and common nettle (*Urtica dioica*) with locally frequent honeysuckle (*Lonicera periclymenum*), occasional pendulous sedge (*Carex pendula*), broad-leaved dock (*Rumex obtusifolius*), hogweed (*Heracleum sphondylium*) and *Chrysanthemum* species. With rare sycamore (*Acer pseudoplatanus*) along the southern boundary. The remnants of gravel and stones are present directly adjacent to the house. A fence is present along part of the southeast boundary.

Photo 16: Rear garden, on the southern side of the site.
