# The Three Daggers, Edington

## Ecological Impact Assessment

November 2025

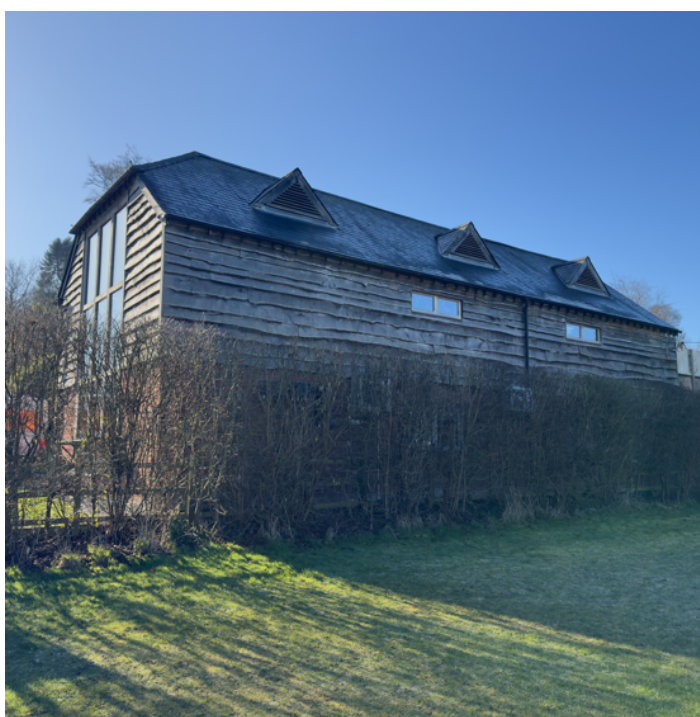
**Figure 3** - The northern elevation also showing hazel hedgerow

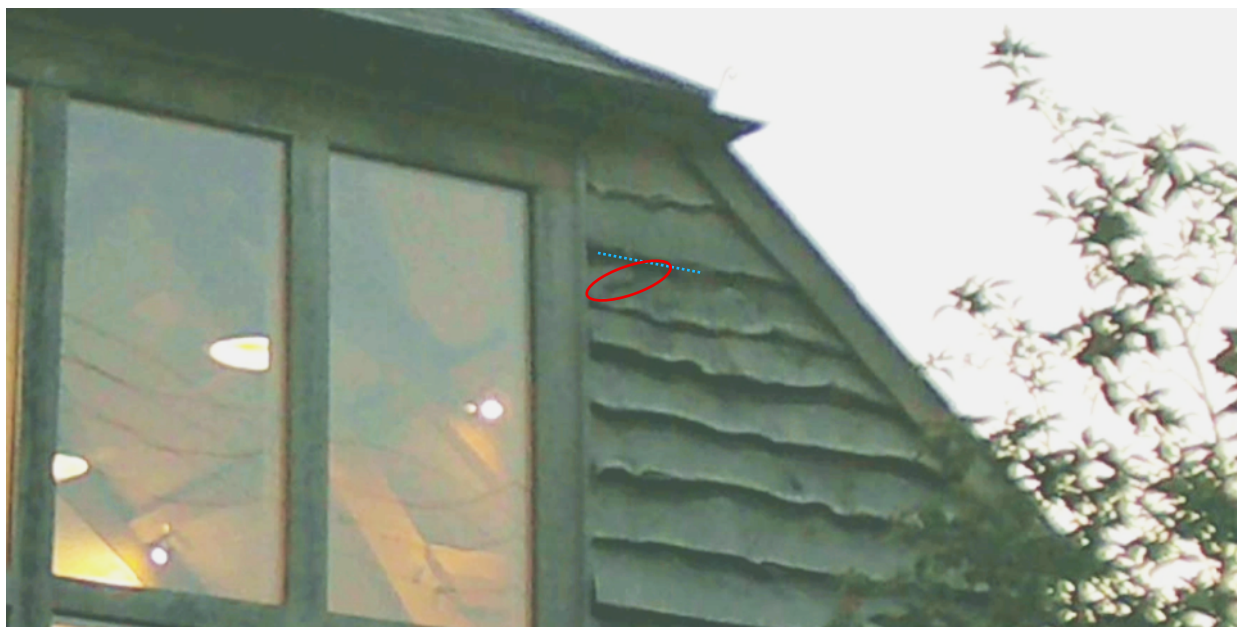
43. A single soprano pipistrelle bat emerged from between the 2<sup>nd</sup> and 3<sup>rd</sup> timber board down from the apex of the eastern elevation hereby referred to as “**Roost 1**” (**Figure 4**).

**Figure 4** – BE1 / 9<sup>th</sup> August 2025 - Screenshot showing emerging soprano pipistrelle (red circle) and roost emergence location (blue dotted line)

- b. During works a precautionary 1m buffer around each confirmed roost access point should be maintained during works to avoid any accidental damage to the roosts.

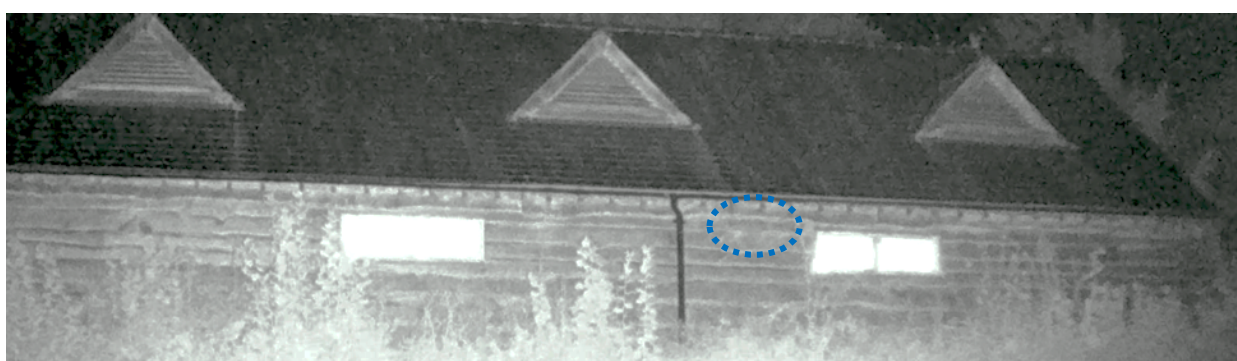
**Figure 7** – Location of potential re-entry of an individual likely *Pipistrellus* sp. bat at northern elevation showing general area of possible re-entry location (dotted blue circle)

47. Two bat roosts were identified during the survey:
  - a. **Roost 1** (an individual soprano pipistrelle day roost);
  - b. **Roost 2** (an individual likely *Pipistrellus* sp. day roost)
48. One additional possible individual (likely *Pipistrellus* sp.) day roost was identified at the northern elevation but could not be confirmed during the surveys.
