Oldbury House, Labour-In-Vain Hill, Calne  
Preliminary Roost Assessment (PRA)

*For Mr. Matthew Taylor*

9<sup>th</sup> December 2025

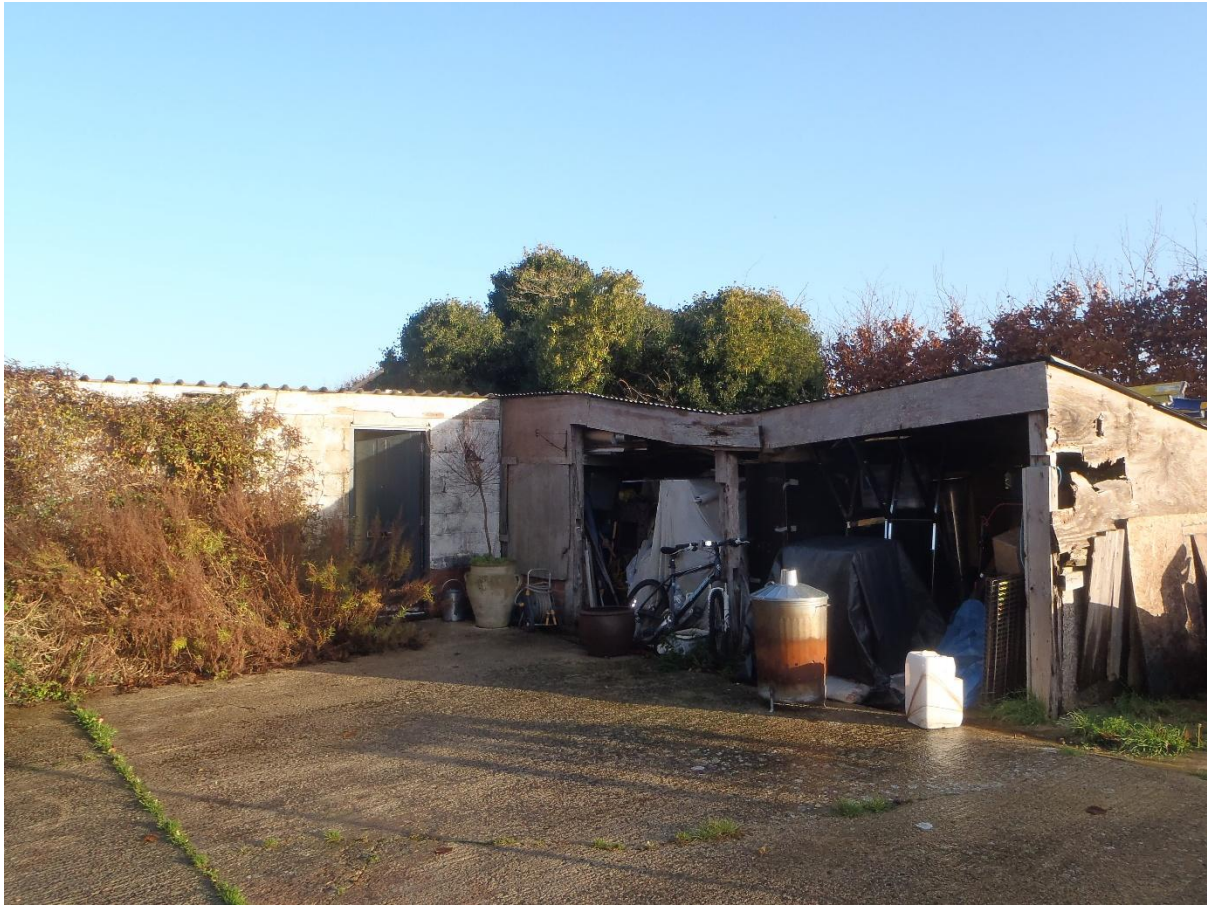
The target buildings are a combination of storage sheds of various constructions located within the curtilage of Oldbury House. To the north of the target buildings there is a gravel driveway and car parking. To the west and south there is a hardstanding patio associated with Oldbury House which is located to the west of the target buildings. Along the eastern side of the target buildings there is a strip of amenity grassland and scattered trees, beyond which is agriculture farmland used for growing arable crops.

*Photograph 1: showing a view of the target buildings (looking north)*

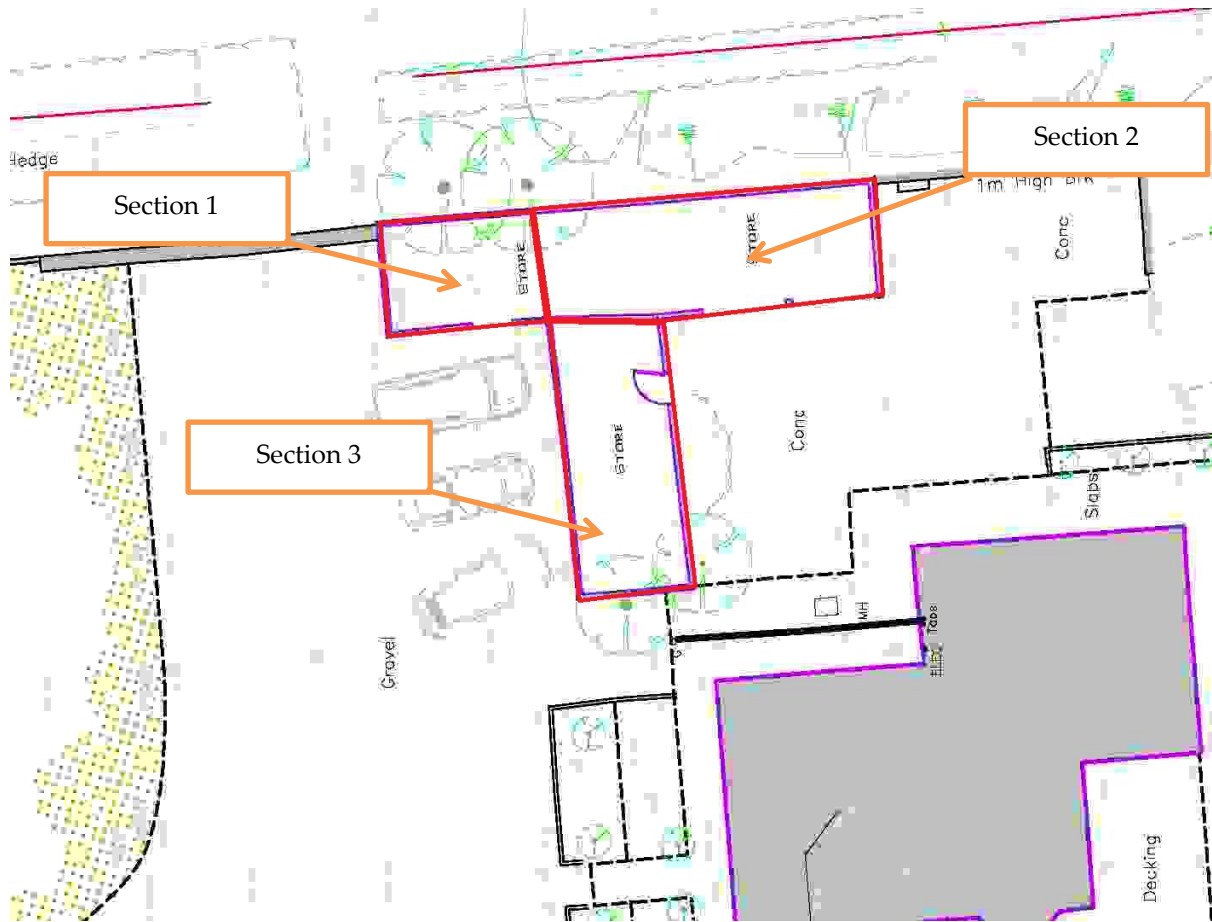
For the purposes of the physical bat survey, the target buildings have been split into three distinct sections based on access and the building construction. This is shown on Figure 2.

Figure 2: showing the building sections

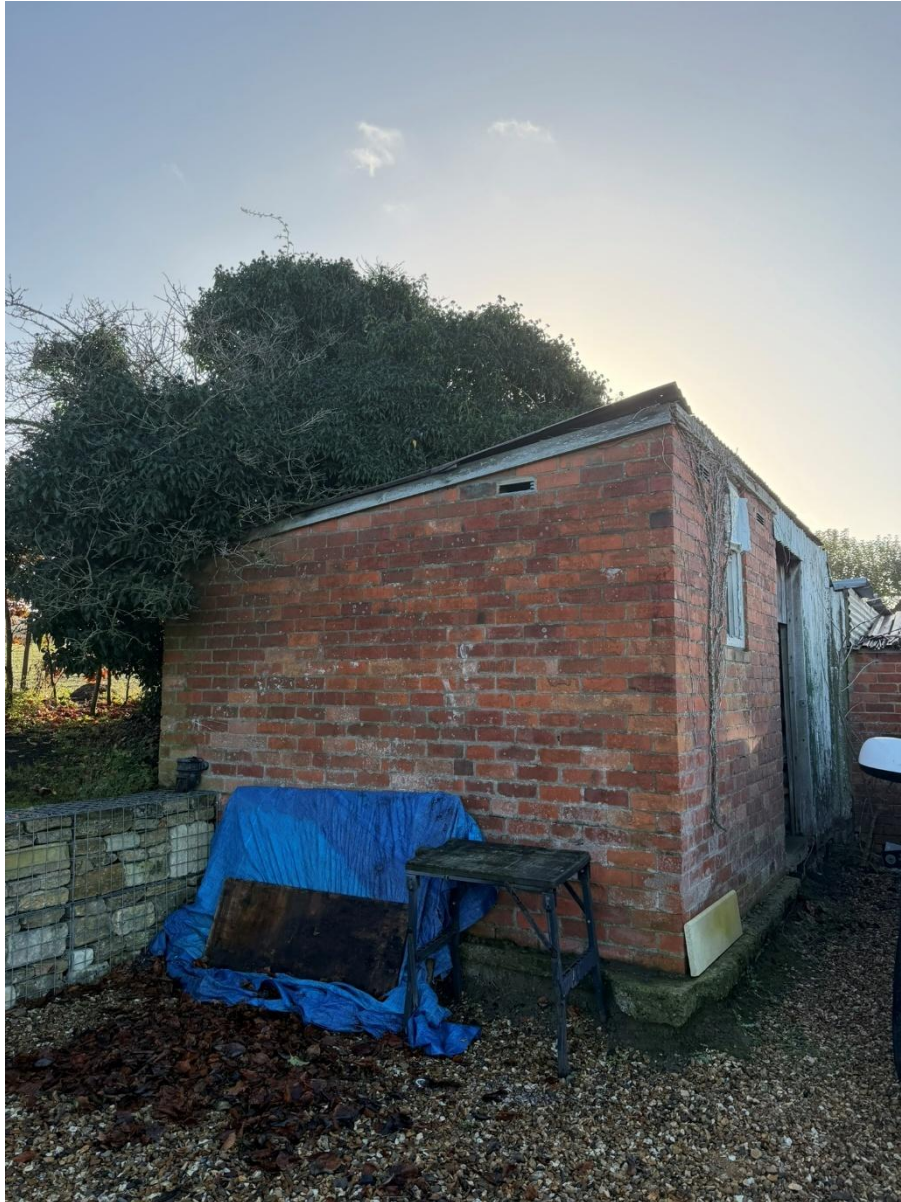
'Section 1' is located to the north-east and is constructed from red brick with a timber frame roof covered with corrugated metal sheets which slopes to the east. Externally the walls of this section were found to be in good condition; however, gaps were noted around the roof, and a door on the western side was open. Holes were also found in the roof structure which allow in wind and rain, thus making the internal areas of this section cold and damp. No evidence of bat activity such as droppings, staining or feeding remains was found on the external surfaces of this section.

Internally this section is used for the storage of logs and timber and no evidence of bat activity such as droppings or feedings remains were found. Wood timbers that make up the roof supports were found to be wet and rotten in places and therefore provide no suitable roosting for bat species.

This section of the building is assessed as providing Negligible Roost Potential and no evidence of bat activity or roosting bats was found during the survey.

*Photograph 2: showing a view of Section 1 of the building*

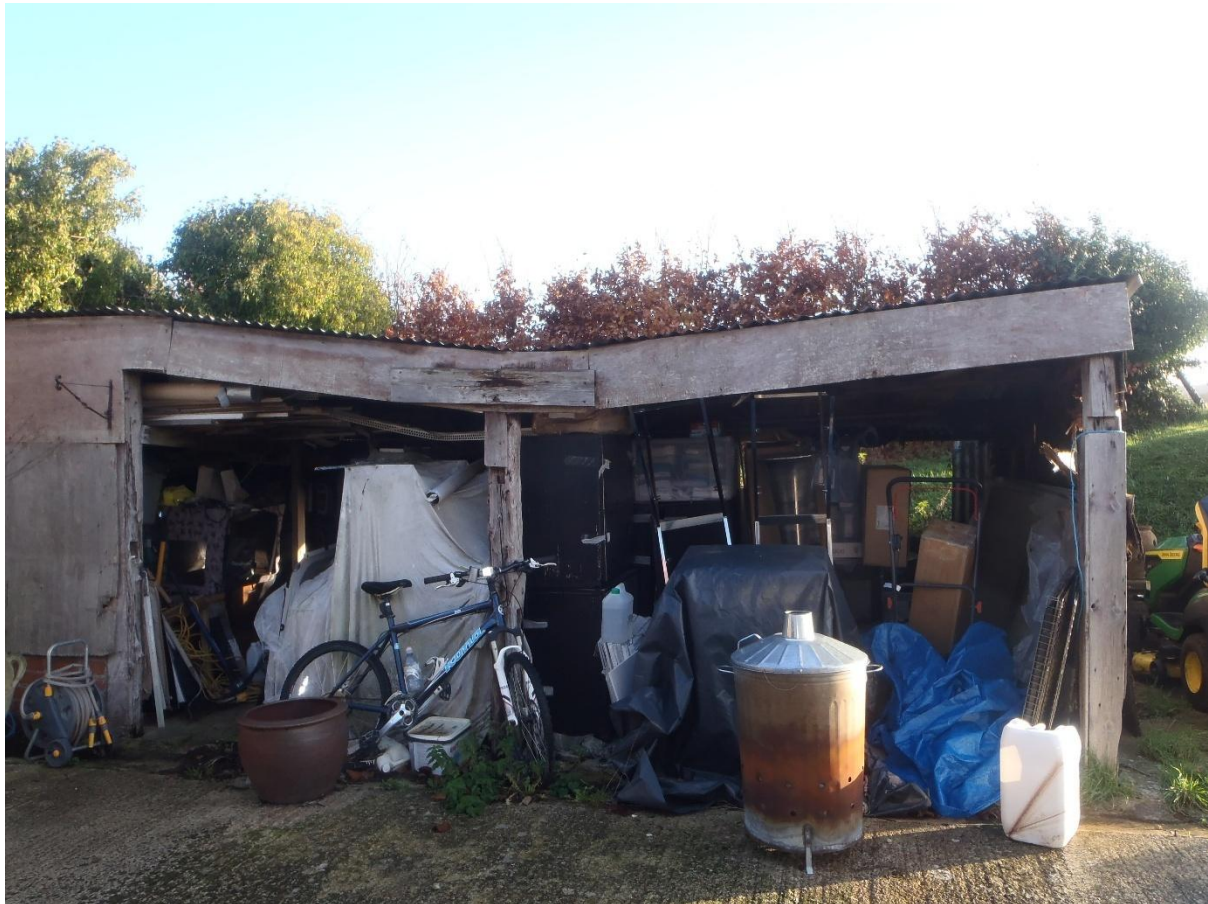
'Section 2' of the building is located to the south-east and is an open structure comprised of a wooden frame with wooden boarding, corrugated metal sheets on the sides and corrugated metal sheets on the roof. This section of the building is used for the storage of building materials.

*Photograph 3: showing a view of Section 2 of the building*

The section of the building is entirely open on the western side and large holes were noted in the walls where timber panels had fallen off. The remaining panels were found to be wet and rotten in places with many peeling away from the structure. Gaps were also found in the roof of the structure, below which damp areas were found.

The open nature of this section of the building makes it unsuitable for bats which require dry and stable conditions for roosting.

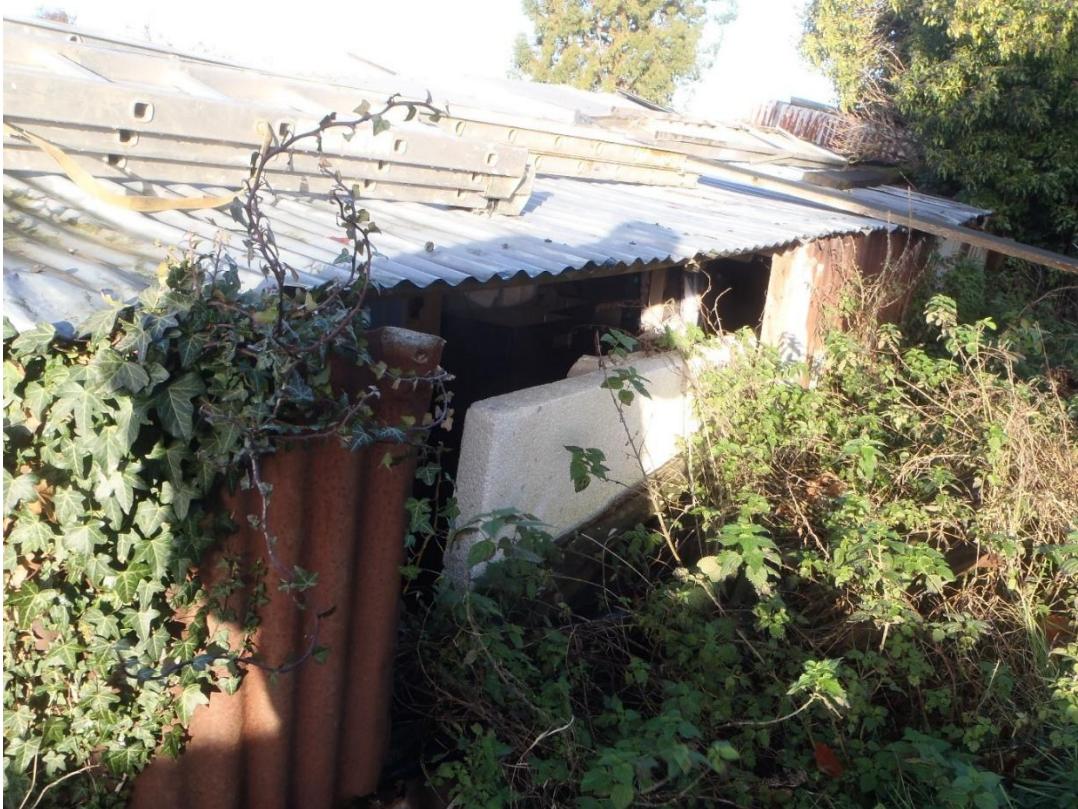
No evidence of bat activity such as droppings or feeding remains were found in this section which is assessed as providing Negligible Roost Potential for bats. Droppings from mice *Mus musculus* were observed in the structure and anecdotal evidence collected at the site suggest rats *Rattus sp.*, may also be found here.

*Photograph 4: showing a view of the rear of Section 2 of the building*

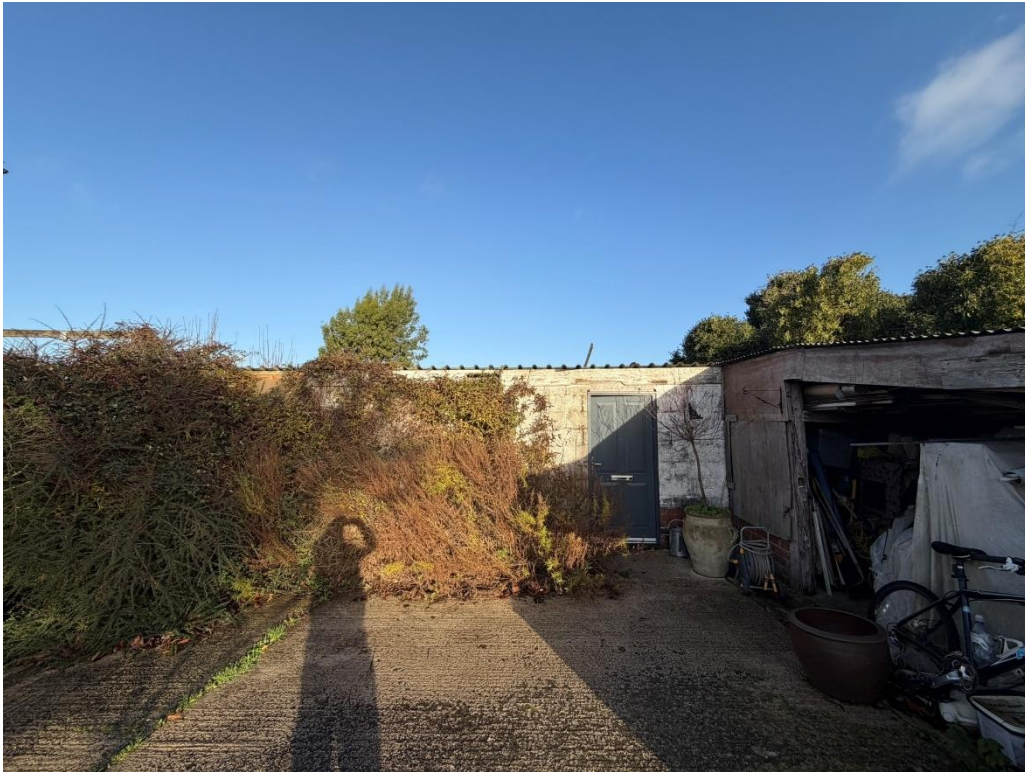
'Section 3' of the building is located to the west and is constructed from red brick and breeze block. The walls were found to be in a good condition; however, some gaps/cracks were found on the north-western corner. Some vegetation is present along the southern wall; however, it is unlikely this hides any further gaps/cracks. The gaps/cracks were inspected for evidence of bat activity and none was found. It was noted that the gaps lead into the internal structure of the building as the walls are only one brick thick in this location. It was however noted that security lighting was present above the gaps/cracks which will illuminate the structure and will therefore deter bats.

*Photograph 5: showing a view of Section 3 of the building*

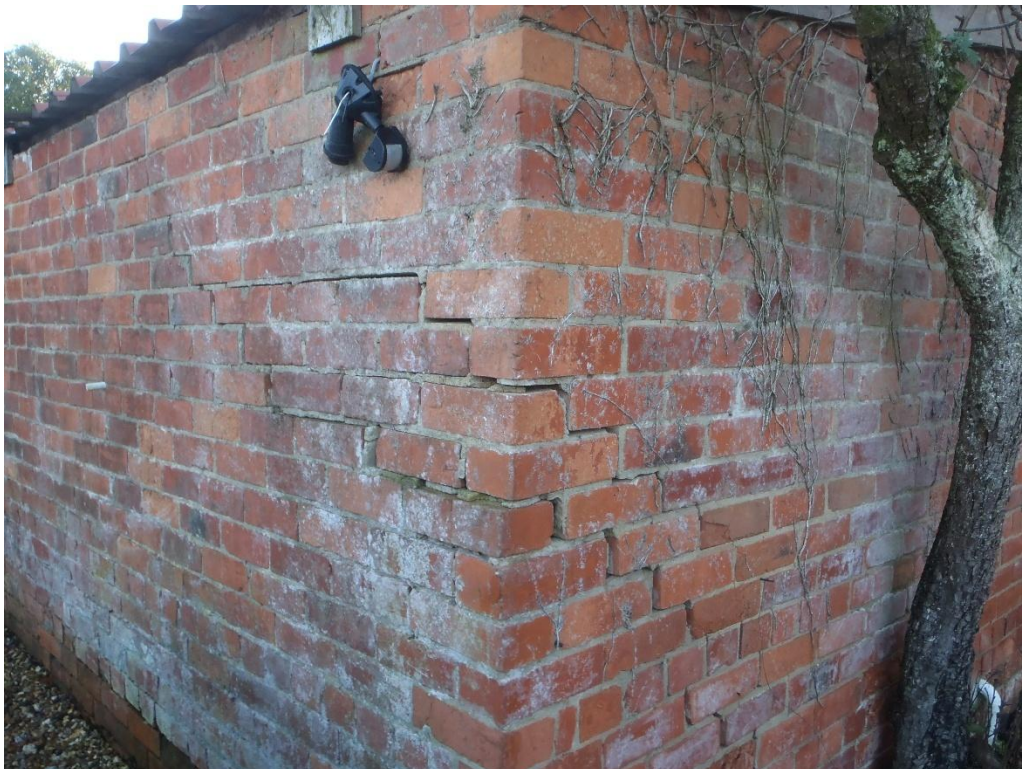
*Photograph 6: showing gaps in the wall of Section 3 of the building*

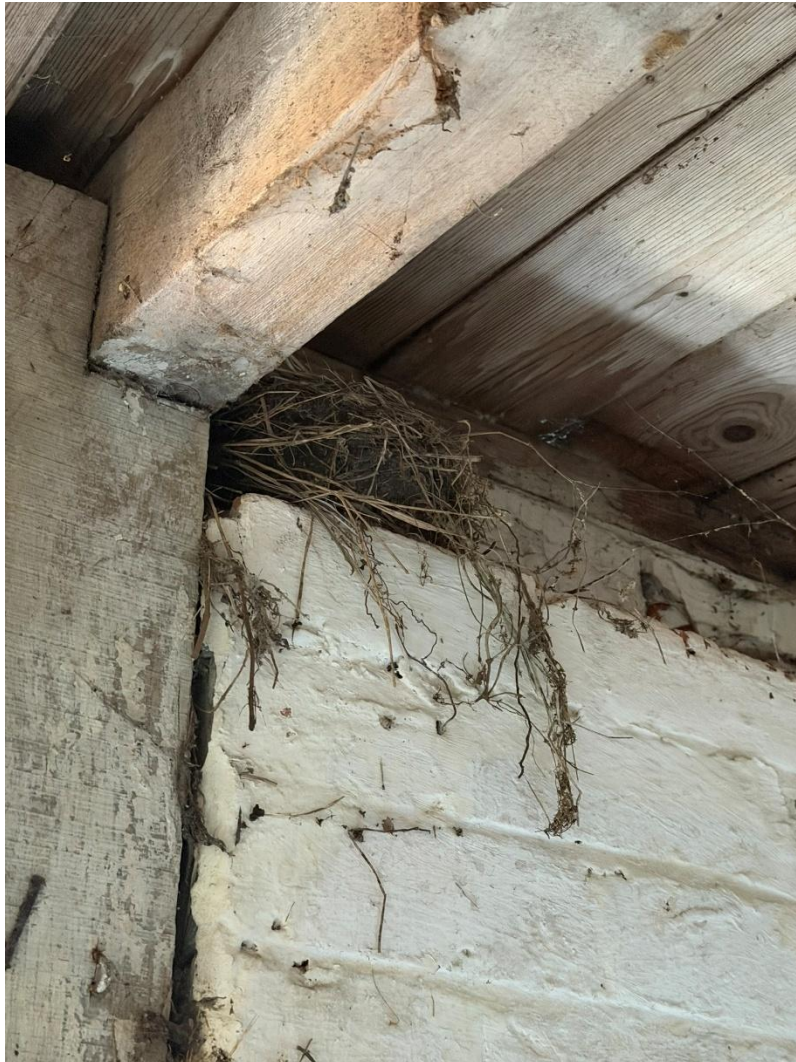
Evidence of nesting birds was found during the survey in Section 1 where an old wren *Troglodytes troglodytes* nest was identified on the wall of the building. Given the timing of the survey, this was not active; however, the building remains suitable to provide nesting habitat for birds.

*Photograph 8: showing a bird's nest within Section 1 the target building*

Evidence of nesting birds was found during the survey with a wren nest identified in Section 1; however, the nest was not active at the time of the survey.

Works should be undertaken out with the breeding bird season (March – August, inclusive), as all nesting birds are protected under the Wildlife and Countryside Act 1981 (as amended).

If works are undertaken within this period, a nesting bird survey would be required no more than 24 hours prior to the works. If nesting birds were found, these areas of the site would need to be protected from disturbance until the young have fledged naturally.
