# **Roost Assessment and Phase Two Bat Surveys**

**Park Cottage, East Grafton,  
Wiltshire, SN8 3DD**

24 September 2025

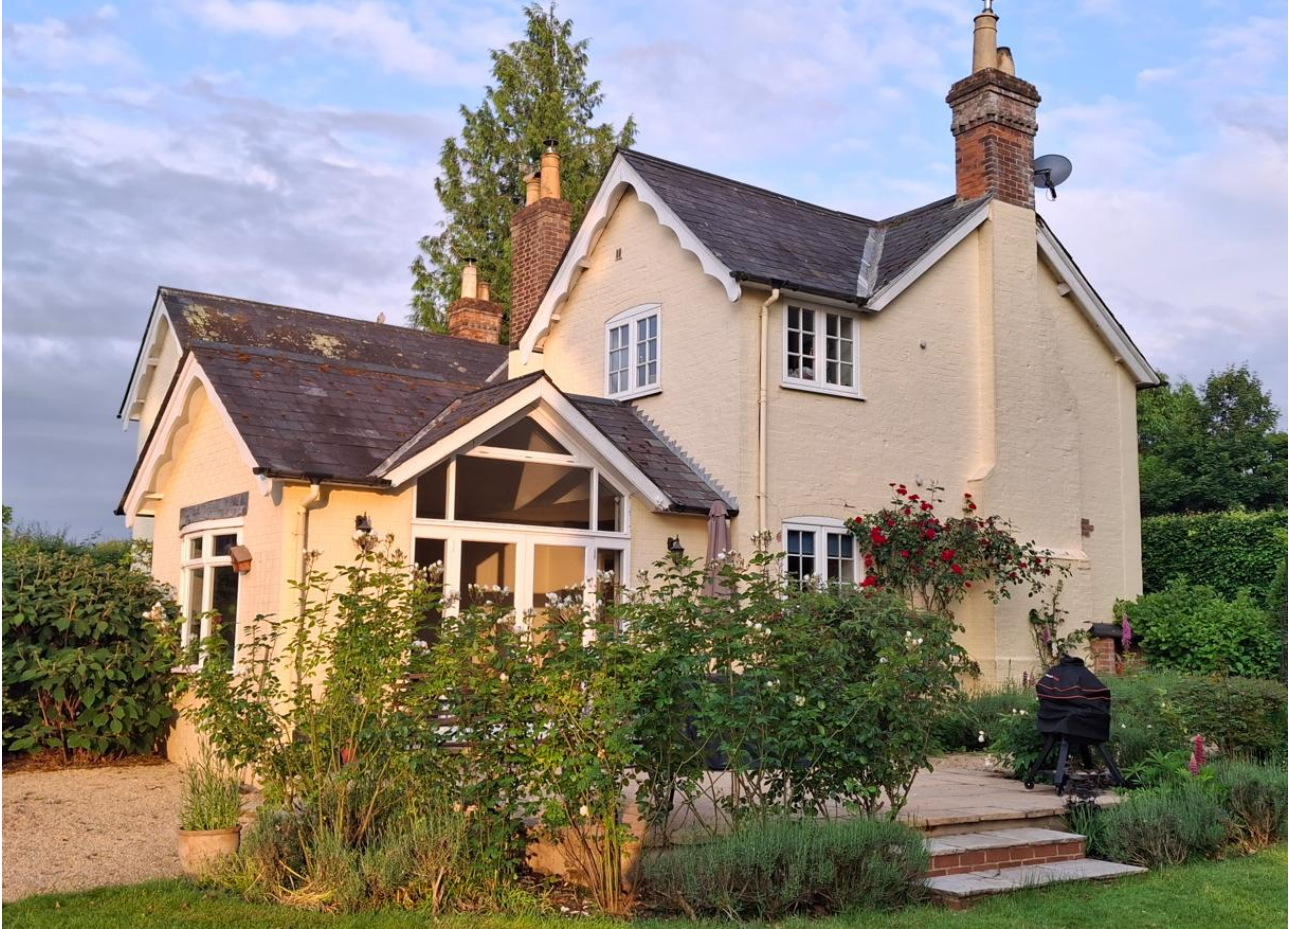
An inspection of the southern elevation found that the brickwork and mortar are in overall excellent condition. with windows and soffits all well fitted to the building and offering no bat roosting potential. On the roof, there are some gaps where tiles have lifted – particularly around the eastern chimney. Lead flashing is also present, both around the base of chimneys and vertically down roof valleys.

To the west, the soffit around the base of the chimney is showing signs of deterioration and offers potential bat access. The client reported that birds occasionally nest within the soffit here. At the lower left side of this gable end, there is a split in the soffit which present further bat roosting potential. Moreover, the roof tiles in this area offer gaps suitable for bat roosting.

**Figure 3: The northwest elevation of B1, with bat roosting potential identified around soffits**

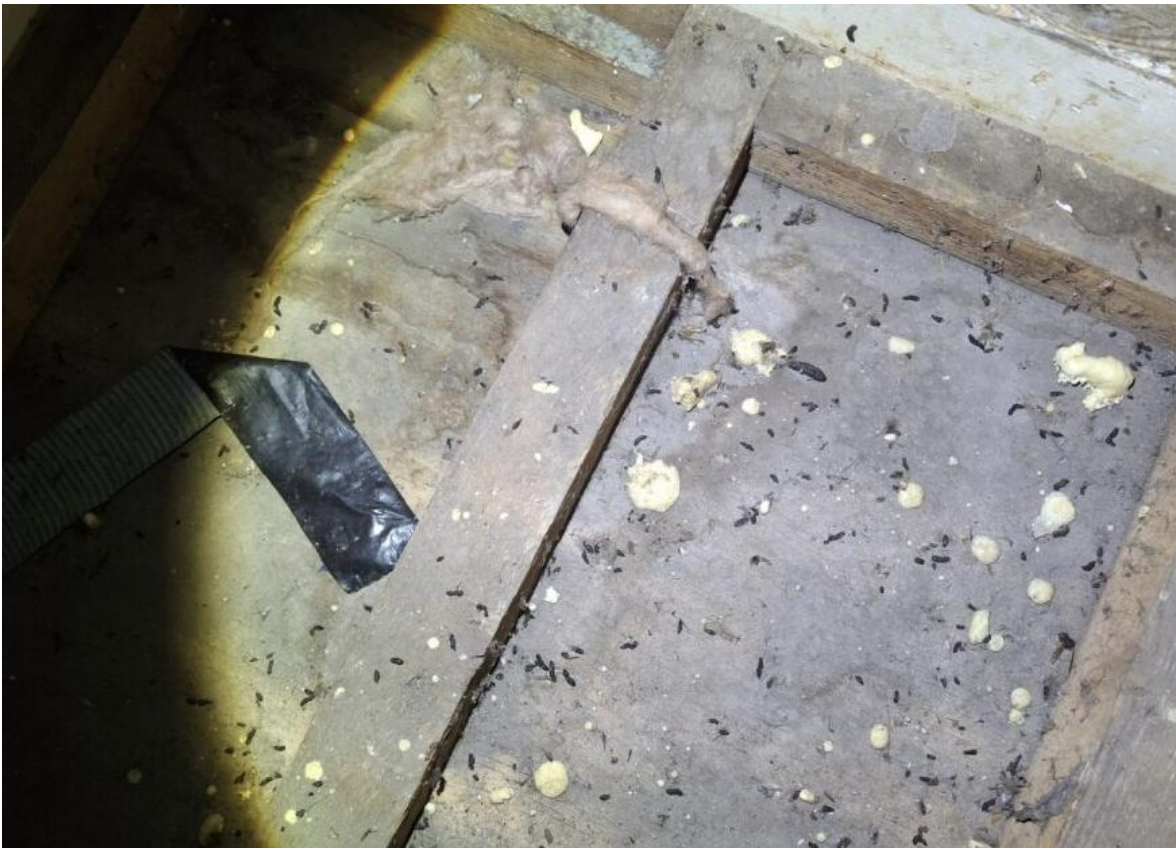
The loft space of B1 was accessed via a hatch on the second floor. A comprehensive inspection was undertaken, extending to both gable ends. No bats were observed during the survey; however, a substantial quantity of bat droppings - numbering in the thousands - was recorded across the loft insulation throughout the entire space.

**Figure 4: Thousands of droppings were present across the loft space**

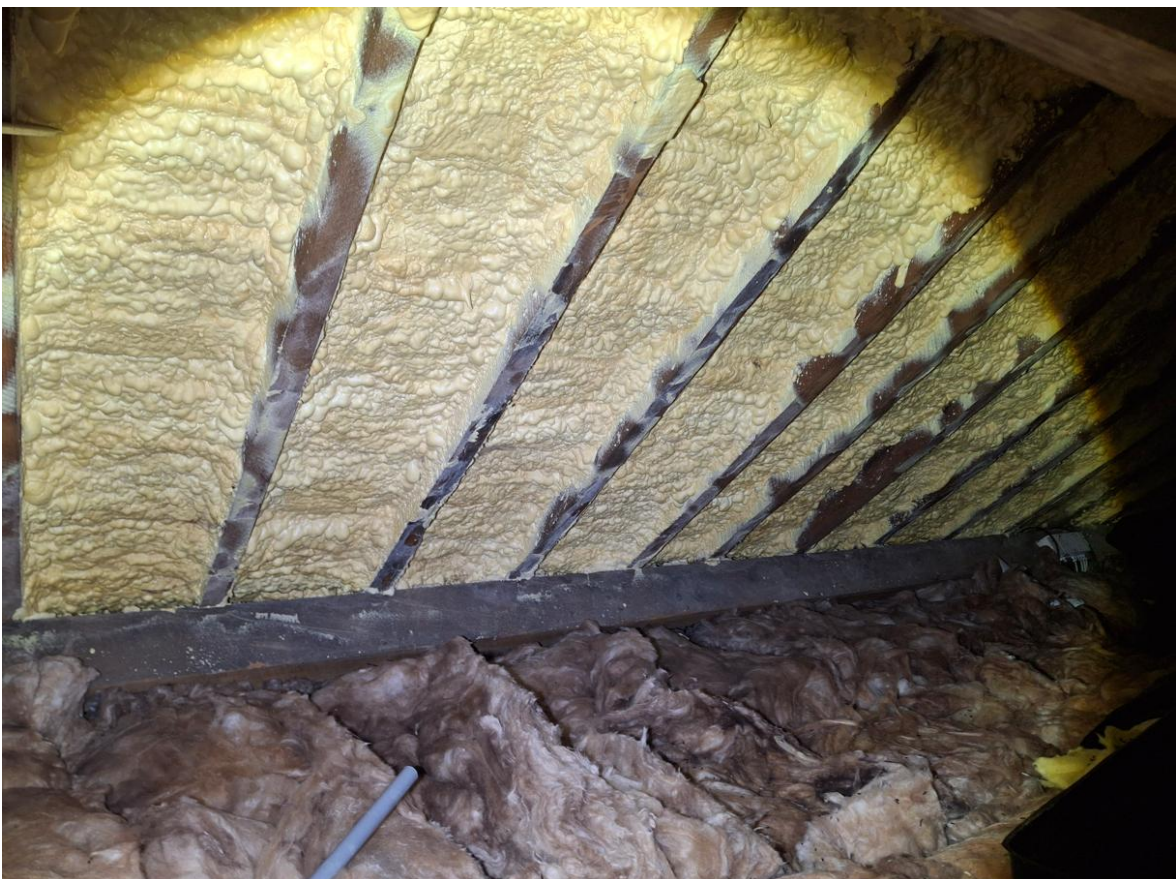
Most of the internal roof surface has been treated with spray foam insulation, effectively sealing off any potential ingress and egress points for bats across most of the loft void. Discussion with the client determined that the spray foam insulation was installed by the previous homeowner (an unknown period prior to November 2023).

**Figure 5: The loft has been sealed with foam insulation**

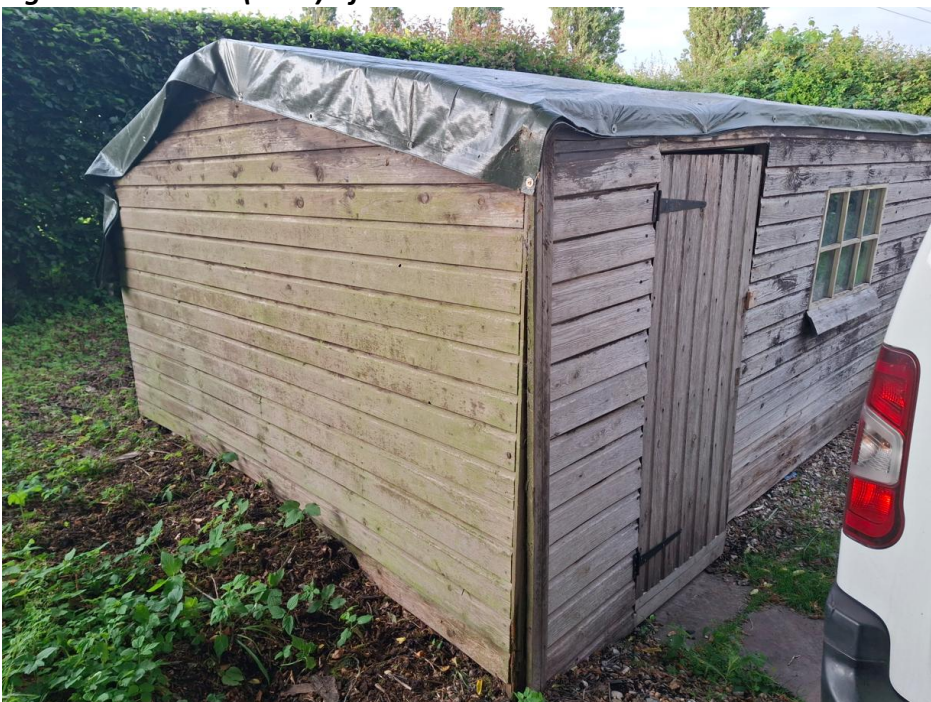
An internal inspection of B2 found no evidence of bats or bat activity. The interior is bright and draughty, providing suboptimal conditions for roosting bats. Externally, the plastic sheeting obscures the roof structure and would obstruct bat access to any potential roosting features.

**As such, B2 is assessed as having negligible bat roosting potential.**

***Figure 6: The rear (west) of B2***

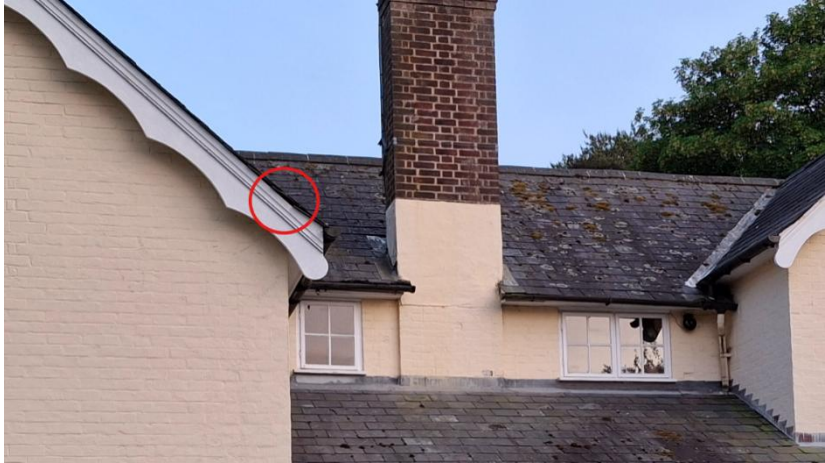
| | <p>No other species were heard or seen.</p> <p><b>Thermal Analysis</b></p> <p>Review of the full footage from the Pixfra Arc A613 thermal camera confirmed that the observations made during the survey were correct, and there was one emergence from the north elevation of Park Cottage.</p> |
| <b>Survey Summary</b> | <p>One common pipistrelle emergence from below a roof tile on the lower right side of the northeast gable end</p> |

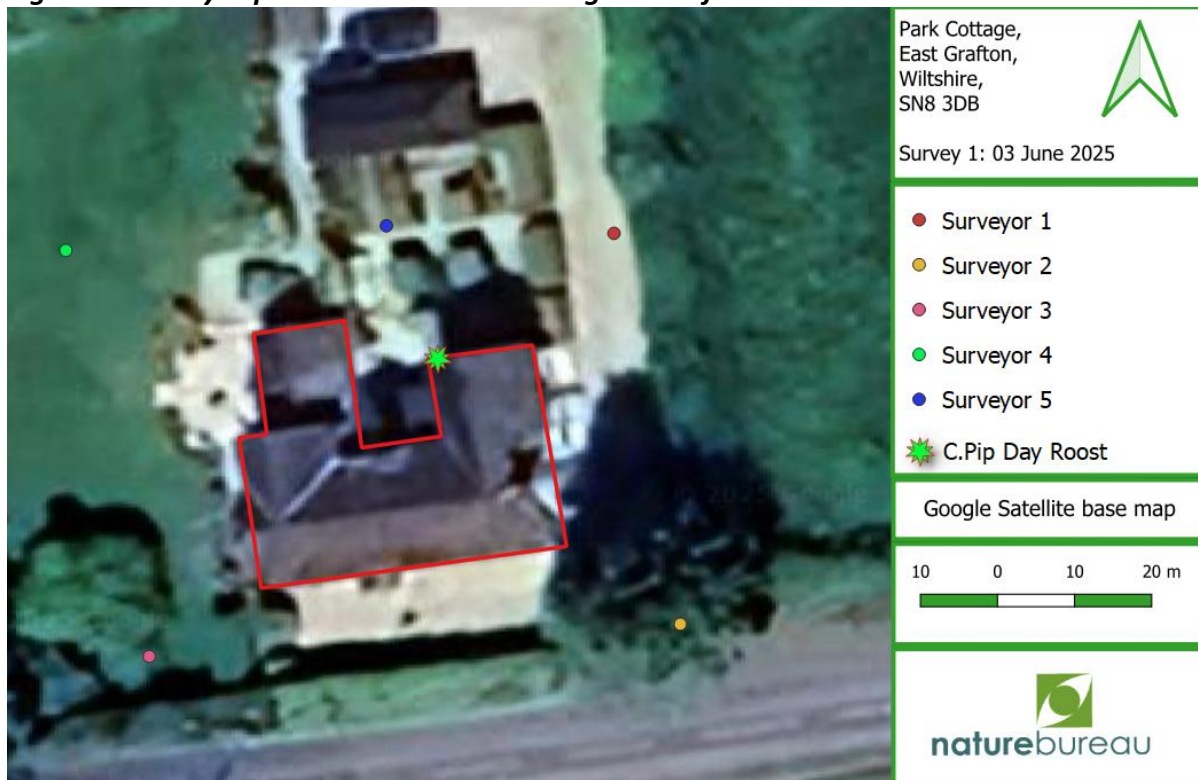
**Figure 7: Surveyor positions and bat roosting results from 03 June 2025**

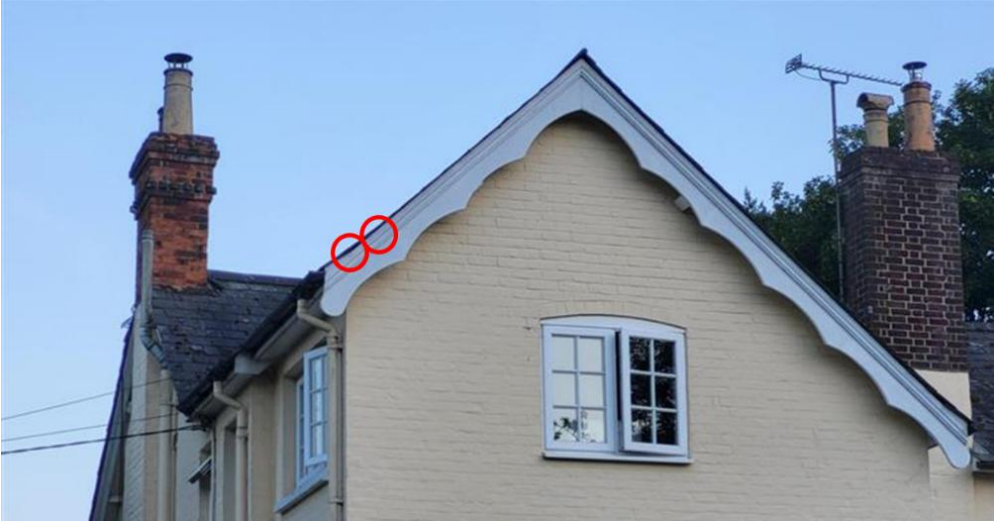
| <b>Surveyor 1</b> | <p>Athena Allen (BSc, MSc, ACIEEM), surveyor with three years' bat surveying experience.</p> <p><b>Two emergences from the northeast elevation of Park Cottage</b></p> <p>Activity began 20 minutes after sunset, at 21:49, when <b>a common pipistrelle bat emerged</b> from below a roof tile on the lower left side of the northeast gable end and flew west. <b>A second common pipistrelle emerged</b> from an area just below this one at 21:53.</p> <p>Common pipistrelles were then observed foraging and commuting across the site in several instances. At 22:14 a common pipistrelle flew north down the driveway from the road, at 22:31 one flew west from the neighbouring site across to the back garden, at 22:37 one was seen circling the back garden to the west of the property, and at 22:38 two bats were seen commuting along the northern border of the site.</p> <p>From 22:29 until the end of the survey, common pipistrelles were also frequently heard but not seen (HNS).</p> <p>At 22:35 a serotine was HNS and at 22:38 a noctule was HNS.</p> <p>No other species were heard or seen.</p> <p><b>IR Analysis</b></p> <p>Review of the full footage from the Nightfox Whisker camcorder confirmed that two emergences occurred from the northeast elevation of Park Cottage.</p> | |

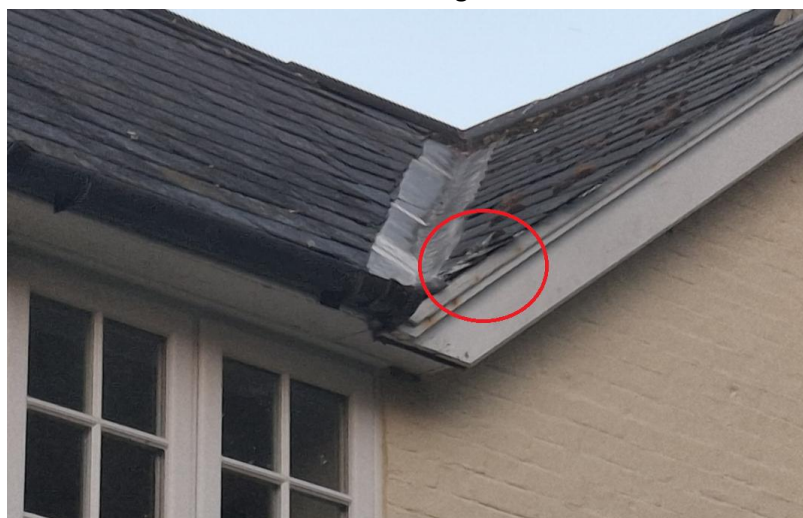
Review of the full footage from the Nightfox Whisker camcorder confirmed that the observations made during the survey were correct, and there was one emergence from the west elevation of Park Cottage.

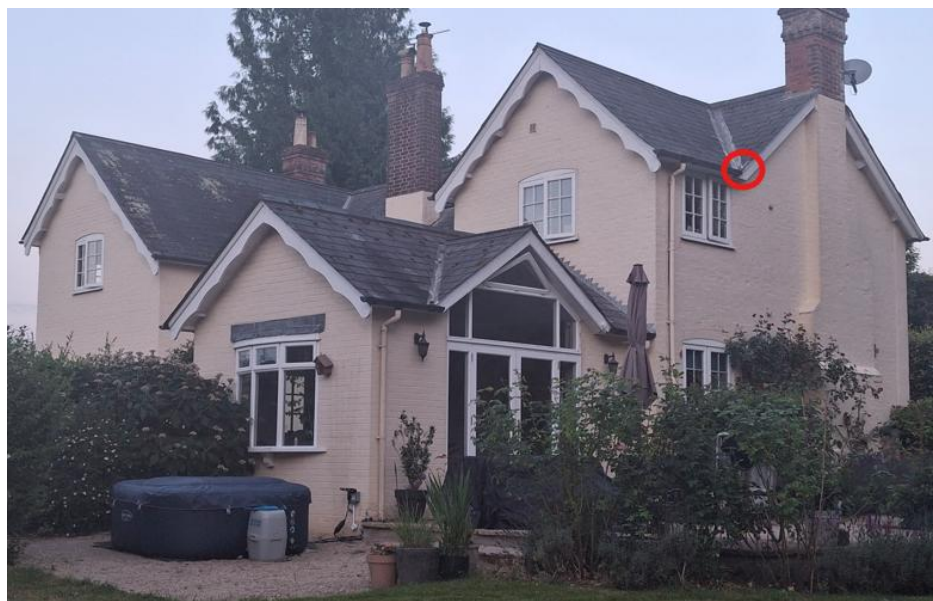
Review of the full footage from the Pixfra Arc A613 thermal camera confirmed that the observations made during the survey were correct, and there was one emergence from the west elevation of Park Cottage.

| <b>Survey Summary</b> | <p><b>Two common pipistrelle bats emerged</b> from below a roof tile on the lower left side of the northeast gable end</p> <p><b>One soprano pipistrelle bat emerged</b> from under roof tiles above the eaves on the left side of the west-facing gable end.</p> |

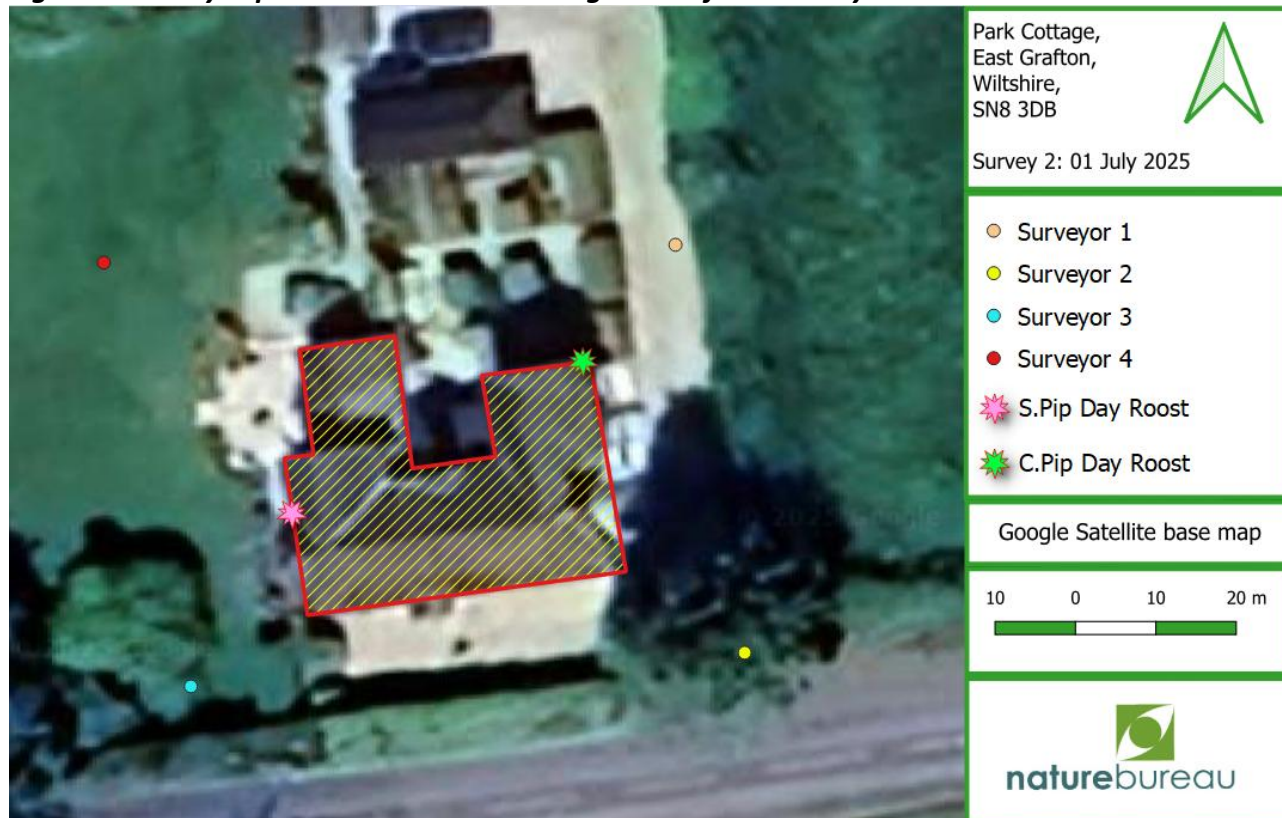
**Figure 8: Surveyor positions and bat roosting results from 01 July 2025**

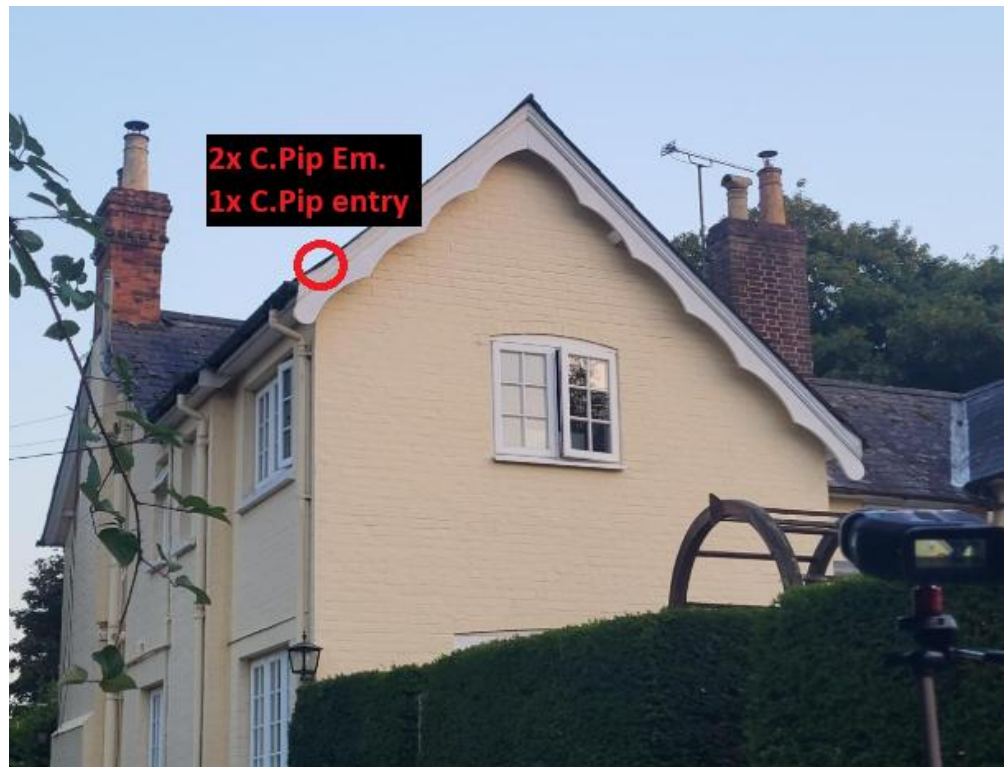
Review of the full footage from the Nightfox Whisker camcorder confirmed two emergences and one re-entry occurred at the northeast elevation of Park Cottage.

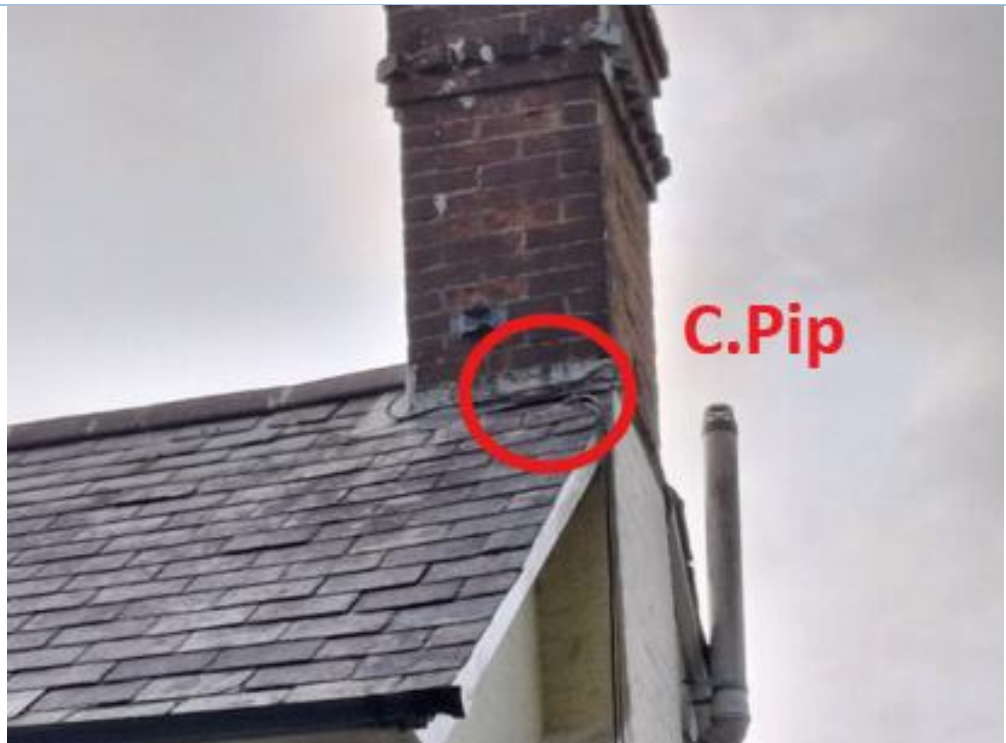
| <b>Surveyor 2</b> | <p>Nathaniel Dove (B.Sc., M.Res), surveyor with three years' bat survey experience and a CL18 bat licence</p> <p><b>One emergence from southeast elevation of Park Cottage.</b></p> <p>Activity began nine minutes after sunset, at 20:46, with a <b>common pipistrelle bat which emerged</b> from a roof tile at the base of the southeast chimney and flew southwest.</p> <p>At 21:01 a common pipistrelle flew from the southwest and headed southeast across the road.</p> <p>At 21:06 a common pipistrelle flew from the north, down the easter driveway above the surveyor.</p> <p>At 21:11 a brown long-eared bat flew towards the surveyor from the southwest of the site and began foraging around the driveway.</p> <p>At 21:26 two serotine bats began foraging over B1, making passes between the south and north of the site. This continued for several minutes.</p> <p>At 21:27 a common pipistrelle bat was heard but not seen (HNS). This foraging activity continued regularly until around 22:03, with two bats making occasional passes over the (eastern) driveway and over the house.</p> <p>At 21:44 a myotis bat was seen (but not heard) as they commuted from the southwest and flew up the driveway towards Surveyor 1.</p> <p>At 22:03 a serotine bat flew from northwest to south over the house.</p> <p><b>Thermal Analysis</b></p> <p>Review of the full footage from the Guide TK612 Thermal Imaging camcorder confirmed that the observations made during the survey were correct, and there was one emergence from the southeast elevation of Park Cottage.</p> |

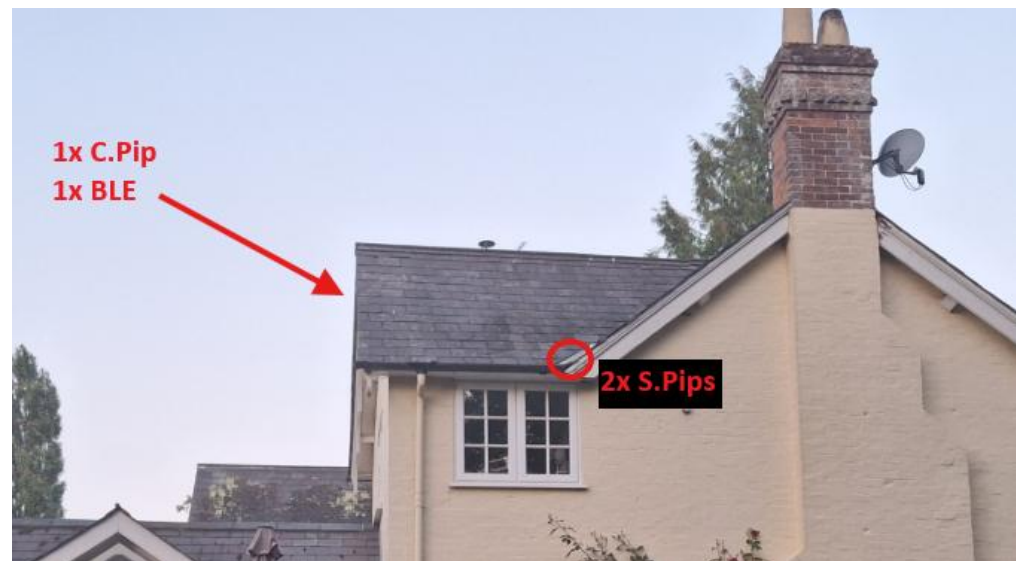
Review of the full footage from the Pixfra Arc A613 thermal camera confirmed that the observations made during the survey were correct, and there were two emergences from the west elevation of Park Cottage.
