## Bat Emergence and Re-Entry Surveys (BERS)

Goatacre Farm, Goatacre, Wiltshire, SN11 9JA

The demolition of all existing buildings and the construction of nine new dwellings.

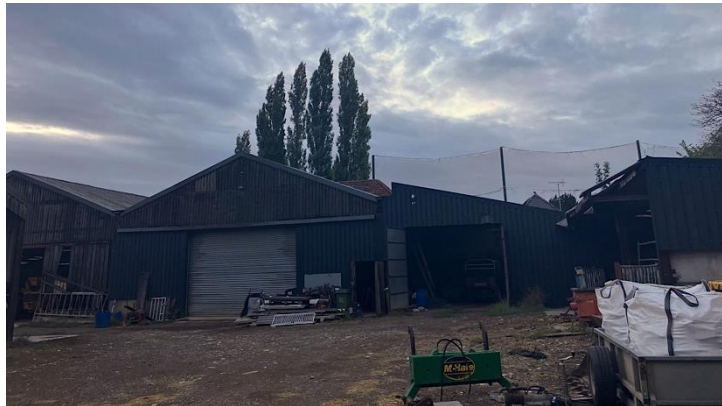
| Date of survey | | | | Sunset; Start - End | | |
|---|---|---|---|---|---|---|
| Surveyor 1 | | <p><b>No emergences</b></p> <p><b>Flight paths:</b> Frequent bat passes through the yard southeast of building B1 in a Southwest direction</p> <p><b>Foraging areas:</b> Constant foraging in the yard south of building B1</p> <p><b>Species:</b> Common pipistrelle, noctule</p> <p><b>Summary of general activity:</b> A common pipistrelle was observed foraging by the opening at the eastern elevation of B2 between 21:03 and 21:06 and again at 22:20 and 22:22. Between 21:16 and 22:49 up to two common pipistrelles were observed foraging in the yard area directly south of B1’s east section. Common pipistrelle activity was then heard and not seen until 22:15.</p> <p>At 21:08 a noctule was heard and not seen</p> | | | <p><i>Full elevation photo showing surveyors view of B1’s south and west elevations</i></p> | |

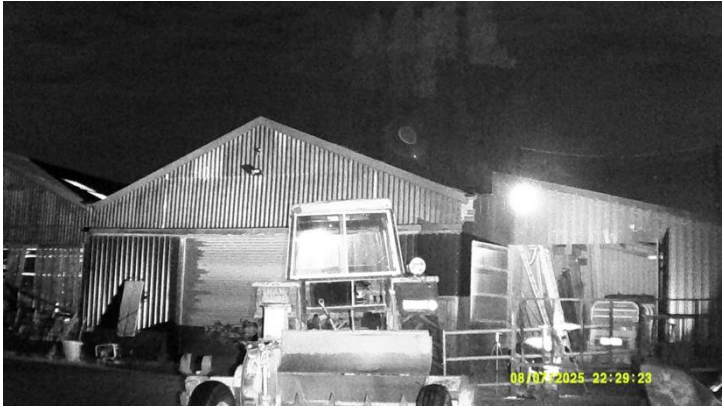
| <p><i>IR position 1</i><br/> <i>Nightfox Whisker x1</i><br/> <i>Nightfox XB5 Pro x1</i></p> | <p><b>No emergences</b></p> <p><b>Summary of general activity:</b> At 22:20 the two common pipistrelles foraging by the southern elevation of B1 can be seen briefly entering B1 via the barn door on the east where they forage until 22:22 and then exit and continue foraging activity outside.</p> | <p>Darkest point photo showing B1's south and west elevations</p> <p>A night-time photograph of a large barn with a corrugated metal roof. A tractor is parked in front of the barn. The image is dark, with some light reflecting off the barn's surface. A timestamp in the bottom right corner reads '08/07/2025 22:29:23'.</p> |

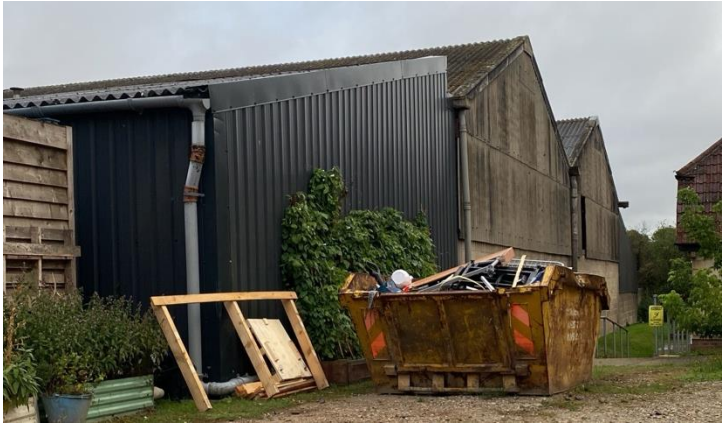
| <p><i>Surveyor 2</i></p> | <p><b>No emergences</b></p> <p><b>Flight paths:</b> N/A<br/> <b>Foraging areas:</b> N/A<br/> <b>Species:</b> Common pipistrelle<br/> <b>Summary of general activity:</b> A common pipistrelle was heard not seen at 21:15</p> | <p>Full elevation photo showing surveyors view of B1's north and east elevations</p> <p>A daytime photograph of a large barn with a corrugated metal roof. In the foreground, there is a yellow skip filled with debris, some wooden planks, and some greenery. The barn is made of dark corrugated metal and has a gabled roof.</p> |

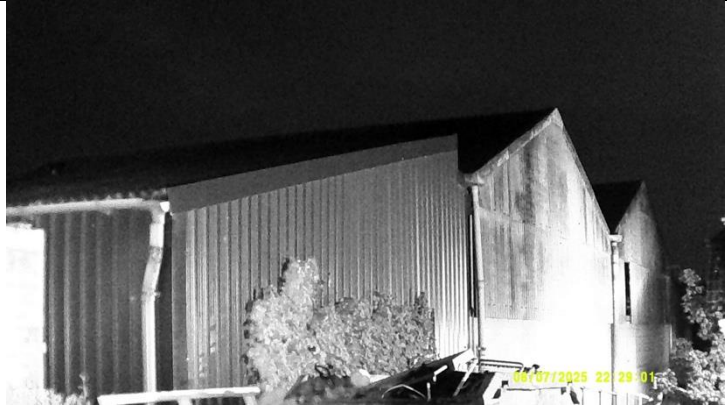
| <p><i>IR position 2</i><br/> <i>Nightfox Whisker x1</i><br/> <i>Nightfox XB5 Pro x1</i></p> | <p><b>No emergences</b></p> <p><b>No additional observations</b></p> | <p>Darkest point photo showing B1's north and east elevations</p> |

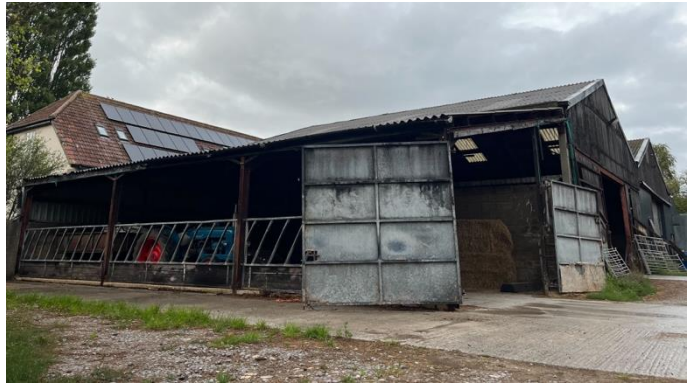
| Surveyor 3 | <p><b>No emergences</b></p> <p><b>Flight paths:</b> Directly south and west of the building</p> <p><b>Foraging areas:</b> Directly south and west of the building</p> <p><b>Species:</b> Common pipistrelle, serotine</p> <p><b>Summary of general activity:</b> Common pipistrelles were frequently observed foraging in the areas west and south of B1's west wing between 20:57 and 21:24. At 21:58 a serotine was heard and not seen.</p> | <p><i>Full elevation photo showing surveyors view of B1's south and west elevations</i></p> |

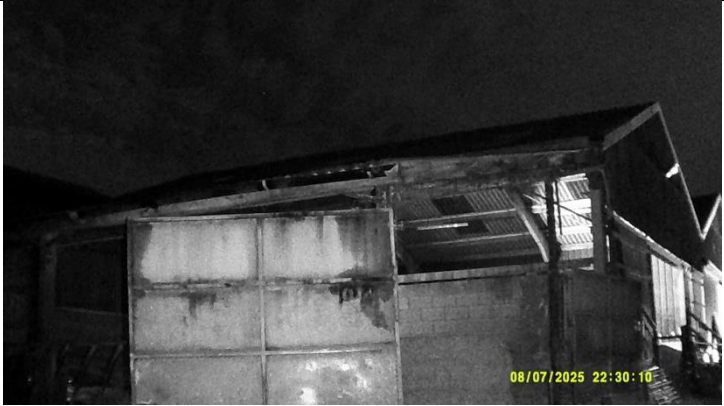
| <p><i>IR position 3</i></p> <p><i>Nightfox Whisker x1</i></p> <p><i>Nightfox XB5 Pro x1</i></p> | <p><b>No emergences</b></p> <p><b>No additional observations</b></p> | <p><i>Darkest point photo showing B1's south and west elevations</i></p> |

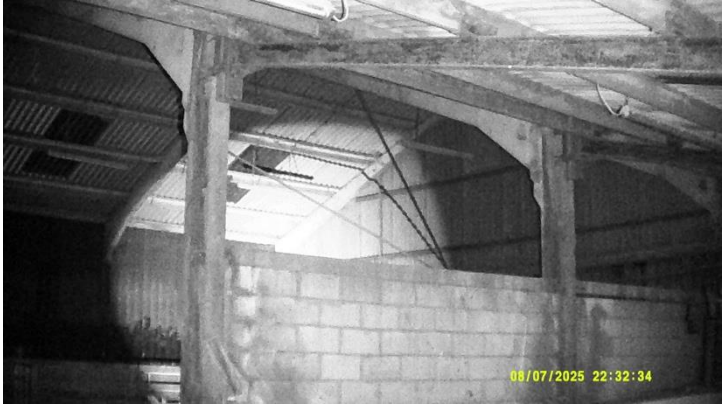
| <i>IR position 4</i><br><i>Nightfox Whisker x1</i><br><i>Nightfox XB5 Pro x1</i> | <p><b>No emergences</b></p> <p><b>Summary of general activity:</b> Between 20:54 – 21:23 a bat is seen foraging within the barn. Later between 22:18 – 22:32 at least two bats are seen not heard foraging within the barn these were identified later via calls as common pipistrelles</p> | <p><i>Darkest point photo showing the inside of B1's west wing</i></p> |

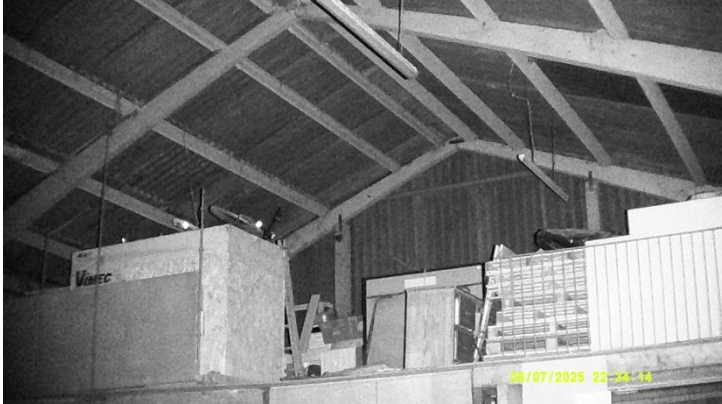
| <p><i>IR position 5</i><br/> <i>Nightfox Whisker x1</i><br/> <i>Nightfox XB5 Pro x1</i></p> | <p><b>No emergences</b></p> <p><b>No additional observations</b></p> | <p><i>Darkest point photo showing the inside of B1's middle section</i></p> |

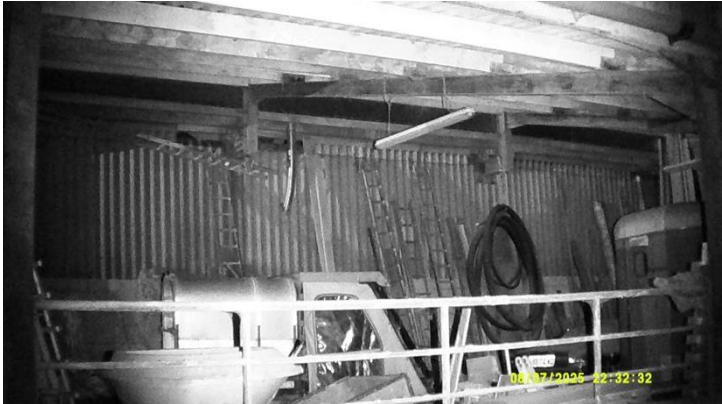
| <p><i>IR position 6</i><br/> <i>Nightfox Whisker x1</i><br/> <i>Nightfox XB5 Pro x1</i></p> | <p><b>No emergences</b></p> <p><b>Summary of general activity:</b> At 22:21 two common pipistrelles are observed foraging inside the building.</p> | <p><i>Darkest point photo showing the inside of B1's east wing</i></p> |

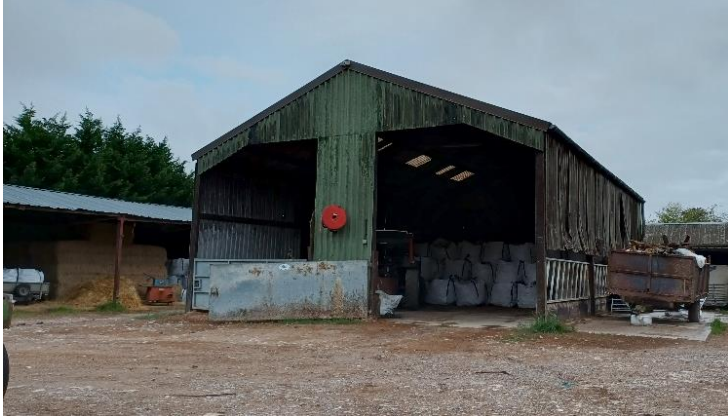
| <p><i>Surveyor 7</i></p> | <p><b>No emergences</b></p> <p><b>Flight paths:</b> Area north of B2 and south of B1 in an east to west direction</p> <p><b>Foraging areas:</b> In the yard area east of B2 outside the main entrance and outside of B1's east entrance</p> <p><b>Species:</b> Common pipistrelle, serotine, noctule</p> <p><b>Summary of general activity:</b> At 21:03 and 21:20 a common pipistrelle was seen foraging around the area outside B2's east elevation close to the entrance. At 21:06 a common pipistrelle was heard not seen and this activity was recorded constantly between 21:12-and 22:29. At 21:06 a common pipistrelle was recorded foraging in front of the northeast elevation of B1. At 21:18, a common pipistrelle was recorded foraging, circling in front of the eastern elevation and then flying off toward the northwest of the site along the northern elevation of B2. This activity was recorded consistently between 21:21 and 21:25.</p> <p>At 21:27 a serotine was recorded heard not seen and then again at 21:29, 21:56 and 22:10.</p> <p>At 21:35 a noctule was recorded as heard not seen.</p> | <p><i>Full elevation photo showing surveyors view of B2's north and east elevations</i></p> |

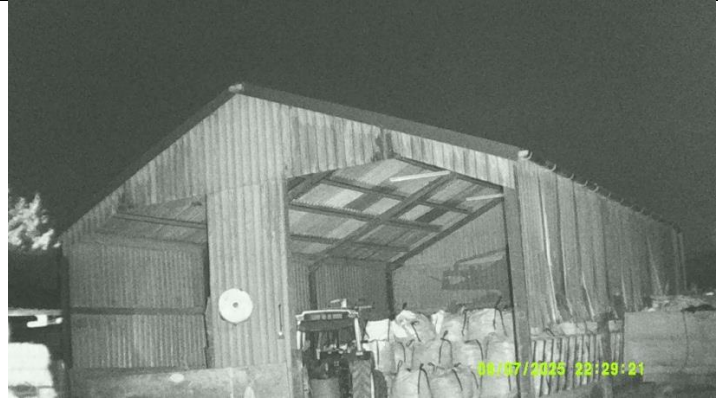
| <p><i>IR position 7</i><br/><i>Nightfox Whisker x1</i><br/><i>Nightfox XB5 Pro x1</i></p> | <p><b>No emergences</b></p> <p><b>Summary of general activity:</b> A common pipistrelle was seen foraging by the opening at the eastern elevation of B2 occasionally foraging inside the building via the barn door on the east elevation at 21:03 and 21:04 and again at 22:19 and 22:22. Common pipistrelle activity was recorded foraging north</p> | <p><i>Darkest point photo showing B2's north and east elevation</i></p> |

| | to south and south to north along the eastern elevation four times between 22:03 and 22:20. | |

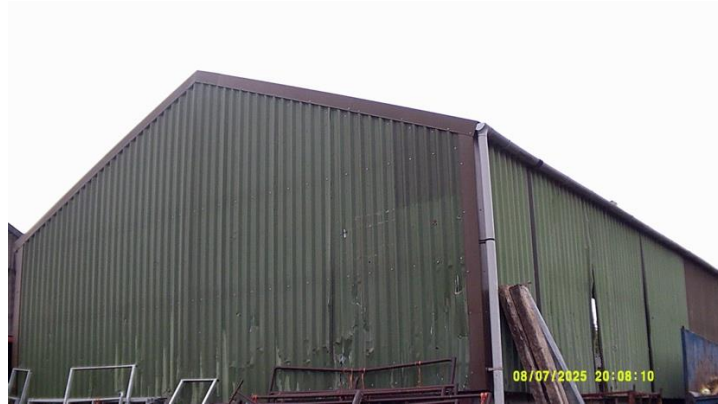
| Surveyor 8 | <p><b>No emergences</b></p> <p><b>Flight paths:</b> Southwest to northeast past B2's southern elevation.</p> <p><b>Foraging areas:</b> In the areas directly east and south of B2</p> <p><b>Species:</b> Common pipistrelle, noctule, serotine</p> <p><b>Summary of general activity</b> At 21:04, 21:20 and 21:37 a noctule was heard and not seen.</p> <p>At 21:05, 21:14, 22:19 and 22:24 common pipistrelles were observed flying southwest to northeast past B2s south elevation. Between 21:23 and 21:27 there was continuous foraging activity along the B2s east and south elevations by at least two common pipistrelles. Common pipistrelles were heard not seen from 21:37 to 21:57.</p> <p>A serotine was observed commuting Southwest to northeast past the building's south elevation. Serotine calls were heard not seen from 21:33 to 22:16</p> | <p><i>Full elevation photo showing surveyors view of B2's south and west elevations</i></p> |

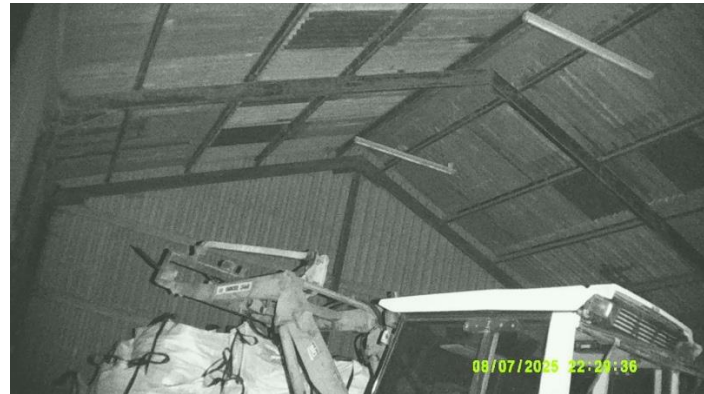
| <i>IR position 9</i><br><i>Nightfox Whisker x1</i><br><i>Nightfox XB5 Pro x1</i> | <b>No emergences</b><br><br><b>Summary of general activity:</b> At 22:20 a bat is seen briefly foraging within the barn before flying east, this coincides with the common pipistrelle observed by Surveyor 7. | <i>Darkest point photo showing the inside of B2</i><br> |

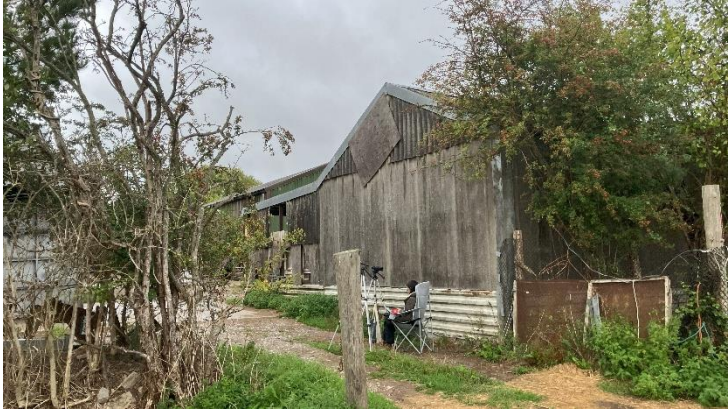
| <p><i>Surveyor 10</i></p> | <p><b>No emergences</b></p> <p><b>Flight paths:</b> N/A</p> <p><b>Foraging areas:</b> Along the hedgerow that borders B3's west elevation</p> <p><b>Species:</b> Common pipistrelle, noctule</p> <p><b>Summary of general activity:</b> At 20:59 and 21:06 a common pipistrelle was heard not seen</p> <p>A noctule was heard but not seen at 21:04, 21:20 and seen foraging above the site at 21:57.</p> <p>From 21:07 to 21:45 constant common pipistrelle foraging activity was observed in the area Northwest of B3 in which multiple bats foraged along the hedgerow west of B3</p> | <p><i>Full elevation photo showing surveyors view of B3's north and west elevations</i></p> |

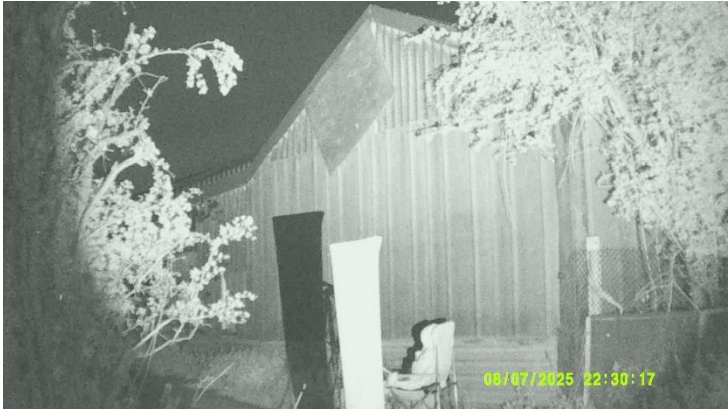
| <p><i>IR position 10</i><br/><i>Nightfox Whisker x1</i><br/><i>Nightfox XB5 Pro x1</i></p> | <p><b>No emergences</b></p> <p><b>No additional observations</b></p> | <p><i>Darkest point photo showing B3's north and west elevation</i></p> |

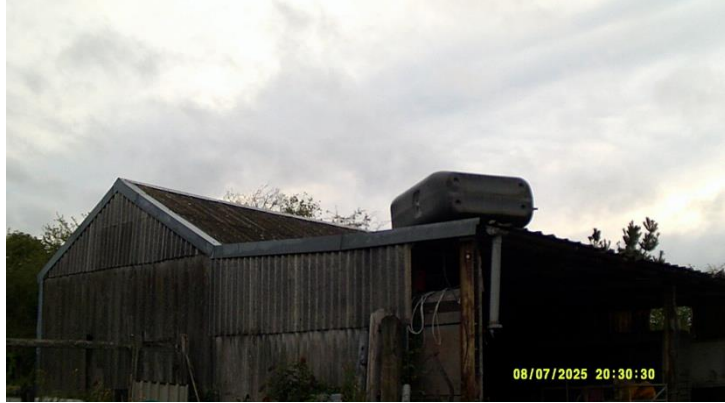
| <p><i>Surveyor 11</i></p> | <p><b>No emergences</b></p> | <p><i>Full elevation photo showing surveyors view of B3's south and east elevations</i></p> |

| | <p><b>Flight paths:</b> East to west direction past the building's south elevation. north to south past B3s east elevation.</p> <p><b>Foraging areas:</b> In the yard area between B2 and B3, directly east of B3</p> <p><b>Species:</b> Common pipistrelle, noctule, brown long-eared, serotine</p> <p><b>Summary of general activity:</b> At 20:42 a serotine was heard not seen.</p> <p>At 21:04 a noctule was heard and not seen.</p> <p>At 21:05 a common pipistrelle was observed flying east to west past B3s south elevation. At 21:14 a common pipistrelle was observed flying north to south past B3's east elevation. Between 21:21 and 21:28 a common pipistrelle was observed foraging in the yard area directly east of B3. Common pipistrelles were heard not seen from 21:38 to 22:19</p> <p>At 21:34 and 21:36 a brown long-eared bat was heard and not seen</p> | |

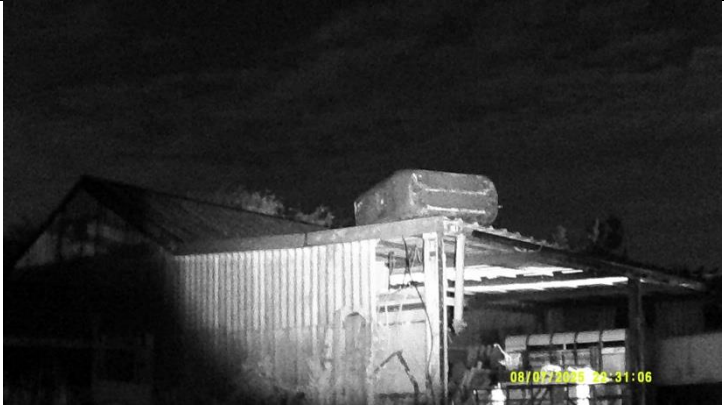
| <i>IR position 11</i><br><i>Nightfox Whisker x1</i><br><i>Nightfox XB5 Pro x1</i> | <p><b>No emergences</b></p> <p><b>No additional observations</b></p> | <p><i>Darkest point photo showing B3's south and east elevation</i></p> |

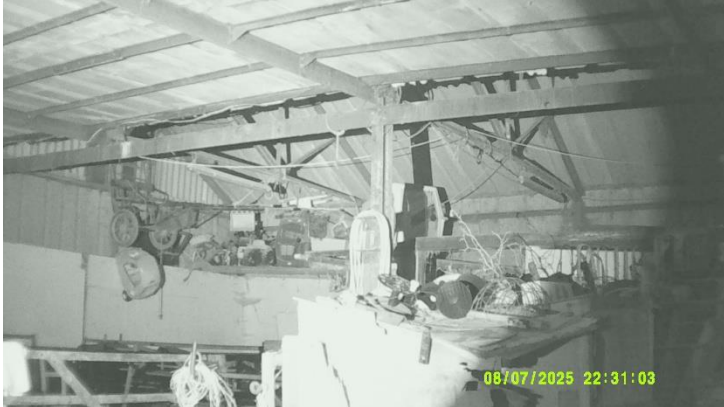
| <i>IR position 12</i><br><i>Nightfox Whisker x1</i><br><i>Nightfox XB5 Pro x1</i> | <b>No emergences</b><br><br><b>No additional observations</b> | <i>Darkest point photo showing the inside of B3</i><br> |

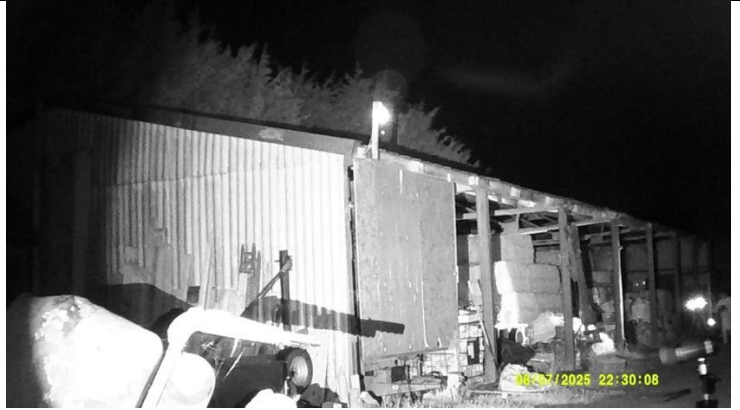
| IR position 13<br>Nightfox Whisker x1<br>Nightfox XB5 Pro x1 | | <p><b>No emergences observed</b></p> <p><b>Summary of general activity:</b></p> <p>At 21:28 a bat can be seen flying west before foraging in the area north of B4's northern elevation. Corresponding calls</p> | | | <p>Darkest point photo showing B4's north and east elevation</p> | |

| | <p>detected at this time suggest that this was a common pipistrelle.</p> <p>A bat can be seen commuting from west to east above the northern elevation of B4 at 22:16 with another commuting from east to west before briefly foraging inside B4s west side and then flying east at 22:17. This activity corresponds with common pipistrelle calls detected during the survey.</p> | |

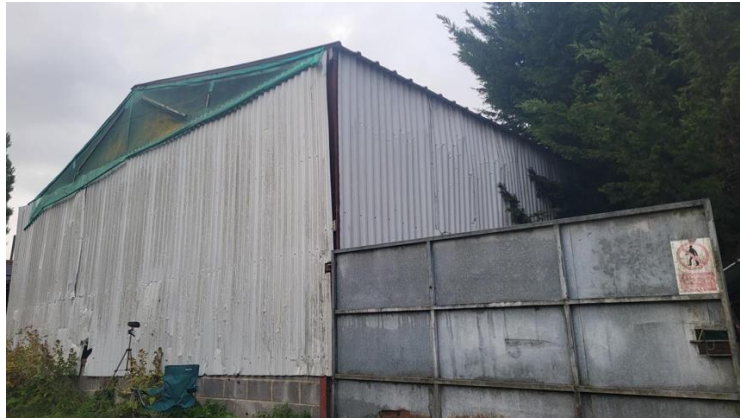
| Surveyor 14 | <p><b>No emergences</b></p> <p><b>Flight paths:</b> North to south and south to north along the track running along B4s west elevation.</p> <p><b>Foraging areas:</b> Next to B4's southwest corner</p> <p><b>Species:</b> Common pipistrelle, noctule, brown long-eared bat</p> <p><b>Summary of general activity:</b> At 21:04 and 21:38 a noctule was heard and not seen.</p> <p>From 21:09 to 22:25 a common pipistrelle was observed sporadically foraging northwards and then southwards along the track running past B4's east elevation. In this time another common pipistrelle was observed foraging south of B4s southern elevation.</p> <p>At 21:37 a brown long-eared bat was observed flying from north to south along the path running past the western elevation of B4.</p> | <p><i>Full elevation photo showing surveyors view of B4's south and west elevations</i></p> |

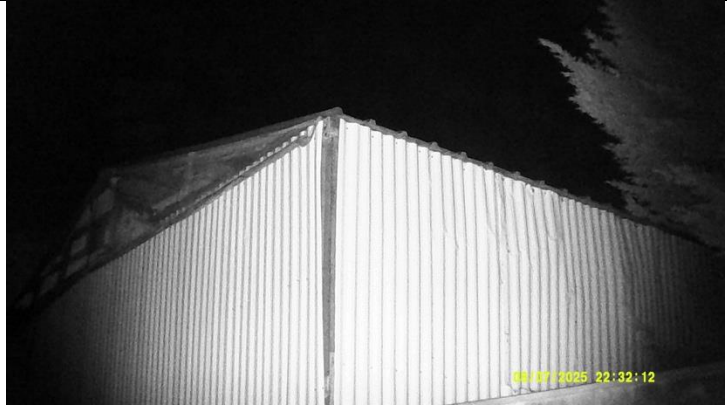
| IR position 14 | <b>No emergences</b> | <i>Darkest point photo showing B4's south and west elevation</i> |

| <i>Nightfox Whisker x1</i><br><i>Nightfox XB5 Pro x1</i> | <b>No additional observations</b> | |

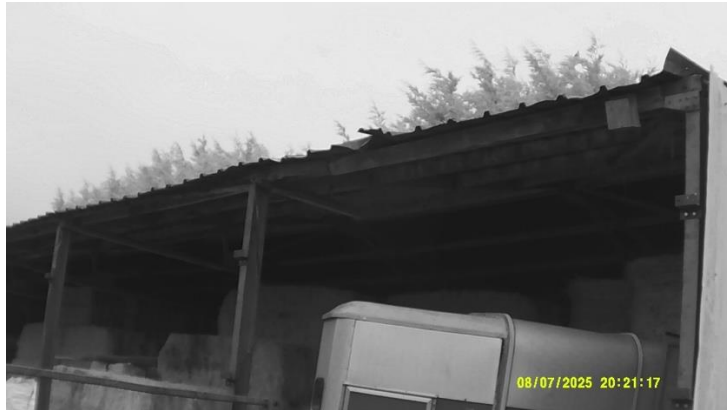
| <i>Surveyor 15</i> | <b>No emergences</b><br><br><b>Flight paths:</b><br><b>Foraging areas:</b><br><b>Species:</b><br><b>Summary of general activity:</b> Between 21:05 and 21:36 2-3 common pipistrelles were observed constantly foraging along B4s north elevation occasionally entering via the open wall to forage and then exiting to the yard area directly to the north. Common pipistrelles were then heard and not seen until 22:22.<br><br>At 21:59 a serotine was heard and not seen. | <i>Full elevation photo showing surveyors view of B4's north and west elevations</i><br> |

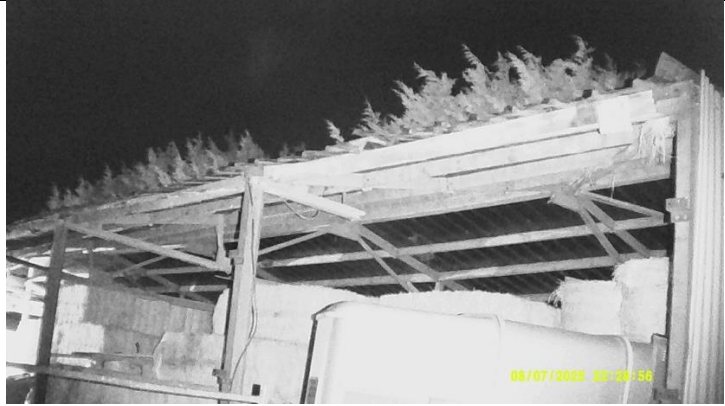
| <i>IR position 15</i><br><i>Nightfox Whisker x1</i><br><i>Nightfox XB5 Pro x1</i> | <b>No emergences</b><br><br><b>No additional observations</b> | <i>Darkest point photo showing B4's north and west elevation</i> |

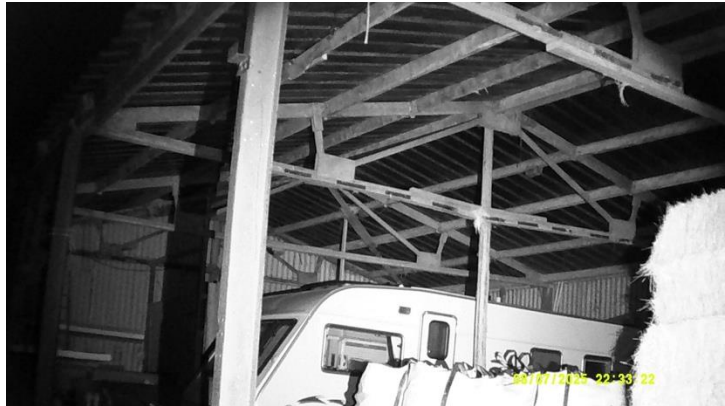
| <p><i>IR position 16</i><br/> <i>Nightfox Whisker x1</i><br/> <i>Nightfox XB5 Pro x1</i></p> | <p><b>No emergences</b></p> <p><b>Summary of general activity:</b> Between 21:07 and 21:37 occasional foraging activity is observed inside, coinciding with common pipistrelle foraging activity observed by Surveyor 15.</p> | <p><i>Darkest point photo inside B4</i></p> |

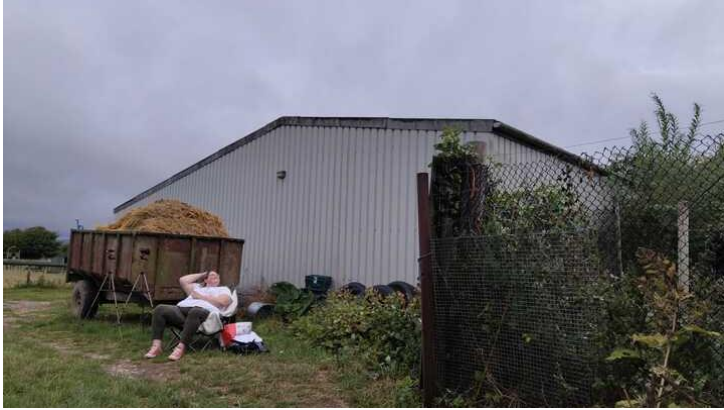
| <p><i>Surveyor 17</i></p> | <p><b>No emergences</b></p> <p><b>Flight paths:</b> west to east along the apex of B5</p> <p><b>Foraging areas:</b> The track located east of B5 and west of B4</p> <p><b>Species:</b> Common pipistrelle, serotine, noctule</p> <p><b>Summary of general activity:</b> Between 21:03 and 22:24 common pipistrelles were regularly heard not seen. Between 21:19 and 21:48 common pipistrelles were observed foraging on the track running north to south to the east of B5. On two occasions common pipistrelles were observed flying west to east directly over B5.</p> <p>At 21:04 and 21:57 Noctules were heard and not seen.</p> <p>At 22:12 a serotine was heard not seen.</p> | <p><i>Full elevation photo showing surveyors view of B5's north and east elevations</i></p> |

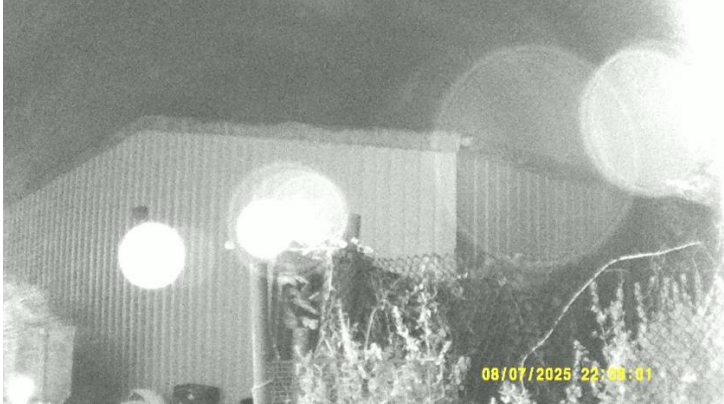
| <p><i>IR position 17</i><br/><i>Nightfox Whisker x1</i><br/><i>Nightfox XB5 Pro x1</i></p> | <p><b>No emergences</b></p> <p><b>No additional observations</b></p> | <p><i>Darkest point photo showing B5's north and east elevation</i></p> |

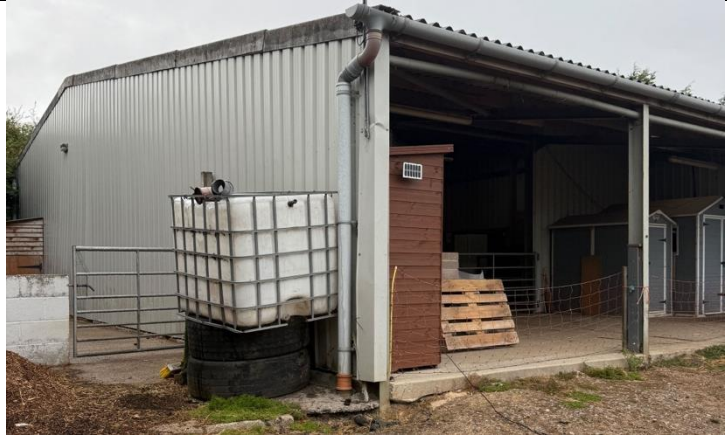
| <p><i>Surveyor 18</i></p> | <p><b>No emergences</b></p> <p><b>Flight paths:</b> N/A</p> | <p><i>Full elevation photo showing surveyors view of B5's south and west elevations</i></p> |

| | <p><b>Foraging areas:</b> The hedgerow running along B5's west elevation.</p> <p><b>Species:</b> Common pipistrelle</p> <p><b>Summary of general activity:</b> Between 21:05 and 21:48 two common pipistrelles were regularly observed foraging along the hedgerow directly west of B5 occasionally and briefly foraging within the inside area of the barn. At 22:08 the last activity was of a common pipistrelle which was heard not seen.</p> | |

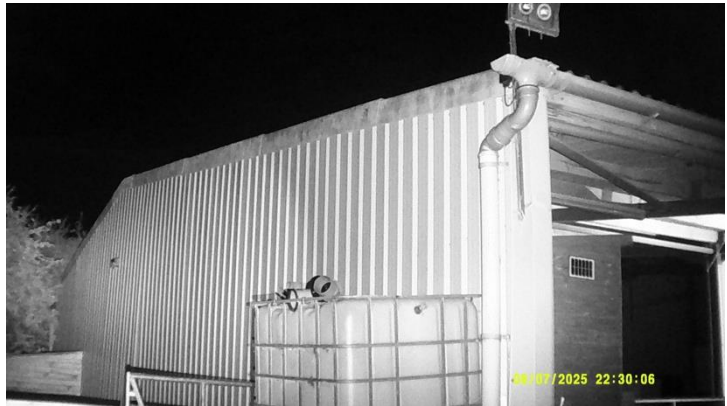
| <p><i>IR position 18</i><br/> <i>Nightfox Whisker x1</i><br/> <i>Nightfox XB5 Pro x1</i></p> | <p><b>No emergences</b></p> <p><b>No additional observations</b></p> | <p><i>Darkest point photo showing B5's south and west elevation</i></p> |

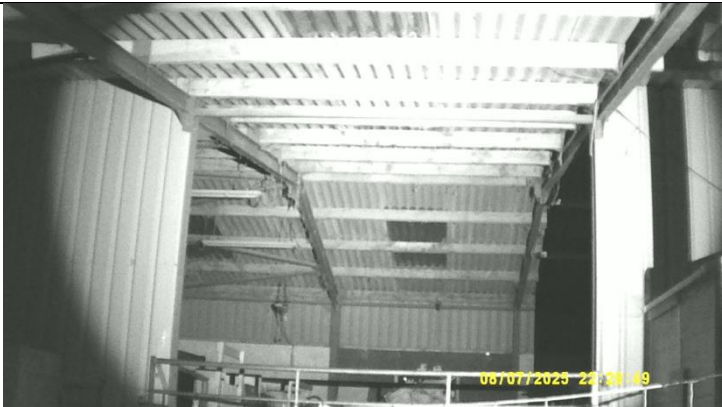
| <p><i>IR position 19</i><br/> <i>Nightfox Whisker x1</i><br/> <i>Nightfox XB5 Pro x1</i></p> | <p><b>No emergences</b></p> <p><b>Summary of general activity:</b> A common pipistrelle is seen to fly in and out of B5 frequently between 21:01 and 21:08 and briefly foraging.</p> | <p><i>Darkest point photo inside B5</i></p> |

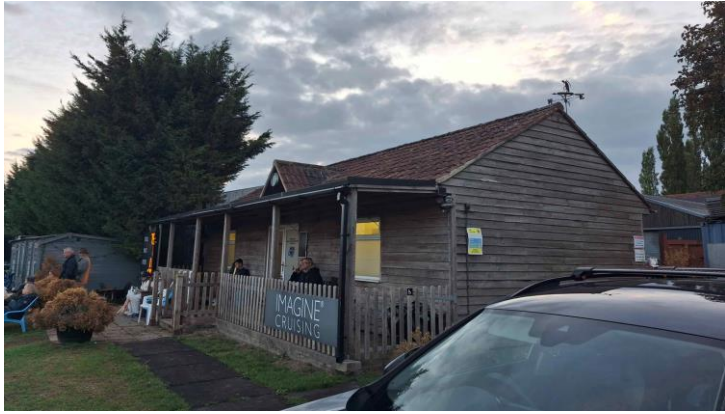
| <p><i>Surveyor 20</i></p> | <p><b>No emergences</b></p> <p><b>Flight paths:</b> In easterly and westerly directions on both the north and south sides of B6. From the treeline north of B6 in both east and west directions.</p> <p><b>Foraging areas:</b> N/A</p> <p><b>Species:</b> Common pipistrelle, noctule</p> <p><b>Summary of general activity:</b> At 20:17 a common pipistrelle was observed commuting east to west past B6's north elevation. Another common pipistrelle was observed commuting from the tree line to B6s north and commuting west at 20:17, 20:25 and 20:42, at 20:56 a common pipistrelle was observed commuting from the same tree line and heading in a east direction. At 20:53 a common pipistrelle was observed commuting northeast to southwest past B6's west elevation. Common pipistrelle calls were then heard not seen until 21:19.</p> <p>Noctules were heard not at 19:58 and 20:24</p> | <p><i>Full elevation photo showing surveyors view of B6's south and east elevations</i></p> |

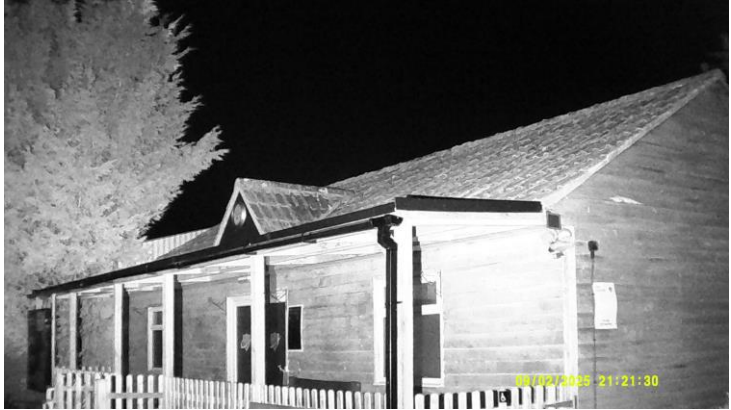
| <p><i>IR position 20</i><br/> <i>Nightfox Whisker x1</i><br/> <i>Nightfox XB5 Pro x1</i></p> | <p><b>No emergences</b></p> <p><b>No additional observation</b></p> | <p><i>Darkest point photo showing B6's south and east elevations</i></p> |

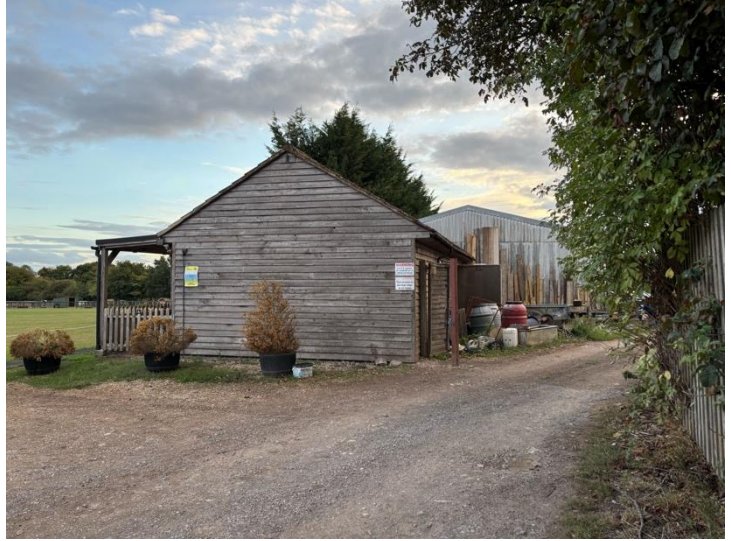
| <p><i>Surveyor 21</i></p> | <p><b>No emergences</b></p> <p><b>Flight paths:</b> In easterly and westerly directions on both the north and south sides of B6. From the treeline north of B6 in both east and west directions. From the south of B6 past the east elevation and then west</p> <p><b>Foraging areas:</b> N/A</p> <p><b>Species:</b> Common pipistrelle, noctule</p> <p><b>Summary of general activity:</b><br/> At 19:58 and 20:23 a noctule was heard and not seen.</p> <p>At 20:17 a common pipistrelle was observed commuting east to west past B6's north elevation. At 20:19 and 20:25 a common pipistrelle was observed commuting from the tree line to B4's north and commuting west. At 20:42 a common pipistrelle was observed commuting north past B6's east</p> | <p><i>Full elevation photo showing surveyors view of B6's north and east elevations</i></p> |

| | elevation and then flying west. Common pipistrelle calls were then consistently heard not seen until 21:20 | |

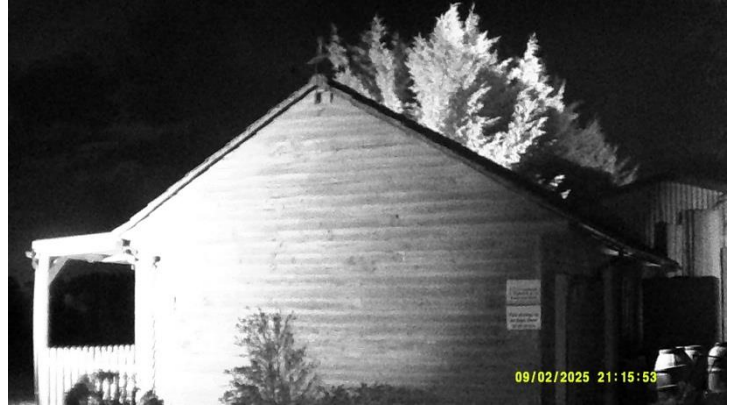
| <i>IR position 21</i><br><i>Nightfox Whisker x1</i><br><i>Nightfox XB5 Pro x1</i> | <b>No emergences</b><br><br><b>No additional observation</b> | <i>Darkest point photo showing B6's north and east elevations</i><br> |

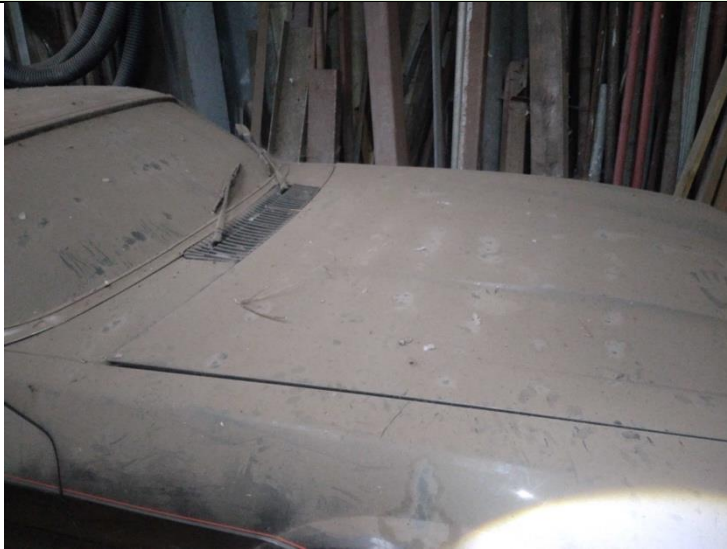
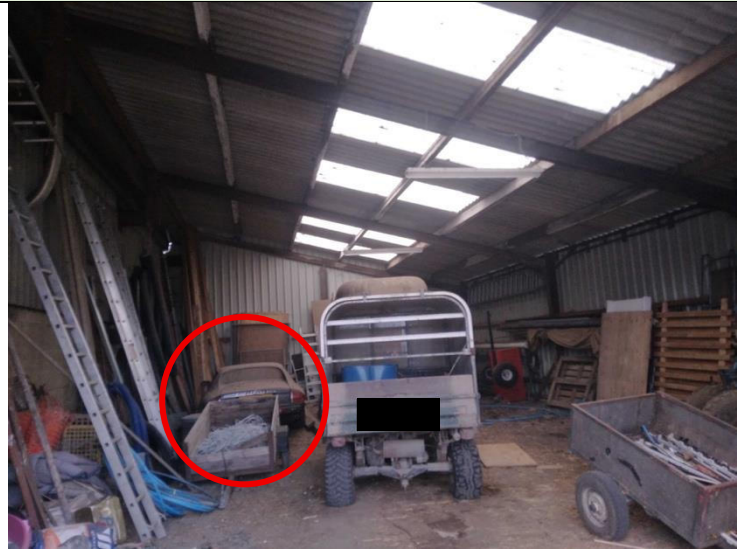
B1: High roost suitability – B1 was assessed as a confirmed roost due to the presence of ~10 droppings (confirmed to be common pipistrelle from DNA analysis) found in the eastern section of the building, scattered on top of a dusty car.

| Field Survey | | |
|---|---|---|
| | <p>B1 Internal: Car where bat droppings were found inside the Eastern section of B1</p> | <p>B1 Internal: east section of B1, the car where droppings were found can be seen left of the trailer circled in red</p> |

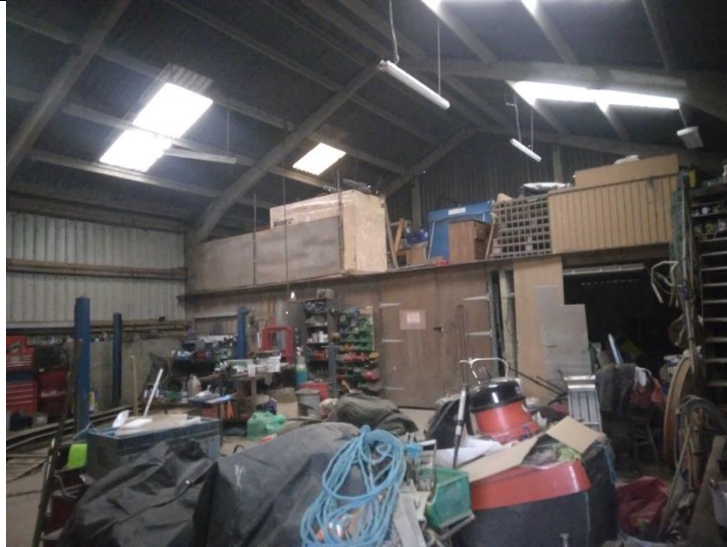
B1 Internal: Middle section of B1

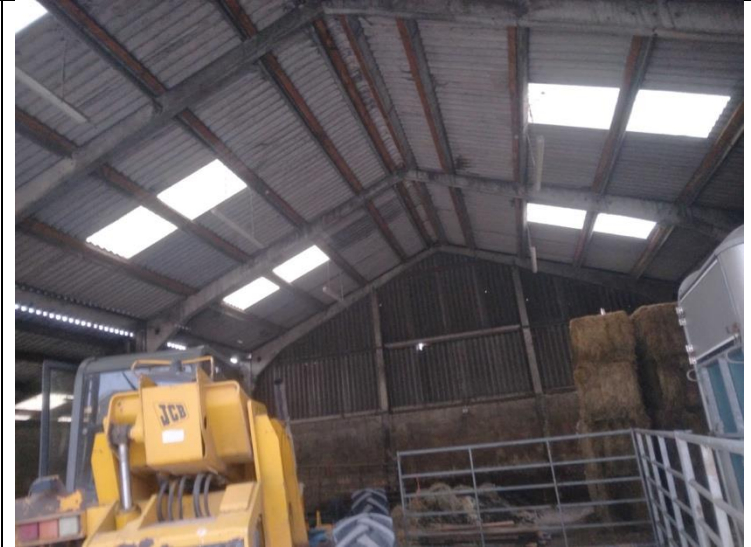
B1 Internal: Western section of B1

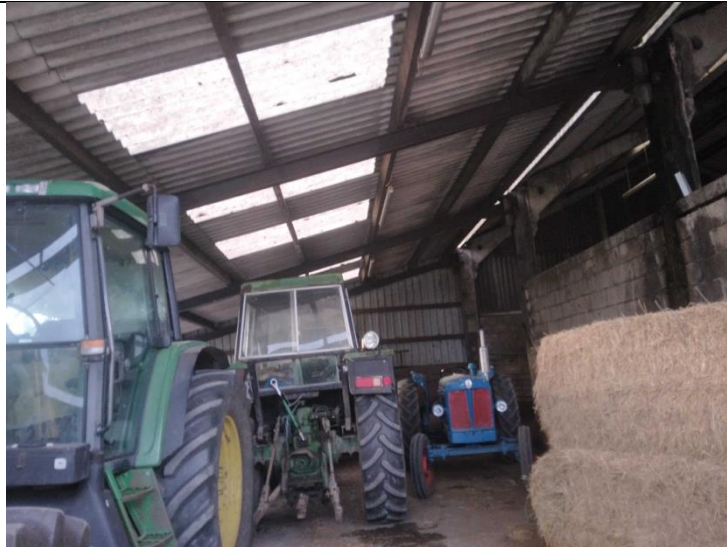
B1 internal: Western section of B1

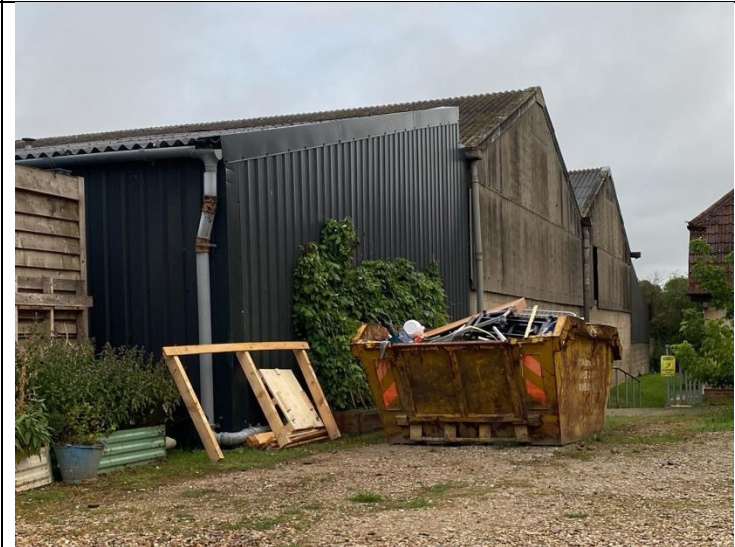
B1 External: Northern elevation of B1

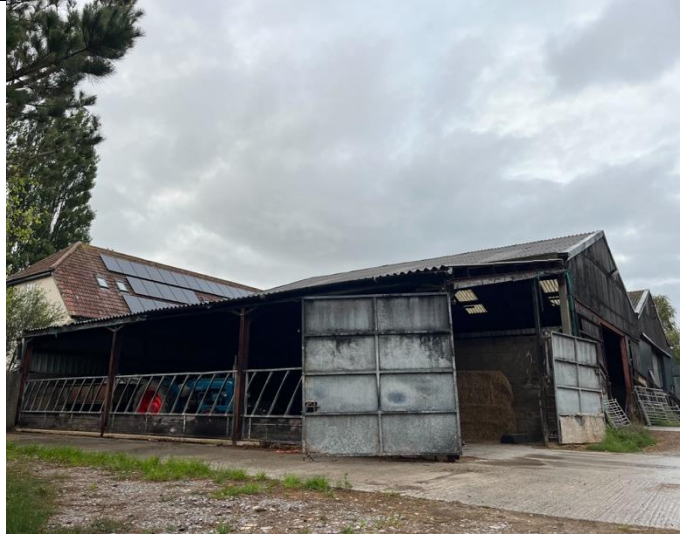
B1 External: south and Western elevation of B1

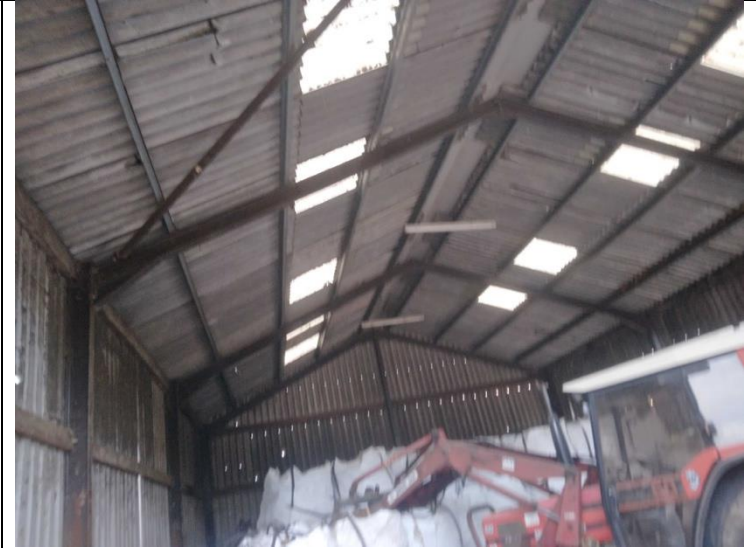
B2 Internal

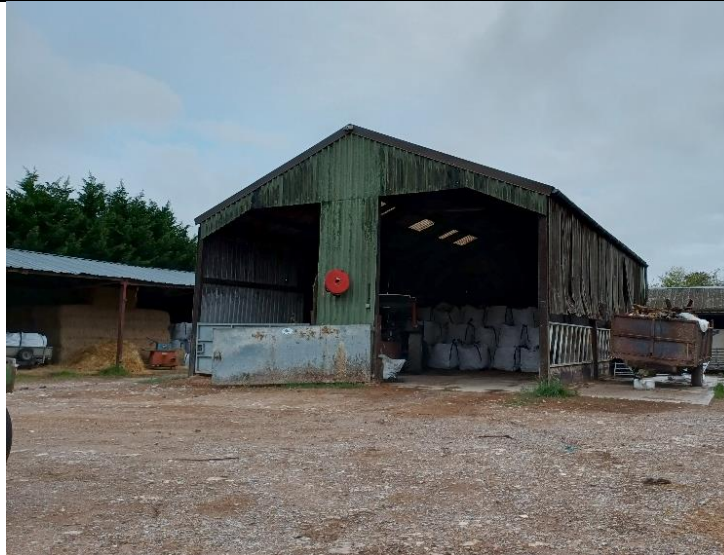
B2 External: north and east elevations of B2

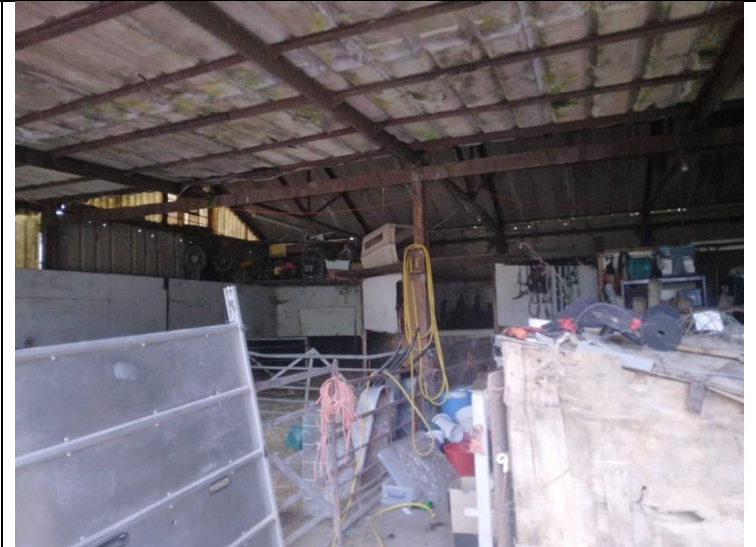
B3 Internal

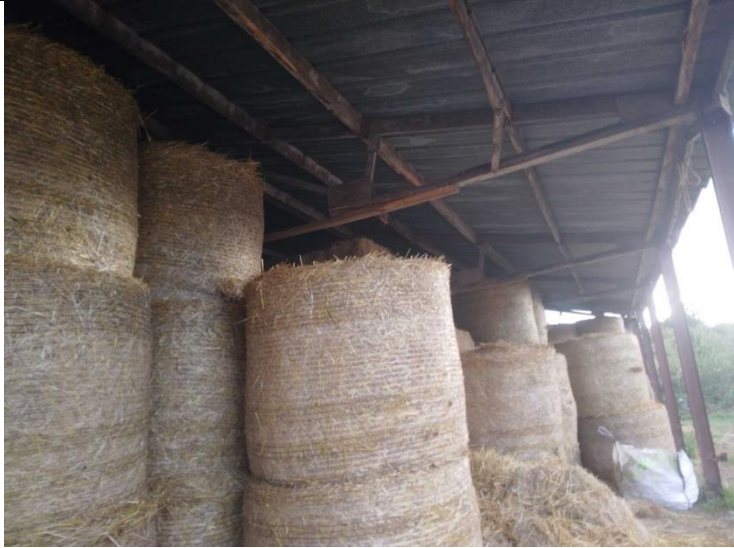
| | B4 Internal | B5 Internal |

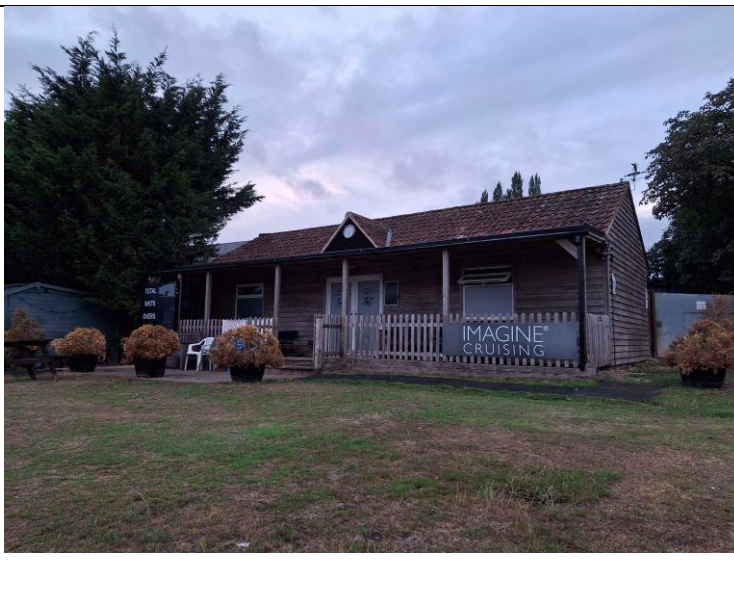
| | B6 External: south and east elevations of B6 | |

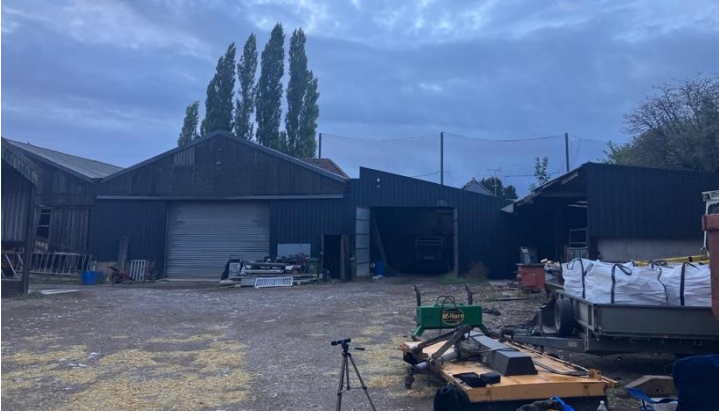
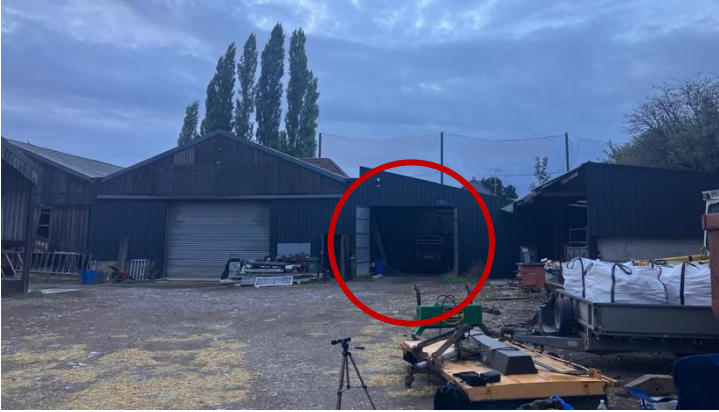
| <i>Surveyor 1</i> | <p><b>Foraging activity within B1 observed</b></p> <p><b>Flight paths:</b> East to west along B1s southern elevation</p> <p><b>Foraging areas:</b> Inside the eastern section of building B1</p> <p><b>Species:</b> Common pipistrelle, noctule</p> <p><b>Summary of general activity:</b> At 20:50 a common pipistrelle was observed foraging by the southeastern section off B1 at 20:53 it was observed entering the building via the door (circled red), where it was observed foraging inside until 20:58 where it was observed exiting and flying west along B1s south elevation. Between 21:01 and 21:04 a common pipistrelle was observed foraging by the east elevation of B2. Common pipistrelle calls were heard not seen regularly from 21:06 to 21:36.</p> <p>At 20:22 a noctule was heard not seen.</p> | <p><i>Full elevation photo showing surveyors view of B1's south and west elevations</i></p> <p><i>Entrance and exit point of foraging common pipistrelle</i></p> |

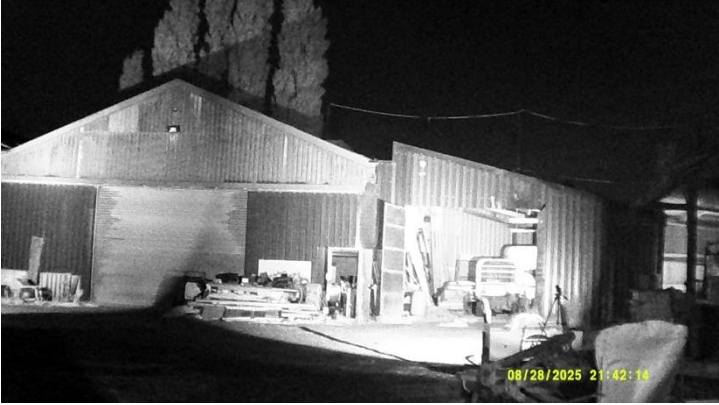
| <p><i>IR position 1</i><br/> <i>Nightfox Whisker x1</i><br/> <i>Nightfox XB5 Pro x1</i></p> | <p><b>Bat entrance and exit confirmed</b></p> <p><b>Summary of general activity:</b> A bat can be seen foraging by the southeast section of B1 at 21:35 coinciding with common pipistrelle calls heard at the same time</p> | <p><i>Darkest point photo showing B1's south and west elevations</i></p> |

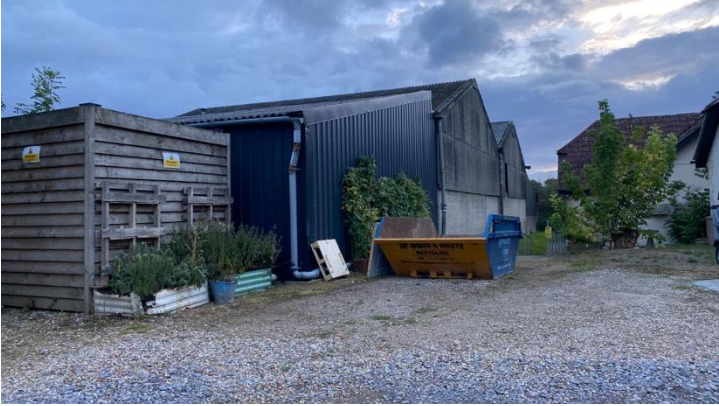
| <p><i>Surveyor 2</i></p> | <p><b>No Emergences</b></p> <p><b>Summary of general activity:</b> N.A.<br/> <b>Flight paths:</b> N.A.<br/> <b>Foraging areas:</b> N.A.</p> | <p><i>Full elevation photo showing surveyors view of B1's north and east elevations</i></p> |

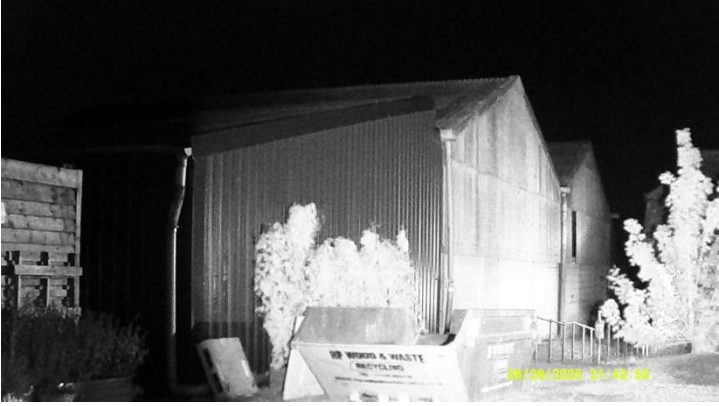
| <p><i>IR position 2</i><br/> <i>Nightfox Whisker x1</i></p> | <p><b>No emergences</b></p> | <p><i>Darkest point photo showing B1's north and east elevations</i></p> |

| <p><i>Nightfox XB5 Pro x1</i></p> | <p><b>No additional observation</b></p> | |

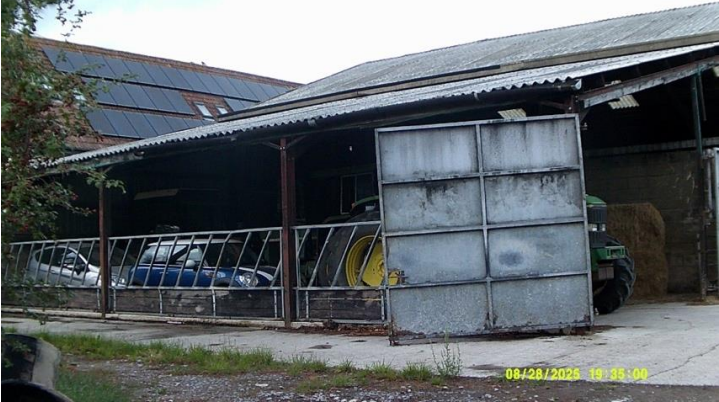
| <p><i>Surveyor 3</i></p> | <p><b>No emergences</b></p> <p><b>Flight paths:</b> N/A</p> <p><b>Foraging areas:</b> In front of the southern elevation of B1.</p> <p><b>Species:</b> Common pipistrelle, Non calling bat and noctule.</p> <p><b>Summary of general activity:</b> The first bat activity recorded during the survey was a common pipistrelle heard and not seen at 20:29, followed by another at 20:34. At 20:35 a common pipistrelle was observed foraging in front of the southern corner and elevation of B1.</p> <p>A bat was seen and not heard foraging in front of the southern elevation at 20:37. Between 20:52 and 21:42 there were four occurrences of common pipistrelles heard and not seen.</p> <p>At 20:56 a noctule was heard and not seen.</p> | <p><i>Full elevation photo showing surveyors view of B1's south and west elevations</i></p> |
