## Bat Emergence and Re-Entry Surveys (BERS)

Goatacre Farm, Goatacre, Wiltshire, SN11 9JA

The demolition of all existing buildings and the construction of nine new dwellings.

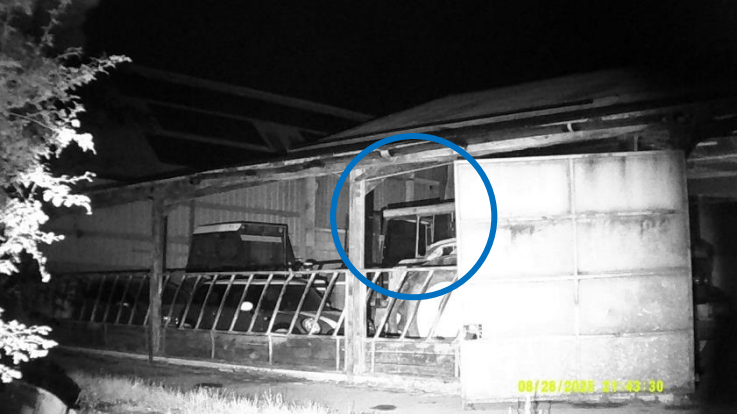
| <p><i>IR position 3</i><br/><i>Nightfox Whisker x1</i><br/><i>Nightfox XB5 Pro x1</i></p> | <p><b>Emergences observed</b></p> <p><b>Emergence:</b> Day roost (Roost one)<br/><b>Species:</b> Common pipistrelle<br/><b>Number:</b> 1<br/><b>Time:</b> 20:36<br/><b>Location of access point:</b> Large barn entrance at the southern end of the eastern elevation (Blue circle)<br/><b>Direction of travel on emergence:</b> West in front of the southern elevation.<br/><b>Notes:</b> The bat was observed foraging within the building before emerging on IR footage. The surveyor did not observe the emergence location. However, upon reviewing B1's IR footage and surveyor notes, no bat was seen entering the building from any direction at this time, confirming that there is a common pipistrelle day roost in the building. The roost location is currently unknown and is likely located between a gap between the corrugated sheeting and beams.<br/><br/><b>Summary of additional observations:</b> A bat was seen foraging within the barn at 20:36 and 20:39.</p> | |

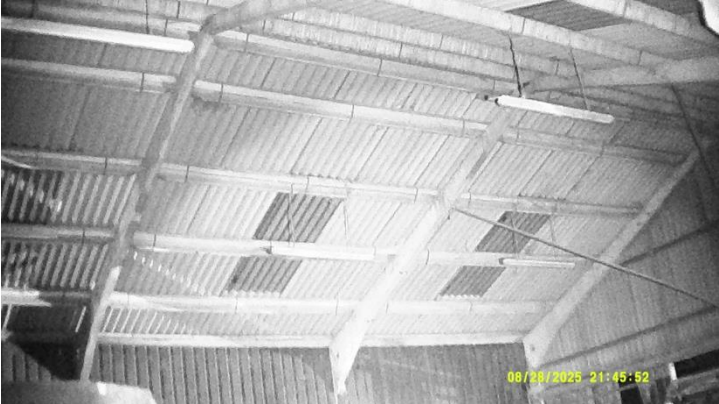
| <p><i>IR position 4</i><br/> <i>Nightfox Whisker x1</i><br/> <i>Nightfox XB5 Pro x1</i></p> | <p><b>Summary of additional observations:</b> A bat can be seen foraging within the building at 20:32 and 20:34</p> | <p><i>Darkest point photo showing the inside of B1's western section</i></p> |

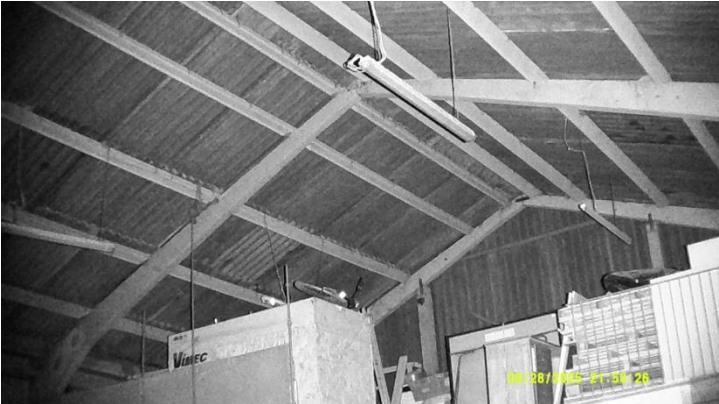
| <p><i>IR position 5</i><br/> <i>Nightfox Whisker x1</i><br/> <i>Nightfox XB5 Pro x1</i></p> | <p><b>No emergencies</b></p> <p><b>No additional observation</b></p> | <p><i>Darkest point photo showing the inside of B1's middle section</i></p> |

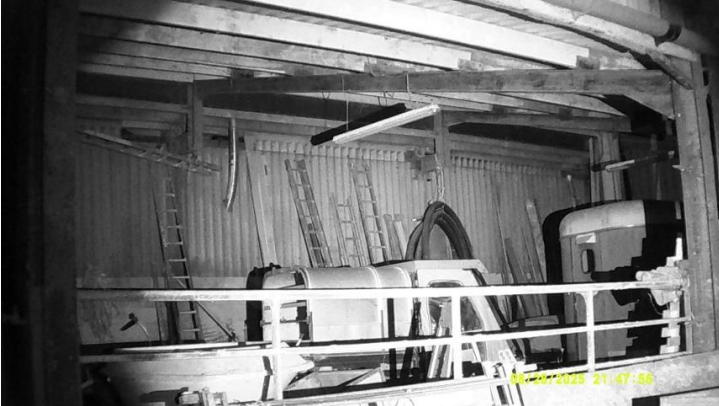
| <p><i>IR position 6</i><br/><i>Nightfox Whisker x1</i><br/><i>Nightfox XB5 Pro x1</i></p> | <p><b>Bat foraging activity</b></p> <p><b>Summary of additional observations:</b> A bat can be seen foraging within the barn at 20:56, 21:40 and 21:46. (confirmed as common pipistrelle by Surveyor 1)</p> | <p><i>Darkest point photo showing the inside of B1's eastern section</i></p> |

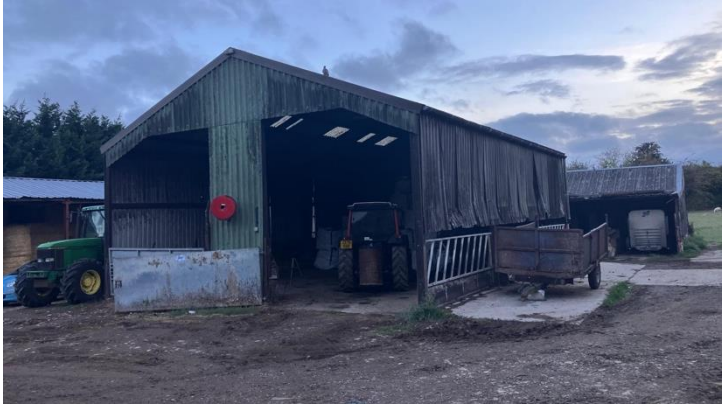
| <p><i>Surveyor 7</i></p> | <p><b>No emergences</b></p> <p><b>Flight paths:</b> Northeast past B2s east elevation</p> <p><b>Foraging areas:</b> Yard area directly east of B2</p> <p><b>Species:</b> Noctule, common pipistrelle, brown long-eared bat</p> <p><b>Summary of general activity:</b> At 19:58, 20:23 and 20:42 a noctule was seen not heard.</p> <p>At 20:16 a common pipistrelle was observed commuting southwest to northeast past B2s east elevation. At 20:41 and 20:52 a common pipistrelle was observed commuting in the yard area east of B2.</p> <p>Between 21:01 and 21:16 a brown long-eared bat was heard not seen.</p> | <p><i>Full elevation photo showing surveyors view of B2's north and east elevations</i></p> |

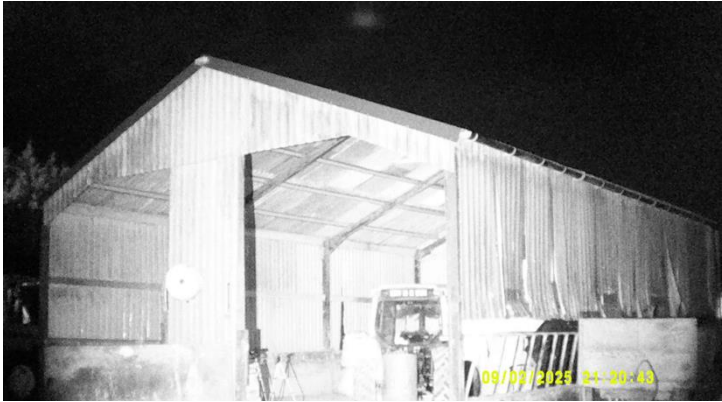
| <p><i>IR position 7</i></p> <p><i>Nightfox Whisker x1</i></p> <p><i>Nightfox XB5 Pro x1</i></p> | <p><b>No emergences</b></p> <p><b>No additional observations</b></p> | <p><i>Darkest point photo showing B2's north and east elevations</i></p> |

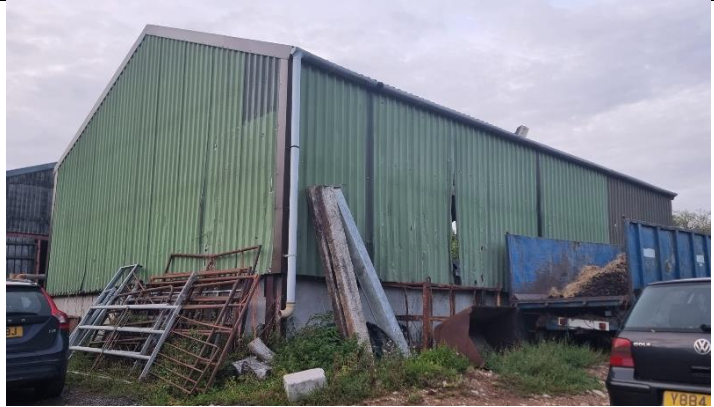
| <p><i>Surveyor 8</i></p> | <p><b>No emergences</b></p> <p><b>Flight paths:</b> Northwards past B2's west elevation</p> <p><b>Foraging areas:</b> The area directly south of B2</p> | <p><i>Full elevation photo showing surveyors view of B2's south and west elevations</i></p> |

| | <p><b>Species:</b> Common pipistrelle, serotine, soprano pipistrelle, noctule</p> <p><b>Summary of general activity:</b> At 19:58 and 20:23 a noctule was heard not seen.</p> <p>Between 19:58 and 19:59 soprano pipistrelle calls were heard not seen three times.</p> <p>At 20:36 a common pipistrelle was observed commuting north past B2s west elevation. Common pipistrelles were regularly observed foraging in the area directly south of B2 and north of B4 from 20:38 to 21: 49. Common pipistrelle calls were then regularly heard not seen until the end of the survey.</p> <p>The final bat was a serotine heard but not seen at 21.17.</p> | |

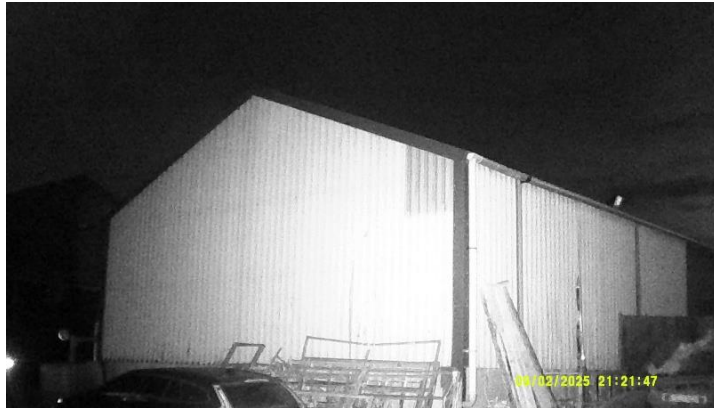
| <p><i>IR position 8</i><br/><i>Nightfox Whisker x1</i><br/><i>Nightfox XB5 Pro x1</i></p> | <p><b>No emergences</b></p> <p>At 20:51 a bat can be seen foraging by B2s east elevation corresponding to common pipistrelle calls heard at the same time.</p> | <p><i>Darkest point photo showing B2's south and west elevations</i></p> |

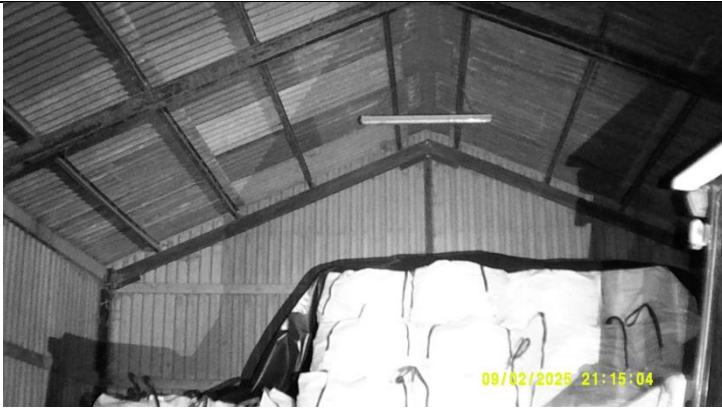
| <p><i>IR position 9</i><br/><i>Nightfox Whisker x1</i><br/><i>Nightfox XB5 Pro x1</i></p> | <p><b>No emergences</b></p> <p><b>No additional observations</b></p> | <p><i>Darkest point photo showing internal of B2</i></p> |

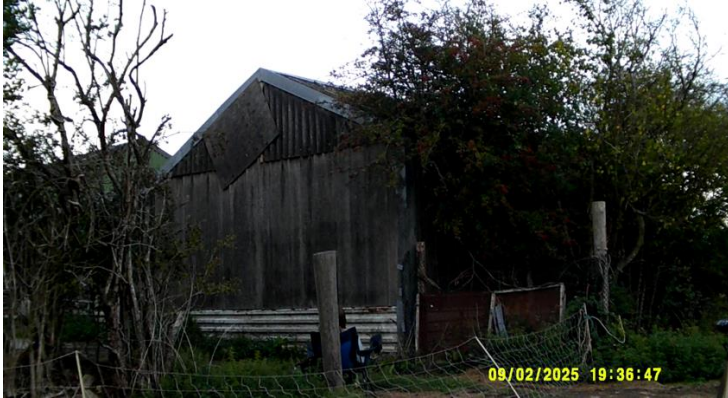
| <p><i>Surveyor 10</i></p> | <p><b>No emergences</b></p> <p><b>Flight paths:</b> In a west direction from B3s northeast corner</p> <p><b>Foraging areas:</b> The hedgerow running along B3s west elevation.</p> <p><b>Species:</b> Noctule, soprano pipistrelle and common pipistrelle</p> <p><b>Summary of general activity:</b> At 20:22 a noctule was seen passing west to south high above the site.</p> <p>A soprano pipistrelle was heard not seen at 20:18.</p> <p>Between 20:23 and 20:47 a common pipistrelle was heard not seen three times. A common pipistrelle was seen foraging northeast to southwest past B3s northwest corner at 20:24, 20:30, and 20:40. A common pipistrelle passed north to west past B3's northwest corner at 20:33 and 20:37.</p> | <p><i>Full elevation photo showing surveyors view of B3's north and west elevations</i></p> |

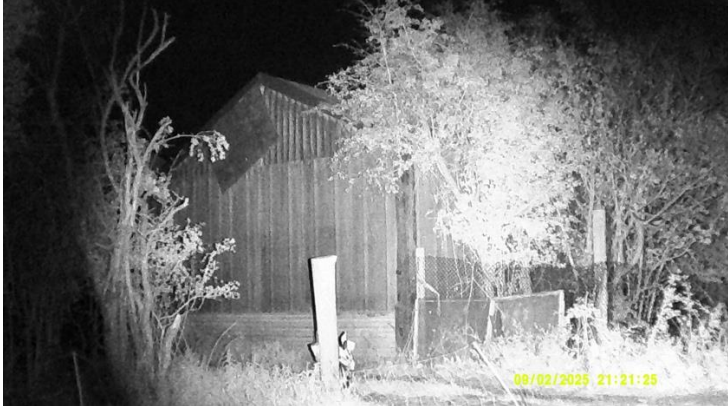
| <p><i>IR position 10</i></p> <p><i>Nightfox Whisker x1</i></p> <p><i>Nightfox XB5 Pro x1</i></p> | <p><b>No emergences</b></p> <p><b>No additional observation</b></p> | <p><i>Darkest point photo showing B3's north and west elevations</i></p> |

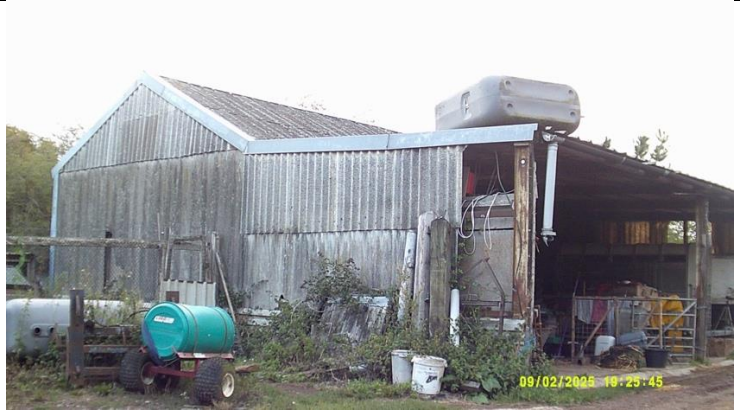
| <p><i>Surveyor 11</i></p> | <p><b>No emergences</b></p> <p><b>Flight paths:</b> N/A</p> <p><b>Foraging areas:</b> The area directly east and southeast of B3</p> | <p><i>Full elevation photo showing surveyors view of B3's south and east elevations</i></p> |

| | <p><b>Species:</b> Common pipistrelle, serotine, noctule</p> <p><b>Summary of general activity:</b> At 19:58, 20:23 and 20:42 a noctule was heard and not seen</p> <p>The first bat activity recorded was a noctule at 19.58, heard not seen and again at 20.23 and 20.42.</p> <p>Between 20:29 and 21:20 there was regular foraging activity of common pipistrelles in the area by the B3's east elevation by multiple bats. During this period common pipistrelles were observed foraging in the area southeast of B3 and north of B4.</p> <p>A serotine was heard not seen at 21.17.</p> | |

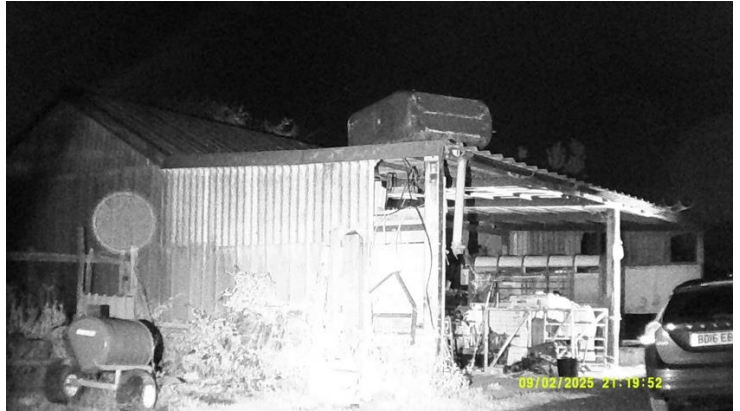
| <p><i>IR position 11</i></p> <p><i>Nightfox Whisker x1</i></p> <p><i>Nightfox XB5 Pro x1</i></p> | <p><b>No emergences</b></p> <p><b>No additional observation</b></p> | <p><i>Darkest point photo showing B3's south and east elevations</i></p> |

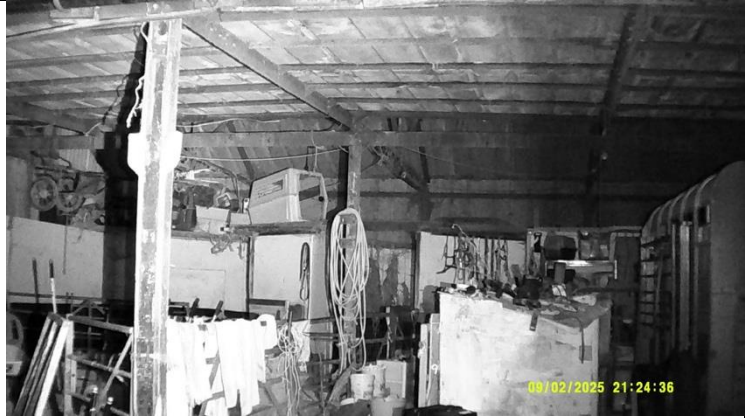
| <i>IR position 12</i> | <b>No emergences</b> | <i>Darkest point photo showing internal of B3</i> |

| <p><i>Nightfox Whisker x1</i><br/><i>Nightfox XB5 Pro x1</i></p> | <p><b>No additional observation</b></p> | |

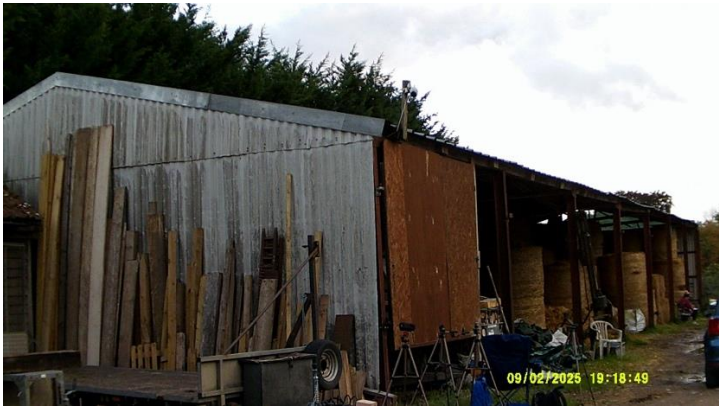
| Surveyor 13 | | <p><b>No emergencies observed</b></p> <p><b>Flight paths:</b> Northeast above B4 and east to west between B4 and B2.</p> <p><b>Foraging activity:</b> Throughout the site.</p> <p><b>Species observed:</b> Noctule and common pipistrelle</p> <p><b>Summary of general activity:</b> At 20:18 a noctule was observed commuting in a northeast direction high above B4</p> <p>At 20:40 and 20:50 a common pipistrelle was observed commuting from east to west between B4 and B2. From 20:41 to the end of the survey there was continuous common pipistrelle foraging activity both seen and heard and not seen north of B4 south of B2.</p> | | <p>Full elevation photo showing surveyors view of B4's north and east elevations</p> | | |

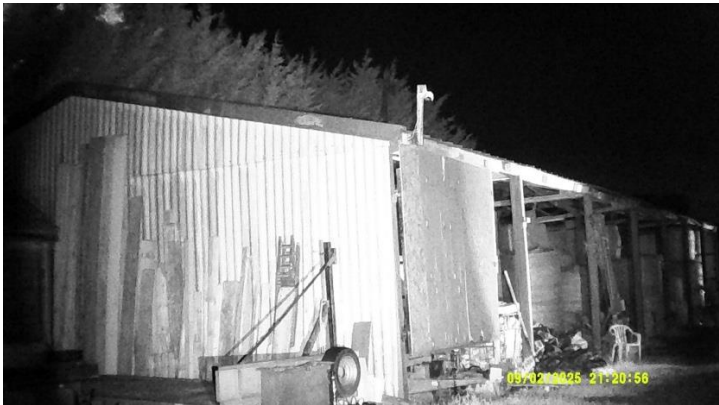
| IR position 13<br>Nightfox Whisker x1<br>Nightfox XB5 Pro x1 | | <p><b>Summary of additional observations:</b></p> <p>At 20:24 a bat can be seen foraging within B4 before exiting and flying west. A bat can be seen foraging within B4 before exiting and flying north at 20:41. At 20:45, 20:50 and 20:52 bats can be seen foraging above and in and out of B4. From 20:55 till the end of the survey bats can be seen continuously foraging above and in and out of B4. As well as commuting west to east above B4. These were confirmed as common pipistrelles by Surveyor 15</p> | | <p>Darkest point photo showing B4's north and east elevations</p> | | |

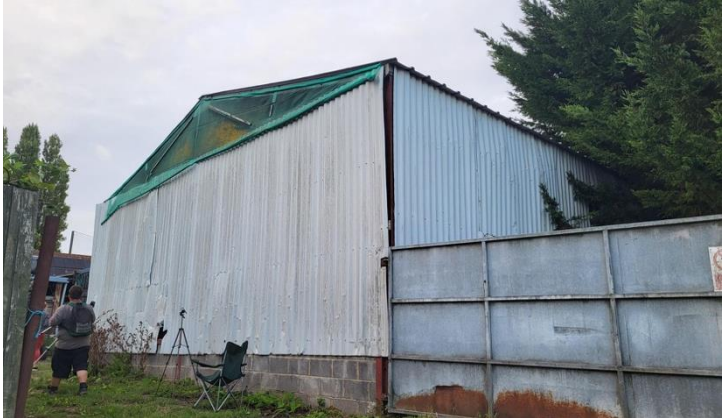
| <p><i>Surveyor 14</i></p> | <p><b>No emergences</b></p> <p><b>Flight paths:</b> N/A</p> <p><b>Foraging areas:</b> In both north and south directions along the track running along B4s west elevation</p> <p><b>Species:</b> Common pipistrelle, soprano pipistrelle, noctule</p> <p><b>Summary of general activity:</b> At 19:58 and 20:23 a noctule was heard not seen.</p> <p>At 20:14, a common pipistrelle was heard and seen foraging at the corner of the south and east elevations of B4 and then north to south along the track that runs along B4s west elevation. Foraging by pipistrelle in this area continued until the end of the survey</p> <p>At 20:26 and 20:56, soprano pipistrelles were observed foraging above the track on B4s east elevation and the southwestern corner of B4.</p> | <p><i>Full elevation photo showing surveyors view of B4's south and west elevations</i></p> |

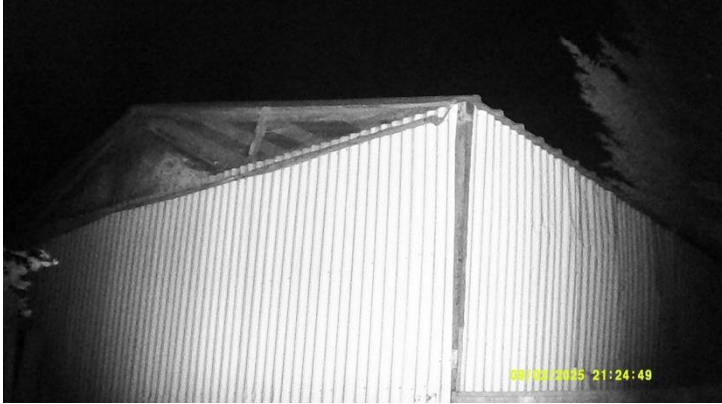
| <p><i>IR position 14</i></p> <p><i>Nightfox Whisker x1</i></p> <p><i>Nightfox XB5 Pro x1</i></p> | <p><b>No emergences observed</b></p> <p><b>Summary of general activity:</b> Constant pipistrelle activity from 20:15 onwards foraging up and down and track along B4s west elevation.</p> | <p><i>Darkest point photo showing B4's south and west elevations</i></p> |

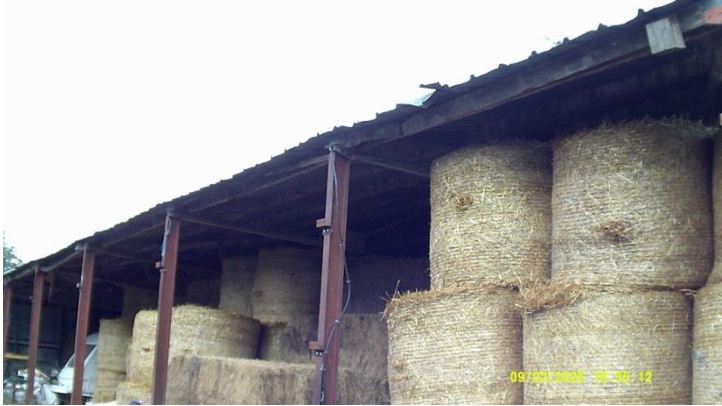
| <p><i>Surveyor 15</i></p> | <p><b>Internal foraging observed</b></p> <p><b>Flight paths:</b> East to west past B4s north elevation.</p> <p><b>Foraging areas:</b> The yard are north of B4 and the inside area</p> <p><b>Species:</b> Common pipistrelle, noctule, serotine</p> <p><b>Summary of general activity:</b> At 19:58 a noctule was observed foraging high above B4.</p> <p>At 20:12 a common pipistrelle was observed foraging in front of B4's north elevation. At 20:15 and 20:25 a common pipistrelle was observed commuting east to west along B4's north elevation. From 20:29 to end of survey there was occasional foraging activity of common pipistrelles in the area north of B4, occasionally entering the building to forage before exiting.</p> <p>A serotine was heard not seen at 21:17</p> | <p><i>Full elevation photo showing surveyors view of B4's north elevation</i></p> |

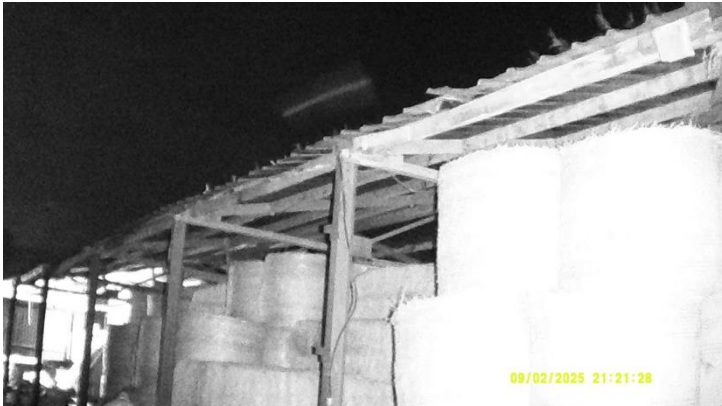
| <p><i>IR position 15</i><br/><i>Nightfox Whisker x1</i><br/><i>Nightfox XB5 Pro x1</i></p> | <p><b>Foraging behaviour observed</b></p> <p><b>Summary of general activity:</b> Frequent common pipistrelle foraging behaviour close to north elevation and occasionally inside B4 from 20:31 to 21:15</p> | <p><i>Darkest point photo showing B4's north elevation</i></p> |

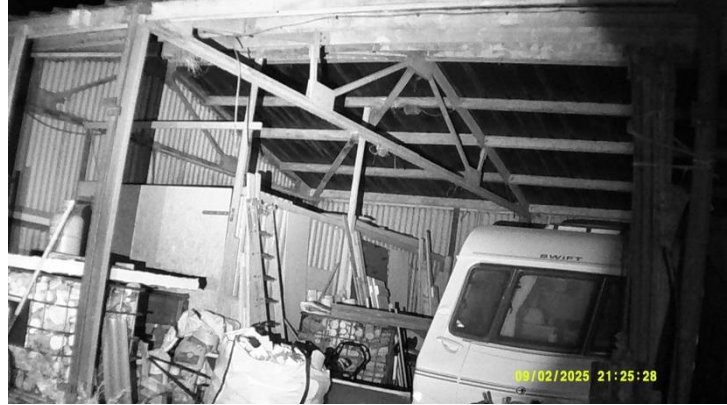
| <p><i>IR position 16</i><br/><i>Nightfox Whisker x1</i></p> | <p><b>Foraging behaviour observed</b></p> | <p><i>Darkest point photo showing inside of B4</i></p> |

| <p><i>Nightfox XB5 Pro x1</i></p> | <p><b>Summary of general activity:</b> Frequent common pipistrelle foraging behaviour internally from 20:29 to 21:09</p> | |

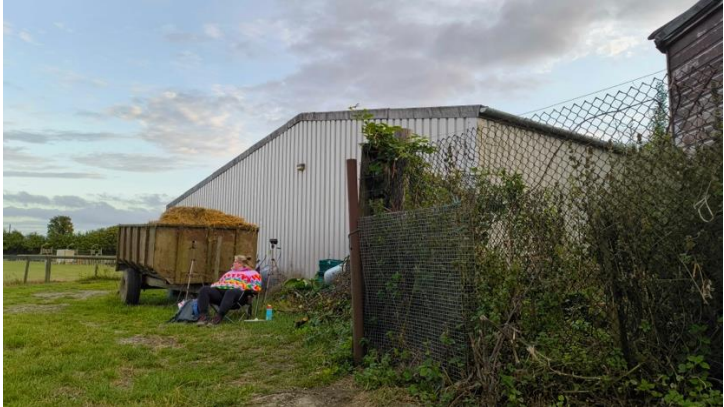
| <p><i>Surveyor 17</i></p> | <p><b>No emergences</b></p> <p><b>Flight paths:</b> N/A</p> <p><b>Foraging areas:</b> The track running along B4's west elevation and the area directly west of B5</p> <p><b>Species:</b> Soprano pipistrelle, noctule</p> <p><b>Summary of general activity:</b> At 19:58 a noctule was heard and not seen.</p> | <p><i>Full elevation photo showing surveyors view of B5's north and west elevations</i></p> |

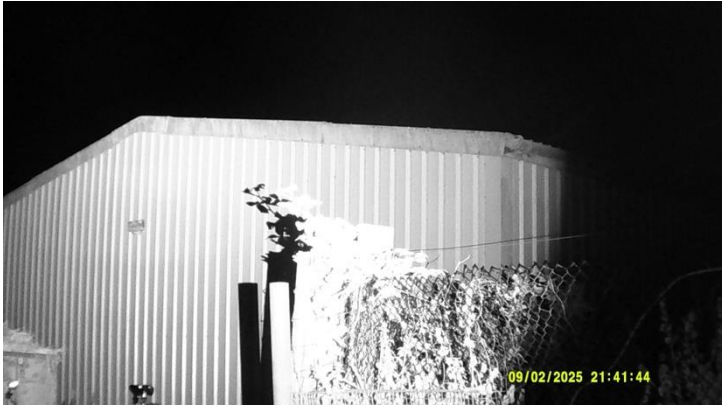
| <p><i>IR position 17</i><br/><i>Nightfox Whisker x1</i><br/><i>Nightfox XB5 Pro x1</i></p> | <p><b>No emergences</b></p> <p><b>No additional observations</b></p> | <p><i>Darkest point photo showing B5's north and west elevations</i></p> |

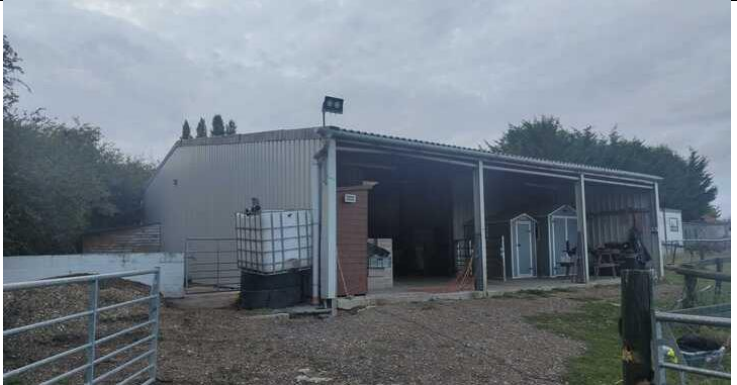
| <p><i>Surveyor 18</i></p> | <p><b>No emergences</b></p> <p><b>Flight paths:</b> West to east along B5s south elevation.</p> <p><b>Foraging areas:</b> The area directly south of B5</p> <p><b>Species:</b> Common pipistrelle, serotine, noctule</p> <p><b>Summary of general activity:</b> At 19:58 and 20:43 a noctule was heard and not seen.</p> | <p><i>Full elevation photo showing surveyors view of B5's south and west elevations</i></p> |

| | <p>At 20:14 a common pipistrelle was observed foraging in the area directly south of B5, joined by a second common pipistrelle at 20:16 that commuted from the south, foraging continued until 20:18. At 20:25 a common pipistrelle was observed commuting west to east just south of B5. Between 20:33 and 20:46 more foraging took place in the area just south of B5. Common pipistrelles were then heard not seen until 21:14</p> <p>At 21:02 a serotine was heard and not seen.</p> | |

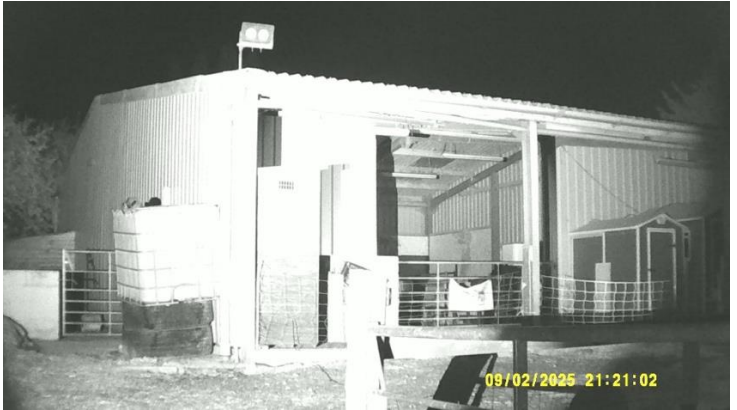
| <p><i>IR position 18</i><br/><i>Nightfox Whisker x1</i><br/><i>Nightfox XB5 Pro x1</i></p> | <p><b>No emergencies</b></p> <p><b>Summary of general activity:</b> Additional foraging to the south of B5 between 20:47 and 21:14 of common pipistrelles, coinciding with surveyor heard not seen observations.</p> | <p><i>Darkest point photo showing B5's south and west elevations</i></p> |

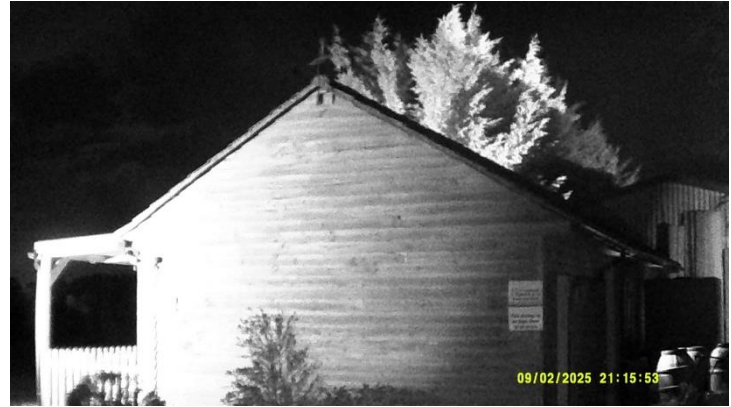
| <i>IR position 21</i><br><i>Nightfox Whisker x1</i><br><i>Nightfox XB5 Pro x1</i> | <b>No emergences</b><br><br><b>No additional observation</b> | <i>Darkest point photo showing B6's north and east elevations</i><br> <p>A black and white thermal image of a wooden building at night. The building has a gabled roof and a small porch on the left. The image is oriented horizontally, showing the north and east elevations. A timestamp in the bottom right corner reads '09/02/2025 21:15:53'.</p> |

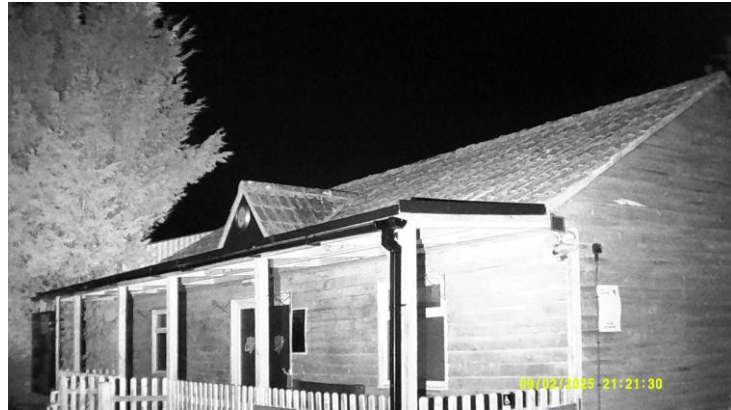
| <i>IR position 20</i><br><i>Nightfox Whisker x1</i><br><i>Nightfox XB5 Pro x1</i> | <b>No emergences</b><br><br><b>No additional observation</b> | <i>Darkest point photo showing B6's south and east elevations</i><br> <p>A black and white thermal image of a wooden building at night. The building has a gabled roof and a small porch on the left. The image is oriented horizontally, showing the south and east elevations. A timestamp in the bottom right corner reads '09/02/2025 21:21:30'.</p> |

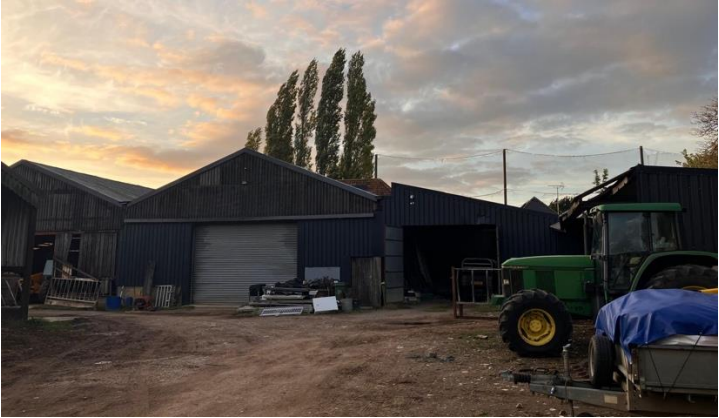
| <i>Surveyor 1</i> | | <b>No emergences</b><br><br><b>Flight paths:</b> N/A<br><b>Foraging areas:</b> By B2's east elevation, by the south elevation of B1's middle section.<br><b>Species:</b> Common pipistrelle<br><b>Summary of general activity:</b> At 19:25 and 19:45 a noctule was heard and not seen.<br><br>At 19:32 a common pipistrelle was observed foraging by B2's south elevation until 19:33. Between 19:34 and 19:45 a common pipistrelle was regularly seen foraging by the south elevation of B1's middle section. Common pipistrelle calls were regularly heard not seen until 20:44.<br><br>At 20:10 a serotine was heard not seen. | | | <i>Full elevation photo showing surveyors view of B1's south and west elevations</i><br> | |

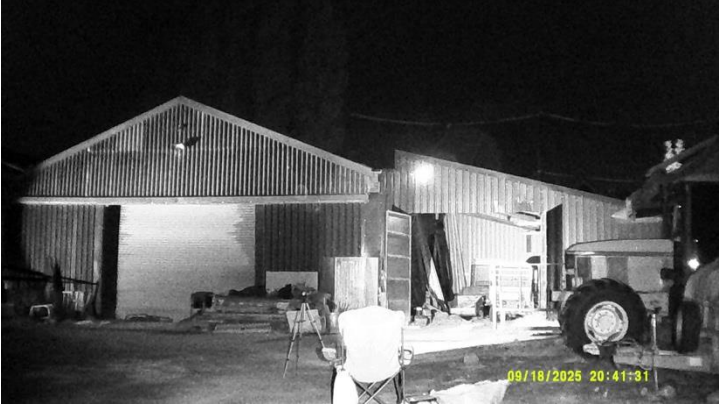
| <i>IR position 1</i><br><i>Nightfox Whisker x1</i><br><i>Nightfox XB5 Pro x1</i> | | <b>No emergences</b><br><br><b>No additional observations</b> | | | <i>Darkest point photo showing B1's south and west elevations</i><br> | |

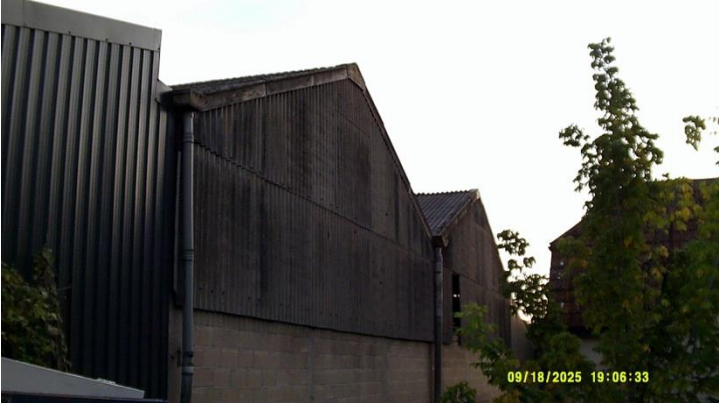
| <p><i>Surveyor 2</i></p> | <p><b>No emergences</b></p> <p><b>Flight paths:</b> N/A</p> <p><b>Foraging areas:</b> N/A</p> <p><b>Species:</b> Common pipistrelle, noctule, soprano pipistrelle</p> <p><b>Summary of general activity:</b> At 19:13 a soprano pipistrelle was heard and not seen.</p> <p>At 19:18,19:42 and 20:13 a noctule was heard and not seen.</p> <p>At 19:45 and 20:13 a common pipistrelle was heard not seen.</p> | <p><i>Full elevation photo showing surveyors view of B1's north and east elevations</i></p> |

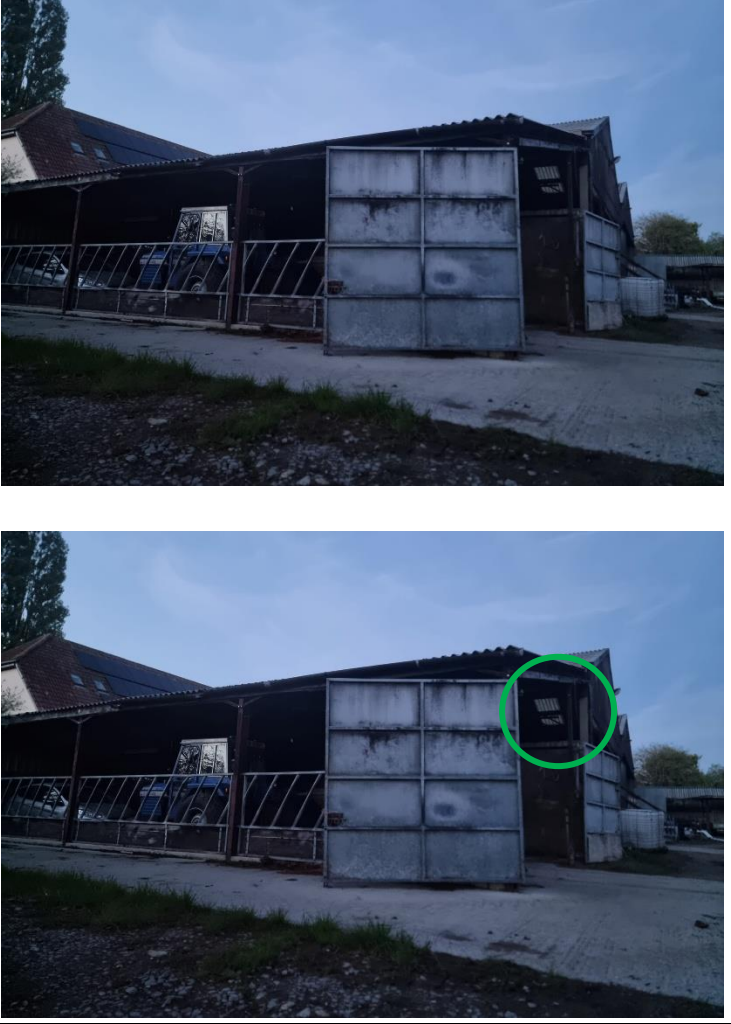
| <p><i>Surveyor 3</i></p> | <p><b>Emergences observed</b></p> <p><b>Emergence:</b> Day roost (Roost one)</p> | <p><i>Full elevation photo showing surveyors view of B1's south and west elevations</i></p> |

| | <p><b>Species:</b> Common pipistrelle</p> <p><b>Number:</b> 2</p> <p><b>Time:</b> 19:31 and 19:32</p> <p><b>Location of access point:</b> Doorway at south-west corner of B1 (green circle)</p> <p><b>Direction of travel on emergence:</b> East into the farmyard.</p> <p><b>Summary of general activity:</b> From 19:10 to 19:45 a noctule was regularly heard and not seen.</p> <p><b>Flight paths:</b> N/A</p> <p><b>Foraging areas:</b> Inside of B1's west section</p> <p><b>Species:</b> Common pipistrelle, noctule</p> <p><b>Summary of general activity:</b> From 19:29 common pipistrelles were heard and soon observed foraging within B1's west section and then seen emerging via the barn door on B1's southwest corner (blue circle) at 19:31 and 19:32. Two common pipistrelles were seen foraging between 19.43 – 19.47 along B1's south elevation. Common pipistrelles were also heard and not seen between 20.05 and 20.12. Upon reviewing B1's IR footage and surveyor notes, no bats were seen entering the building from any direction at this time, confirming that there is a common pipistrelle day roost in the building. The roost location is currently unknown and is likely located between a gap between the corrugated sheeting and beams.</p> | |

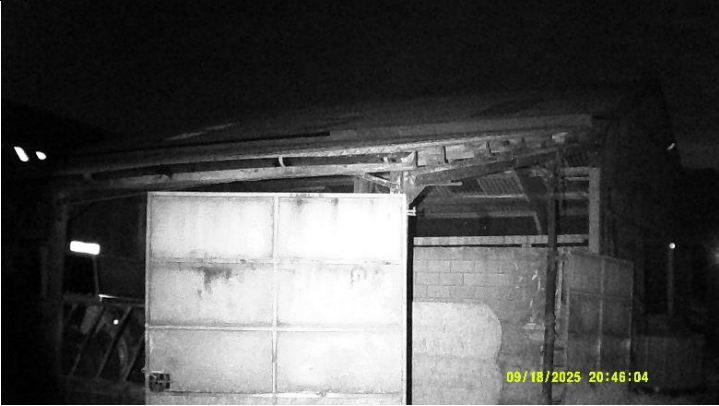
| <p><i>IR position 3</i></p> <p><i>Nightfox Whisker x1</i></p> <p><i>Nightfox XB5 Pro x1</i></p> | <p><b>Emergences confirmed:</b> Roost one</p> <p><b>Species:</b> Common pipistrelle</p> <p><b>Number:</b> 2</p> <p><b>Time:</b> 19:31 and 19:32</p> <p><b>Location of access point:</b> Doorway at south-west corner of B1</p> | <p><i>Darkest point photo showing B2's south and west elevations</i></p> |

| | <p><b>Direction of travel on emergence:</b> East into the farmyard.</p> <p><b>Notes:</b> Upon reviewing B1's IR footage and surveyor notes, no bats were seen entering the building from any direction at this time, confirming that there is a common pipistrelle day roost in the building. The roost location is currently unknown and is likely located between a gap between the corrugated sheeting and beams.</p> <p><b>No additional observations</b></p> | |

| <i>Recommendations</i> | <p><b><u>Building B1</u></b></p> <p>A Bat Licence from Natural England is required to legally permit the works. This requirement exists independently of the planning system and is required whether planning permission is needed or not, and whether this is listed as a condition of planning or not.</p> <p>Additional survey requirements:</p> <ul style="list-style-type: none"> <li>• If the licence is not submitted by 18 December 2025 a Material Changes Check will be required.</li> <li>• If the licence is not submitted by 1 May 2026 updated dusk surveys will be required.</li> <li>• As other buildings on site could be functionally connected to the survey building, a daytime bat walkover will be needed to inspect the other buildings on site to assess whether there could be any additional impacts.</li> </ul> |

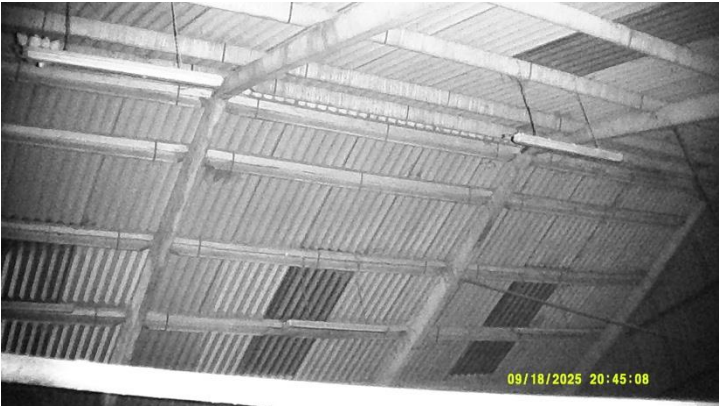
| <p><i>IR position 4</i><br/> <i>Nightfox Whisker x1</i><br/> <i>Nightfox XB5 Pro x1</i></p> | <p><b>No emergences</b></p> <p><b>Summary of general activity:</b> At least two bats can be observed foraging within the inside area from 19:29 to 19:30, which coincides with common pipistrelle calls heard by Surveyor 3.</p> | <p><i>Darkest point photo showing internals of B2s western section</i></p> |

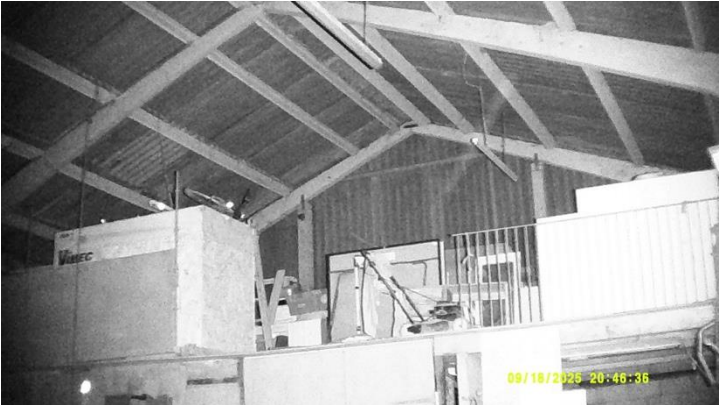
| <i>IR position 5</i><br><i>Nightfox Whisker x1</i><br><i>Nightfox XB5 Pro x1</i> | <b>No emergences</b><br><br><b>No additional observations</b> | <i>Darkest point photo showing internals of B2s middle section</i><br> |

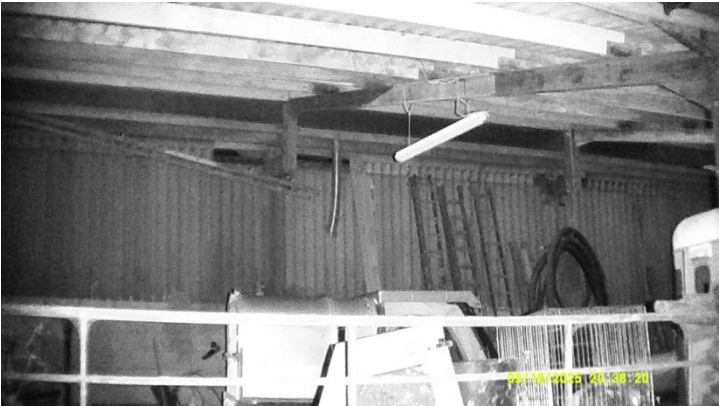
| <i>IR position 6</i><br><i>Nightfox Whisker x1</i><br><i>Nightfox XB5 Pro x1</i> | <b>No emergences</b><br><br><b>No additional observations</b> | <i>Darkest point photo showing internals of B2s eastern section</i><br> |
