## Preliminary Ecological Appraisal and Roost Assessment

Goatacre Farm, Goatacre, Wiltshire, SN11 9JA

This report is prepared to inform a planning application with the Wiltshire Council. The proposal is described as:

The demolition of all existing buildings and the construction of nine new dwellings.

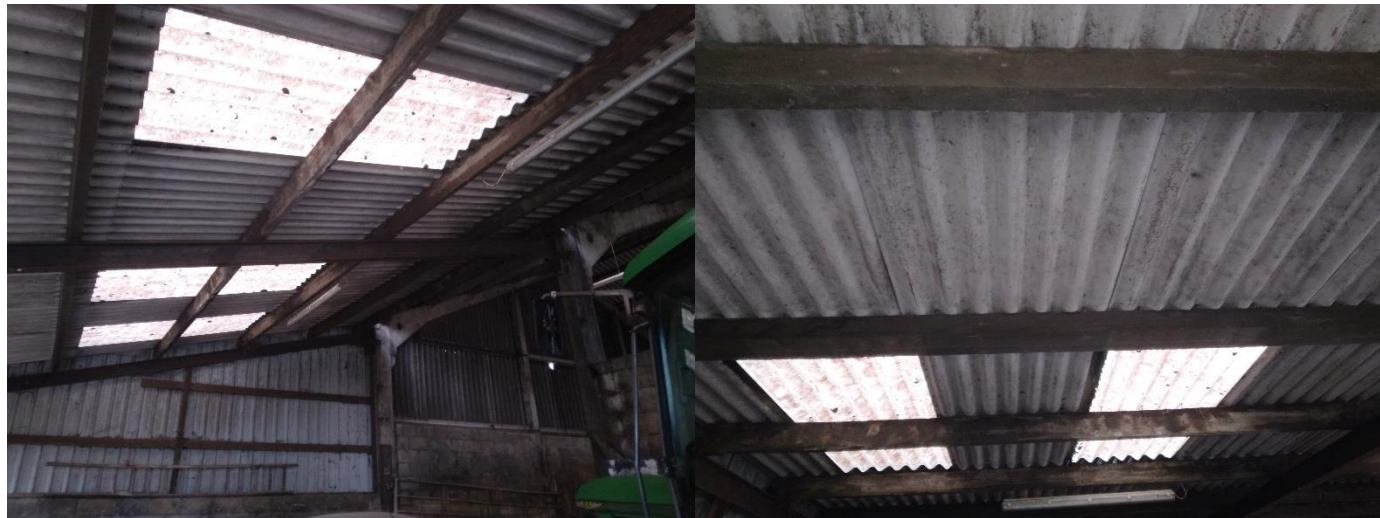
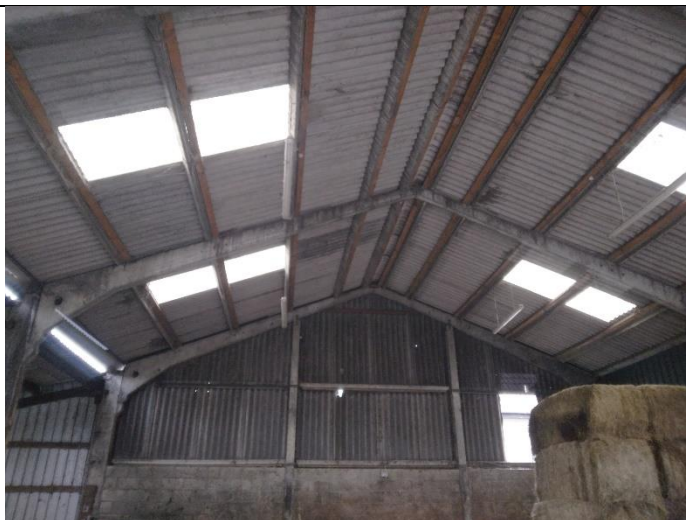
*Internal space IS1*

B1 is a large agricultural building. It features an 'M'-shaped corrugated roof with PVC skylights. There were corrugated sheeting and wooden boarding on the elevations. The building had additional corrugated lean-to roofs on the western and eastern elevations. The southern elevation had flood lighting. The building exhibited signs of wear, resulting in exterior crevices and access points. B1 was split into three internal spaces (IS1 – IS3). B1 is a confirmed roost due to the presence of droppings found on top of a dust-covered car in IS3 (~10 droppings). A sample of droppings was taken for DNA analysis and sent off for DNA analysis. This confirmed the species to be common pipistrelle. The DNA analysis report is included in Appendix 5. No loft void (vaulted) was present within B1. The roof was in good condition and well-lit due to the PVC skylights. The internal temperature was 17 °C, and the humidity was 80%.

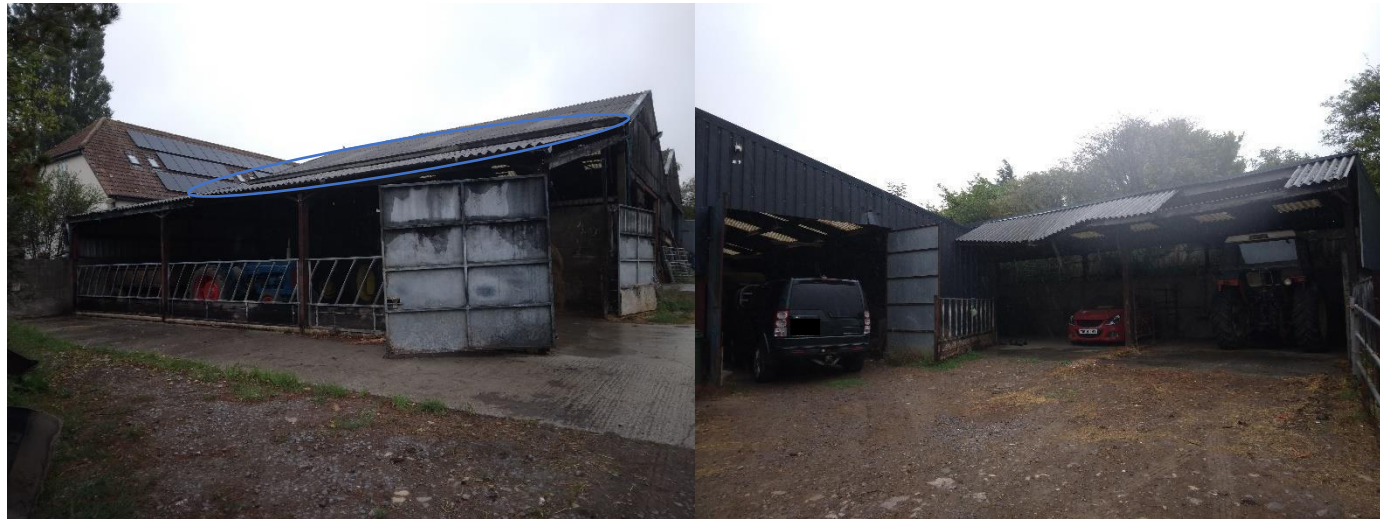
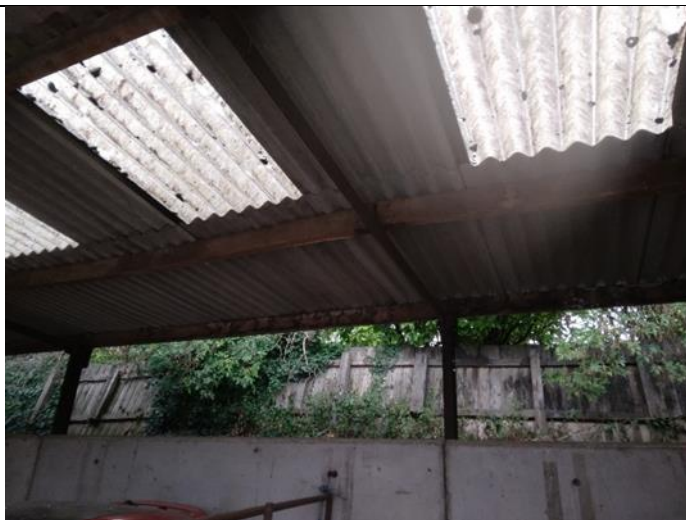
*Western elevations*

There are external and internal features that may provide roosting opportunities for crevice-dwelling bats and conceal evidence of roosting bats. The roosting and access features of B1 include:

- Gaps between the corrugated sheets (circled in blue)
- Gaps between corrugated sheets and beams (circled in red)

B1 was of high habitat value due to its suitable crevice-dwelling roost features and access points, as well as the presence of bat droppings, and the limited lighting around the building.

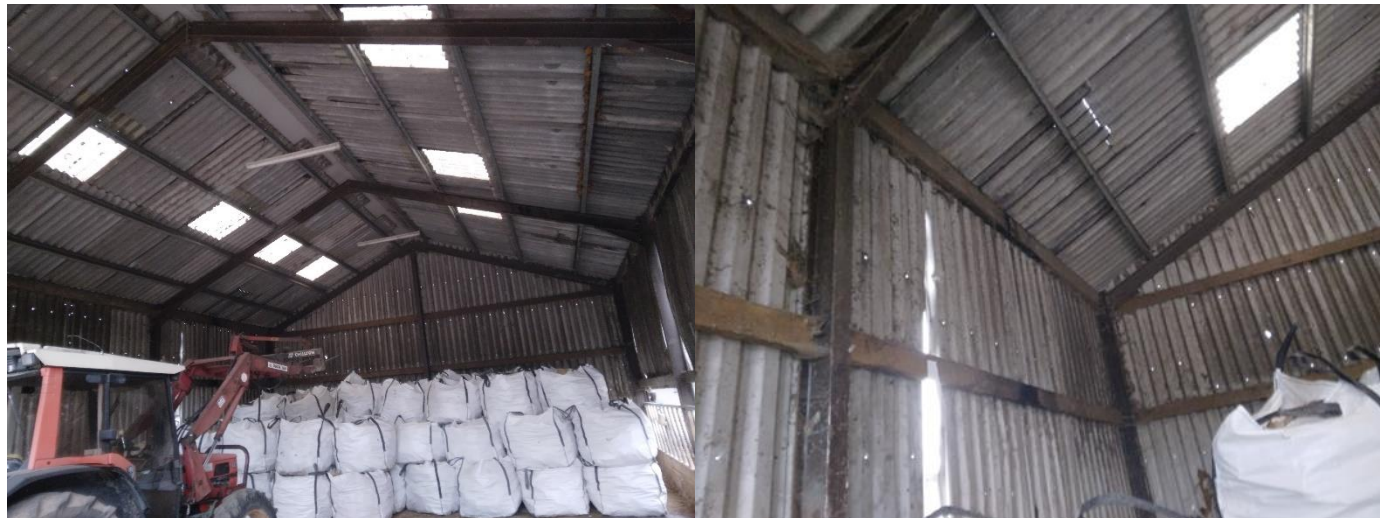
B2 is an agricultural building with a pitched corrugated roof and PVC skylights. There was corrugated sheeting on the elevations. The northern elevation would be subject to light spill from the floodlighting on B1. The building exhibited signs of wear, resulting in exterior crevices and access points. No loft void (vaulted) was present within B2. The roof was in poor condition (holes in the corrugated sheeting) and well-lit due to the PVC skylights. The internal temperature was 16 °C, and the humidity was 82%. No evidence of bats was identified during the survey of B2.

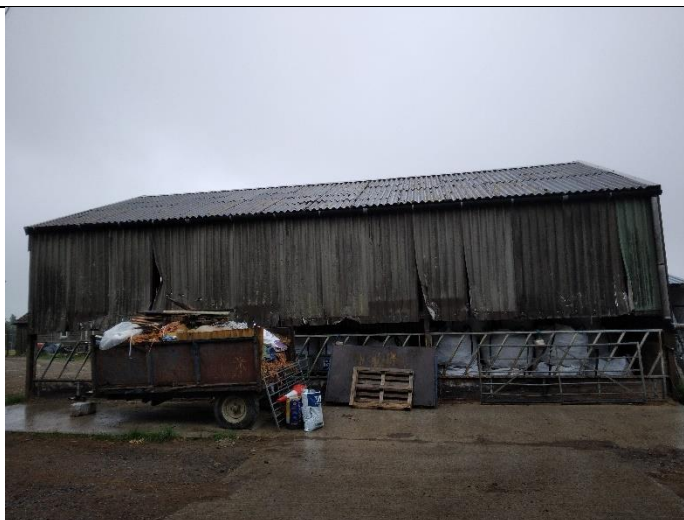
*Northern elevation*

There are external and internal features that may provide roosting opportunities for crevice-dwelling bats and conceal evidence of roosting bats. The roosting and access features of B1 include:

- Gaps between corrugated sheets and beams (circled in red)

B2 was of moderate habitat value due to its suitable crevice-dwelling roost features and access points, as well as the limited lighting around the building.

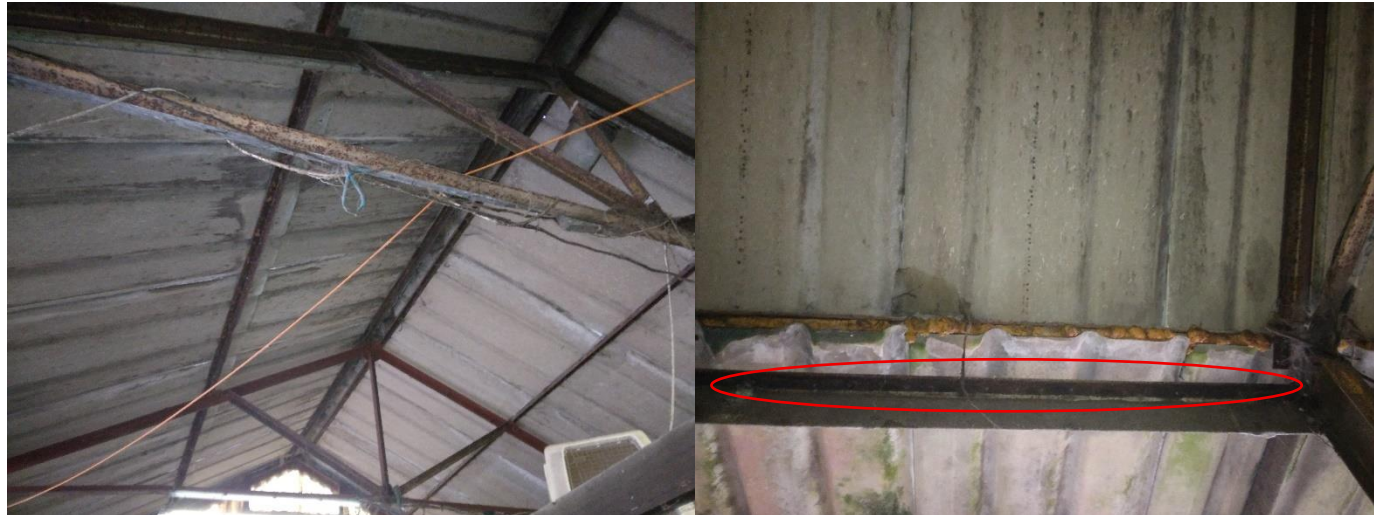
B3 is an agricultural building with a pitched corrugated roof and a flat roof. The building exhibited signs of wear, resulting in exterior crevices and access points. No loft void (vaulted) was present within B3. The roof was in good condition. The internal temperature was 16 °C, and the humidity was 81%. No evidence of bats was identified during the survey of B3.

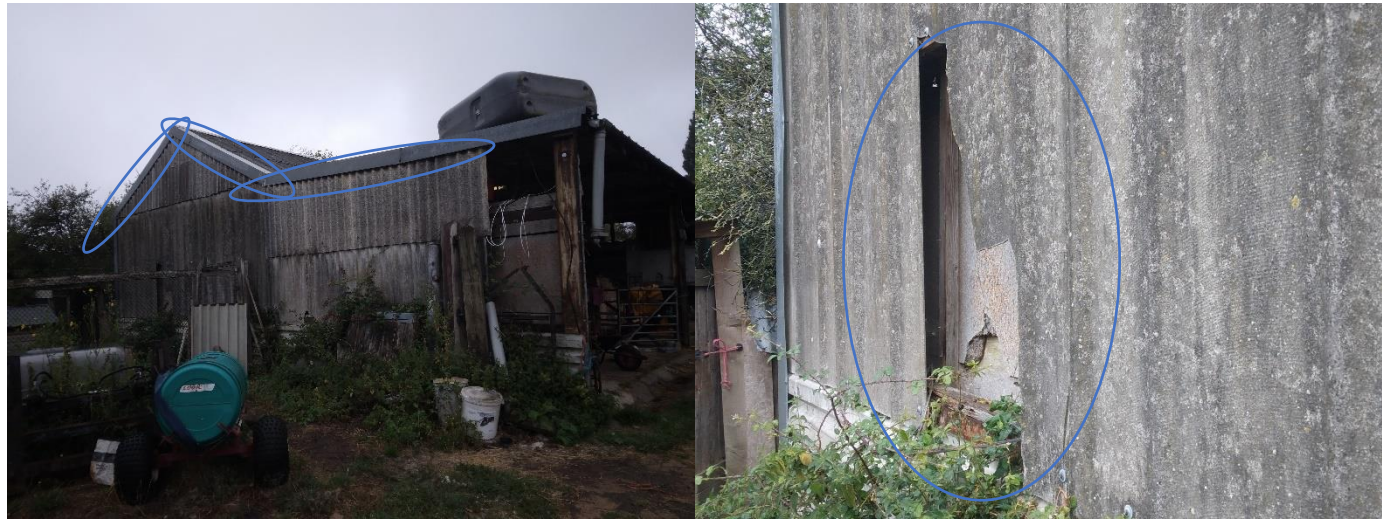
*Southern elevation*

There are external and internal features that may provide roosting opportunities for crevice-dwelling bats and conceal evidence of roosting bats. The roosting and access features of B3 include:

- Gaps between the corrugated sheets (circled in blue)
- Gaps between corrugated sheets and beams (circled in red)

B3 was of moderate habitat value due to its suitable crevice-dwelling roost features and access points, as well as the limited lighting around the building.

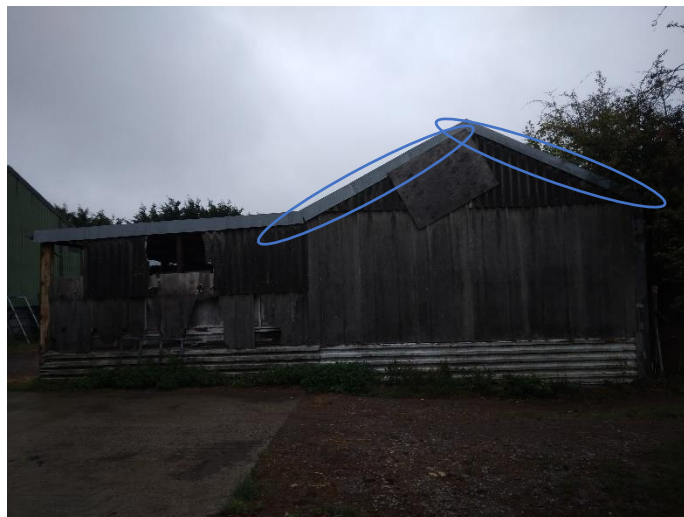
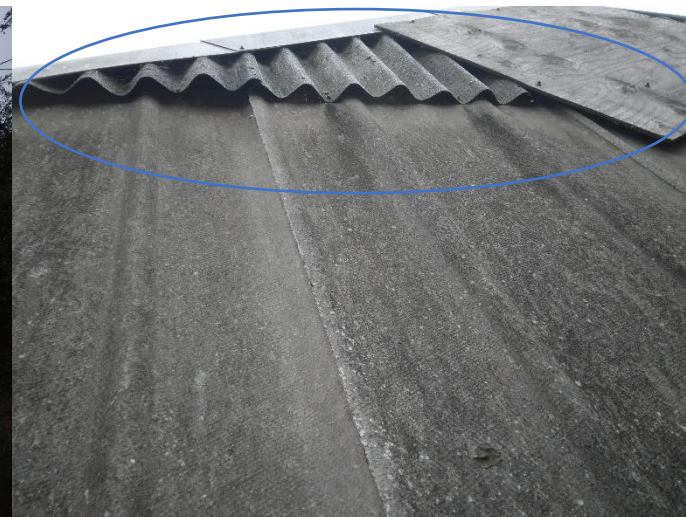
*Western elevation*

B4 is a large agricultural building with a pitched corrugated roof. The building exhibited signs of wear, resulting in exterior crevices and access points. No loft void (vaulted) was present within B4. The roof was in good condition. The internal temperature was 17 °C, and the humidity was 82%. No evidence of bats was identified during the survey of B4.

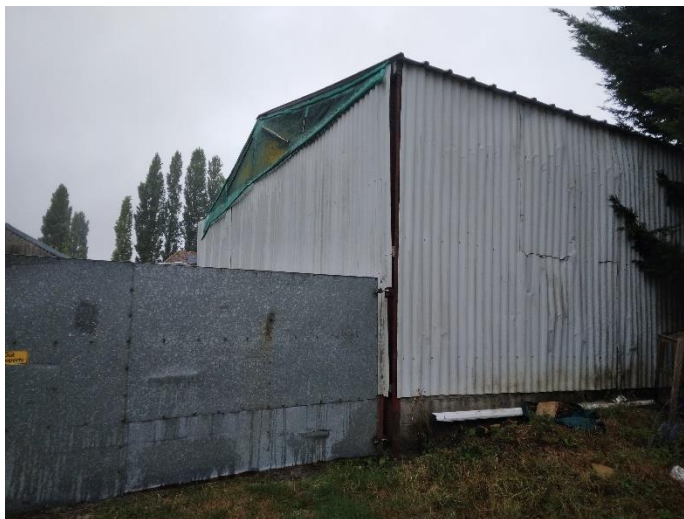
*Southern and western elevations*

There are external and internal features that may provide roosting opportunities for crevice-dwelling bats and conceal evidence of roosting bats. The roosting and access features of B4 include:

- Gaps between the corrugated sheets (circled in blue)
- Gaps between corrugated sheets and beams (circled in red)

B4 was of moderate habitat value due to its suitable crevice-dwelling roost features and access points, as well as the limited lighting around the building.

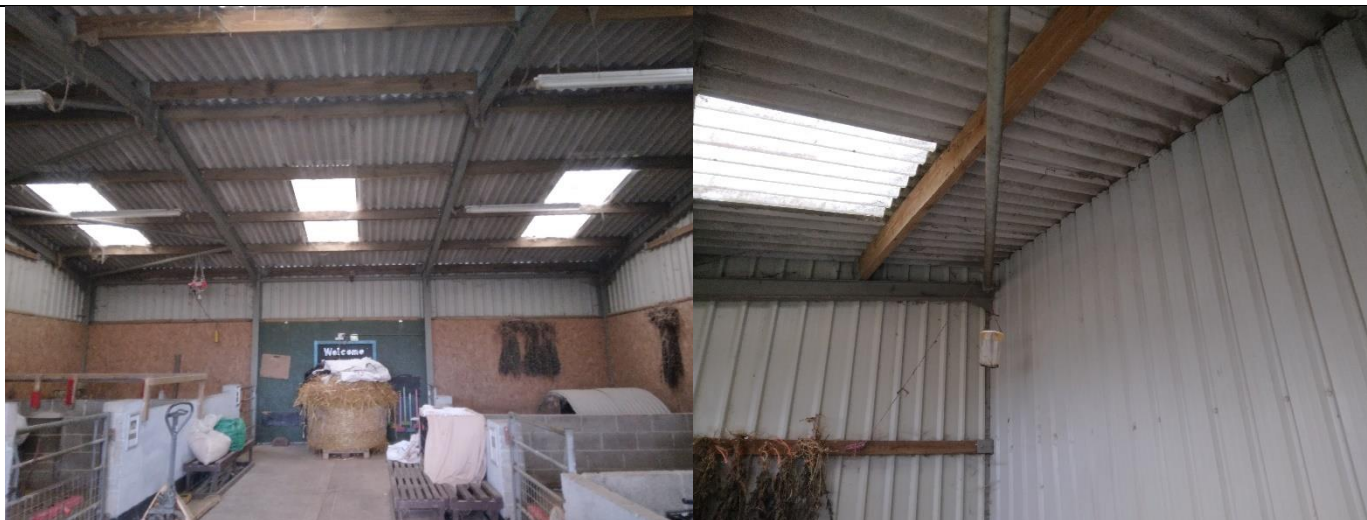
B5 is a large agricultural building with a saltbox corrugated roof. The building exhibited signs of wear, resulting in exterior crevices and access points. The western and eastern elevation have exterior lighting. No loft void (vaulted) was present within B5. The roof was in good condition. The internal temperature was 17 °C, and the humidity was 80%. No evidence of bats was identified during the survey of B5.

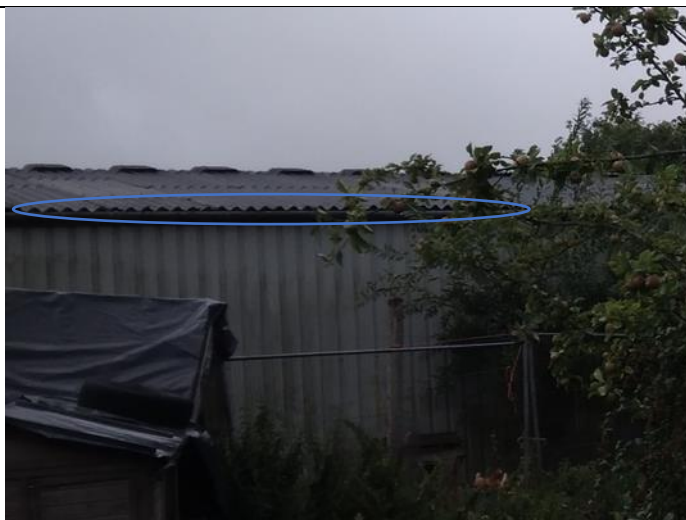
*Northern elevation*

There are external and internal features that may provide roosting opportunities for crevice-dwelling bats and conceal evidence of roosting bats. The roosting and access features of B5 include:

- Gaps between the corrugated sheets (circled in blue)
- Gaps between corrugated sheets and beams (circled in red)

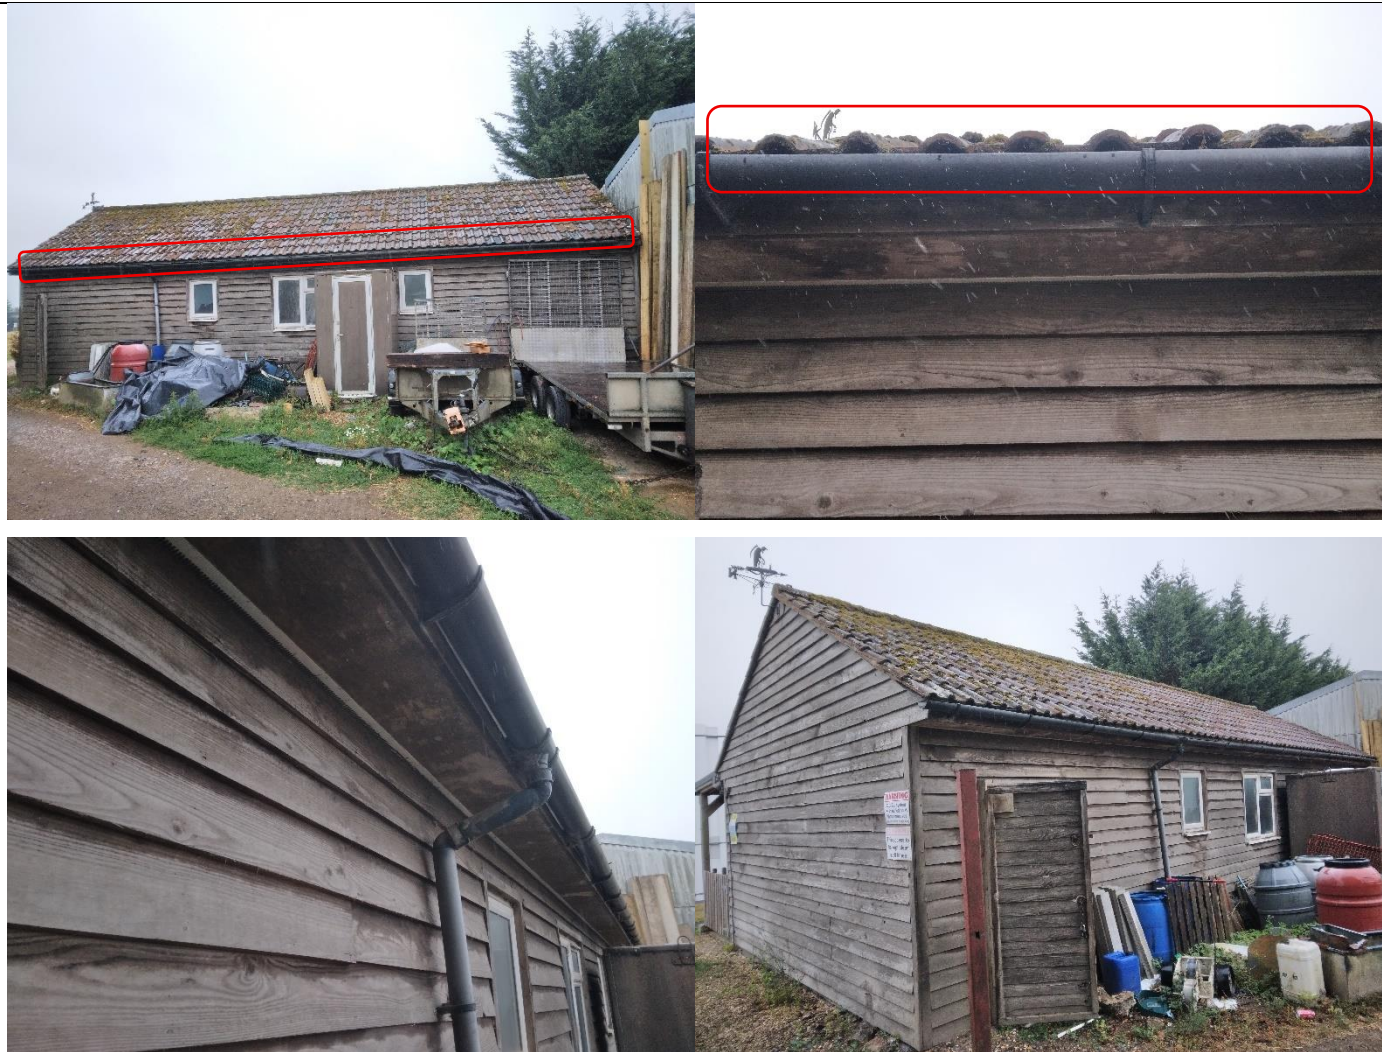
| | <p>B5 was of moderate habitat value due to its suitable crevice-dwelling roost features and access points, as well as the limited lighting around the building.</p> <p><u>Building B6 (no evidence – moderate roost suitability)</u></p> <p>B6 is a single-storey pavilion with a pitched (double Roman tile) roof. The building is wooden-clad on all elevations and has wooden soffit boxes on the southern and northern elevations. The southern elevation had a wooden (flat roof) porch. The loft hatch in building B6 was swollen, and it could not be opened. Therefore, further evidence may have been missed.</p> <p>There are external features that may provide roosting opportunities for crevice-dwelling bats and conceal evidence of roosting bats. The roosting and access features of B6 include:</p> <ul style="list-style-type: none"><li>- Lifted roof tiles (circled in red)</li></ul> <p><i>Northern elevation</i></p> |

B6 was of moderate habitat value due to its suitable crevice-dwelling roost features and access points, as well as the limited lighting around the building.

| <i>Recommendations</i> | <p><b><u>Foraging and commuting habitats</u></b></p> <p>Lighting mitigation may be required based on the outcome of the night bat surveys.</p> <p>Enhancements are dependent on the outcome of further surveys.</p> <p><b><u>Roosting habitats</u></b></p> <p><b><u>Building 1</u></b></p> <p>As B1 is a confirmed roost, three bat emergence and re-entry surveys are required during the active bat season (optimal May to August, suboptimal September) to characterise the roosts present. At least two of the surveys should be completed during the optimal survey period mid-May to August inclusive.</p> <p>Infra-red cameras should be used as an aid. Surveys should be a minimum of three weeks apart.</p> <p>Three surveyors are required to provide full coverage of the building. Three additional unmanned IR cameras are required to provide coverage of the internal space of the building.</p> <p>An EPSL application to Natural England will be required. The EPSL application requires that surveys have been undertaken within the most recent active bat season and planning permission must have been granted and all relevant wildlife-related conditions have been discharged prior to submission.</p> <p>A Material Changes Check will be required within three months of the EPSL submission, if no survey work has been undertaken within that period. If bat droppings were found during the PRA, a sample will need to be sent off for DNA analysis to confirm the bat species present, to inform the EPSL application. Biological records data will also need to be obtained to inform the application.</p> |

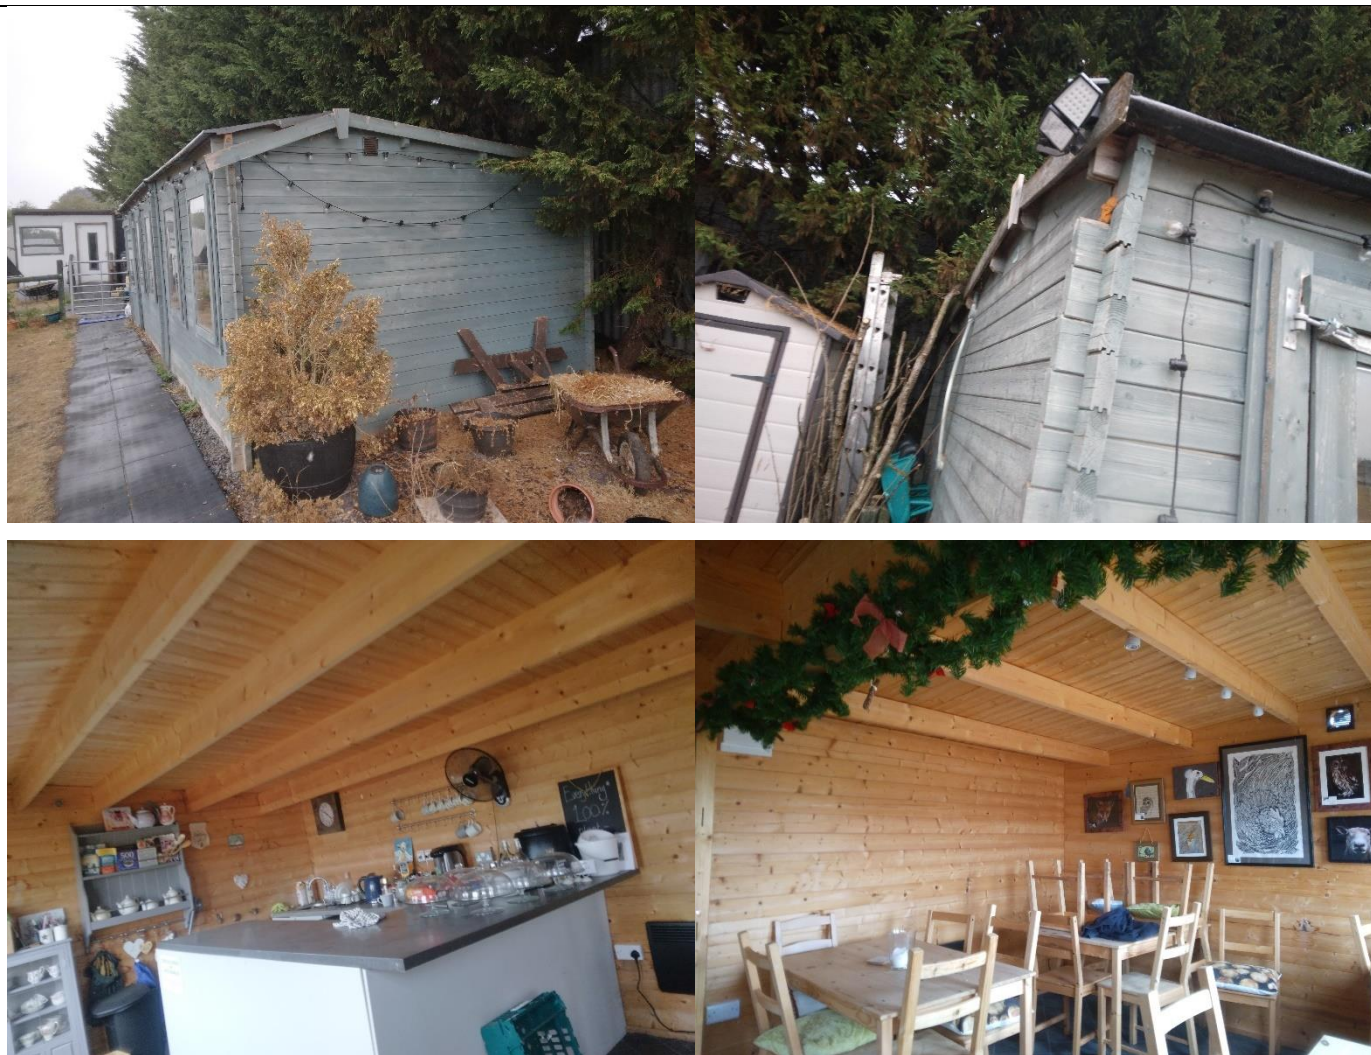
B7 is a single-storey wooden storage unit. The internal space is sealed and well-lit with no roosting features. No suitable exterior crevices were noted, and the building was considered negligible as it lacked suitability for crevice and loft-dwelling bats (due to being well-sealed and significant light spill).

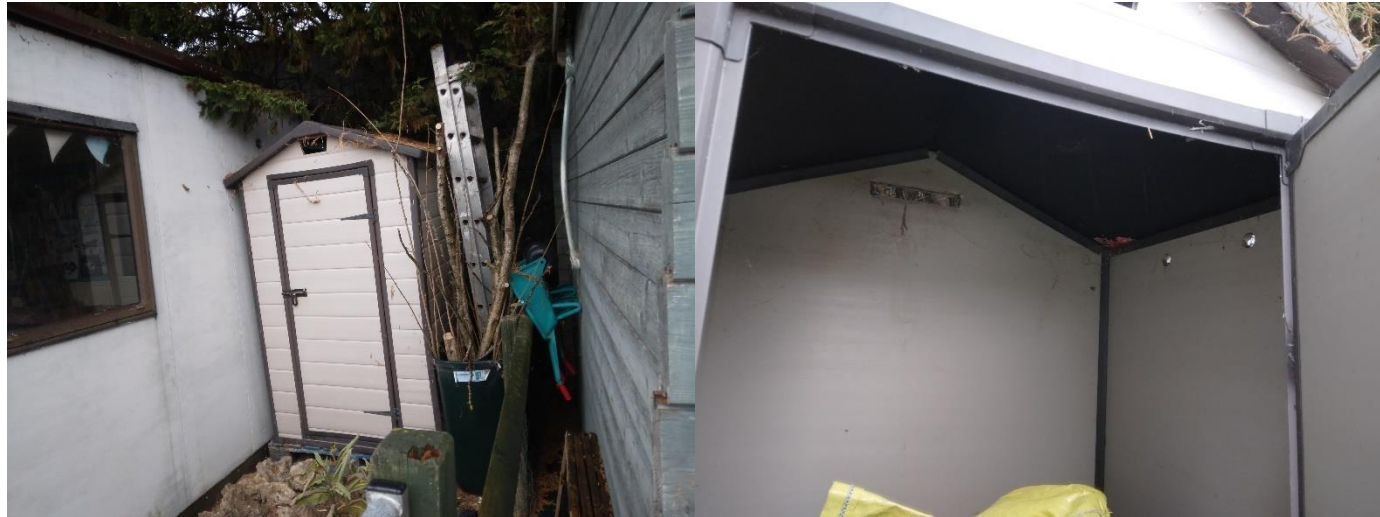
B8 is a small storage shed. No suitable exterior crevices were noted, and the building was considered negligible as it lacked suitability for crevice and loft-dwelling bats (due to being well-sealed and temperature fluctuation).

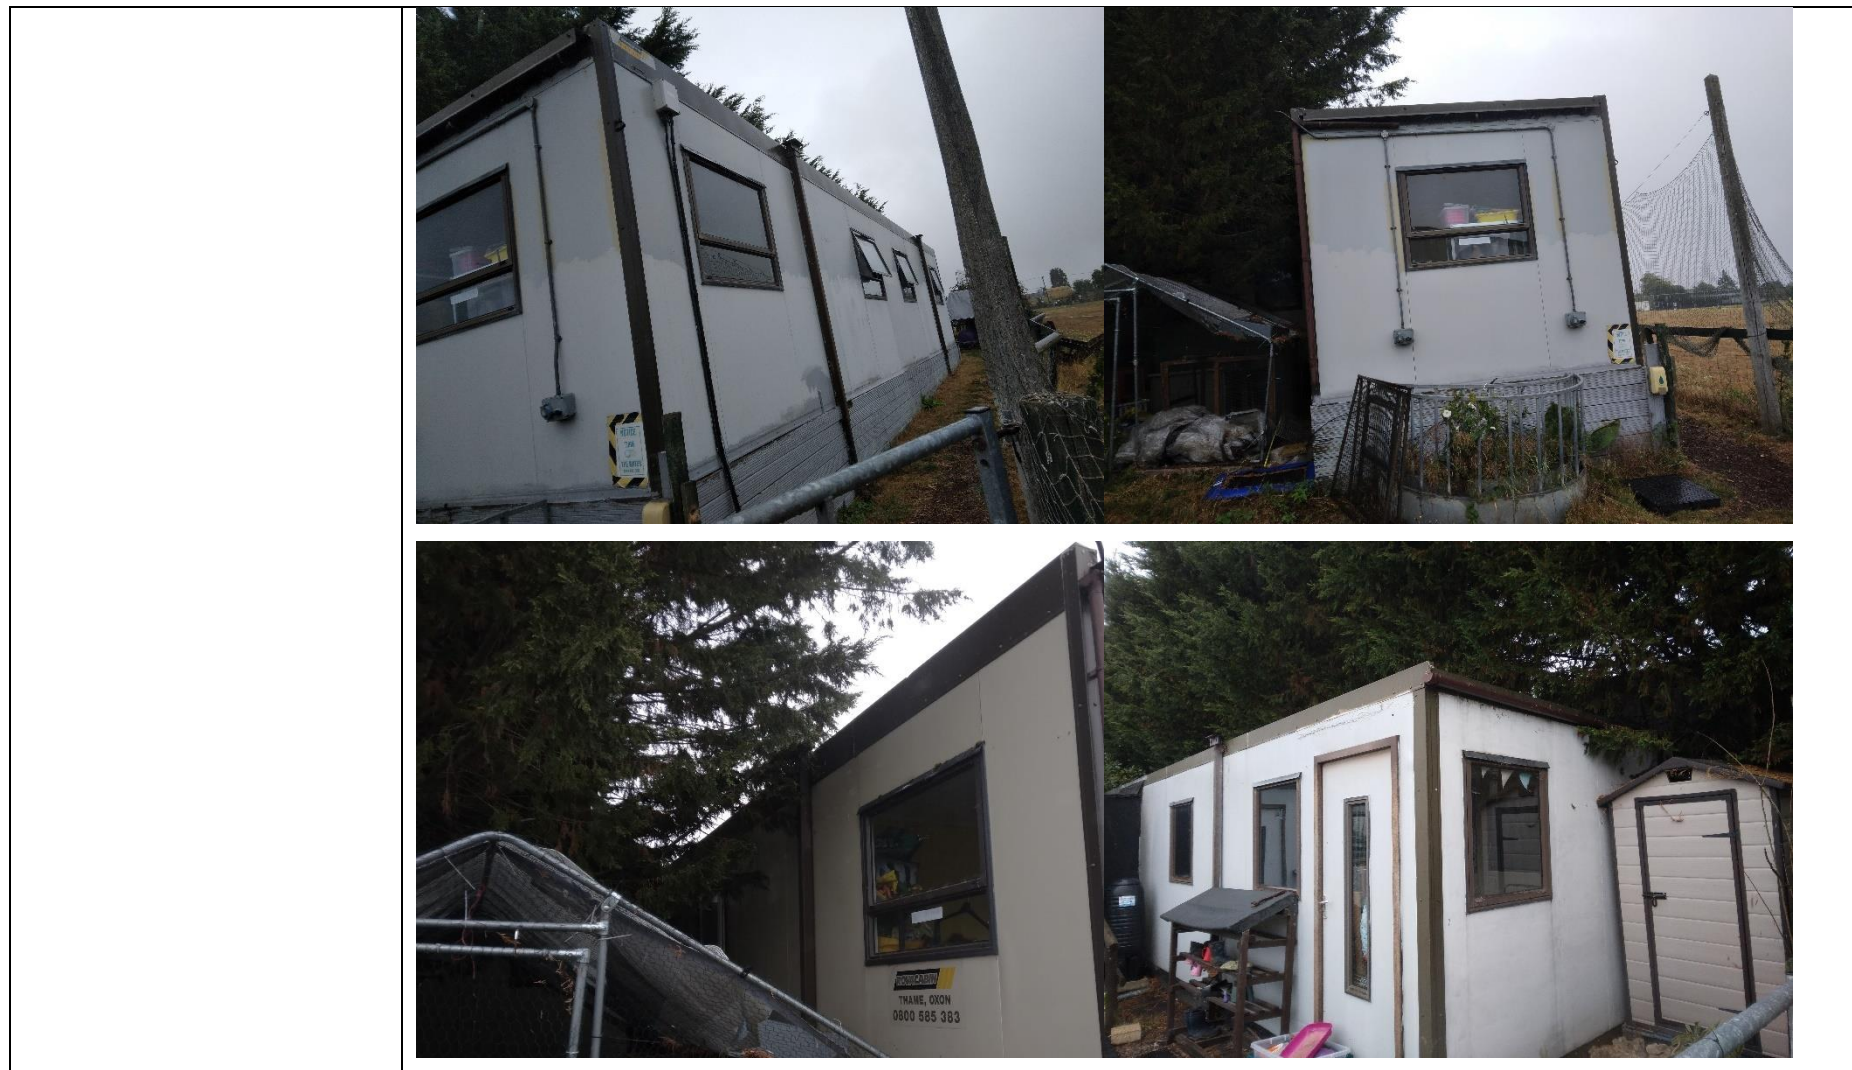
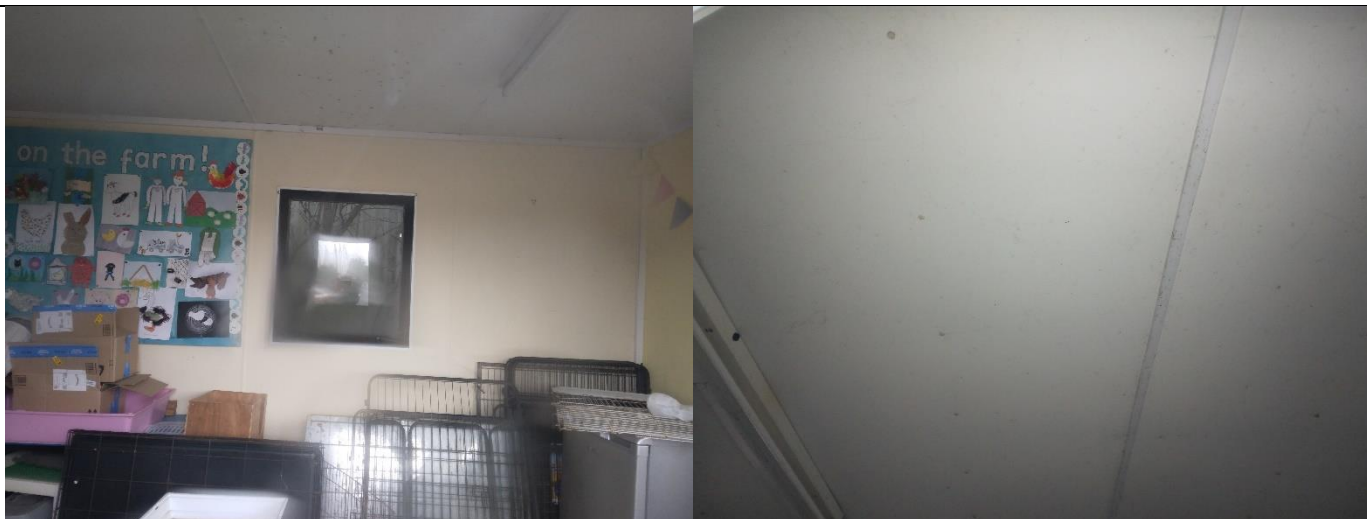
B9 is a single-storey temporary static unit. The internal space is sealed with no access features. No suitable exterior crevices were noted, and the building was considered negligible as it lacked suitability for crevice and loft-dwelling bats (due to being well-sealed, damp and significant light spill).

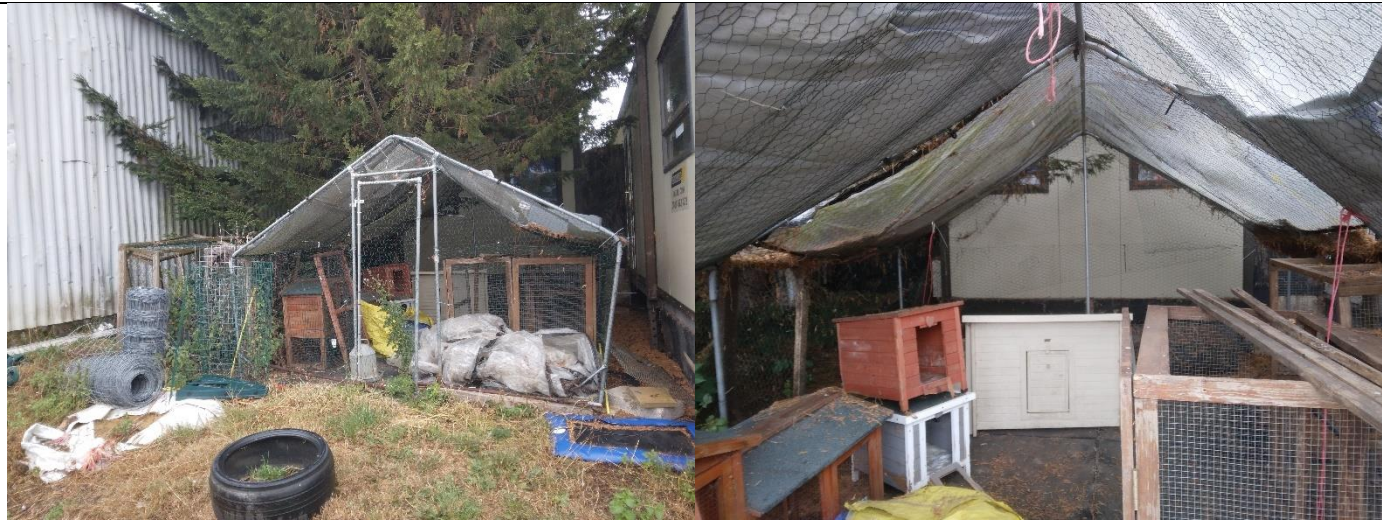
B10 is a small chicken run. No suitable crevices were noted, and the building was considered negligible as it lacked suitability for crevice and loft-dwelling bats (light spill and temperature fluctuation).

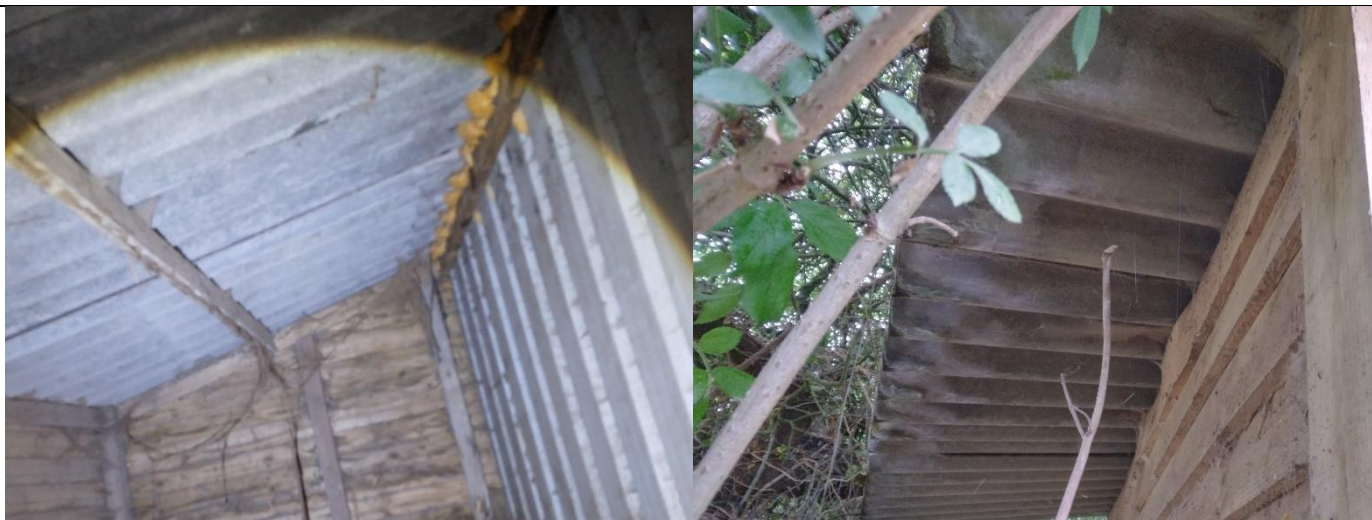
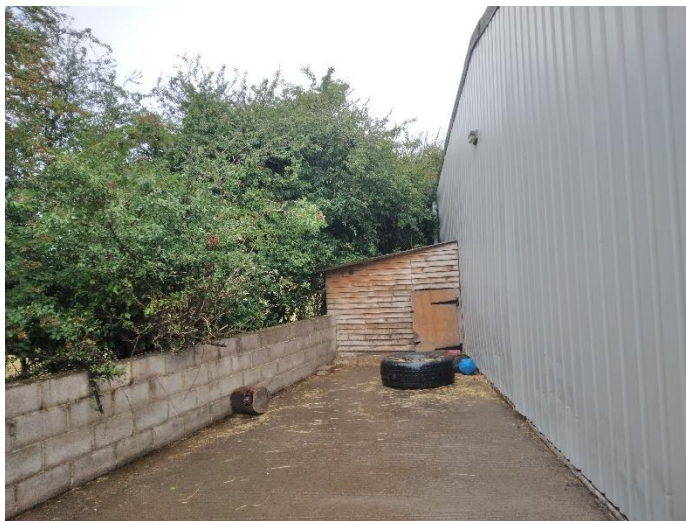
B11 is a small animal shelter. The internal space is sealed with no access features. No suitable exterior crevices were noted, and the building was considered negligible as it lacked suitability for crevice and loft-dwelling bats (due to being well-sealed).

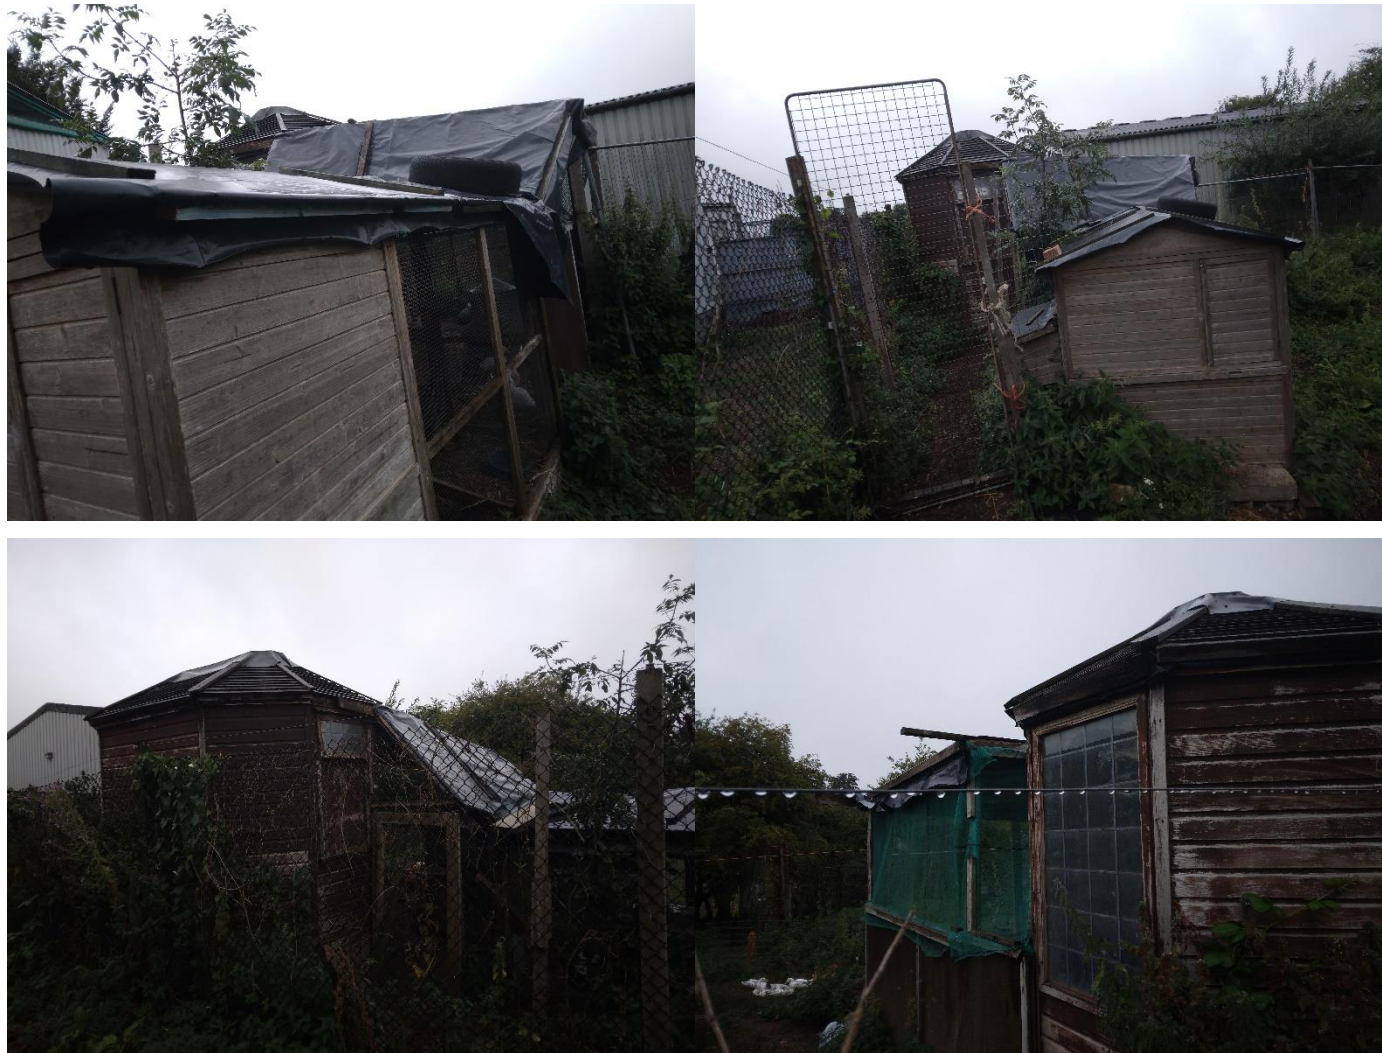
B12 is a large chicken coop. No suitable exterior crevices were noted, and the building was considered negligible as it lacked suitability for crevice and loft-dwelling bats (due to being well-sealed).

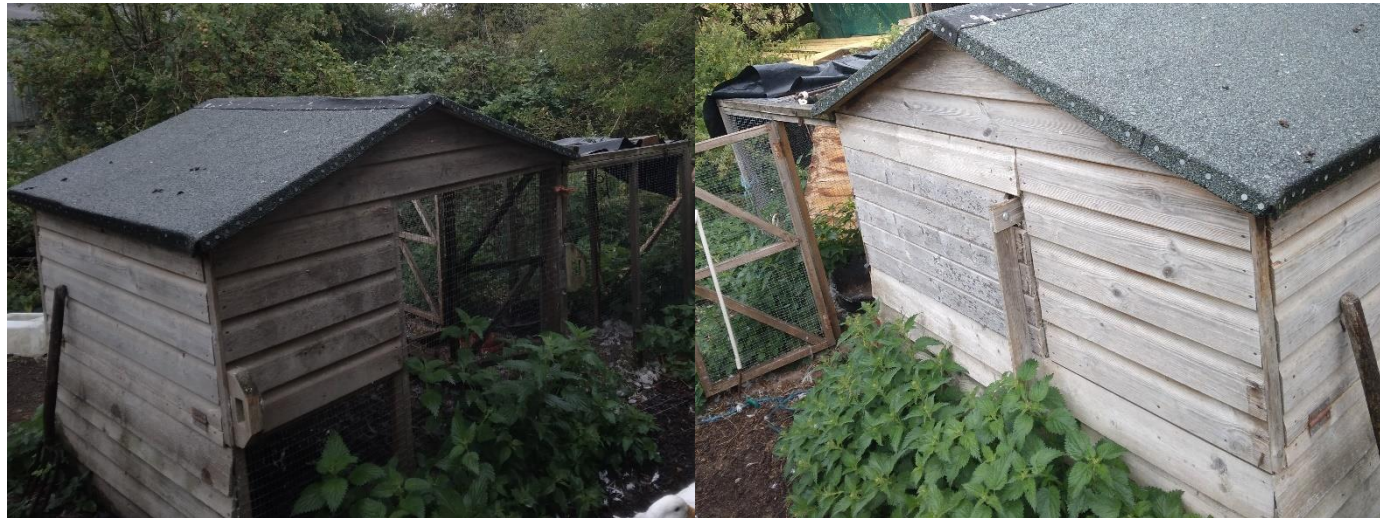
B13 is a small chicken coop. The internal space is sealed with no access features. No suitable exterior crevices were noted, and the building was considered negligible as it lacked suitability for crevice and loft-dwelling bats (due to being well-sealed).

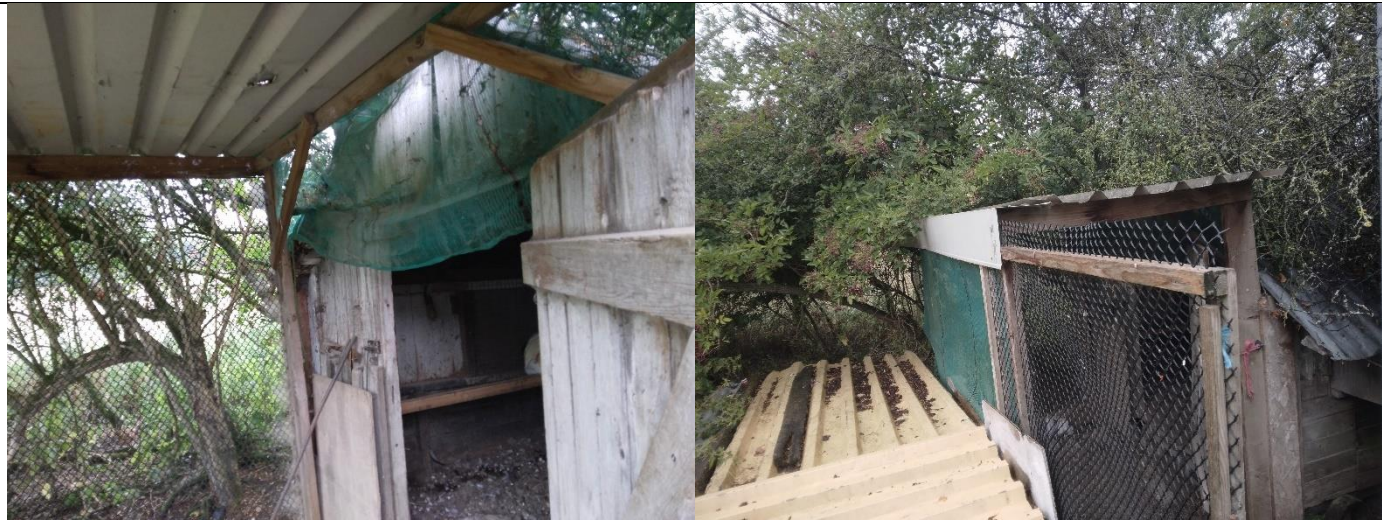
B14 is a large chicken coop. The internal space is sealed with no access features. No suitable exterior crevices were noted, and the building was considered negligible as it lacked suitability for crevice and loft-dwelling bats (due to being well-sealed).

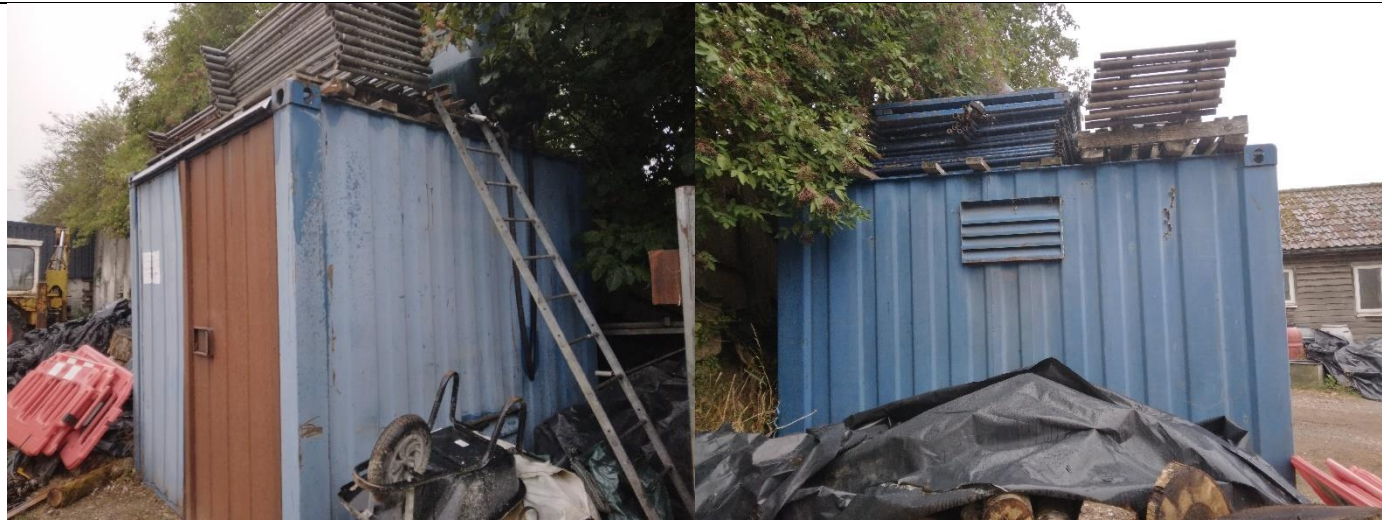
B15 is a small shipping container. No suitable crevices were noted, and the building was considered negligible as it lacked suitability for crevice and loft-dwelling bats (well-sealed and temperature fluctuation).

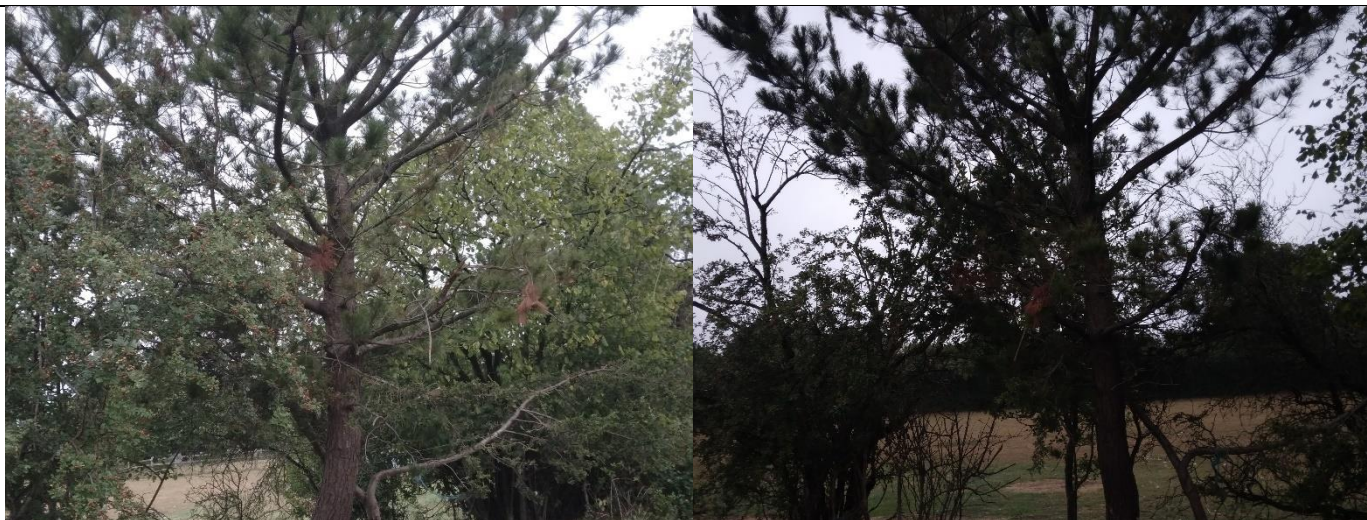
Tree T2 (Potential roosting value - None)

T2 is an immature Scots pine with no ecological niches or evidence of human disturbance. The tree has an excellent natural form and appears in good condition. However, it does not seem to have suitable roosting features.

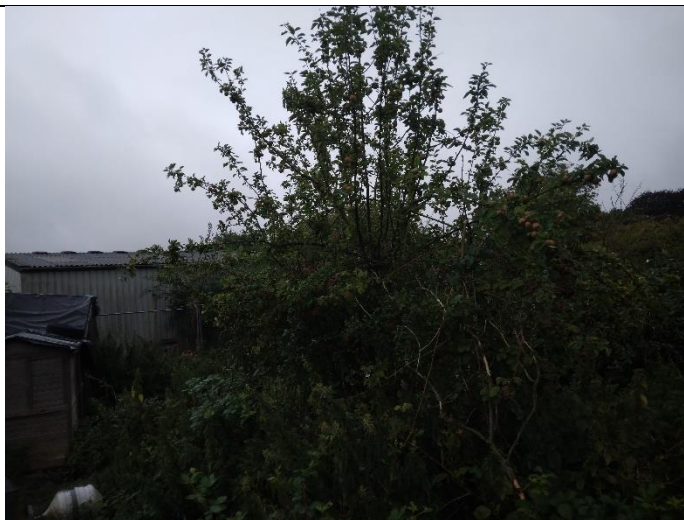
Tree T4 (Potential roosting value - None)

T4 is an immature crab apple with no ecological niches or evidence of human disturbance. The tree has an excellent natural form and appears in good condition. However, it does not seem to have suitable roosting features.

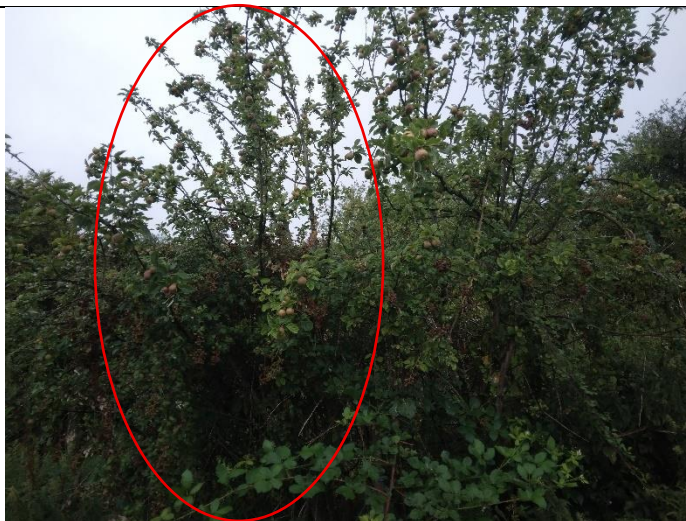
Tree T5 (Potential roosting value - None)

T5 is an immature crab apple with no ecological niches or evidence of human disturbance. The tree has an excellent natural form and appears in good condition. However, it does not seem to have suitable roosting features.
