## Preliminary Ecological Appraisal and Roost Assessment

Goatacre Farm, Goatacre, Wiltshire, SN11 9JA

This report is prepared to inform a planning application with the Wiltshire Council. The proposal is described as:

The demolition of all existing buildings and the construction of nine new dwellings.

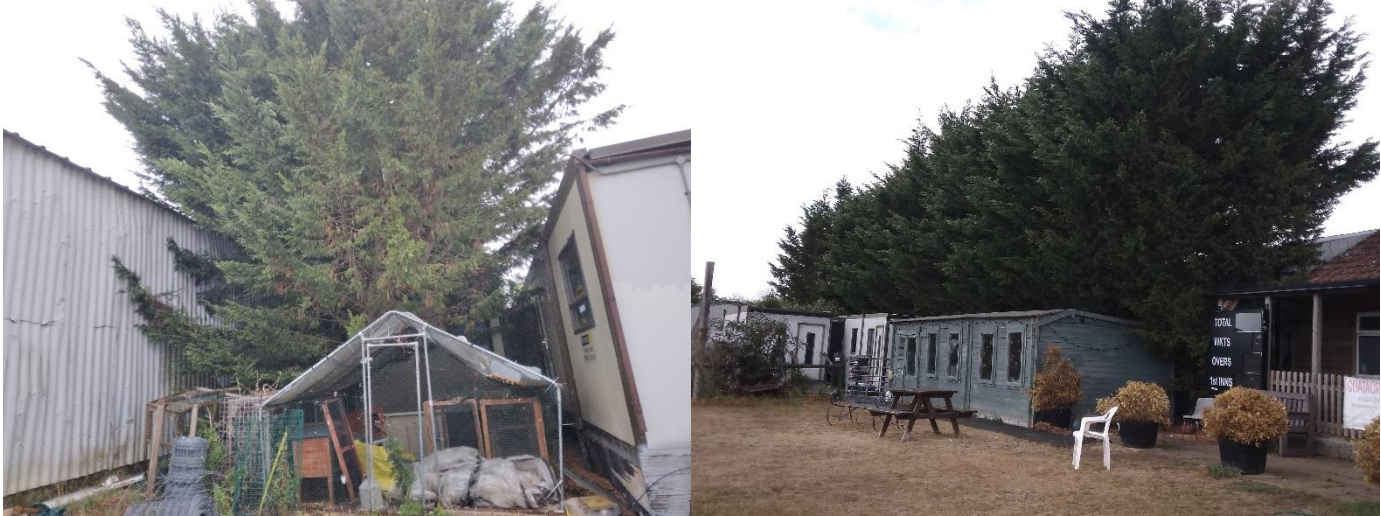
Group of trees G1 (Potential roosting value - None)

G1 is a group of eight Semi-mature Leyland cypress with no ecological niches or evidence of human disturbance. The trees have an excellent natural form and appear to be in good condition. However, they do not seem to have suitable roosting features.

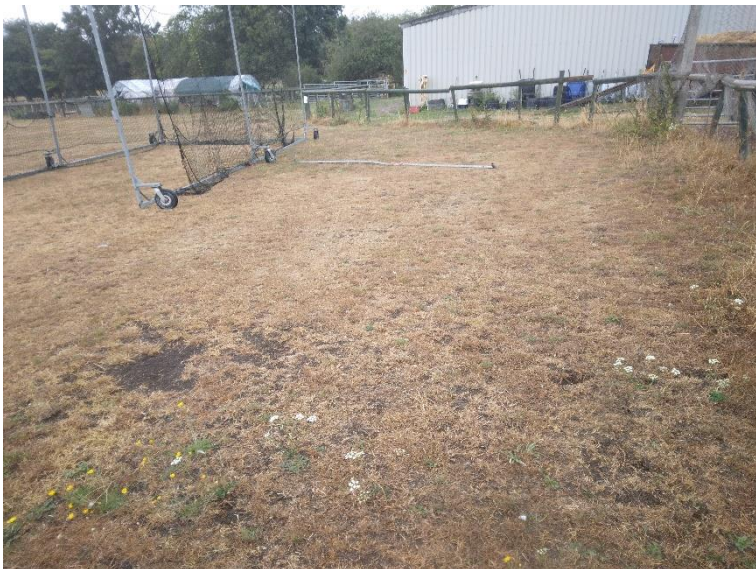
Photo 1: Looking west at the recreational cricket grounds, including modified grassland, hardstanding and buildings.

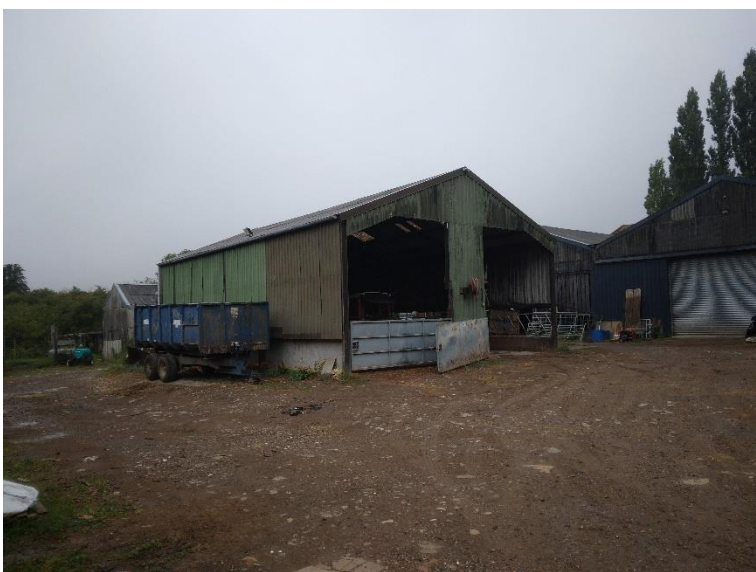
Photo 2: Looking north-east at the areas of hardcore and buildings.

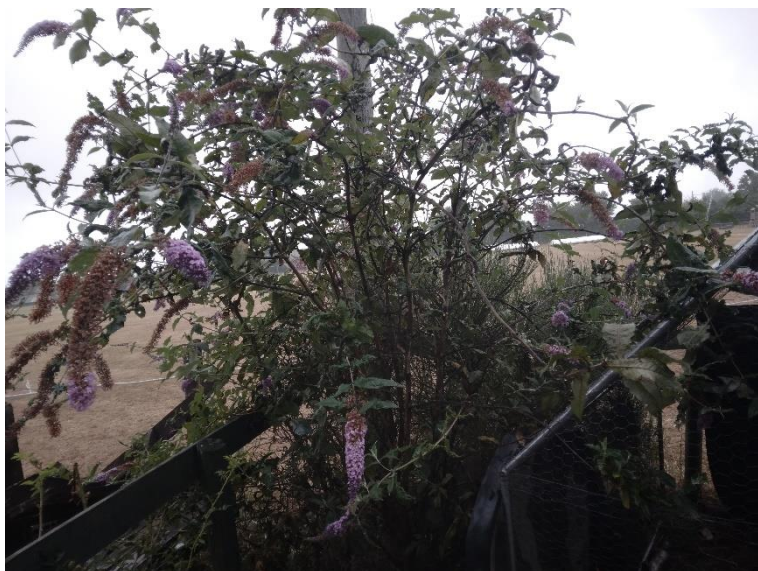
Photo 3: Looking at the buddleia (TN2) on the southern boundary of the site.

| Recommendations | The buddleia should be dug up, including its roots, and disposed of in accordance with appropriate controlled waste measures. | | |

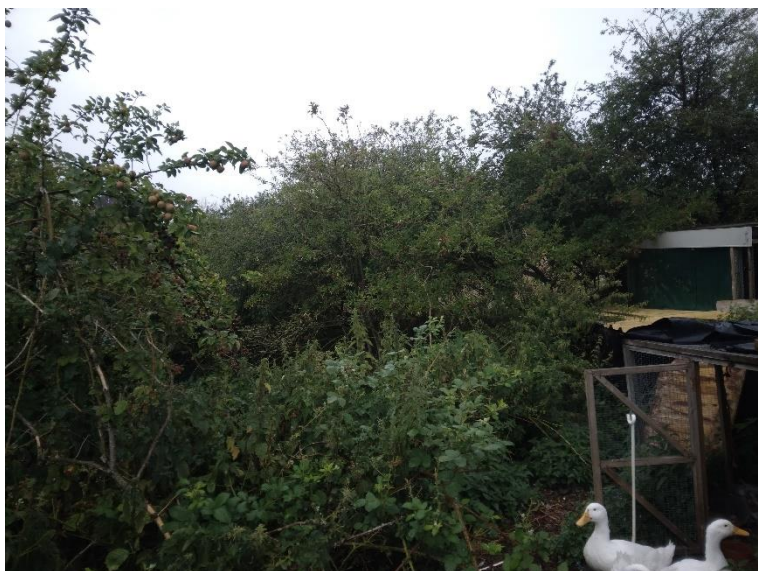
Photo 4: Looking west at the area of mixed scrub and tall forbs.

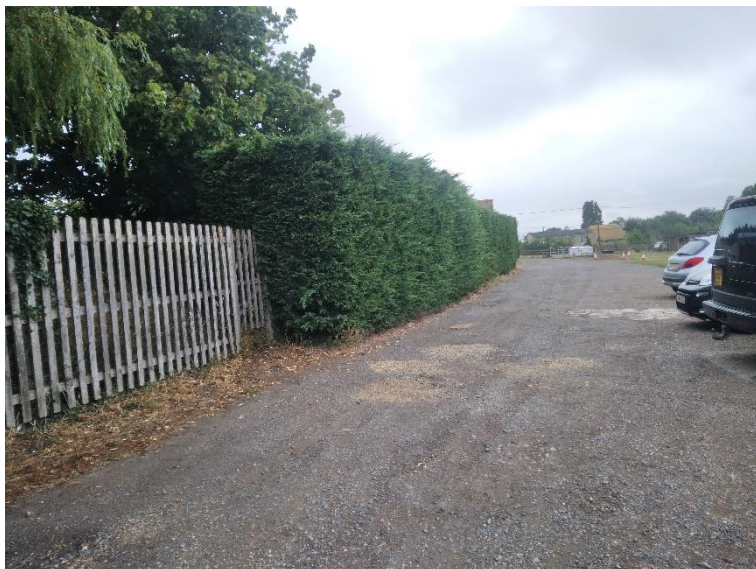
Photo 5: Looking east at the hedgerow, hardcore car park and track.

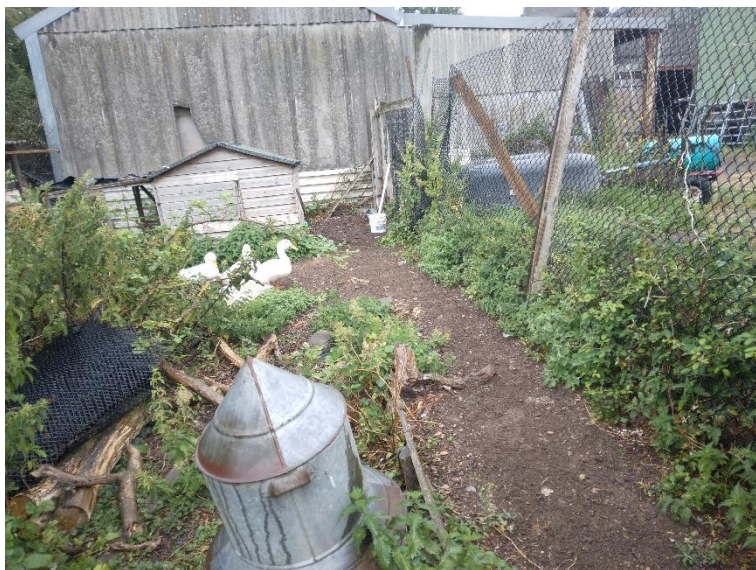
Photo 6: Looking east at the areas of bare ground and tall forbs.

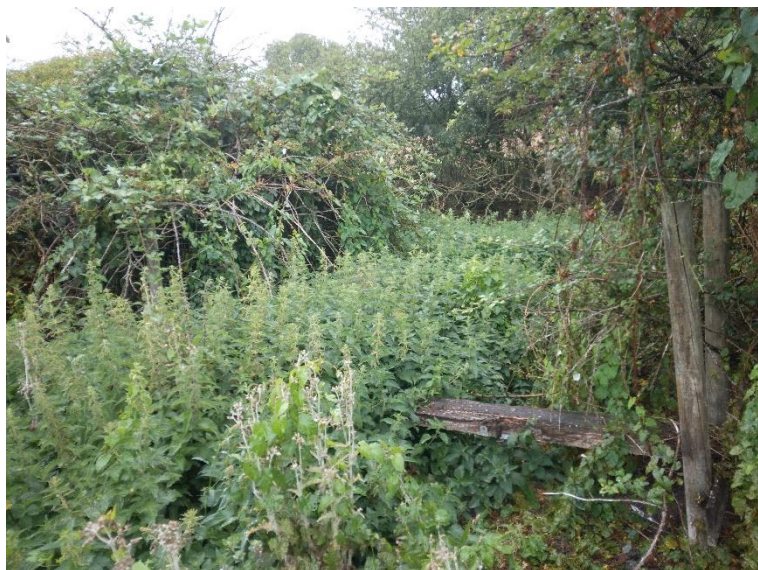
Photo 10: Pond P1 (dry).

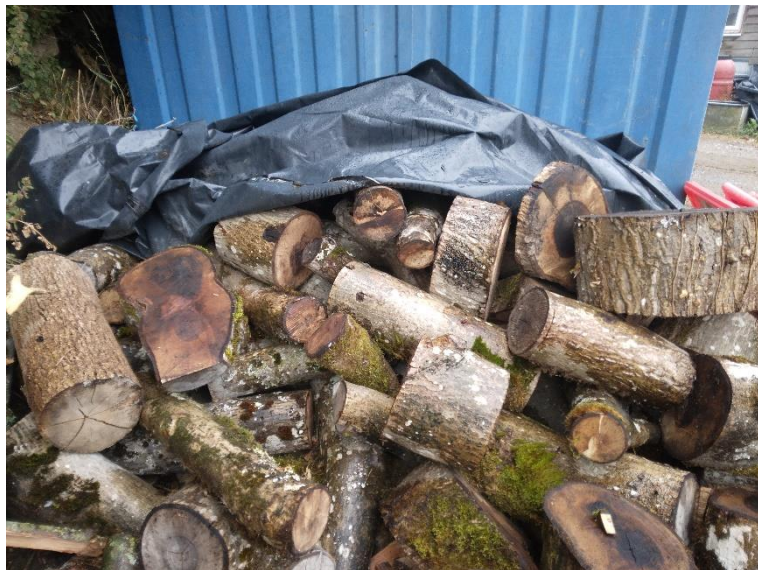
Photo 11: TN1 Log pile.

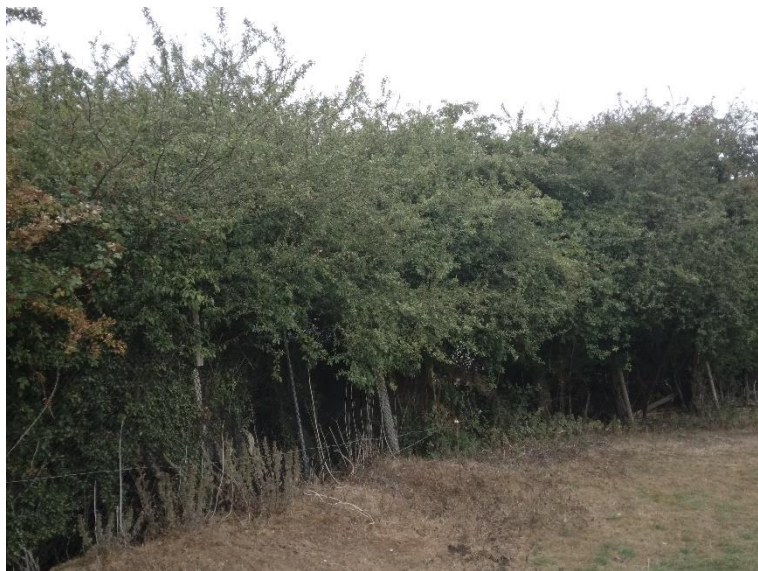
Photo 12: Stock fencing alongside the western boundary.
