## East Facing door.

## South Facing original front door.

## Repair and like for like replacement of South Facing porch.

## Granite Setts to delineate boundary/driveway

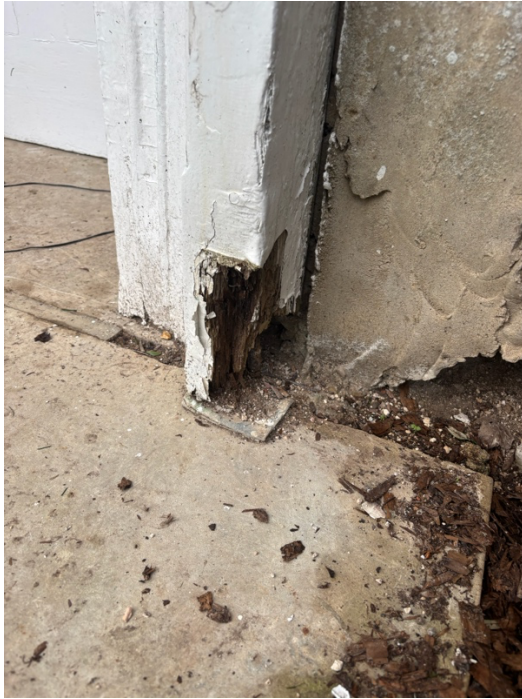
Existing rot

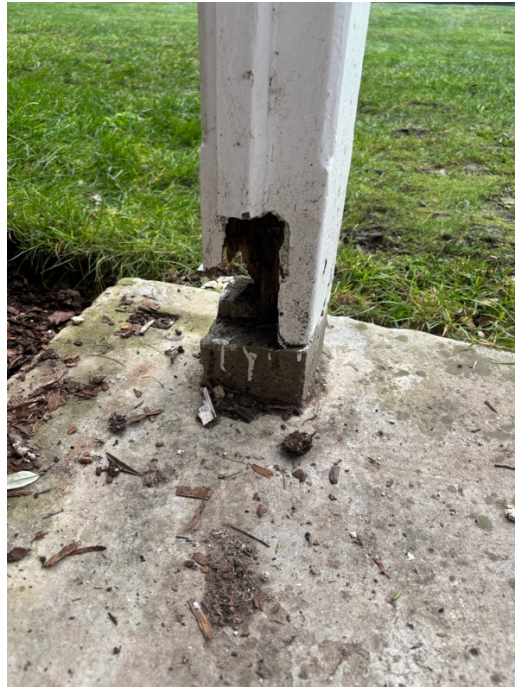
Existing rot to posts

Proposed sandstone post staddle stone at base of uprights to prevent future rot.

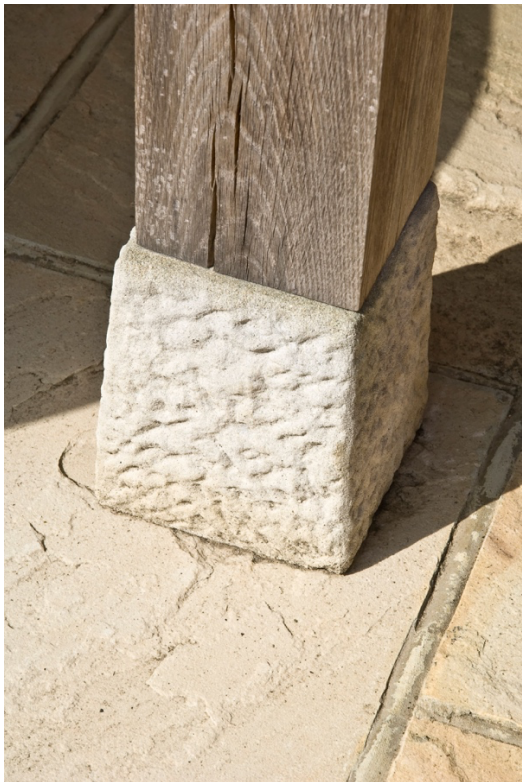
Example style of staddlestone footing

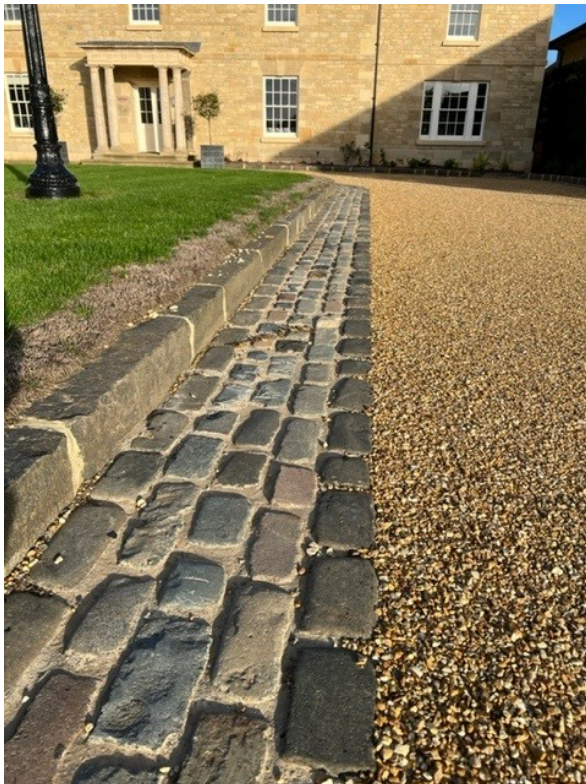
Granite setts to be similar in size and colour to these.
