# **Historic Building Development Analysis**

**East end of North Boundary Wall,  
35 Rollestone Street, Salisbury, Wiltshire.**

**Historic Building Impact Assessment**

Reference: 25990

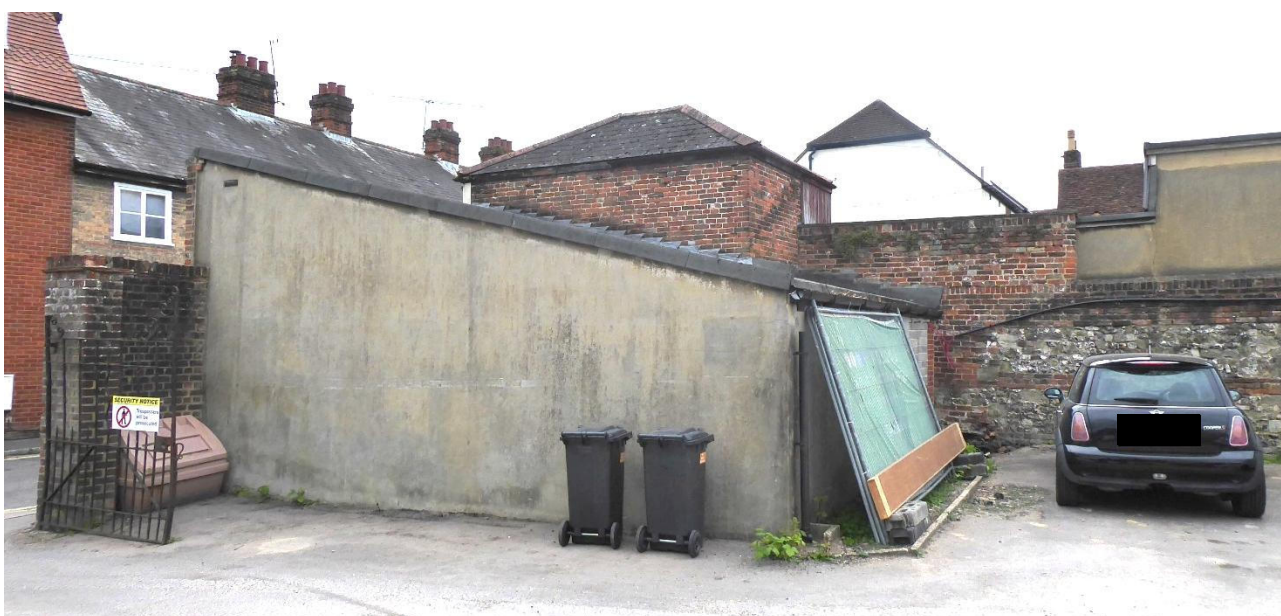
Fig: East end of north boundary to 35 Rollestone Street from the north

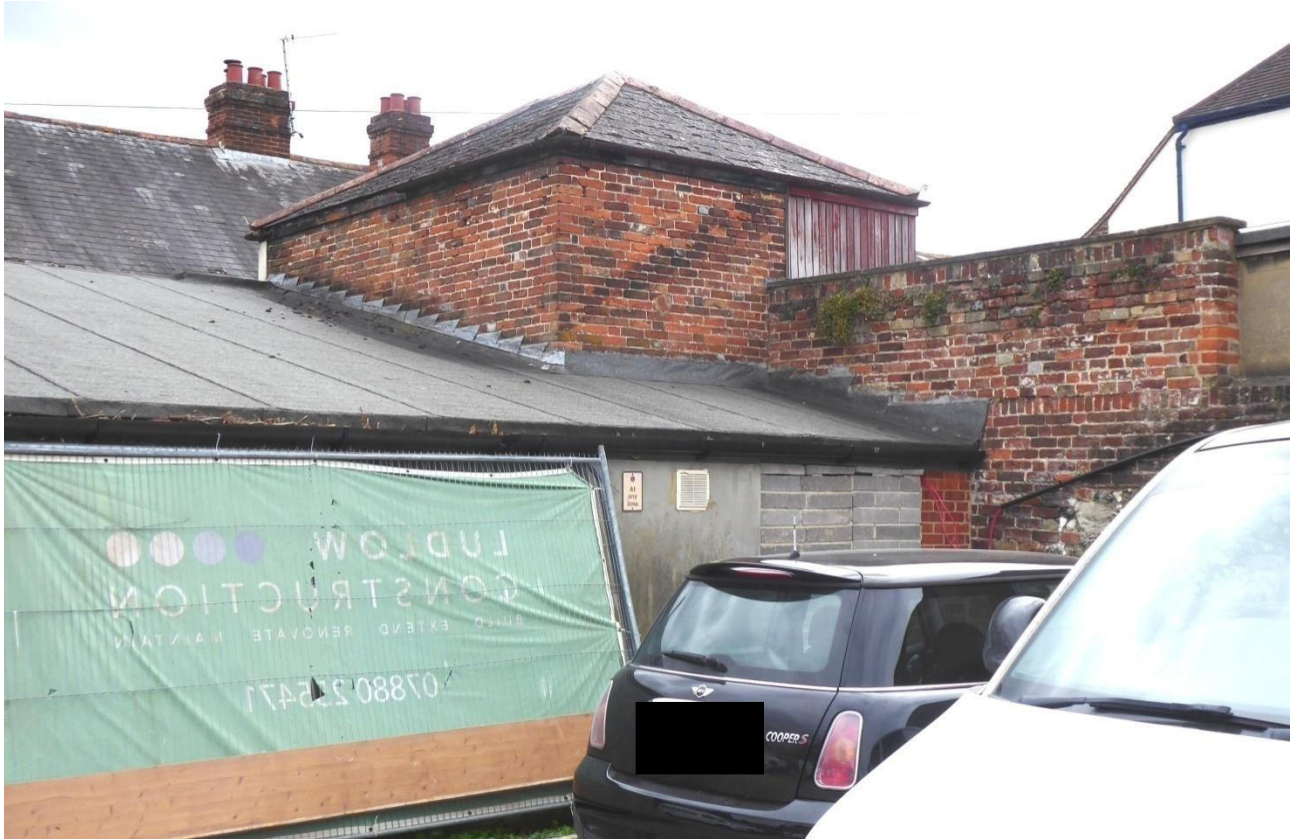
Fig: Boundary wall abutment to two storey section from the northwest

The wall under consideration is at the east end the north boundary of this site and which provides support to a single storey building, where this has elements that could date to the late 18<sup>th</sup> o early 19<sup>th</sup> centuries and has been subsequently altered and adapted in to the late 20<sup>th</sup> C.

Of this part the north wall is of indifferent quality brickwork possibly some two hundred years old, but where the remainder of that part has had significant changes wrought upon it in the intervening years. This boundary wall shows where it has been raised to provide support to buildings over several phases as indicated by the various stages of work that can be seen within it.

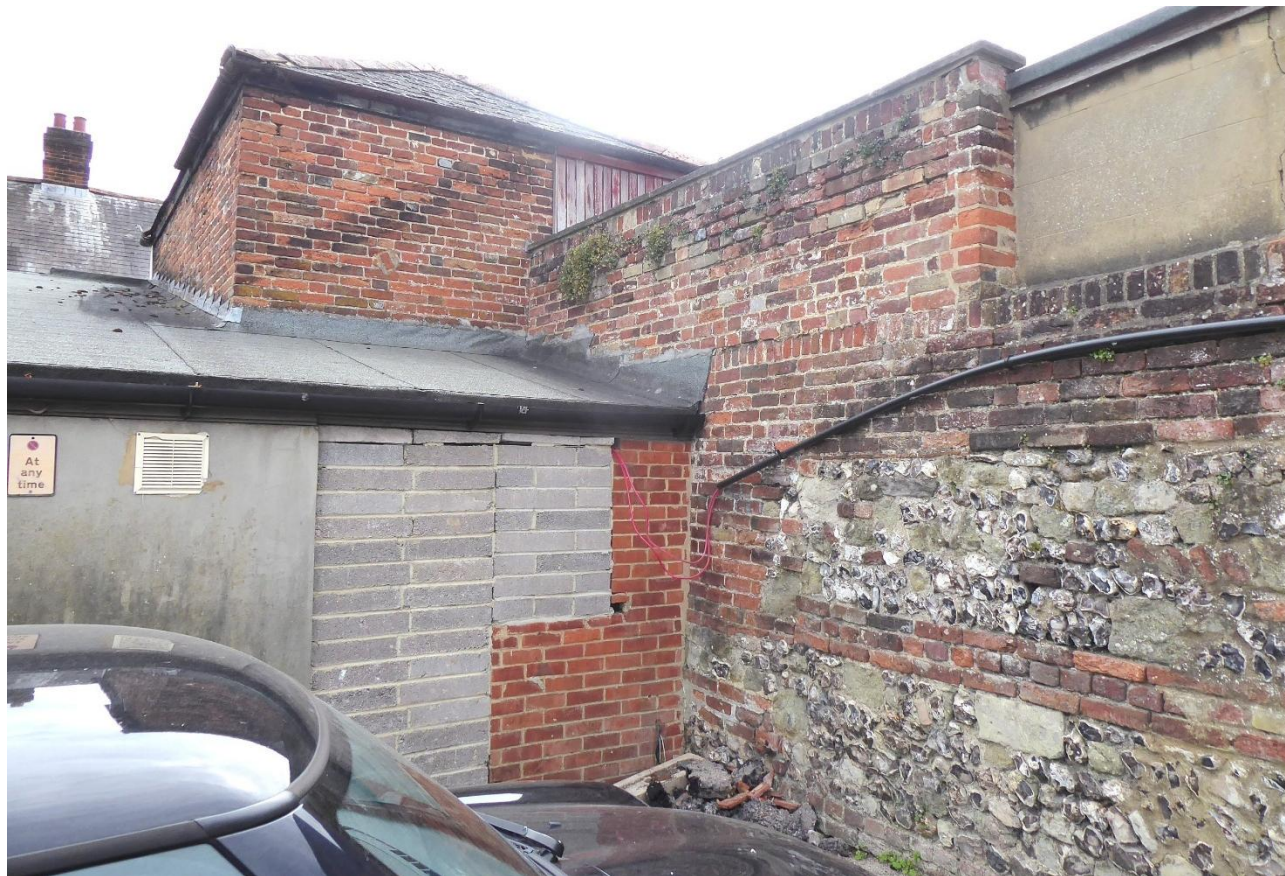
Fig 2.1: East end of north boundary to 35 Rollestone Street with attached shed

- 2.1.1 The wall forms the north boundary to 35 Rollestone Street, where it also provides support to single storey structure running from the back of a two storey building to the street frontage at the east end and further back along the site to the west. This wall backs on the grounds to the back of 26 Endless Street.
- 2.1.2 On the north side, against the east wall 26 Endless Street site, this wall is abutted by a small single storey structure. This has a mono pitch roof that runs from the street frontage down along the side of No 35 and then returns across the west side and closes off to the boundary wall on the north side of this site.

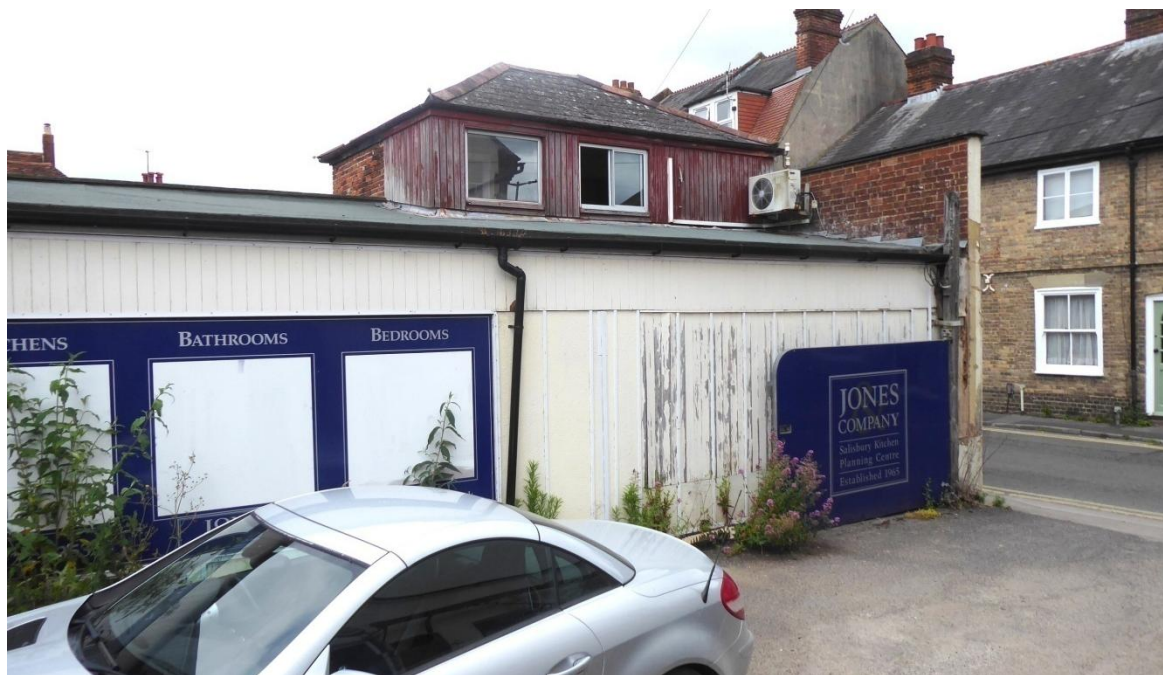
Fig 2.2.2: Single storey building against the north boundary wall

- 2.2.2 The single storey section, that also continues to the west along the north boundary of the site. This is all a modern mono pitch structure, this being former bathroom and kitchen showrooms, that extend back from a set of show room type windows in the street end of the block at the back edge of the pavement.
- 2.2.3 Planning permission for the demolition and rebuilding of this section of the north boundary wall was approved under planning application reference PL/2024/03210.

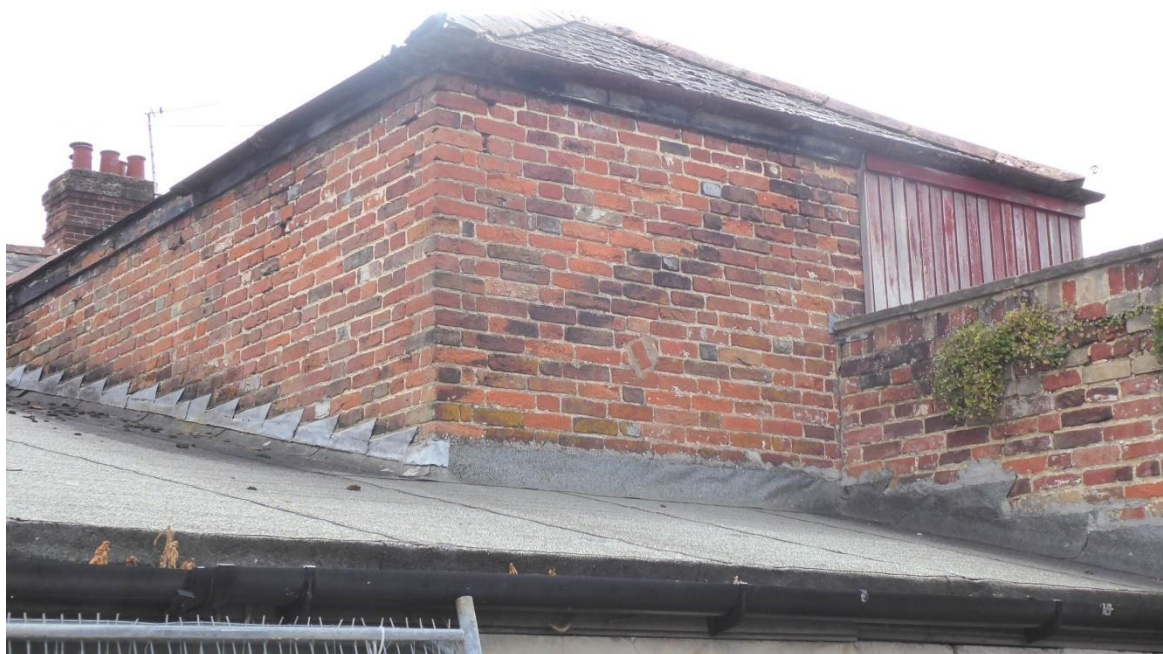
Fig 3.3.1: Boundary wall abutment to the two storey block

- 3.1.1 At the east end of the boundary wall it abuts to the west side of the two storey structure that sits to the back edge of the pavement to Rollestone Street. This has walls that are a mixture of construction, being solid brick on the north side and the west side being a mixture of brick and vertical timber cladding.

- 3.1.2 The brickwork on the west and north side, where visible, is in clay bricks of an orangey brown colour that are laid in a light buff lime mortar with flush jointing. The brickwork, style and form is laid in a nominal Flemish garden wall bond, is of a size and character to suggest a dating to the late 18<sup>th</sup> C or early 19<sup>th</sup> C.

- 3.1.3 The north boundary wall to the back of the single storey showroom has, from what can be seen from the 26 Endless Street side, flint and rubble brick and stone panels between brick bands and is approximately 1.8 m high. This is laid in lime mortar of a pale grey colour, is topped with a course of brick on edge and use bricks that appear to be of an early – mid 19<sup>th</sup> C type.

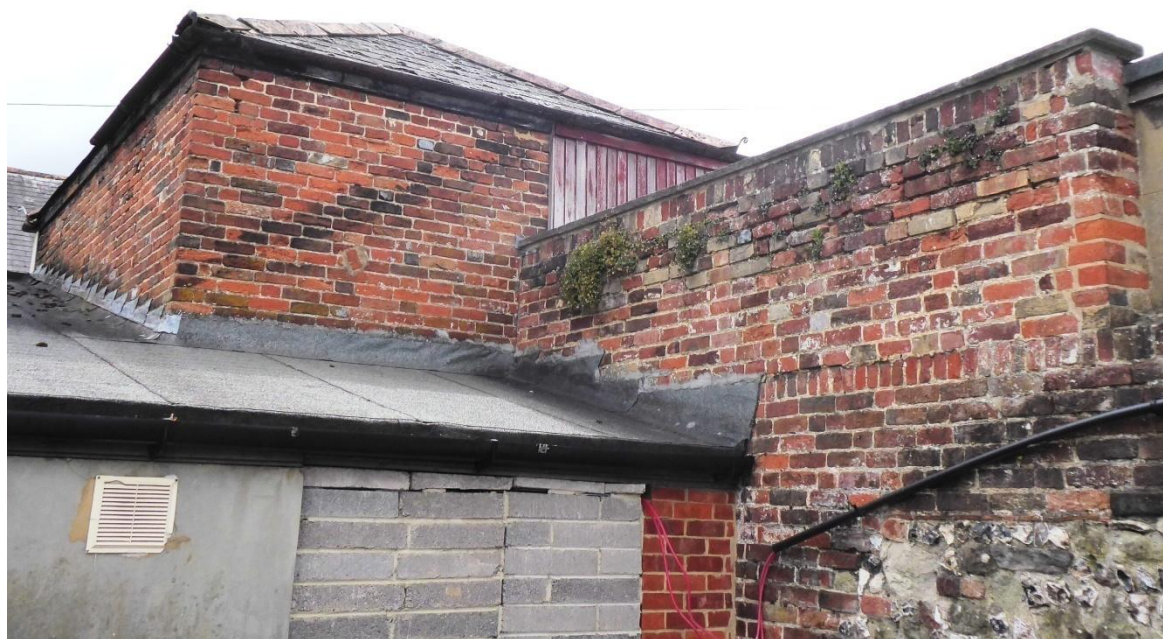
Fig 3.3.9: North boundary wall abutment to two storey block from west

- 3.1.4 At the east end of the north boundary wall, where it abuts the west side of the two storey part of N° 35 there is a straight joint showing this is a later construction. At this end it can also be seen where the wall head has been lifted to the higher eaves height with brickwork of an early 20<sup>th</sup> C style and form. Then to the west of this part the wall has been raised behind to form the back of the modern showroom and which is finished with render that has been scribed to resemble ashlar masonry.

- 3.1.5 On the north side is the abutting roof of the outbuilding in the grounds of 26 Endless Street where this has had flashings crudely cut in to the face to 'weather-in' the roof coverings to that structure. The west wall to this structure has also been cut and bonded in to the face of the wall, causing further disruption.

- 3.1.6 As there was no access to the interior of this north side shed permitted it was not possible to determine how much further this structure has impinged on the fabric of the boundary wall.

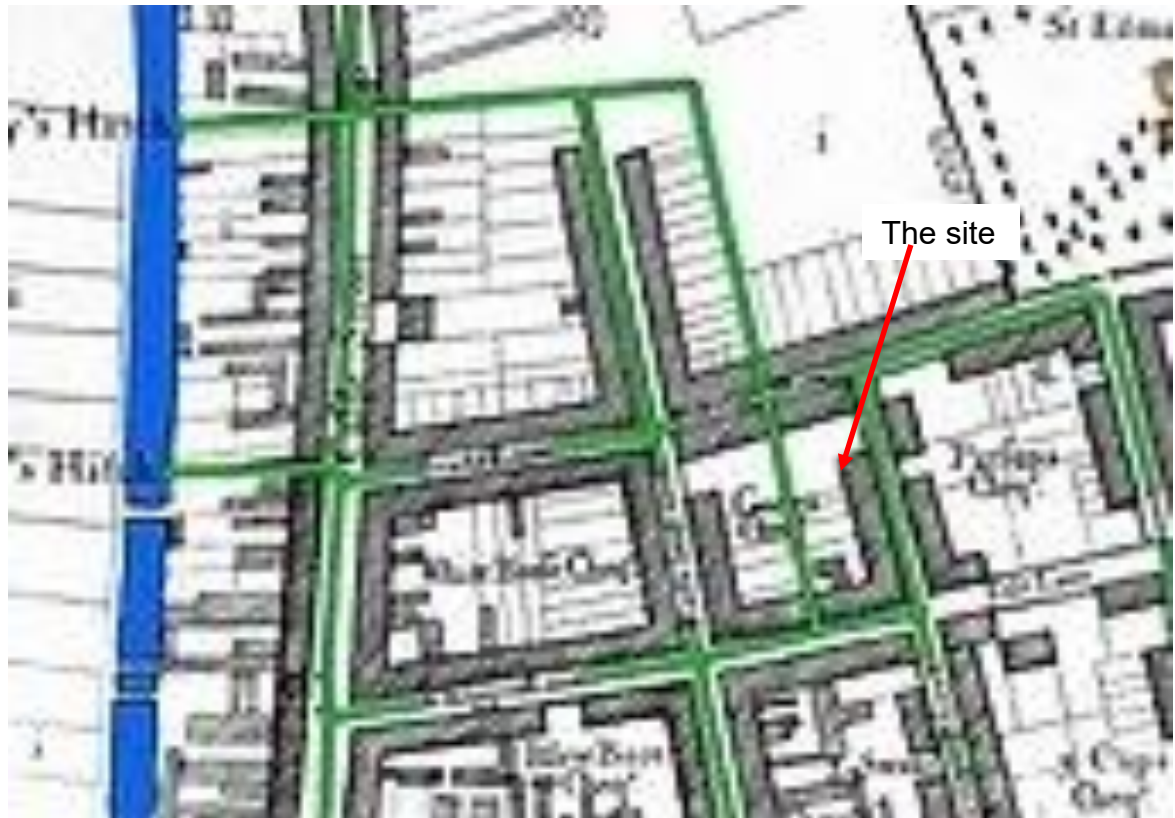
Fig 5.1.2: Extract from William Naish map of Salisbury

- 5.1.3 Running down from the north to the south, across the rear of 26 Endless Street and then this plot, is what would appear to be one of the Salisbury City conduits, shown green on this map. That appears to run through the north side wall of this site,

possibly where there is a low and narrow doorway, with a stone surround, seen on the other side of this.

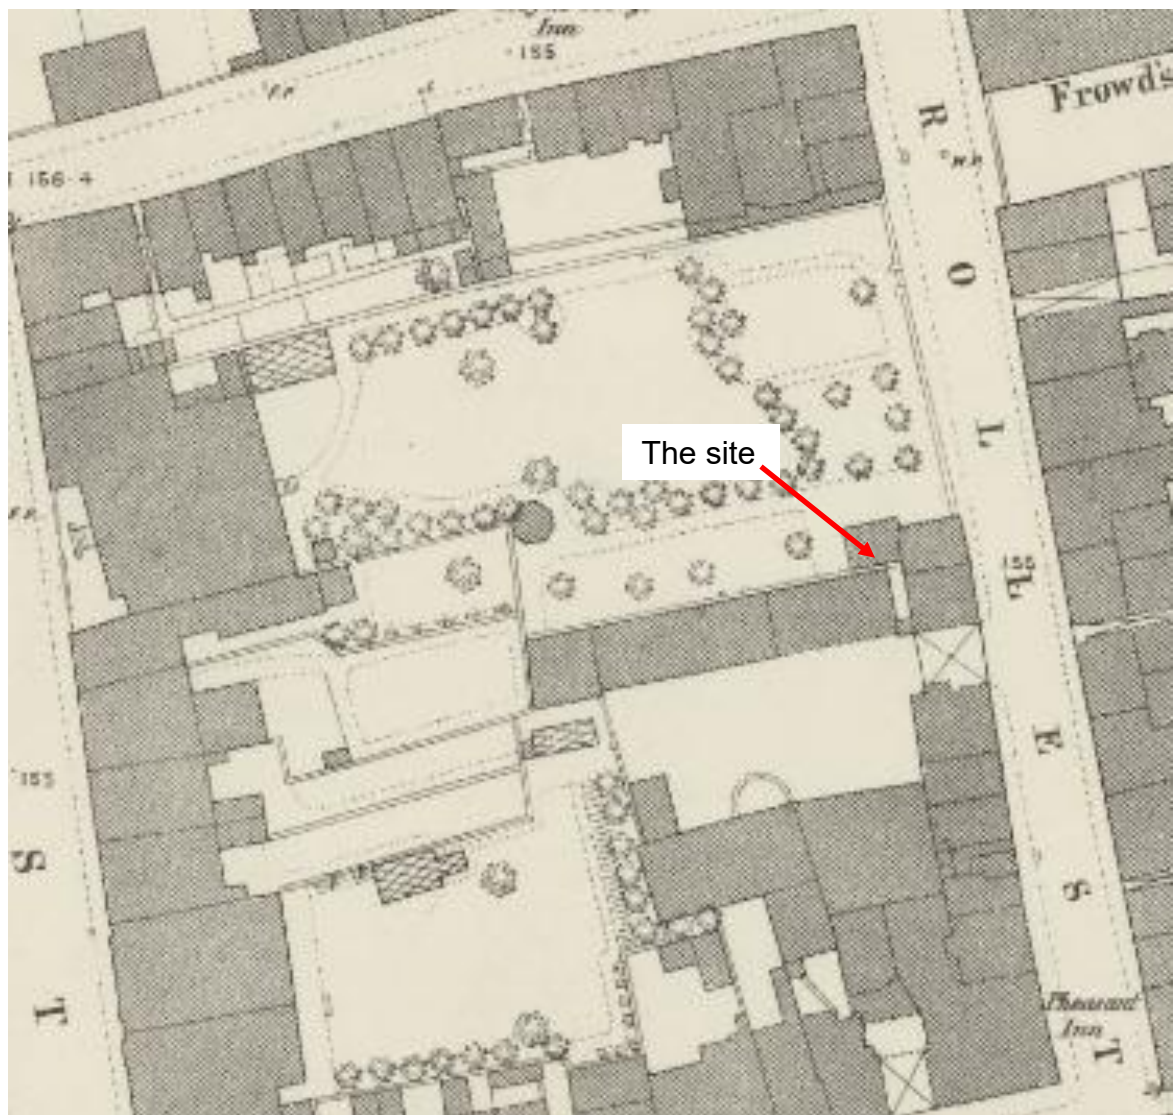
- 5.1.4 The first large scale and accurately surveyed map of this area is the Ordnance Survey (OS) town map of Salisbury, drawn at a scale of 1 – 500 and published in 1880. This shows the site at that time quite clearly and amongst those is a small rectangular block at the Rollestone end of the wall to the north side of this site. It has a slight overlap of the north side boundary wall in to the rear part of 26 Endless Street. There is another, almost comparatively sized building, of the west side of this within the grounds of 26 Endless Street in the position of this part of the boundary wall.

Fig 5.1.4: 1880 OS town map series extract

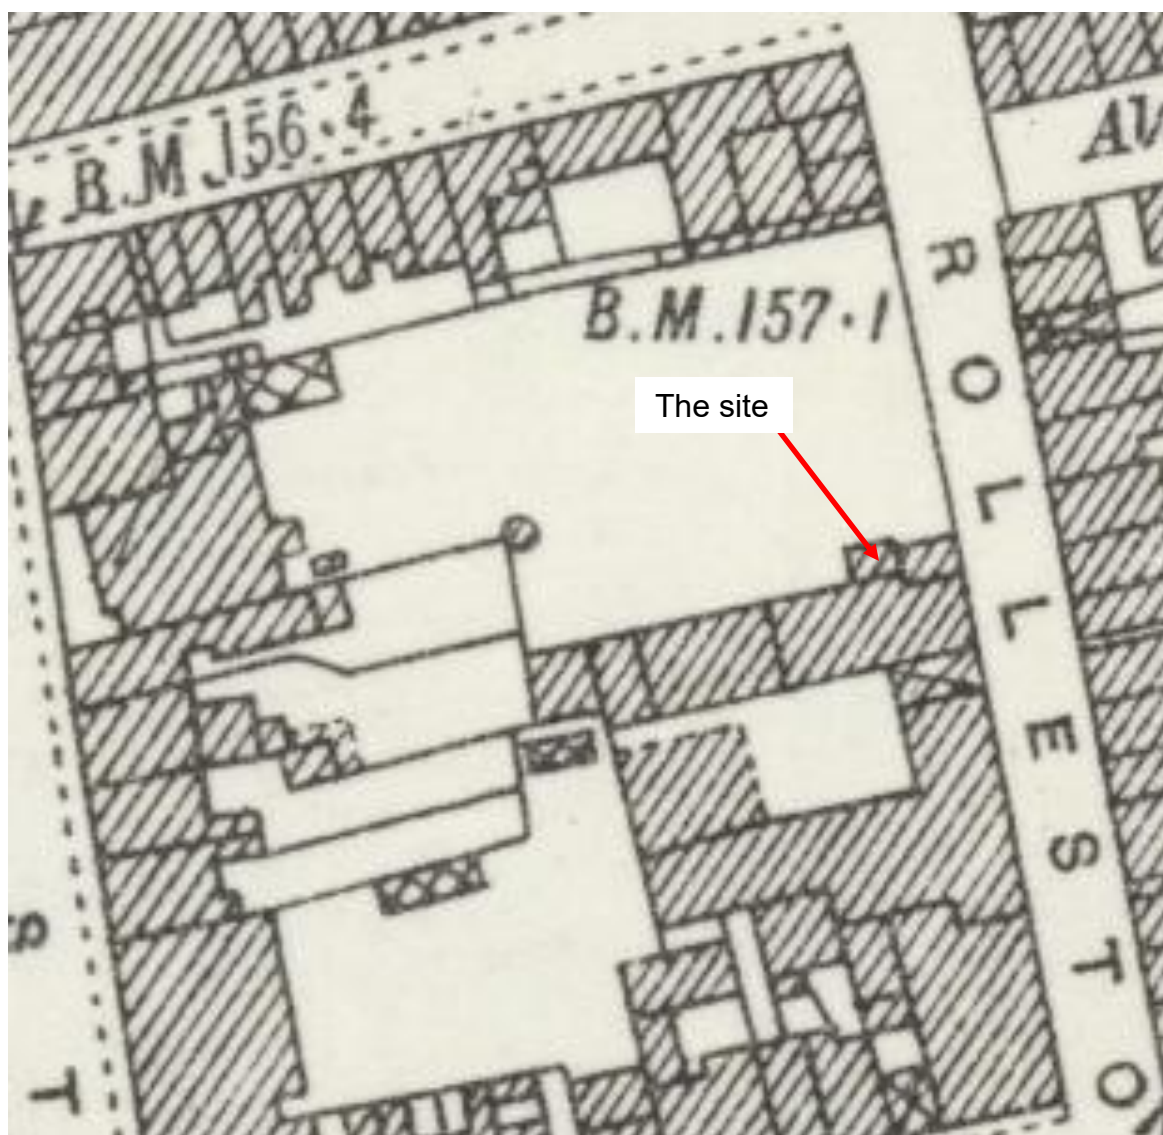
- 5.1.6 On the following 25" scale OS map of 1926 the large adjoining south side building has been removed and the street front block restored to that seen on the 1880, including the arch from the road to the yard at the back. The building on the west side, in the garden of 26 Endless Street, is still seen.

Fig 5.1.7: 1926 OS 25" scale map extract

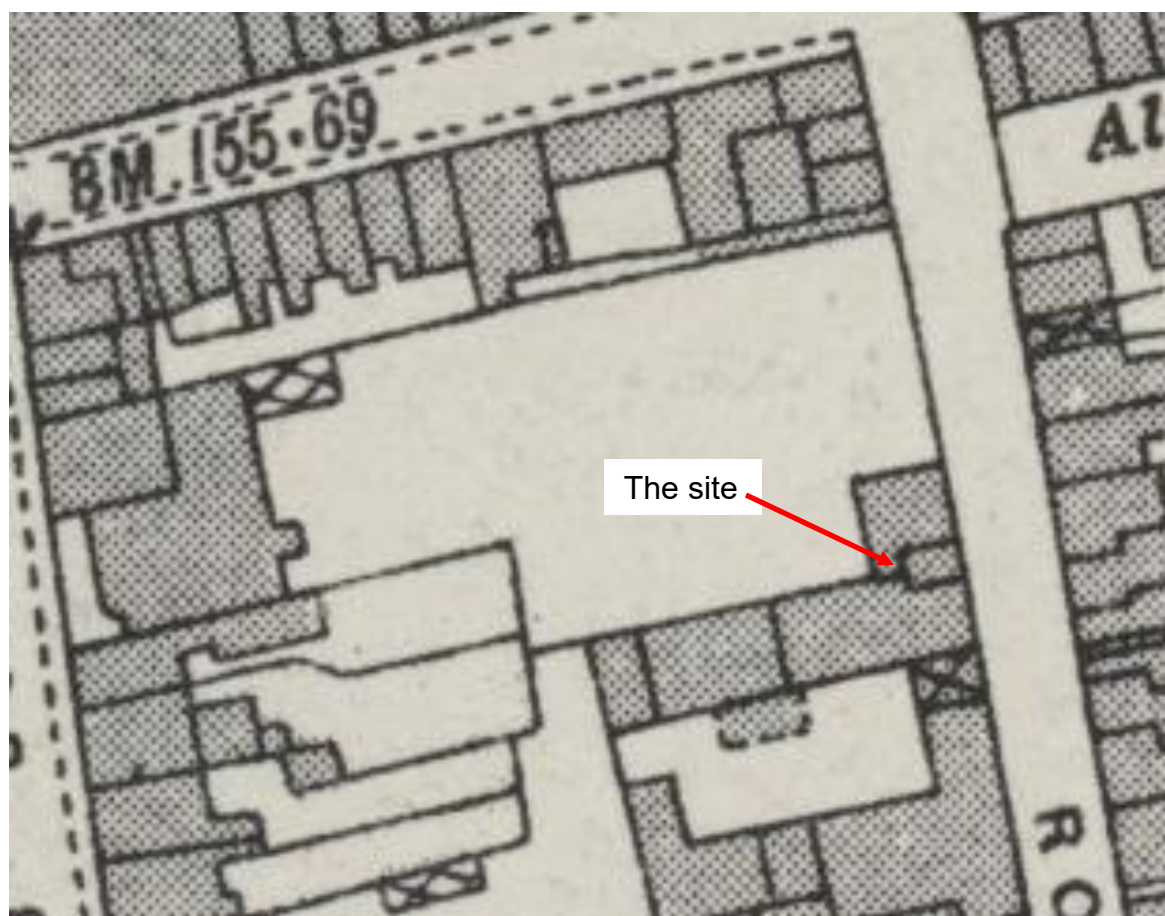
- 5.1.7 By the time of the 1939 edition of the 25" scale map, the northeast corner buildings, adjacent to 35 Rollestone Street, are much the same as seen on previous maps, apart from that of 1900. However, the building on in a comparative position in 26 Endless Street has been removed and there is a much larger block wrapping around from the west to the north sides.

Fig 5.1.8: 1939 OS 25" scale map extract

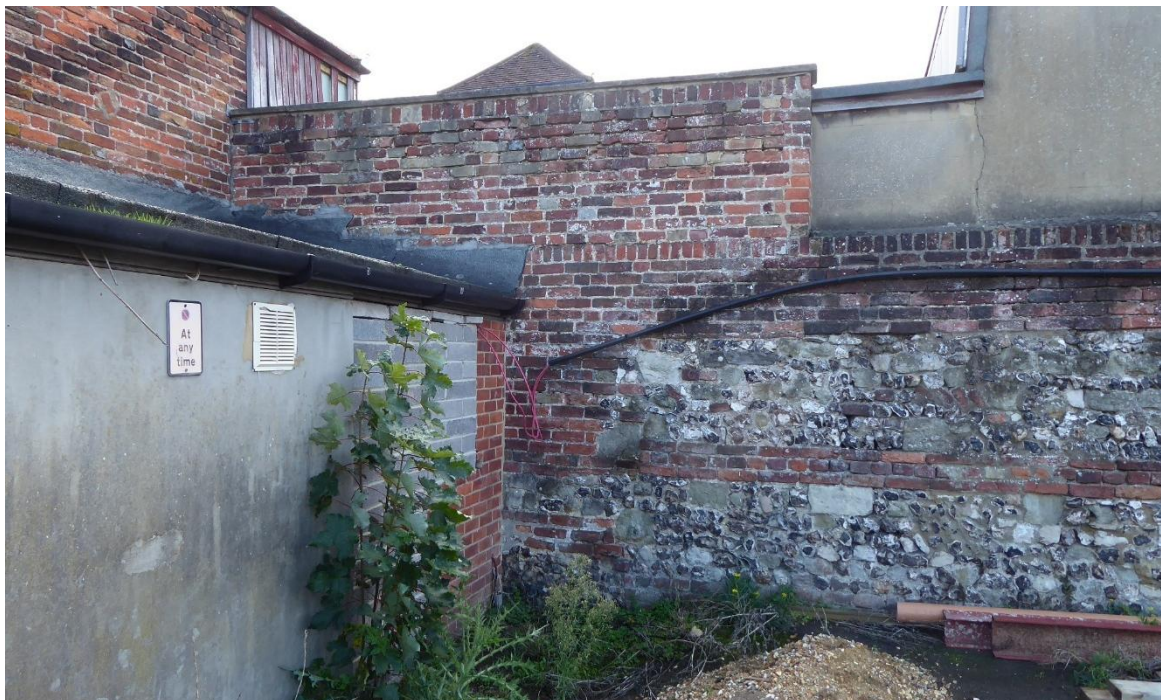
Fig 7.1.4: Varied build phases to north boundary wall

- 7.1.1 The north boundary wall to the rear part of 26 Endless street is of solid brick a flint construction that from its overall style and form suggests it is of early to mid 19<sup>th</sup> C date. However at the east end it has evidently been raised in the early 20<sup>th</sup> C in plain brickwork and then further to the west it has been raised in rendered blockwork in the late 20<sup>th</sup> C to support the top of the single storey showroom roof.
