## 36 Bath Road, Bradford-on-Avon Wiltshire

### *Heritage Assessment*

CA Project: CR1964

CA Report: CR1964\_1

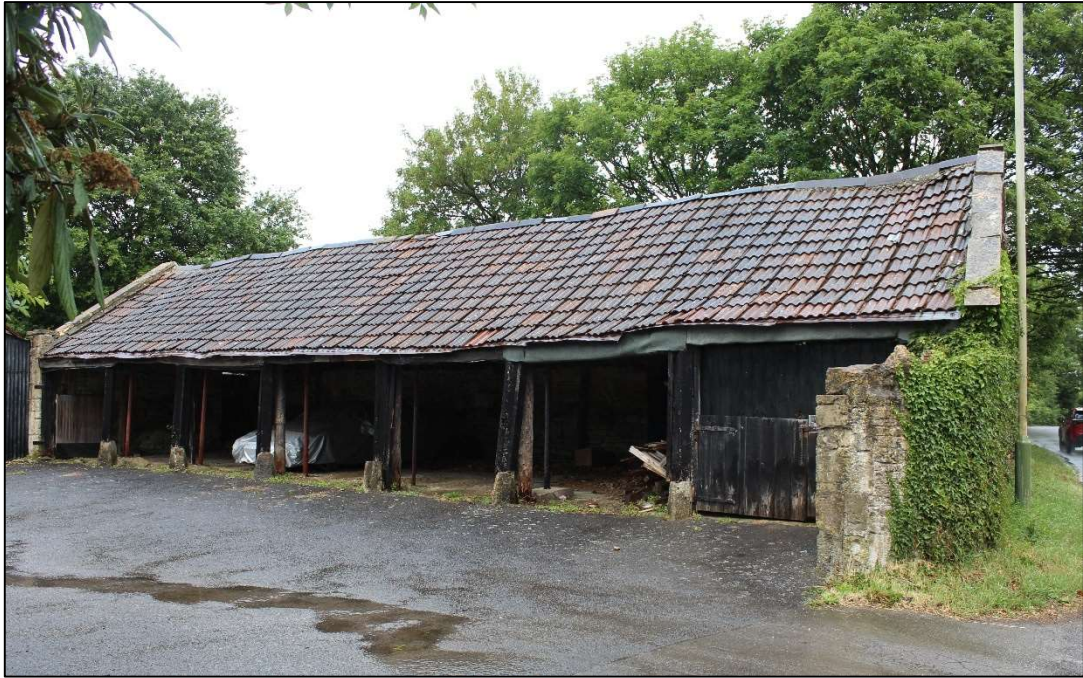
the Site and its east elevation directly addresses Bath Road. The building is a former detached former open-sided cow shed. It is a single-storey structure with a rectangular planform and is aligned on a north-east to south-west axis (Photo 3). Its open-sided elevation has seven bays formed by six timber posts resting on padstones, and faces south to overlook what would have been the former farmyard (Photo 3).

**Photo 3**      **Building A: south-east elevation**

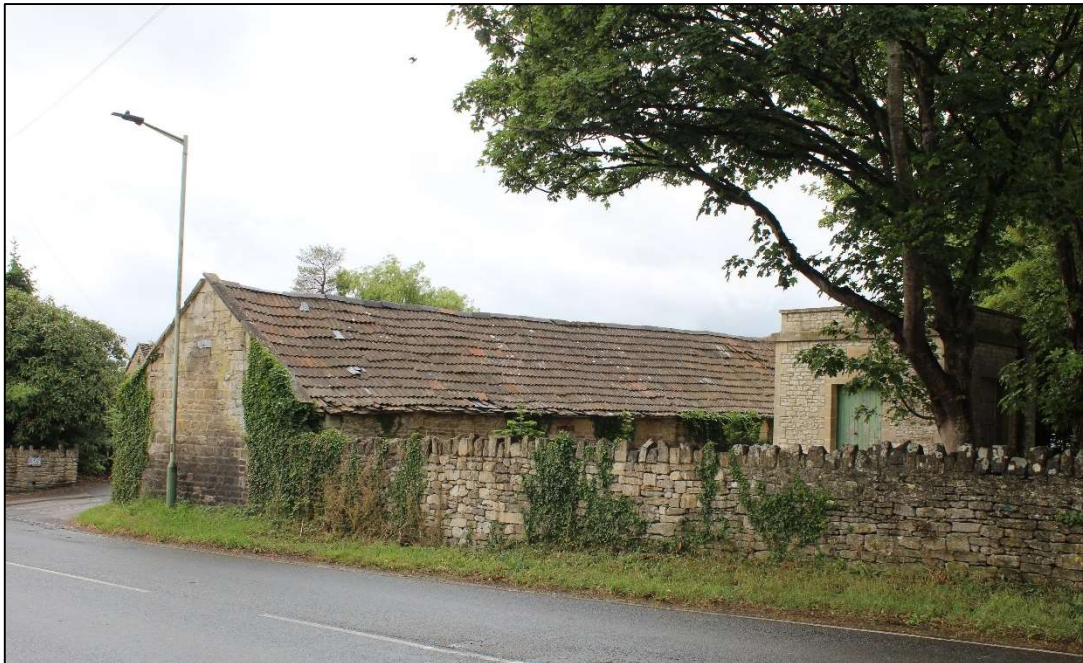
**Photo 4**      **Building A: north-east and north-west elevations of Building A, as viewed from Bath Road**

- 
- 4.5. The Building is constructed of coursed random limestone rubble walling with a gabled roof structure (Photo 4). The roof is presently covered in pantiles but may have historically been covered in stone tiles, as is seen on many of the other traditional buildings in the town, and there do appear to be remnants of some tiles at eaves level on the north elevation (see Photo 4).

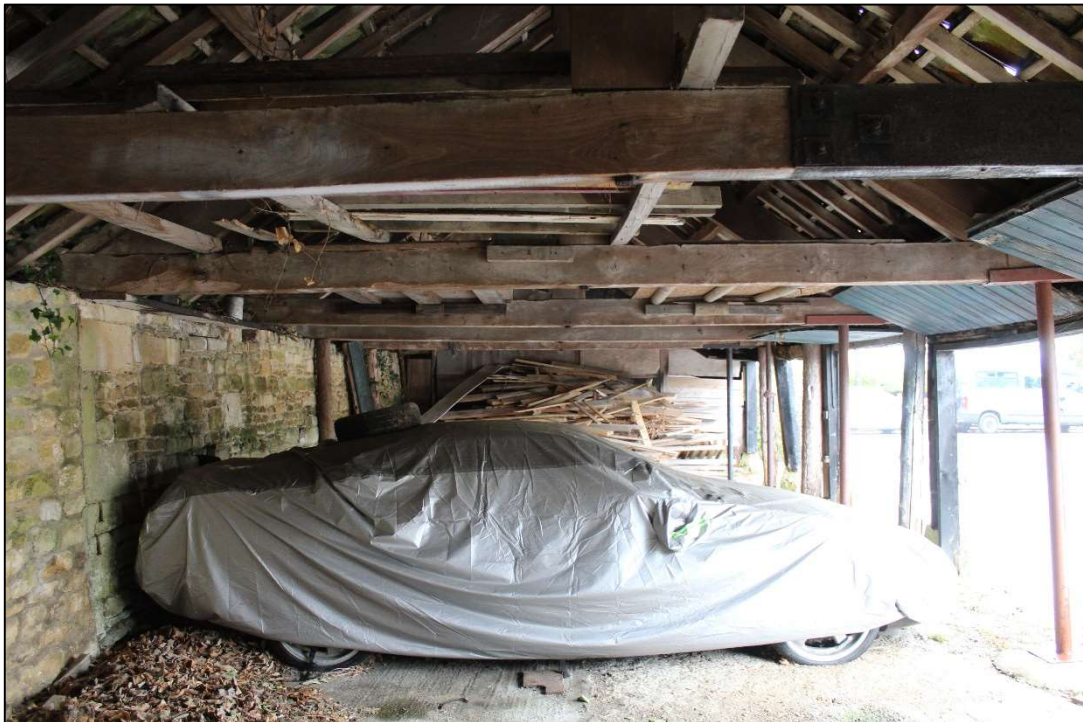
**Photo 5**                      **Building A: interior view, looking north-east**

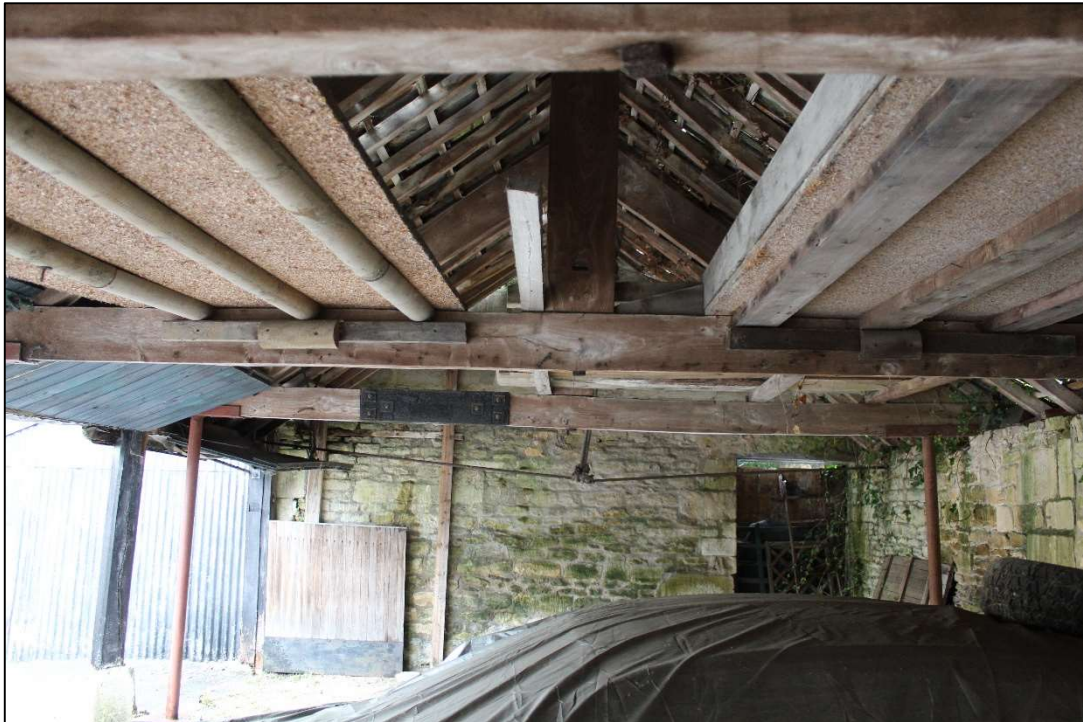
**Photo 6**      **Building A: interior view, looking south-west**

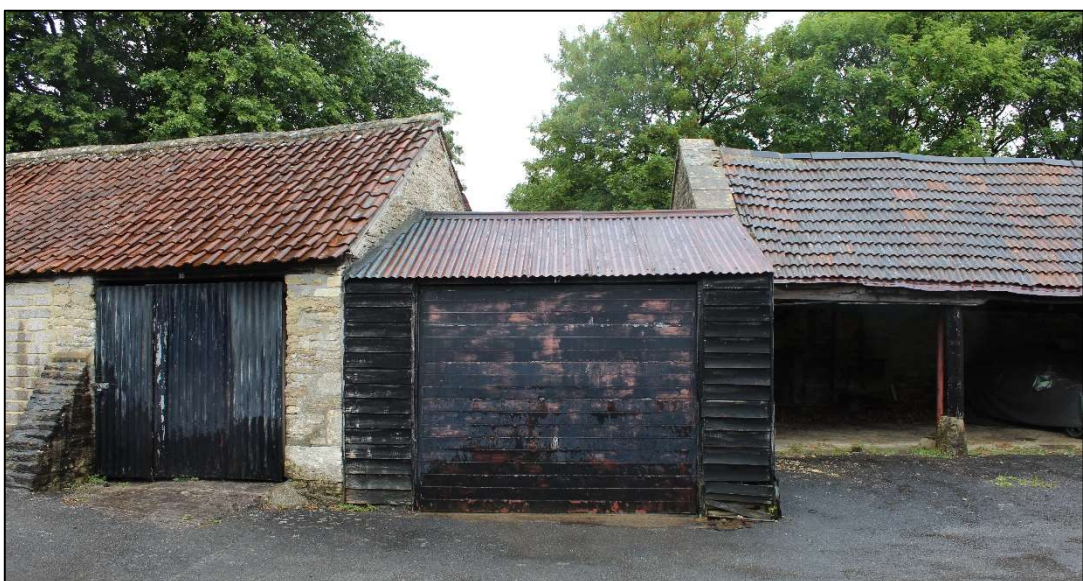
- 4.7. Historic mapping shows that this structure was constructed somewhere between 1925 and 1975. Access to the interior was not possible at the time of the site visit, but it appears to be a simple timber-framed structure with external painted weatherboarding, corrugated metal roof and an up and over garage door (Photo 7). It was likely built as a small garage or for storage purposes, and has no heritage significance.

**Photo 7**      **Building B: South-west elevation**

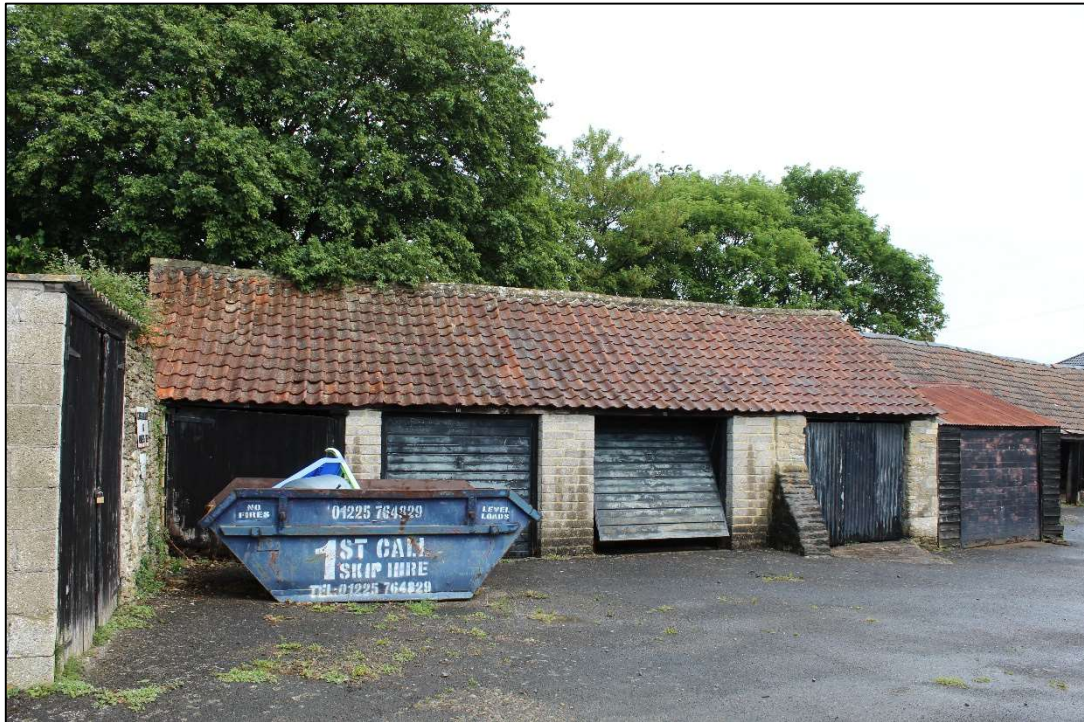
- 4.8. Historic mapping indicates that Building C was constructed around the mid-late 19th century, and was extant by 1886. It is one of three surviving stone-built farm buildings on Site associated with the former Lower Bearfield Farm, and is considered to have some limited heritage significance
- 4.9. Building C is situated on the north side of the Site; it is a one-storey structure with rectangular planform and is orientated on an east-west axis, with its principal south-facing elevation overlooking the former central farmyard (Photo 8). It has been heavily altered both internally and to the south elevation to create four garages with modern up-and-over doors, which has somewhat obscured its historic appearance and form. Its original function is unclear, although at one stage it had external animal pens (Fig. 2) and was likely used as an animal shelter.

**Photo 8**      **Building C: south elevation**

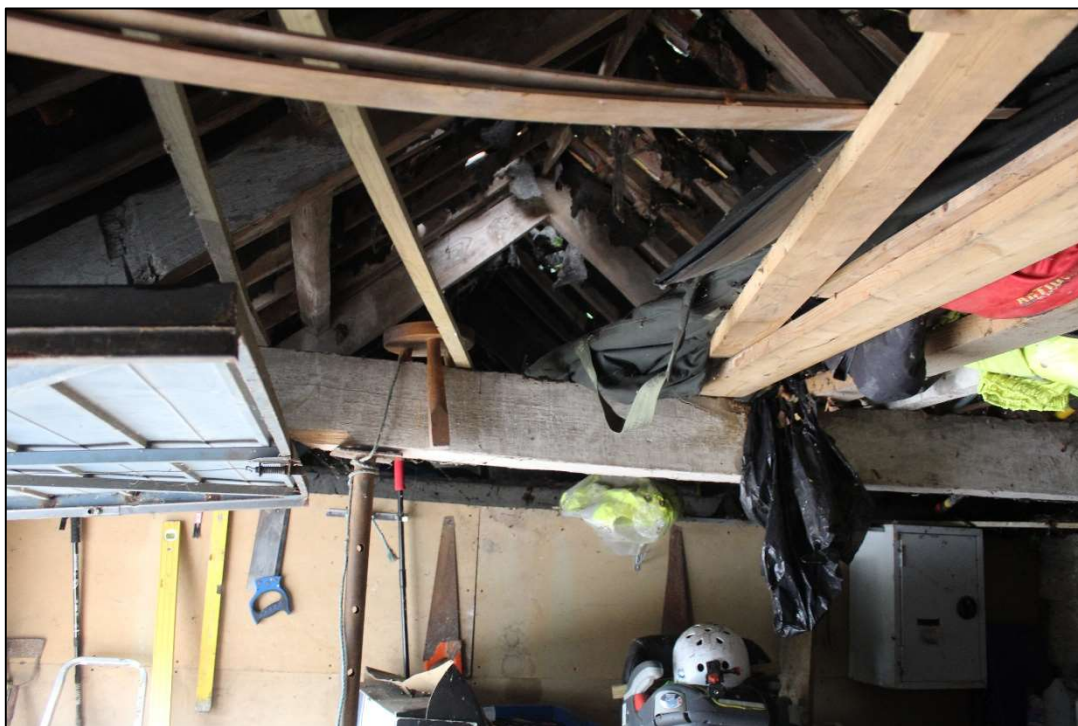
**Photo 9**      **Building C: roof structure**

- 4.11. The interior of the Building has been altered and subdivided, although the painted rubble walls were partially visible (Photo 10). The roof structure is exposed internally; the roof trusses are of a very simple and rustic form of principal rafters, tie beams and clasped purlins with common rafters and battens supporting the roof covering. There were no other visible historic features of note (Photo 9).

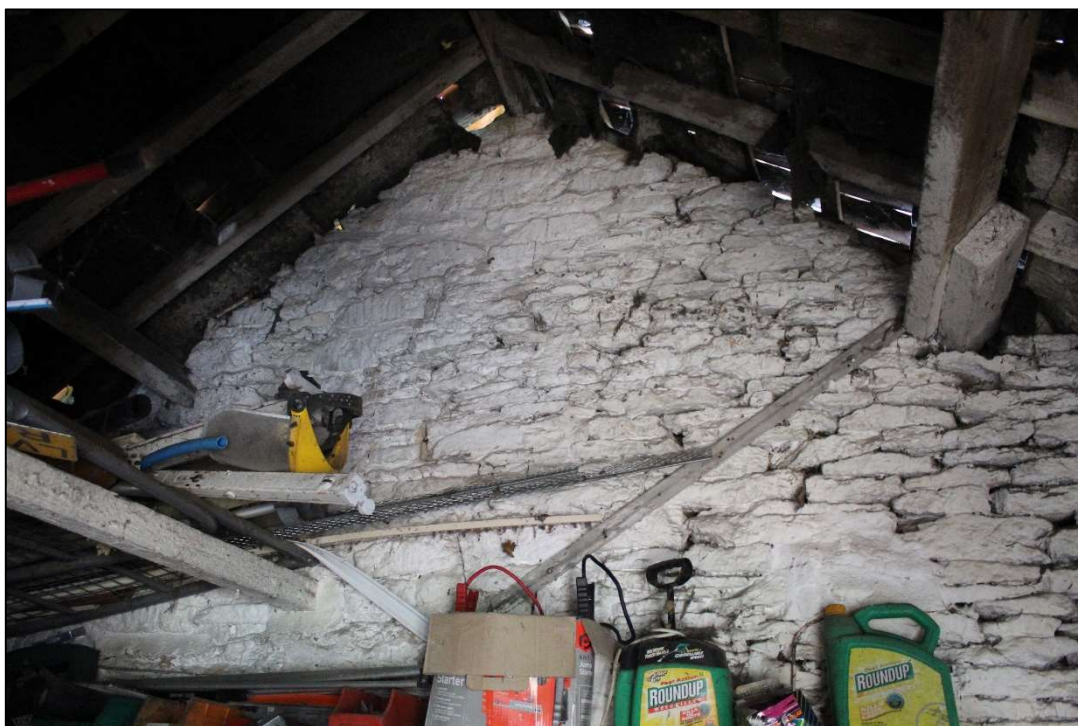
**Photo 10**      **Building C: material detail**

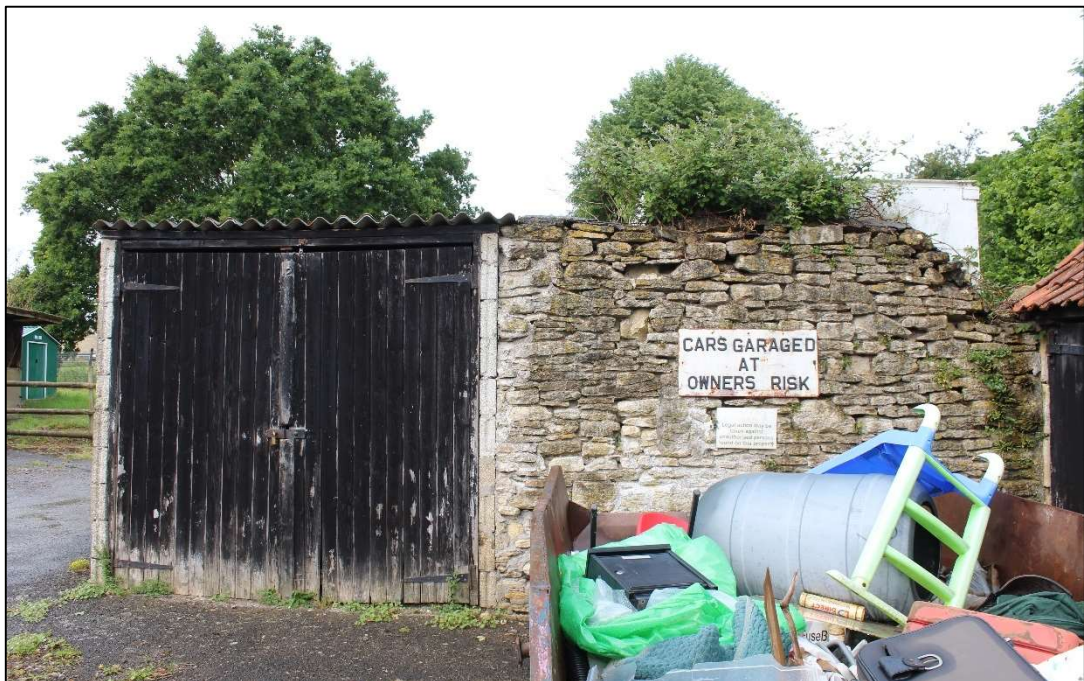
- 4.12. Building D is a small modern garage constructed in the late 20th century, with blockwork walls, a flat corrugated roof covering and timber garage doors (Photo 11 and Photo 12). As with the other late 20th century buildings on site it was built as a garage/storage facility. It has a rectangular planform and is aligned on an east-west axis. The building has no heritage significance. At its north-east corner it is attached to a section of limestone rubble walling which connects to the south-west corner of Building C. This section of wall is a 19th century survival and is probably the rear (west) wall of the former animal pens which once stood in this location (see Fig. 2).

**Photo 11**      **Building D: east elevation**

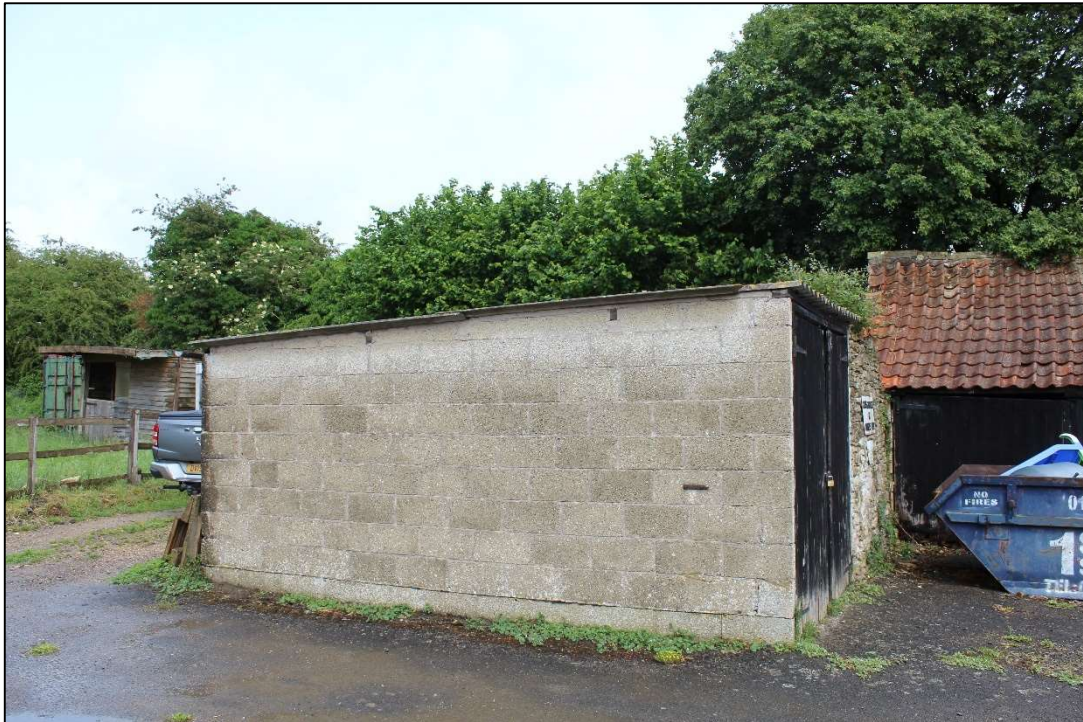
**Photo 12**      **Building D: south elevation**

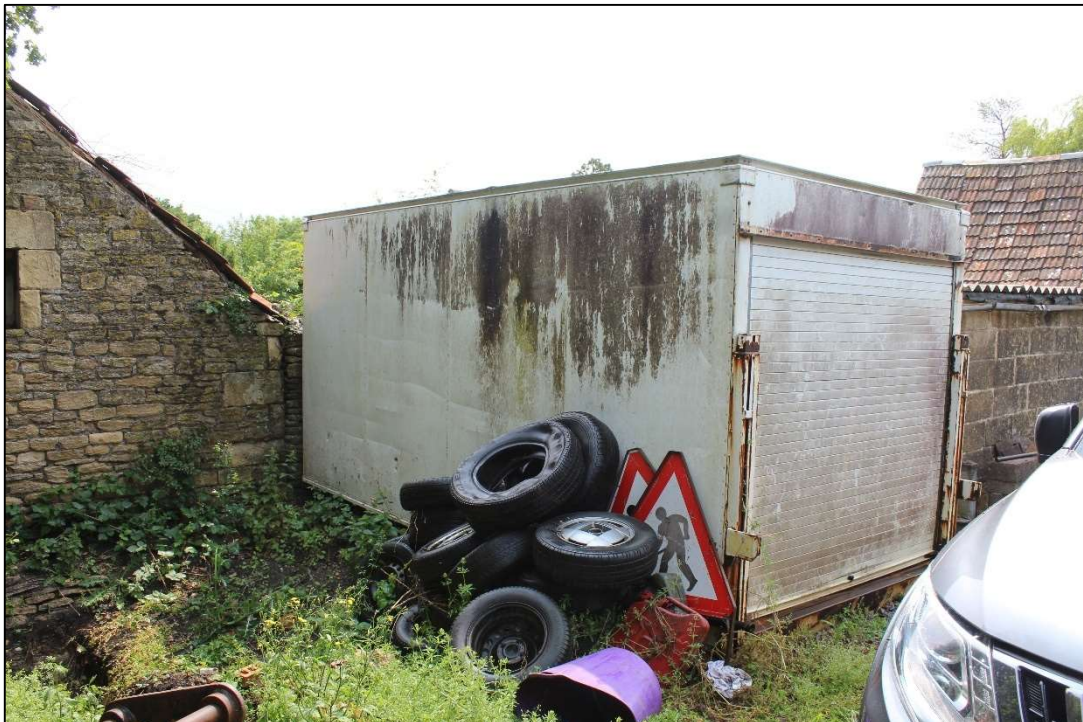
**Photo 13**      **Building E overview, looking south-east**

- 4.13. This structure appears to be a 21st century metal storage container located adjacent to Building C and Building D; it has no heritage significance (Photo 13).

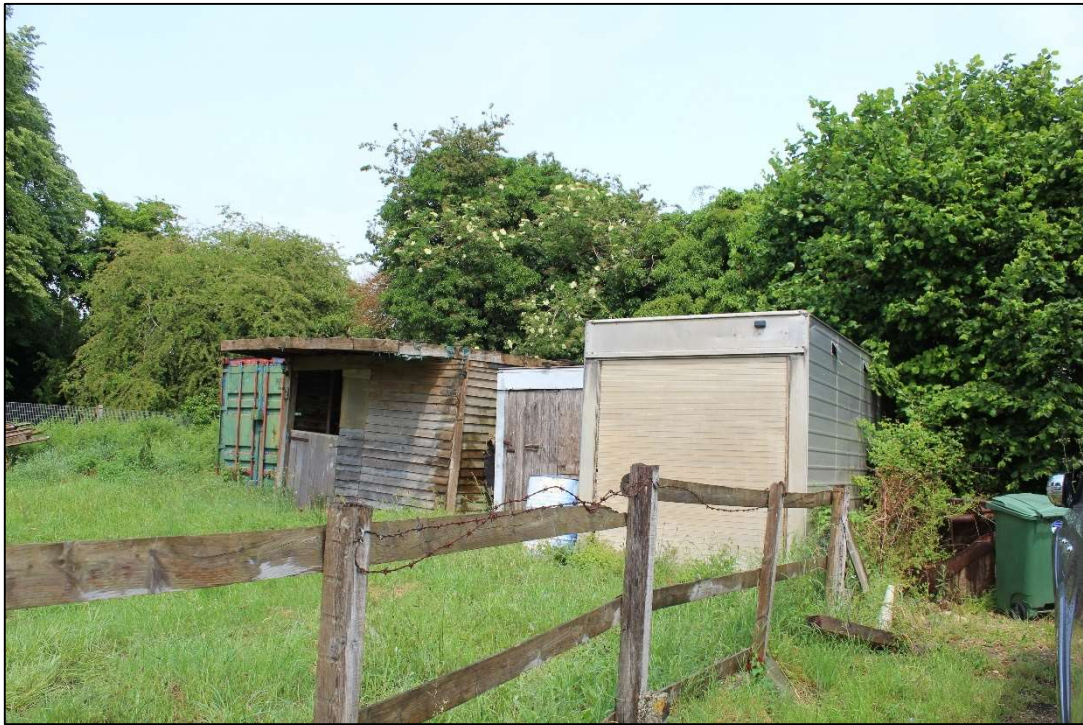
**Photo 14**      **Buildings F-I, looking north-west**

- 4.14. Building F is a small rectangular prefabricated metal storage unit with roller door to the south elevation. Building G is a smaller rectangular prefabricated metal storage unit with south-facing timber door. Building H is a rectangular timber stable building with a south-facing stable door sheltered by a flat overhanging roof structure. Building I is a freestanding shipping container (Photo 14). These structures were all added in the late 20th or 21st century and have no heritage significance.

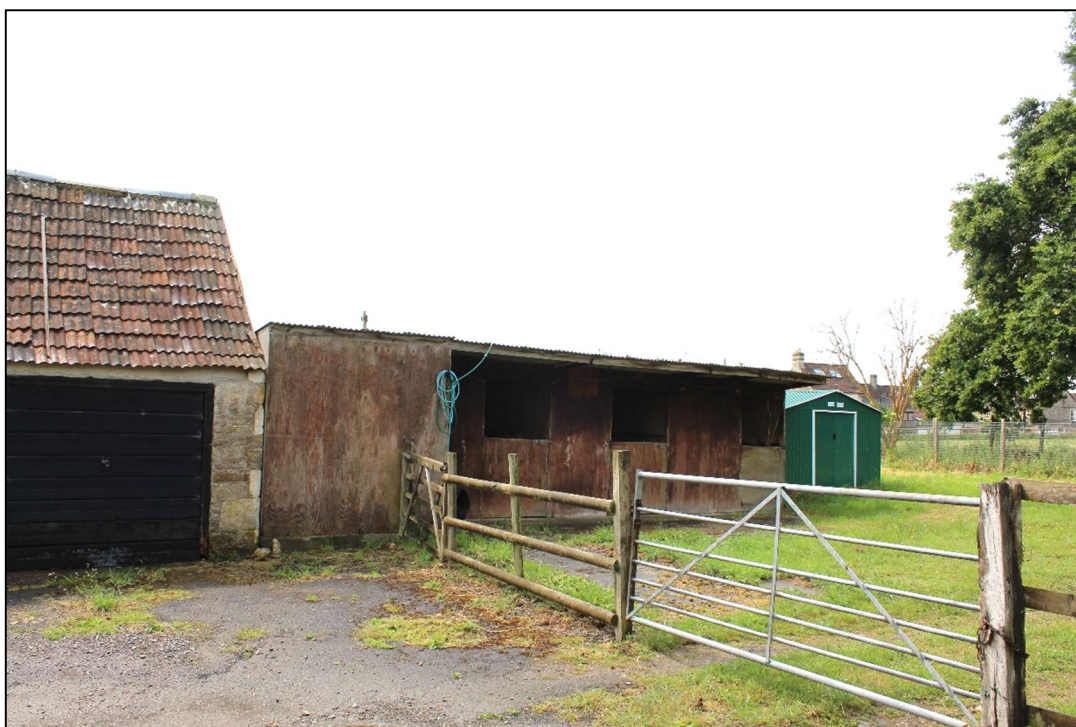
- 4.15. Building J is a freestanding timber shed with north-facing door and corrugated roof. Building K is a timber stable building with plywood sheets to the exterior, a flat corrugated roof, and four individual stable units; three with north facing doors and one with a west facing door (Photo 15). These structures were all added in the late 20th or 21st century and have no heritage significance.

**Photo 15**      **Buildings J and K, looking south-west**

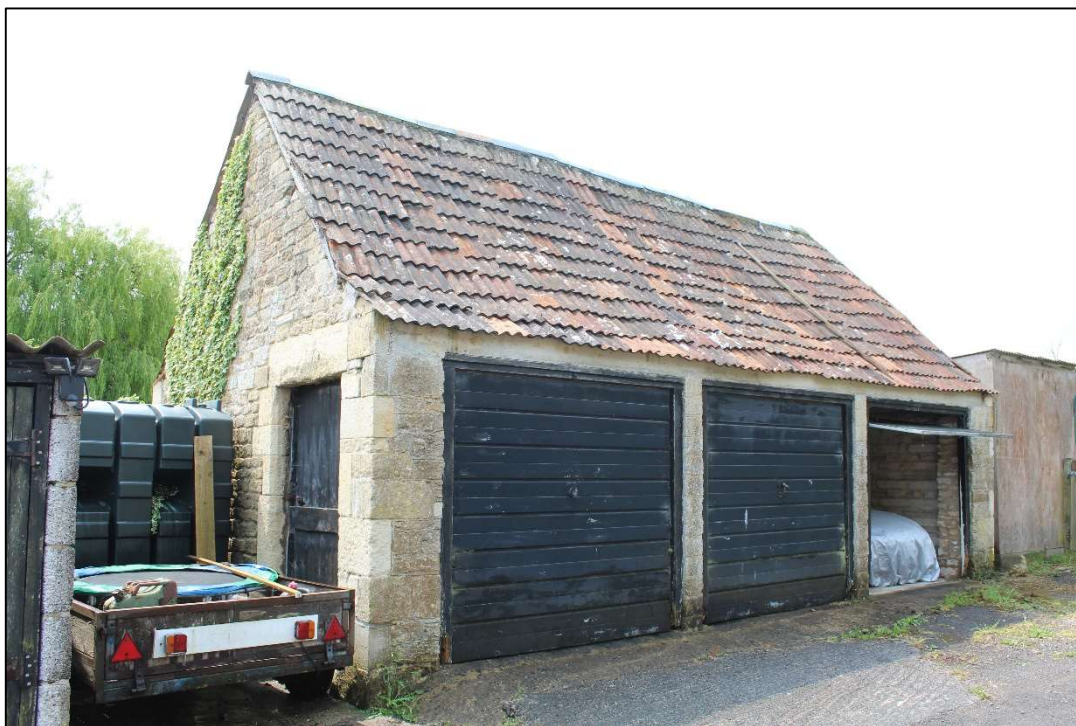
smaller opening in the south-west elevation at roof level with timber batten hatch door, which is a further indication that this may have been a former hayloft area.

**Photo 16**      **Building L: north-west (principal) and north-east elevations**

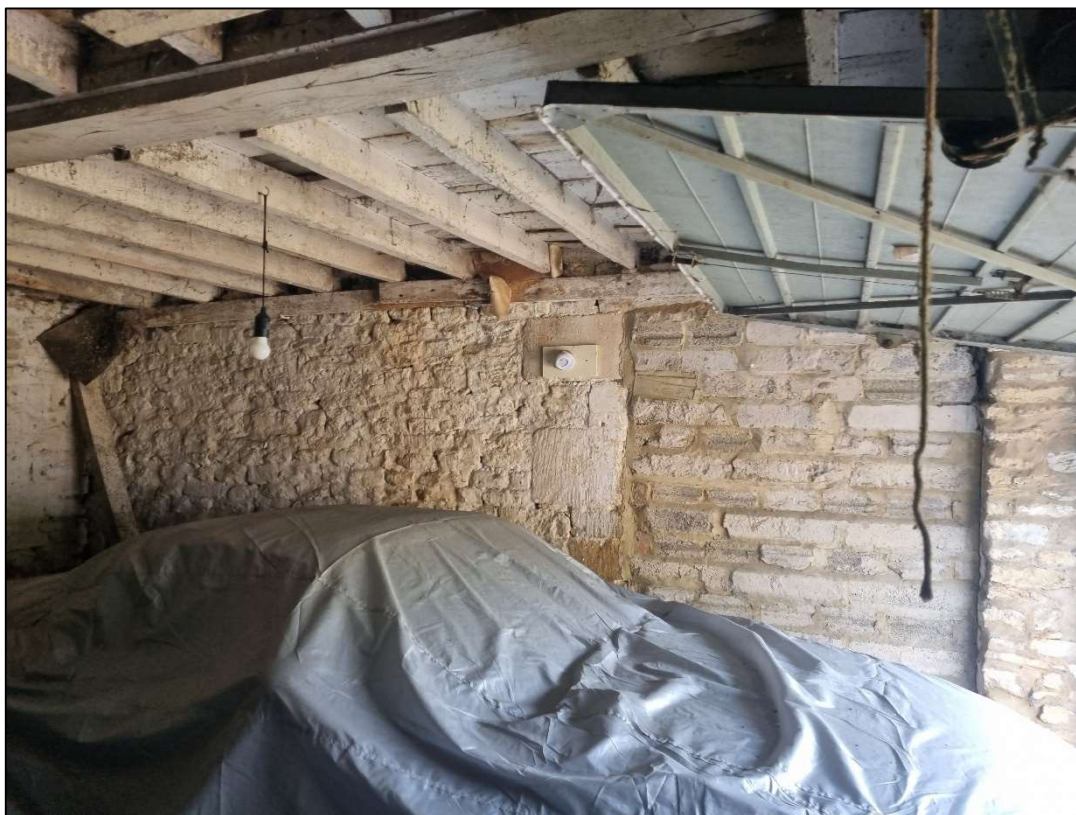
**Photo 7**      **Building L: interior view looking south-west, showing blocked opening**

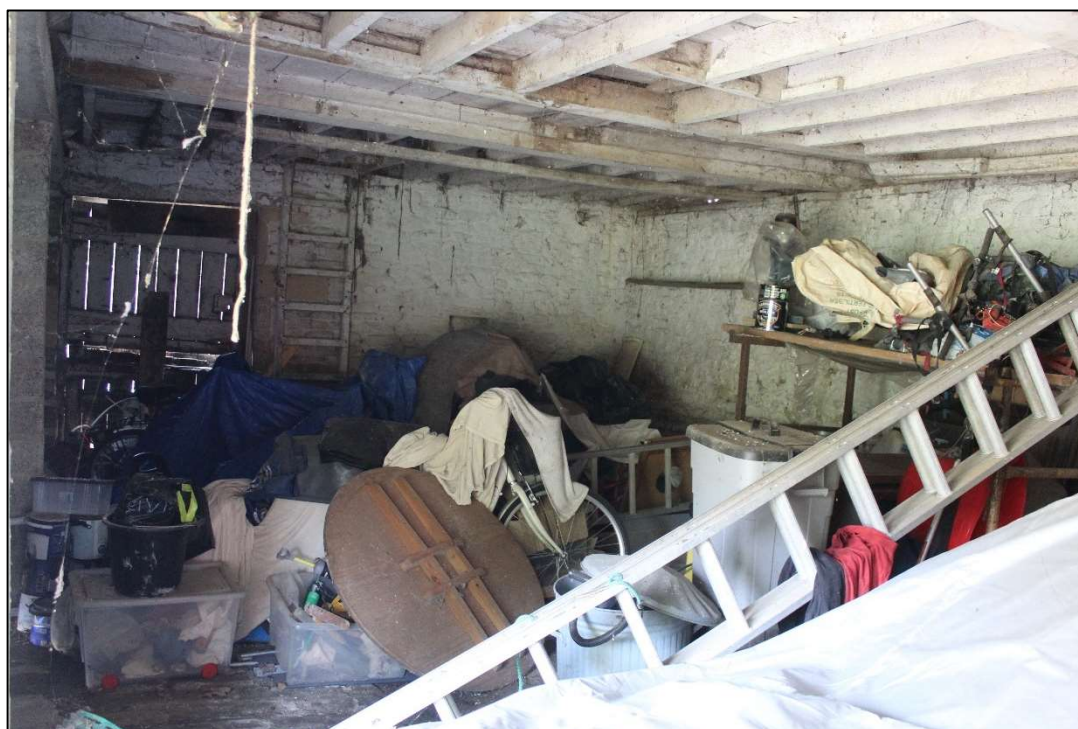
**Photo 18**      **Building L: interior view looking north-east**

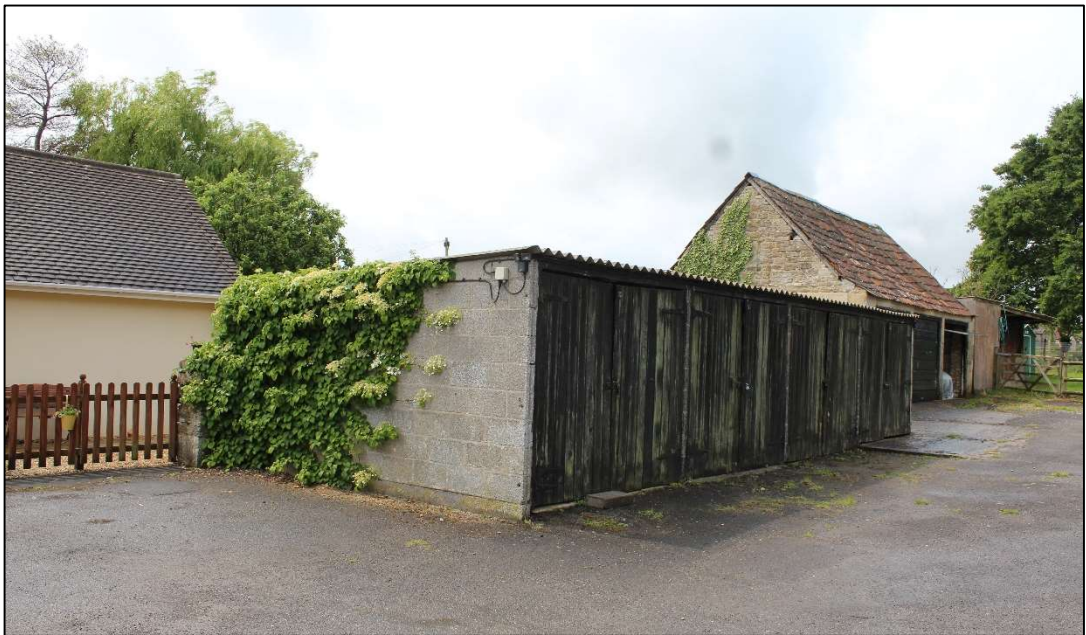
- 4.21. Buildings M and N both comprise a row of late 20th century garages. They are of rectangular planform and orientated on a north-east to south-west axis. They are constructed of modern blockwork walls, flat roof (likely timber) with corrugated metal covering, and timber batten and ledge garage doors with metal strap hinges (Photos 19 and Photo 20). They are modern structures of no heritage significance.

**Photo 19**      **Building M, looking south-west**

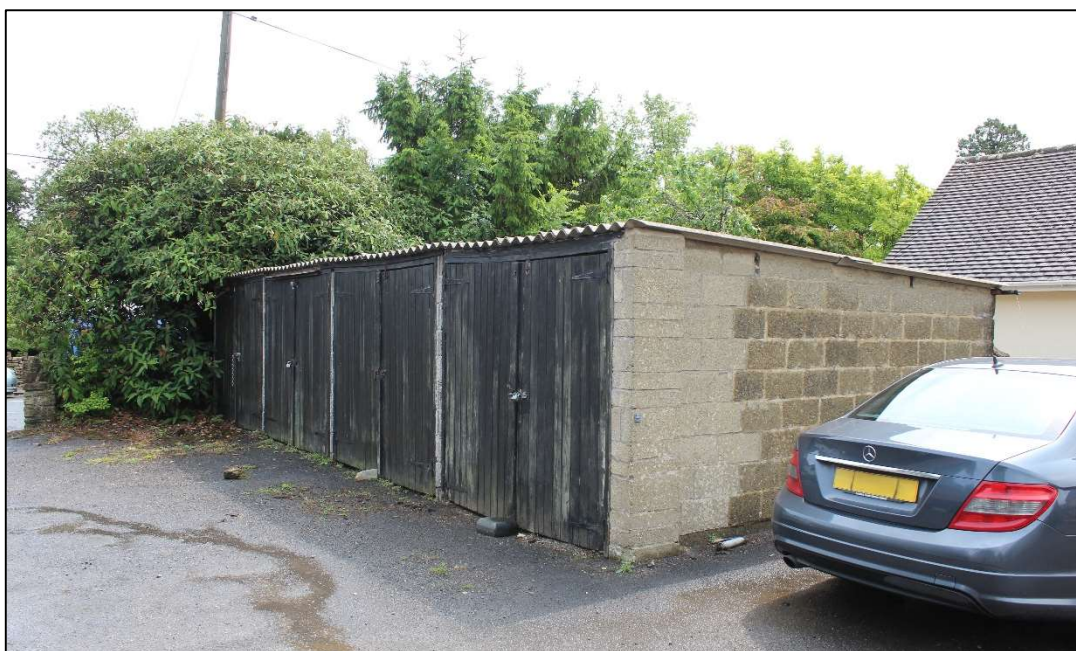
**Photo 20**      **Building N, looking south-east**

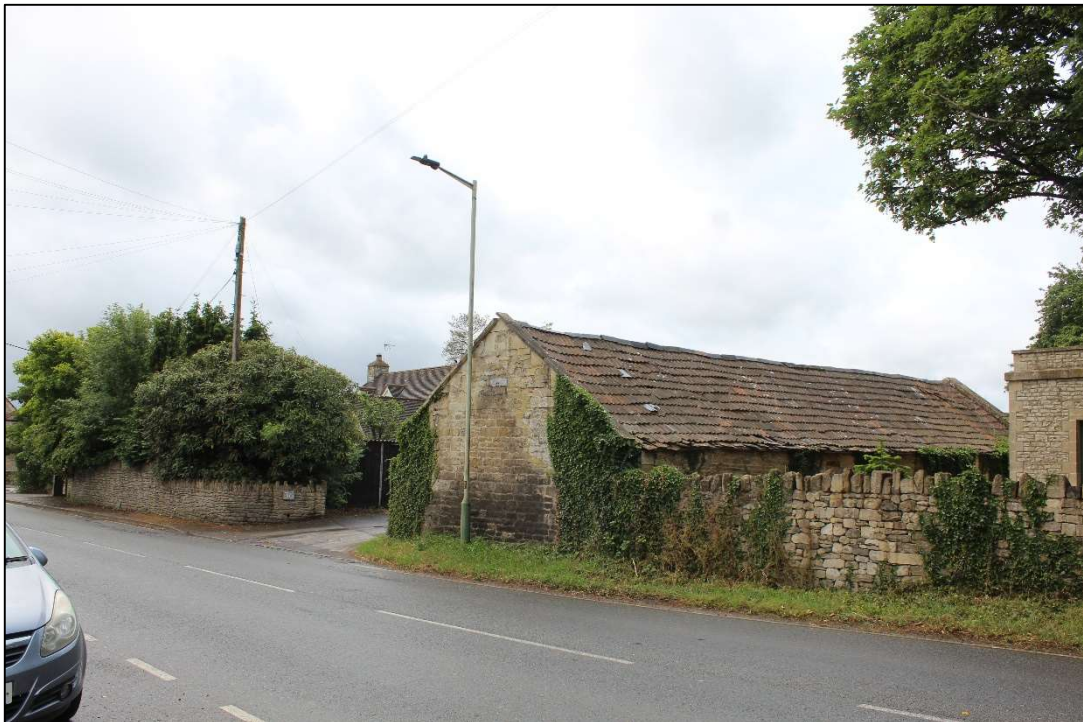
**Photo 30** View of the Site from Bath Road when approaching the Conservation Area boundary, with Building A in the foreground

- 5.24. The 19th century cow shed directly addresses Bath Road, and is perceivable from longer distance views (c. 40m away) when travelling south along the road (Photo 29, Photo 30); as one approaches and moves past the Site, the opening of the entrance allows for views towards the other 19th century buildings and an appreciation of the form and layout of the former farmstead group (Photo 30 and Photo 1). These views facilitate a deeper understanding of the rural farming history of this part of the Conservation Area and the Site marks the physical transition point from the rural setting into the northern settlement boundary of the Conservation Area.

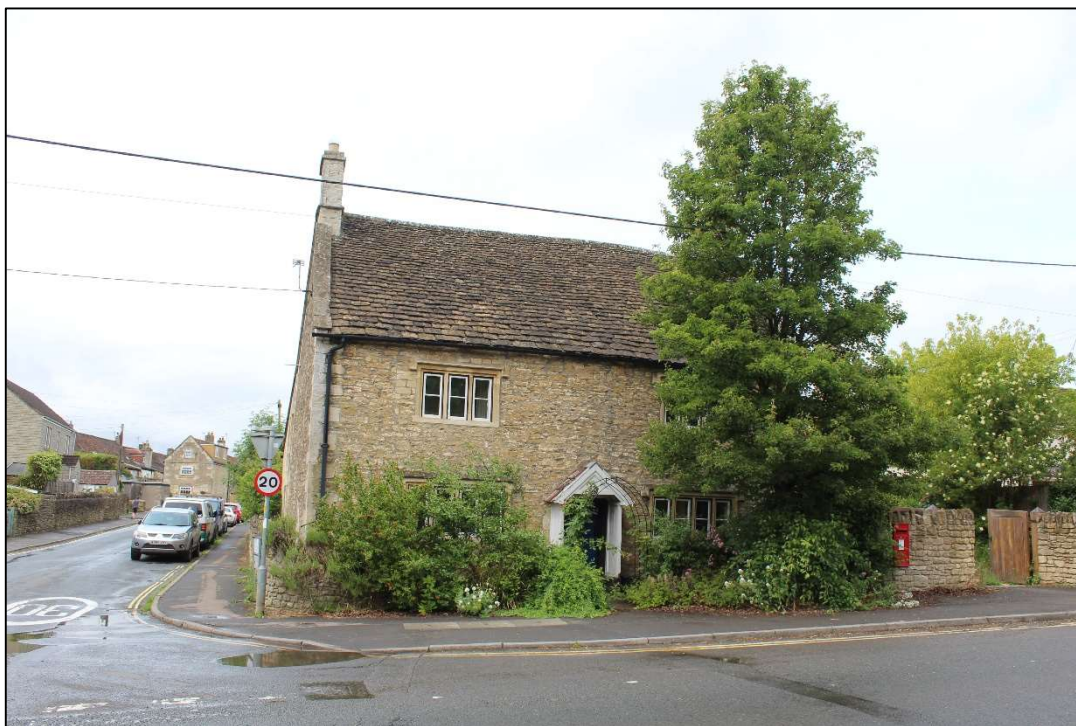
**Photo 31** Bath Road Post Office: principal elevation as viewed from Bath Road

- 5.31. 35 Bath Road is located towards the northern edge of Bradford on Avon. It is aligned on an east to west axis with its front (east) elevation directly addressing Bath Road (Photo 31). Bath Road (the A363) was laid out as part of the Bradford Turnpike Trust in the 1790's as a road to Bath, before which there was possibly a more minor road in the same location which is the main thoroughfare connecting the north side of the settlement to the town centre (Photo 28). The Listed Building has been physically bordered by these roads since at least the late 18th century, and it is prominent and visible from the streetscape and acts as a focal point at the junction between the two roads. This orientation and aspect makes a positive contribution to its significance.

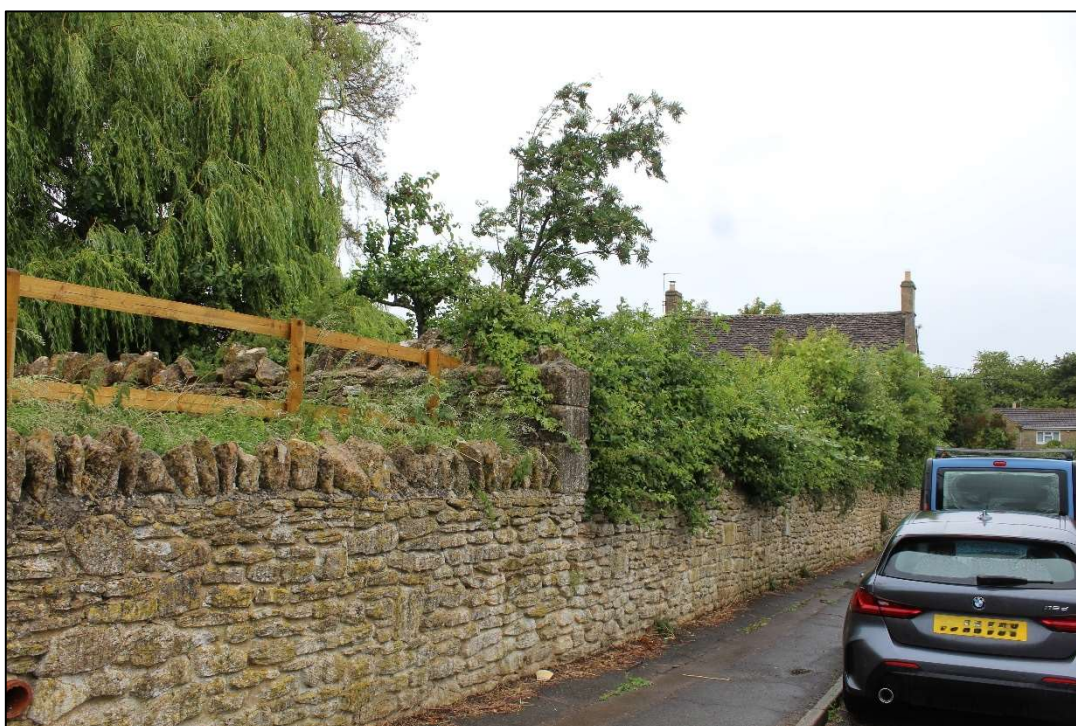
**Photo 32** View towards Bath Road Post Office's rear elevation and garden, as view from Ashley Road

- 5.32. 35 Bath Road is situated in the south-east corner of a rectangular enclosed garden plot with an abundance of mature trees, shrubs and hedges to the borders of the plot (Photo 32). Historic mapping illustrates that these gardens have surrounded the
