Land adjacent to 36 Bath Road, Bradford-on-Avon,  
BA15 1SR

## Preliminary Ecological Appraisal

**For:** Crossman Acquisitions

**Document Date:** 12<sup>th</sup> September 2025

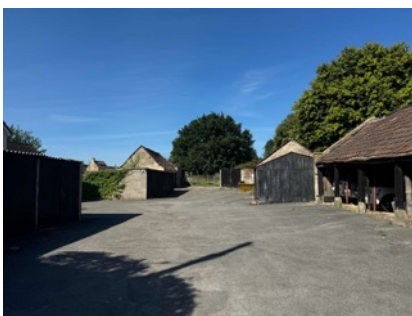
| Habitats | Description |
|---|---|
| <b>Hard standing (u1b – developed land; sealed surface)</b> | The buildings are set around an open area of tarmac that extends across the majority of the site. |

1: View of the hard standing and buildings.

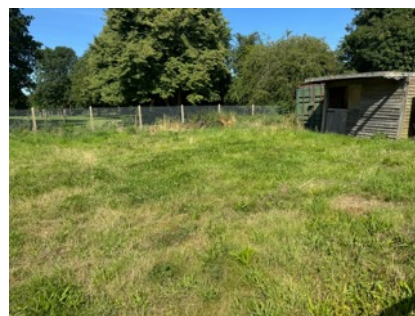
| Habitats | Description |
|---|---|
| <b>Poor semi-improved grassland (g4 – modified grassland)</b> | The west portion of the site is an area of grassland that does not appear to be regularly managed but is generally a species-poor sward. It is dominated by Perennial Rye-grass with frequent Fescue sp., Dandelion, White Clover and Ribwort Plantain, and occasional Black Medick, Self-heal and Yarrow. At the peripheries are occasional Red Clover, Perennial Sow-thistle, False Oat-grass, Common Nettle, Creeping Cinque-foil, Broad-leaved Dock and Dove's-foot Crane's-bill. |

2: Poor semi-improved grassland at the rear of the site.

- 4.2 The site is composed of common habitats that have generally low to moderate ecological value. The hedge will be retained and while the grassland will be lost, this was species-poor and does not qualify as NERC priority habitat. Any impact as a result of loss/changes to habitats is considered to be negligible.

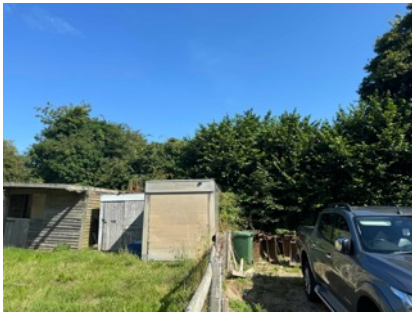
| Habitats | Description |
|---|---|
| <b>Species-poor hedge (h2a – native hedgerow)</b> | There is an over grown hedge on the west half of the north boundary formed by Hawthorn, Elder, Hazel and overgrown with Ivy. |

3: Overgrown hedge on part of the north boundary.

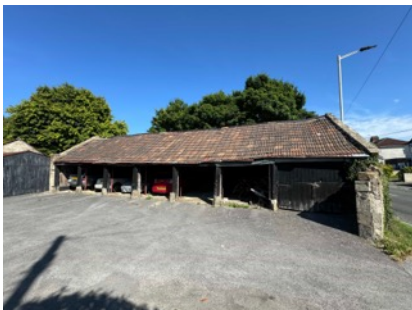
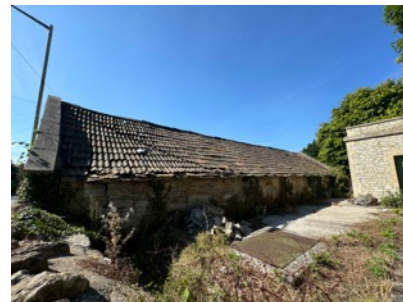
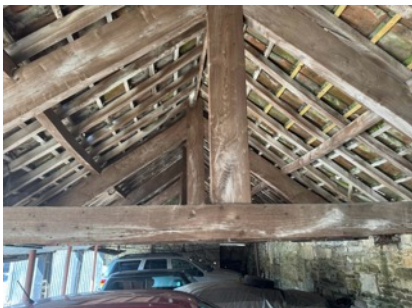
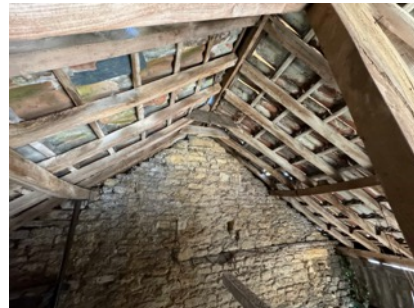
| Building 1 - Range | Description |
|---|---|
| External | <p><b>General:</b> An open fronted range with garage section, currently used for storage vacant church building with both two and single storey sections.</p> <p><b>Roof:</b> Clay plan-tile of gable end construction.</p> <p><b>Walls:</b> Solid stone walls.</p> <p><b>Eaves:</b> Open eaves.</p> <p><b>Verges:</b> Parapet walls.</p> <p><b>Cladding:</b> None.</p> <p><b>Dormer windows:</b> None.</p> <p><b>Chimneys:</b> None.</p> |
| Internal | <p><b>General:</b> The building is open throughout with the exception of a partial wall spearting the garage section from the main section. The main interior is well-lit through the open front and numerous gaps under tiles.</p> <p><b>Roof Structure:</b> Traditional timbers of rafters, principal rafters</p> |

| <b>Potential access points</b> | The interior of the building is directly accessible through the open front. Numerous gaps under tiles and at the eaves. |
| <b>Potential roosting features</b> | <p>Although the main interior of the building is accessible to bats, this is deemed generally unsuitable for roosting as it is well-lit and no evidence of bats was recorded.</p> <p>A small number of gaps under roof tiles allow potential access for bats to small crevices under tiles and there numerous gaps in timber work and along the tops and within the stone walls</p> <p>No evidence of bats was recorded associated with the building.</p> |
| <b>Evaluation</b> | <p>No evidence of bats was found and the main interior is generally unsuitable being well lit and draughty. There were however a large number of minor crevices throughout that could used by individual or low numbers of bats.</p> <p>The building is classified as providing <b>low potential</b> for roosting bats.</p> |

4: Front (east) elevation.

5: Rear (west) elevation.

6: Interior – main section.

7: Garage section interior.

| Buildings | Impact Assessment |
|---|---|
| 1, 2 and 7 | <p><b>Roost damage/destruction:</b> Unknown. The work would result in the loss and disturbance of bat roosts, if present.</p> <p><b>Roost modification:</b> Unknown. Modification of roosts, if present.</p> <p><b>Roost disturbance:</b> Potential for disturbing or injuring bats, if present when the works take place, through exposure, noise and vibration, causing them to fly during the day making them vulnerable to predation.</p> <p><b>Effect on foraging/commuting:</b> No significant impact predicted. The site provides limited value to foraging bats and habitats suitable for commuting are absent. The effects of new lighting and changes in building layout are not expected to be significant given that bat activity associated with the site is expected to be minimal.</p> |

| Building | Further Surveys |
|---|---|
| 1, 2 and 7 | <b>Number of Surveys:</b> The buildings are deemed to be of low suitability for roosting bats; therefore, one dusk emergence survey is required to identify any roosts or conclude absence.<br><br><b>Required Number of Surveyors:</b> Six. |

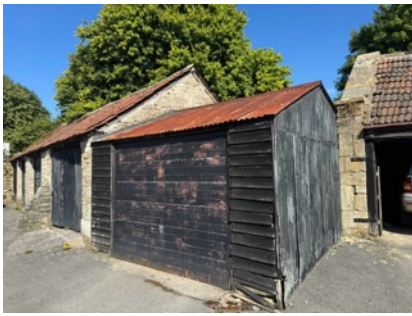
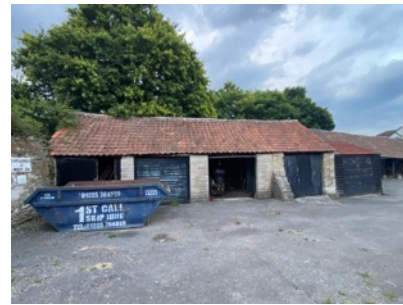
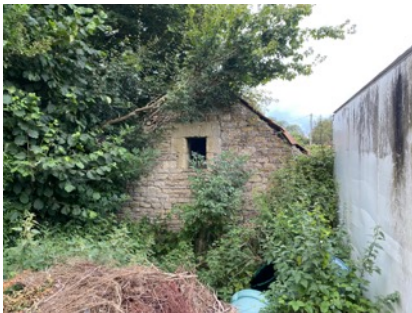
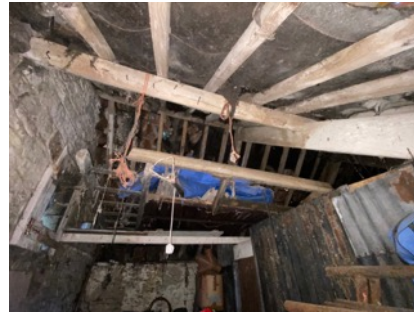
| Buildings 2 and 3 - Garages | Description |
|---|---|
| <b>External</b> | <p><b>General:</b> Stone garage block with attached timber garage.</p> <p><b>Roof:</b> Clay plan-tile of gable end construction on Building 3. Corrugated sheet metal on Building 2.</p> <p><b>Walls:</b> Solid stone walls and timber plank with metal garage doors.</p> <p><b>Eaves:</b> Open eaves.</p> <p><b>Verges:</b> Timber end rafters and open.</p> <p><b>Cladding:</b> None.</p> <p><b>Dormer windows:</b> None.</p> <p><b>Chimneys:</b> None.</p> |
| <b>Internal</b> | <p><b>General:</b> The buildings are open throughout with no enclosed roof voids.</p> <p><b>Roof Structure:</b> Traditional timbers of rafters and purlins.</p> <p><b>Roof Lining:</b> Bitumen felt but largely deteriorated.</p> <p><b>Insulation:</b> None.</p> <p><b>Roof Voids:</b> No enclosed roof voids.</p> <p><b>Other:</b> N/A.</p> |
| <b>Potential access points</b> | <p>The interiors of the buildings are directly accessible through numerous gaps under tiles and at the eaves.</p> |
| <b>Potential roosting features</b> | <p>The main interiors of the buildings are accessible to bats and are mostly dark spaces which are partially lit through gaps at the eaves. Building 2 is generally unsuitable on account of its sheet metal roof but Building 3 has numerous small crevices under tiles and there are gaps in timber work and along the tops and within the stone walls</p> <p>No evidence of bats was recorded associated with the building.</p> |
| <b>Evaluation</b> | <p>No evidence of bats was found but the main interior is generally dark being well lit and there are a large number of minor crevices throughout that could used by individual or low numbers of bats.</p> <p>The building is classified as providing <b>low potential</b> for roosting bats.</p> |

8: Building 2.

5: Building 9.

6: Building 10 – west elevation.

7: Building 11 interior.

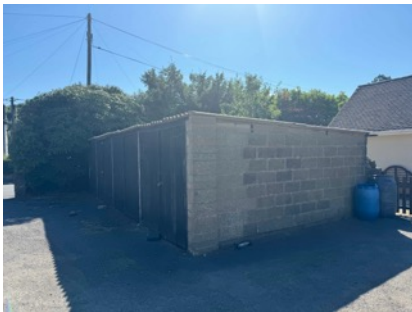
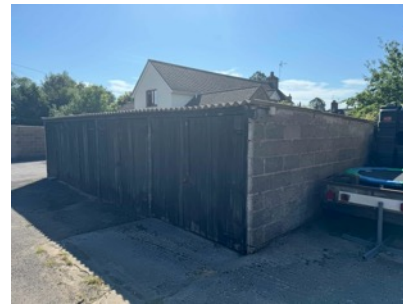
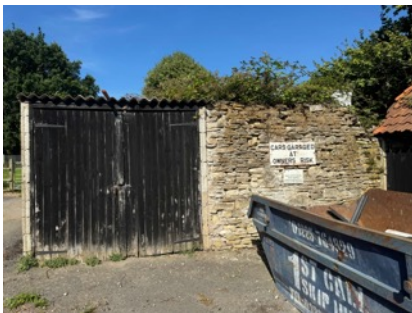
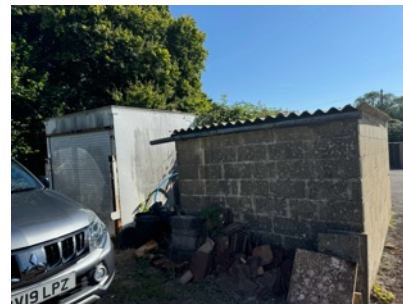
| Buildings 4, 5 and 6 – Modern/Stone garages | Description |
|---|---|
| External | <p><b>General:</b> Modern garages.</p> <p><b>Roof:</b> Corrugated asbestos/cement board</p> <p><b>Walls:</b> Concrete block (Building 6 also has a partial stone wall)</p> <p><b>Eaves:</b> Open eaves.</p> <p><b>Verges:</b> Open.</p> <p><b>Cladding:</b> None.</p> <p><b>Dormer windows:</b> None.</p> <p><b>Chimneys:</b> None.</p> |

| <b>Potential access points</b> | The interiors of the buildings are accessible through gaps at the eaves between the walls and roof sheets. |
| <b>Potential roosting features</b> | Minor gaps along the tops of the walls but the interiors are not suitable. A full inspection of the gaps did not find any evidence of bats |
| <b>Evaluation</b> | No evidence of bats was found after a full inspection of minor gaps.<br><br>The building is classified as having <b>negligible potential</b> for roosting bats. |

8: Building 4.

9: Building 5.

10: Building 6 – front.

11: Building 5 – rear.

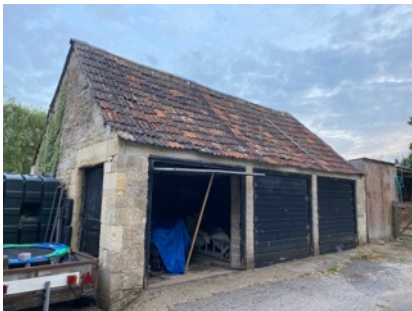
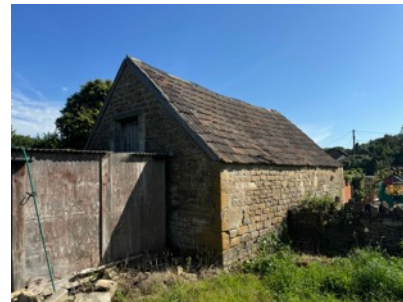
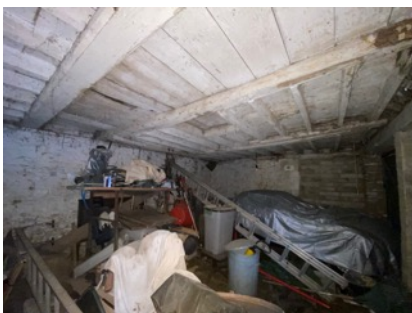
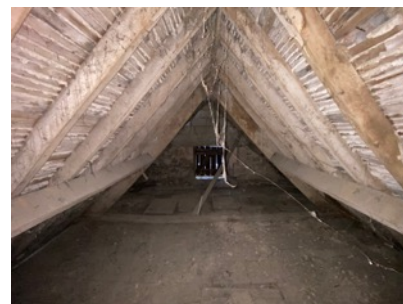
| Building 7 | Description |
|---|---|
| <b>External</b> | <p><b>General:</b> Stone garage block.</p> <p><b>Roof:</b> Clay plan-tile of gable end construction.</p> <p><b>Walls:</b> Solid stone walls with metal garage doors.</p> <p><b>Eaves:</b> Open eaves.</p> <p><b>Verges:</b> Timber end rafters.</p> <p><b>Cladding:</b> None.</p> <p><b>Dormer windows:</b> None.</p> |

| <b>Internal</b> | <p><b>General:</b> The building interior is separated into ground floor garages with a first floor set within the roof void.</p> <p><b>Roof Structure:</b> Traditional timbers of rafters and purlins.</p> <p><b>Roof Lining:</b> Lath and plaster.</p> <p><b>Insulation:</b> None.</p> <p><b>Roof Voids:</b> The first floor is an enclosed roof void access through a hatch and hay loft door.</p> <p><b>Other:</b> N/A.</p> |
| <b>Potential access points</b> | Gaps around the doors, gaps in the hayloft door and numerous gaps in the verge mortar and between tiles. |
| <b>Potential roosting features</b> | <p>The main interior of the building is accessible to bats and are mostly dark spaces which are partially lit through gaps at the eaves and around doors. There are numerous small crevices under tiles and there are gaps in timber work and along the tops, and within, the stone walls</p> <p>No evidence of bats was recorded within the building.</p> |
| <b>Evaluation</b> | <p>No evidence of bats was found but the main interior is generally dark being well lit and there are a large number of minor crevices throughout that could be used by individual or low numbers of bats.</p> <p>The building is classified as providing <b>low potential</b> for roosting bats.</p> |

12: Building 7 – front.

13: Building 7 – rear.

14: Building 7 – ground floor.

15: Building 7 – roof void.

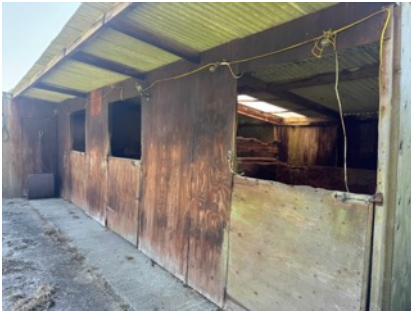
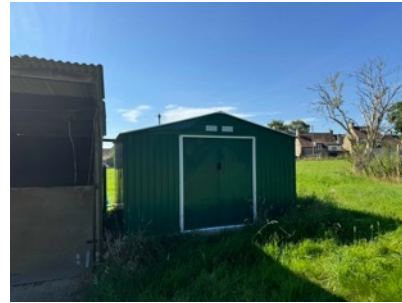
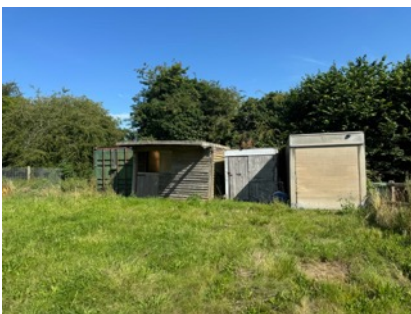
- 3.9 Buildings 8 to 14 are unsuitable for roosting bats being makeshift stables and metal sheds and a container.

12: Building 8.

13: Building 9.

14: Buildings 11 to 14.
