## GROUND INVESTIGATION REPORT

Proposed Residential Development  
Fives Court, Mere, Wiltshire

Report No: PO-22-039/GIR

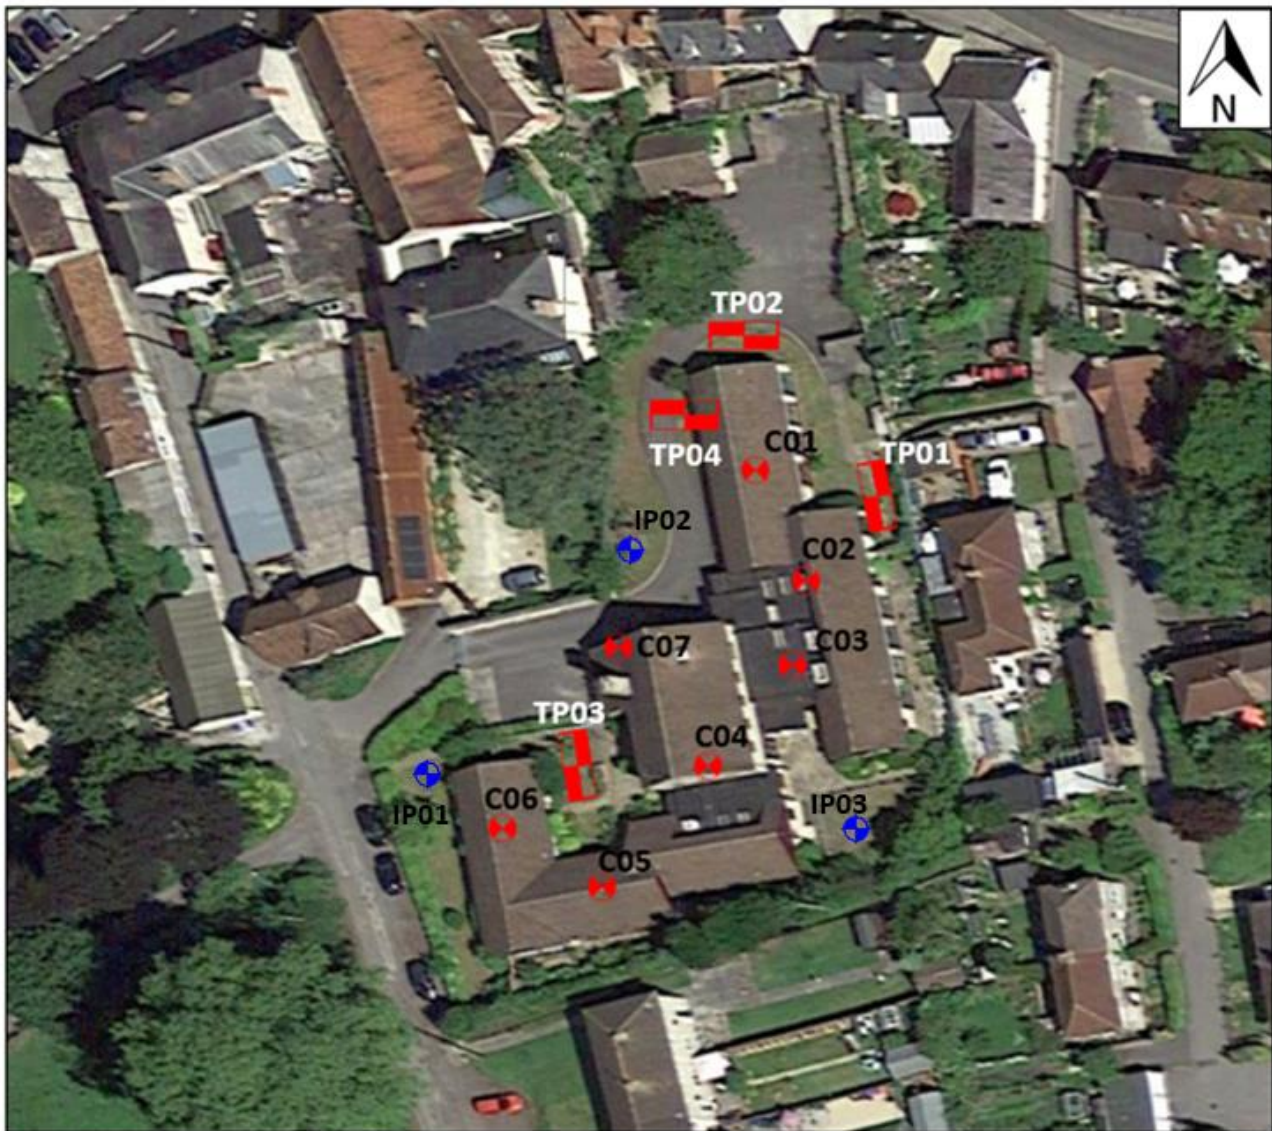
**Drawing 3.1:** Exploratory Hole Location Plan

The exploratory hole logs and in-situ test results are presented in **Annex A** and **Annex B** respectively, and their locations shown on **Drawing 3.1** below.
