Heritage Statement and Existing Joinery Condition  
Listed Building Consent Application - No 29 Kingsbury Street, Marlborough, SN8 1JA  
Replacement of Windows and Sashes

## 6. Existing Joinery – Current Description and Condition

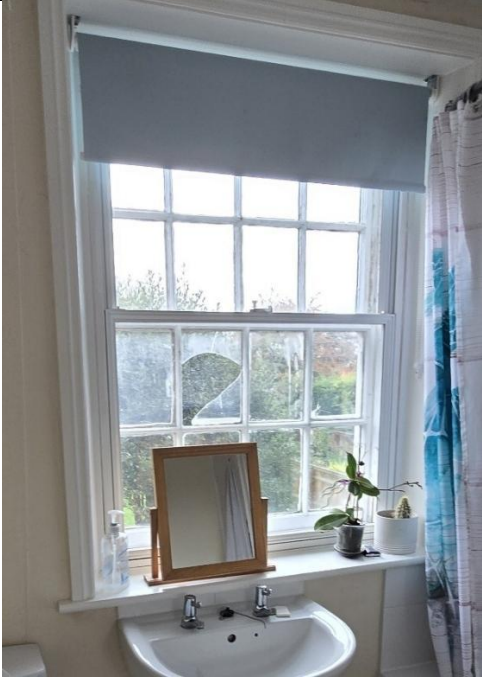
| <p>Description:</p> <p>Joinery. Softwood. Vertical sliding rope-hung with concealed counterweight. One horizontal and three vertical glazing bars.</p> <p>Glazing. Eight panels. 4mm single-glazed float glass. External traditional putty bead. Secondary glazing installed.</p> | |
| <p>Condition Notes:</p> <p>Main external box frame is maintained and serviceable. As part of this project the counter-weight ropes will be renewed and the frame serviced. The upper sash is in a better condition than the lower.</p> <p>The lower sash has been repaired in the past. As a result, some of the joinery is newer whilst some may still be original.</p> <p>Most of the glass in this sash has been replaced at some point in the past.</p> <p>Both top and bottom rail of the lower sash have now failed and are beyond repair. The sash no longer opens safely.</p> <p>The window furniture is old pattern and may be reused.</p> | |

The proposed replacement doors and windows will be faithful copies of the profiles and dimensions of the existing joinery. The proposal seeks to change the material used from softwood to hardwood in order to improve both the functionality and longevity of the external joinery. The proposal will maintain the historical significance of the property. The front elevation's contribution to the Conservation Area street scene is not impacted. Harm to the fabric of the building is insubstantial.

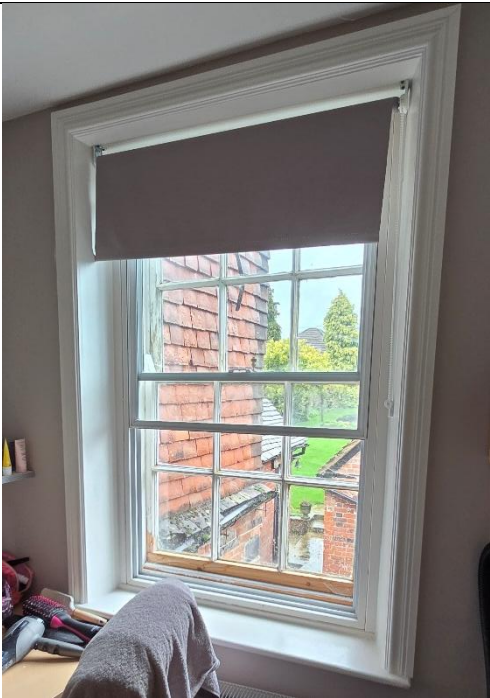
| <p>Description:</p> <p>Joinery. Softwood. Vertical sliding rope-hung sashes with concealed counterweights. One horizontal and two vertical glazing bars.</p> <p>Glazing. Six panels each sash. 4mm single-glazed float glass. External traditional putty bead.</p> <p>Secondary glazing installed.</p> | |
| <p>Condition Notes:</p> <p>Main external box frame is maintained and serviceable. As part of this project the counter-weight ropes will be renewed and the frame serviced.</p> <p>Neither sash is good condition and both no longer operate as opening units.</p> <p>Most of the glass in these sashes have been replaced at some point in the past.</p> <p>Parts of the frame joinery have been repaired or replaced in the past. The quality of this work was poor and has resulted in harm to the sash frame – particularly the lower sash.</p> <p>Both upper and lower sashes are beyond repair</p> <p>The window furniture is old pattern and may be reused.</p> | |

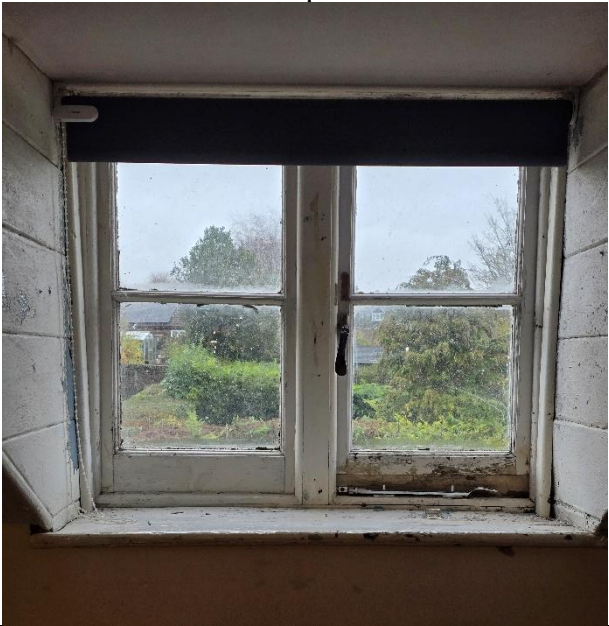
| <p>Description:</p> <p>Softwood. Two casements, one fixed, one side-hung outward opening. Single horizontal glazing bar to each casement.</p> <p>Glazing. Two panels per casement. 4mm single-glazed float glass. External traditional putty bead.</p> <p>No secondary glazing installed.</p> | |
| <p>Condition Notes:</p> <p>Both windows are newer units with machine-cut profiles and modern furniture and fixtures. The joinery is low quality wide-grained soft wood. The workshop methods and style of furniture indicate that the windows probably date to late last century – 1980's / 1990's.</p> <p>The glazing is clear 'non-wavy' modern glass.</p> <p>A lack of maintenance combined with poor quality repairs have left both in a non-serviceable and unrepairable condition.</p> | |
