## Preliminary Roost Assessment

7 The Square, Ramsbury, Wiltshire, SN8 2PE

This report is prepared to inform the construction of a dormer extension on the northern roof elevation of the existing building.

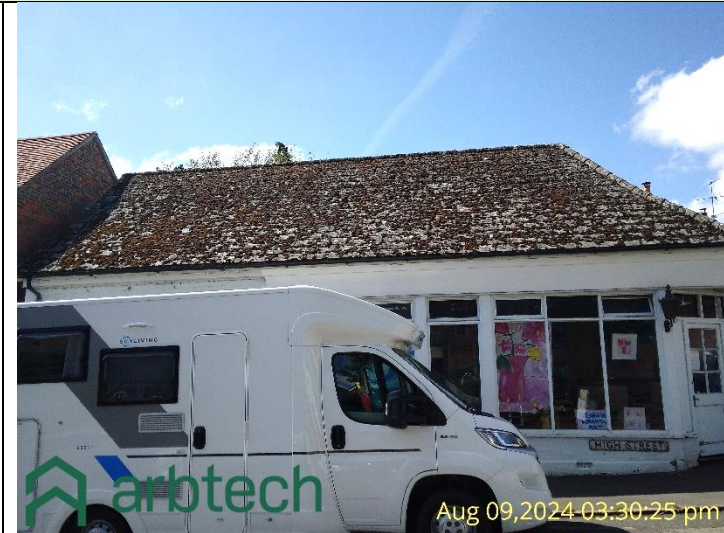
B1 is one storey commercial building. It is a semi-detached structure, with a gable fronted end on the west elevation, and a 1m gap between this and the adjacent residential building.

It is a single pitched roof, with field tiles of slate and a ridge and hip tile of concrete.

There are 5 glass inserts in the roof acting as skylight windows in the loft.

There is a flat roof extension on the north elevation, with roofing felt lining the roof and corrugated metal lining the breeze block walls. There is a wisteria and young ash trees growing against this flat-roof extension.

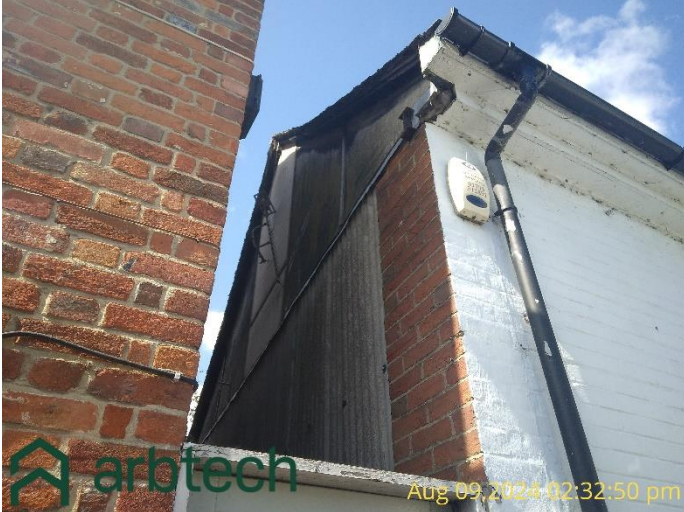
| Feature | Materials | Condition/description | Suitability/access/evidence of bats |
|---|---|---|---|
| Walls | Red brick original on west gable wall, painted on all other elevations.<br>Corrugated material on east gable walls | Numerous raised boards on north east and west elevations, particularly pronounced one east and west ends.<br><br>There were no features around the east gable walls and the corrugated material placed on this wall. | None. |

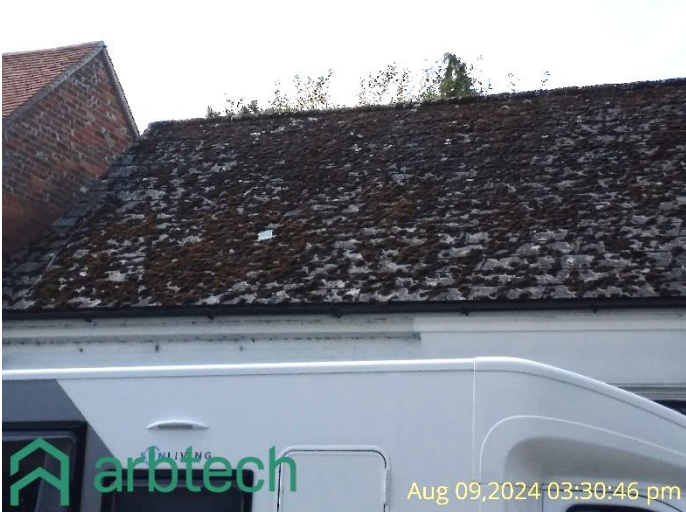
| Roof | Slate field tiles.<br>Cement ridge and hip tiles<br><br>Glass skylight windows | Single pitched roof, with slate tiles. No tiles lifted or slipped, and no gaps around glass panels used as skylights.<br>Thick layer of moss following the shape of the tiles, blocking up any potential gaps there may be.<br>No roosting features observed. | None |

| <i>Enhancements</i> | Bat access tiles can be installed into the roof of B1 during works on the northern elevation. This will provide roosting opportunities to crevice-dwelling species in the vicinity as pipistrelle are listed on EPSLs within 500m of the site |
