# DESIGN & ACCESS STATEMENT

## MANOR FARM,

RODBOURNE, MALMESBURY

REVISION C—JUNE 25

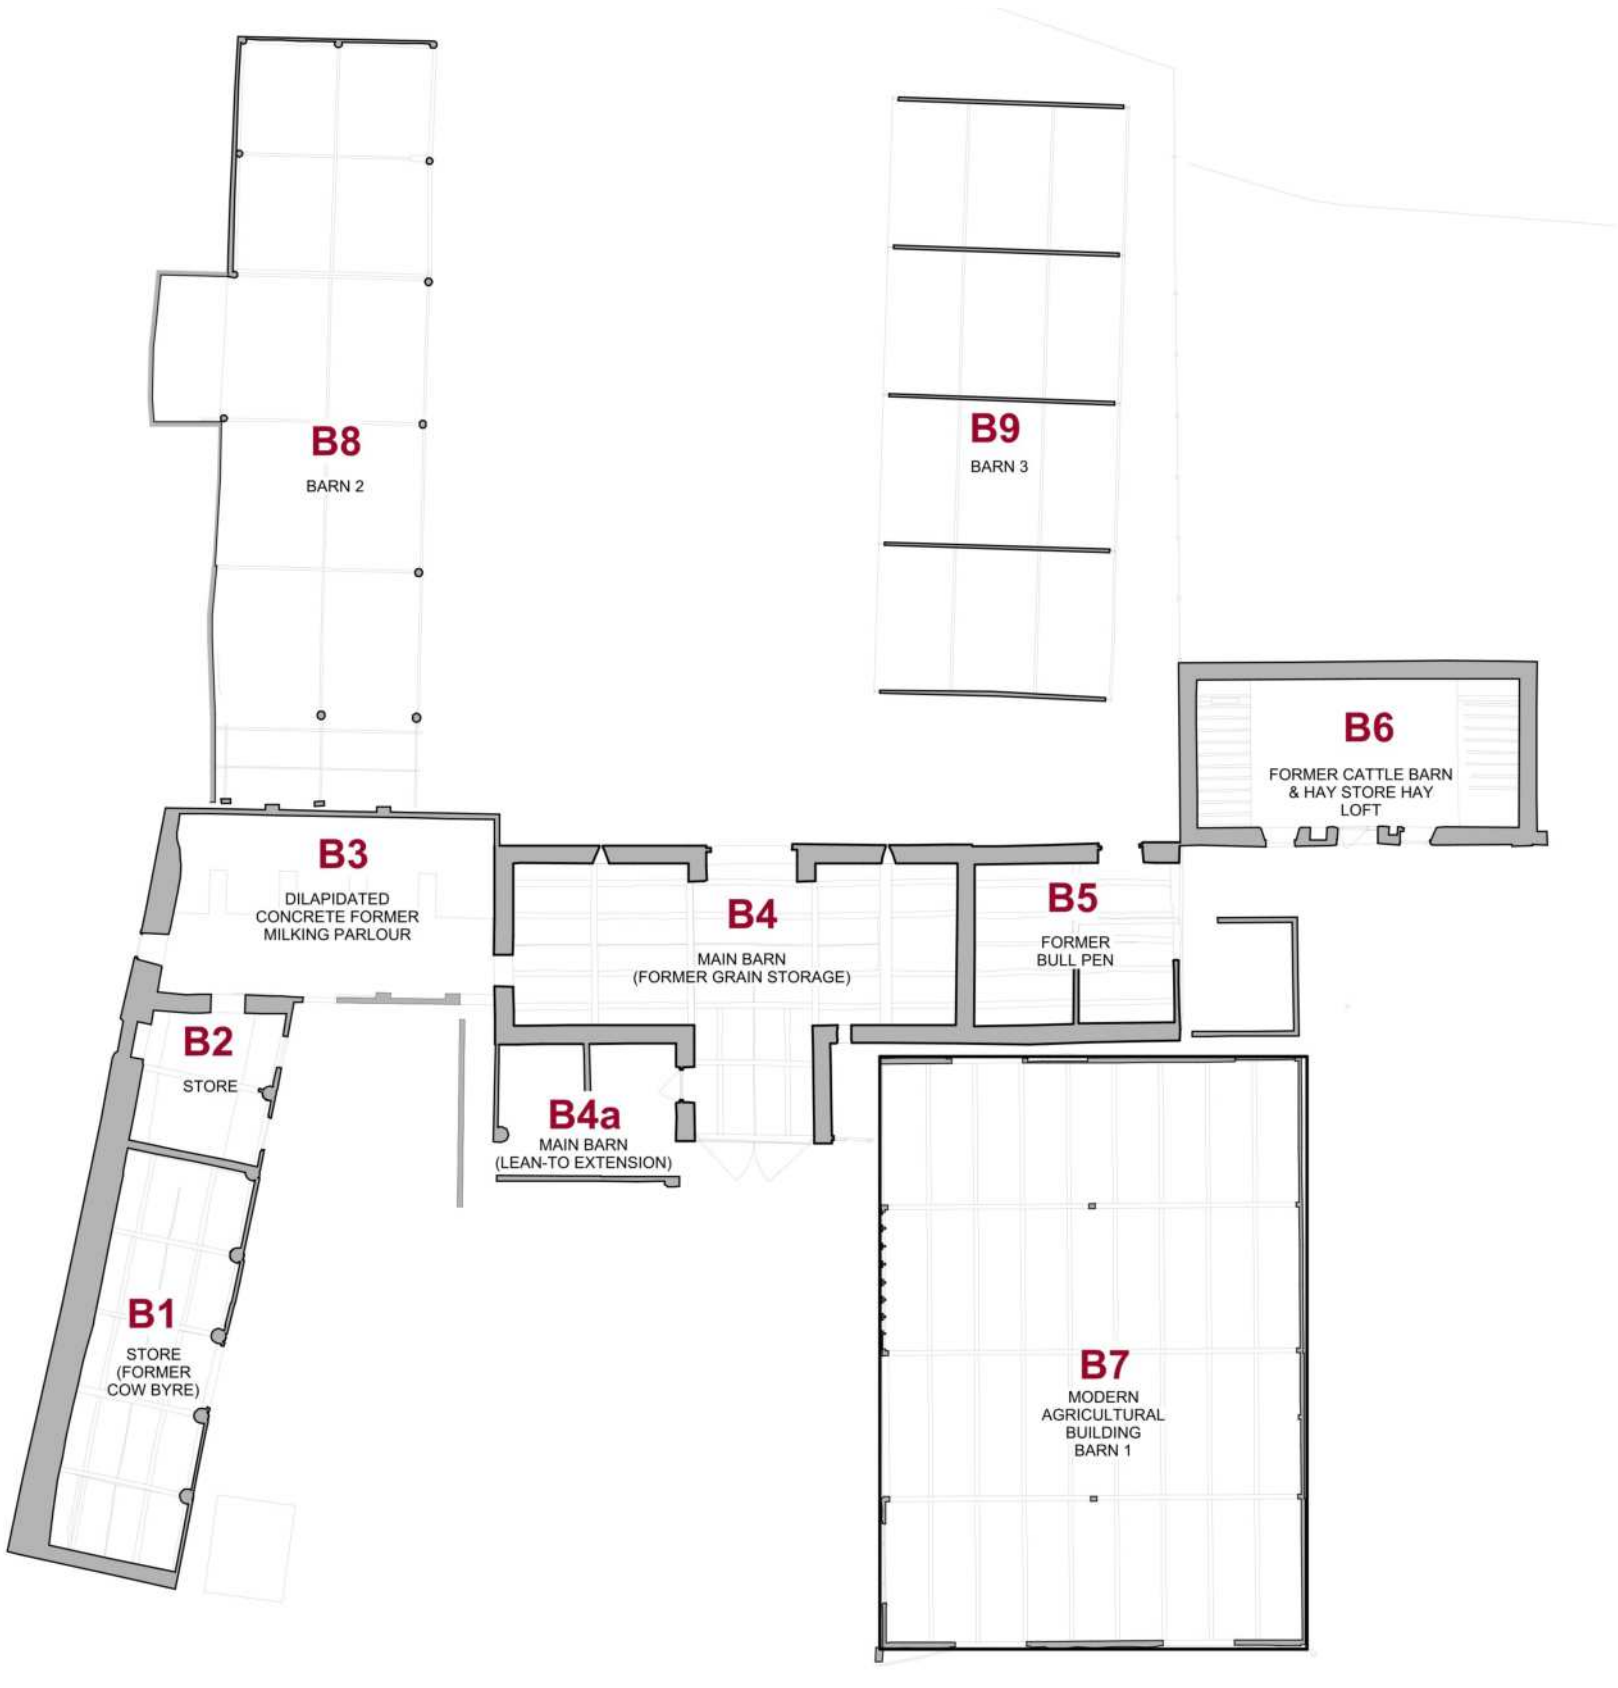
Fig.04 MWA Full Existing Site Plan—A key reference for building names and abbreviations used within this application and supporting documentation

Existing Site Plan acting as a key for the building names & abbreviations used within this application

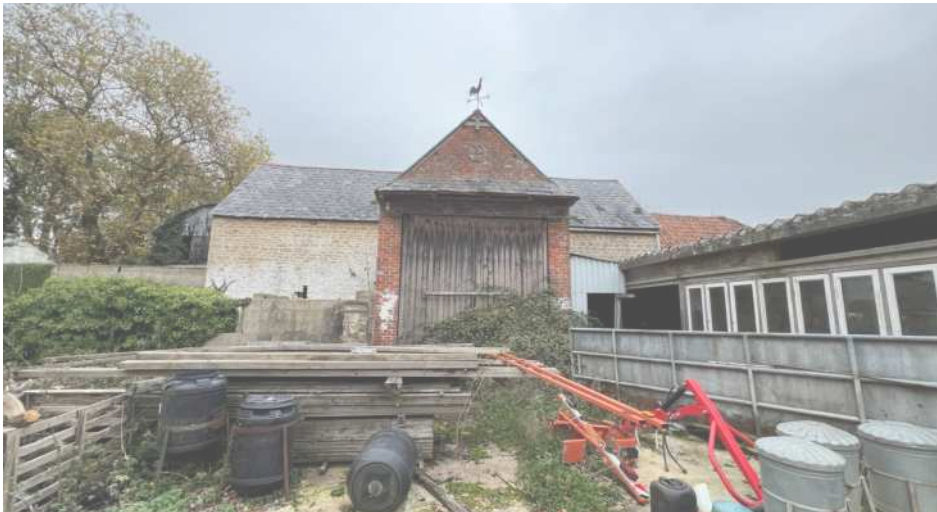
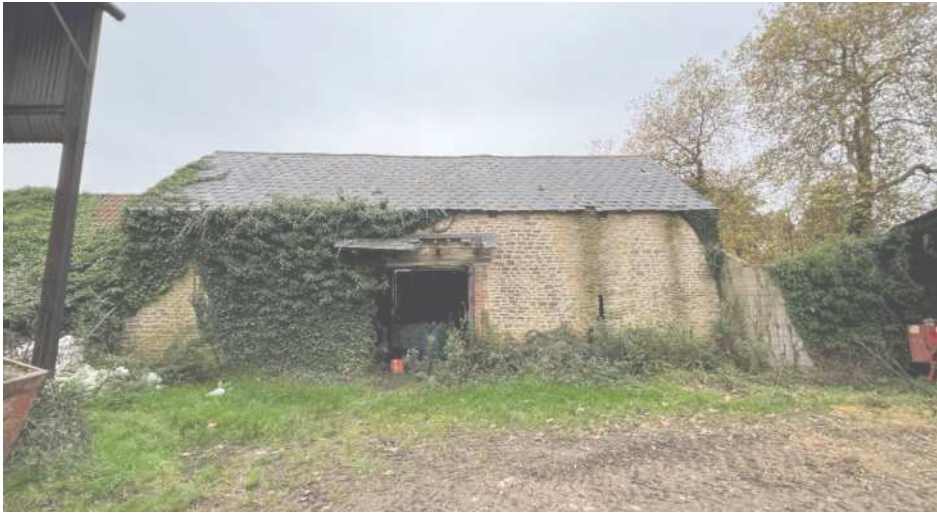
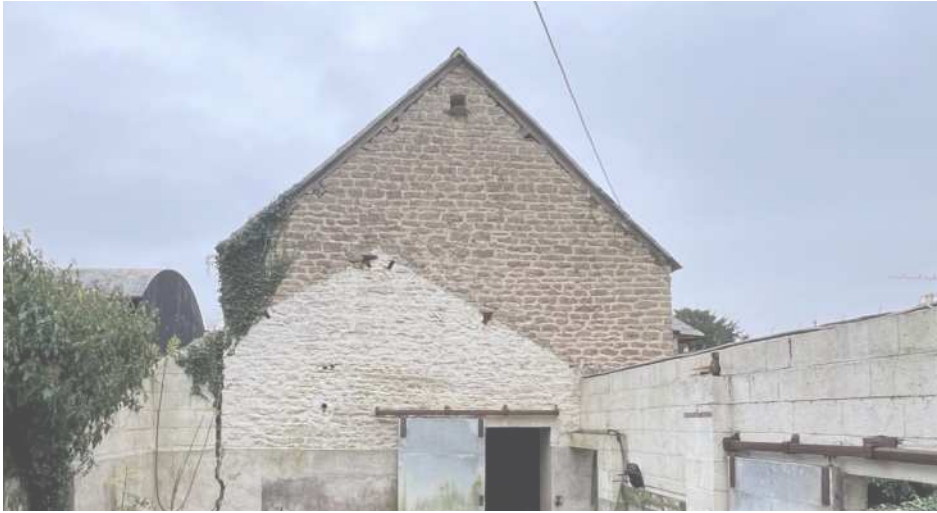
A Cotswold stone barn built in 1848 with a projecting brick gable that sports tall opening doors to the primary elevation with a plainer rear elevation.

Formally used for grain drying and storing

The main barn is still in relatively good condition. However as the site has evolved through the years, the main barn has lost its hierarchy and status as the dominate structure on the site., instead being over powered by adjacent barns and over projecting extensions.

*It is therefore proposed to be retained & repaired where required .*

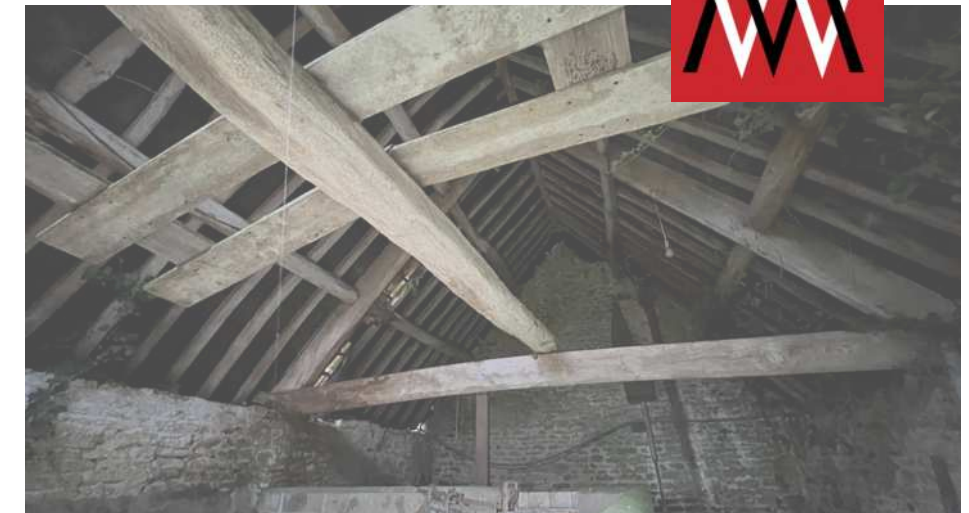
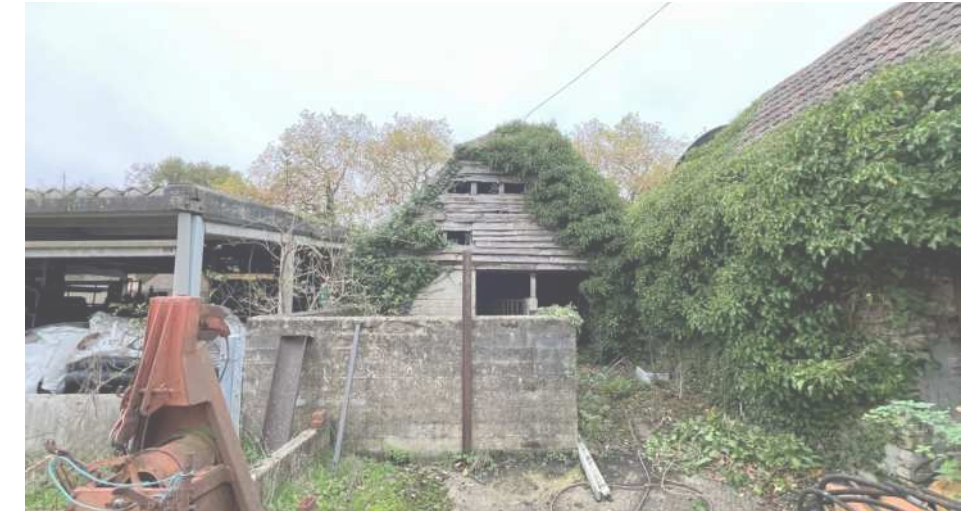
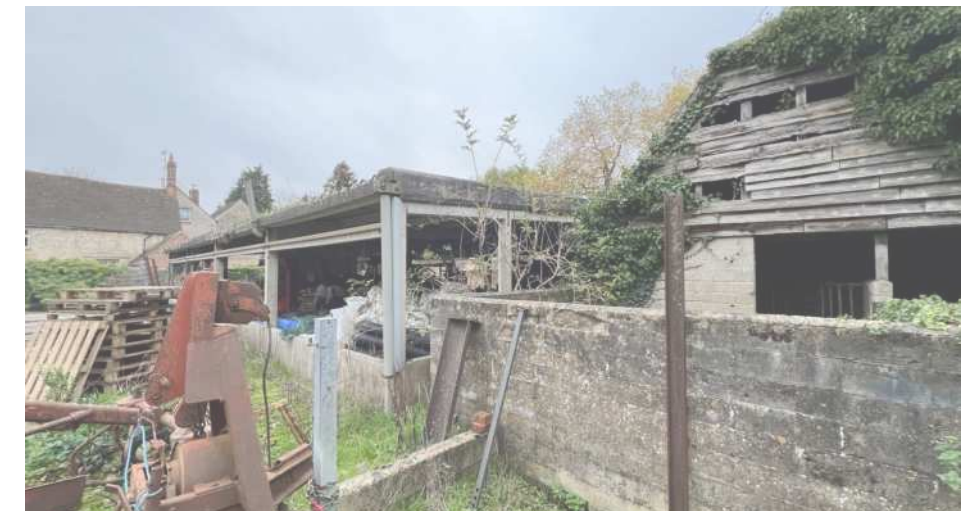
**Animal Stable:** (Fig. 16 - 18) (*Ecology Report: Building 5*)

The Animal Stable is single-storey, constructed from stone and concrete blockwork, with a pitched clay tile roof. At the southern end the top part of the wall comprises single-layer, over-lapping timber ship-lap some of which is missing. The building abuts the southern end wall of the main barn.

This structure posed limited architectural merit however the potential that the space offer in adjacency to the main barn has been noted.

*It is therefore proposed to be retained & repaired where required*

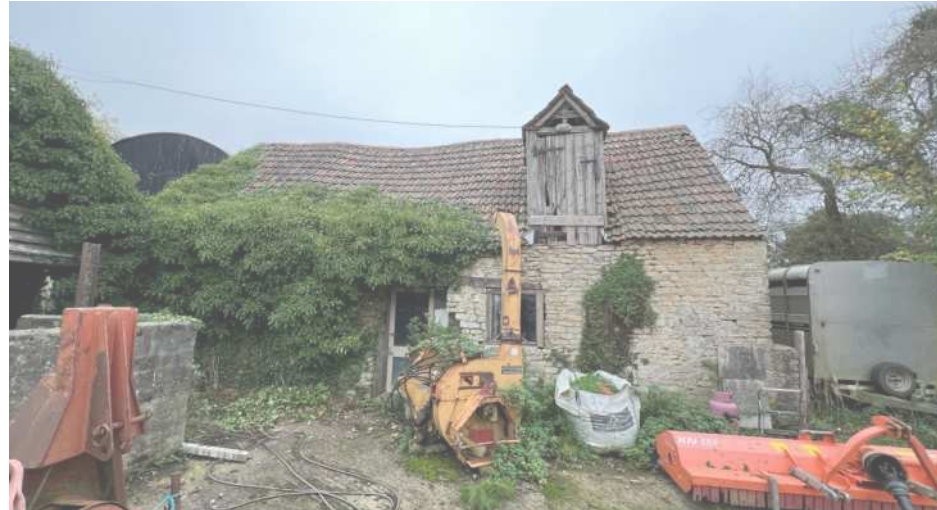
Fig.19 View of Existing

The building is constructed from Cotswold stone with a clay tile roof, this clay roof tile has fallen into disrepair specifically on the north-east elevation (Fig 20). The building also contained a large dormer to the roof (Fig 19)

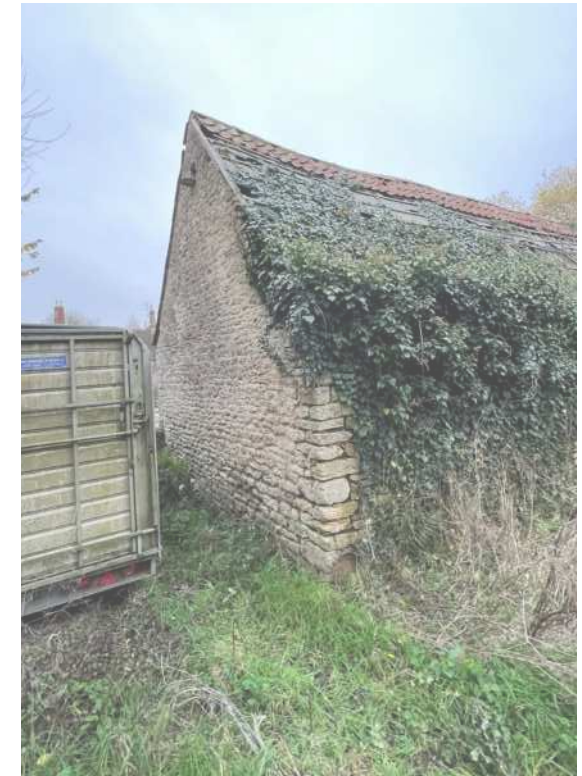
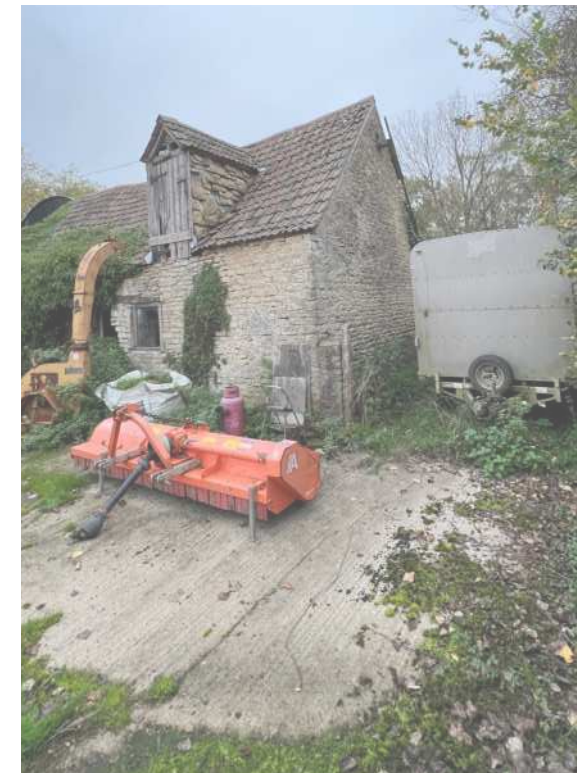
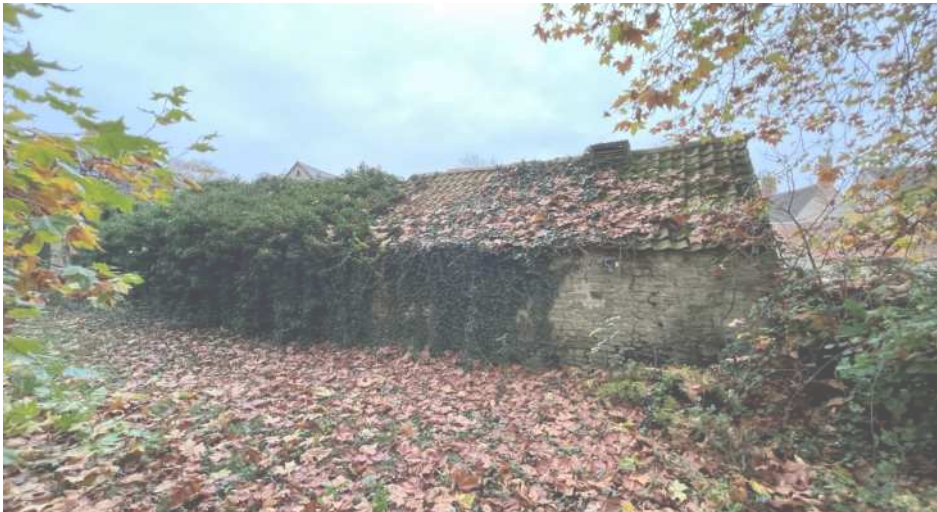
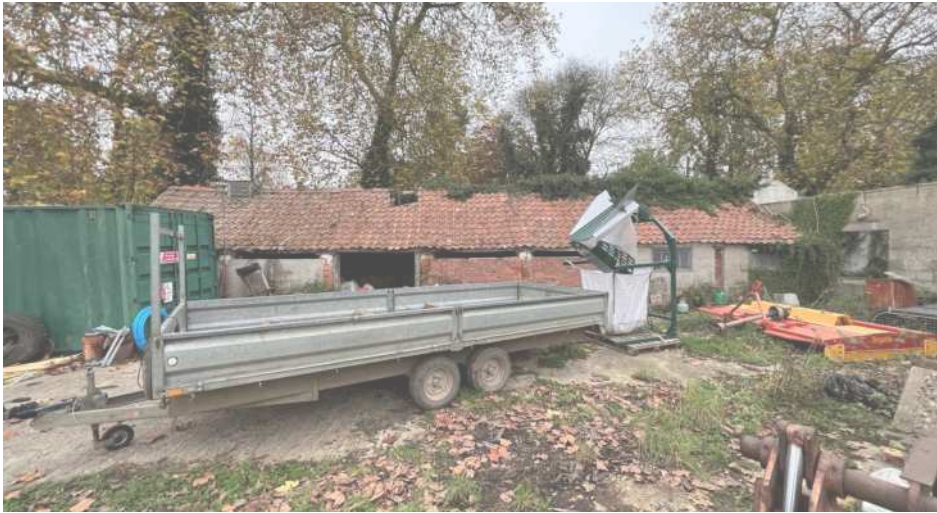
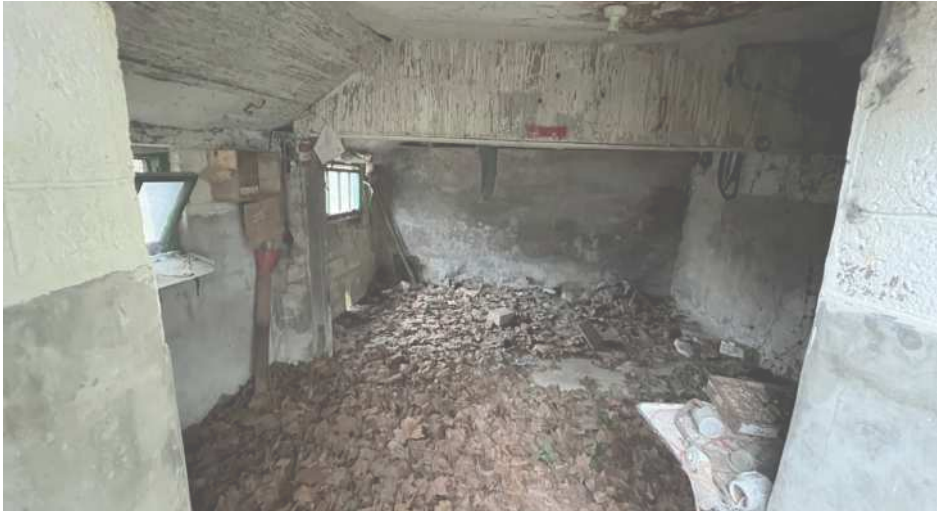
Historically the Structure has been used as a livestock store with a hay loft at its first floor.

The existing building possesses architectural and historical character, meriting its retention and reuse.

*It is therefore proposed to be retained & repaired where required*

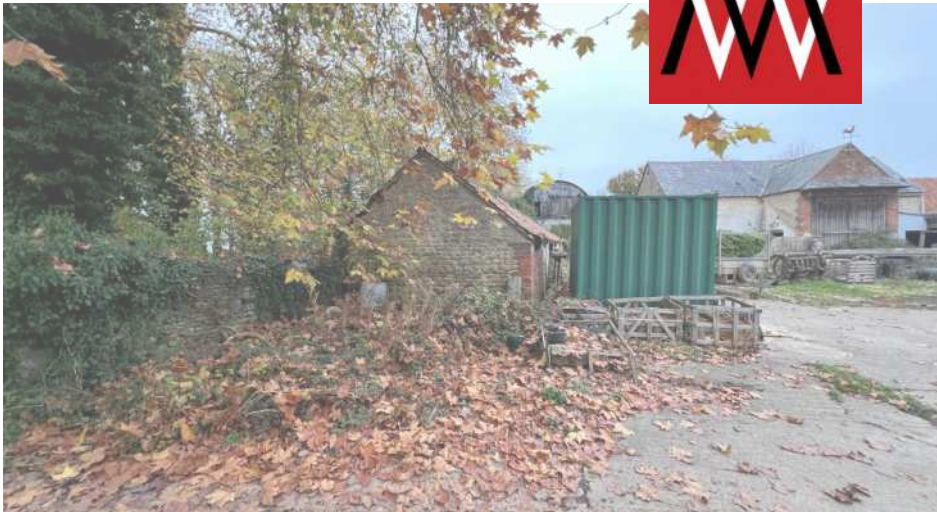
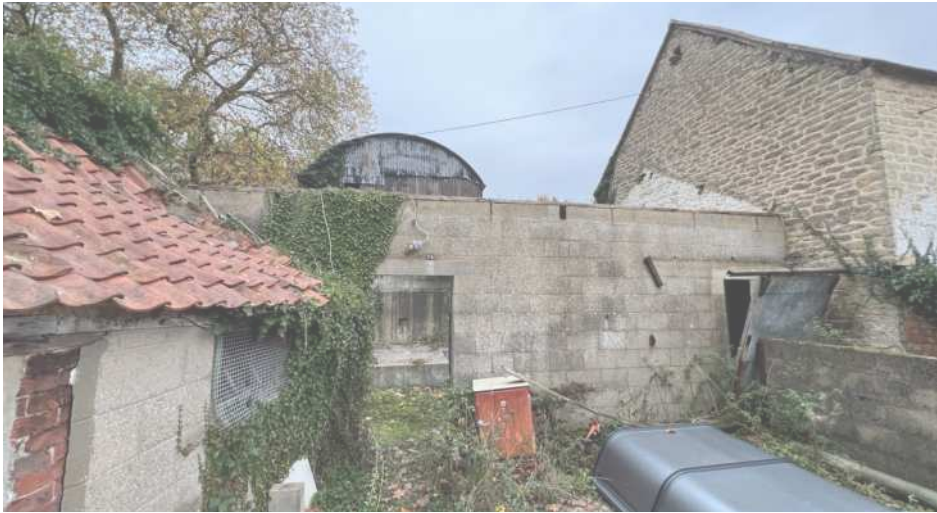
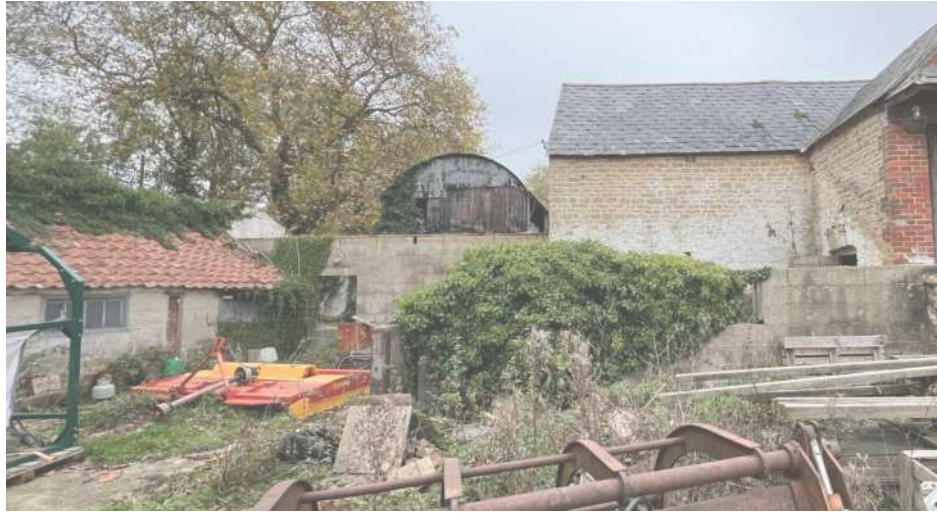
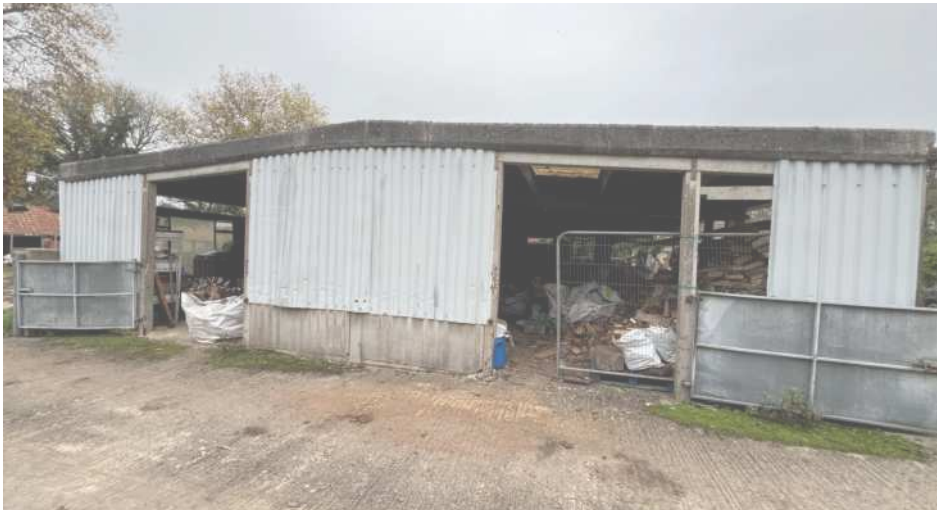
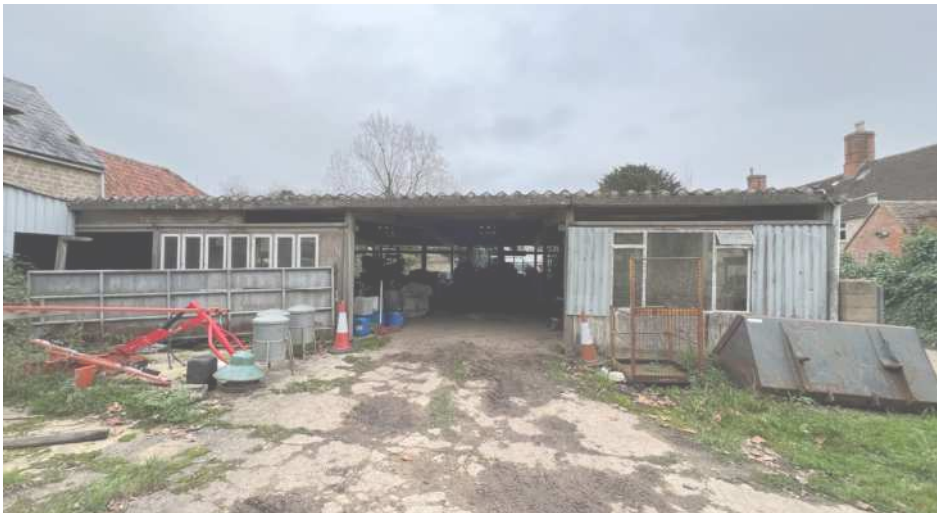
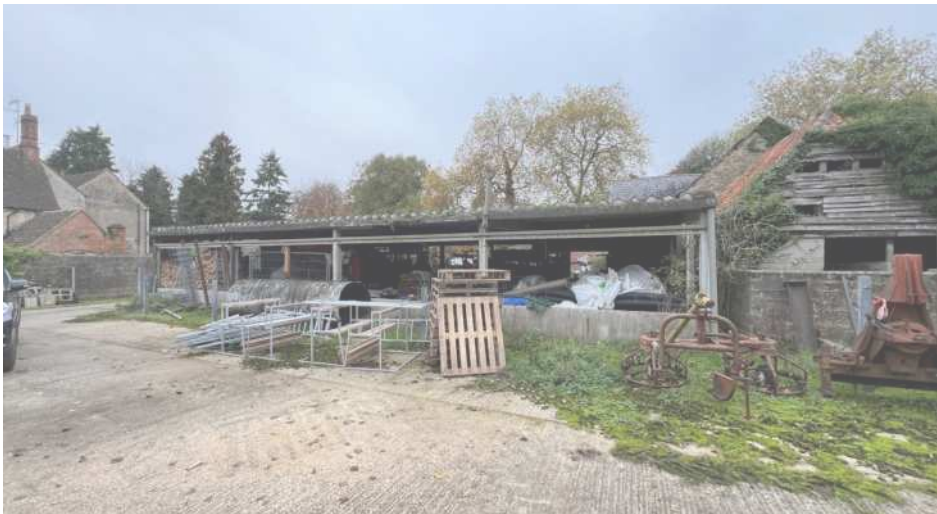
The Cow Byre building has architectural merit, particularly in its brick circular columns. However, the concrete & brickwork infill panels that have been added in front of the columns detract from their possible visual impact.

It is proposed that these infill pieces are replaced with timber boarding which will achieve a more subtle appearance, the new wall will also be located primary behind the circular columns as to enhance their hierarchy within the building character.

Further, the roof is proposed to be raised as to achieve adequate head height for the proposed accommodation within.

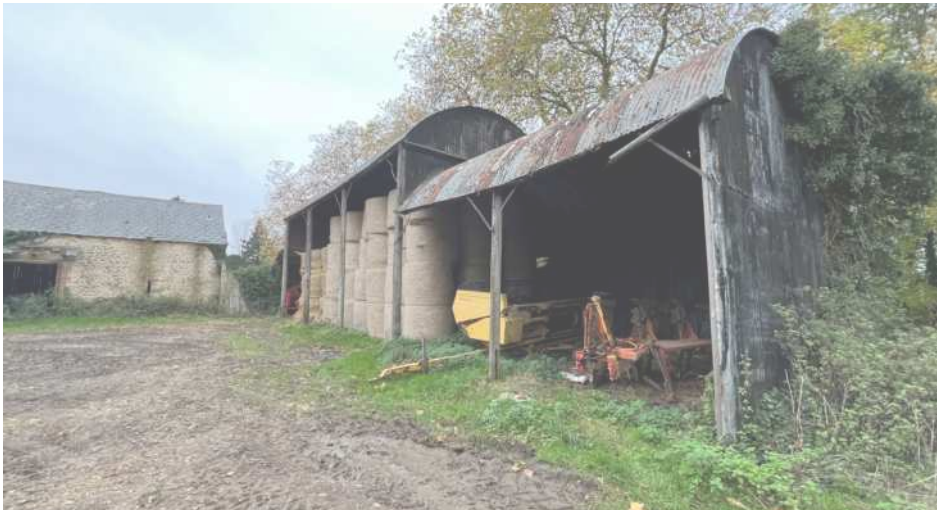
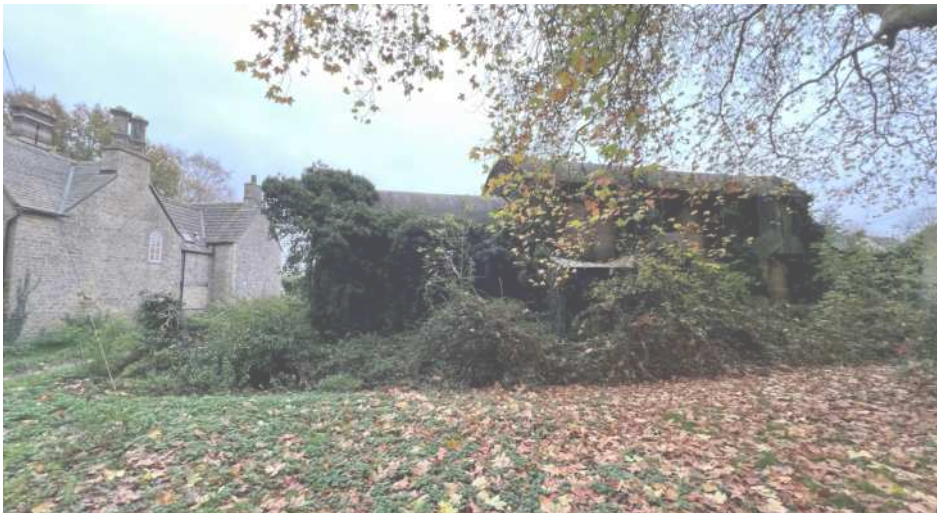
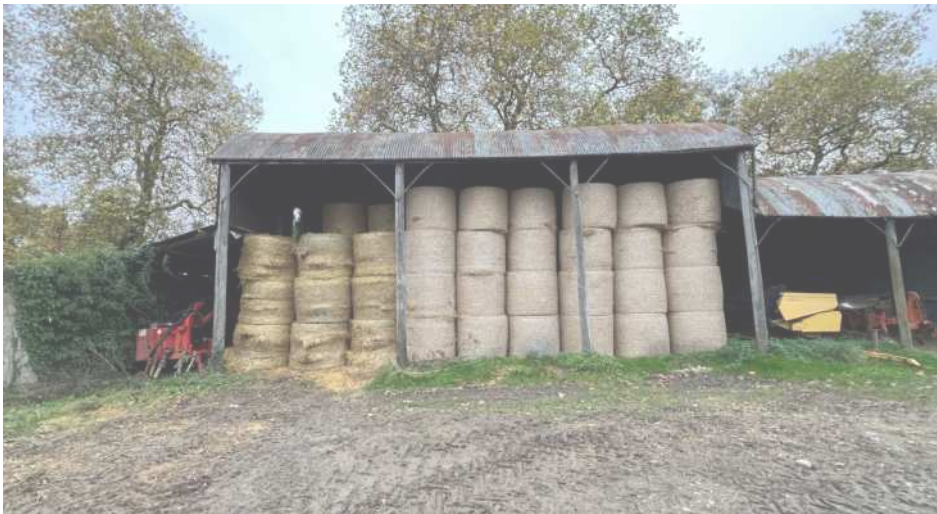
A large pole barn has an existing area of **126m<sup>2</sup>**

Located to the east of the farmyard, Barn 2 is to the rear of the main barn.

Currently the an open pole barn is used to store machinery and as a hay barn

Barn 2 obscures the view onto the main barn and is one of the later additions to the site with limited to no architectural merit

*It is therefore proposed to be demolished*

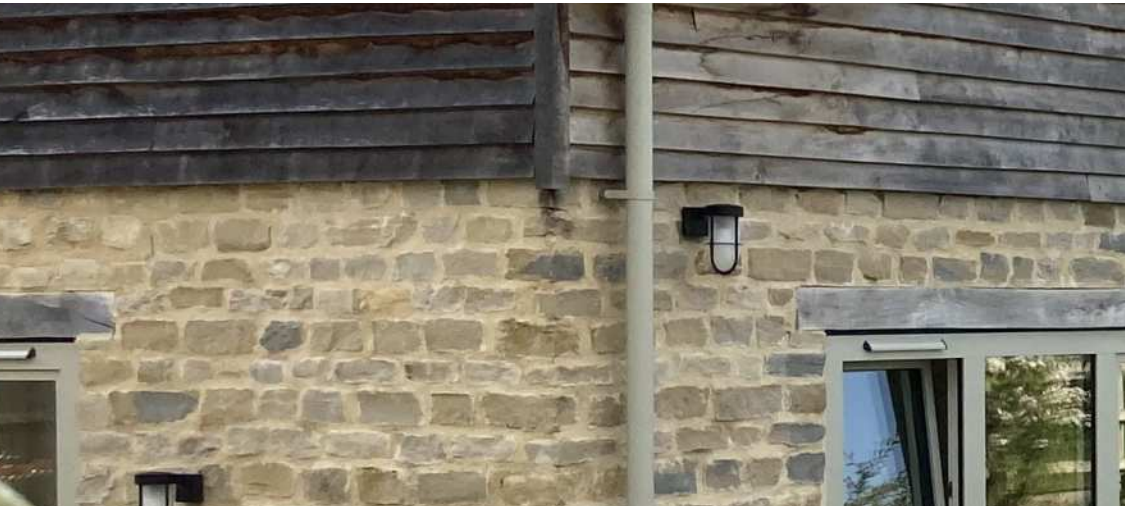
Fig.50 Example of similar proposed Material palette — Cotswold Stone—to match existing.

The proposed materials for this project have been carefully selected to complement the historic existing fabric of the buildings. We have taken into account the materials, colours, and textures of the surrounding area to ensure that the new construction is in harmony with its surroundings.

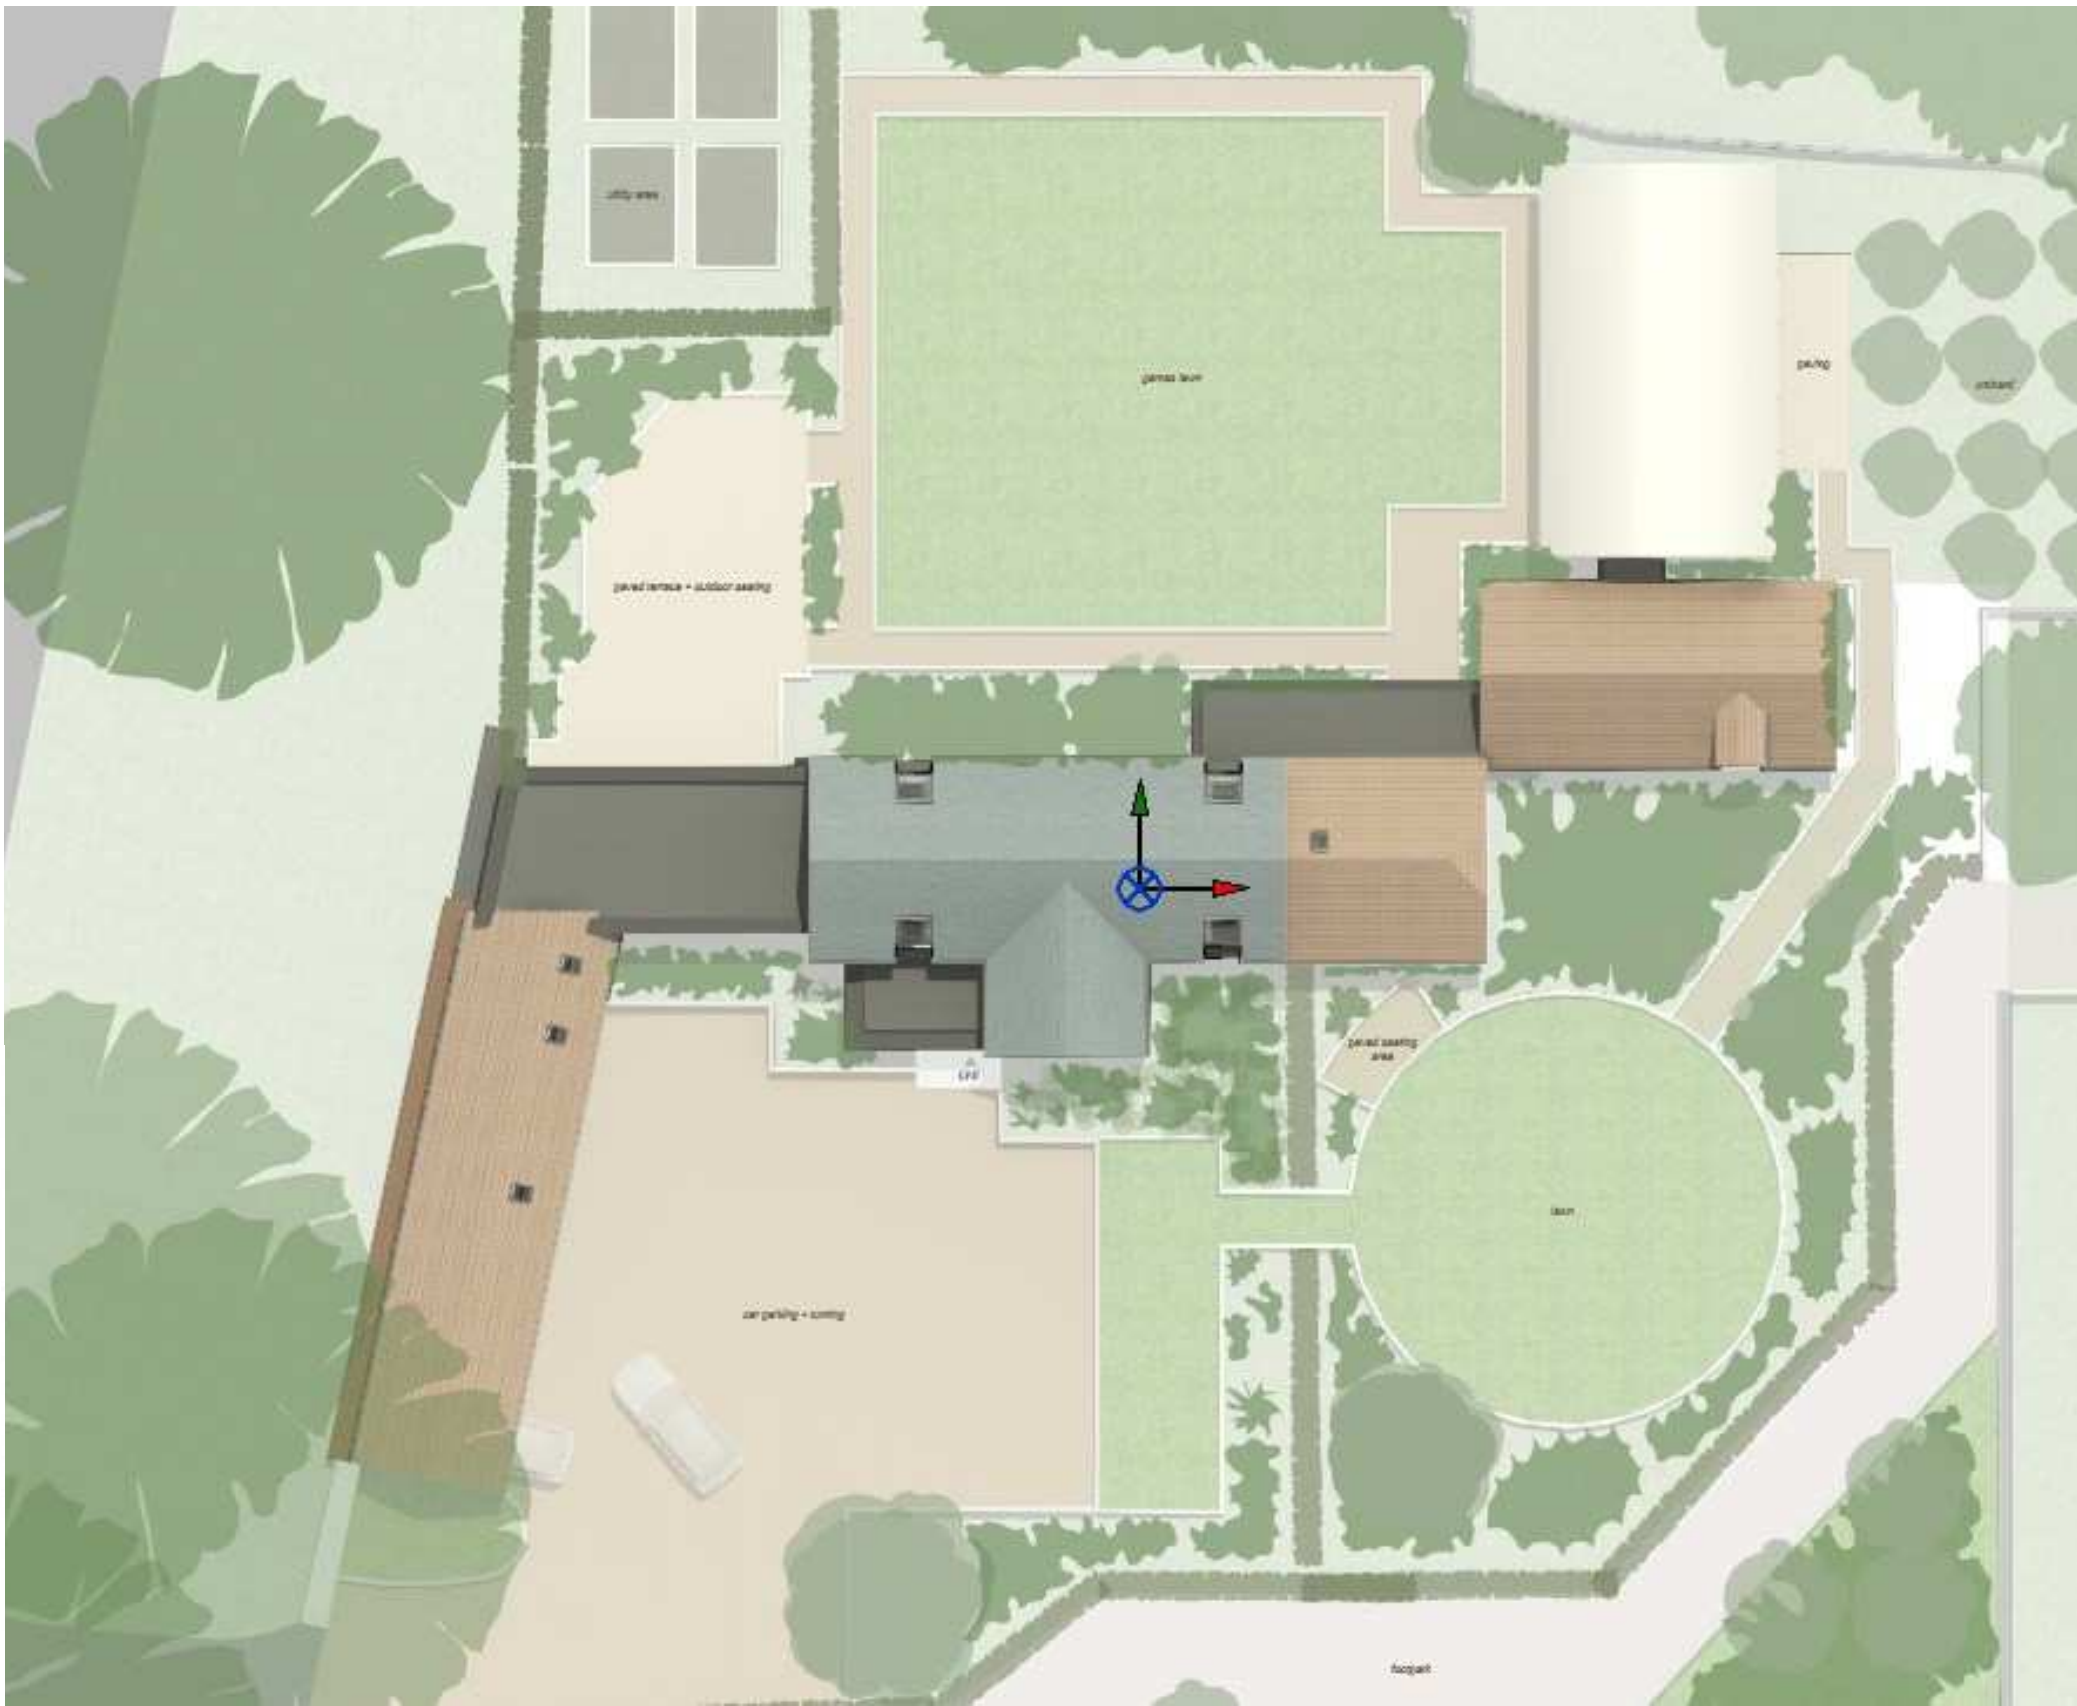
Fig.56 MWA Proposed Site Plan/ Landscaping Drawing based on Landscape Designer plan  
See submitted drawing '23041-PL106-PROPOSED SITE PLAN\_MASTERPLAN'

The proposed landscaping strategy represents a significant enhancement to the setting of the proposed new dwelling and the surrounding area. Historically, the site has been heavily industrialised, dominated by expansive areas of hardstanding and large-scale barns which created a harsh environment with limited visual or ecological value. The removal of these barns and associated structures will substantially improve the visual amenity of the site, both for future occupants and within the wider landscape context.

The introduction of this landscaping, including planting, lawned areas, and boundary hedgerows, will help to soften the visual impact and promote a more sympathetic relationship with the surrounding rural setting. These green spaces will not only provide an enhanced outlook from the dwelling itself, but also improve views into and across the site, contributing to the overall character and quality of the local landscape.

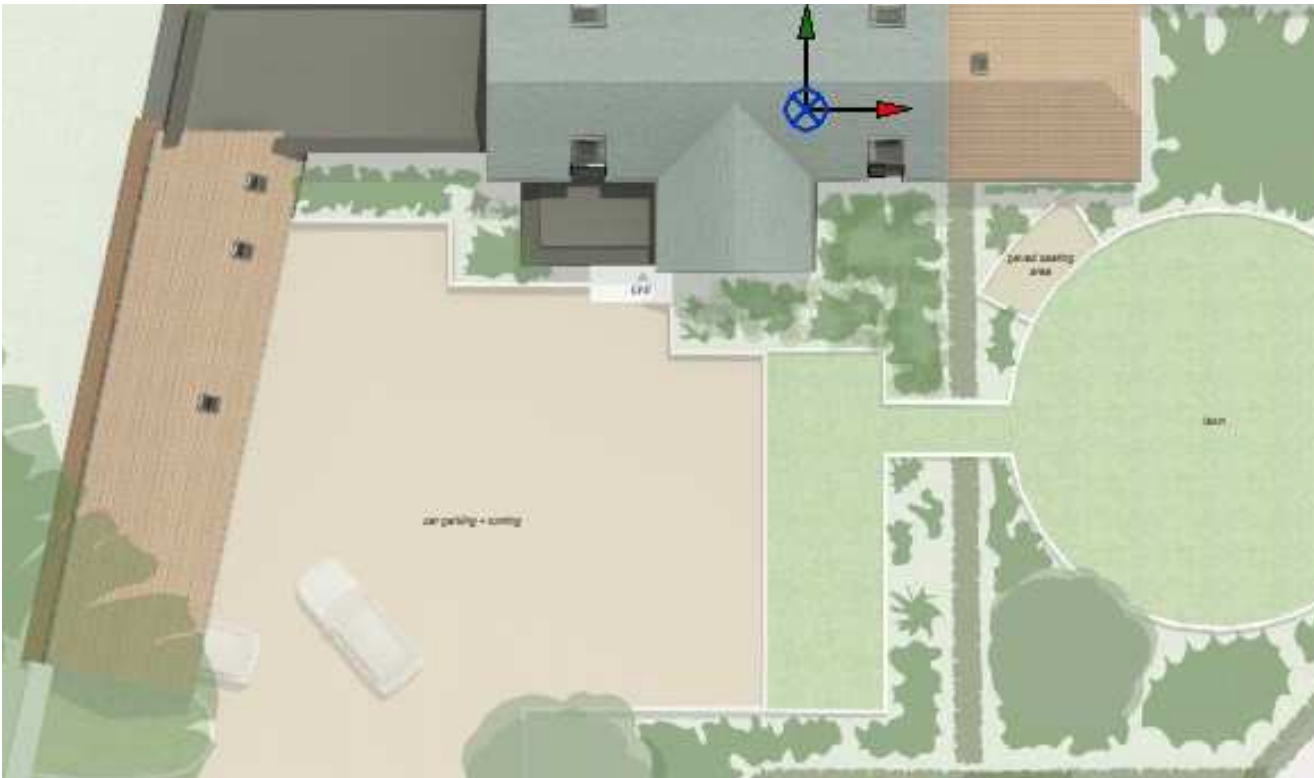
Fig.57 Proposed Site Plan—Car Barn /Car Parking / Turning Area  
See submitted drawing '23041-PL106-PROPOSED SITE PLAN\_MASTERPLAN'

Min 3no spaces have been provided to the dwelling with additional car barn garaging located within the retained circular brick pier cow byre.

Existing access to site unchanged

Storage is provided for secure long term storage of bicycles within existing cow byre

A refuse/recycling compound for refuse and recycling bins is to be provided adjacent to the kitchen entrance with collection from the existing access road.

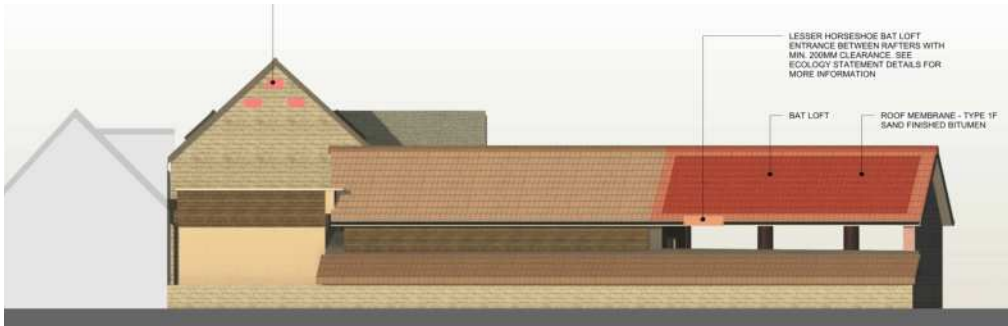
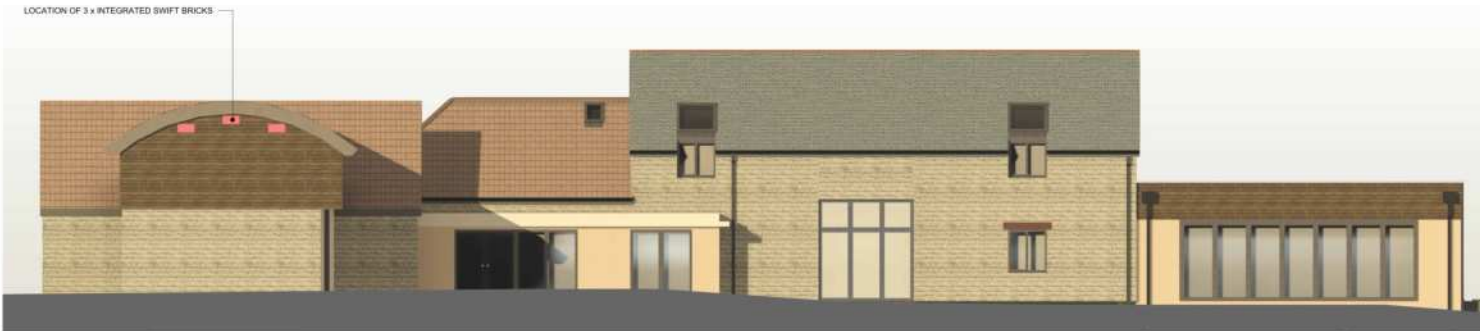
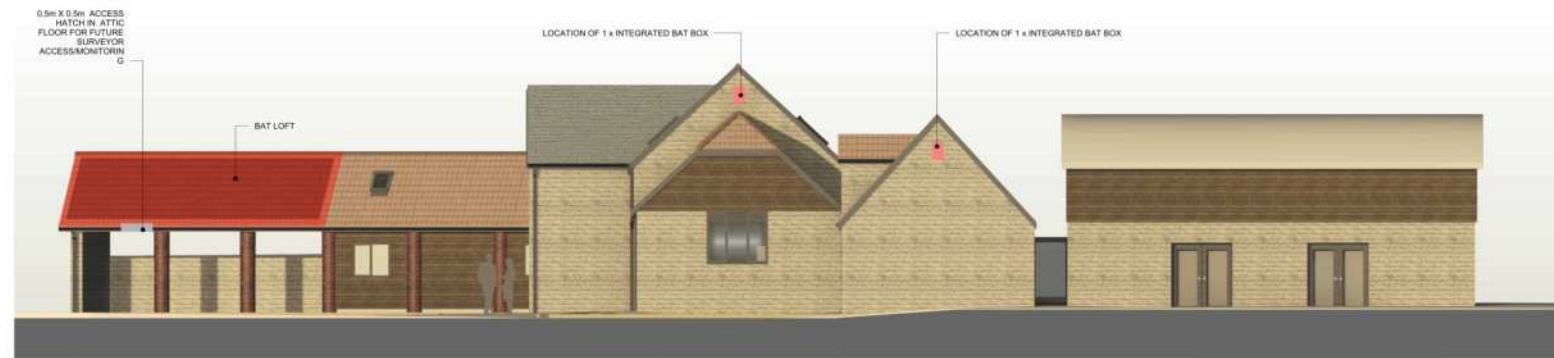
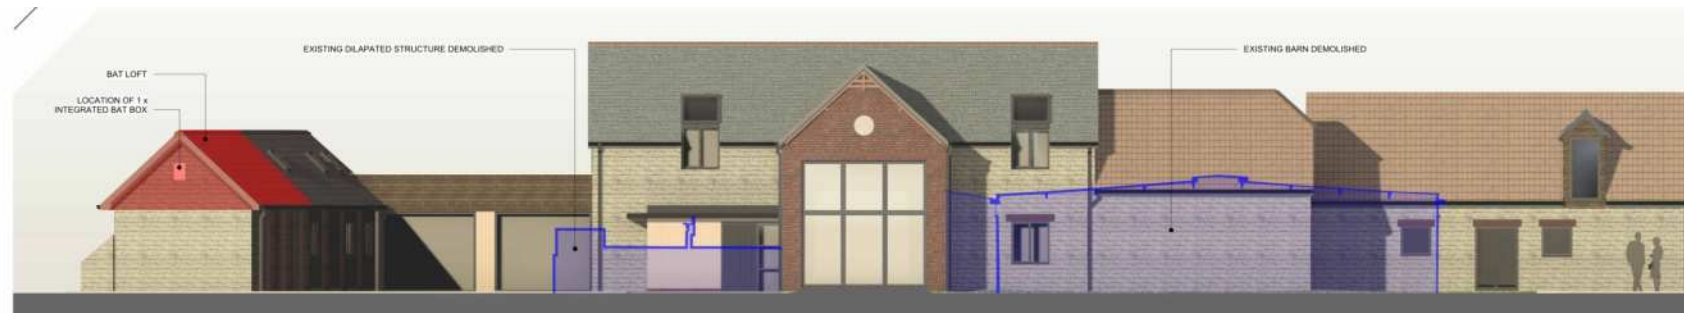
Fig.59 Proposed Elevations with Environmental Consultation Comments added  
See submitted drawing '23041-PL110-PROPOSED ELEVATIONS - ENVIRONMENTAL CONSULTATION'

As a result the cow byre that is proposed to become a partial car barn with kitchen /utility will accommodate a replacement bat loft, as per the specialist report details and specification.
