## **BAT & BIRD SURVEY & STRATEGY**

### **THE THREE MAGPIES, MEYSEY HAMPTON, WILTSHIRE**

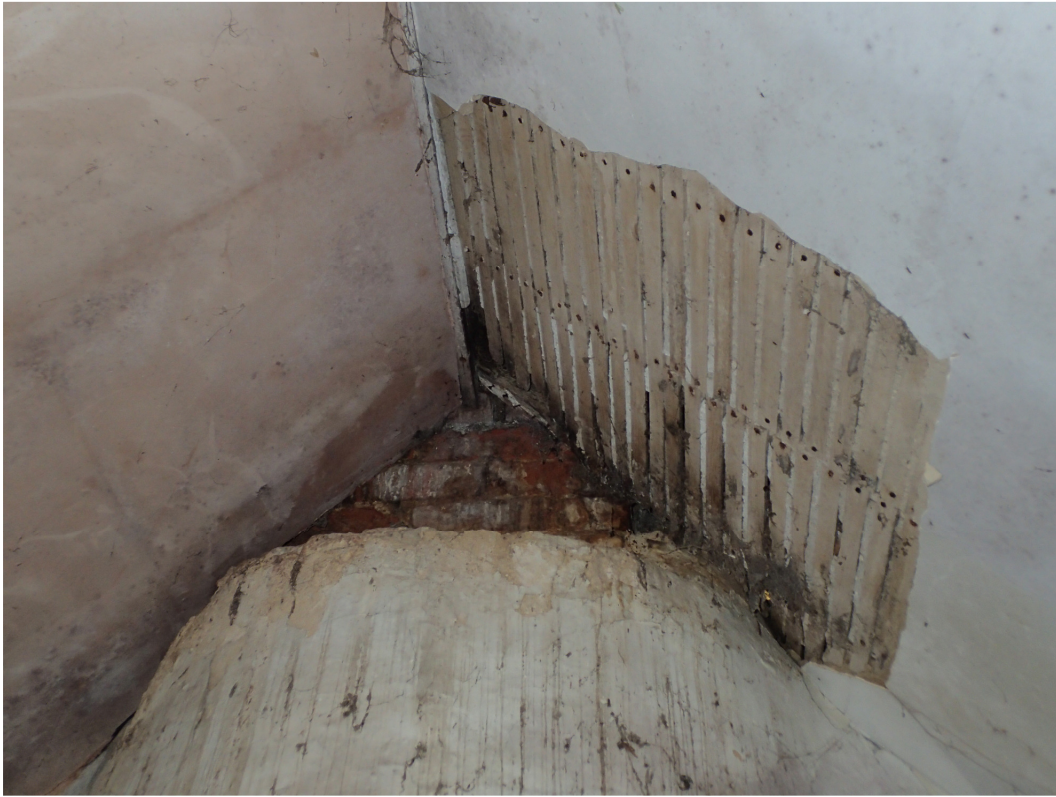
24. The stone roofs had partly collapsed at the stables end and rear of the house. Temporary repairs were in place with plastic sheeting under and tarpaulin over the holes.

27. In the loft the underside of the stone slates on battens could be seen, with pinpricks of daylight. No signs of bats were found in it, and the underside of the roof was cobwebby.

*House – loft (temporary repair visible)*

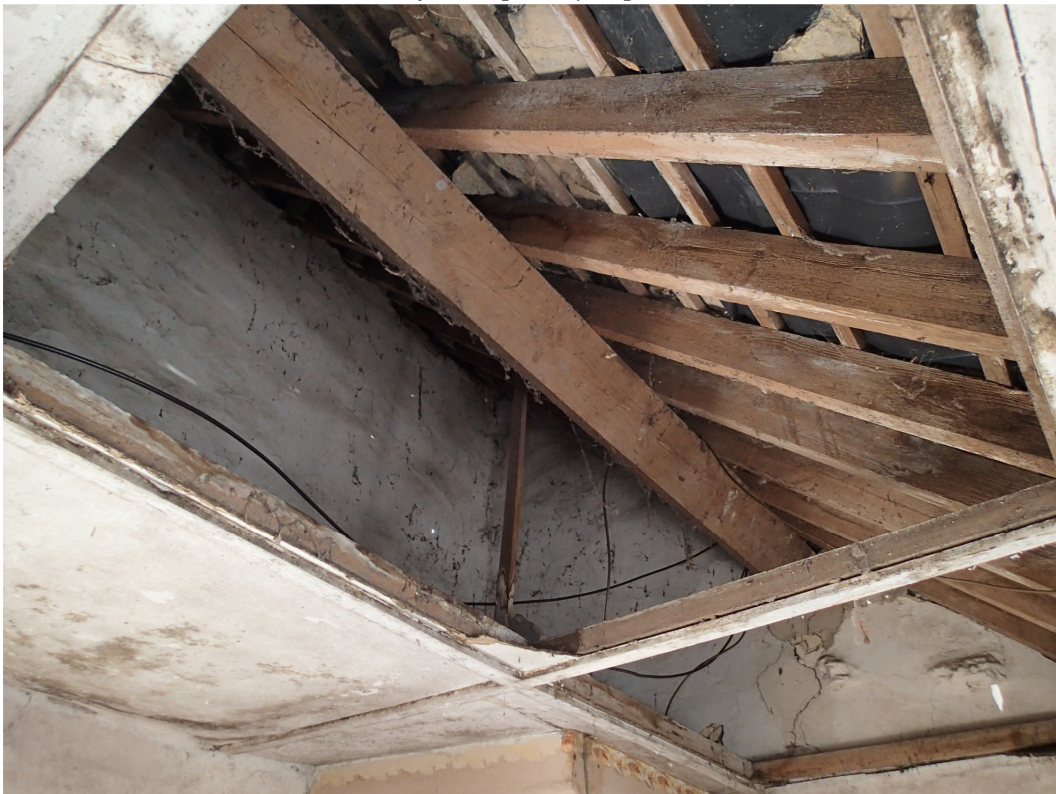
29. The stable had an open doorway, which was therefore accessible to bats as well as via holes in the roof.
30. Within the stable was a hayloft accessible from within it. The stone slates sit on battens (no felt), and the roof was partially collapsed. Roof timber joints were tight. No signs of bats were found.

*Hayloft*
