Stratford Court &  
Braemar Lodge,  
Stratford Road,  
Salisbury

## Ecological Briefing Note

Report Number: 11294\_R01d\_IS\_MM

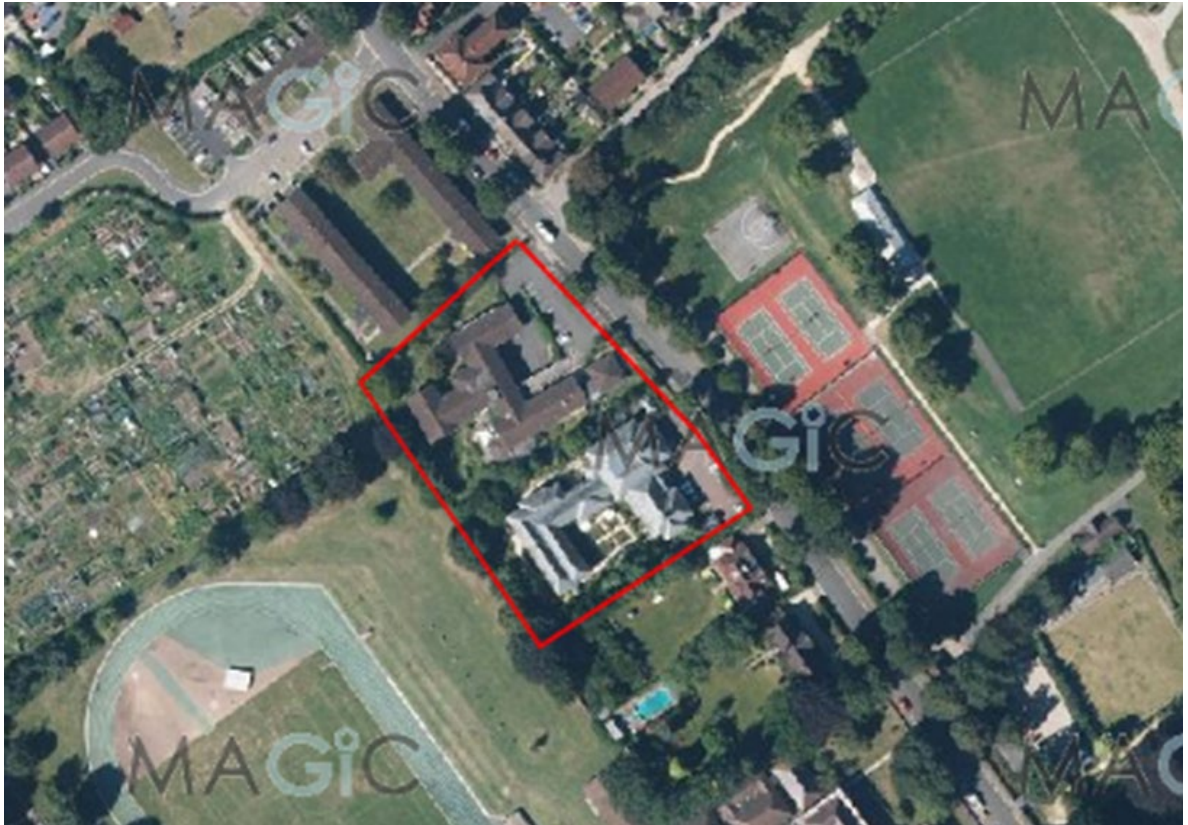
- A2.2 The site habitats are shown on **Figure 2.2**; described alphabetically below.

**Figure 2.2: Aerial image of the site habitats, with red line boundary (Magic; accessed 25.03.2019).**

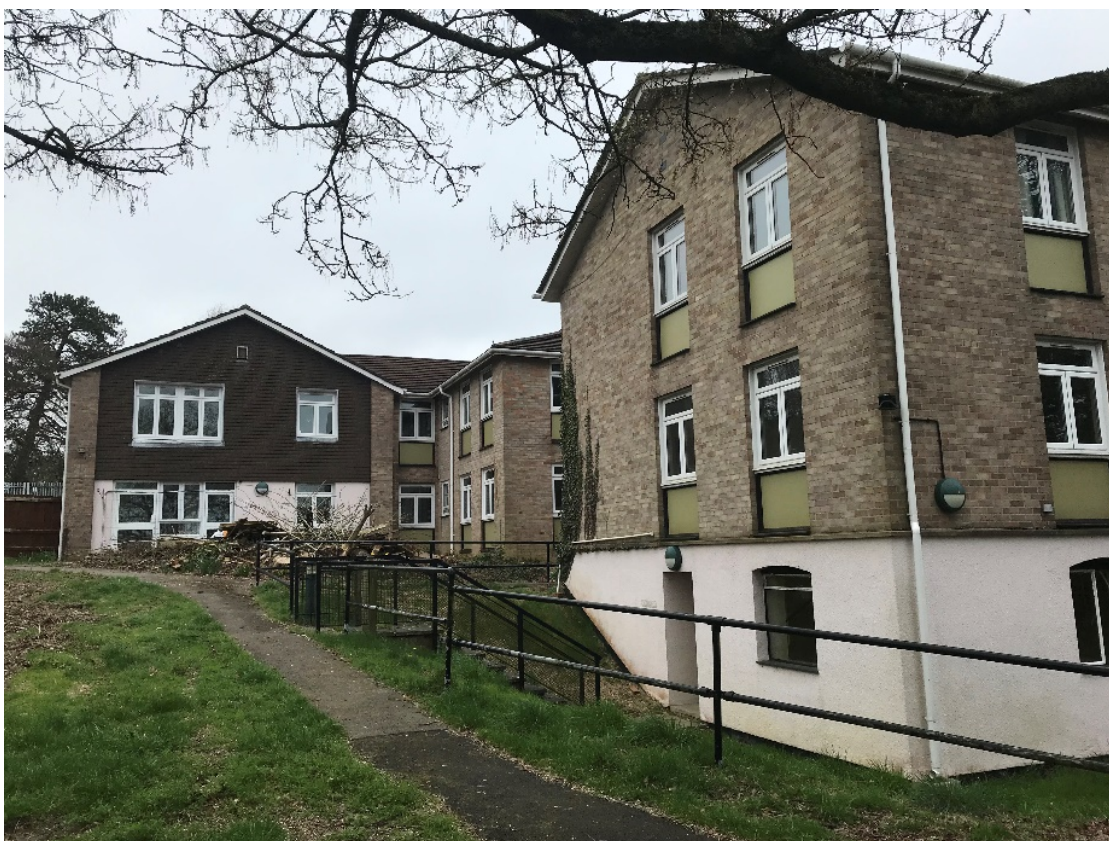
- A2.4 Stratford Court, B1 (Photograph 1 – 4) is a disused former care home building, built in c. 1970s. B1 is constructed of brick; with hipped and pitched roofs, plastic and wooden soffits/fascias, and some lead flashing. The roofs are covered with concrete pantiles in fairly good condition, with a few gaps underneath where the tiles are damaged or missing. Occasional gaps are present under ridge tiles where the mortar has disintegrated (Photograph 4). A few holes are present within the wooden soffits (Photograph 5). Hanging tiles are present at the north-west aspect of the north wing and the south aspect of the south-east wing, with lead flashing at the window (Photograph 1 and 3). Windows and doors are in good condition and are kept shut.

***Photograph 1: B1; north and west wing; north-west aspect; view from the western site corner.***

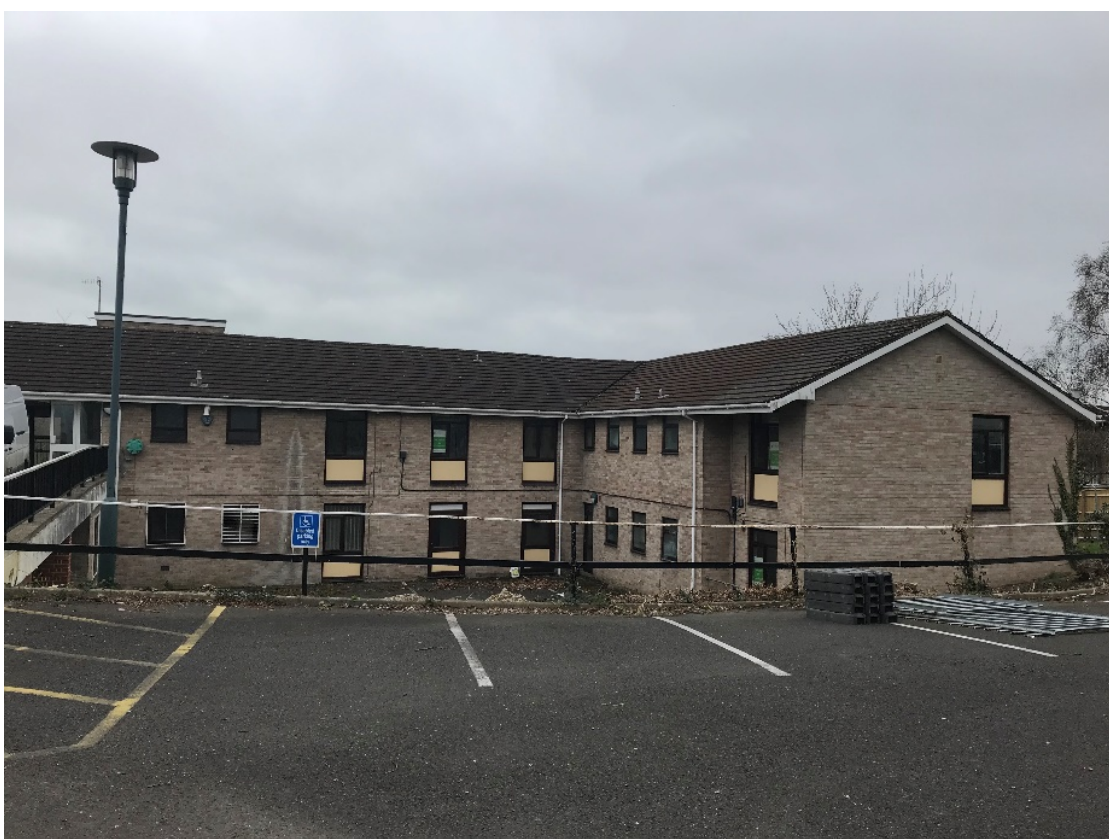
***Photograph 2: B1; north wing; north-east aspect; view from the northern site corner.***

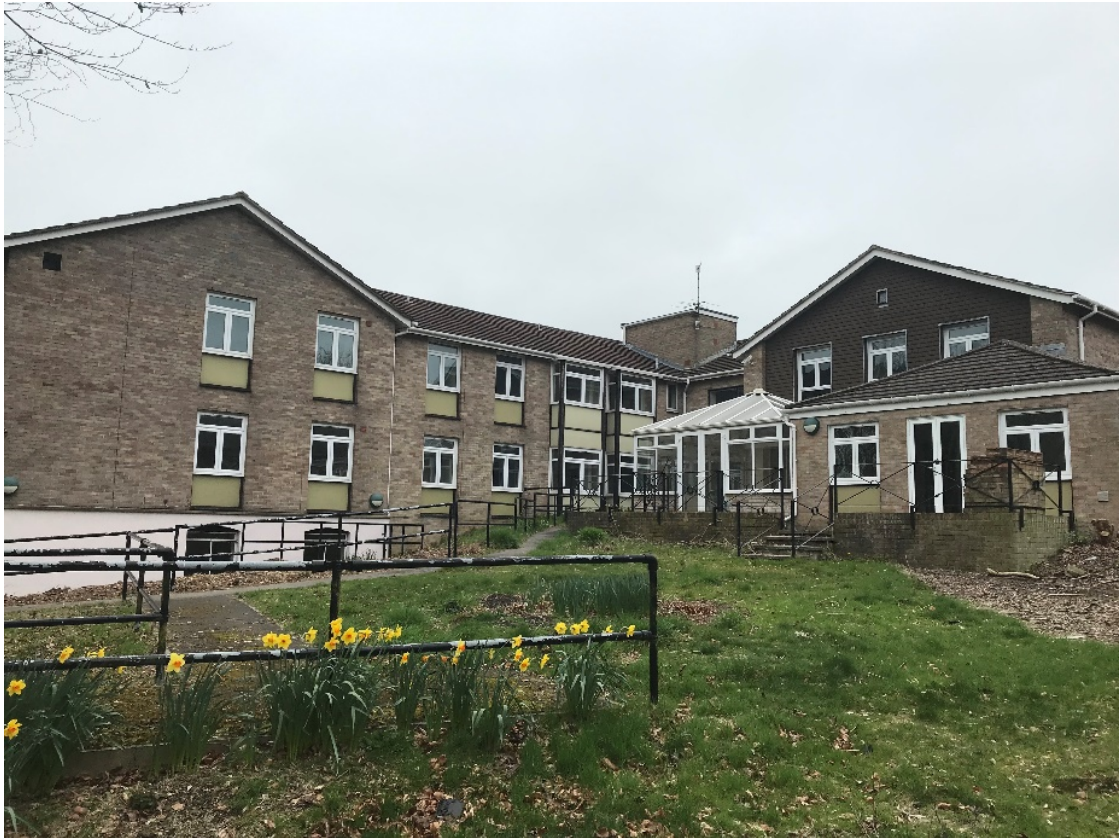
**Photograph 3: B1; west and south-east wing; south aspect; view from the southern site corner.**

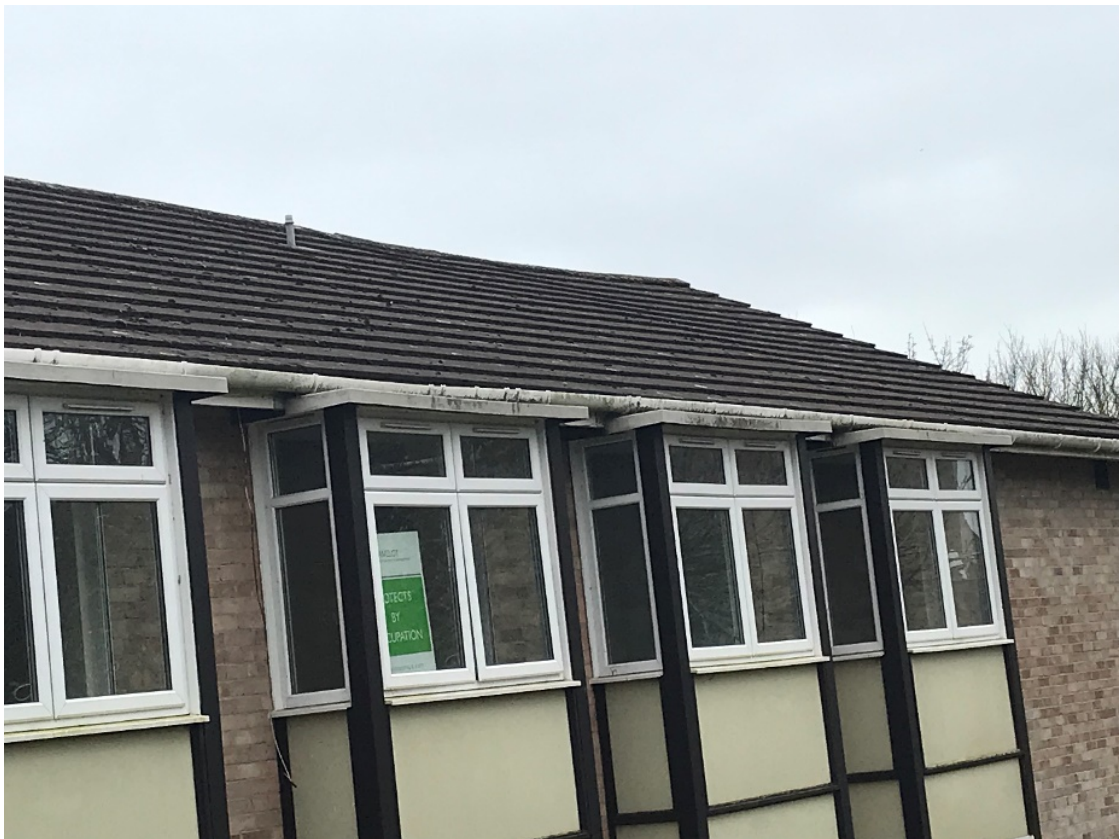
- Stratford Court was assessed to have **low bat potential** due to the presence of a few lifting tiles/lead flashing (these may lead to batten spaces between the tiles and hessian roofing felt), occasional gaps between bricks, and gaps/holes at the wooden soffits.

**Photograph 4: B1; south-east wing; north-west aspect; view from the north. Gap under the end ridge tile visible.**

- As bats are highly mobile species that frequently switch roosts, therefore, as a precaution, potential roost features (PRF) should be dismantled by hand under a Precautionary Working Method Statement (PWMS); supervised by a licensed bat worker (LBW). LBW will deliver a toolbox talk to contractors prior to work starting. If a bat is found during PWMS works, work will stop, the ecologist will contact NE for advice and obtain an EPS licence if required.
- In order to make the PWMS effective, one night-time survey prior to work start is required to assess bat activity levels at the site. The night time survey could be carried out during the planning application determination period. If roosting bats are identified, a NE EPS licence will be required.

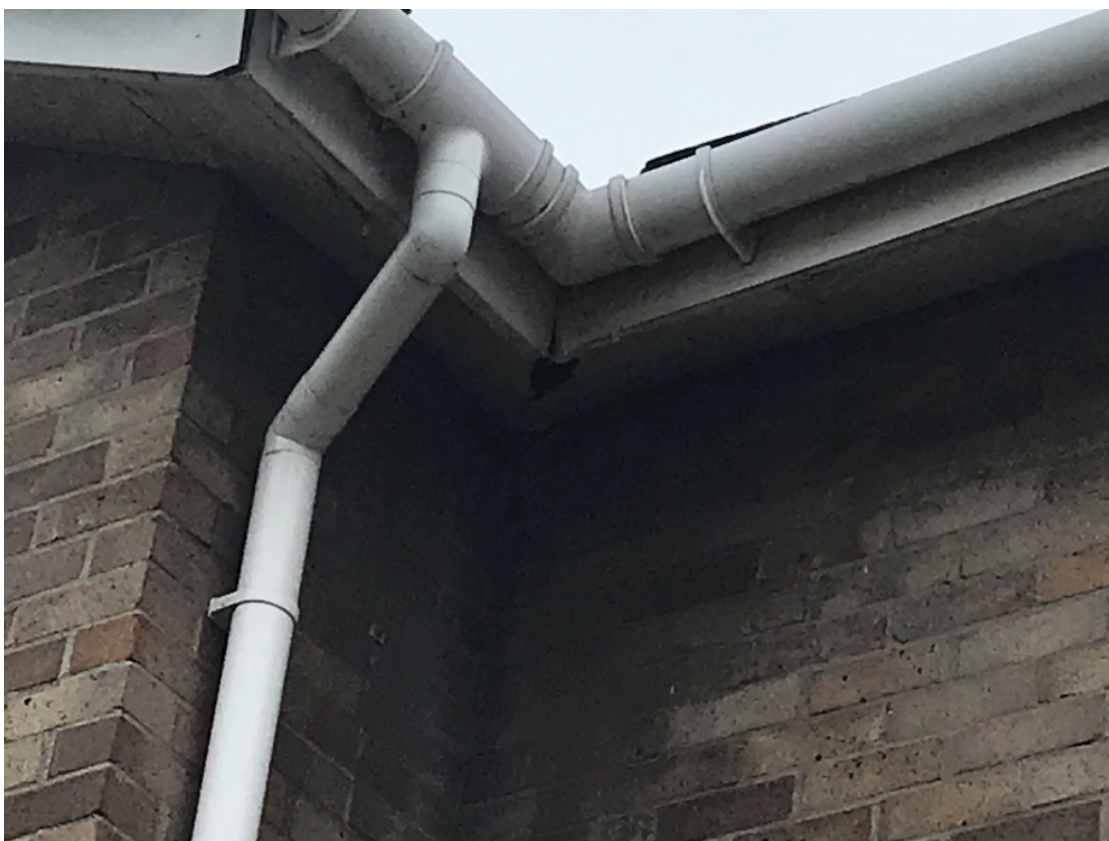
**Photograph 5: B1; west wing; south-west aspect. Hole in the soffit visible.**

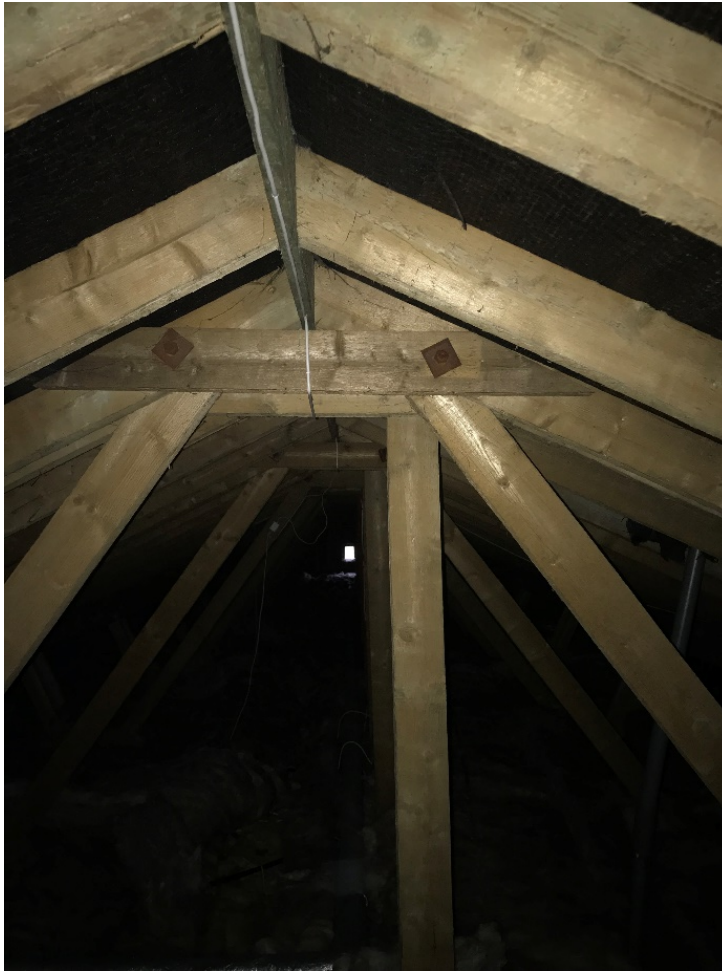
- A2.5 Loft spaces exist within the roof void. The loft void in the south-east wing is accessible via a service hatch, with partial access only possible due to the presence of false ceiling and the loft void being covered by fibreglass insulation. No access was possible into the north and west wing loft voids.
- A2.6 The south-east loft void has ventilation slots at the north-east and south-west gables. Hessian roofing felt in good condition is present, with wooden rafters, ridge board, collar beams, hangers, and supporting beams (Photograph 6).

***Photograph 6: B1; south-east wing loft void.***

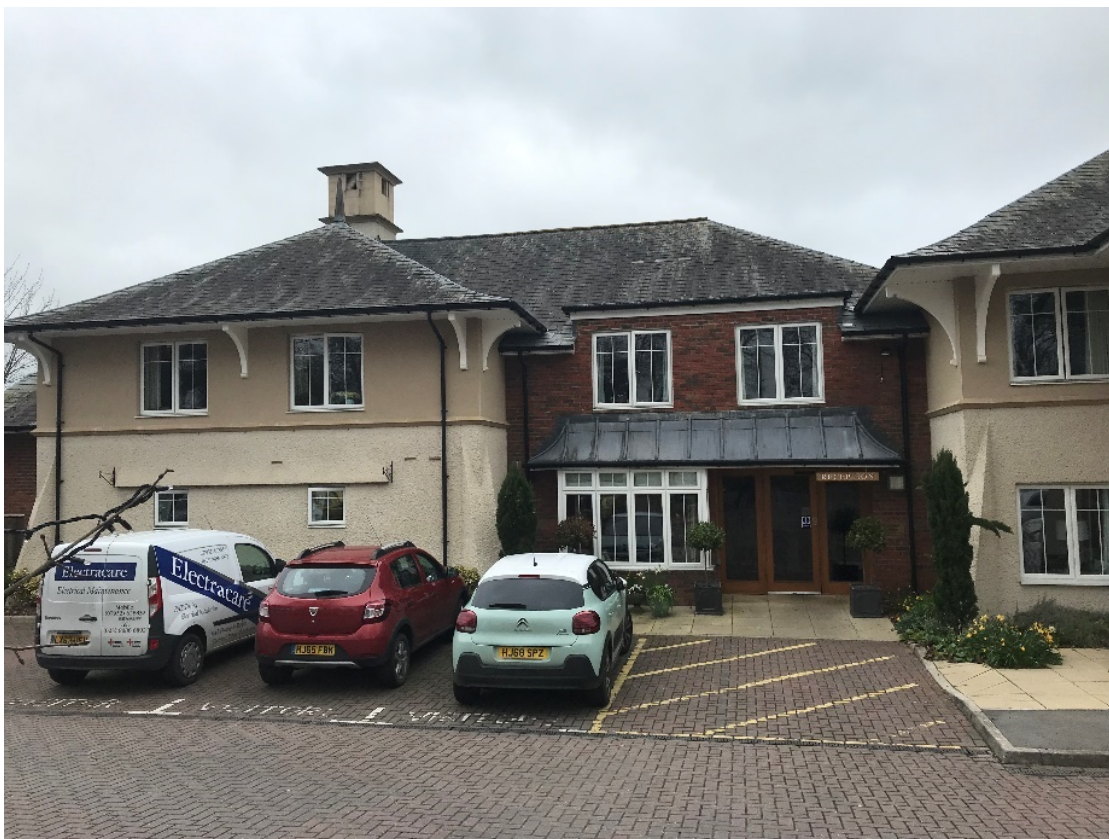
- A2.8 Braemar Lodge, B2 (Photograph 7 and 8) is a current care home. It is constructed of brick; rendered on some aspects and is well maintained.

**Photograph 7: B2; south-east wing, north-east aspect. View from north-east.**

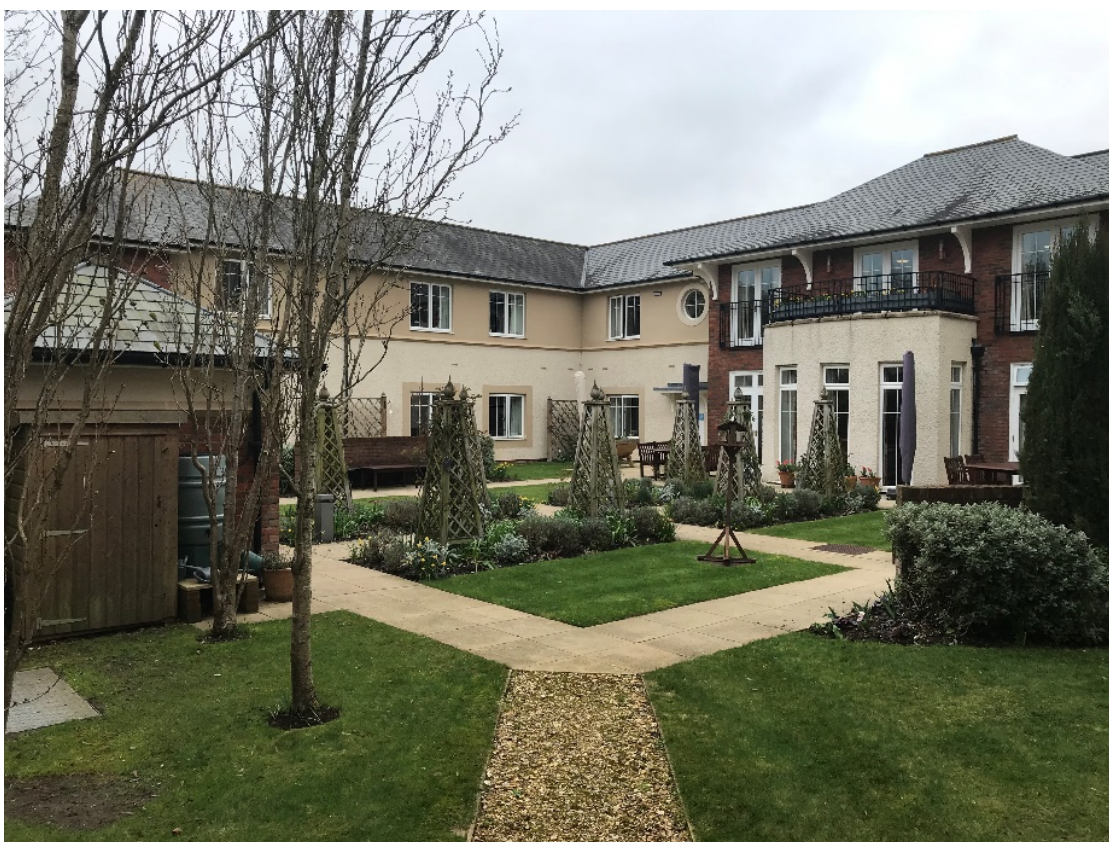
**Photograph 8: B2; courtyard between south-west, north, and south-east wing. View from south.**

A2.9 B2 roof is covered in well-sealed slate tiles in good condition. Two loft voids are present, both with a cluttered truss roof construction. The north wing loft void houses the boiler tanks.

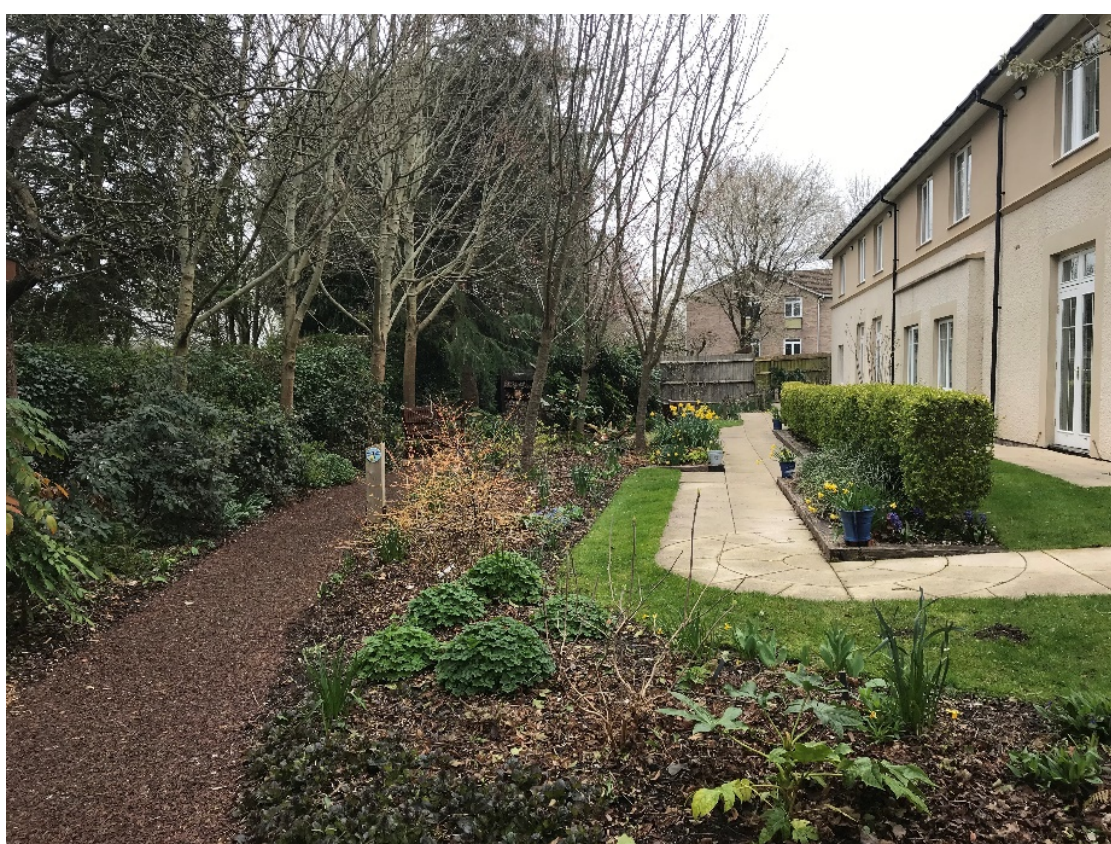
A2.11 Areas of amenity grassland, ornamental vegetation and shrubs are scattered around B1 and B2. A tree line with shrubs forms the south-west boundary (Photograph 9) comprised of beech *Fagus sylvaticus*, maple *Acer* sp., conifers, sycamore *Acer pseudoplatanus*, wild privet *Ligustrum vulgare* and ornamental species. Young birch *Betula* sp., cherry *Prunus* sp. trees with shrubs/ornamentals are situated at the woodland walk almond the south-east and south-west boundary of B2, and also form the boundary between B1 and B2. Bird boxes are installed at the woodland walk, as well as homes for insects, hedgehogs, and amphibians. Compost piles are present.

**Photograph 9: Woodland walk (B2's south-west boundary), with a boundary tree line, scattered trees/shrubs and wildlife enhancement features.**

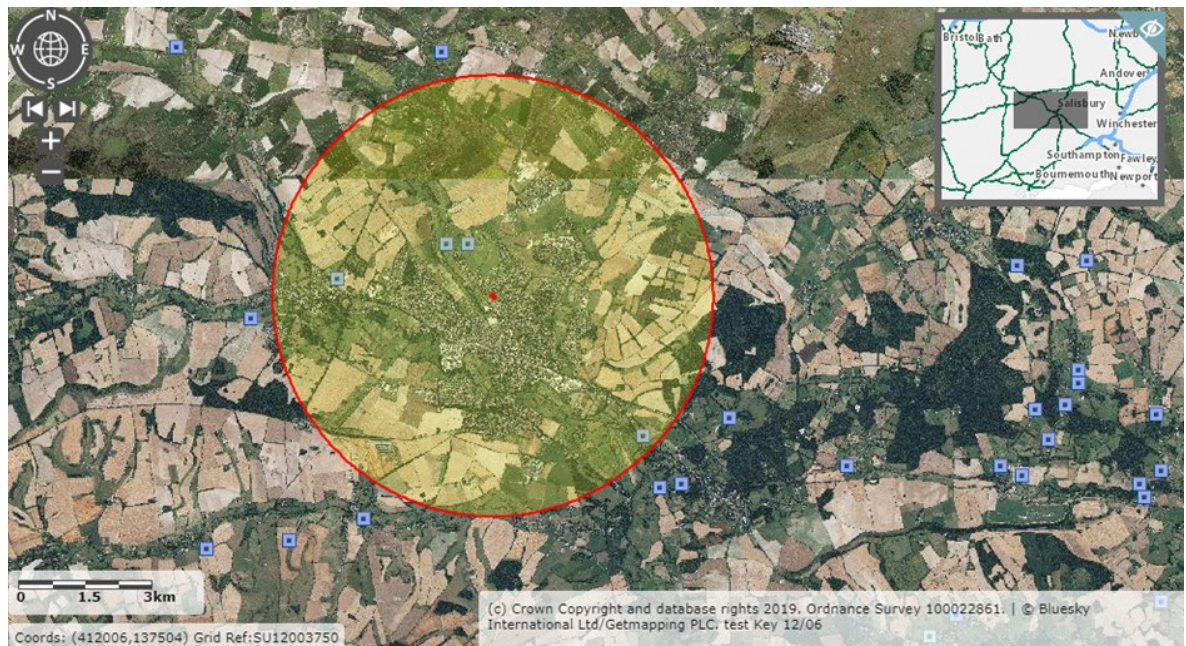
**Figure 3.1: NE EPS bat licences issued within a 5km radius of the site (Magic; accessed 25.03.2019)**

A3.1. NE Magic website shows several NE EPS bat licences (**Figure 3.1** below) issued within a 5km radius of the site:

- 1.2km north-west, licence EPSM2011 – 3675, issued for brown long-eared bat. Licence allows the destruction of a resting place; valid between 18/11/2011 and 30/09/2013;
- 1.5km north-west, licence EPSM2010 – 2618, issued for common pipistrelle, soprano pipistrelle, serotine bat, brown long-eared bat, Natterer's bat. Licence allows the destruction of a resting place; valid between 04/07/2011 and 30/09/2014;
- 3.5km west, licence 2014-4895-EPS-MIT, issued for brown long-eared bat, common pipistrelle, soprano pipistrelle. Licence impacts on and allows the destruction of a breeding site; valid between 03/04/2014 and 01/11/2017; and
- 4.6km south-east, licence 2016-25790-EPS-MIT-1, issued for brown long-eared bat, soprano pipistrelle. Licence impacts/damages breeding site and allows damage/destruction of a resting place; valid between 10/10/2017 and 31/10/2026.
