| Client | Project | WFFMAP<br>SURVEYS AND MAPPING<br>CHARTERED SURVEYORS<br>RICS<br>Edenvale Young Associates<br>30, Queen Charlotte Street,<br>Bristol, BS1 4HJ<br>for<br>Cereal Partners UK,<br>Staverton, Trowbridge,<br>BA14 6PG. | |
|---|---|---|--|
| Surveyed: DJI VM MB, SW | Appts: R. Flew | River Avon and Weston Cut Leat<br>Staverton<br>Flood Risk Analysis | |
| | | ISM-EYA-2025s2247-RAIL-X-01 | |

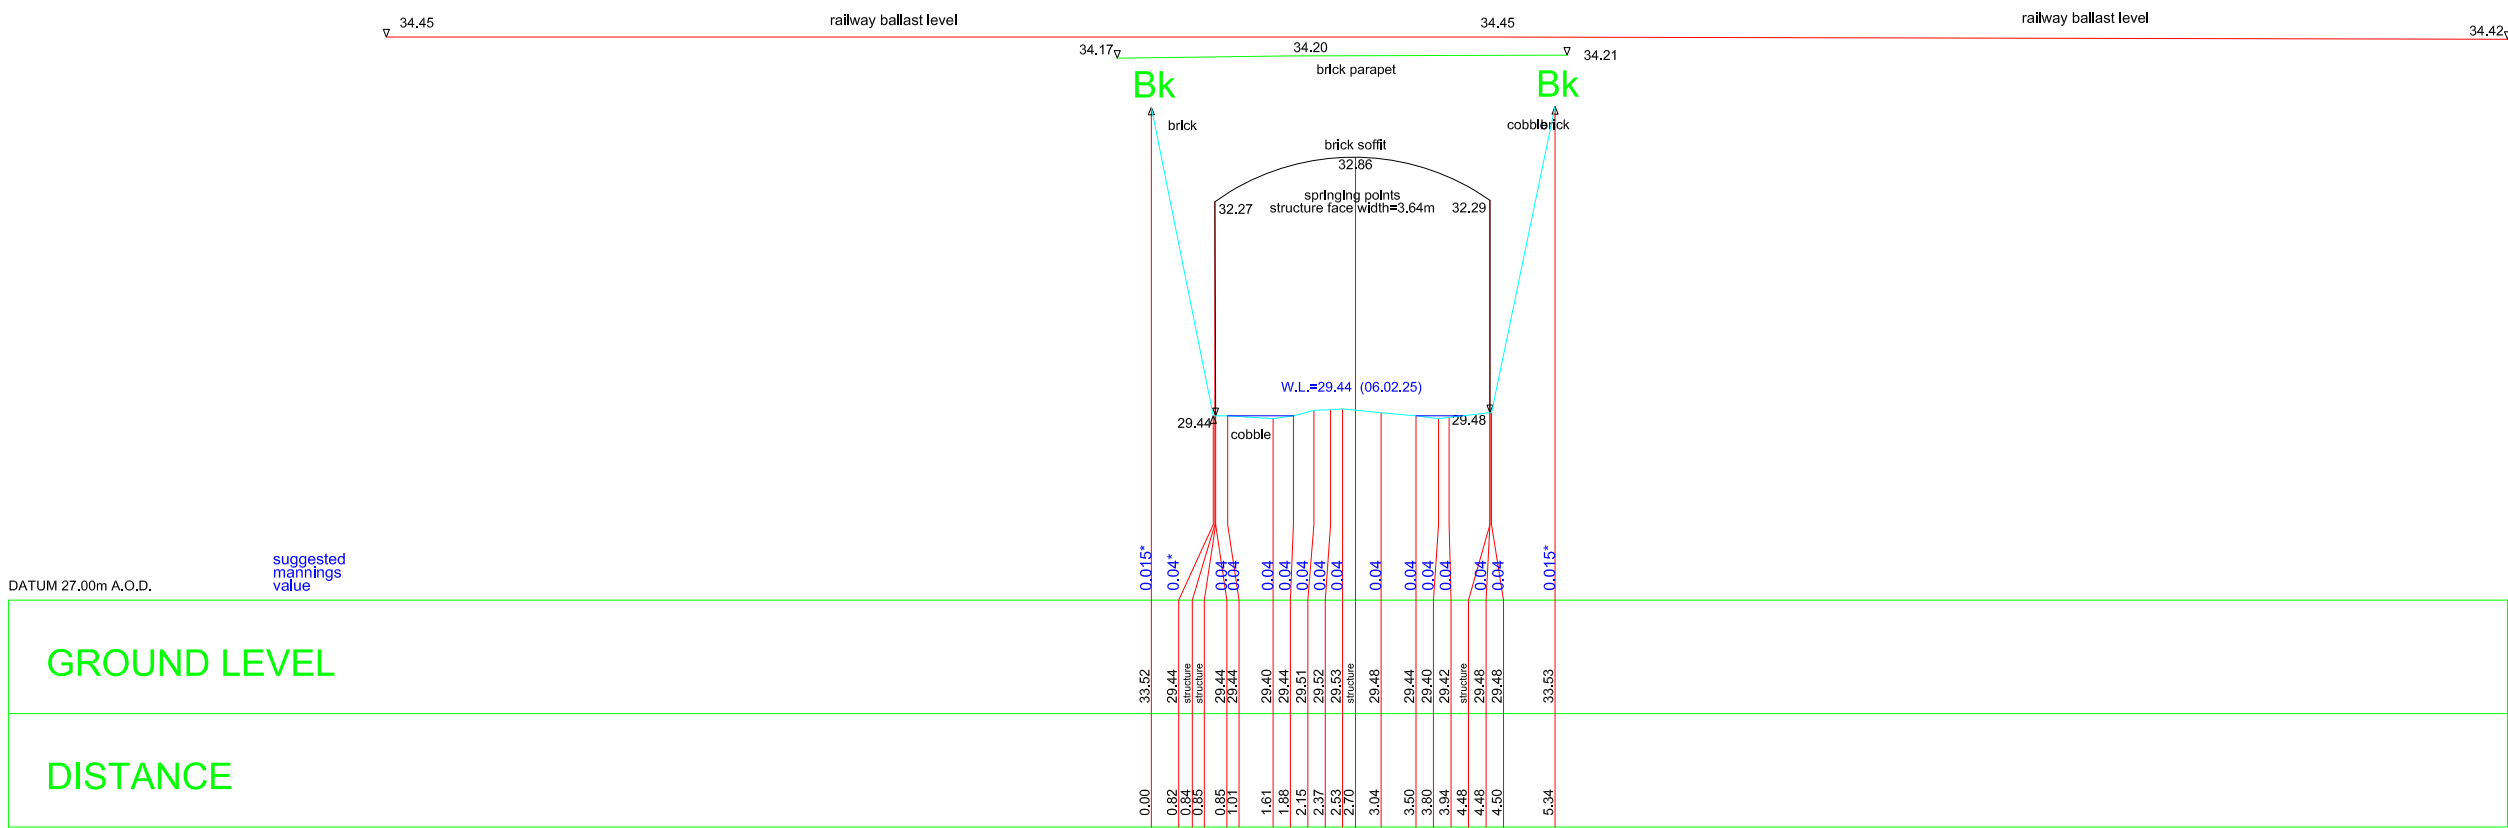
Rail Culvert 3 CS RA13.0010  
Centre OSNG Coordinates E.386245.81 N.161105.83

Structure no. 1, Railway Culvert 3  
(upstream face of structure)  
Description: Masonry Arch Culvert

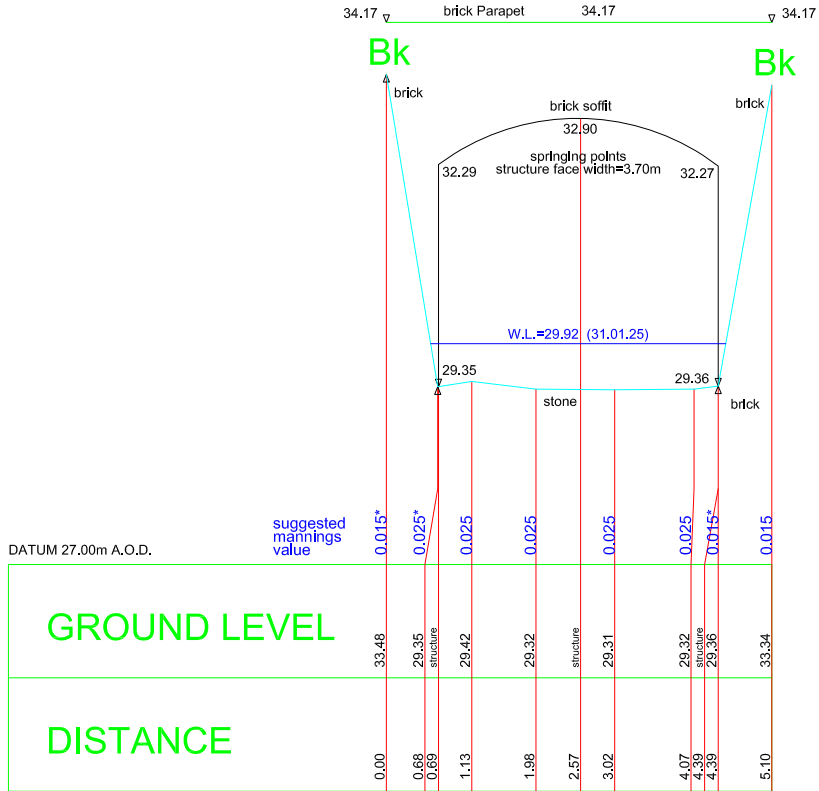
Rail Culvert 3 CS RA13.0001  
Centre OSNG Coordinates E.386251.03 N.161098.00

Structure no. 1, Railway Culvert 3  
(downstream face of structure)  
Description: Masonry Arch Culvert  
Structure Length = 9.40m

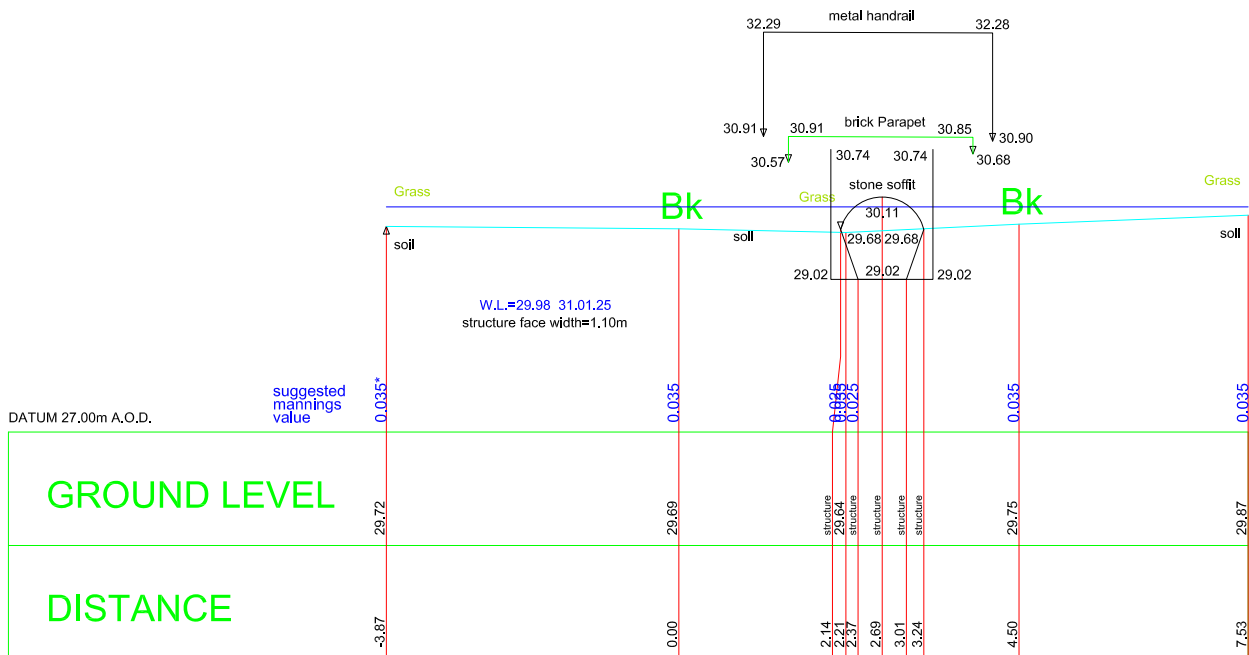
Rail Culvert 2 CS RA12.0002  
Centre OSNG Coordinates E.386419.55 N.161181.93

Structure no. 1, Railway Culvert 2  
(downstream face of structure)  
Description: Masonry Culvert

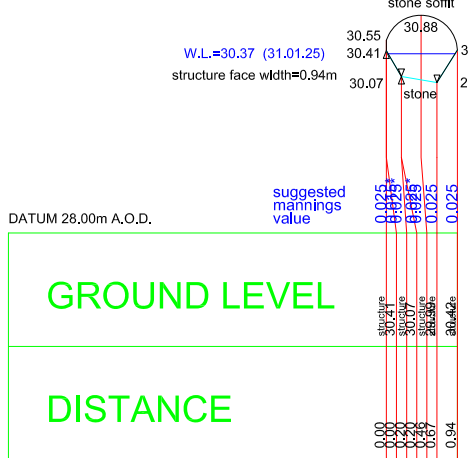
Rail Culvert 1 CS RA11.0021  
Centre OSNG Coordinates E.386733.91 N.161363.84

Structure no. 1, B3105 Culvert 1  
(upstream face of structure)  
Description: Masonry Arch Culvert  
Note: No access inside railway fence - Underwater observations approx  
Interital GNSS Unit Used

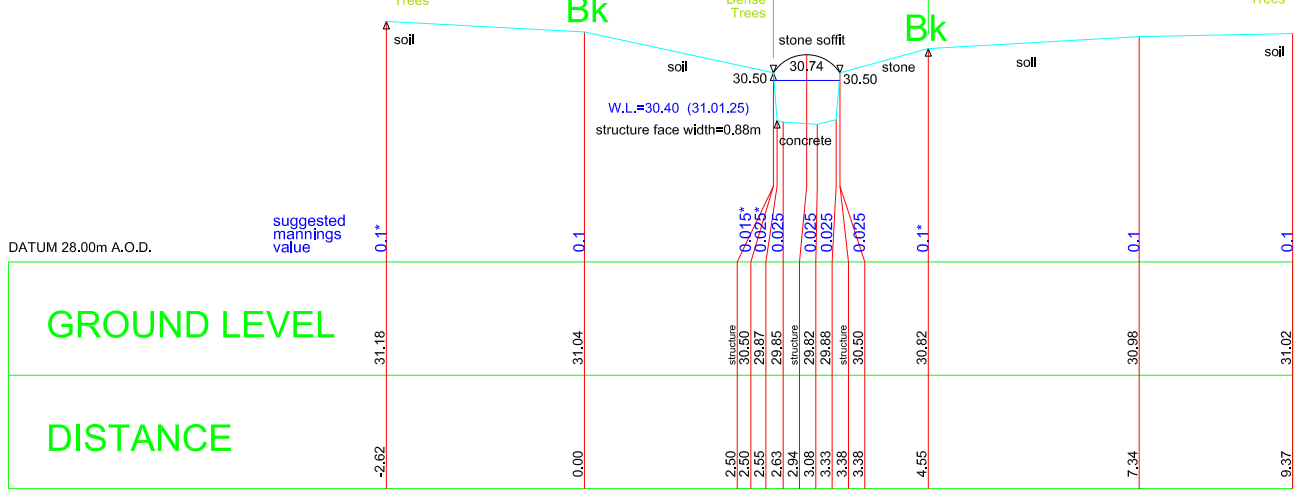
Rail Culvert 1 CS RA11.0001  
Centre OSNG Coordinates E.386744.00 N.161346.44

Structure no. 1, B3105 Culvert 1  
(downstream face of structure)  
Description: Masonry Arch Culvert  
Structure Length = 21000m
