## GROUND INVESTIGATION REPORT

Fives Court, Mere, Wiltshire

Report No: PO-22-039

**Project Name : Proposed Residential Development**

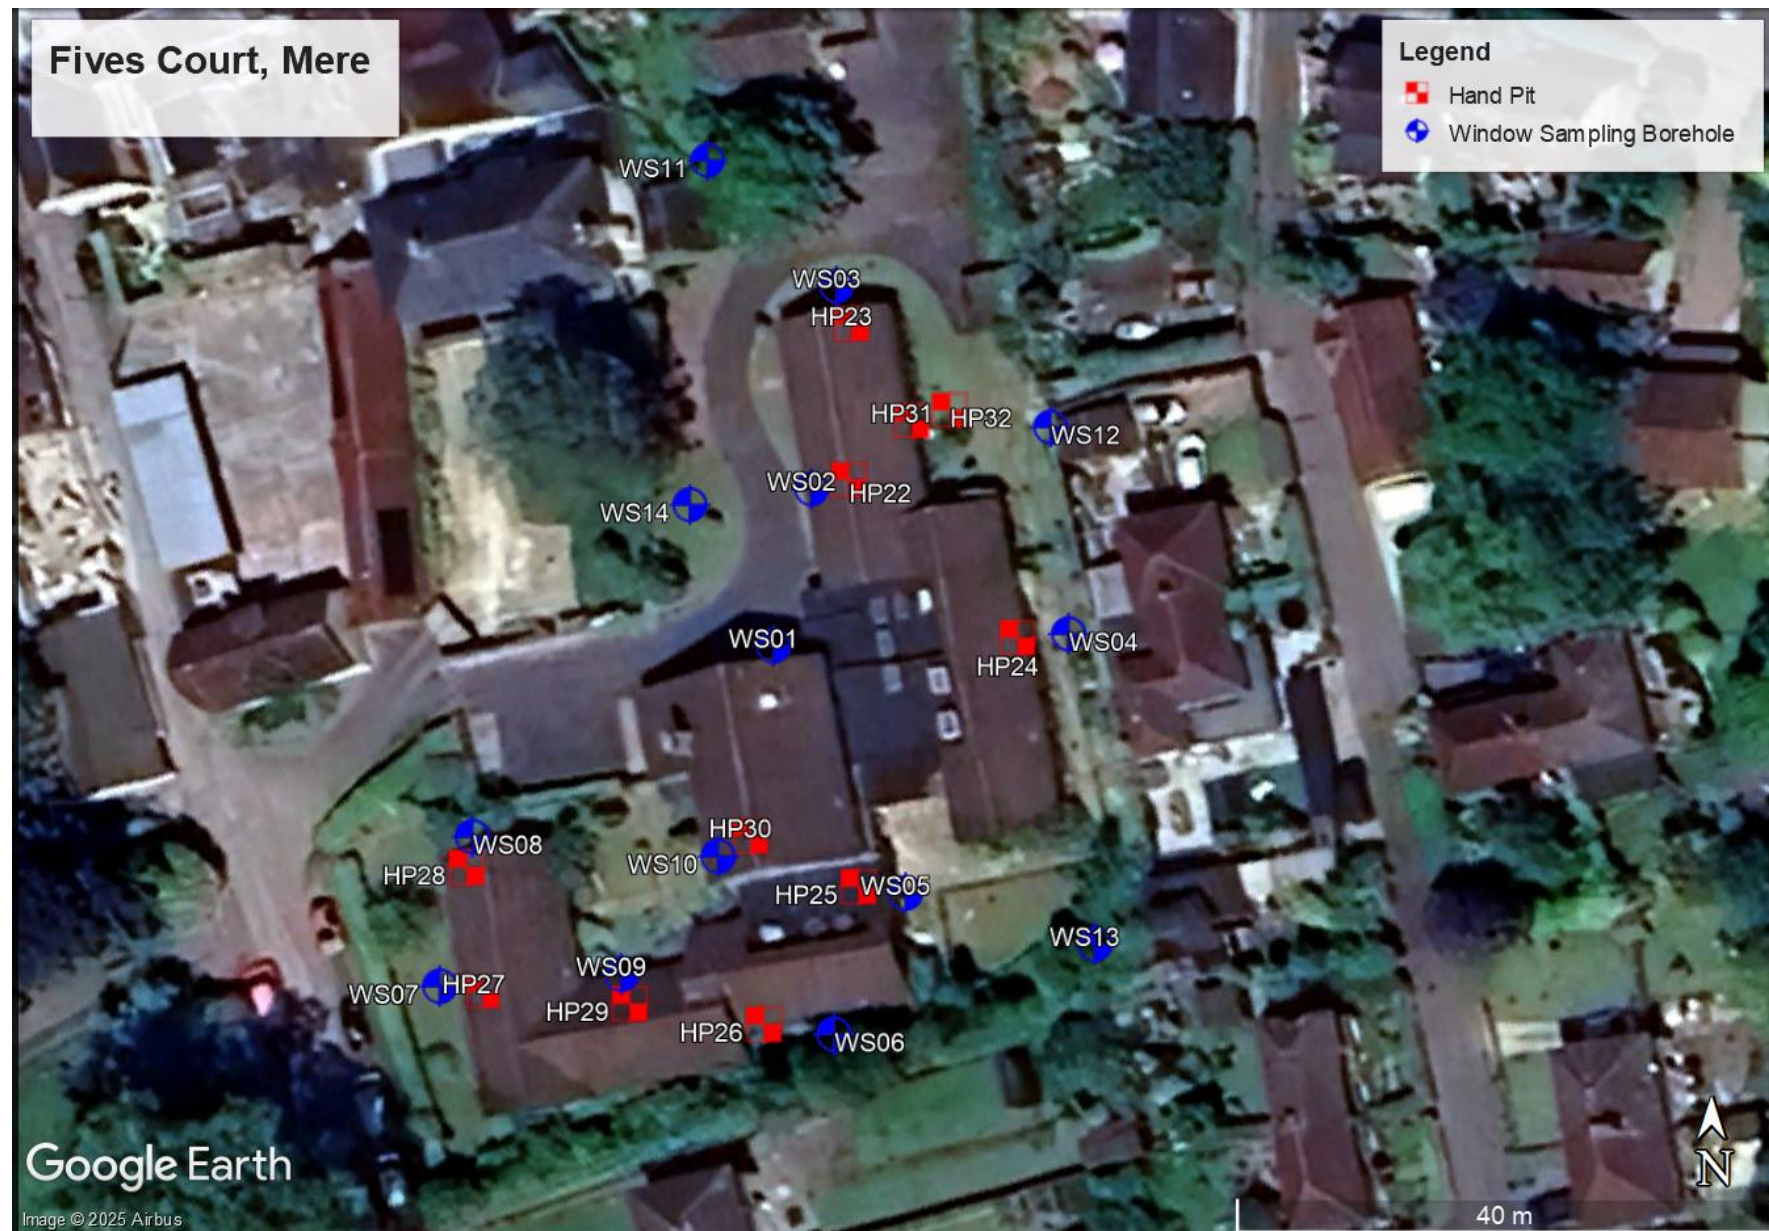
**Drawing 3.1:** Exploratory Hole Location Plan – January 2025

The exploratory hole logs are presented in **Annex A** respectively, and their locations shown on **Drawing 3.1 and 3.2** below.
