James Walker  
3 Chubb Close,  
Malmesbury,  
Wiltshire  
SN16 9JW

## Technical Note: Bat Survey at 3 Chubb Close, Malmesbury

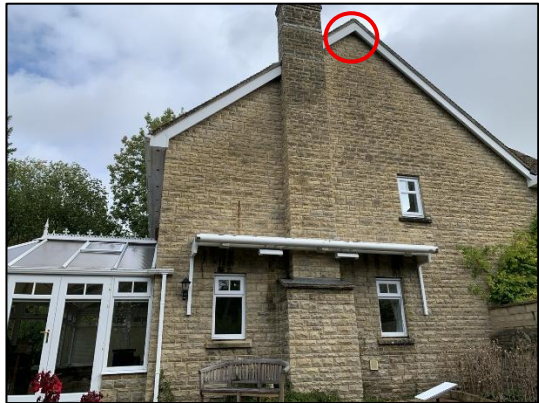
- 3.2 The building is a residential dwelling of traditional construction, and modern design circa early 1990s. The building comprises stone cavity walls, UPVC windows and gutters, and pitched interlocking roof tiles. All the external walls and roof structure are in good condition with no gaps or features suitable for bats. The rear elevation includes a UPVC conservatory (photo 2), which has no features suitable for bats, there is also a small lean to (photo 5), which has a clear plastic roof, minimising its suitability for night roosting bats. The soffits around the front and rear elevations sit tight to the wall (example at photo 6), however, at the northern and southern gables, there are gaps between the soffit box and the wall, providing potential access points for bats (see photos 3 and 7).

*Photo 3 Side South elevation*

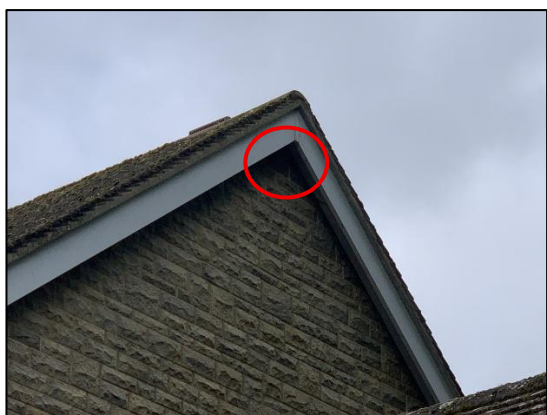
*Photo 7 Southern soffit – bat roost entrance*

- 3.5 The structures survey and DNA analysis have confirmed there is a Serotine bat roost located in the soffit box on the southern gable of the building, this is a common roost location for this species of bat. The entrance to the roost is via gaps between the soffit box and the wall at the apex of the gable. Due to the time of year the survey was undertaken, an emergence survey was not carried out, as it was considered to be too late in the season to provide meaningful results. This means that an assessment of the number of bats using the roost has not been confirmed.

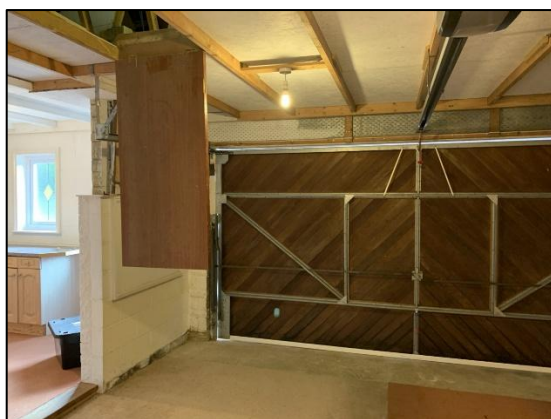
- 3.4 The northern section of the building includes a single storey garage and utility room which is well illuminated from windows (photo 8), above which there is a loft void with trussed roof and bituminous felt. No evidence of bats was found within the garage or loft void.

*Photo 8 Garage - internal*

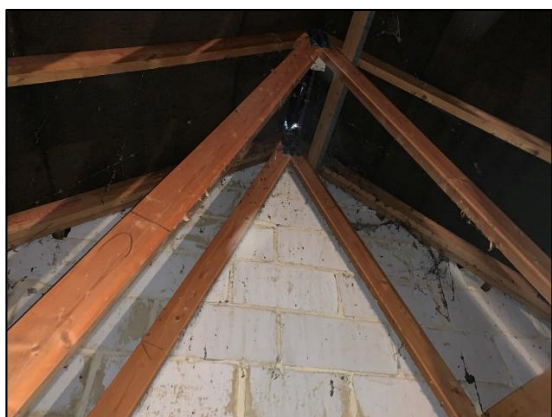
- 3.3 Internally there is a loft void above the main house (photos 9 and 10) which is trussed and cluttered (e.g. water tanks), with bituminous felt beneath the tiles. At the southern gable end (photo 9) there were bat droppings on the wall and a cluster of approximately 100 droppings on the floor. The droppings were assessed to have likely dropped down from the top of the gable where there was an obvious gap in the brickwork adjoining the roof. The size of the droppings were indicative of a large bat (confirmed as Serotine through DNA analysis – see appendix 1). The location of the droppings coincides with the external gaps in the southern soffit which was assessed to be the roost entrance (photos 3 and 7). The actual roost is assessed to be within the soffit box itself (with droppings falling onto the internal gable wall and loft floor from the soffit box). This is quite a typical roost location for this species of bat. The loft void itself is not assessed to be a roost, particularly as there were no other droppings observed throughout the remainder of the loft void.

*Photo 9 Loft void gable end with bat droppings*
