**Showell Farmhouse and granary,  
Showell, Chippenham, SN15 2NU**

**Historic Building report  
Report no. B6909**

**January 2021**

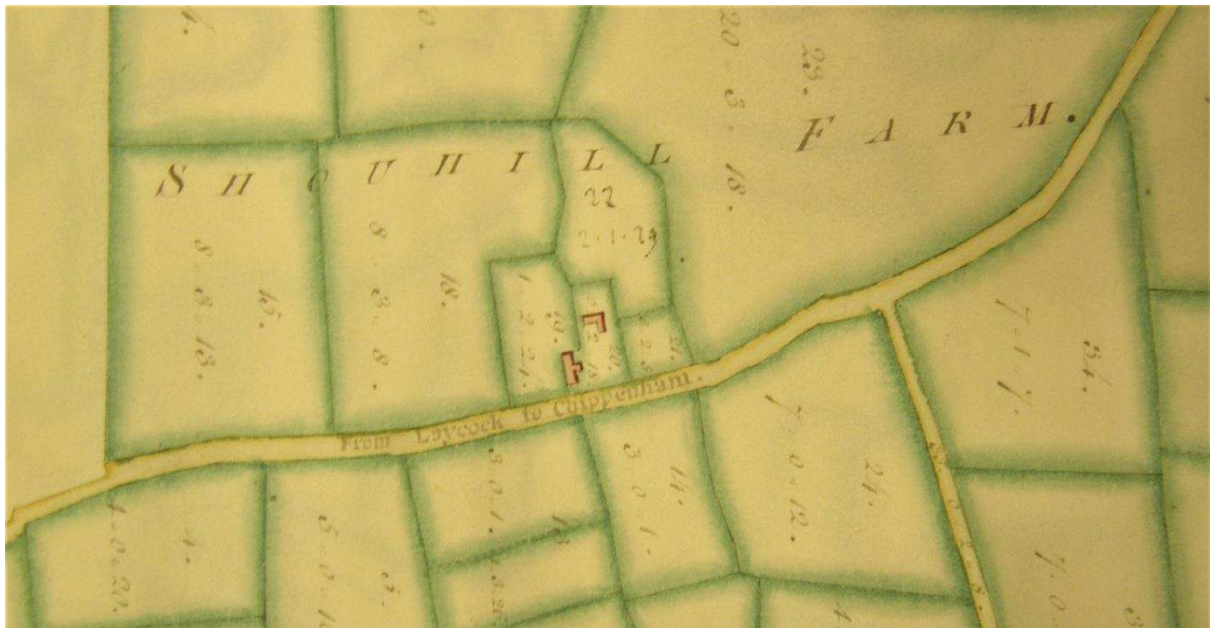
**Fig.4 Detail of above focussing on the site of Showell Farm**

In a book of five maps of farms and lands in Lacock dated to c1750 the site of Showell farm is shown<sup>8</sup> then marked as 'Shouhill Farm' (**figs.3 & 4**). The isolated site shows only two buildings: an L-shaped farmhouse and a barn in the same positions as today. No other buildings are shown, though there are likely to have been other structures on the site such as smaller outbuildings, hay-ricks and fenced enclosures.

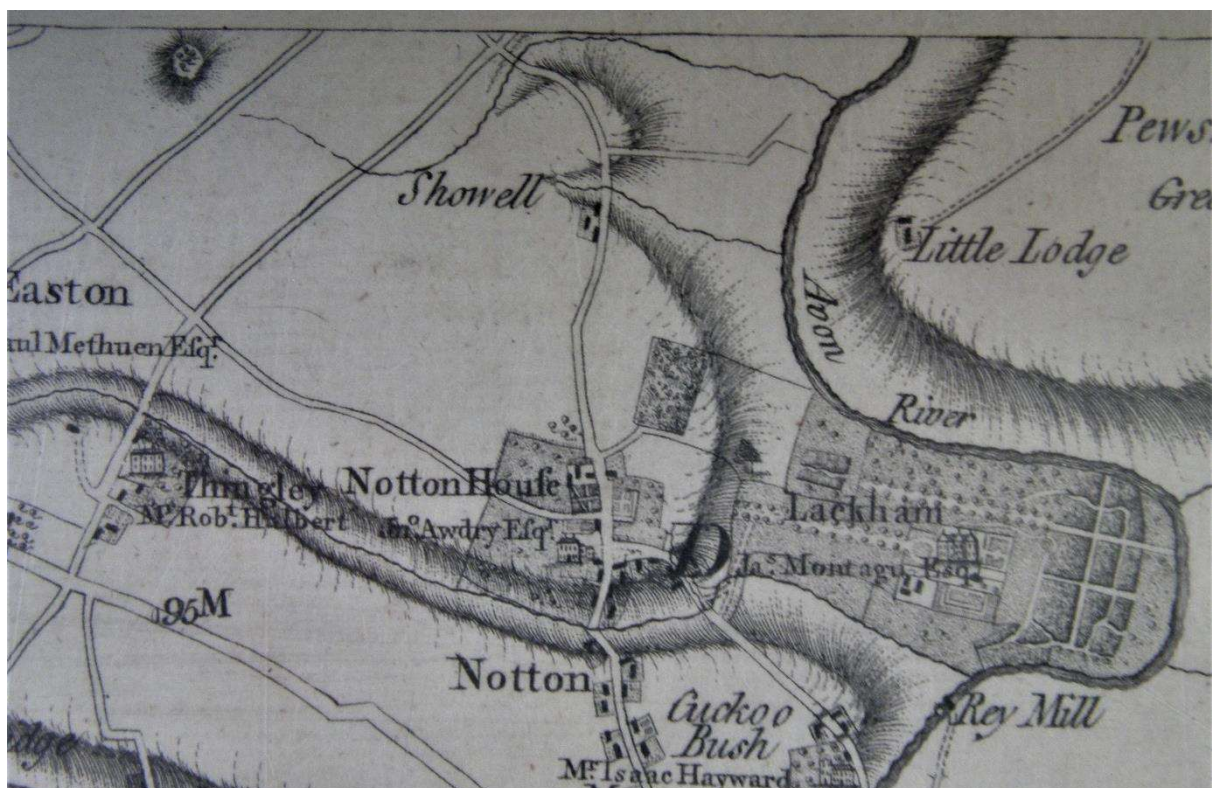
**Fig.5 Extract from Andrews and Dury map of Wiltshire, 1773. Showell is at the top of the image**

By 1773 Showell is shown as a distinct hamlet north of Notton (**fig.5**). All the development is shown on the west side of the road on the site of Showell Farm.

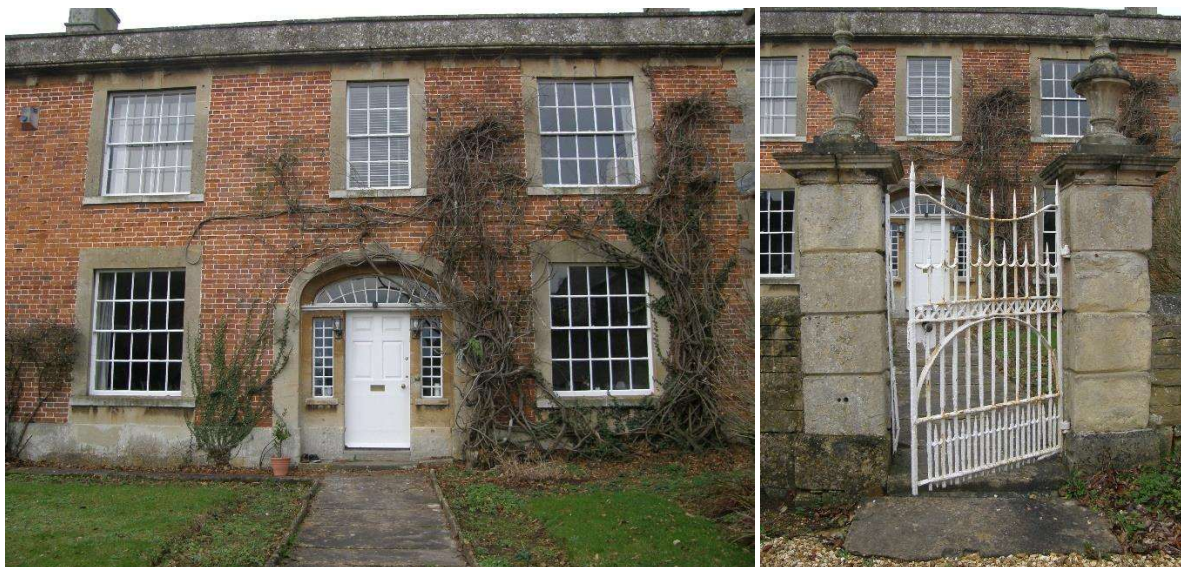
**Fig.13 Main east elevation Fig.14 Rusticated gate piers with urn finials and probably original gate**

Showell Farmhouse faces east (**fig.13**) across a small garden enclosed by a dwarf wall (missing its pier-high railings) with gate piers (**fig.14**). The principal face is constructed symmetrically over two storeys. The entrance is contained within an elliptical arch with an original overhead. On either side of the older 6-panel door are integral side-lights with replacement glazing. Plain ashlar frames contain 10x10 sashes.

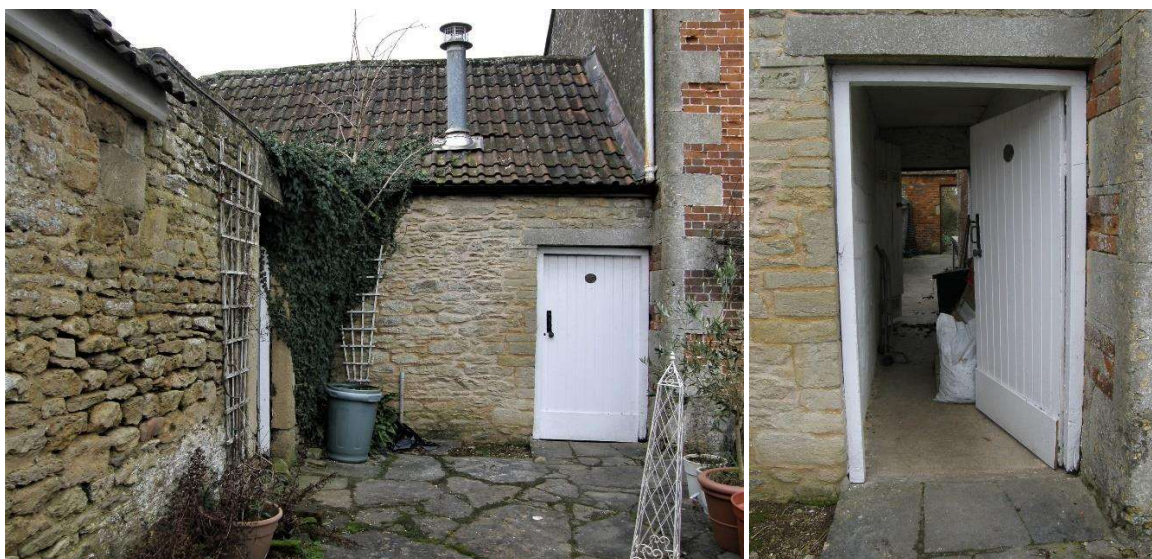
**Fig.15 Outbuilding and passageway to reach service areas to the south of the house**

To the left is a pantile-roofed rubblestone outbuilding housing the boiler and stone passageway into the back of the house (**fig.15**). The doorway has been repointed and a new concrete lintel has replaced the likely timber one (**fig.16**). The partition to the boiler room has been replaced in concrete blocks. The tithe map of 1840 indicates that the passage was not roofed originally.

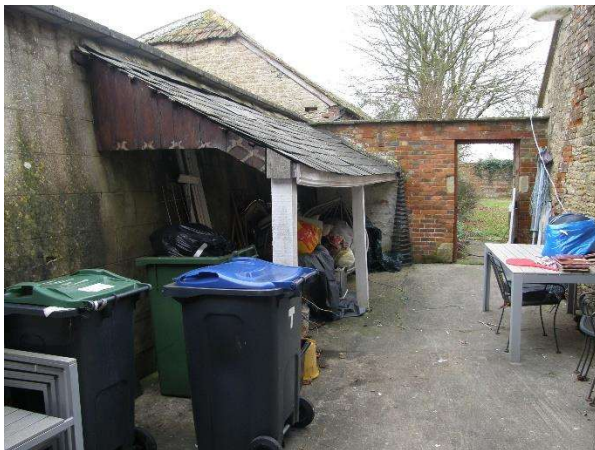
**Fig.17** Rear yard

The area to the south of the house comprises a concreted yard with an open-fronted lean-to fuel house roofed in slate, standing on timber posts (**fig.17**). This appears to be leaning against a rubblestone wall lined with concrete blocks. At the rear of the house is a modern roofed passage between the principal reception room and the single-storey kitchen block, formerly unroofed until the later 20<sup>th</sup> century. Of interest is an area of brickwork extending in a central full-height strip from ground to eaves (**fig.18**). Where the render has come away, brickwork is visible. The most obvious explanation is that the reception room once enjoyed views to the west before the single-storey kitchen wing was added before 1840. Subsequent to this addition the ground and first floor west-facing windows were blocked up. The kitchen was an addition very soon after the new farmhouse was built in c1830, as the current footprint is seen on the 1840 tithe map. It is likely that the original kitchen was in the older wing and later relocated behind the principal reception room.

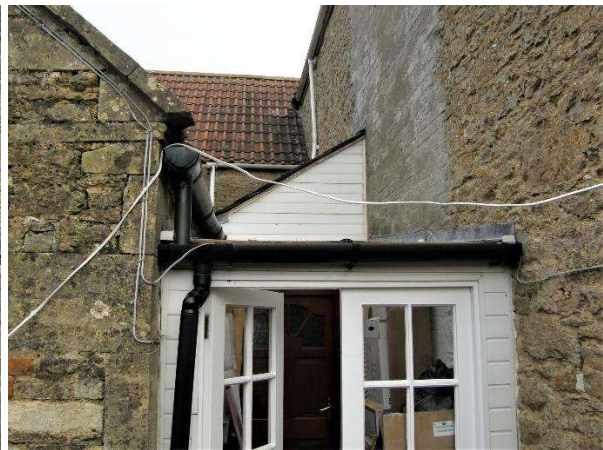
**Fig.18** Modern passage between front and rear ranges

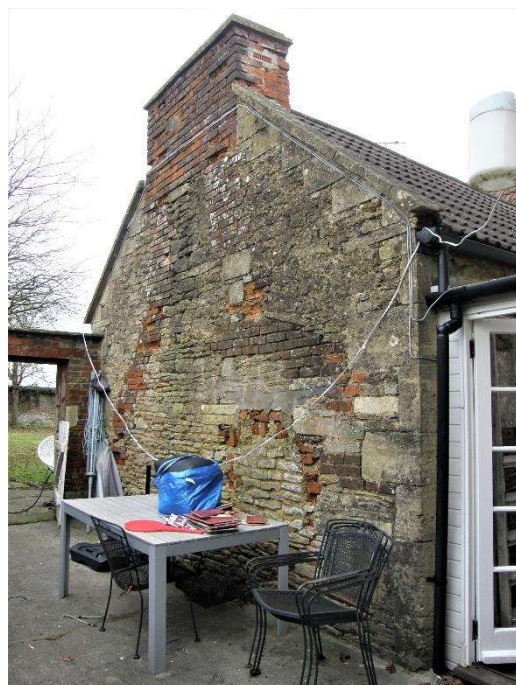
**Fig.19** South gable end of kitchen

The single-storey kitchen has vertical joint to the rest of the farmhouse. It is of rubblestone with some brick infill of openings. A small single light at the south end was filled in early with rubblestone. The gable end is partially in brick along the line of the flues, and a low, infilled opening seems to indicate the position, perhaps, of a projection of a bread oven (**fig.19**).

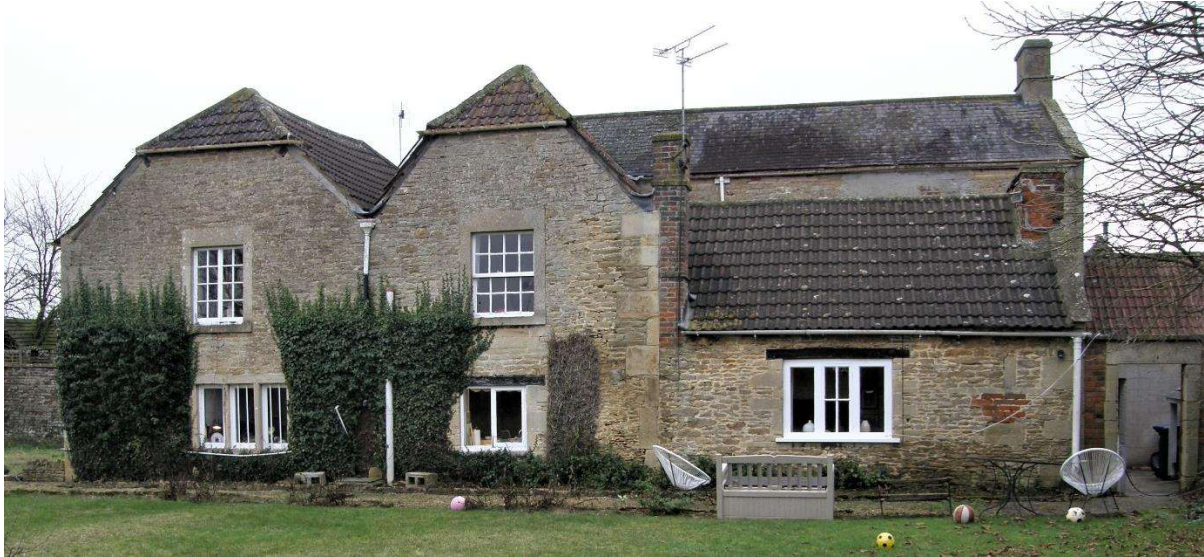
***Fig.20 Rear (west) elevation***

Dairying had become a major industry in the county in the 18<sup>th</sup> century and dairy workshops were often added at the back of farmhouses, or accommodated in-line with the main range<sup>26</sup>. The windows frames at first floor are both the same plain ashlar as at the front, despite being of different dates. The ground floor opening to the present kitchen is modern under an old timber lintel. The former dairy has two large 3-light plain frames on the north and west sides.

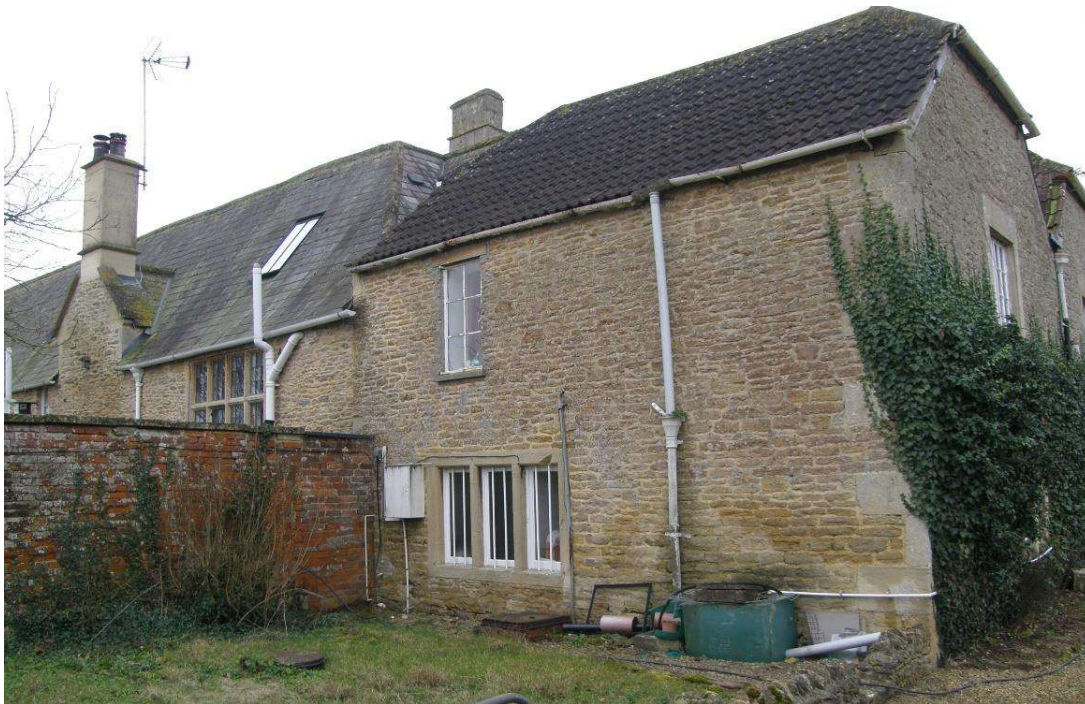
***Fig.21 North elevation of dairy***

The north elevation stonework appears to be continuous from the Dove House, though the 1840 tithe award map shows the dairy to be an addition. Shading on the stone relates to staining from the gutter. At first floor is a Crittal-type casement window that has been let in (**fig.21**).

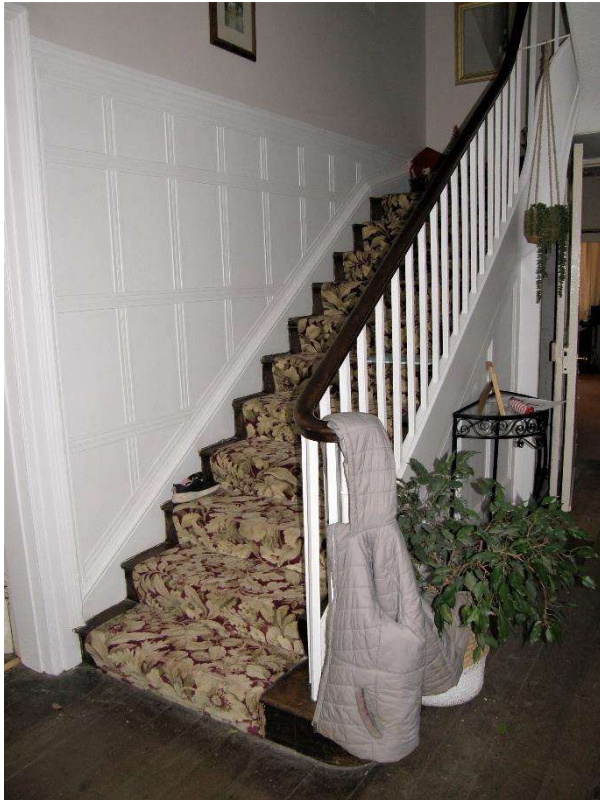
**Fig.22 Straight flight stair**

Tall ceiling heights throughout the front range. The hall is central in the building and entered through a 6-panel door on butt hinges. Double fascia architrave with close-moulded element. Stilted arched overlight spanning door and 16-pane side-lights with plain glazing bars. The elliptical overlight has narrow chamfered bars and it is supposed that the side-lights have been replaced as the glass itself is modern.

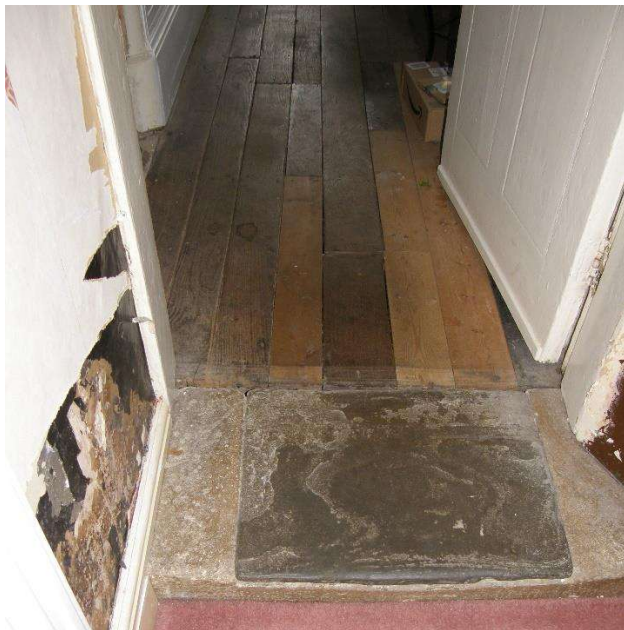
The floorboards here are of oak with signs of shrinkage gaps, so suggesting these are original. Adjacent to the front door a foot-well has been cut in. At the rear of the passage are several softwood repairs at the back door (**fig.23**).

***Fig.23 Limestone step with Pennant sandstone repair***

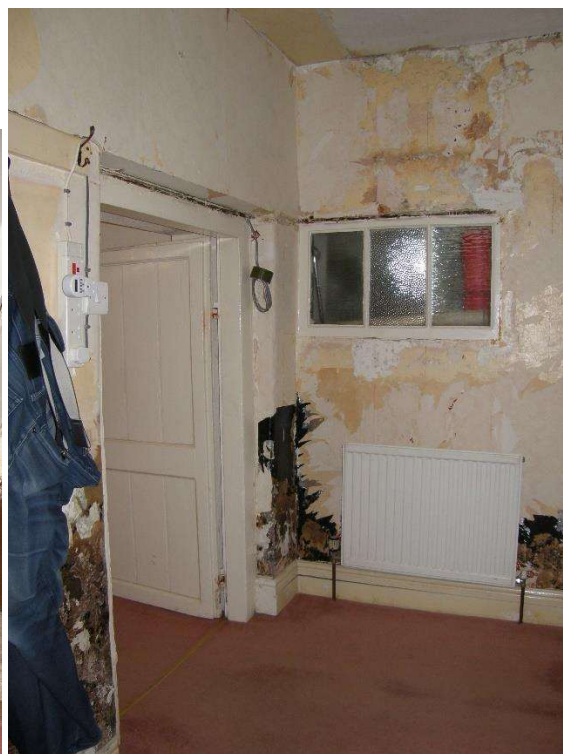
***Fig.24 Borrowed light into larder and door to rear of house***

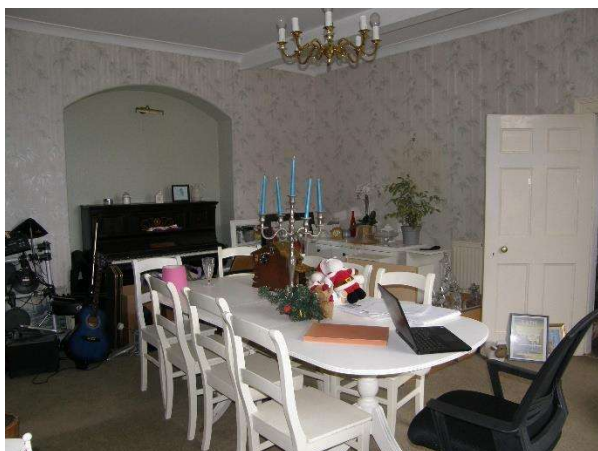
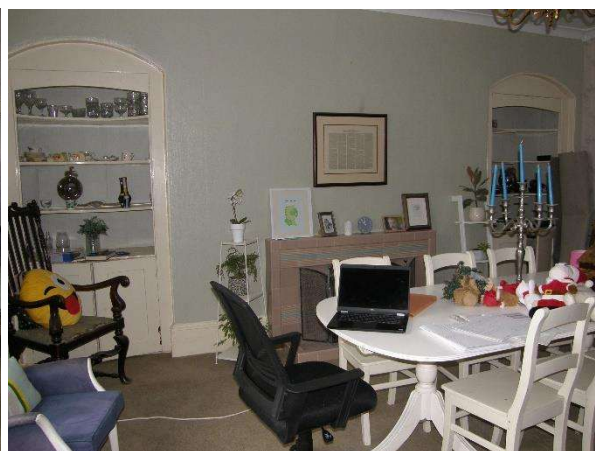
The principal reception room. Plain ceiling, probably with original lath and plaster, with boxed or plastered transverse beam. Plain walls with good, high skirting board with deep mouldings as hall. There is an elliptical-headed recess in the rear wall which very probably contained a garden doorway (**fig.25**). The south wall has a central fireplace, now with a 30s or 40s moulded tiled surround and raised hearth. On either side are display cabinets with shaped shelves and elliptical heads (**fig.26**). 6-panel door and 10 x 10 sash, no horns, moulded glazing bars. Panelled below. Suspended, carpeted floor.

***Fig.25 South reception room with rear arched recess Fig.26 Arched recesses either side of fireplace***

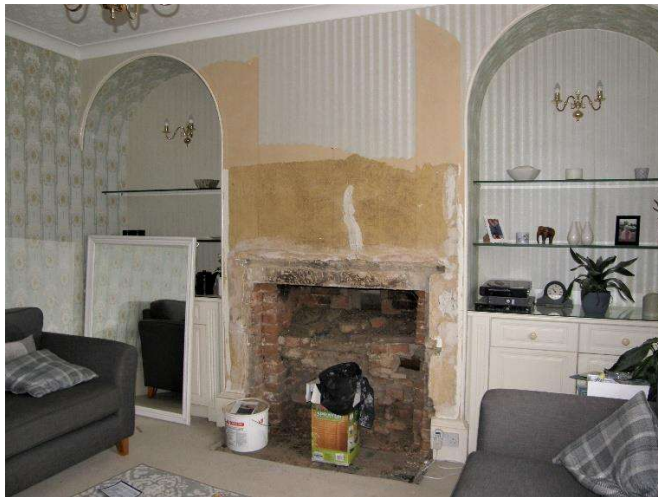
The smaller of the two reception rooms. Plain ceiling as above, modern coving. Suspended carpeted floor as above. Fireplace surround removed, replaced with a C20 surround recently removed to show outline of original surround<sup>27</sup>. Ragged edges show a hair plaster. Plain stone lintel with brick nostril back infilled during 20<sup>th</sup> century with cemented rubble. Art Nouveau green tiled hearth indicate the removed fireplace surround was probably remodelled around 1900. On either side is a round-arched staff-moulded recess, now with glass shelves and modern cupboards (**fig.27**). 6-panel door and window as in south room.

**Fig.27 Fireplace with flanking recesses**

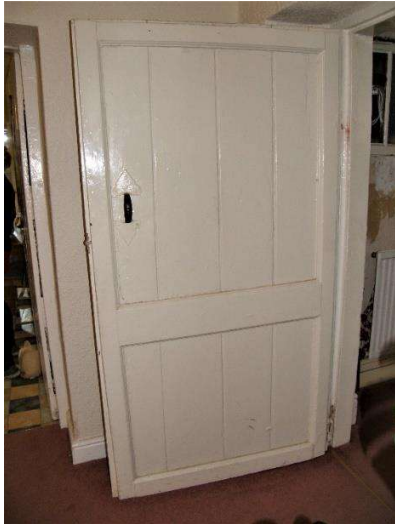
Plain ceiling with modern coving and skirtings. The walls are lined. Suspended carpeted floor. Good 2-panel door with wide planks and handle with blacksmith-wrought handles. Hung on substantial t-strap hinges, possibly a 17<sup>th</sup> century door reset from the earlier house (**fig.28**). Later door to present kitchen of narrow planks (**fig.31**). 3-light window with modern glazing and sill (**fig.29**).

**Fig.28 2-panelled door**

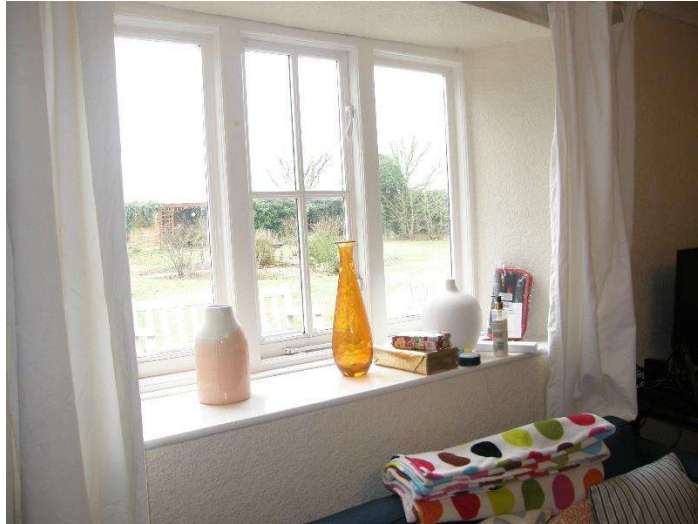
**Fig.29 Old kitchen/sitting room window**

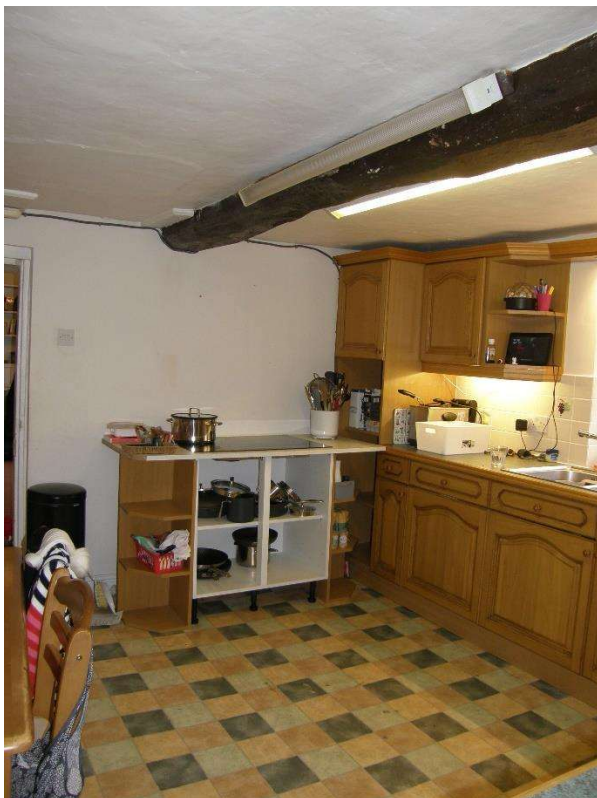
This was once one room with the present larder to the east. A 20<sup>th</sup> century stud wall now divides them, lined on the kitchen side with plasterboard. The ceiling appears to be original lath and plaster. There is a transverse beam with a rough chamfer (**fig.30**). All other surfaces are modern including the modern lino over a solid floor. Good 19<sup>th</sup> century door to the utility room/office. Modern 2-light window to west. A mark in the ceiling indicates the position of a fireplace across the south-west corner where the chimney breast passed through the ceiling. The brick flue is still externally visible.

**Fig.30 Transverse beam**

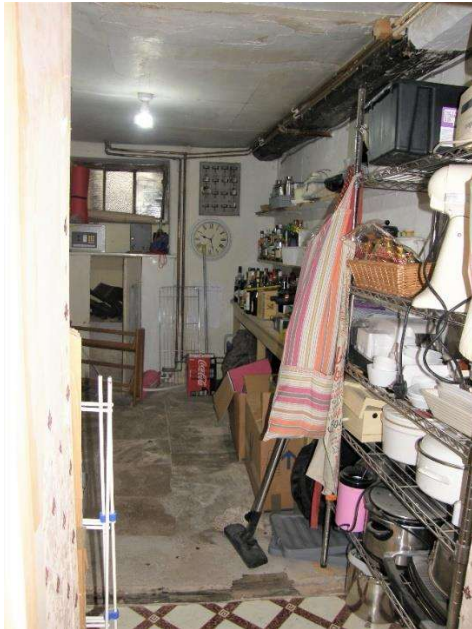
On the other side of the partition is a 17<sup>th</sup> century beam with a small chamfer and ogee stops at the north end (**figs.32 & 33**). In the larder is a very good fitted 17<sup>th</sup> century cupboard made up of a small-panelled scratch moulded front with doors on cockshead hinges (**fig.35**). The sides of the cupboard are made up of staggered large boards. It is likely to be in its original position. On the south side is a former doorway now used as a cupboard with borrowed light over. The floor here is of square stone setts. Good 19<sup>th</sup> century planked door to front range.

**Fig.32 Chamfered beam in larder**

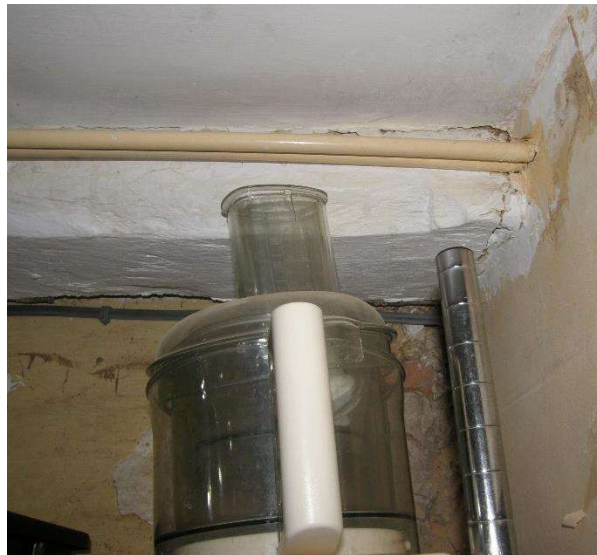
**Fig.33 Ogee stop at north end of beam**

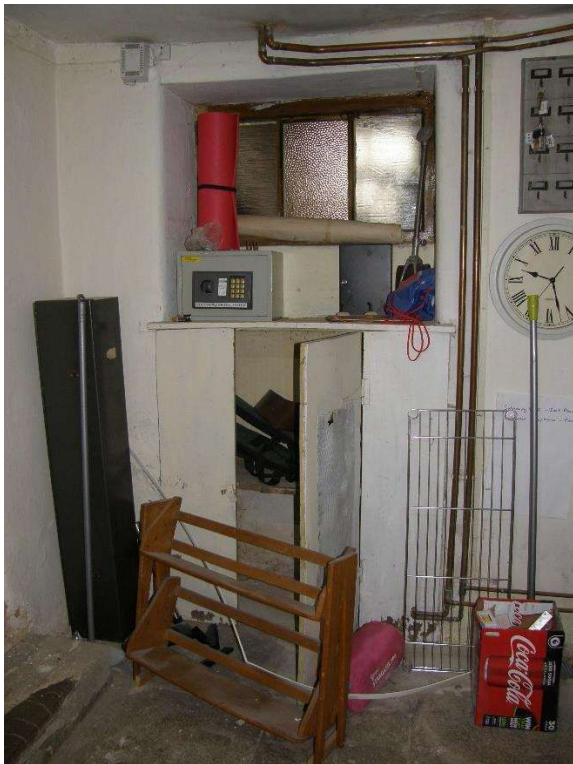
**Fig.34 Former doorway from larder to front range**

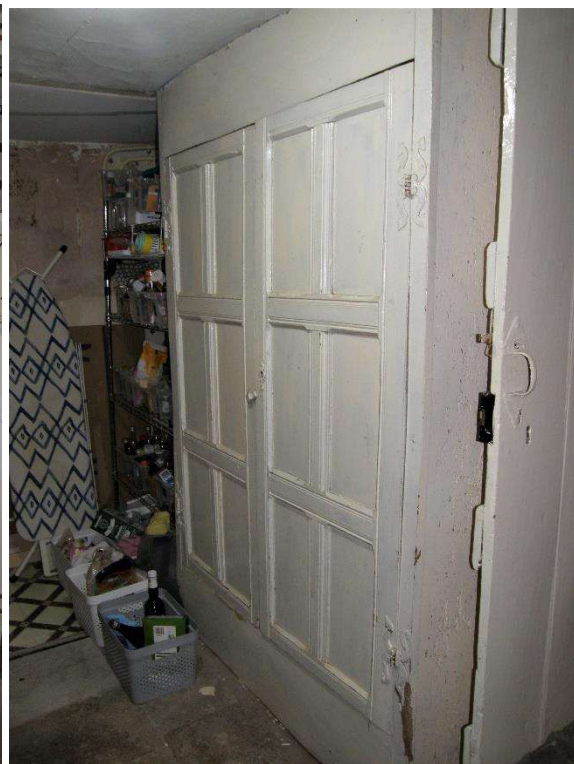
**Fig.35 17<sup>th</sup> century fitted cupboard**

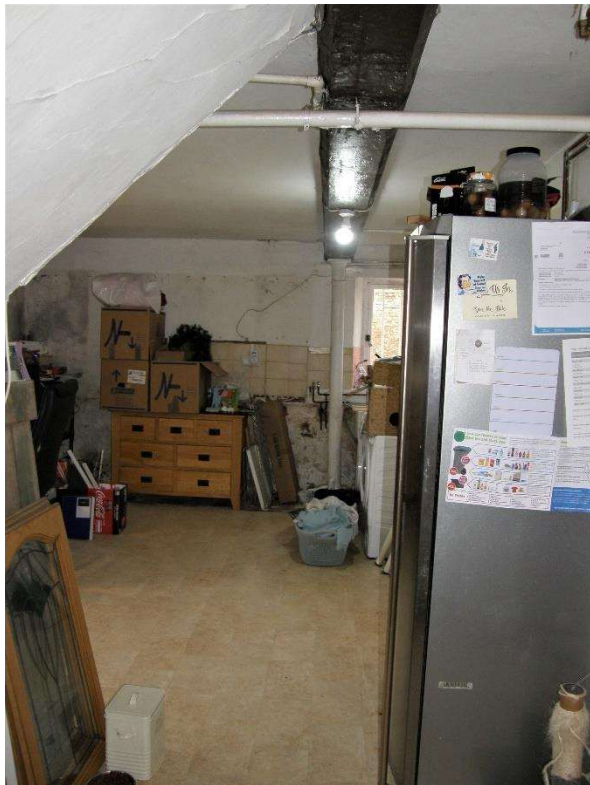
One step down from the kitchen/larder. This was also once one large room with the bathroom added as a dairy and cheese room between 1840-1886. Typically, it has its own separate enclosed stair rising to the cheese room. Plain ceiling with transverse beam additionally supported at the north end on an iron stanchion (**figs.36**). The walls are partly lined, but on the north wall are three deep holes for fixed furniture, perhaps a worktop. There is a 3-light window on the west side with modern glazing as above. On the north side is a similar window with modern glazing. Plain painted stone.

**Fig.36 Dairy looking north**

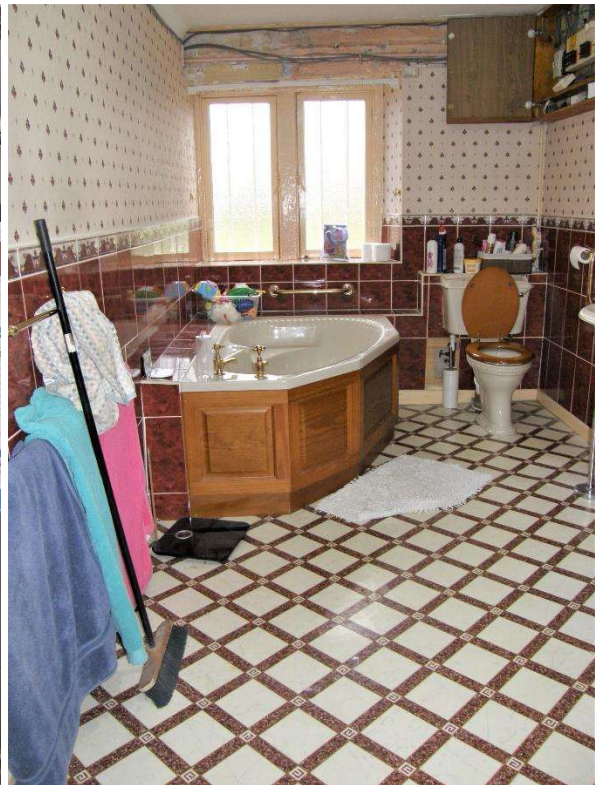
Beyond the modern stud partition is a bathroom lit by a 2 lights of the north window containing modern glazing (**fig.37**).

**Fig.37 Bathroom**

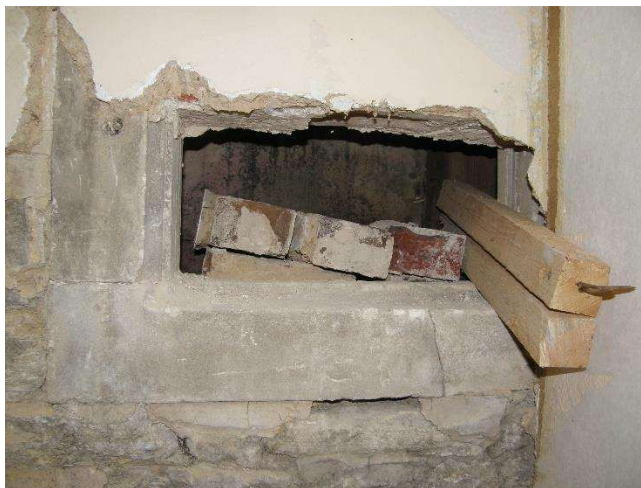
On the south wall the face of a large 2-light moulded stone window has been exposed (**figs.38-40**). It has ogee moulding to the former exterior face into the present room, and plain chamfered on the inner side. This type of moulding on the mullion suggests a c1700 or earlier date. It has been blocked in with brick presumably after 1840 when the dairy was added. On the south side of the wall is timber lining to the room on the other side (**fig.40**). On the north side of the east bedroom is a two-light Crittal-type window.

***Fig.38 Formerly exterior north wall and window at rear of house before the addition of the dairy and cheese room***

***Fig.39 Detail of exposed window***

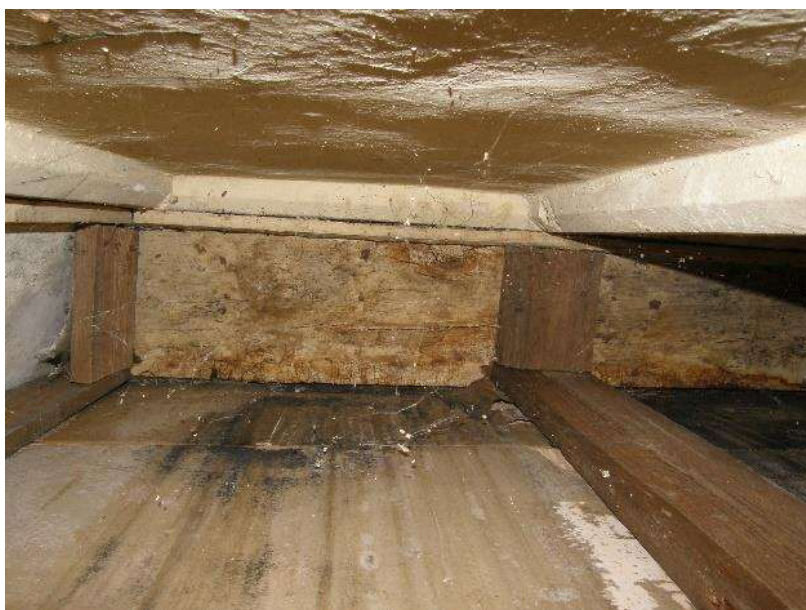
***Fig.40 Interior of window void showing chamfered side of mullioned frame***

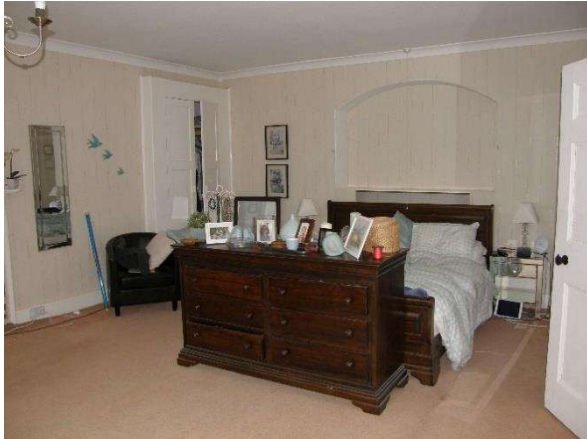
**Fig.41 Possible blocked window on west wall**

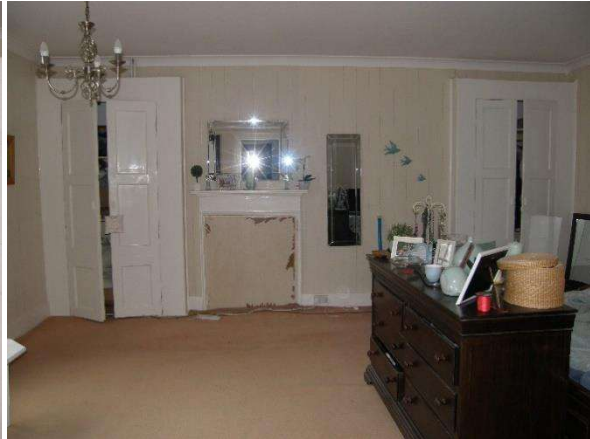
Plain ceiling with coving. Plain, possibly original skirting boards. Carpeted floor. On the south wall is a c1900 light painted timber surround with a plain mantel on a moulded bracket. There is a hob-grate inside the boarded opening (personal communication). 10x10 large sash, no horns. 6-panel door. Reeded-type architrave surround. Rear (west) wall has similar recess to room below which may suggest there was once a window in this position. Now partly filled in with a shelf. Good fitted cupboards of 6-panels. Probably later 19<sup>th</sup> century or early C20.

**Fig.42 Blocked fireplace and built-in cupboards**

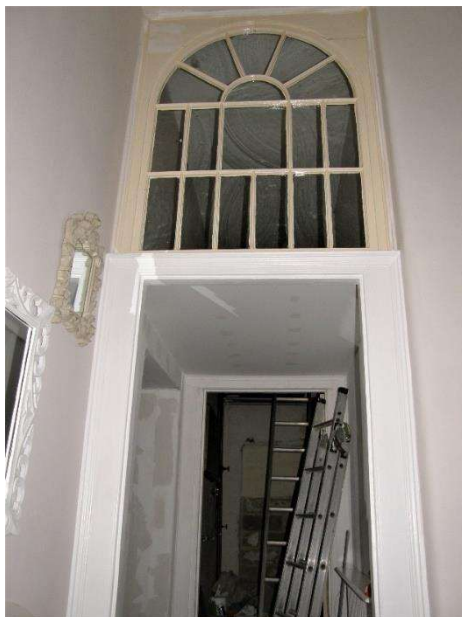
**Fig.43 Borrowed light to rear of first floor**

Good arched borrowed light over corridor to rear of house (**fig.43**). The corridor continues in a dog-leg to bedroom 3.

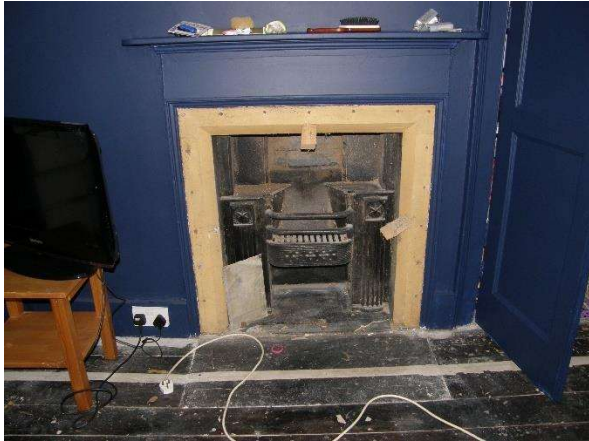
Plain ceiling. All as above. Old elm floor, not carpeted (**fig.45**). Painted black at margins in c1900. Painted stone fireplace (**fig.44**). Plain chamfered surround. Hob grate inside. Older full-height fitted cupboards, prob late 19<sup>th</sup> century /early c20.

**Fig.44 Painted stone fireplace with hob-grate**

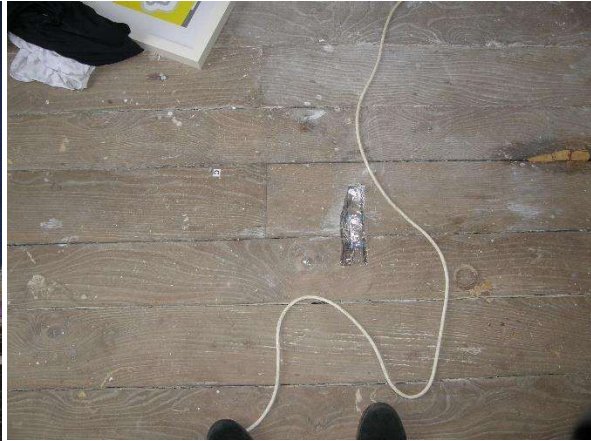
**Fig.45 Bare elm boards**

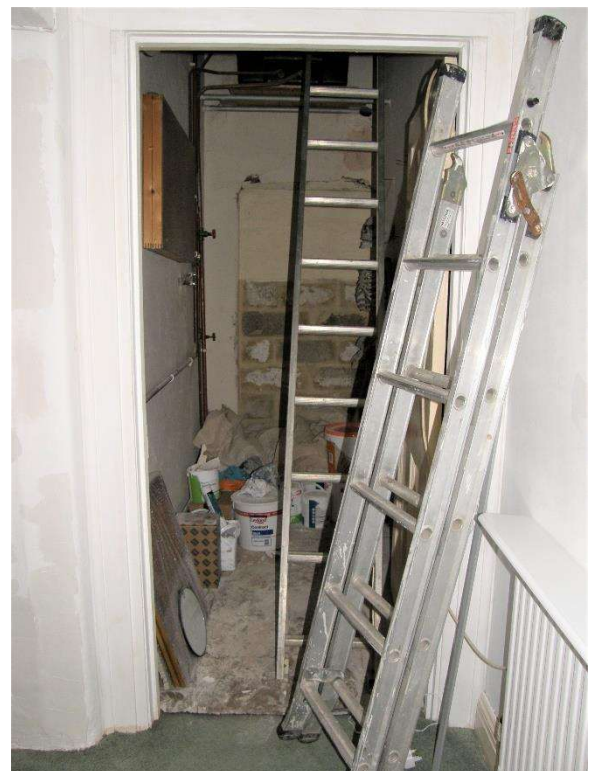
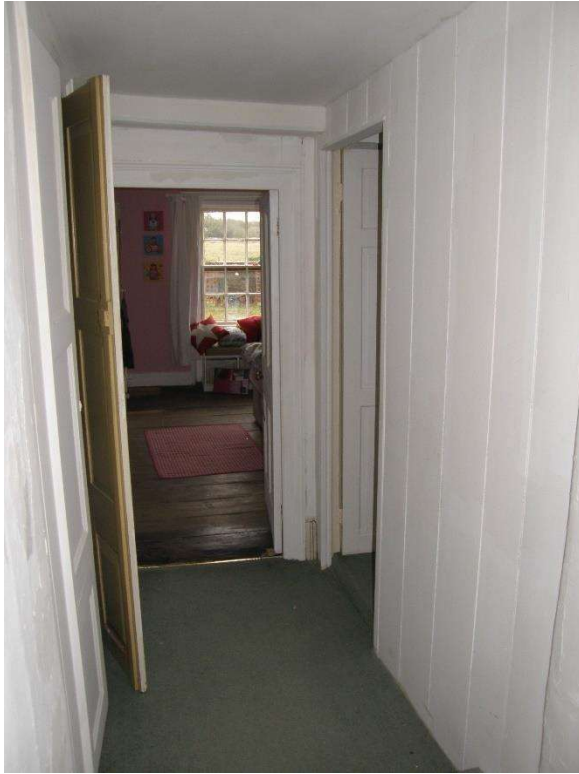
Plain room with lath and plaster ceiling. Transverse beam with small chamfer (fig.48). Orig. boarded skirtings. Good wide original elm boards. 8x8 sash. The room was originally larger but part on the east side divided to form a box room, now an en-suite shower room and cupboard opposite (fig.47)

***Fig.47 19<sup>th</sup> century division of original room***

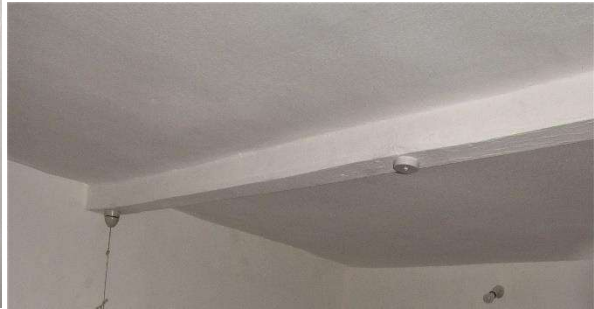
***Fig.48 Plain beam dividing ceiling***

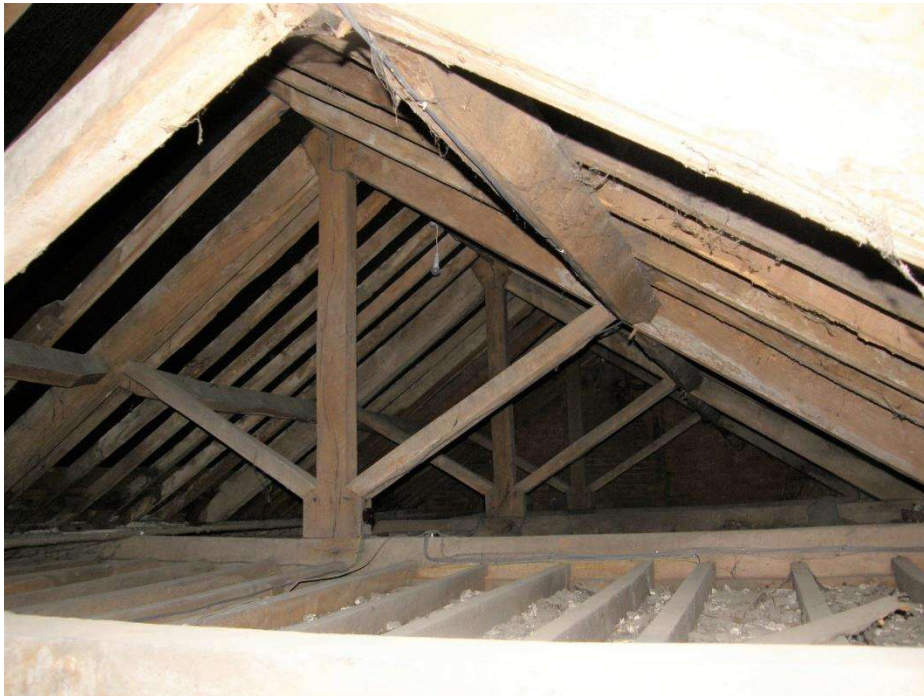
When the house was re-organised in c1830 it was re-roofed in shallow hardwood king-post trusses typical for the period (**fig.49**). There is one row of purlins cut back at the principal rafters. Access to the roof is from the first floor box room at the back of bedroom 2.

***Fig.49 King post roof of 5 bays over main range***

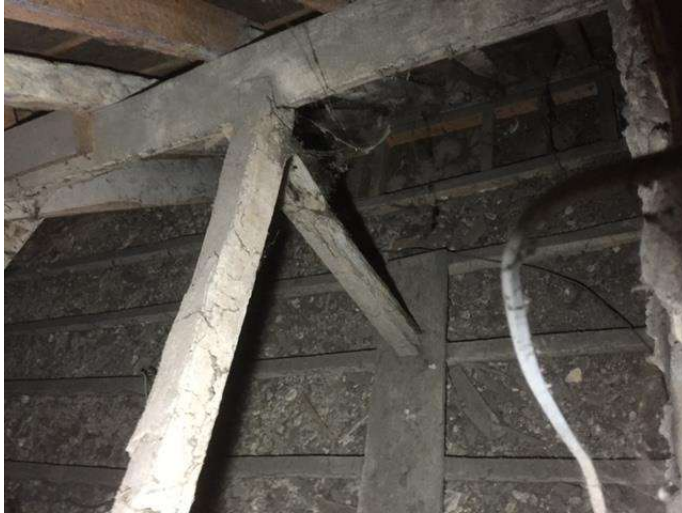
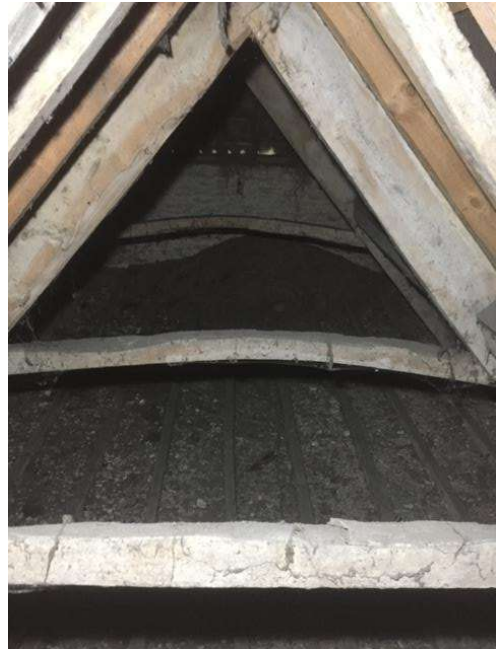
Of sawn softwood. Interestingly, the timbers are whitewashed, suggesting that the roofspace was once open from the room below. The visible truss apex is haunched – a very typical feature of 18<sup>th</sup> century carpentry, as are the narrow curved collars that have a birds-mouth joint with the row of butt purlins (**figs.50 & 51**)

***Figs.50 & 51 Roof over rear wing. Photos by Gary Bennett***

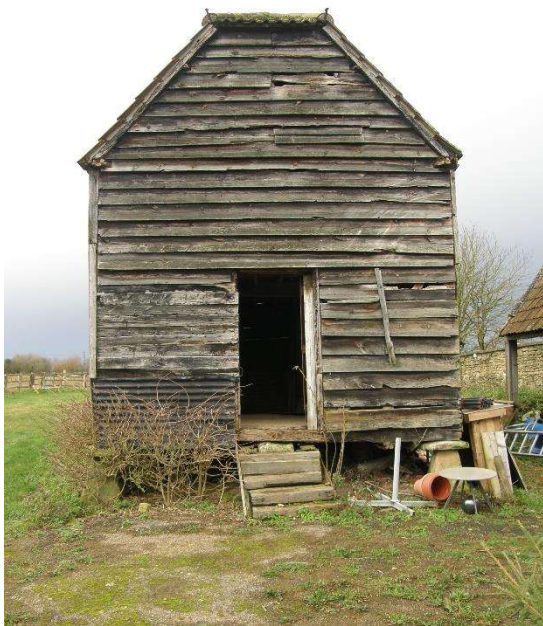
**Fig.52 East elevation**

The late C18 granary is situated near to the south end of the house. These were often placed within sight of the farmhouse as grain was a precious commodity. It is a small granary standing on 3 x 3 mushroom-shaped stone staddles, facing east (**figs.52**). The timber frame was originally clad with feather-edged elm boards, and has a half-hipped roof clad in double-Roman tiles, though it is likely to have been stone-tiled. The entrance is accessed by an ad hoc step arrangement of loose concrete blocks and timber baulks (**fig.53**). At the south-west corner one of the staddles may have sunk slightly (**fig.55**), though it is shown in the same position in 1986 when the granary was in good condition<sup>28</sup>.

Much of the original elm weatherboarding has been replaced with narrower softwood boarding partly held in place by thin studs applied vertically across them and nailed in place. This is associated with the letting in of a window on the south elevation, which does not appear on photographs of July 1986. The underside of the granary appears to be intact, with narrow joists resting on a frame and transverse central beam (**fig.58**). Corrugated iron cladding to the lower part of the walls has been in place since at least 1986.

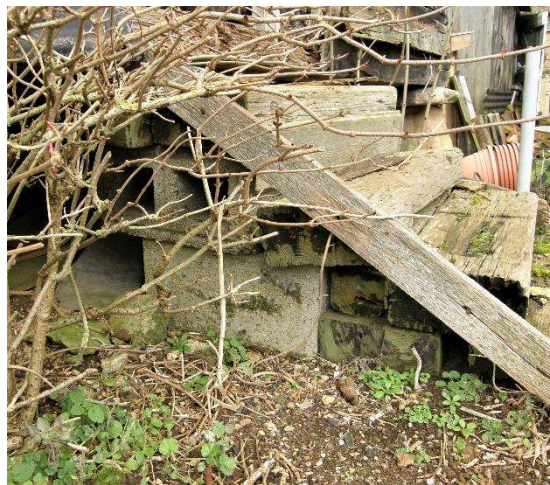
**Fig.53 Steps up to door**

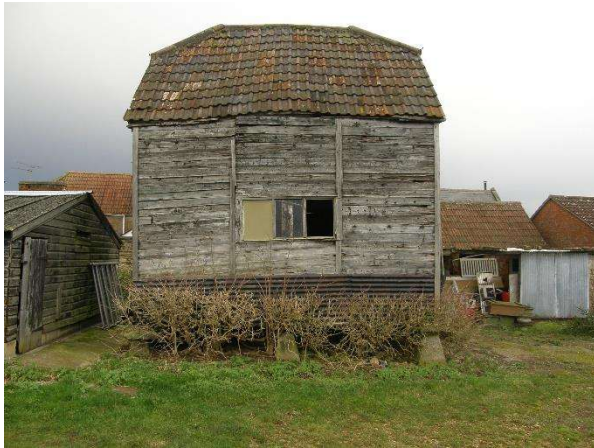
**Fig.54 South elevation**

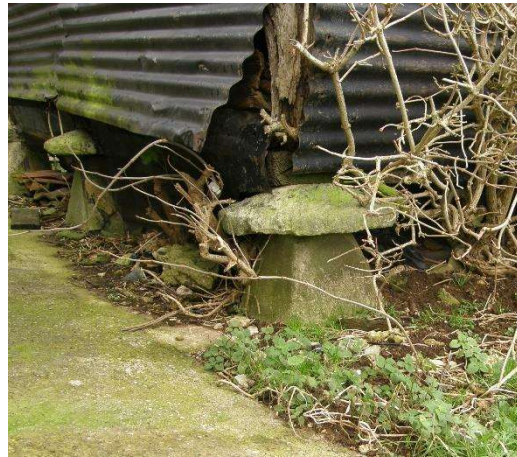
**Fig.55 Sunk staddle in south-west corner**

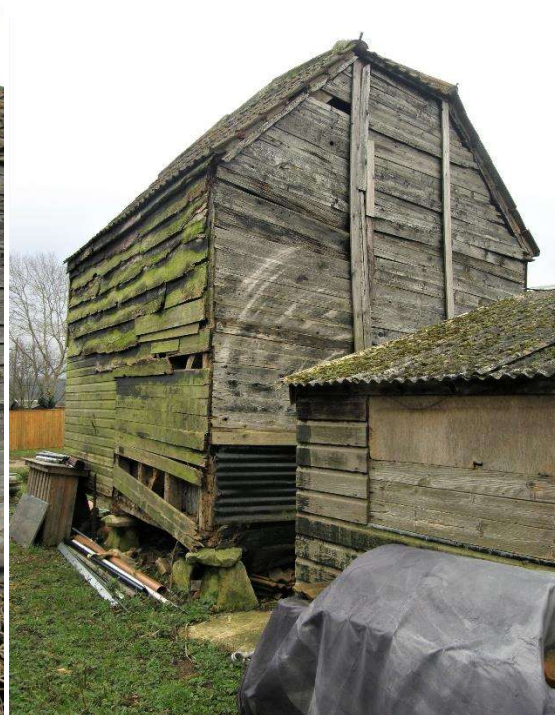
**Fig.57 North and west elevations**

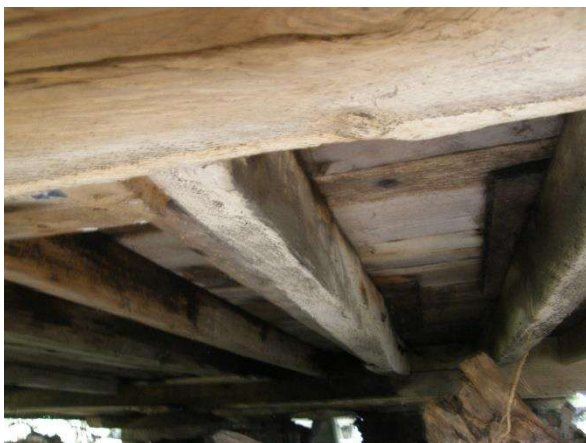
**Fig.58 Underside of granary**

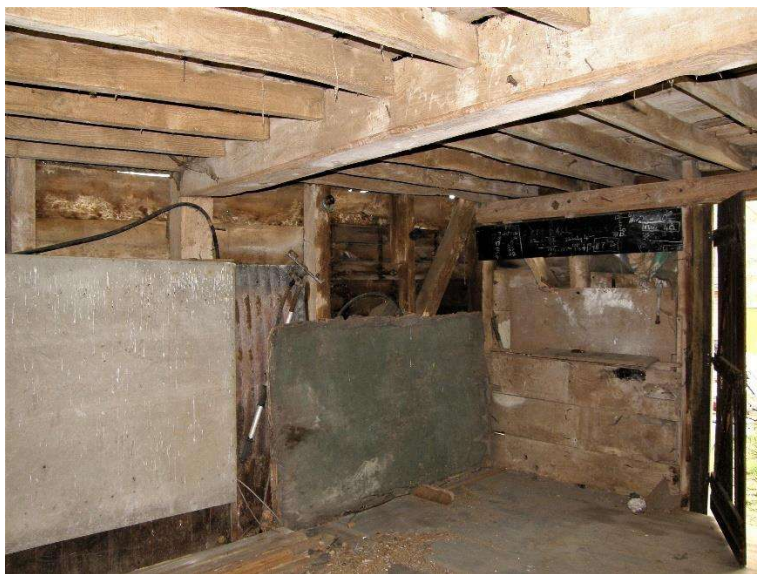
The interior of the granary is also intact, though the sawn elm frame is rotted in parts due to water ingress. A deep and narrow transverse beam crosses the ceiling north to south carrying narrowly-spaced deep joists (**fig.61**). At either end the beam rests in a notch in the central post (**fig.61**). The interior was once also boarded and this has been partly replaced with corrugated iron. Construction is of sawn studs with long diagonal braces from each corner, typical of c1800. Part of the frame is resting on an acro-prop.

**Fig.60 Interior with some remaining boarding on east wall**

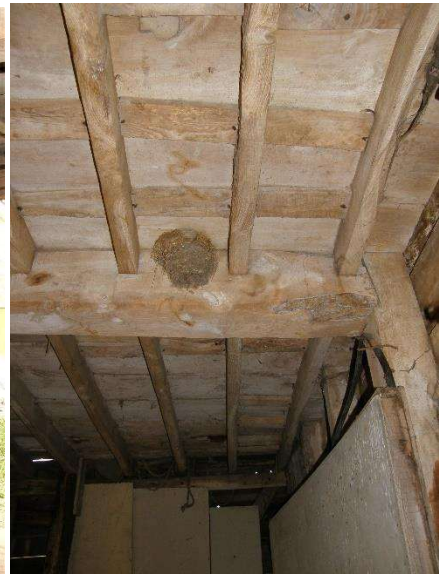
**Fig.61 North end of beam resting on notch**

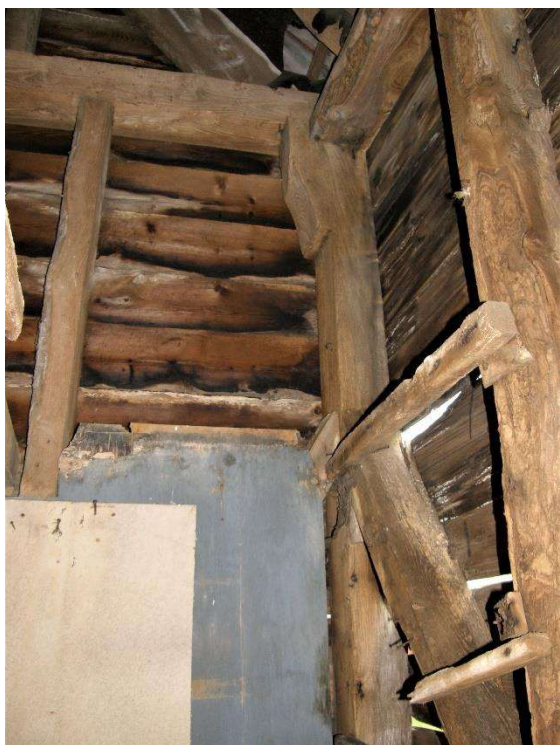
The loft was originally reached by a fixed loft ladder in the south-east corner, and some remains still cling to the frame (**fig.62**). The tops of the posts supporting the ties have shaped jowl posts (**fig.62**) Vertical boarding lining the walls still survive (**fig.63**). Sacks of grain would have been stored in the loft.

**Fig.62** Former position of ladder to loft over

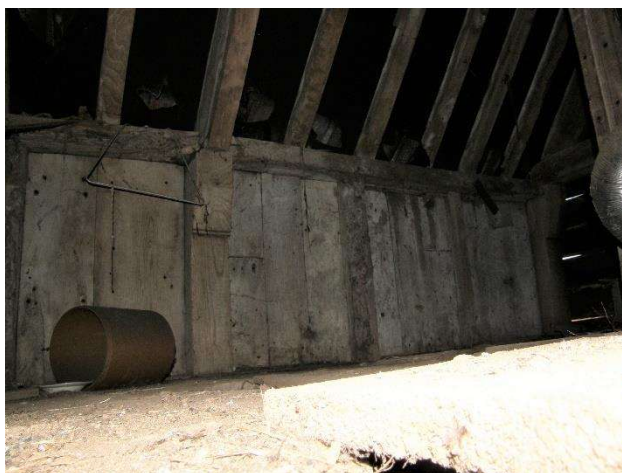
**Fig.63** Vertical board lining in loft
