**Showell Farmhouse and granary,  
Showell, Chippenham, SN15 2NU**

**Historic Building report  
Report no. B6909**

**January 2021**

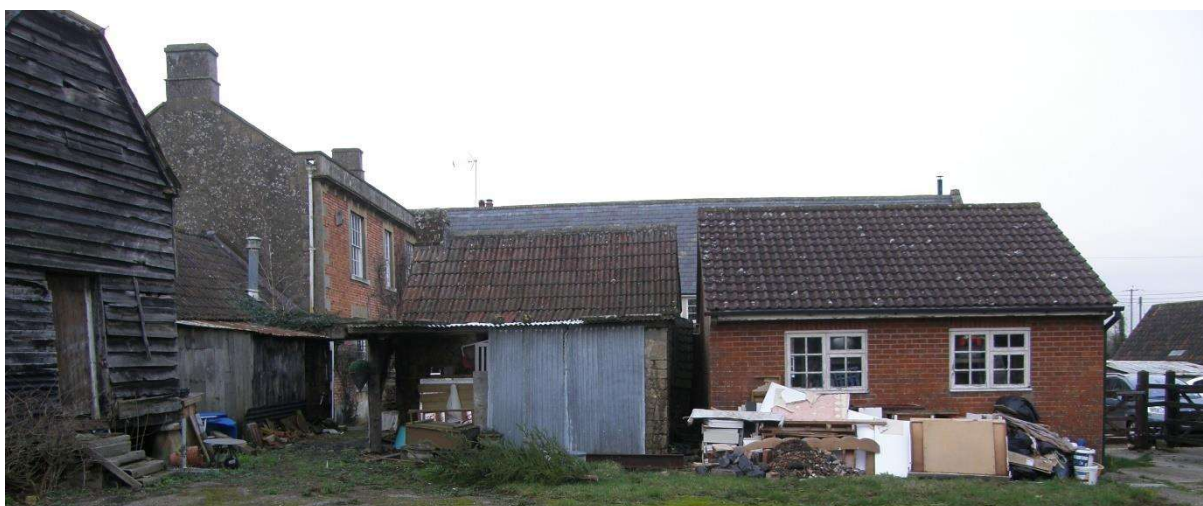
Forming the south side of the courtyard are a former earlier 19<sup>th</sup> century **wash house** of stone with a triple Roman tile roof (**fig.64**). Inside are the remains of a hearth formerly holding a wash copper. A former farmsteads survey of 1986 was informed that this small building was formerly also used as a bacon-smoking house, and at the time of the survey was being used as a farm office<sup>29</sup>

**Fig.64 Rear of wash house and brick building replacing two stone pigsties with yards**

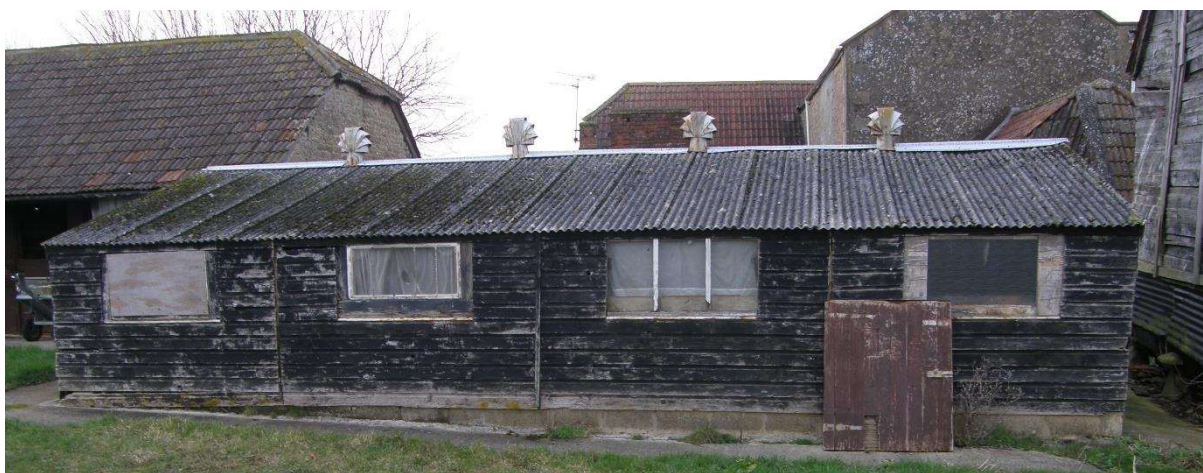
Adjoining the granary on the west side is a timber dairy with a corrugated iron roof, built after 1924 (**fig.65**). It is mentioned in the sale particulars of 1927. Interior not seen.

**Fig.65 Dairy between 1924-7, south elevation**

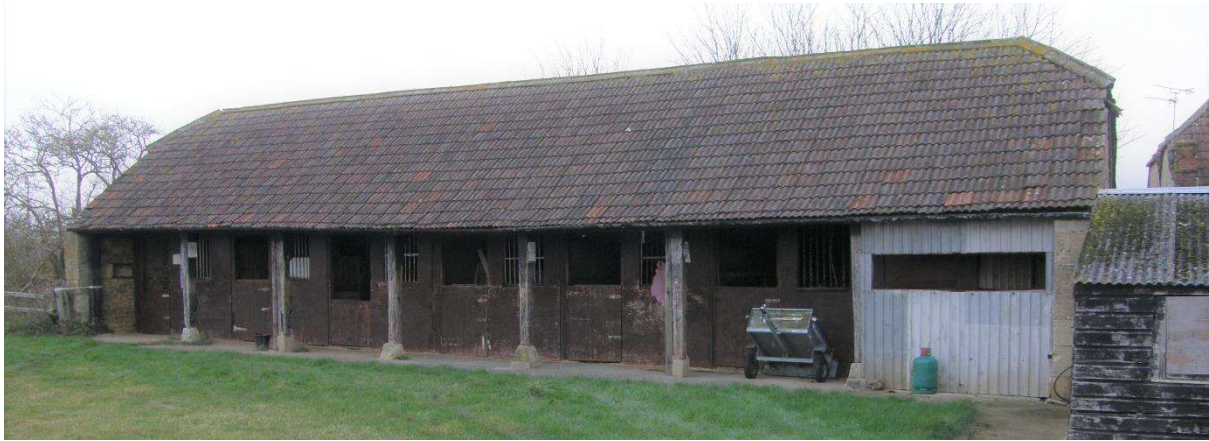
Adjoining to the east of the dairy is a former 8-bay stone with triple Roman tile-roofed cowshed altered during the earlier 20<sup>th</sup> century to a cart-horse stable (**fig.66**). On the Ordnance Survey mapping of 1886 it is shown as an open-fronted building. The stable fittings were added subsequently. The interior partitions are evidently later and the ceiling made up of a mixture of materials including metal rods (**fig.67**). The front of the stalls cuts across wall-cupboards at either end (**fig.68**) The roof has a typically 19<sup>th</sup> century king-post trusses.

***Fig.66 Cart horse stable, south elevation***

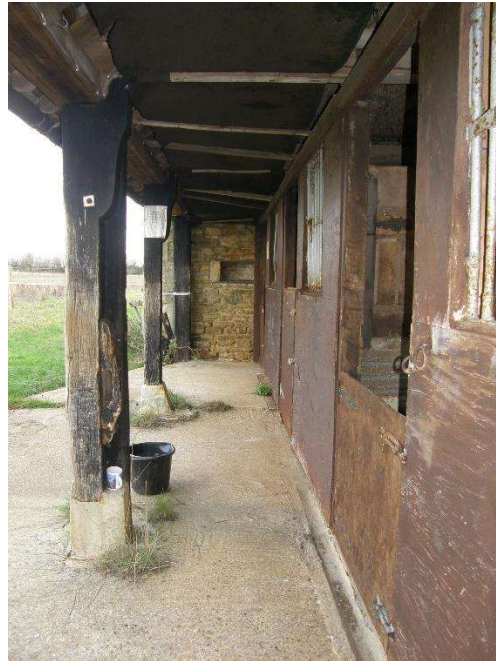
***Fig.68 View west along open front***
