## PRELIMINARY ECOLOGICAL APPRAISAL LAND & BUILDINGS AT SHOWELL FARM CHIPPENHAM, SN15 2NU

## PRELIMINARY ECOLOGICAL APPRAISAL

### LAND & BUILDINGS AT SHOWELL FARM CHIPPENHAM, SN15 2NU

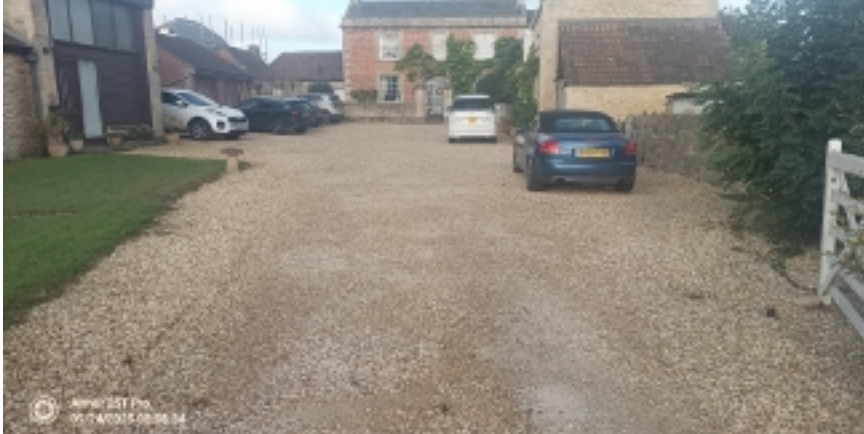
**Photo 1.** Showing access to site via existing grave drive and parking area

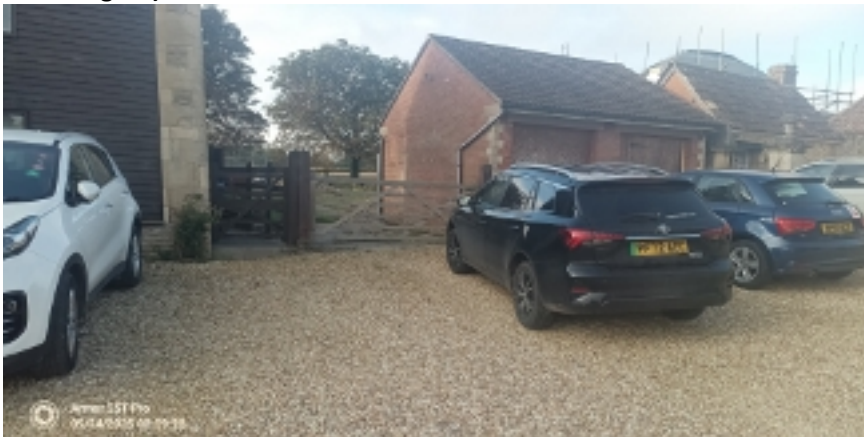
**Photo 2.** Access to site via gravel area between existing buildings (through five bar gate)

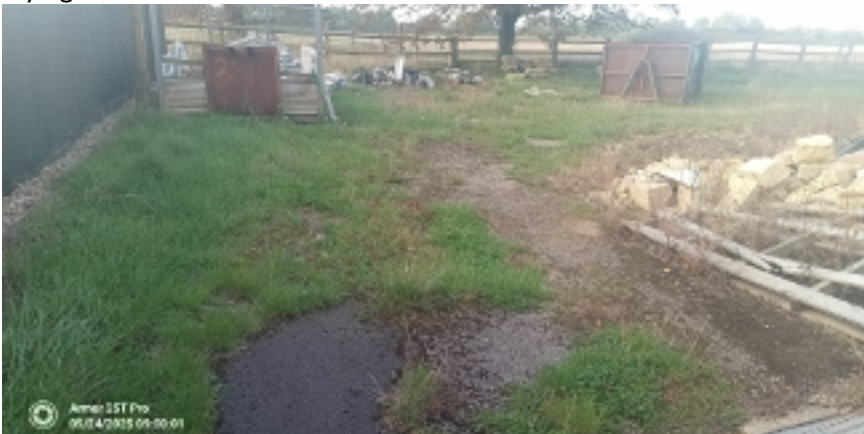
**Photo 3.** Showing eastern end of site looking south with tarmac hard yard area partly overgrown with grass with items including building materials laying around.

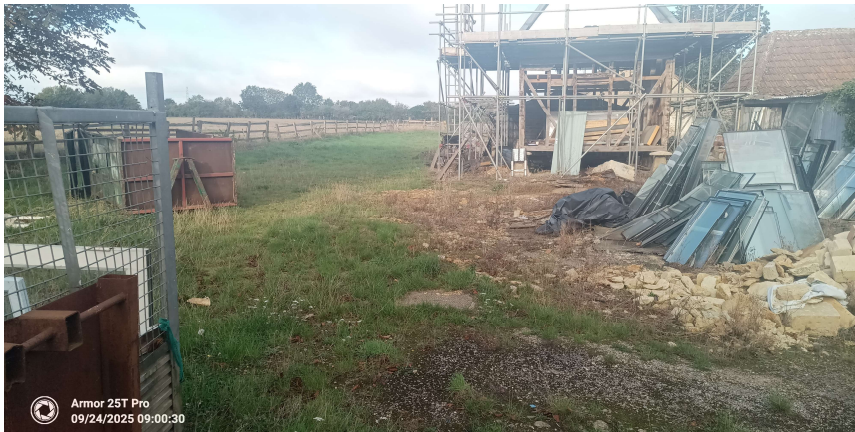
**Photo 4.** View of site looking west with piles of building materials and other items in places. The Old Granary building (with scaffolding) can be seen in the middle distance.

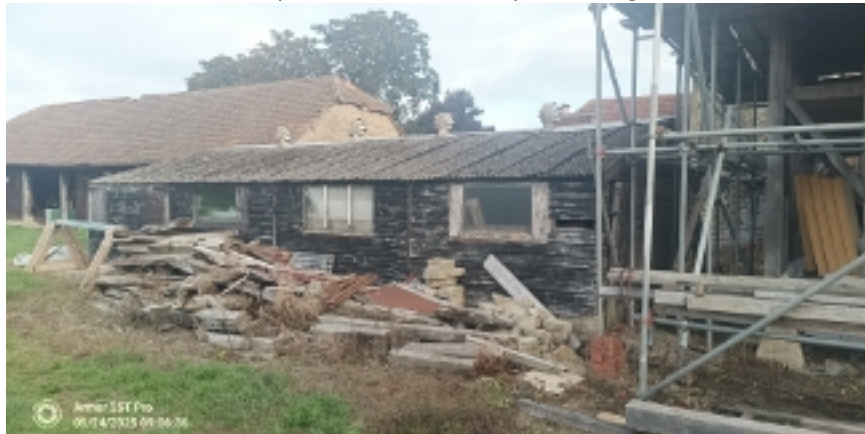
**Photo 5.** Looking north-west with the Cart Shed to the left, the large timber shed in the centre and part the Old Granary to the right

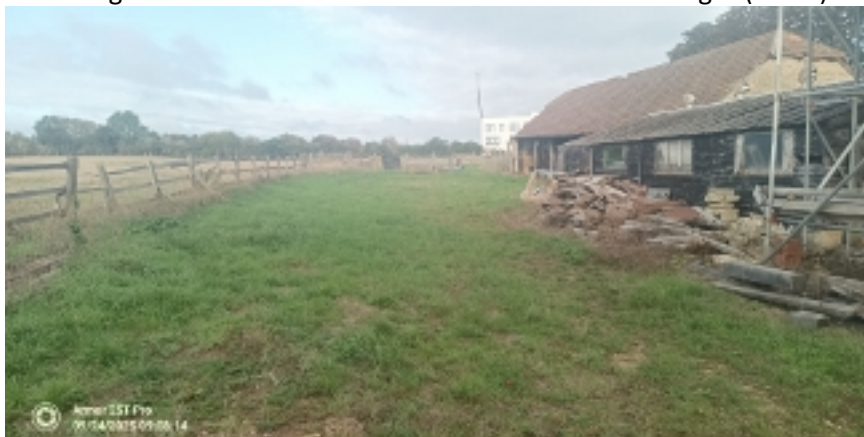
**Photo 6.** Showing the site looking west with the improved grass field in centre & the large the timber shed & then the Cart Shed on the right (north)

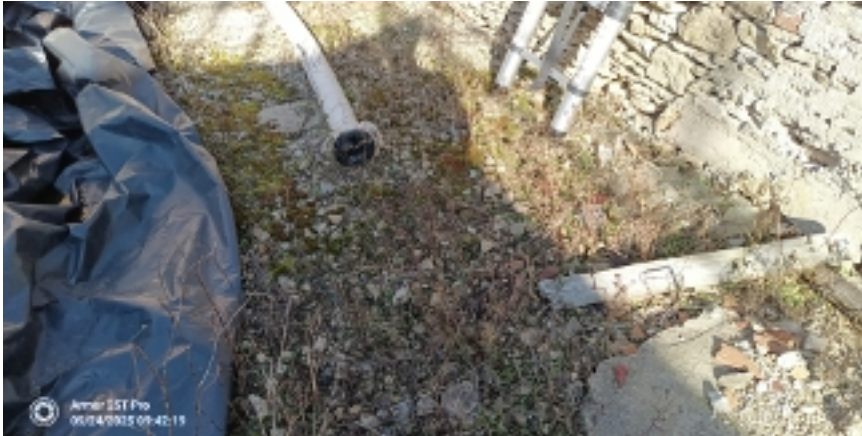
**Photo 7.** Showing of the part area between the timber shed and garden wall

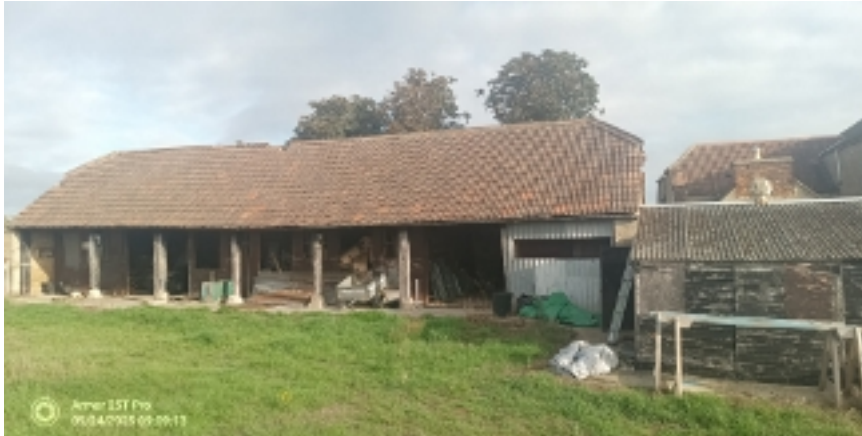
This open fronted farm building of some age was of a timber frame construction with an apex roof clad with Roman clay tiles with no underlining or roof void (please see Photos 8-12 below). No signs of bats were found in or outside of the building. This building was assessed as having an intermediate bat roost suitability. Please see section 6.1 Bats of section 6. Conclusions and Recommendations below.

**Photos 8.** Showing open fronted barn/shed called the 'Cart Shed'

- **An ecologist licensed by Natural England to survey for bats should carry out presence/absence surveys of the Cart Shed and Lean-to shed. In the case of the Cart Shed, this would involve a minimum of two separate visits; one dusk emergence and one pre-dawn return survey carried out between May and**

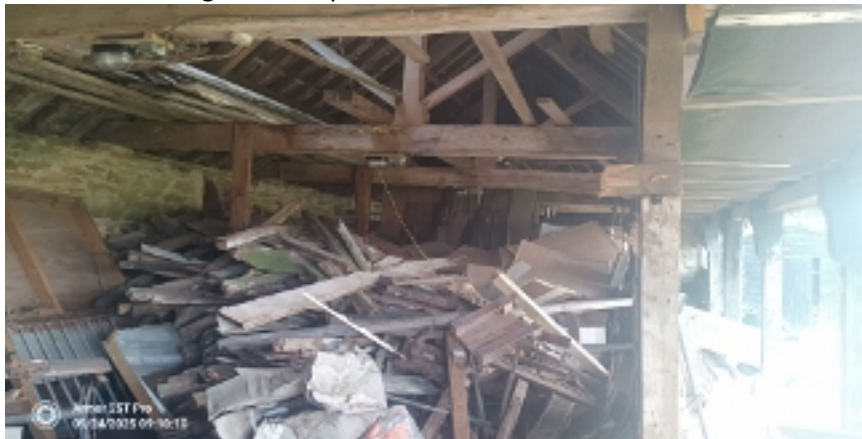
**Photo 9.** Showing inside of part of the cart shed

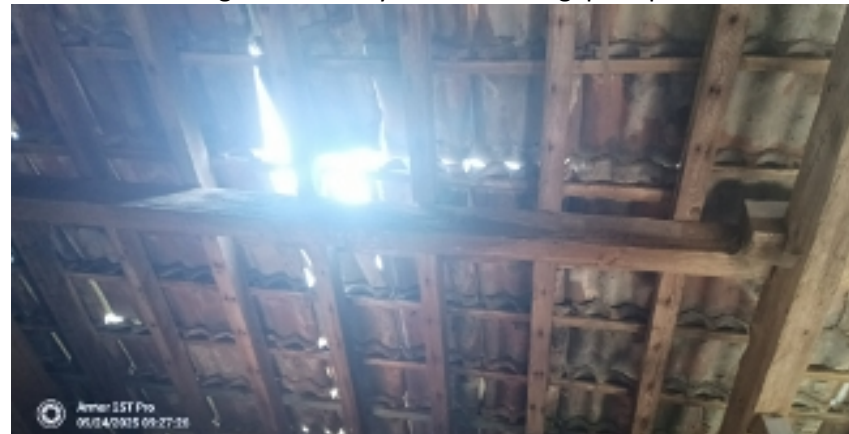
**Photo 10.** Showing un-lined clay tile roof with gaps in places

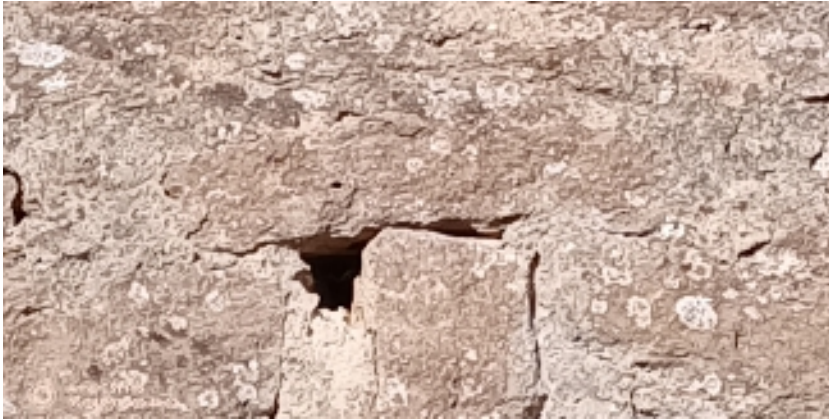
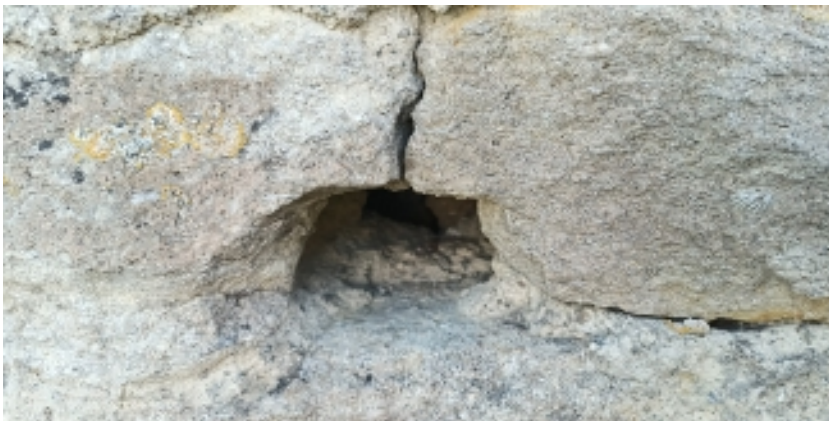
**Photos11.** Showing cavities in stonework of the west gable end wall of the Cart Shed offering some potential as a bat roost location

The timber shed and the Granary were assessed as having a Negligible bat roost suitability. The Cart Shed had a number of cavities in the stone work at the gable ends which could be used by bats for roosting and there is always the possibility that individual bats might roost within the building in gaps between timbers/joints for example. In view of the holes in the walls, which appeared to go in some way, this building was assessed as having Moderate bat roost suitability. The Lean-to shed was assessed as having a Low bat roost suitability.

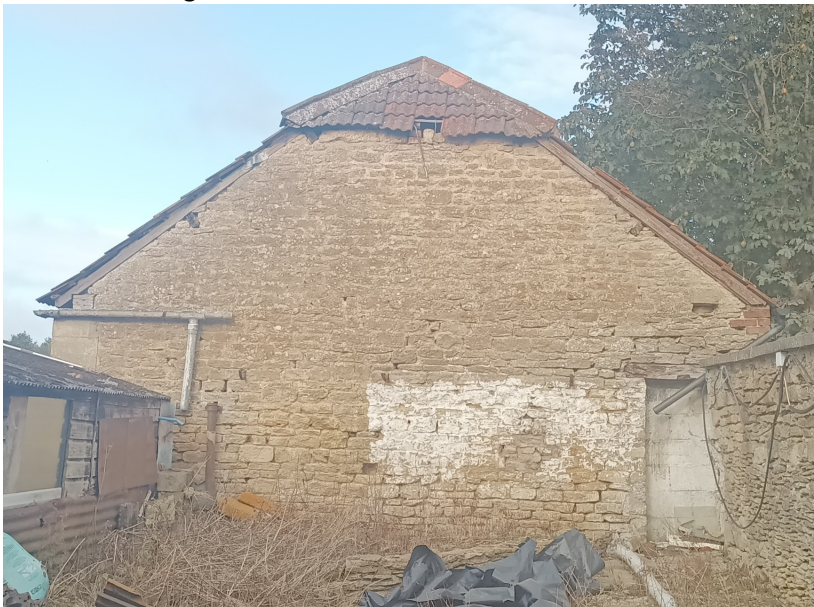
**Photo 12.** East gable end of Cart Shed with some holes in the laid stone

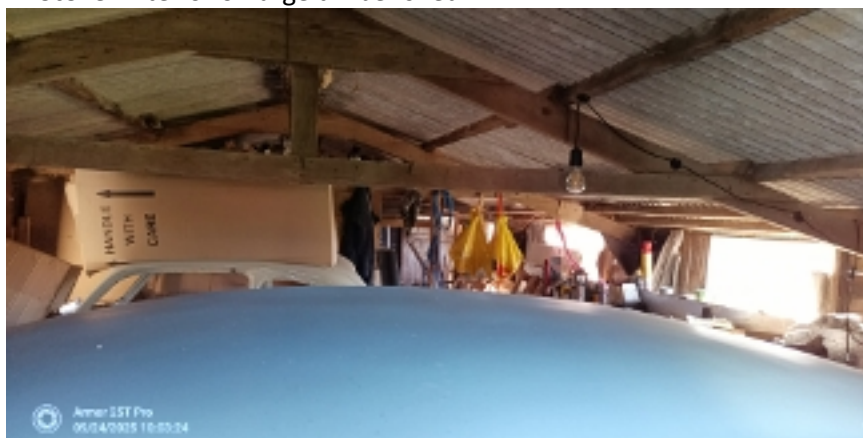
This shed consisted of a large shed clad with timber boarding on a timber frame with a shallow apex and timber frame roof clad with corrugated asbestos type material roof with no cavity or underlining. There were a number of windows on the south facing wall allowing ample light into the building. This shed was being used for the storage of cars and other materials (please see Photo 13 & 14 below). No bat signs were found in this building. The building was assessed as having a negligible potential as a bat roost.

**Photo13.** Interior of large timber shed

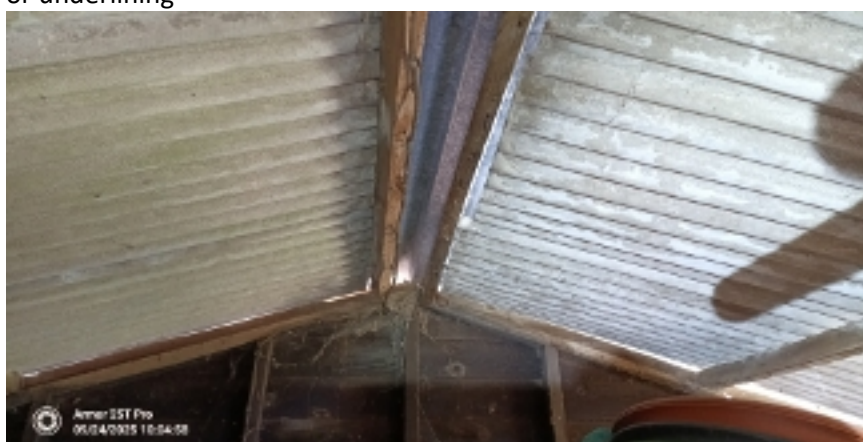
**Photo 14.** Internal corrugated asbestos type material roof with no cavity or underlining

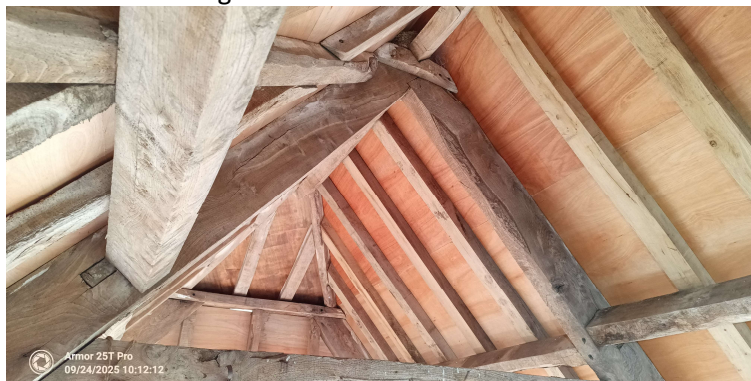
This old timber framed granary building, sitting on staddle stones, was undergoing significant building works at the time of the Appraisal and as such, the sides of the building were almost completely open giving full daylight. The roof had foam insulation with plywood boarding beneath where the tiles would sit, but the roof was not clad with tiles at that time but was covered with a temporary plastic sheet. No signs of bats were identified within this structure and it was assessed as having a negligible bat roost suitability in its current state. Please see Photos 15-17 below:

**Photo 15.** Showing internal roof structure

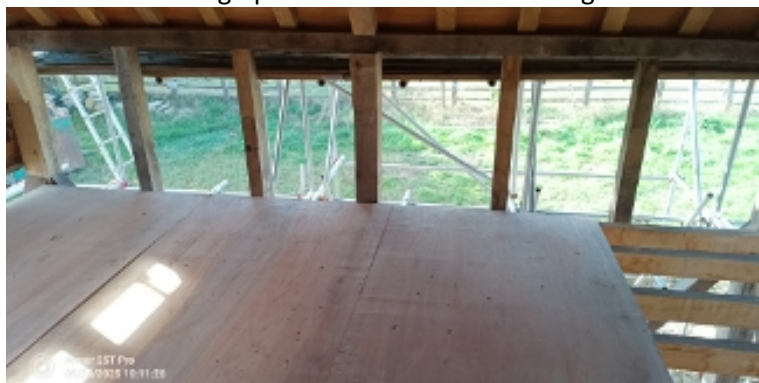
**Photo 16.** Showing open unlined sides of building

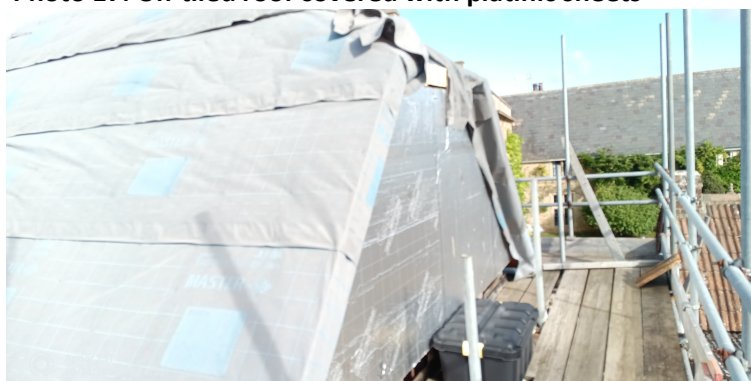
**Photo 17.** Un-tiled roof covered with plastic sheets

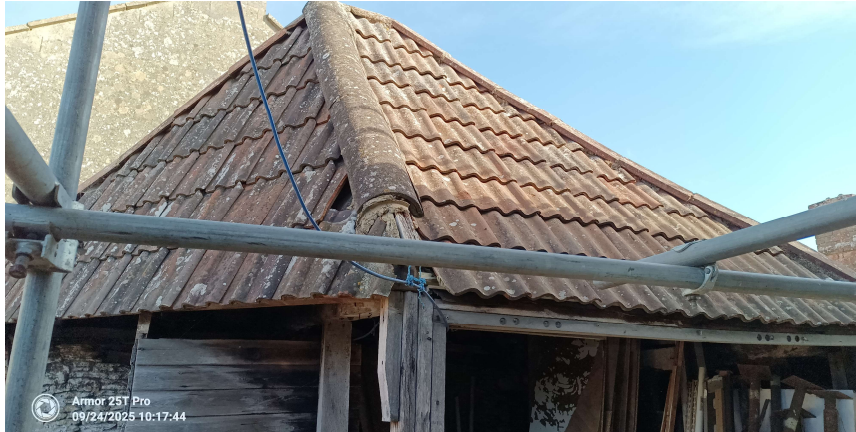
This building was a lean-to shed off a wall surrounding Showell Farmhouse garden to the north. The building consisted of a timber framed open fronted structure clad with Roman roof tiles the majority of which had no underlining, although the tiles to the front did have bituminous felt beneath. There was no roof void and the inside of the shed was fairly well lit with daylight (please see photos 18-19 below). No signs of bats were identified within this building. The Roman clay tiles with felt beneath could potentially be used by some species of bats as an occasional roosting location outside of the hibernation period. This structure was assessed as having a Low roost suitability. Please see section 6.1 Bats of section 6. Conclusions and Recommendations below.

**Photo 18.** Showing lean-to shed

September, with at least one survey between May and August. The Lean-to shed would require a minimum of one dawn emergence or one dusk return survey between May and August.

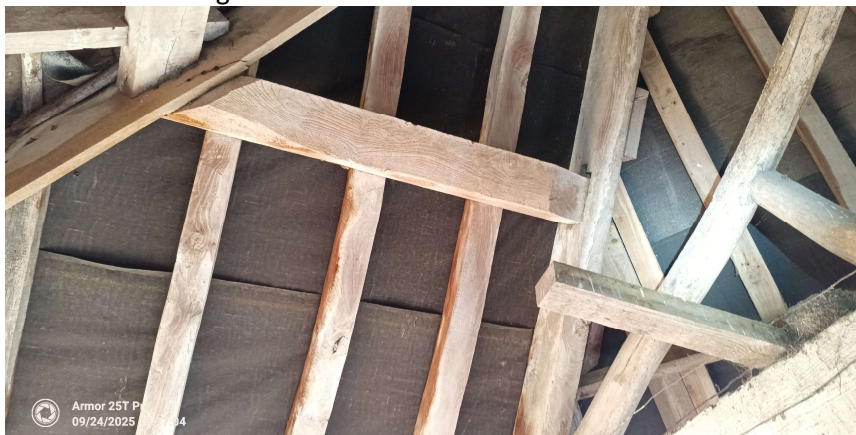
**Photo 19.** Showing some roof tiles underlined with felt

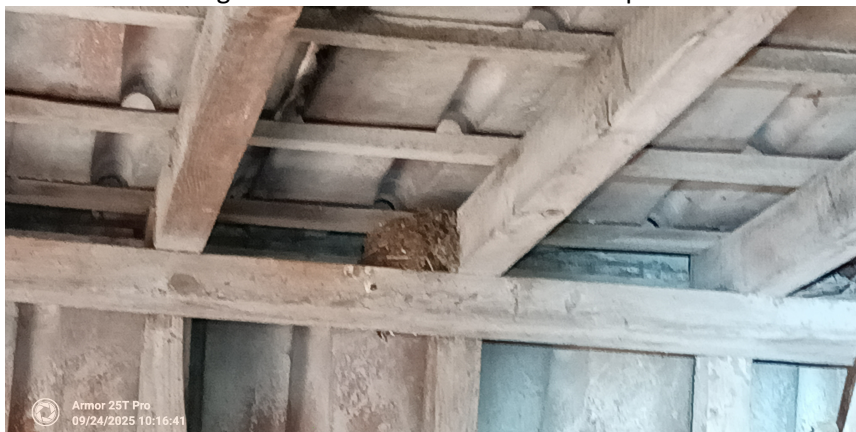
A number of swallow nests were identified on roof beams within the Cart Shed and two were identified on beams in the lean-to shed (please see Photos 20 & 21 below). The other two buildings offered some low potential as bird-nesting habitat and no other nests were identified. Please see section 6.2 Nesting Birds of section 6. Conclusions and Recommendations below for precautionary advice to protect nesting birds along with mitigation/ enhancement advice.

**Photo 20.** Showing swallow nest on roof timber of open fronted section Cart Shed

- Ideally, any building work affecting the buildings should be undertaken outside of the bird-nesting season (which is March-August inclusive *although birds can sometimes nest outside of this period*). It is important to remember that nesting birds can become trapped within a building or exclude from a nest site if existing gaps in walls, roofs and doors are blocked during the nesting season. However, if it is deemed essential to carry out works during the nesting season then the area of works should be checked by the ecologist prior to the work. If it is deemed likely that a nesting birds will be disturbed then the works will be delayed until the fledglings have left the building/nest.

- **Mitigation & enhancement measures to replace the loss of the swallows nests and give a net gain for birds should be included as part of the development, should it be given consent. We would recommend the installation of a number of swallow nest boxes under the eaves of the converted buildings. This would replace the existing nests with more nesting locations than would be lost. These boxes should be included on the design drawings with input from the ecologist in terms of type and siting.**

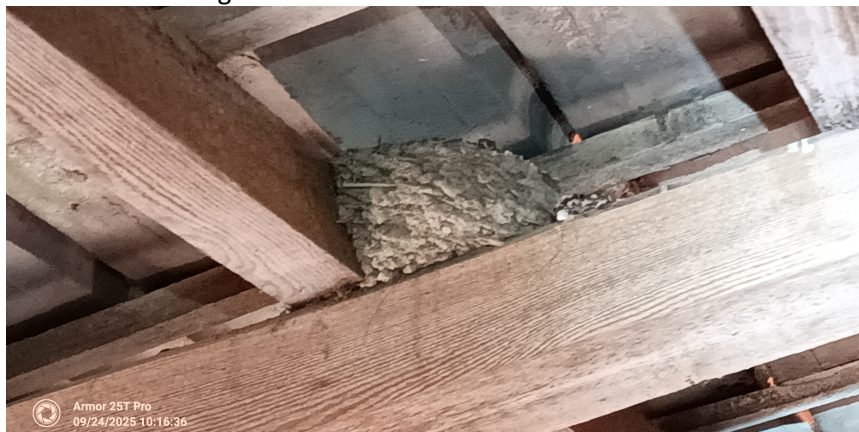
**Photo 21.** Showing swallow nest on roof timber of extension shed

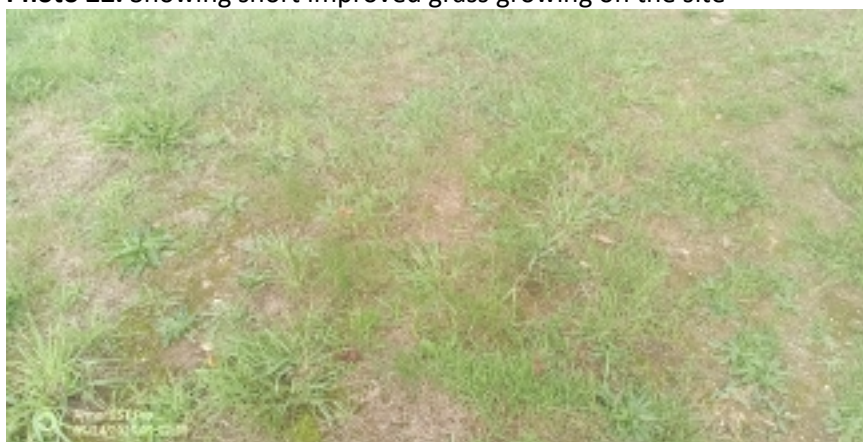
The site consisted of buildings, a tarmac hard standing (partly overgrown by short grass) along with an area of short improved grass (please see Photo. 22 below) which we understand is cut regularly. There were some piles of dumped building waste on the site. The habitats on the site were assessed to have a low potential to support reptiles. The Data Search found 7 records of slow worm, 4 records of grass snake, 1 record of adder and 1 record of viviparous lizard from within 1km of the site (not close to the site). No further survey for reptiles was considered necessary.

**Photo 22.** Showing short improved grass growing on the site
