PHASE 1 & 2 BAT SURVEY REPORT

CLARKS MILL AND MILL HOUSE  
STALLARD STREET  
TROWBRIDGE  
BA14 8HP

JULY 2018

ON BEHALF OF GREENWARD ASSOCIATES

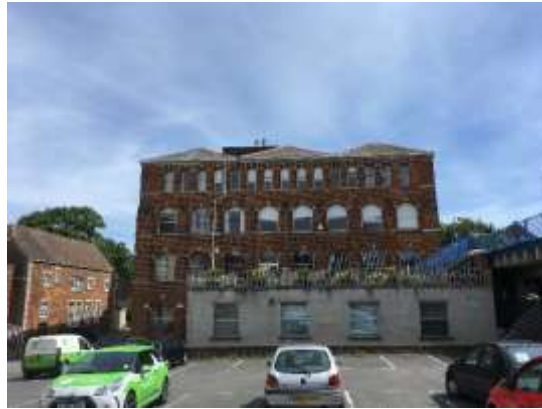
Photo 2: South west elevation

Swifts (*Apus apus*) were observed emerging and re-entering in the gaps in between the gutter and the wall on the south western corner of Clarks Mill. Herring gull (*Larus argentatus*) chicks were observed on the flat roof of Clarks Mill and wood pigeons (*Columba palumbus*) were nesting in the tower.

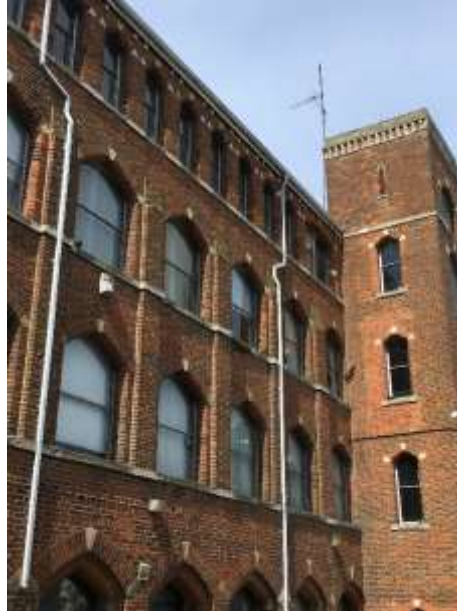
Photo 4: View of tower and north east elevation

- The building is constructed from brick and stone and is four storeys high. The building is currently derelict.
- A brick tower comprising a stair well is located on the north-eastern elevation.

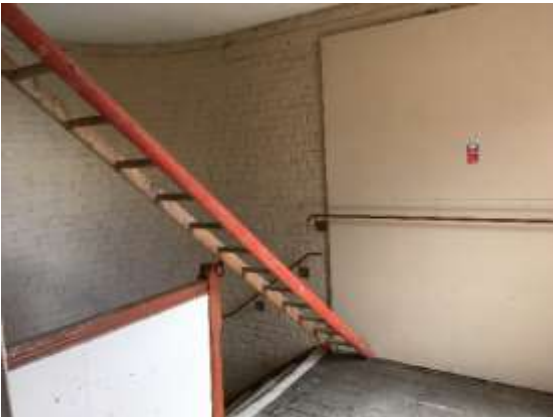
Photo 5: Internal view of tower

- A square tunnel leading to the roof was visible from the top floor with a metal grill covering.
- A void was present above the tower. The void is approximately 3metres high and brick walls were visible. Dense cobwebs were also noted.

- The tower itself has previously been used by pigeons with droppings recorded on the floor. A ladder leading to the void was noted however access was not obtained. Asbestos containing material was noted within this area.

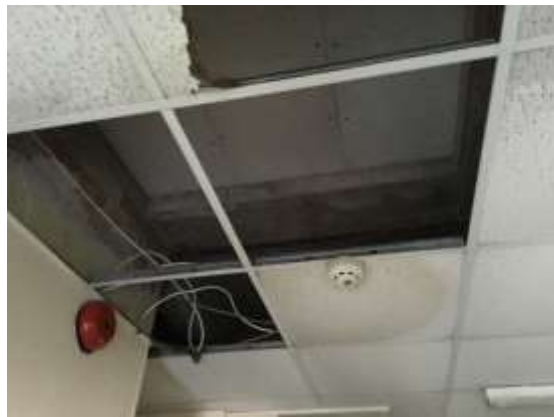
Photo 6: Internal view on top floor

- Window and door frames are aluminium in construction.
- No access into the roof voids were possible. The top floor comprised suspended ceilings with evidence of water damage in places, and potential asbestos coating in areas.

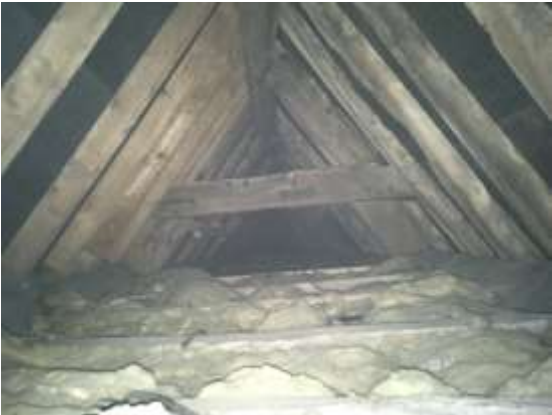
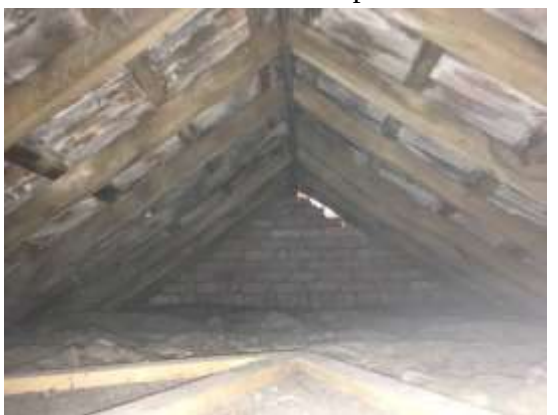
Photo 11: Roof void on south west elevation Photo 12: Roof void on north west elevation

- A roof void on the north western elevation is pitched and measures approximately 9 metres in length, 3 metres wide and 2 metres high. No roofing felt is present and the tiles are visible. Fibre glass insulation is present and evidence of wasp nests that had been treated along with dead wasps were recorded within the void and in the room below the void. Debris was present throughout due to numerous gaps. The gable end wall is constructed from brick whilst a plaster board wall is present where the void connects to the main void.

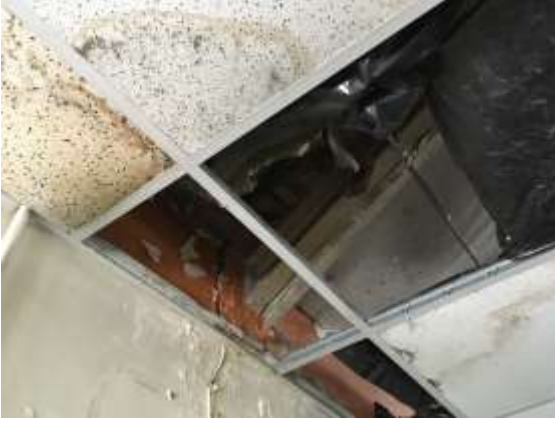
Photo 13: Internal view of single storey

- The single storey roof void is approximately 2 metres high, 20 metres in length and 9 metres wide. A suspended ceiling is present, but visibility into the void was available where ceiling panels had been removed/ damaged through water ingress. The void is partially pitched and flat and visibility straight into the glass void was recorded. The void was lined with plaster board, with bitumen under felt recorded in areas. Wooden rafters and steel supports were noted along with fibre glass insulation.
