Issued: January 2026  
Author: Stephen Twine

Issue 4: 16 January 2026

1.01 The following Design and Access Statement has been prepared to support an application for Listed Building Consent to carry out essential repairs to the existing Moat Bridge on the Devizes Castle site.

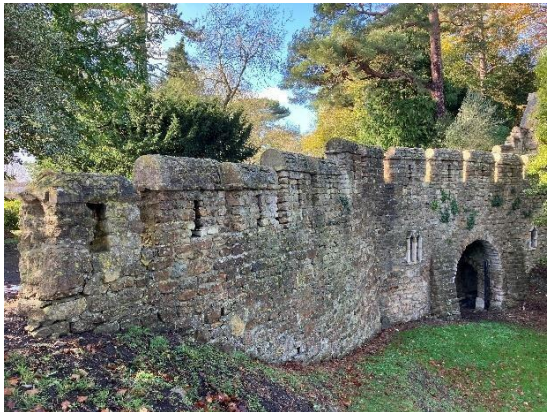
Fig 1: Moat Bridge East Elevation

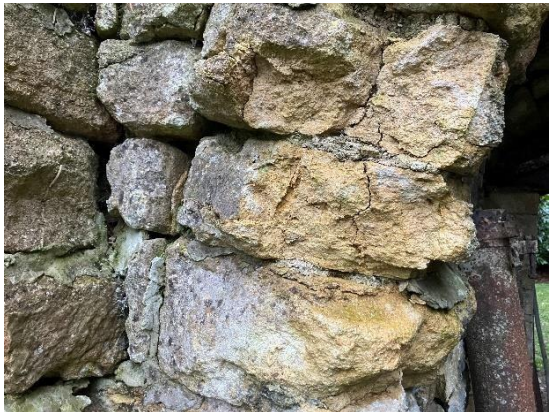
Fig 2: Left side of Arch 1

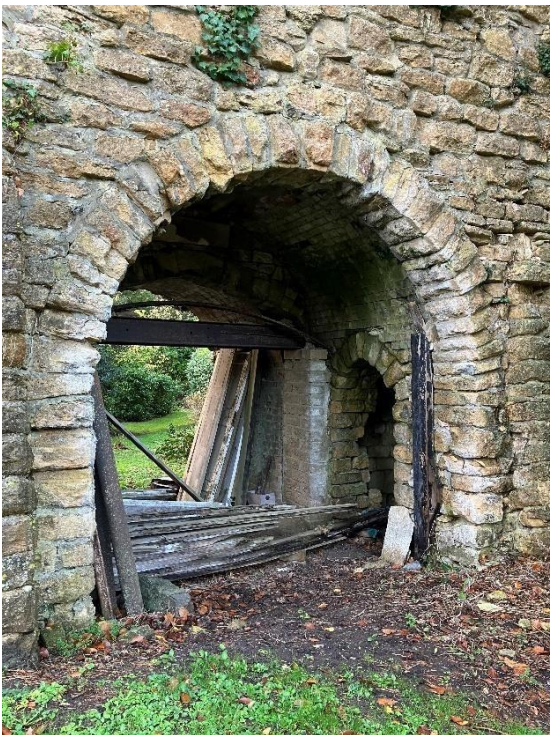
Fig 3: Arch 1 with doorway to Chamber 1

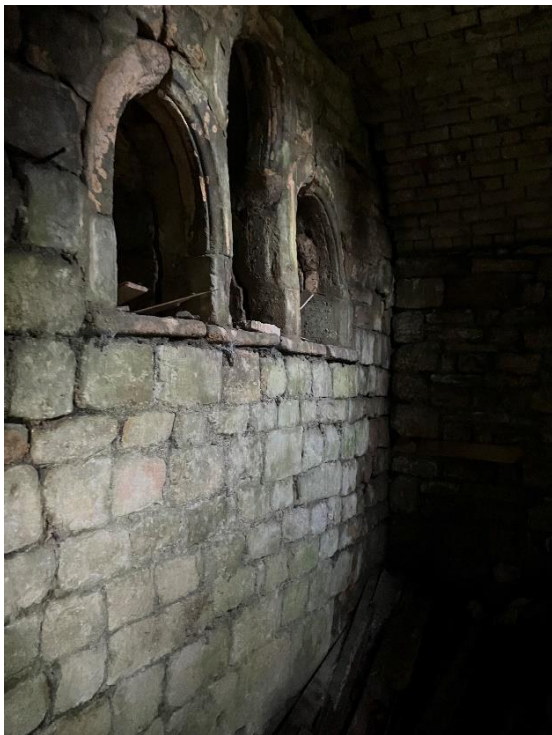
Fig 4: Window between Chamber 1+4

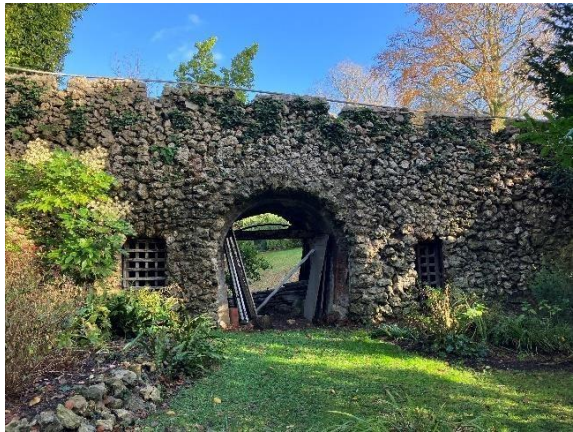
- 3.03 The west elevation of the bridge presents itself with a Tufa stone facing.

The ivy growth on this façade has been removed as part of maintenance works and to facilitate closer inspection of the condition of the Tufa stone facing, much of which is loose inadequately bedded.

Fig 5: Moat Bridge West Elevation.

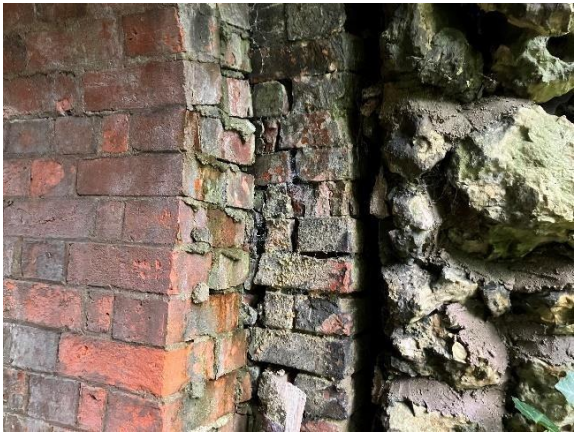
Fig 6: Brickwork to south side of Arch 2.

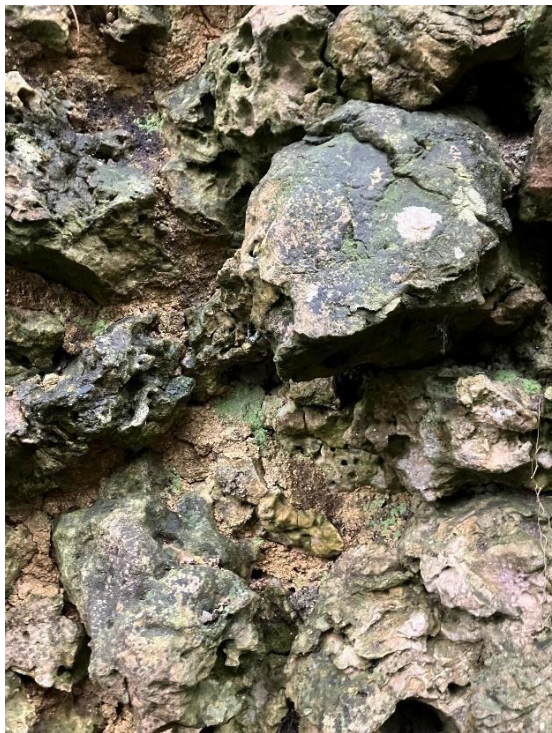
Fig 7: Tufa stone facing bedding mortar.

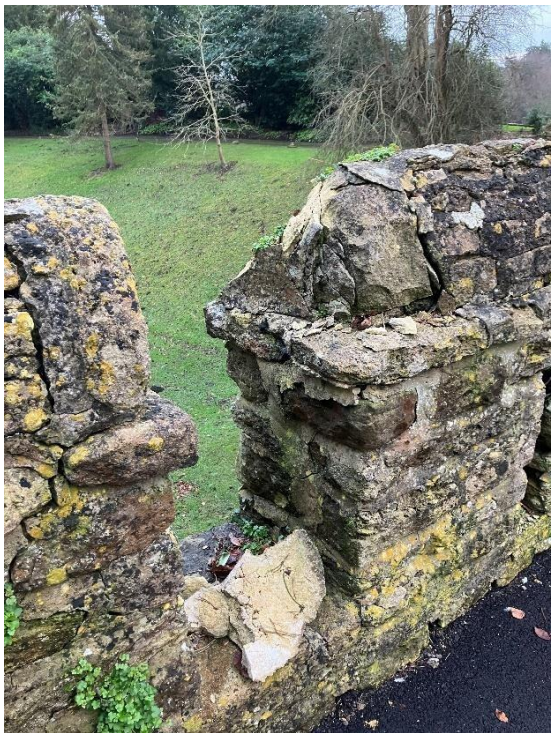
Fig 8: Hard Cement parapet pointing.

- 6.02 The removal of hard cementitious pointing (relatively shallow surface pointing) will allow the raking out of existing joints to a depth of at least 40mm and will provide an adequate bedding for the stonework, much of which has minimal bedding. Informed by mortar analysis, suitable repointing can be carried out in lime-based mortars which will relate more closely to the original mortar mixes used and reduce the aggressive decay and spalling occurring in the masonry.

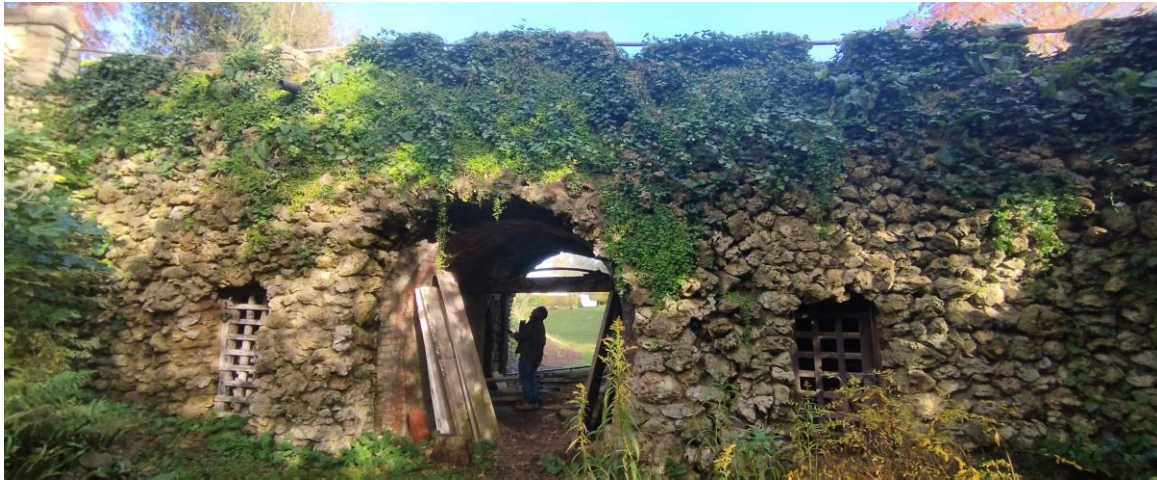
The principal area of concern is the cracking and displacement on the western side of the bridge and the need to tie the bridge back together where the different phases of work have separated, and where structural collapse has left voids of unbonded sections of masonry.

Fig 9: West Elevation outer facings to be tied back to internal structure; vegetation to be removed and gaps grouted following anchors installation.

- A grid in Cintec anchors on the west face to tie back the outer walls and facings to the arches and bridge internal structure.
- Removal of debris and vegetation for gaps in structures, with subsequent grouting in conjunction with the Cintec anchors.
- Replacement of missing/collapsed areas of brickwork and stonework to ensure structural integrity of structure.
- Rebuilding of individual merlons and cappings where in poor condition or where displaced due to impact damage.
- Removal of modern block and steel beam structure from below main arch following Cintec Anchor repairs.
- Rebuilding of internal windows where fractured and collapsed – or consider propping via infilling with masonry 'plug'.

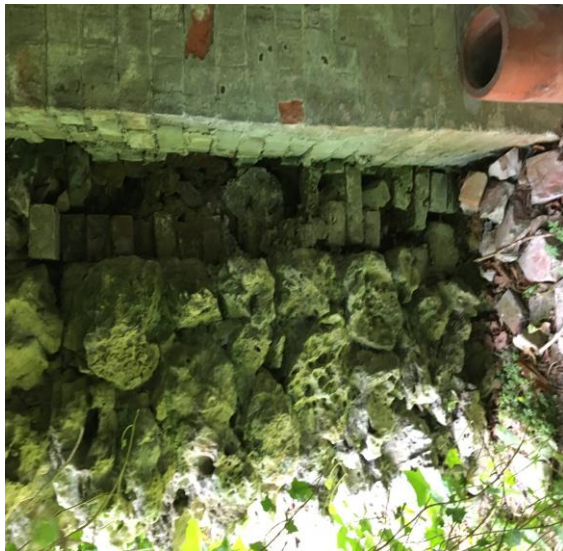
Fig 10: Collapsed brickwork at Western arch.

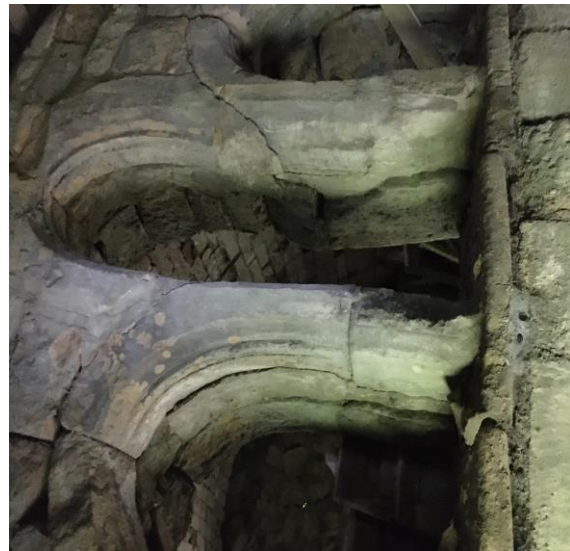
Fig 11: Fractured/collapsed stonework to internal windows.

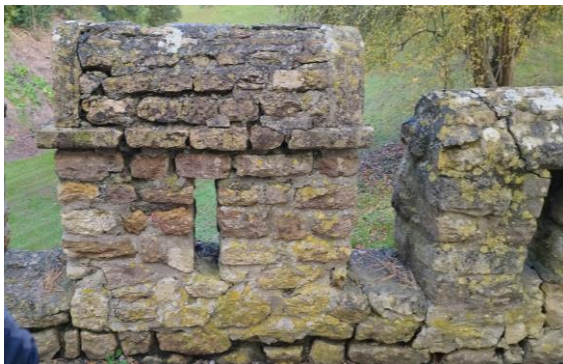
Fig 12: Merlon cappings to be rebuilt.

Conservation repairs, including some rebuilding of parapet walls (principally merlons and their cappings) will allow the bridge structure to weather correctly.

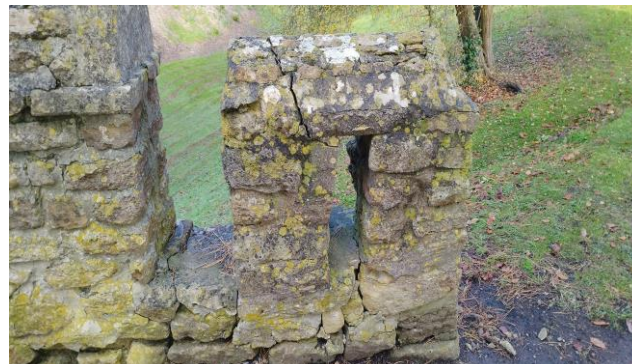
Fig 13: Merlon cappings to be rebuilt

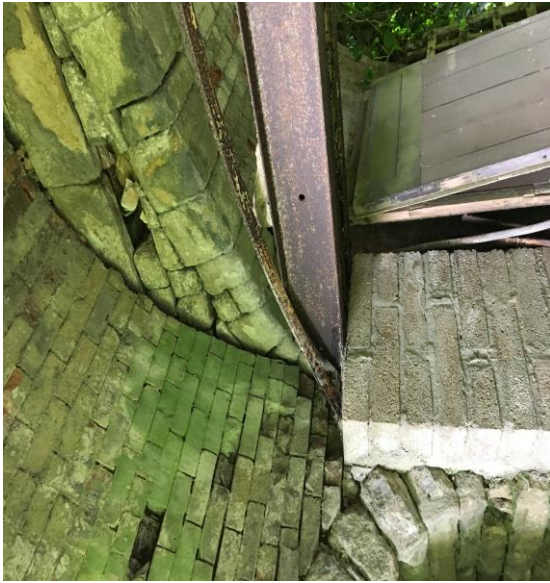
Fig 14: Block and steel beam support to be removed.

These structural repairs will allow the removal of the more recent unsympathetic repairs/support (blockwork piers and steel beams) from within the central arch and allow the structure to return to its original configuration.

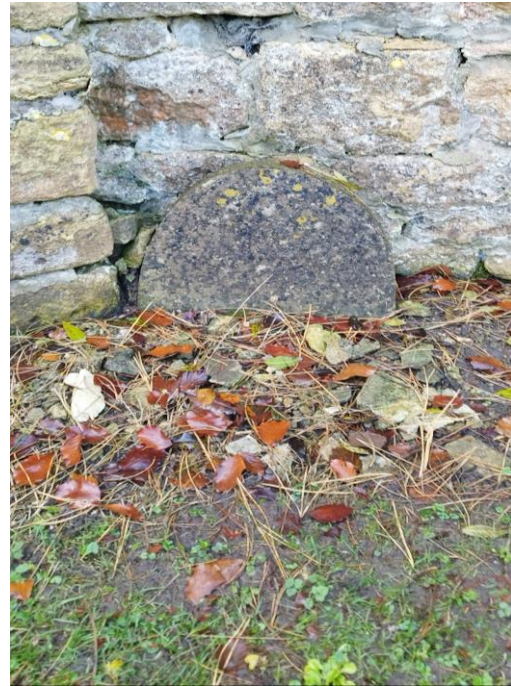
The masonry parapet walls on the east side are topped with a domed coping formed in bedded stone slips, with stone end blocks, a number of which have been replaced with concrete, while others are missing altogether.

Fig 15: Dislodged merlon end cappings to be reinstated.

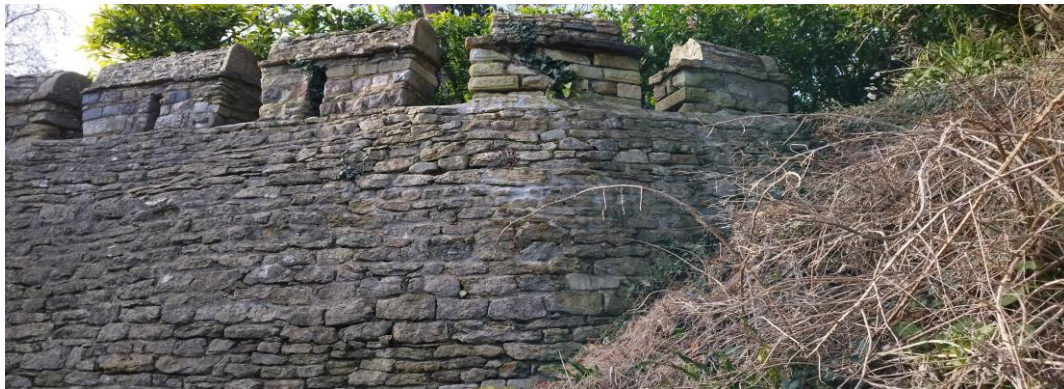
Fig 16: Areas of cement mortar pointing on East Elevation to be raked out and repointed using lime-based mortar.

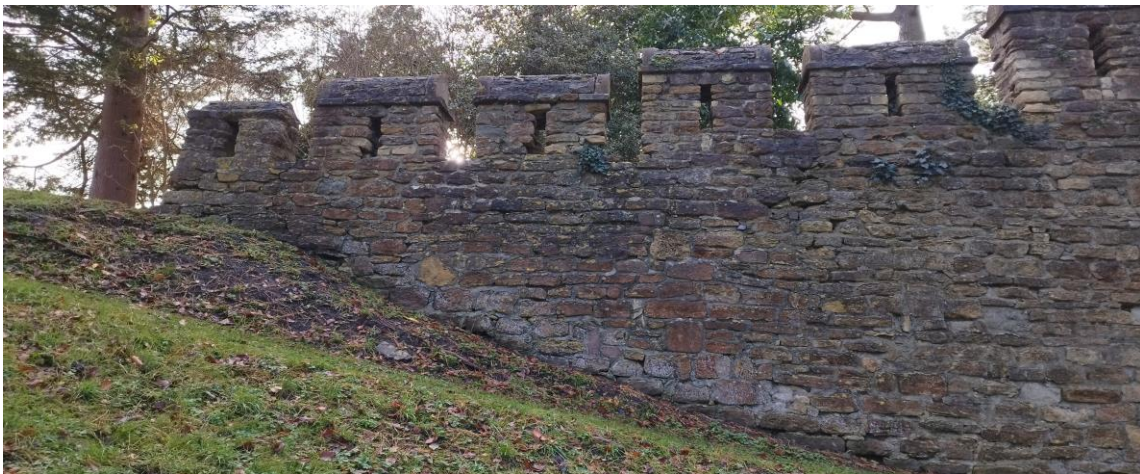
Fig 17: Areas of cement mortar pointing on East Elevation to be raked out and repointed using lime-based mortar.
