## UPDATED BAT SURVEY

BUILDINGS AT  
MANOR FARM  
LOWER ROAD  
ERLESTOKE  
SN10 5UE

| <b>Survey dates:</b> | 11 September 2024<br>12 September 2024 |

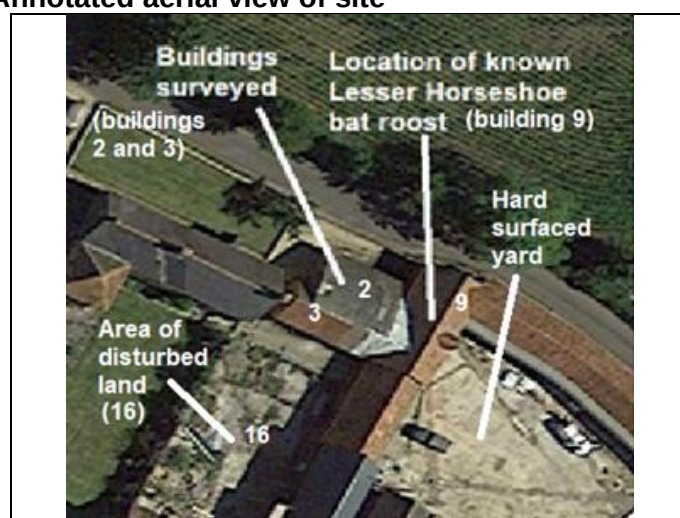
**Figure 2** Annotated aerial view of site

- 4.1.1** Only buildings 2 and 3 were surveyed since no evidence of bats or potential bat roost features (other than in the loft space of building 9) was found on previous survey of the other buildings on the site and the risk of bats being present in the other buildings was assessed as nil.

- 4.1.2** Buildings 2 and 3 had previously been identified as access routes being used by Lesser Horseshoe bats to the roost in building 9 and as dark flying space.

- 4.1.3** Building 3 remained as previously surveyed with dense climbing vegetation reaching up the wall to the roof on the south west corner of the building. Building 2 remained as previously surveyed although since previous survey a large rectangular opening had developed in the north east corner of the roof slope.

- 4.1.4** No bats were observed roosting within these buildings although no access was possible to the roof void of building 3 due to the unsafe condition of the floor. No bats were seen or detected flying within these buildings as a result of disturbance of survey on a warm late summer day.

- 4.1.5** Building 2 intersected with the roofs of building 9 and 3 at the eastern end and this connectivity remained. During previous survey Lesser Horseshoe bats had been observed flying through this gap into building 2.

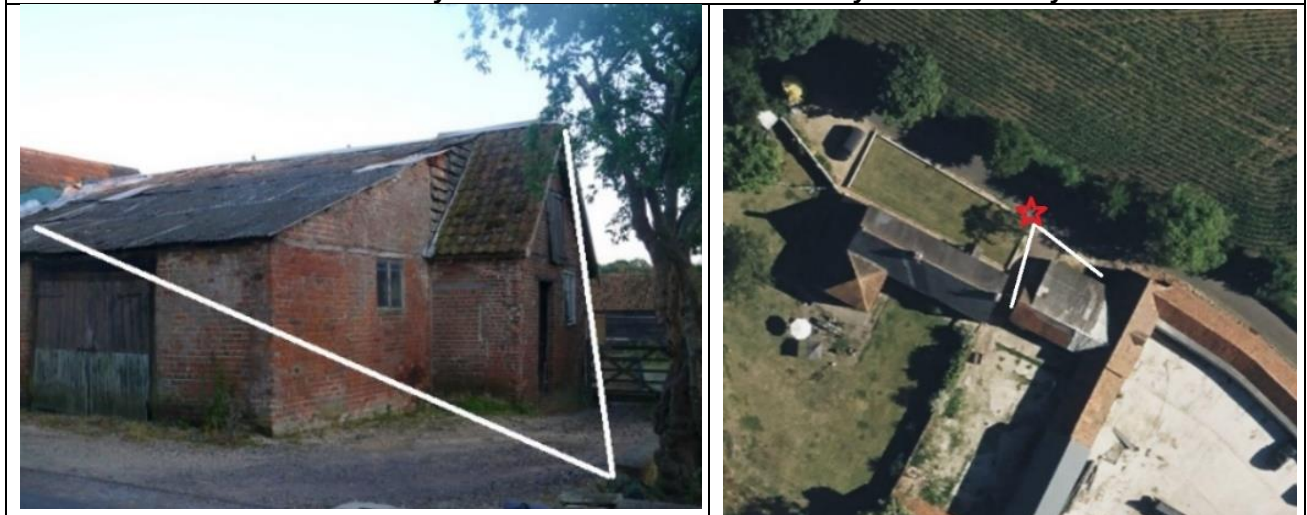
**Field of view indicted by white line and location of surveyor indicated by red star**

- 4.2.1** The focus of survey of 11 September 2024 was the northern and western elevations of the buildings surveyed. These elevations included the lean-to (building 2) with a monopitch roof and the western gable ended elevation of building 3 where some deterioration of the structure had occurred and timber weatherboarding was present.

- 4.2.2** No bats were observed emerging from the structure of these buildings but Common and Soprano pipistrelles were active in the area flying in from the west along the lane and through the gap between the building surveyed and adjacent farmhouse. These bats could be seen and detected feeding in the area to the south of the building surveyed together with bats which flew into this area from the south west.

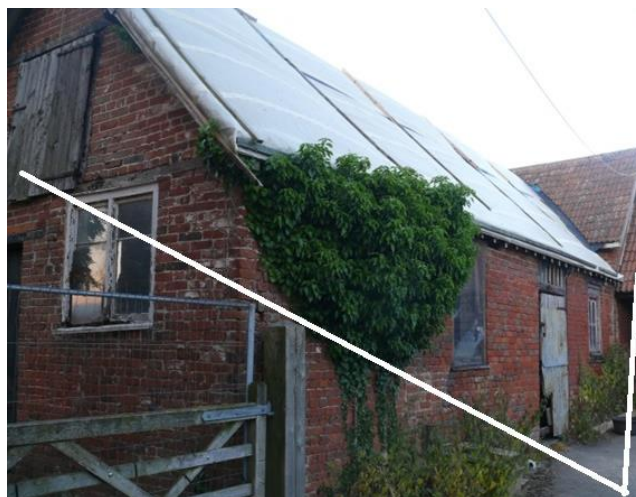
Field of view indicated by white line and location of surveyor indicated by red star

- 4.3.1** The focus of survey of 12 September 2024 was the southern and western elevations of the buildings surveyed. These elevations included the barn (building 3) and its western gable ended elevation where some deterioration of the structure had occurred and timber weatherboarding was present.

- 4.3.2** Lesser Horseshoe bat activity appeared reduced compared to the survey of the previous night when bats were very active within building 2 although some were observed emerging from gaps in the door present on the southern elevation of building 3 and detected and observed flying within its interior. Air temperature was several degrees lower than on survey of 11 September 2024. After emergence these bats seemed to prefer route through the covered passageway between buildings 8 and 9 flying through this in an easterly direction.

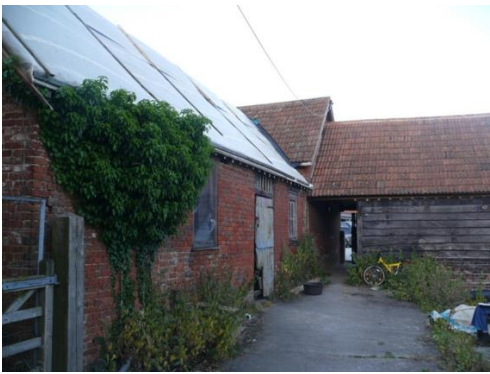
| Building 3 | |
|---|---|
| Southern elevation of building 3 showing growth of colonising ivy, intersection of the roof with building 9 and passageway between buildings 8 and 9 | Western gable end of building 3 |

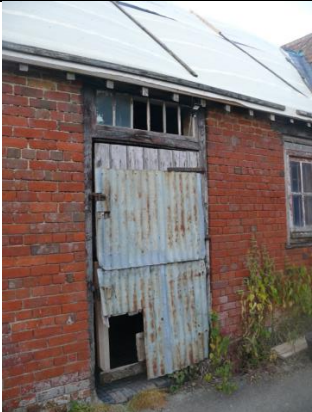
| Building 3 | |
|---|---|
| Timber and corrugated metal door with timber frame and likely former ventilation gap above, also showing window | Undersurface of roof void of building 3 showing surrounding pitching gap |

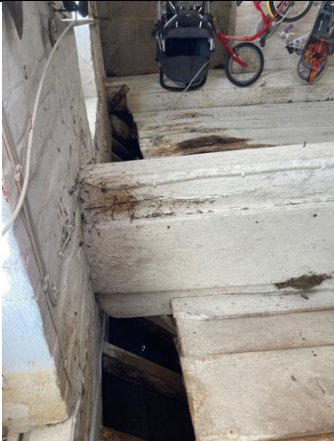
| Building 3 | |
|---|---|
| Undersurface of roof void of building 3 showing surrounding pitching gap | Gap between rafters of roof frame where the roof of building 3 intersects with the roof of building 9 (location of known Lesser Horseshoe bat roost) |

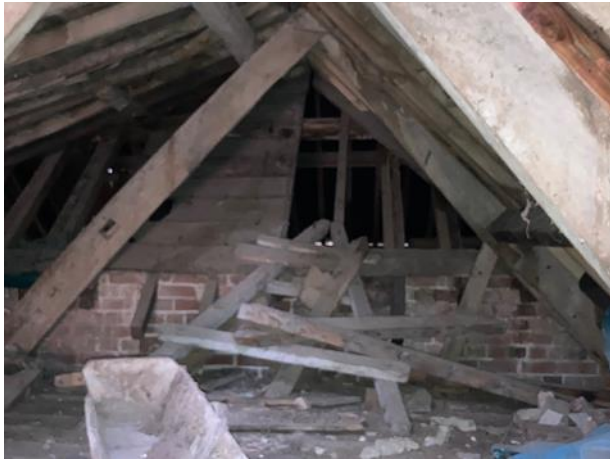
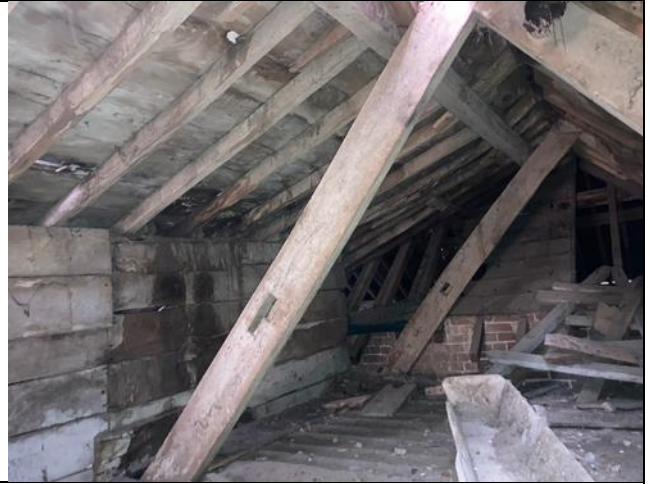
Roof void of building 3 taken by inserting camera through pitching gap

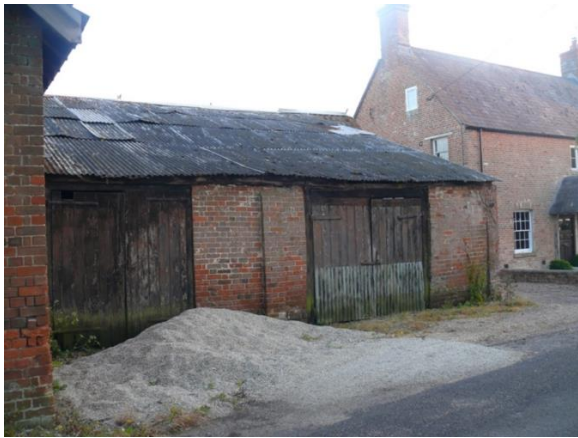
Northern elevation of building 2

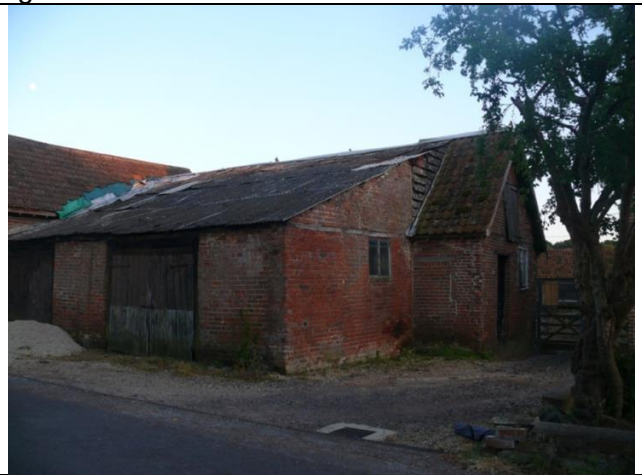
Western elevation of building 2 showing intersection with building 3

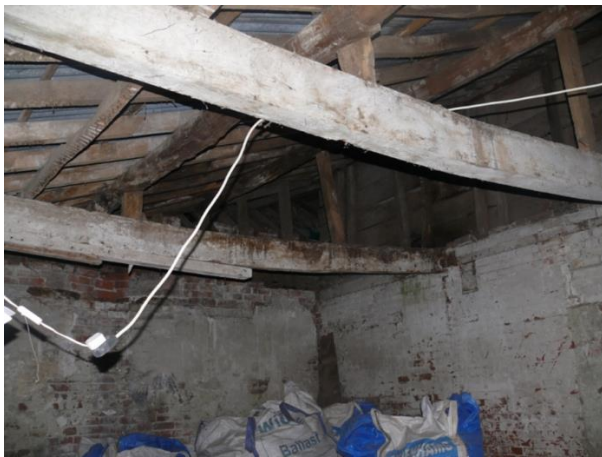
Eastern interior of building 2

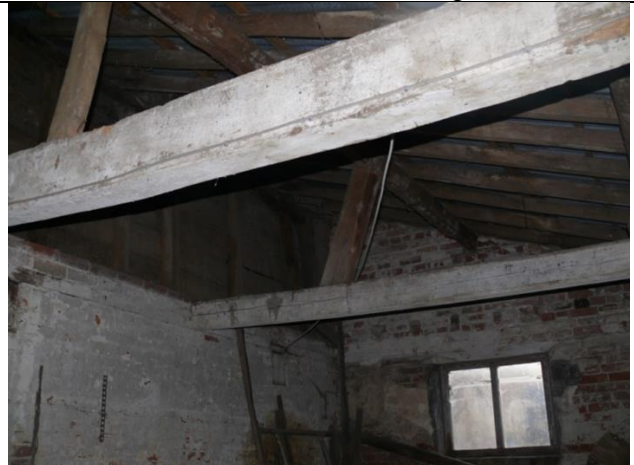
Western interior of building 2

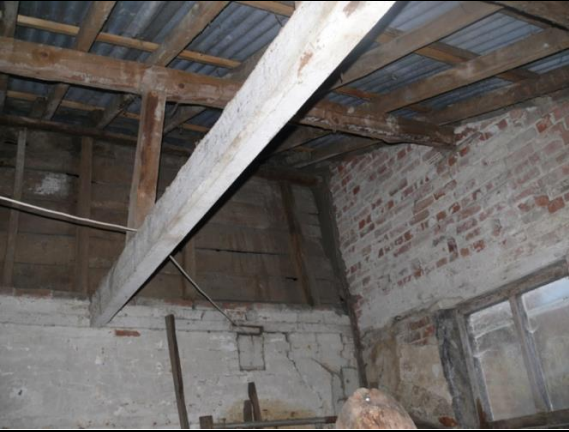
| <p>Unlined under surface of corrugated sheet metal roof covering and timber roof frame</p> | <p>Single skinned weatherboarding which tops the northern rear wall of building 2,</p> |

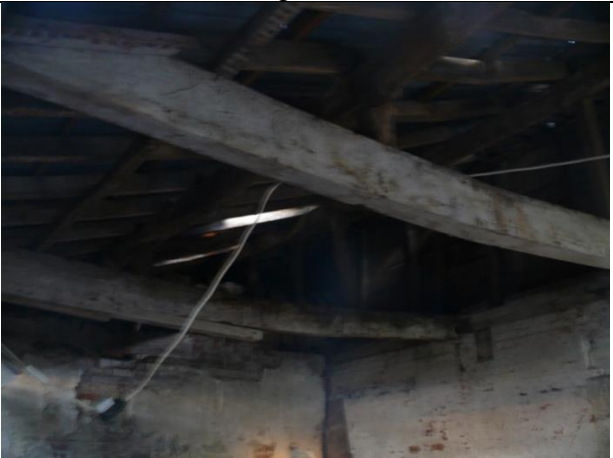
| <p>Light entering the dark interior of building 2 where corrugated metal roof sheet overlap</p> | <p>Intersection of roof frames of building 2, 3 and 9</p> |

- 7.3 A key element of this strategy should be the use of low transmittance glass to minimise the risk of spillage of domestic lighting on the routes used by Lesser Horseshoe bats emerging from the roost at dusk and careful design of external lighting.
