**New Petrol Filling Station & Retail store**

**At 101 Pickwick Road Corsham.**

## **Drainage Strategy Report**

**Report Ref : DSR-2537-R1**

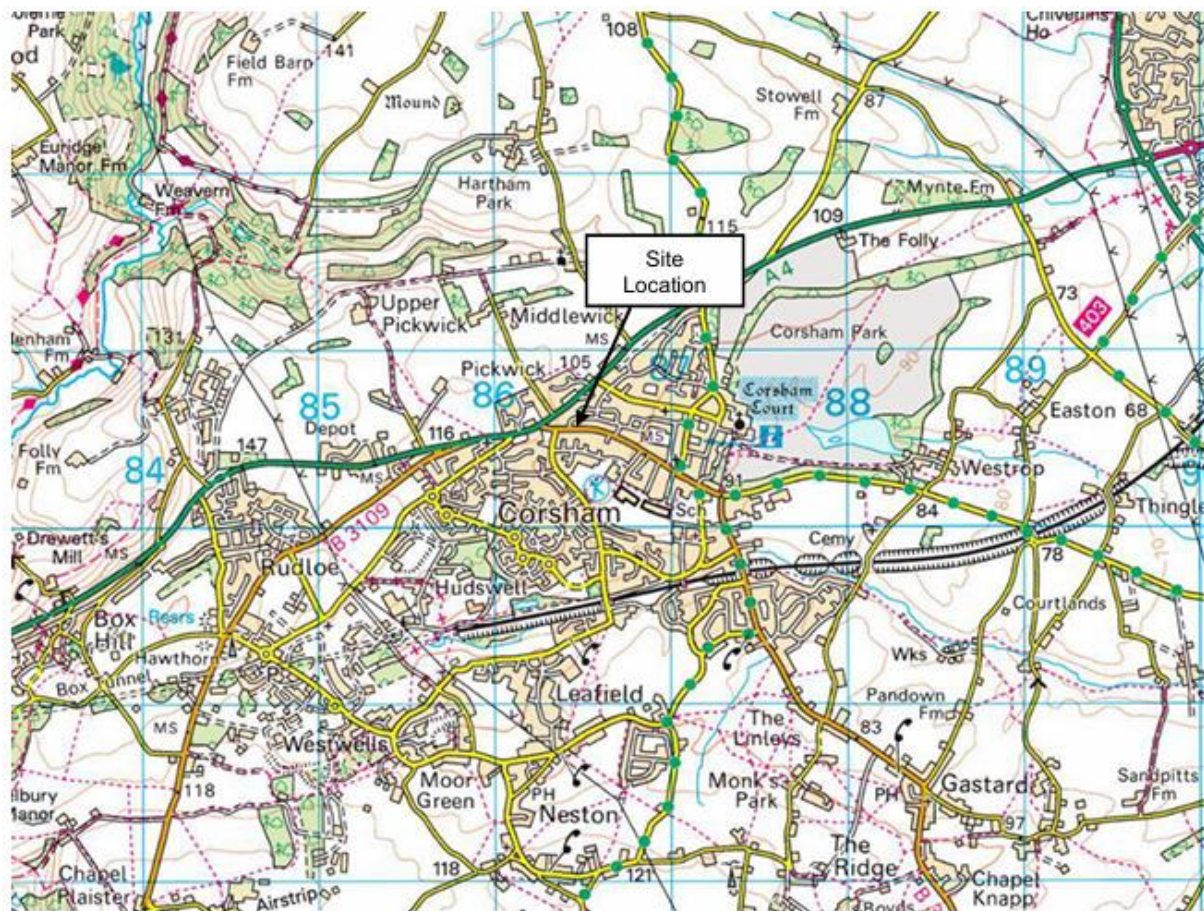
Figure 1 – Site location on ordnance survey map.

The site is located at 101 Pickwick Road in Corsham, adjacent to the junction with Dickins Avenue. Currently the site is occupied by a petrol filling station and is predominately covered with hardstanding. The area surrounding the site is residential. See Figures 1 & 2.
