# **WESTBURY CHALK QUARRY EXTENSION** **PLANNING APPLICATION**

## ***ENVIRONMENTAL STATEMENT***

**WESTBURY CHALK QUARRY**  
**Proposed Chalk Quarry Extension, Planning Application**

**Environmental Statement**

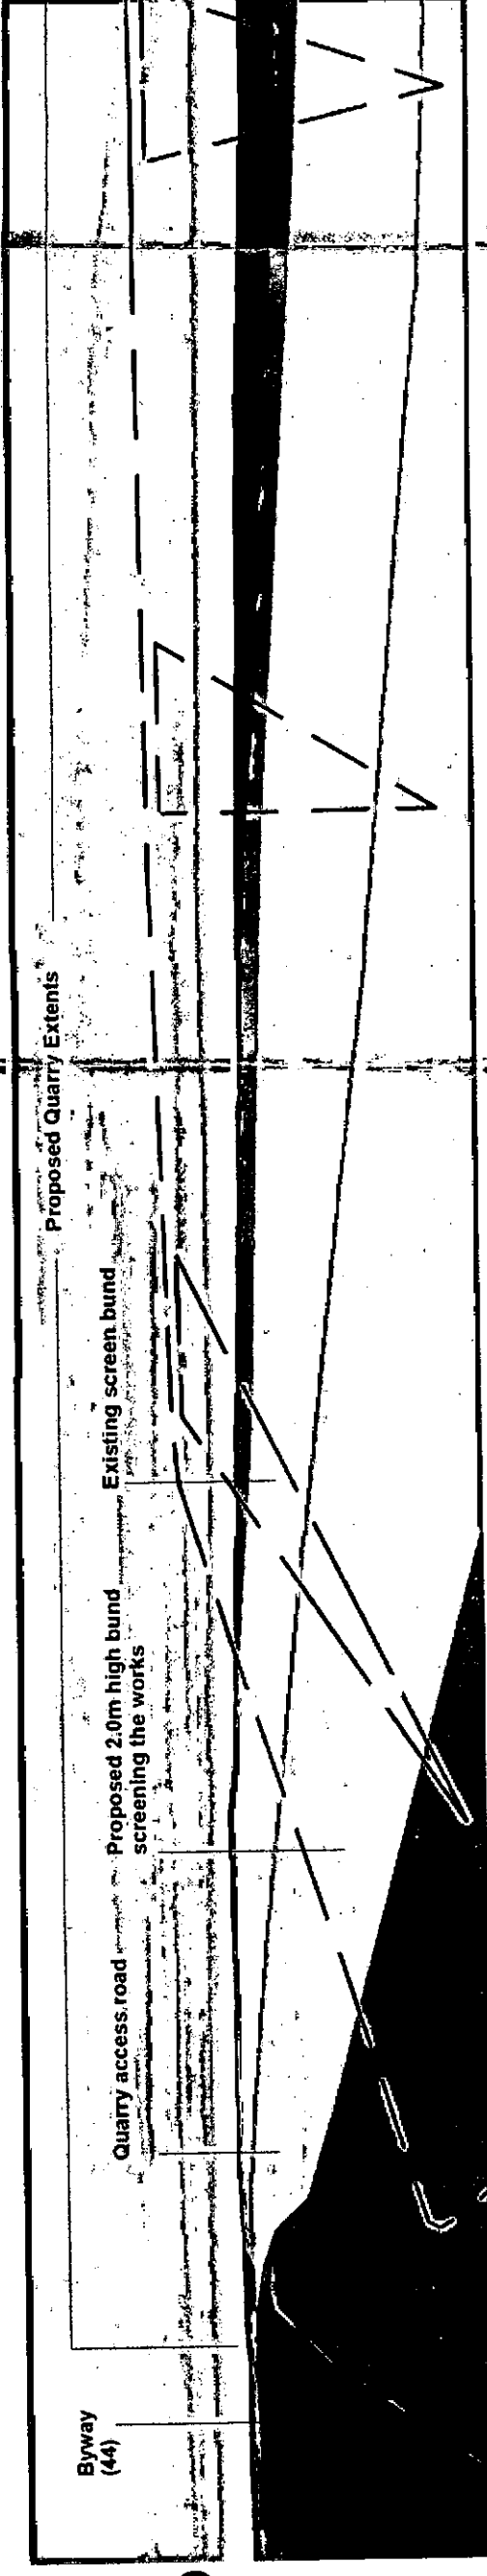
Drawing No.  
**5.19**

VIEWPOINT 1A (1 OF 2) - EXISTING CONDITIONS

VIEWPOINT 1A (1 OF 2) - COMPUTER MODEL OF PROPOSED PHASE 1

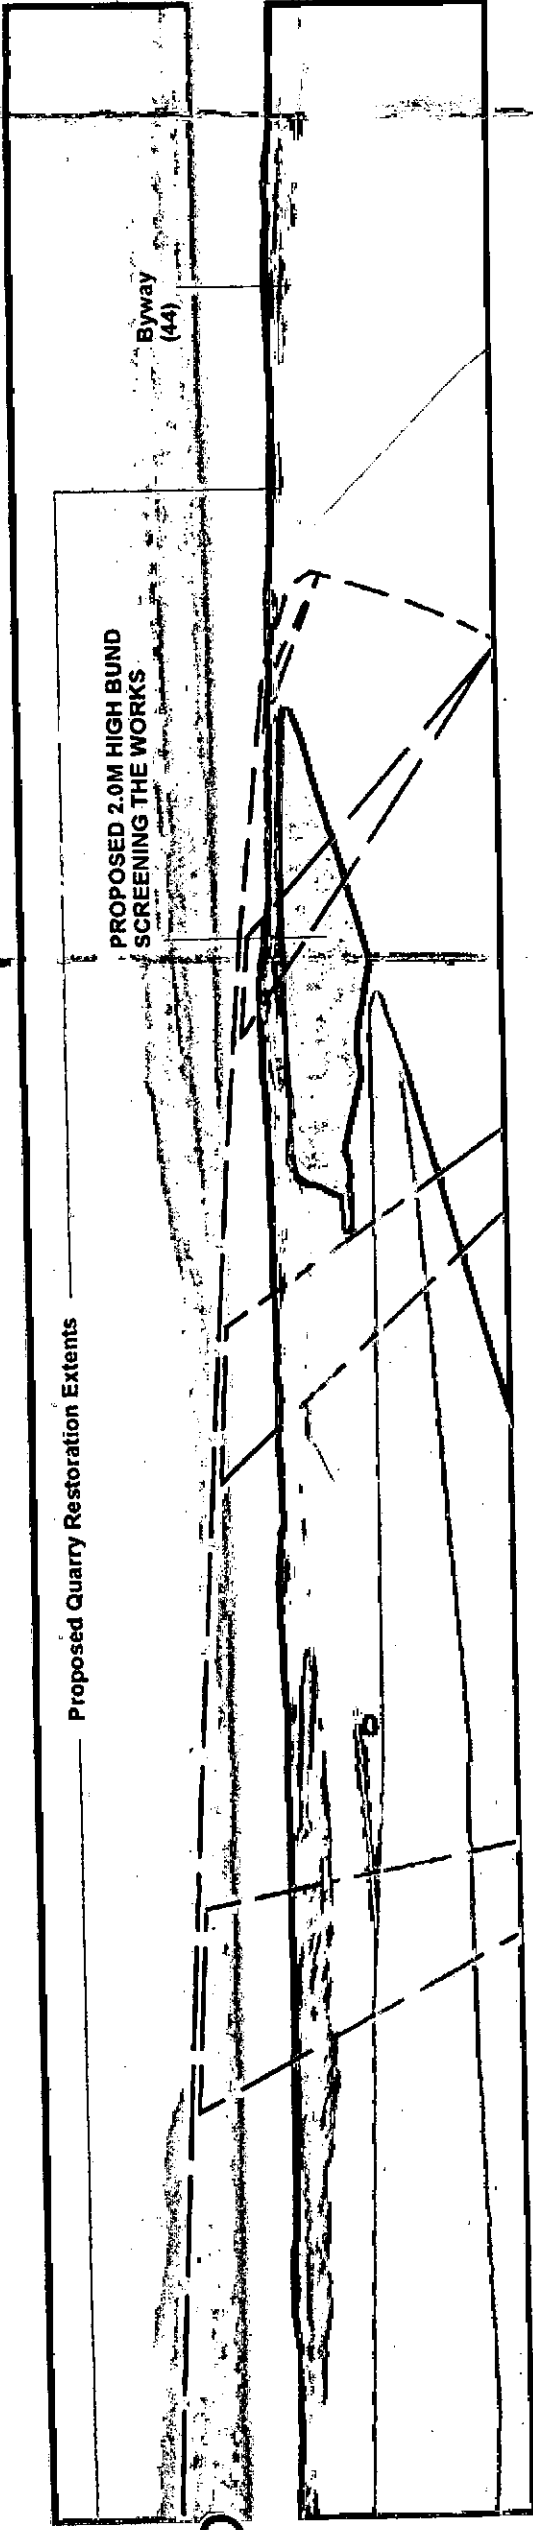
| Drawing No. | 20 (1 of 2) |

VIEWPOINT 1A (2 OF 2) - EXISTING CONDITIONS

VIEWPOINT 1A (2 OF 2) - COMPUTER MODEL OF PROPOSED PHASE 1

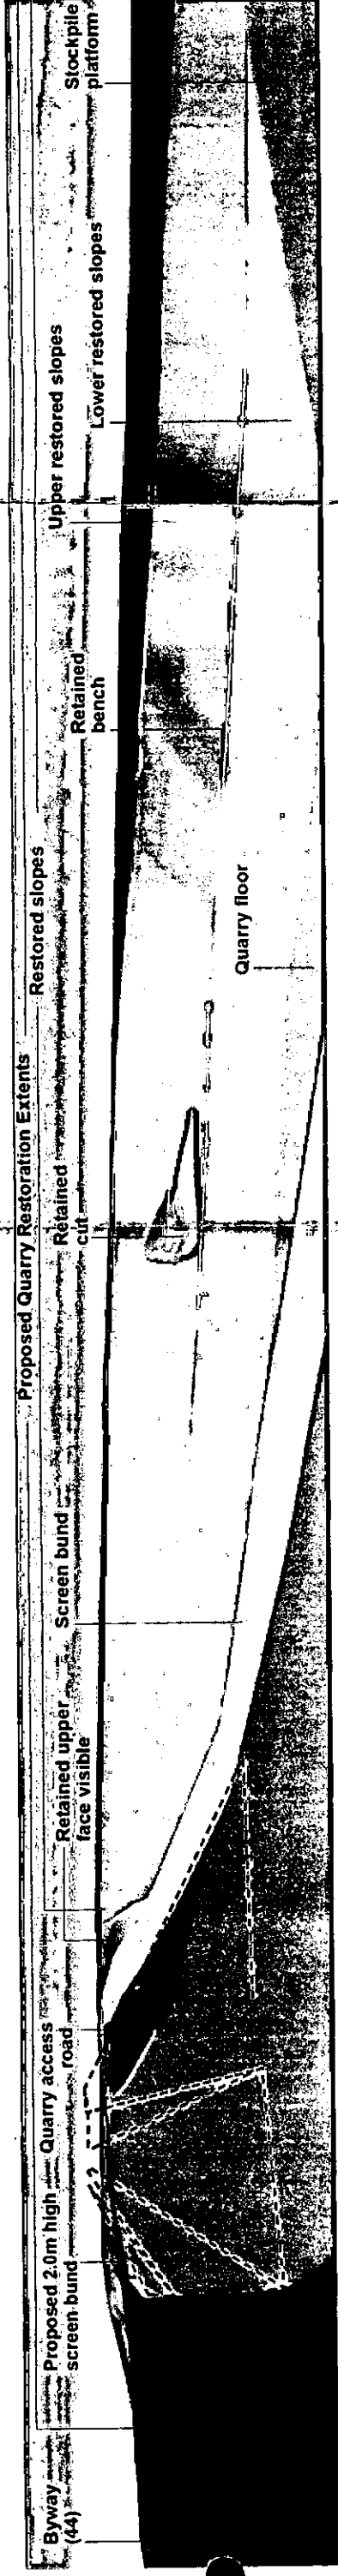
21 (1 of 2)

VIEWPOINT 1B (1 OF 2) - EXISTING CONDITIONS

VIEWPOINT 1B (1 OF 2) - COMPUTER MODEL OF PROPOSED RESTORATION

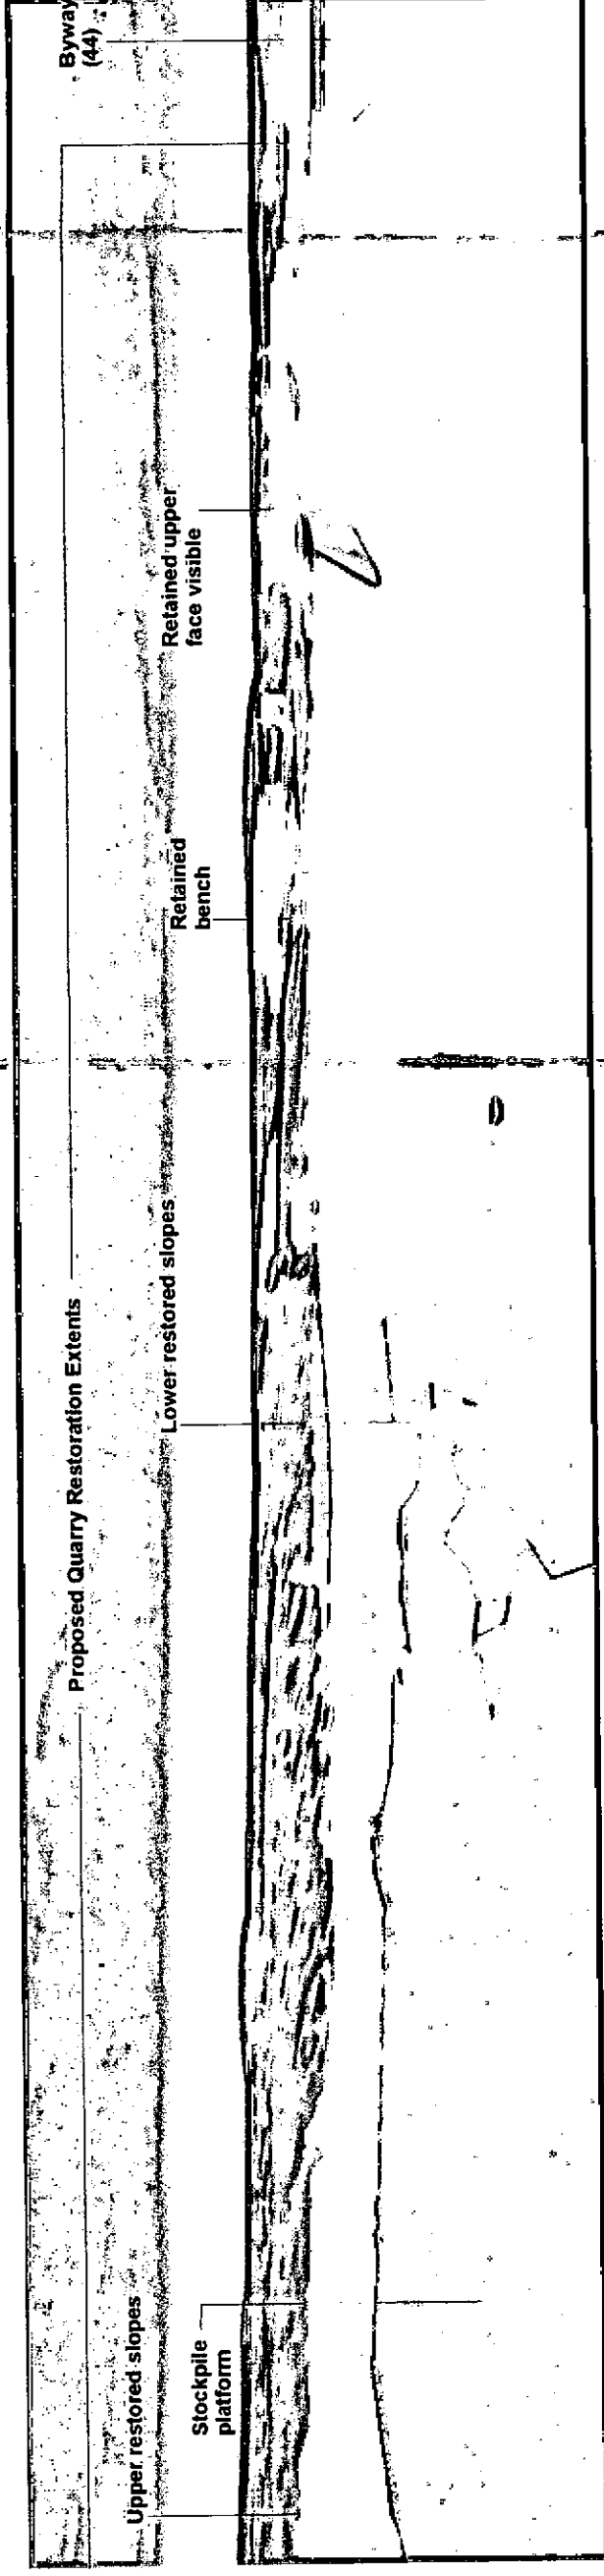
| Drawing No. | 21 (2 OF 2) |

VIEWPOINT 1B ( 2 OF 2) EXISTING CONDITIONS

VIEWPOINT 1B ( 2 OF 2) COMPUTER MODEL OF PROPOSED RESTORATION

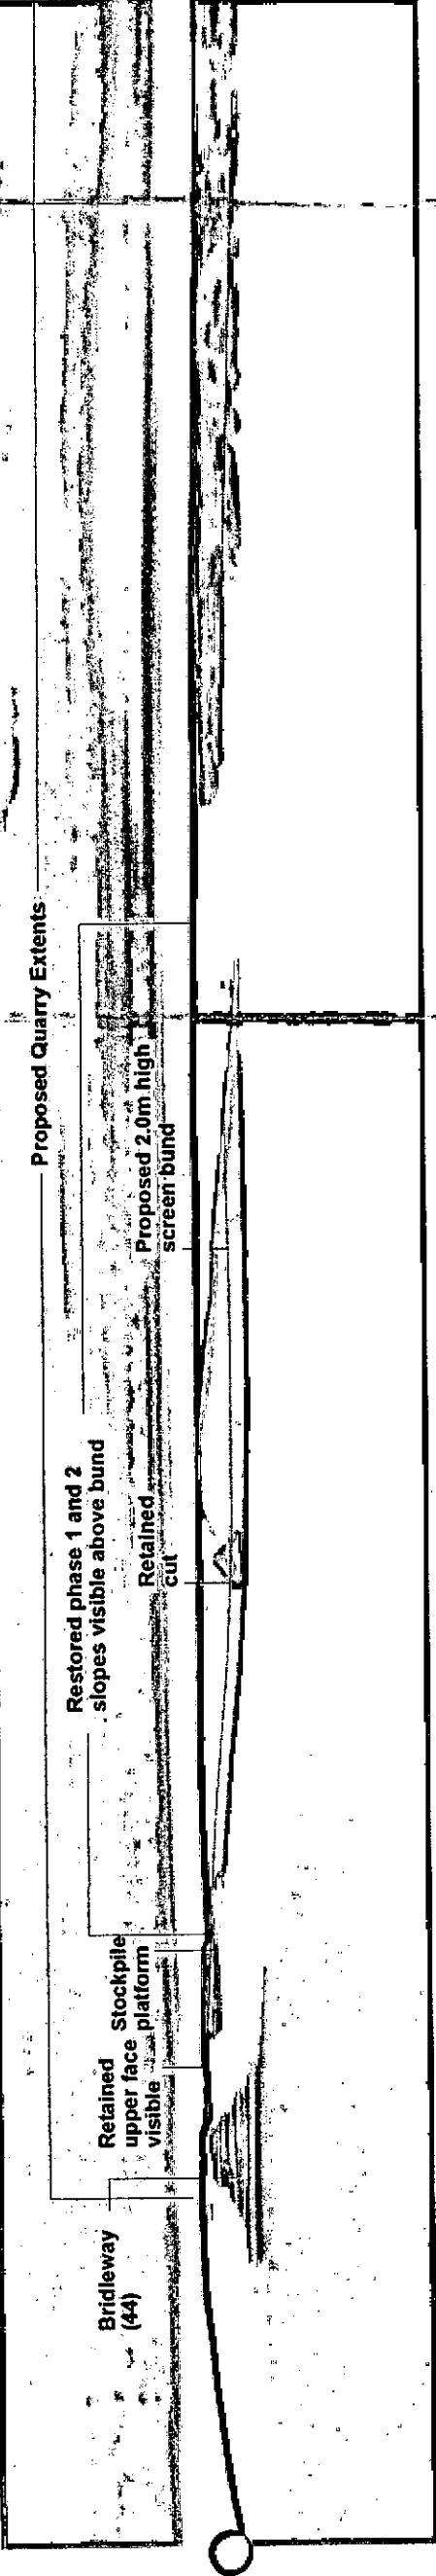
5.22 (1 of 2)

VIEWPOINT 1C ( 1 of 2 ) EXISTING CONDITIONS

VIEWPOINT 1C ( 1 of 2 ) COMPUTER MODEL OF PHASE 3

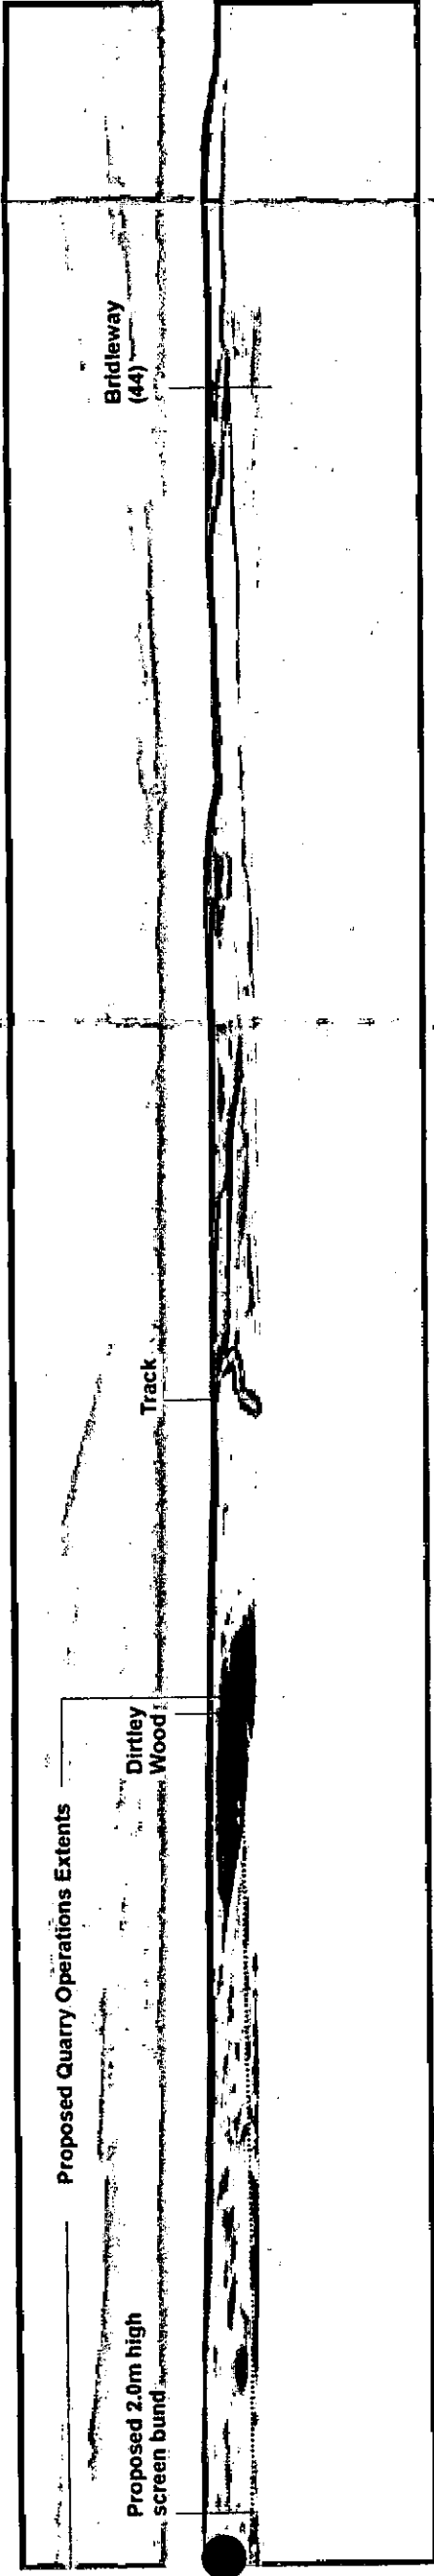
Drawing No.  
**5.22 (2 of 2)**

VIEWPOINT 1C ( 2 of 2 ) EXISTING CONDITIONS

VIEWPOINT 1C ( 2 of 2 ) COMPUTER MODEL OF PHASE 3

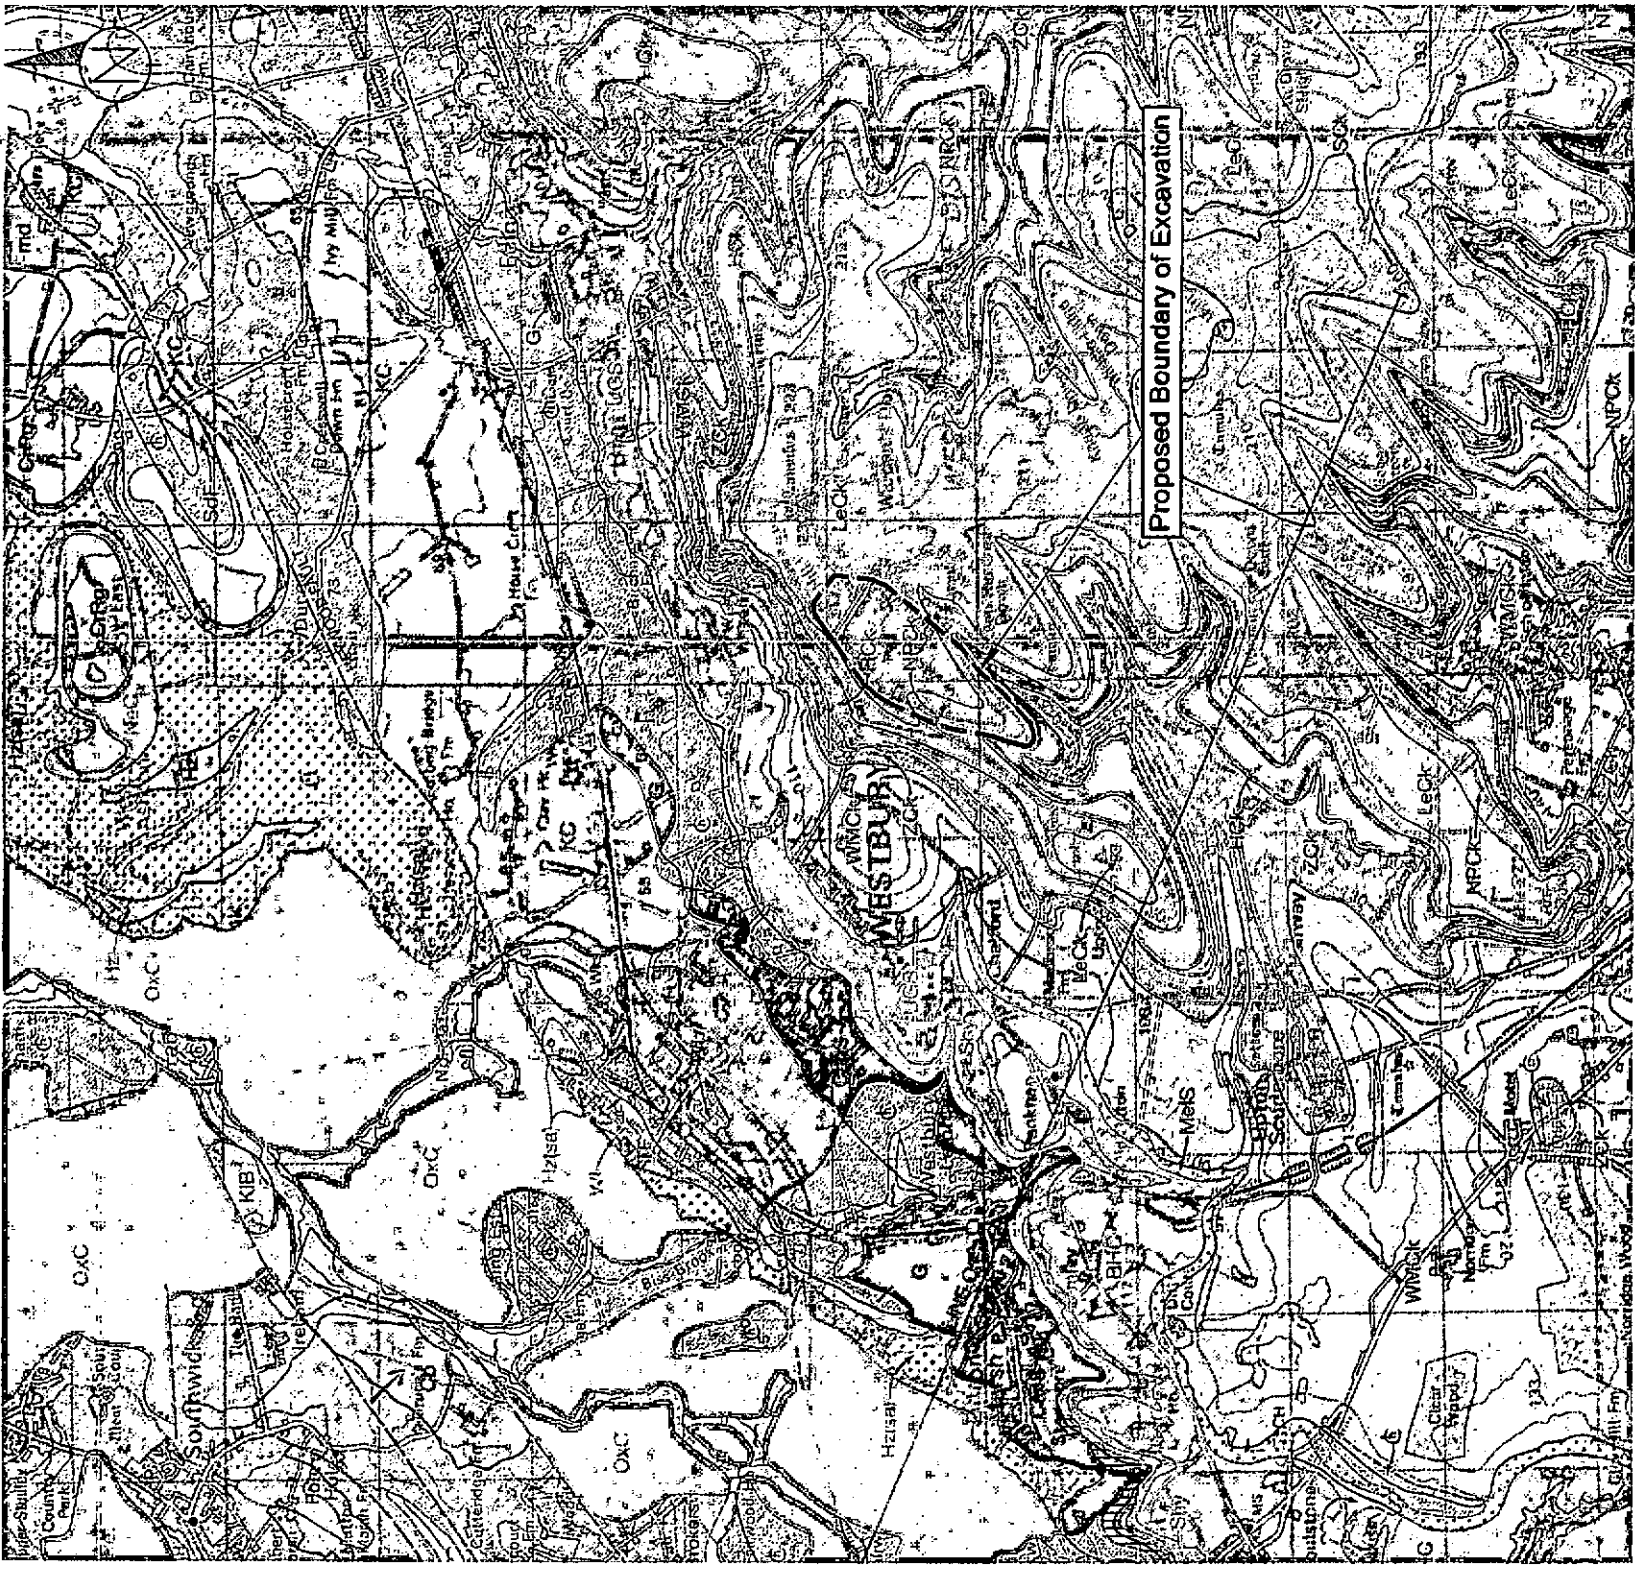
**Drawing Title:**  
Figure 6.2  
Outcrop Solid and Drift Geology Extension

GENERALIZED VERTICAL SECTION  
Scale 1:2400 (1 cm to 24 m)

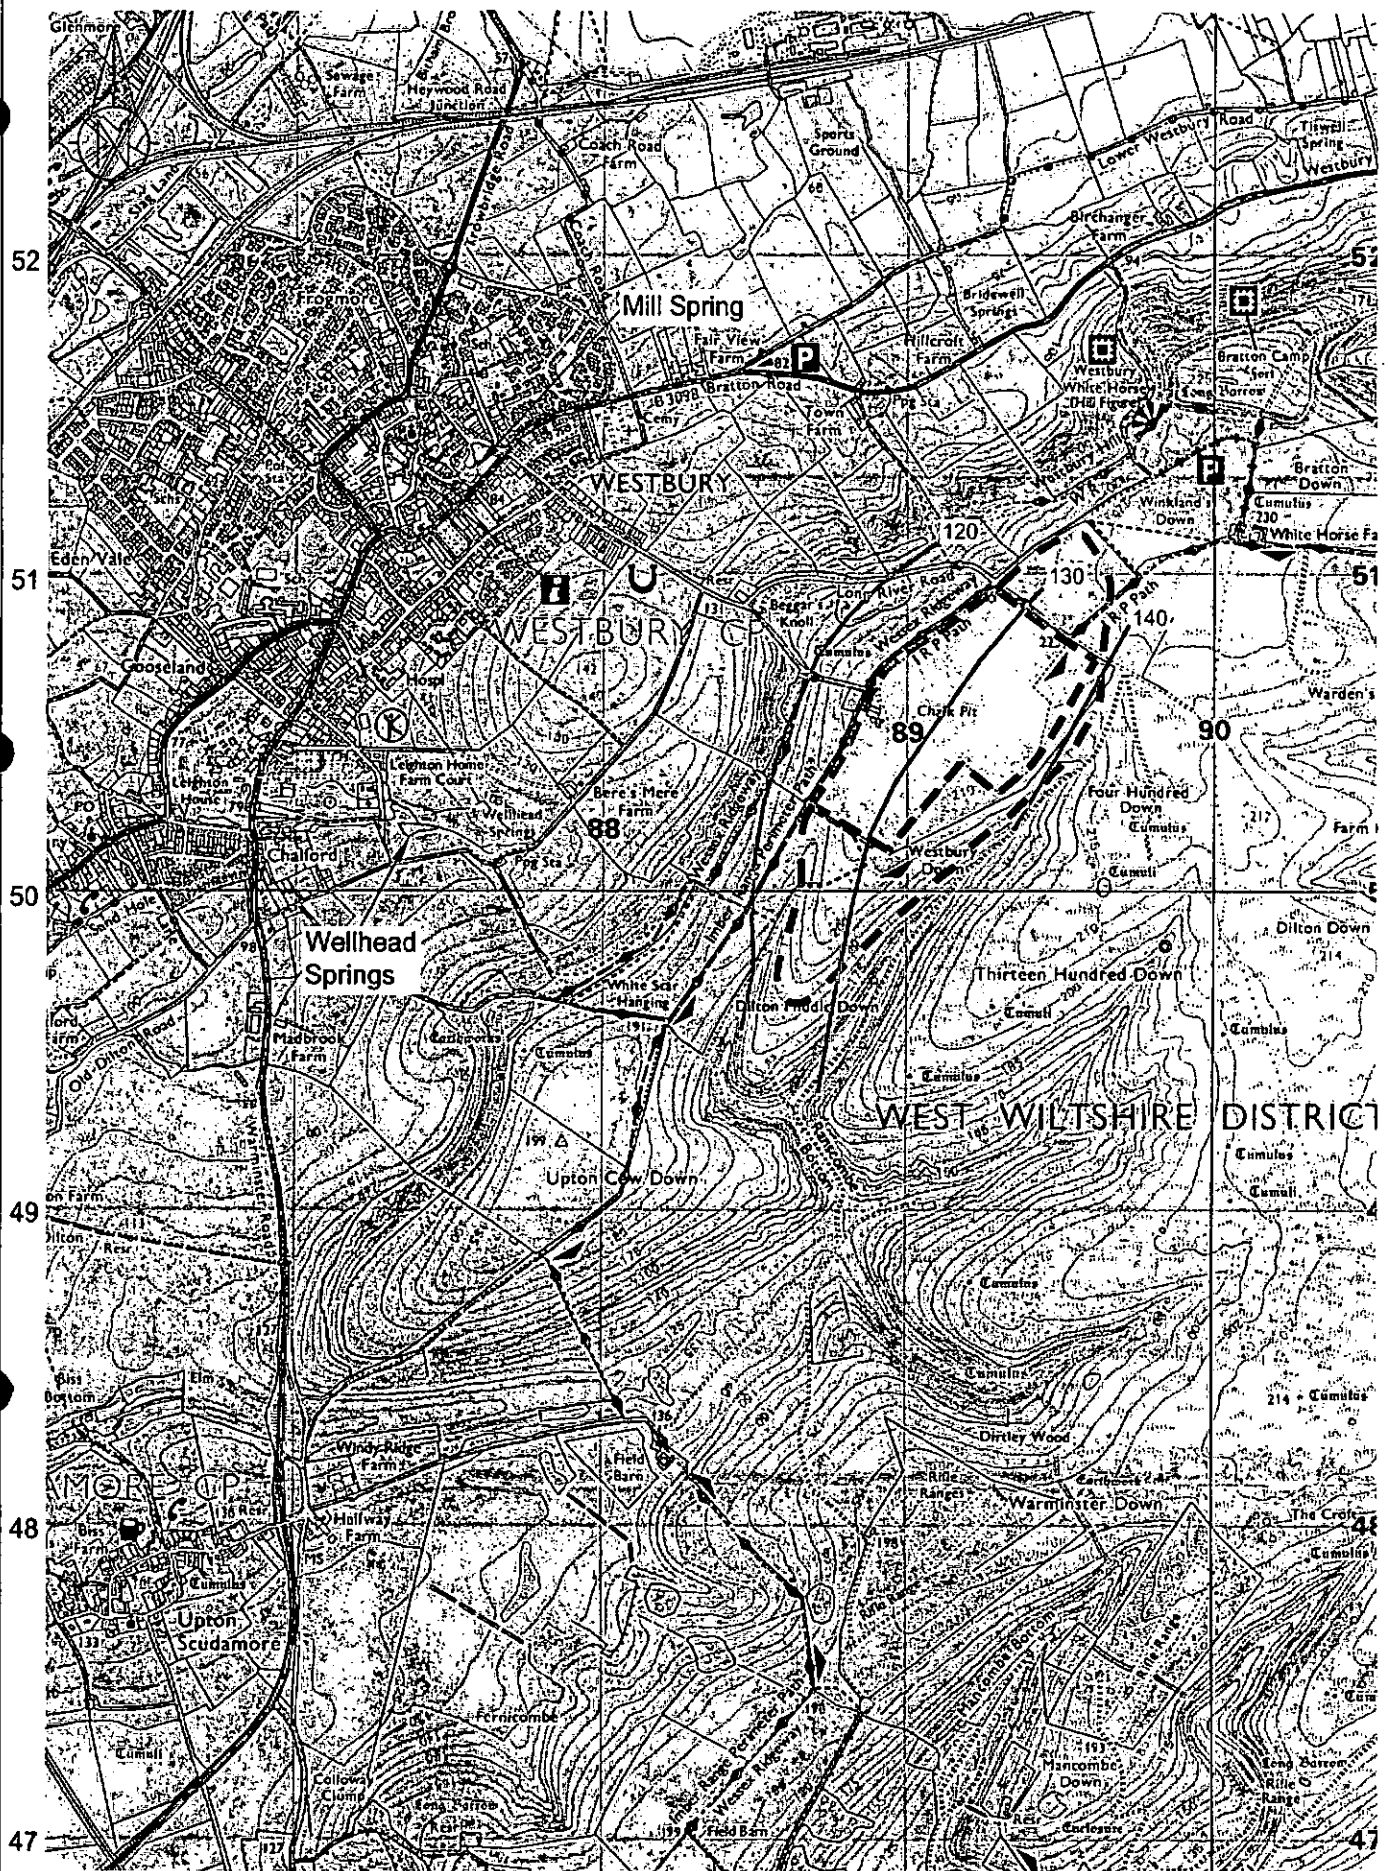
Job Title:  
**Westbury Quarry**  
Drawing Title:  
**Figure 6.9**  
**Maximum Groundwater Levels (mAOD)**

- Existing Excavation Boundary
- - - Extension Excavation Boundary
