3123 Tottenham House Stables Ground Floor  
Finishes Rev C 230126

**Approval of Details Application to partially  
discharge Condition 20(Floors) of Listed  
Building Consent (Ref:18/00195/LBC)**

**The Existing consented floor buildup- an Assessment of the current position and the reasoning for modifications.**

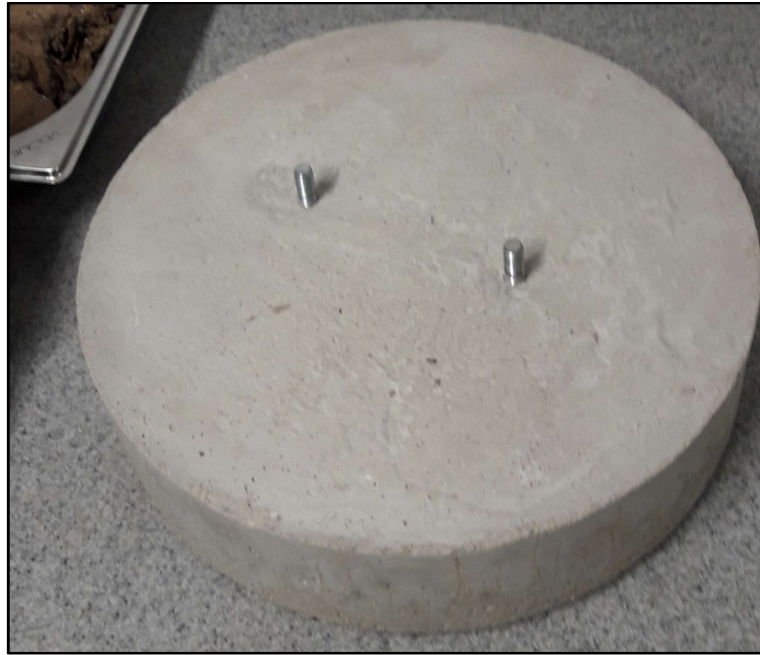
Figure 2 Cast concrete slab prior to use in the modular slab experiment.

The concrete and limecrete were cast as circular slabs, as shown in Figure 2, to fit the modular set-up. Two bolts were cast into the slab to facilitate installation and removal. The concrete and limecrete slabs were of thickness 84mm and 86mm  $\pm$ 2mm respectively. They were cast to fit the apparatus, which had an internal diameter of 355mm  $\pm$ 1mm with a gap around the perimeter of approximately 10mm. Slabs were installed within 2-4 weeks of casting and had not completely cured.

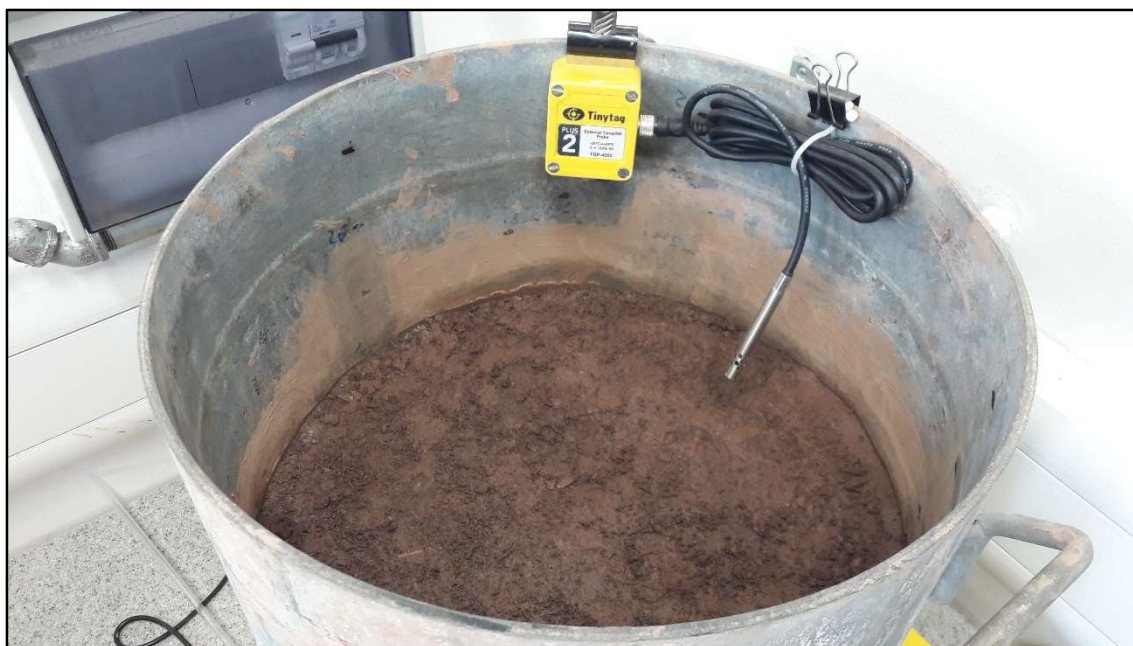
Figure 4 Initial saturation of the bare soil surface.

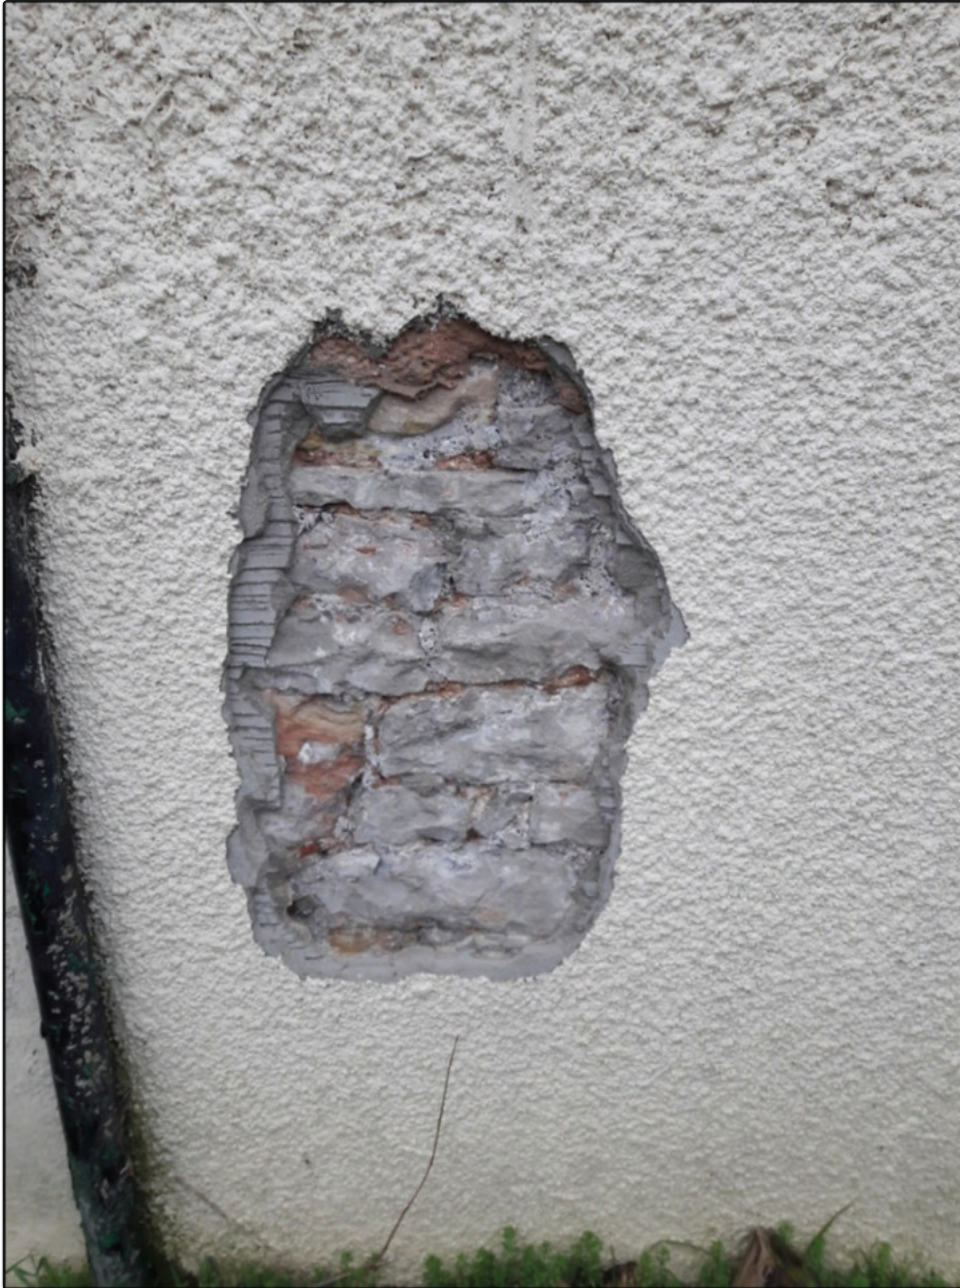
Figure 3.

The external face of the pantry wall at Court House.

A 3-year monitoring programme was undertaken to measure moisture levels in a 600 mm thick, composite rubble-core masonry wall at Court House; a private residential property in Caldicot, Wales ([Fig. 2](#)). Court House is a Grade II listed building originating from the 16th or 17th Century [8]. The masonry wall was located on the north elevation of the house and formed the external wall of an unheated, flagstone-floored room that was used as a pantry during the monitoring period ([Fig. 3](#)).
