# Site Investigation Report

194668.1.USI

Auger were commissioned by Sedgwick International UK to undertake a site investigation and CCTV inspection of the underground drainage within the area of concern (AOC) at the property.

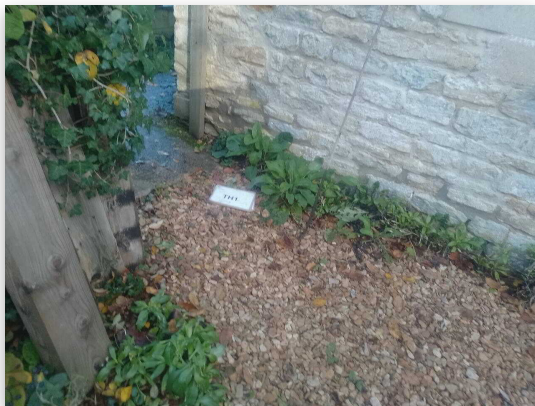
Fig 1.1: Trial Hole 1 Location

TH1 was undertaken in the desired location, we were able to expose the footings and we collected the requested soil and root samples.
