# Site Investigation Report

194712.1.1.TSI

Auger were commissioned by Sedgwick International UK to undertake a site investigation within the area of concern (AOC) at the property.

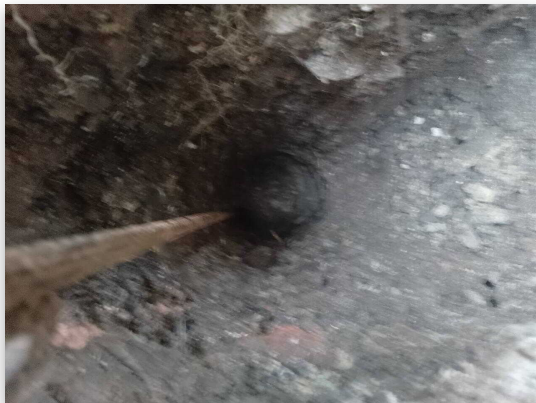
Fig 1.1: Trial Hole 1 Location

TH1 was undertaken in the desired location. We were able to expose the footings and collected the requested soil and root samples. We were unable to reach the required depth in TH1 because we encountered impenetrable ground that our engineer could not auger through. Within TH1, we also took footing measurements from the **extension**, which are shown in Trial Hole Log 1b below.

We attempted a remote borehole to obtain additional samples; however, we again encountered impenetrable ground that our engineer was unable to auger through. Should further samples be required, a quote to re-attend the property with a mechanical rig to attempt an additional borehole can be provided upon request.
