**Pickwick Service Station,  
Corsham**

**PHASE ONE ENVIRONMENTAL ASSESSMENT REPORT  
(PRELIMINARY RISK ASSESSMENT)**

| Report | CP20210 CL 002 |

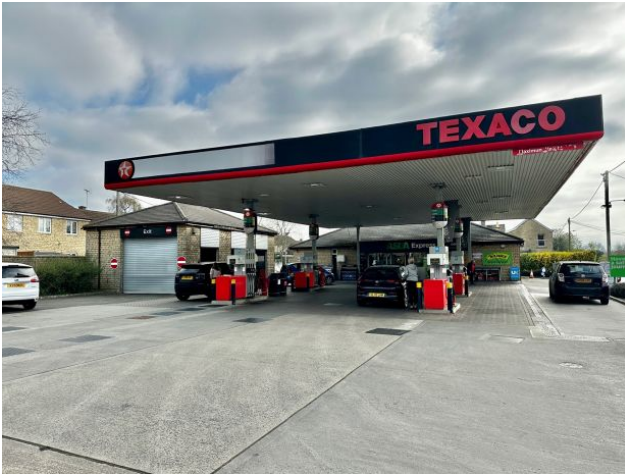
Photograph One: Central forecourt area

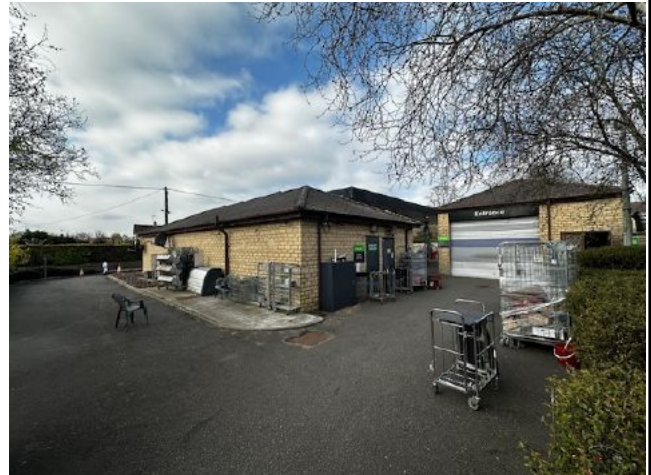
Photograph Two: Rear of existing sales building
