# Coles Farm, Alcombe

## Preliminary Bat Roost Assessment

August 2025

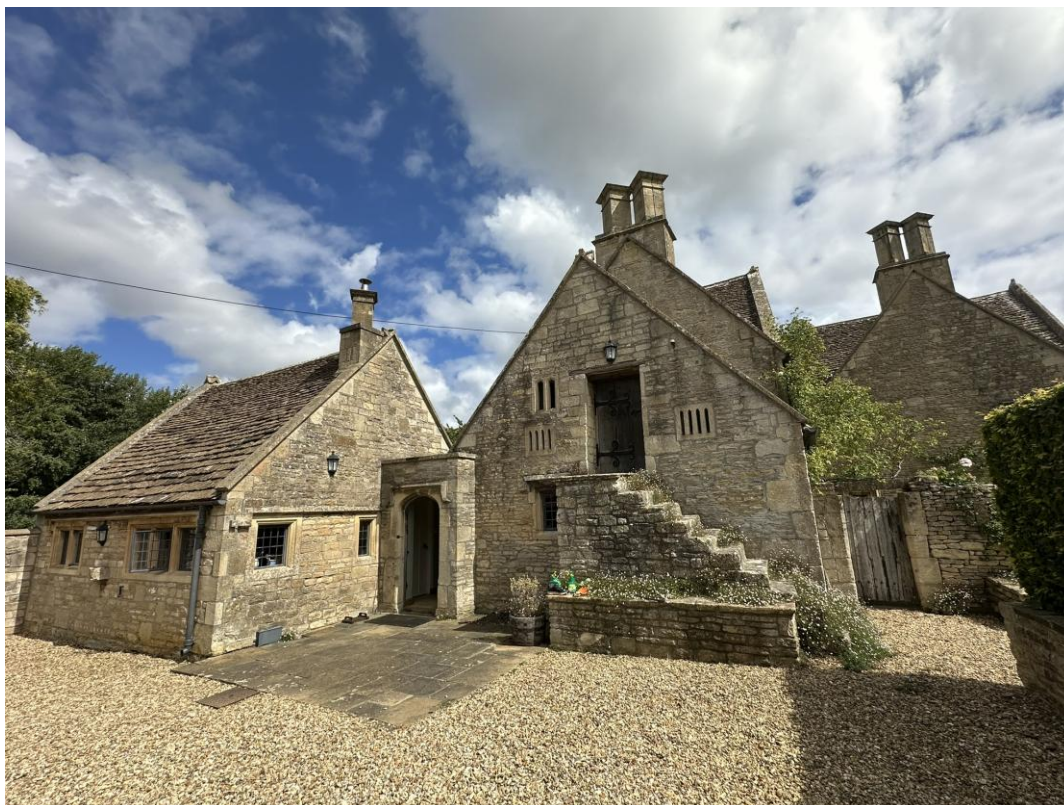
- Gaps in stonework on the south-east elevation (Target Note 1, Annex 1).
  - A gap at the apex on the north-west elevation (Target Note 2, Annex 1).
- 4.2.5 Internally, there is one large, L-shaped roof space and a smaller roof space over the kitchen. The L-shaped roof space is approximately 1.5m in height and 3m width. It has a combination of a traditional Bitumen-type liner and lath and plaster, both in poor condition with sections of the roof tiles visible, with gaps, and notably one large gap evident (Target Note 3, Annex 1). The roof space is uncluttered apart from one section containing a water tank.

Photograph 1: North-west elevation of the house.

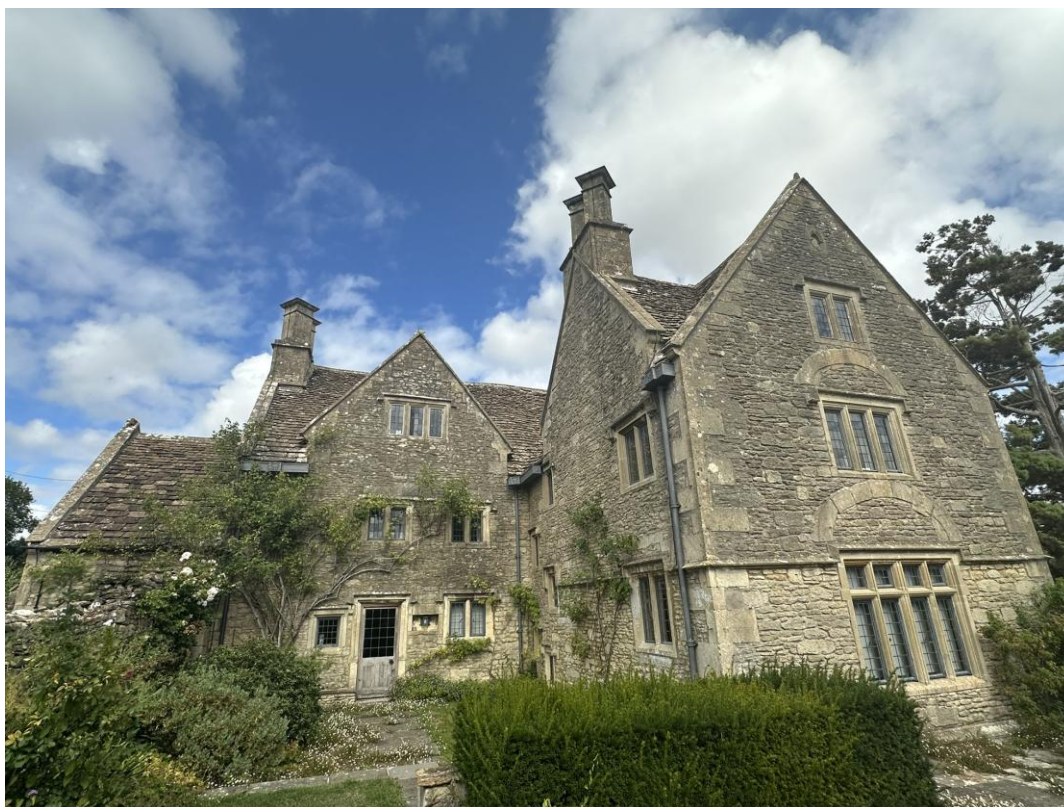
Photograph 2: South-west elevation of the house.

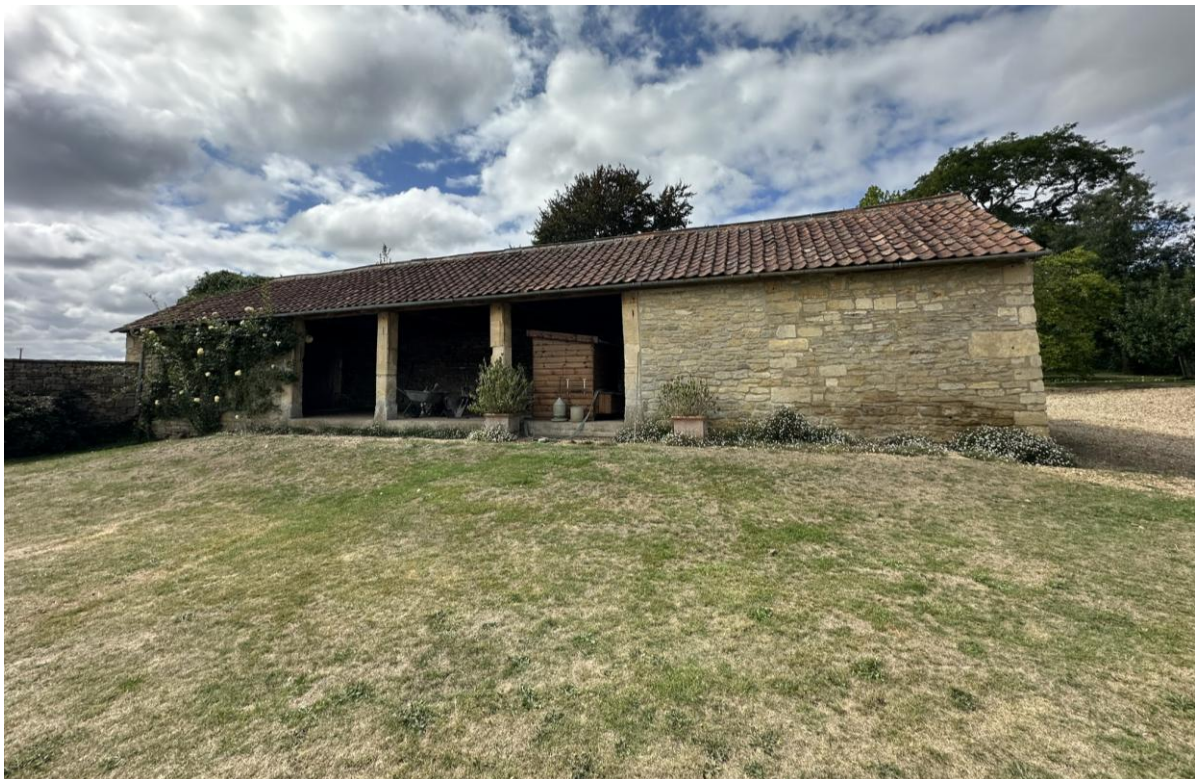
- 4.2.9 Externally, there are a moderate number of raised roof tiles (Target Note 6, Annex 2), a low number of gaps in the stonework on the north-west elevation (Target Note 7, Annex 2), gaps at the roofline on the south-west elevation (Target Note 8, Annex 2) and the south-east elevation is partially open-sided (Target Note 9, Annex 2). The shed has gaps around a timber door (Target Note 10, Annex 2).

Photograph 4: Partially open south-east elevation of Outbuilding 1.

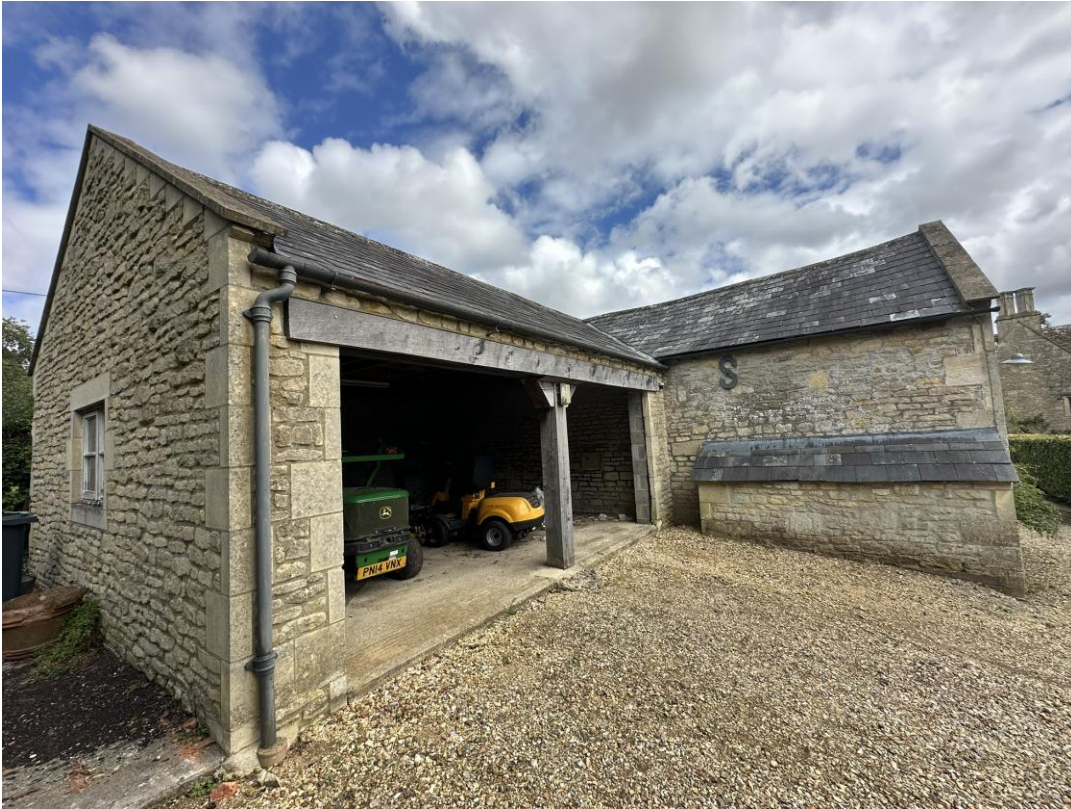
- 4.2.13 Externally, there are a low number of raised tiles (Target Note 12, Annex 2), there are a low number of cracks in mortar and gaps in stonework (Target Note 13, Annex 2), a hole in the south-east elevation (Target Note 14, Annex 2), the south-west elevation is partially open-sided (Target Note 15, Annex 2) and there are gaps around door frames on the south-east elevation (Target Note 16, Annex 2).

Photograph 5: North-east and south-west elevations of Outbuilding 2.

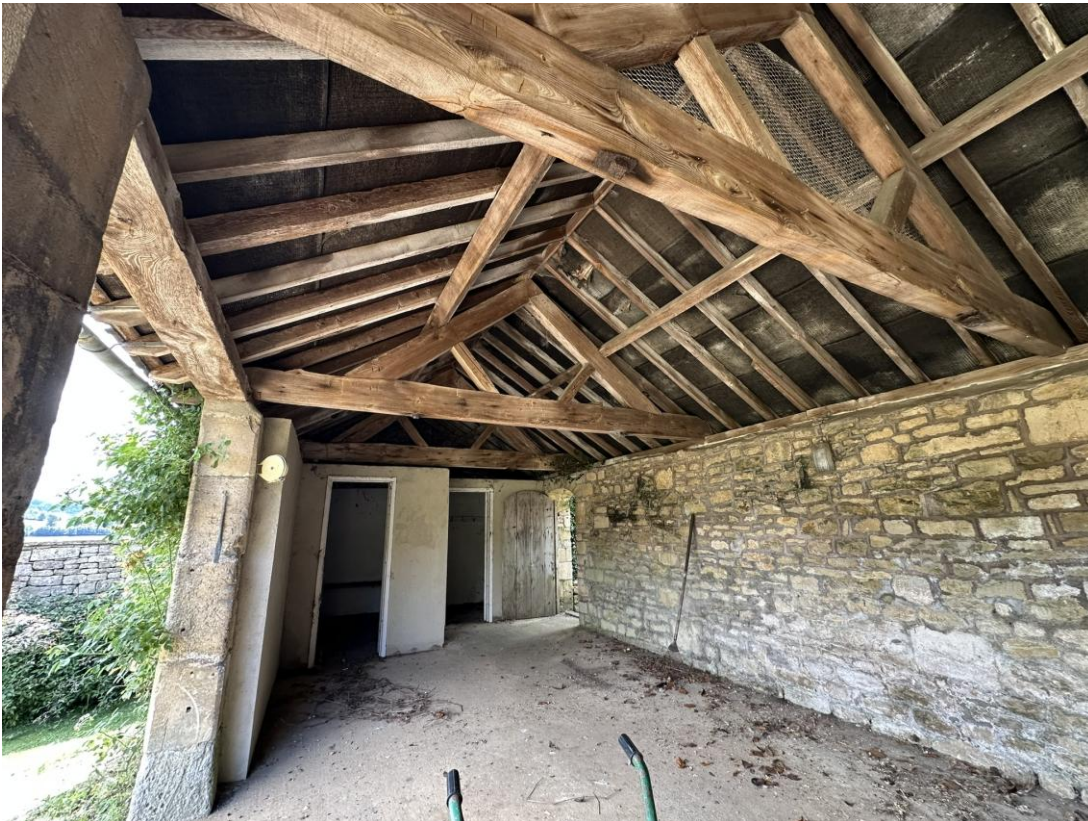
- 4.2.10 Internally, the outbuilding and shed form one space and are open to the roof with no dark and enclosed spaces. There are a timber-framed roof structure and a traditional Bitumen-type liner, which is in poor condition with sagging and gaps.

- 4.2.11 Approximately 50 fresh bat droppings and approximately 500 old bat droppings were found within the outbuilding, and a swallow's nest was present (Target Note 11, Annex 2). A sample of the bat droppings was collected for DNA analysis to confirm species.

- Outbuilding 1 – DNA analysis confirmed bat droppings belonging to brown long-eared bat and lesser horseshoe, indicating day/night roosts for low numbers of these species.

Photograph 6: The internal area of Outbuilding 1.

- 6.2.1 Three bat surveys should be undertaken of the outbuildings to provide further information on the identified bat roosts and to identify any other roosts that may be present. The bat surveys should be undertaken between May and mid-September and spaced three weeks apart.
- 6.2.2 The results of the surveys will inform an appropriate protection and mitigation strategy and European Protected Species Licence, which will be required for works to the outbuildings.

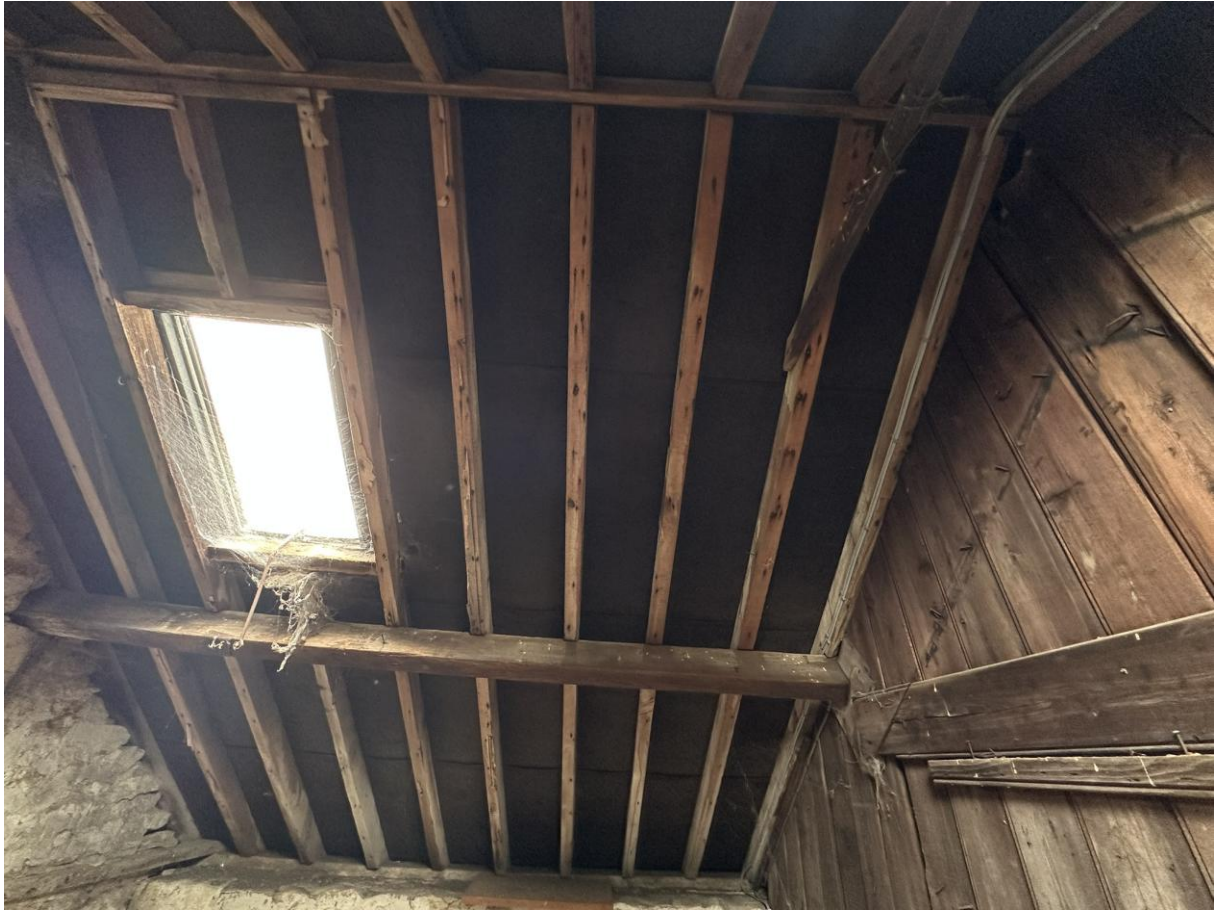
- 4.2.14 A bird box is attached to the south-west elevation (Target Note 17, Annex 2).
- 4.2.15 Internally, the space is open to the roof with no dark and enclosed roof spaces. It is well-lit from a skylight. There are a timber-framed roof structure and a traditional Bitumen-type liner, which is in good condition.

- 4.2.16 A low number of bat droppings were found inside, and two swallows' nests (Target Note 18, Annex 2). A sample of the bat droppings was collected for DNA analysis to confirm species.

- Outbuilding 2 - DNA analysis confirmed bat droppings belonging to lesser horseshoe, including a day/night roost for low numbers of this species.
- 5.1.2 The house and outbuildings are suitable to nesting birds. There is a bird box attached to Outbuilding 2 and both outbuildings supported swallow nests at the time of the survey.

Photograph 7. The internal area of Outbuilding 2.
