# Validation Report

Former Westbury and District Hospital, The Butts, Westbury, Wiltshire

Backhouse (Westbury) JV Limited

TN/SR/17497/VR/01

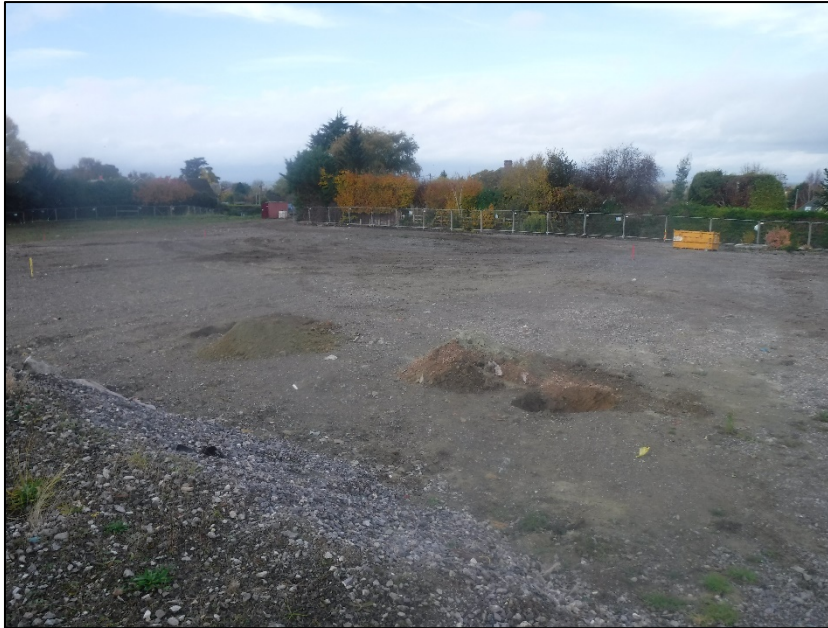
**Plate 1**

The area of the former tank, viewed from the southeast.

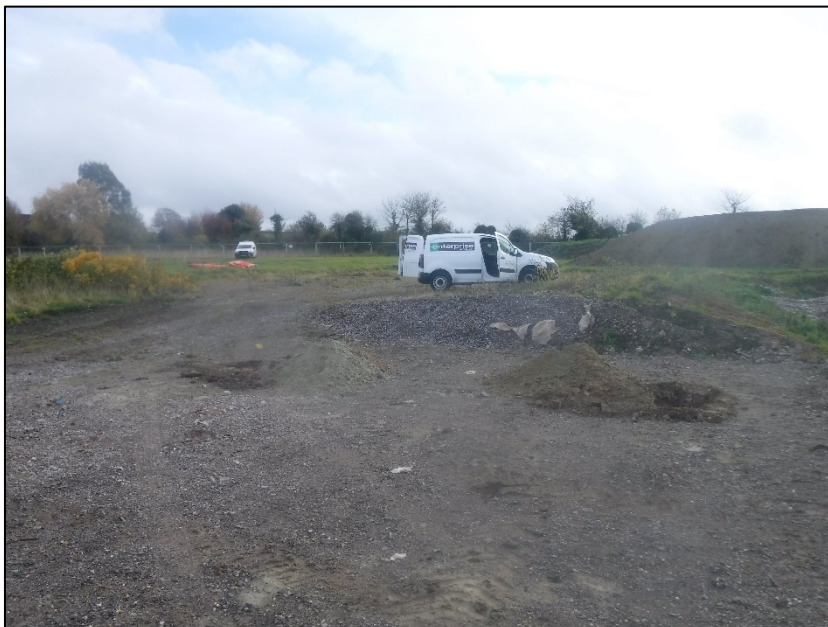
**Plate 2**

The area of the former tank, viewed from the northwest.

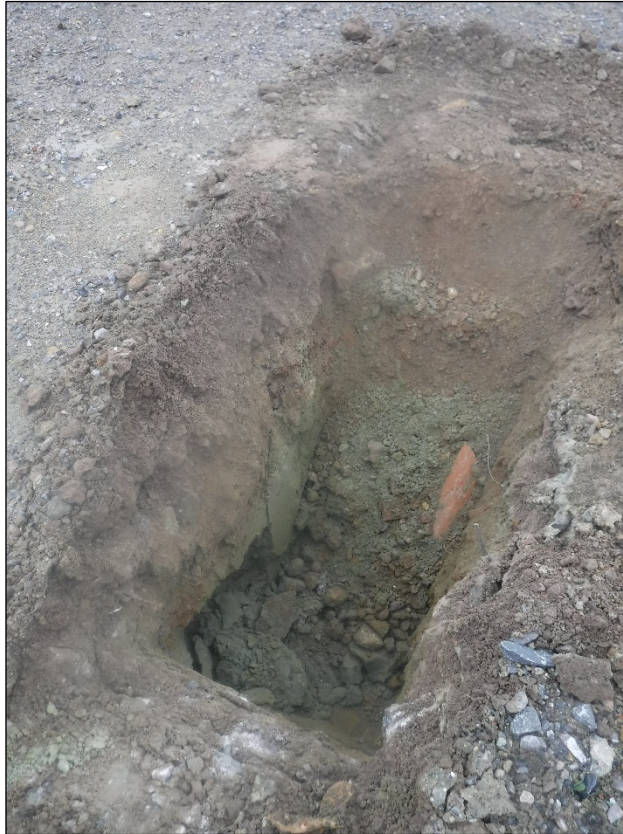
**Plate 3**

| STRATA | | | SAMPLES & TESTS | | |
|---|---|---|---|---|---|
| 0.00-0.30 | | MADE GROUND: Purplish grey or grey sandy fine to coarse subangular to subrounded gravel of limestone with some pieces of metal, brick, concrete, plastic, bitmac and wood. | 0.20 | J | |
| 0.30-0.70 | | MADE GROUND: Greenish or yellowish brown slightly gravelly sand with occasional pockets of purplish grey sandy gravel and occasional pieces of brick and bitmac. Gravel is fine to coarse subangular to subrounded of limestone. | 0.50 | J | |
| 0.70-1.00 | | (Loose) greenish brown SAND. (Upper Greensand Formation). | 1.00 | J | |

Shoring/Support: None.  
Stability: Stable.  
Groundwater: None encountered.

Ground conditions encountered in TP101.

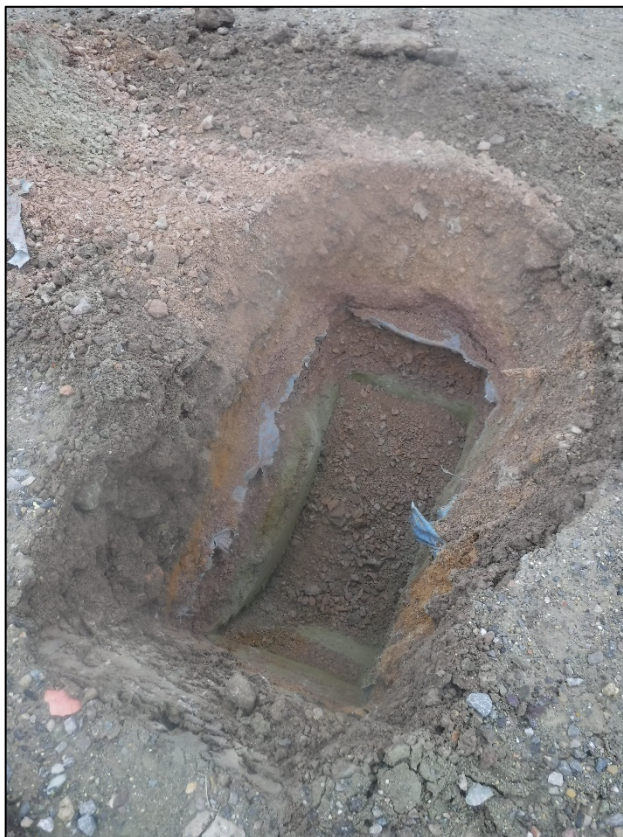
**Plate 4**

| STRATA | | | SAMPLES & TESTS | | |
|---|---|---|---|---|---|
| 0.00-0.50 | | MADE GROUND: Brown or greyish brown sandy gravelly silty clay or sandy fine to coarse subangular to subrounded gravel of limestone with some pieces of brick, concrete, bitmac and plastic. | 0.30 | J | |
| 0.50-0.60 | | MADE GROUND: Yellowish brown or purplish brown sandy fine to coarse subangular to subrounded gravel of limestone underlain by a blue plastic membrane. | 0.70 | J | |
| 0.60-0.80 | | MADE GROUND: Pinkish brown sandy fine to coarse subangular to subrounded gravel of limestone.<br>(Loose) greenish brown SAND. (Upper Greensand Formation). | 1.00 | J | |

Shoring/Support: None.  
Stability: Stable.  
Groundwater: None encountered.

Ground conditions encountered in TP102.

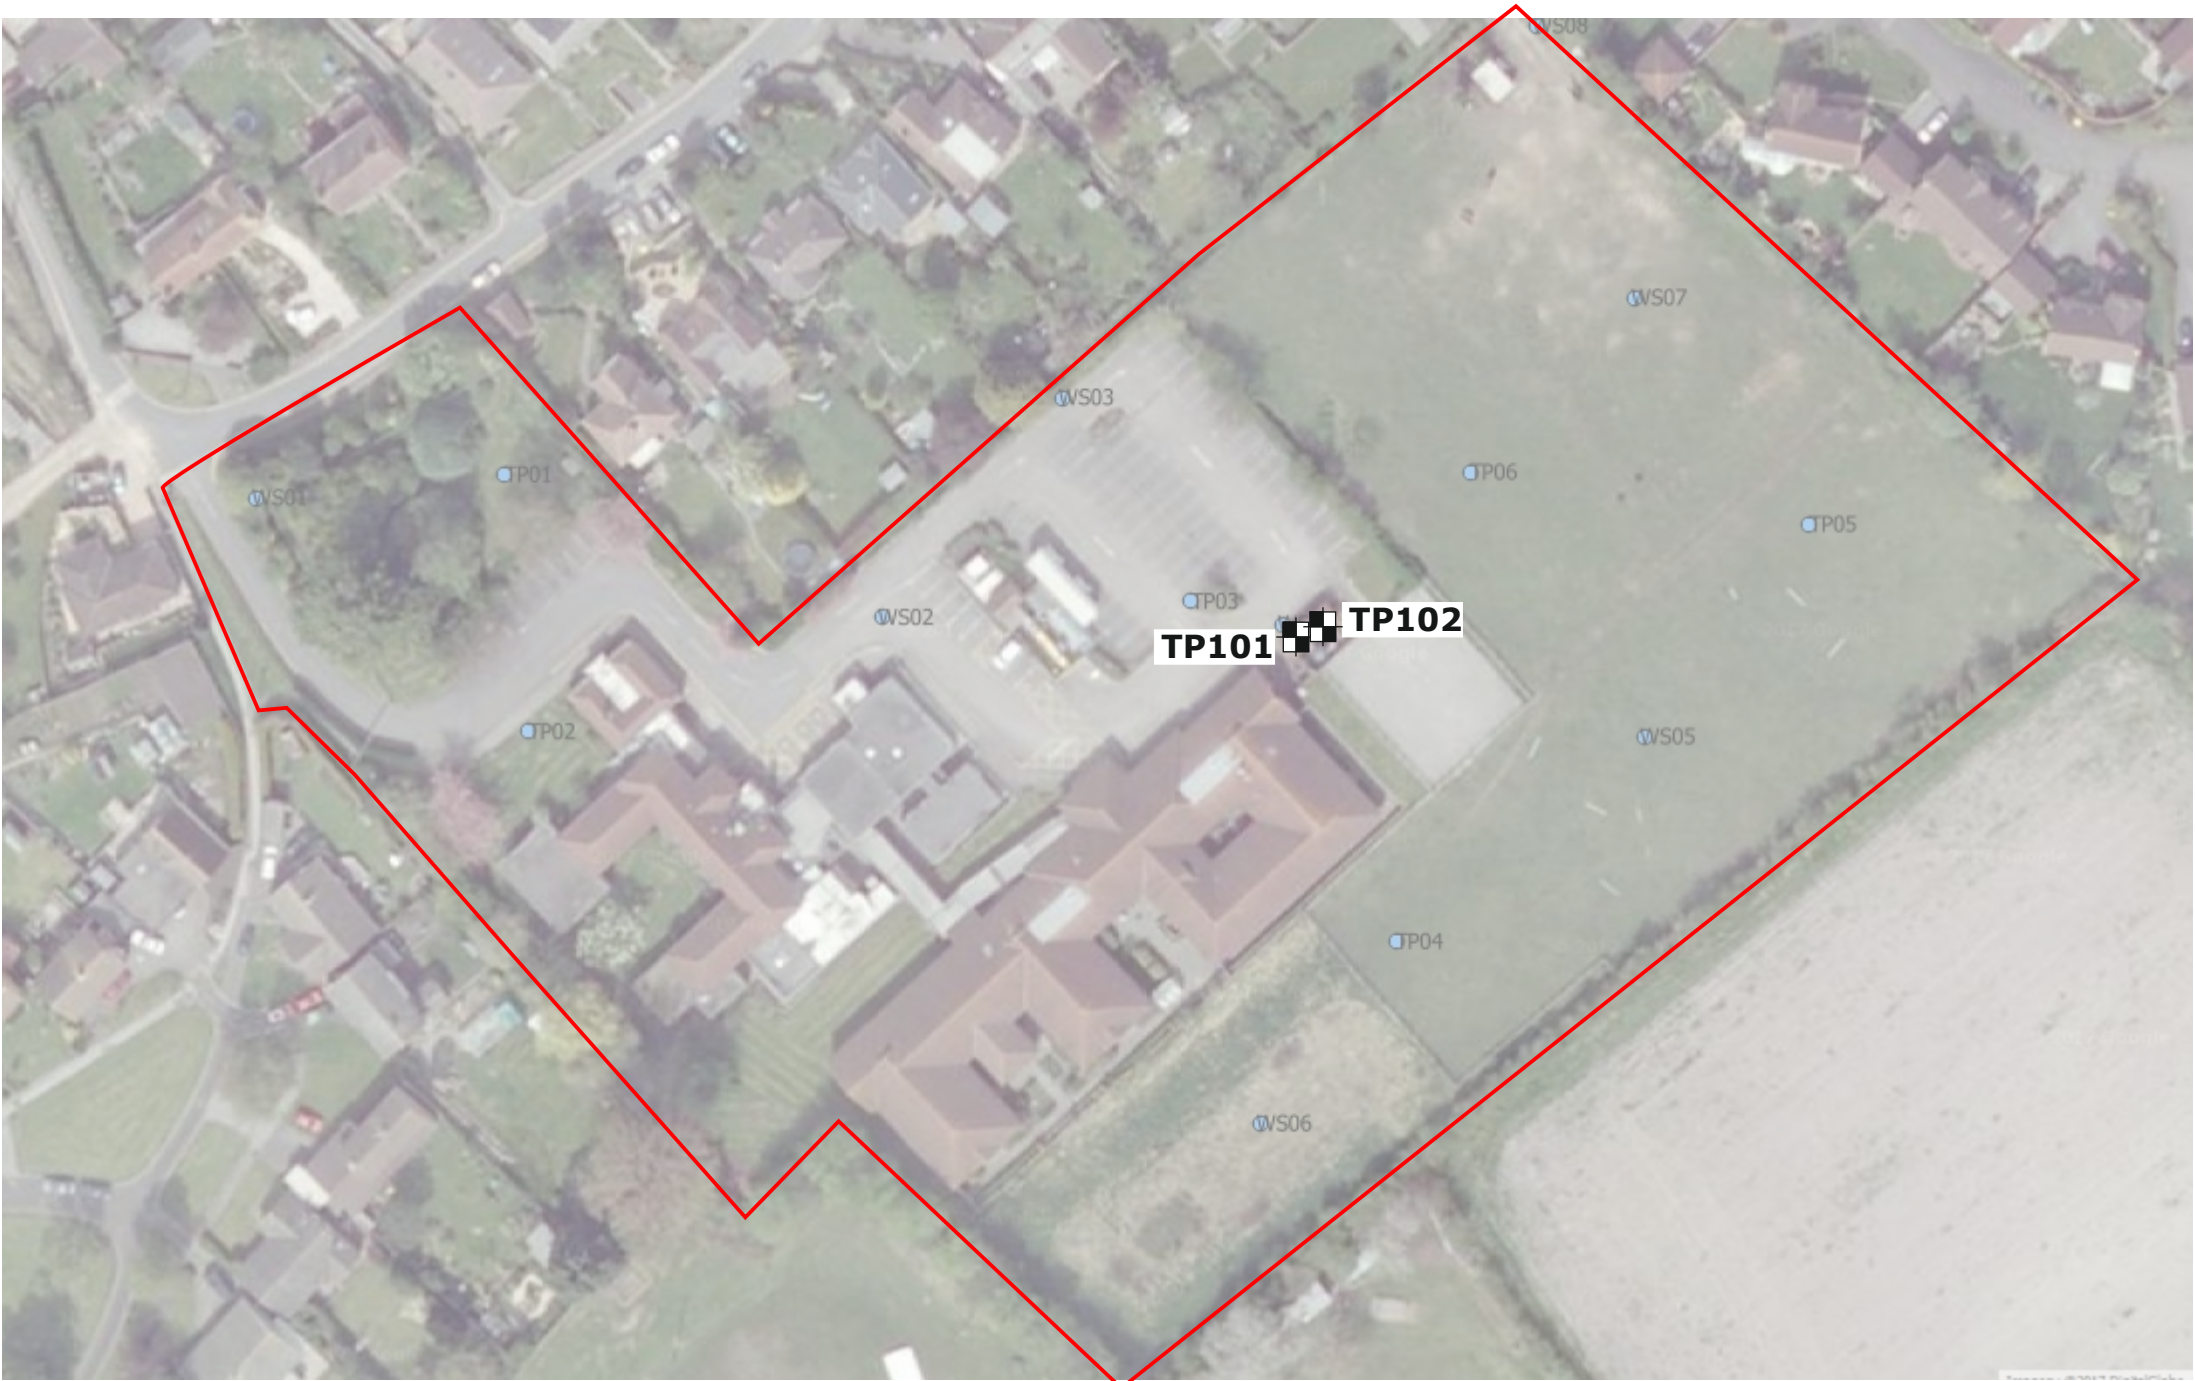
## **TRIAL PIT LOCATION PLAN**

Details of ground and groundwater conditions encountered can be found on the trial pit logs (Appendix A) and photographs (Appendix B). The trial pit locations are shown on the trial pit location plan (Dwg. No. 17497/02, Appendix D).
