| Stourhead Estate Office<br>Floor and Wall repairs | | | |
| Existing Ground floorplan and section | | | |

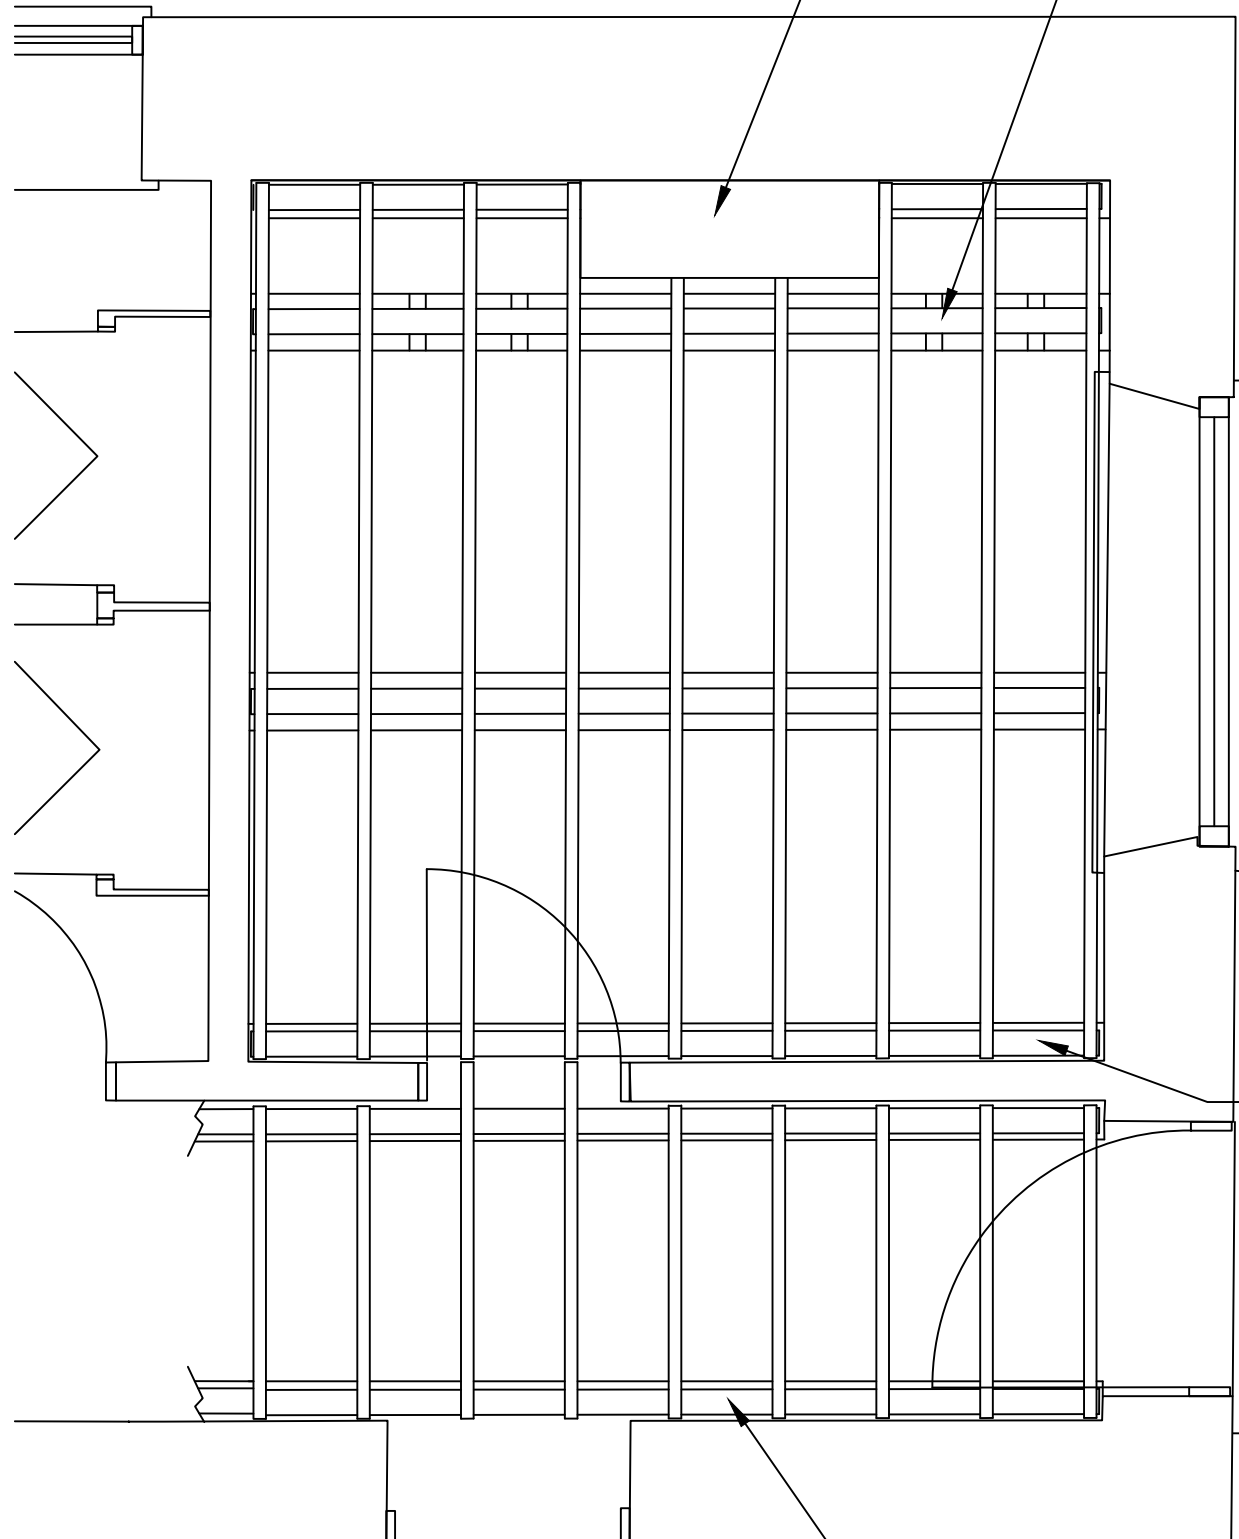
EXISTING FLOOR DETAIL 1:30

- sole plate decayed (removed)

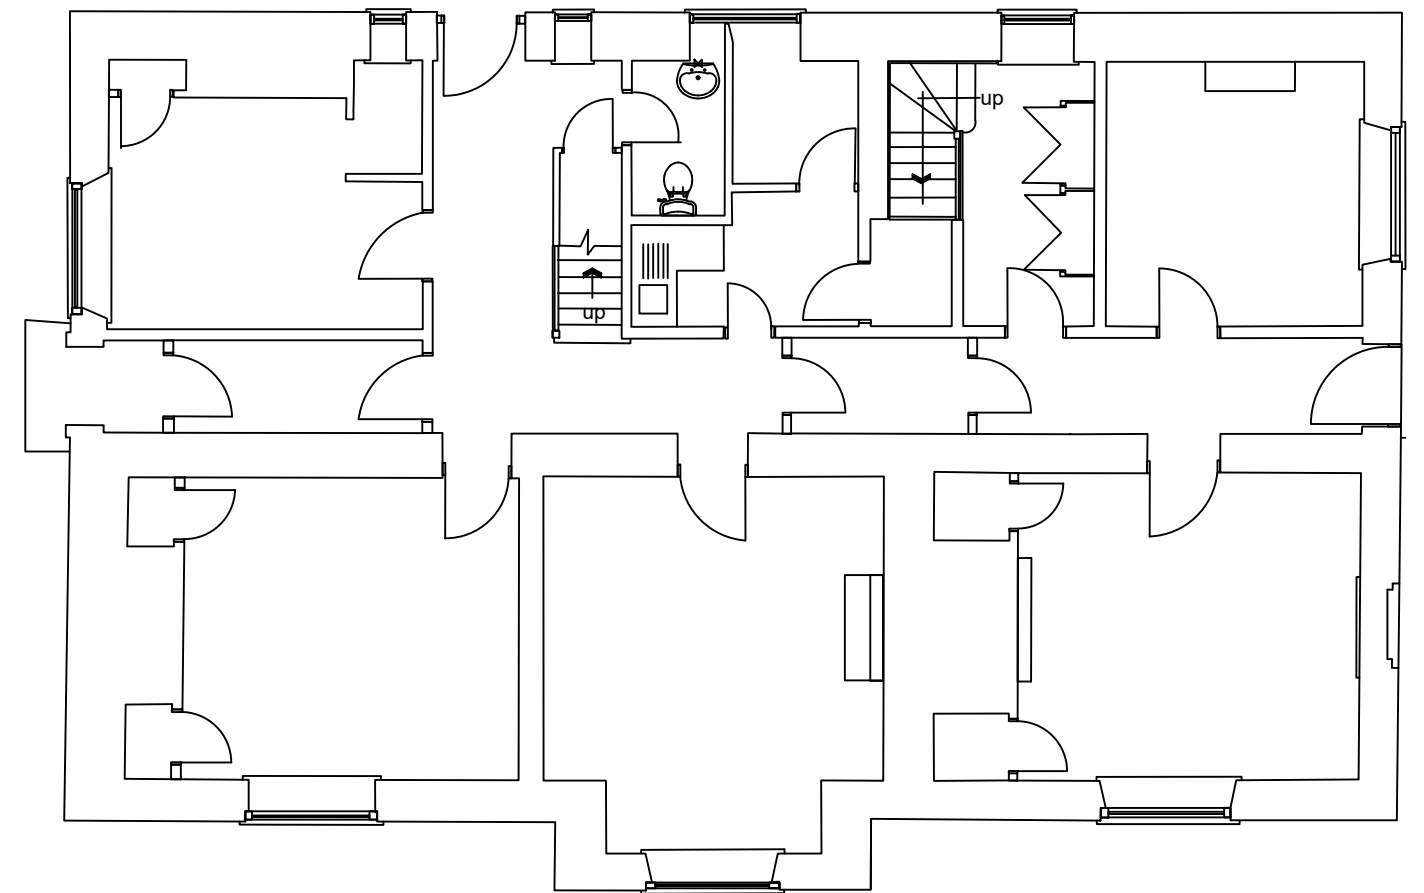
EXISTING GROUND FLOOR PLAN 1:100

- sole plate decayed (removed)

office floor joists  
decayed (removed)

- Floor spongy - sole plate decay

- wall sole plate decayed

- hall floor joists  
(not yet inspected)
