## Design and Access Statement

REV A  
V1013  
Bulford Manor Wall Repairs  
January 2026

This Heritage Statement has been prepared on behalf of VIVO Defence Services in support of rebuilding a section of boundary wall at Bulford Manor, Bulford.

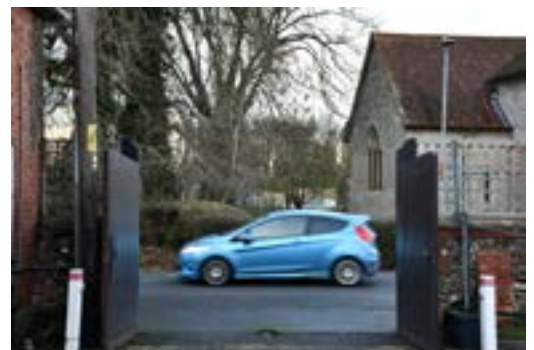
Later gateway onto road

The Bulford Manor Stables form part of the 1890s service wing built for J.L Hill at the south-east corner of the 18th Century range. The service wing was built of flint and stone to the north and red brick to the south. The gateway in the wall is likely a later addition which has contributed to the severe lean of the wall and subsequent failures.

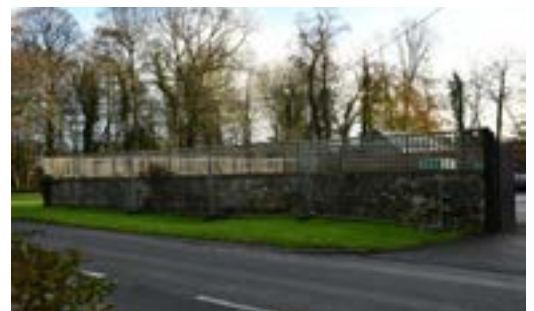
View of the wall from the Church of St Leonard

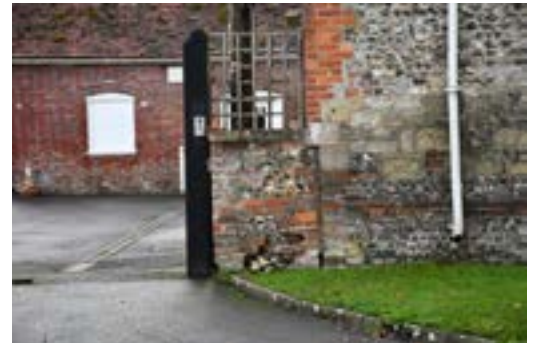
Junction with the Bulford Manor Stables and gateway

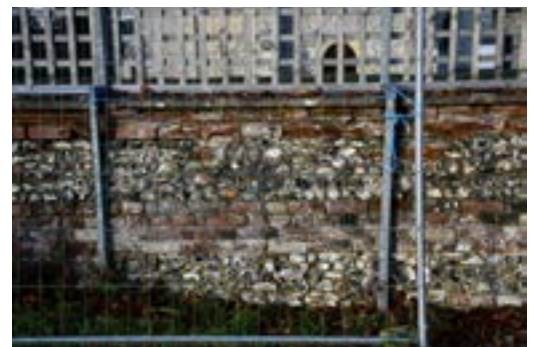
Currently, the trellis is fixed flush to the outer face of the wall using metal brackets driven into the ground. This method avoids damage to the historic fabric of the wall, and will be reused upon reconstruction.

Metal brackets for trellis

| Description of proposed works | Impact on historic fabric | Impact on setting/ character | Overall impact on significance | Extent of impact | Heritage Benefit/Mitigation |
|---|---|---|---|---|---|
| Trellis removed and reinstated as before. | Low | Low | Low | Low | The trellis acts as a privacy screen and a deterrent to break-ins. It's current fixing method has minimal impact on the historic fabric, and will be reused. |
