## COLES FARM, WILTSHIRE

### HISTORICAL DEVELOPMENT

1.0 INTRODUCTION

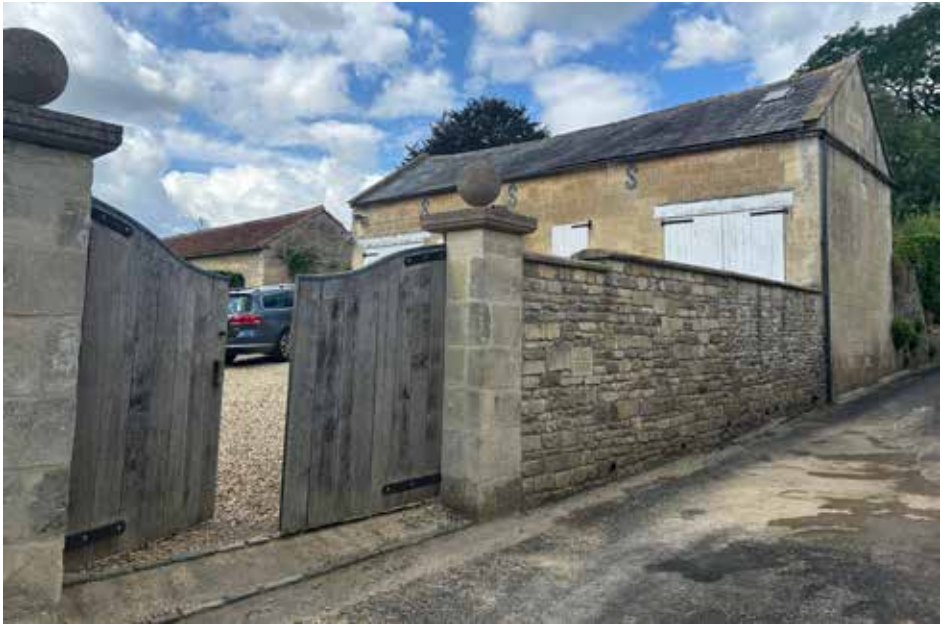
Entrance to the former farmyard from the road. The walls and gates were constructed in the late twentieth century. In the background is the nineteenth-century stable and coach house.

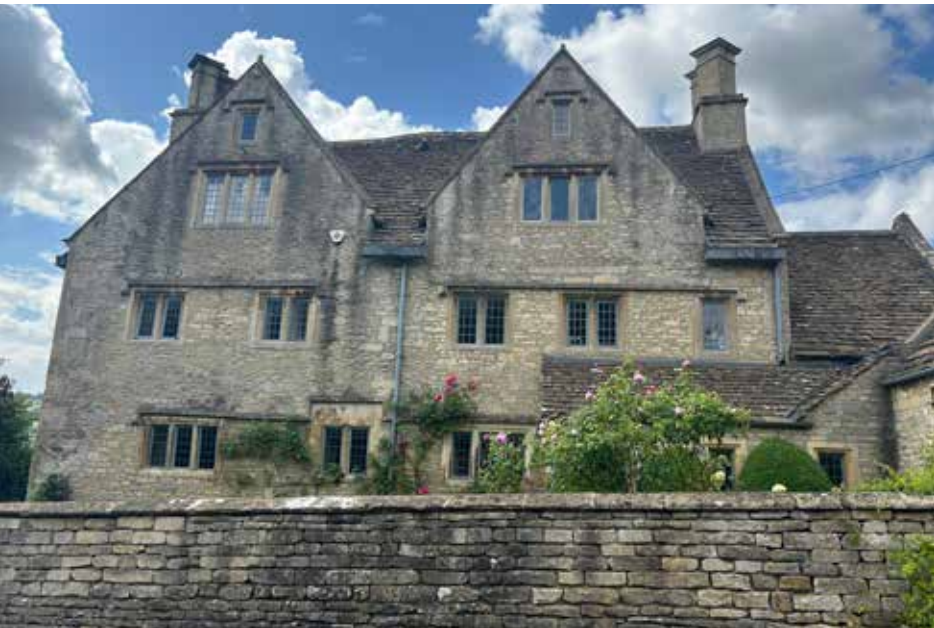
*The north-eastern elevation, facing towards the road, thought to be the earliest phase of the building.*

Facing the road is the north-eastern elevation, which has two prominent gables each containing date stones, the details of which will be discussed in this document. This range is thought to be the earliest part of the house, dating from the early 1600s. Each gable contains a single light over a 3-light mullioned window. At first floor level are two 2-light windows to the left under a single hood mould, and two 2-light windows and a single light opening under a single hood mould to the right. At ground floor level there are two 3-light windows to each side of a 2-light window - a modern insertion of the mid-twentieth century, all under a continuous hood mould. To the far right hand side of this elevation is a late twentieth-century passage extension, which links to an old outbuilding, converted into the kitchen in the twentieth century, and a lower height ex-agricultural outbuilding. The stone wall facing the road appears to date from the twentieth century, replacing an earlier hedge.

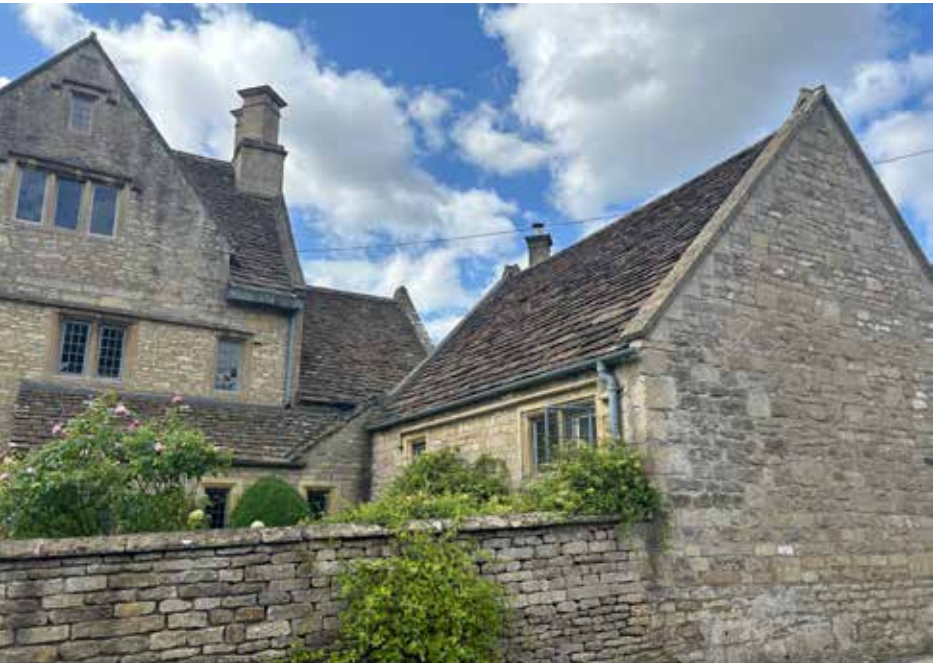
*View from the road towards the former outbuilding attached to the north-eastern facade. This outbuilding was converted into the kitchen in the late twentieth-century.*

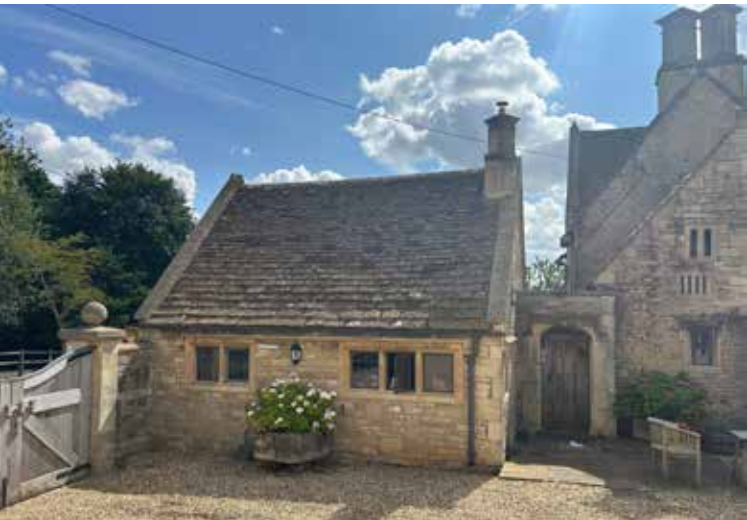
*View of the former outbuilding, now a Kitchen, taken from the south-west, with the twentieth-century entry door to the right.*

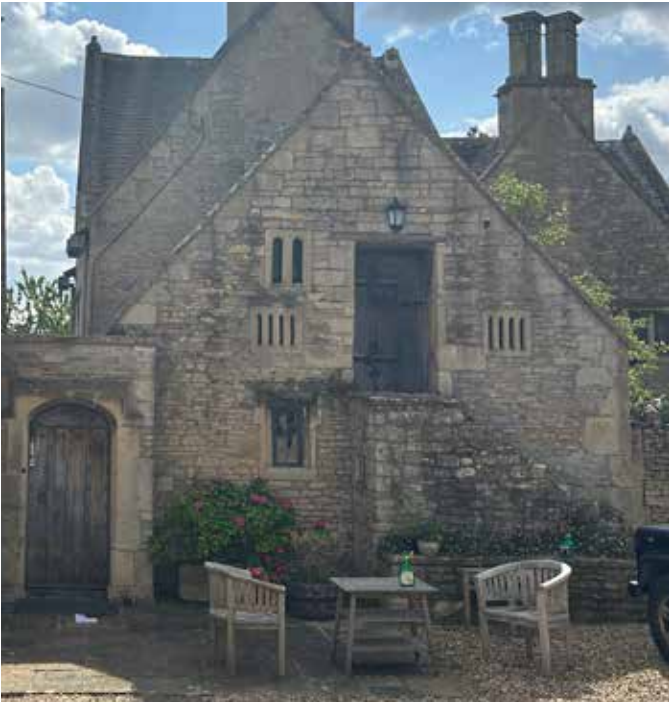
*Left: Detail of the former agricultural building to the south-west, thought to have originated as a granary with a hayloft over. It is now a utility room with dressing room over. To the left is the modern door into the entrance lobby.*

The north-western elevation faces onto the entrance drive. Adjacent to the access gates is the former outbuilding (now the kitchen). This is attached to the main house by a twentieth-century entrance door and lobby. Adjoining this, at the end of the main house, is a one-and-a-half-storey former agricultural building. The main elevation to the south-west

has two sets of 4-light lancet windows and a larger 2-light lancet window with hollow spandrels. An external stone staircase leads up to a first floor doorway. The original use of this structure is much debated but it possibly originated as a granary with a hayloft over. It has since been converted into a utility space, with a dressing room over, attached via a modern passage from one of the bedrooms in the main house.

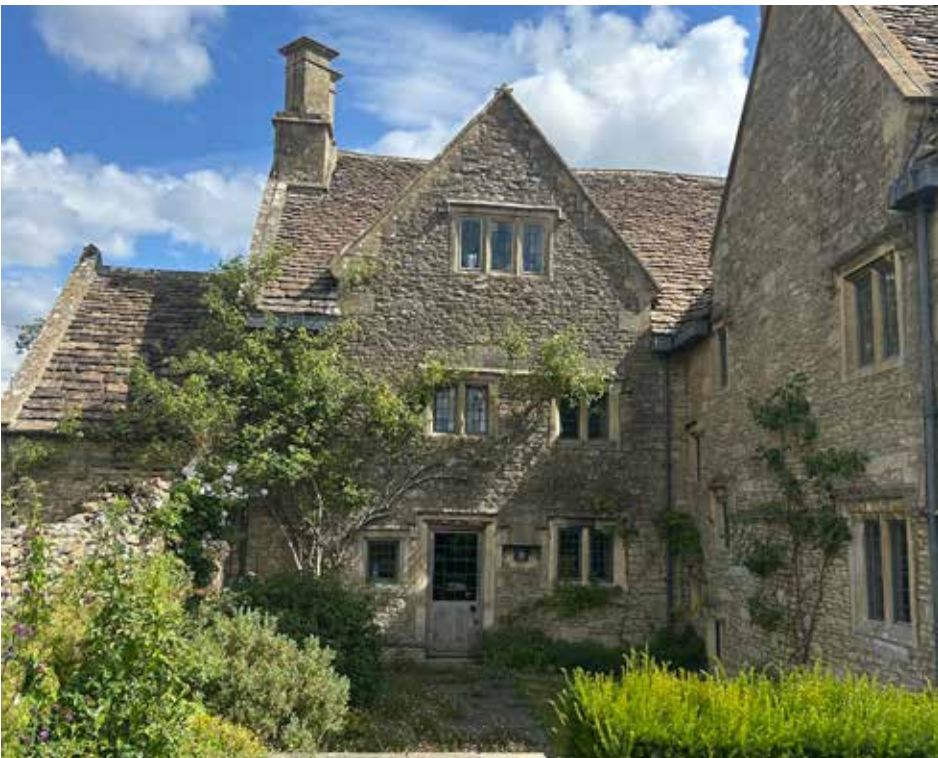
The south-western elevation of the main house is gabled, containing a 3-light mullioned window at second floor level. At second floor level are two 2-light windows under one hood mould. At ground floor level is a part glazed door providing access to the dining room, thought to be the old kitchen of the house. To one side is a single light, and to the right is a small recess and a 2-light mullioned window, all under hood moulds.

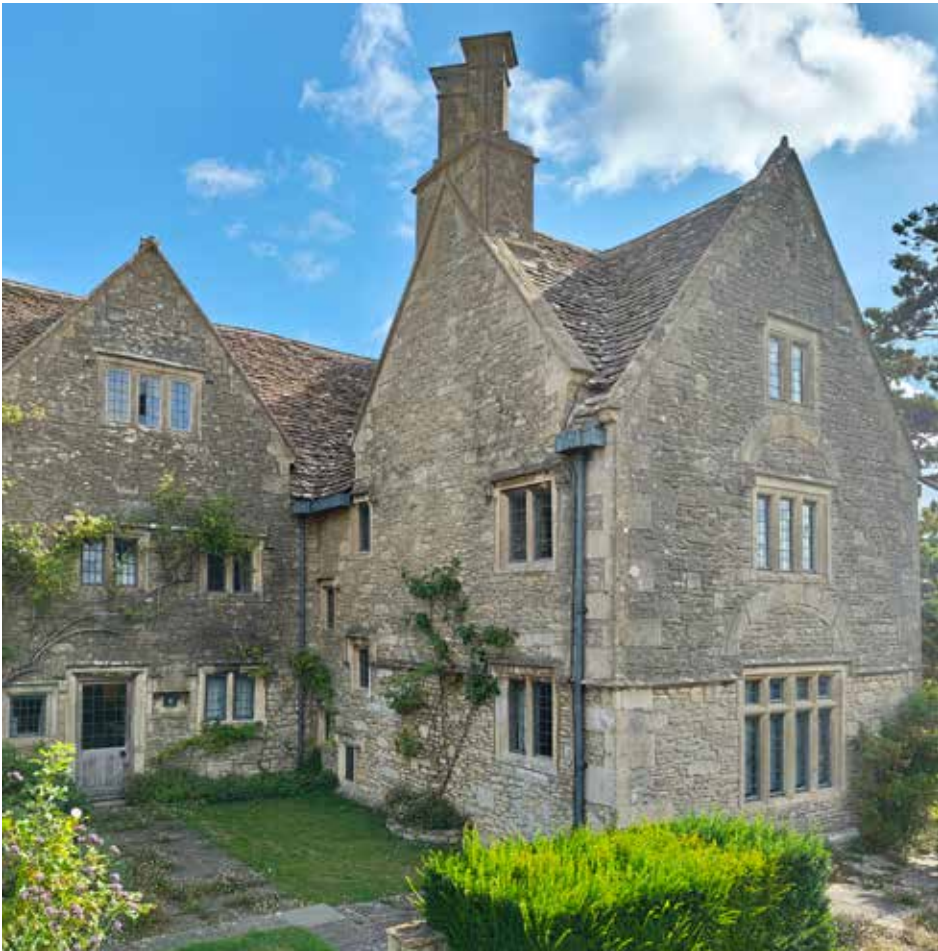
*View of the north-western and south-western elevations of the 'parlour wing' that extends to the south-west of the earlier core.*

Projecting to the south-west behind the main, earlier house is a rear wing, generally referred to as the 'parlour wing' in this document. This wing is a slightly later addition to the earlier range, thought to have been constructed around c.1645-49. The north-west elevation of the wings contains a series of five stepped windows that correspond with the staircase within. To the right are two 2-light mullions, both with hood moulds, at ground and first floor level. The end, south-west facing elevation is gabled, with a blind oval window and 2-light mullion at second floor level. The 3-light window below has a hood mould over and a relieving arch. The ground floor 4-light king mullion window to the parlour is a twentieth-century replacement but it retains its original relieving arch over. The hood mould over the window runs around the entire ground floor as a string course and there is a stone plinth running around the entirety of the wing.

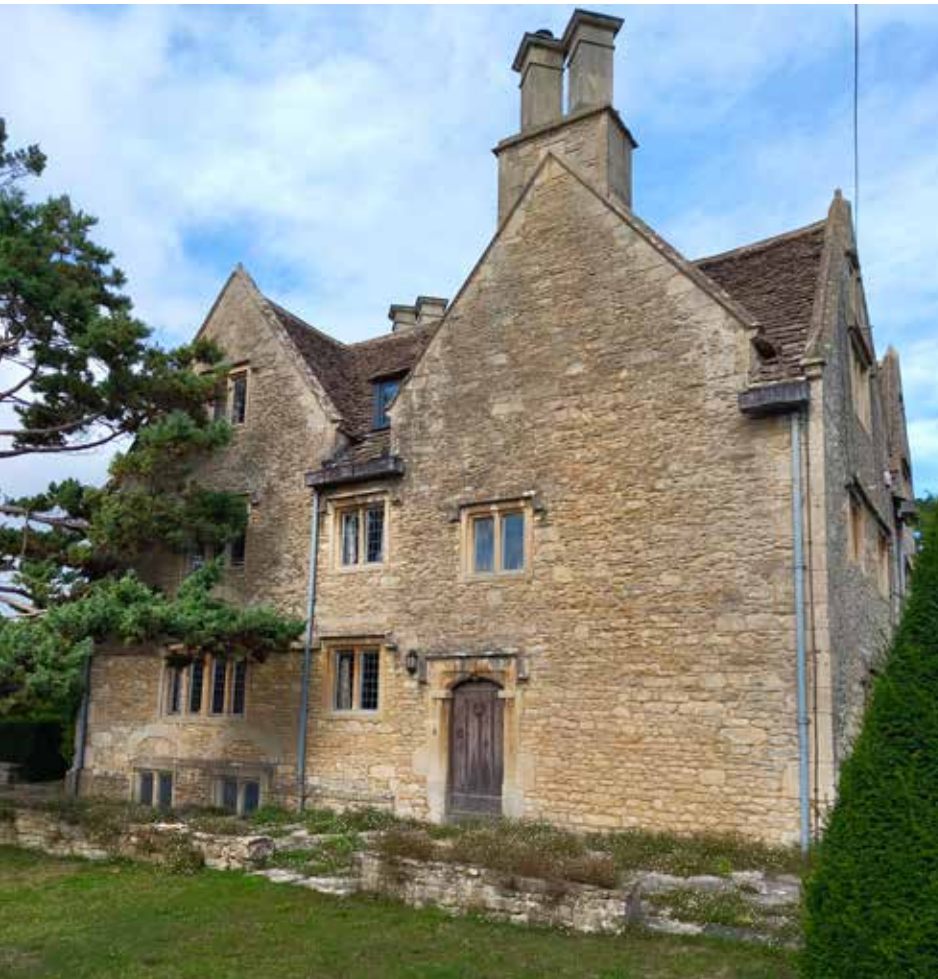
*View of the south-eastern elevation.*

The south-eastern elevation of the house is discussed in detail in this document. The left hand side of the elevation forms part of the parlour wing of c.1645. The gable contains a blind oval window and 2-light mullion at second floor level, a 3-light mullion with a relieving arch over at first-floor level, and a 4-light king mullion window with relieving arch at ground floor level. Underneath are two, 2-light windows with the plinth stepped over, and relieving arches above, both lighting the

basement space under the parlour. The hood mould over the ground floor window extends around the ground floor windows as a string course. At the centre of the elevation are two, 2-light windows at ground and first floor level. To the right is the end gable of the original long range facing the road. This has a 2-light mullioned window at first floor level, and a door set in a moulded Tudor-arched surround with impost, keystone and hood mould. As discussed later in this document, this door may have been moved from its original location further along the elevation.

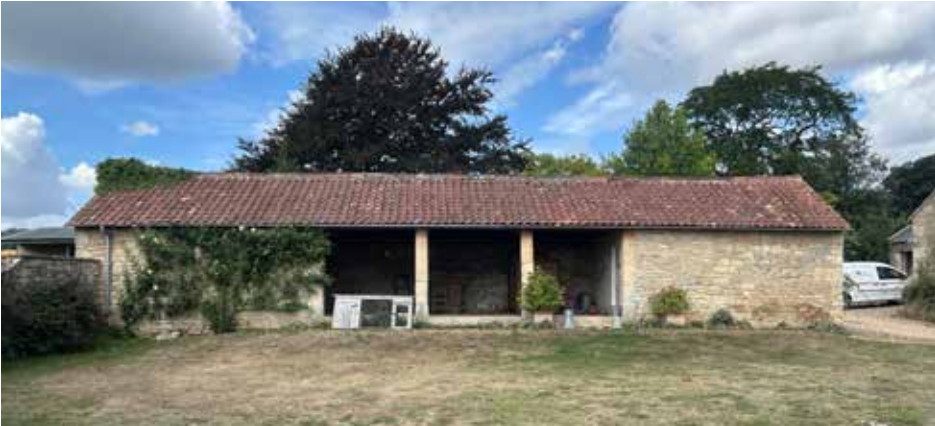
The former cowshed facing to the south-east, which would originally had two more open bays to either end of the existing building. The lawn in front was the site of a swimming pool in the 1970s and the building was converted to use as a dedicated pool house at that time.

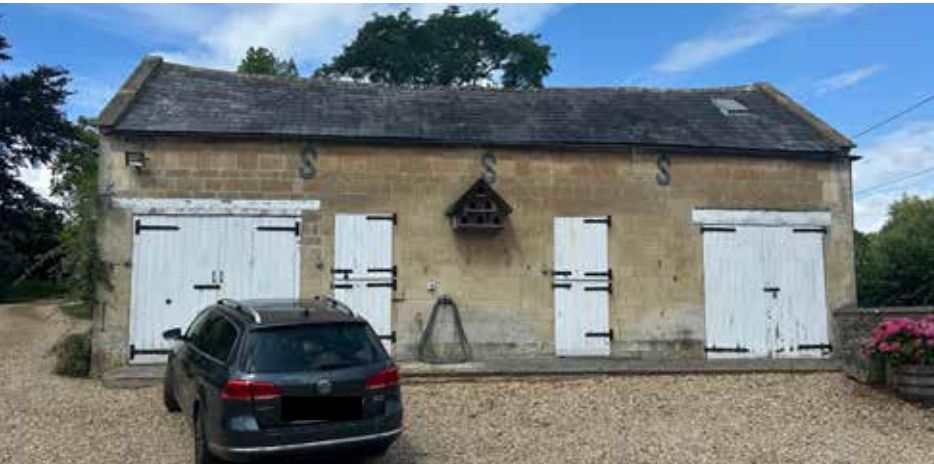
The south-eastern elevation of the nineteenth-century stable and coach house, adjacent to the boundary with the road. This building is now in domestic use.

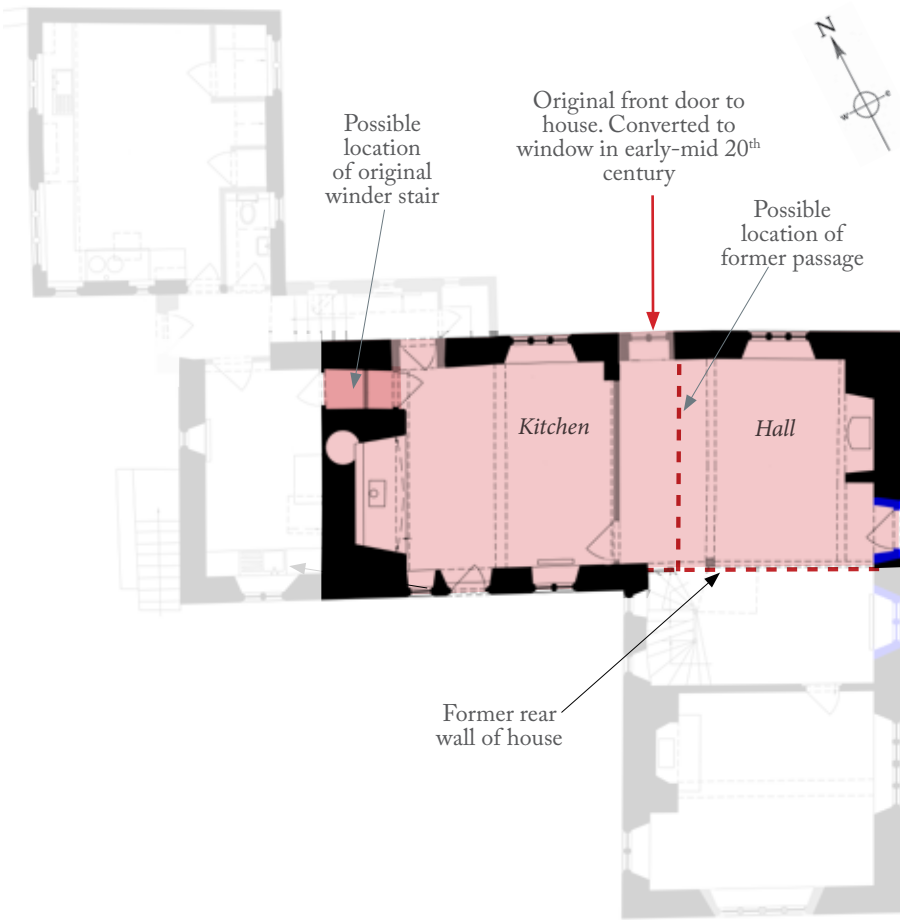
Diagram highlighting the original core of the house, which may have been on the site when Peter Webb purchased it in the 1630s. The front door would have been facing the road.

Standing building evidence appears to support this theory. The original, earliest part house on the site would have comprised only the range facing north-east towards the road, the gables of which contain the two date-stones (see figure below). This wing would have contained a kitchen to the west (now the dining room) and a hall to the east (now a living room). Therefore, although the left hand gable on this range contains the datestone marked 'PW 1646', this cartouche may have simply been added to commemorate the commencement of Webb's alterations to the house, and not the construction of the earlier range.

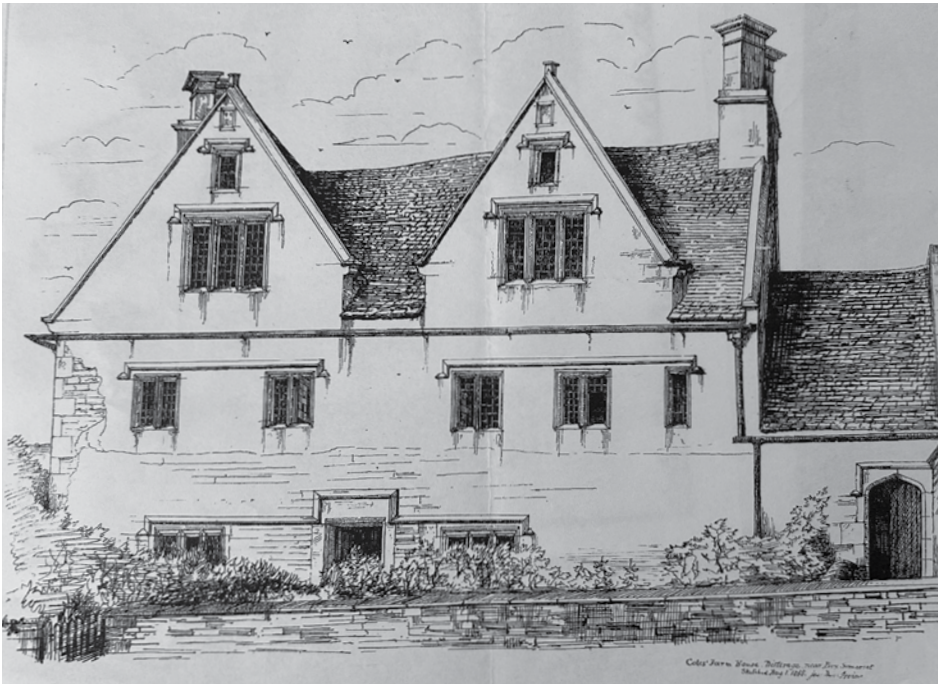
Engraving of 1868 showing the north-eastern elevation facing towards the road, and the former doorway with a hood mould over. There also appears to be a gate to the left of the image, suggesting there was access from the road. The original entrance to the granary can be seen to the far right.

At that time, it seems likely that the north-eastern elevation was the front facade of the house. An engraving from the early-twentieth century shows a doorway on the north-eastern elevation facing the road, since converted to a window in the twentieth century. When first constructed, the hall may have been separated from the main front door by a passage, which would have led to the rear of the house, roughly on the site of the existing stair. Prior to this time, the stair was likely a simple winder stair, possibly located to the west, by the old kitchen fireplace. The engraving also shows a gate set within the wall to the road, and the original doorway to the granary to the far right, discussed later in this document.

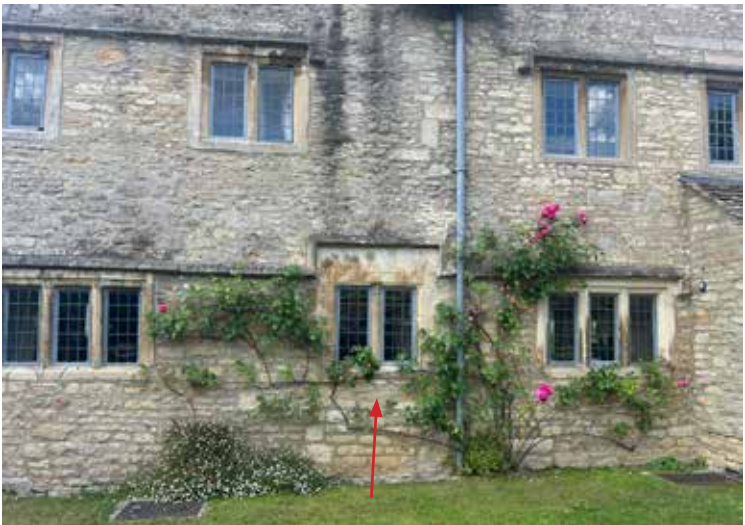
Left: Modern photo showing the blocked doorway on the north-eastern front, now a window to the hall.

accessed via the existing flight of external stone steps. The window is possibly a reuse from another building. Originally, this space would have had a separate access from the north-eastern elevation, as shown on the 1868 engraving of the house. The doorway was removed as part of the later, 1970s works, when a new passage was created on the north-eastern side of the house.

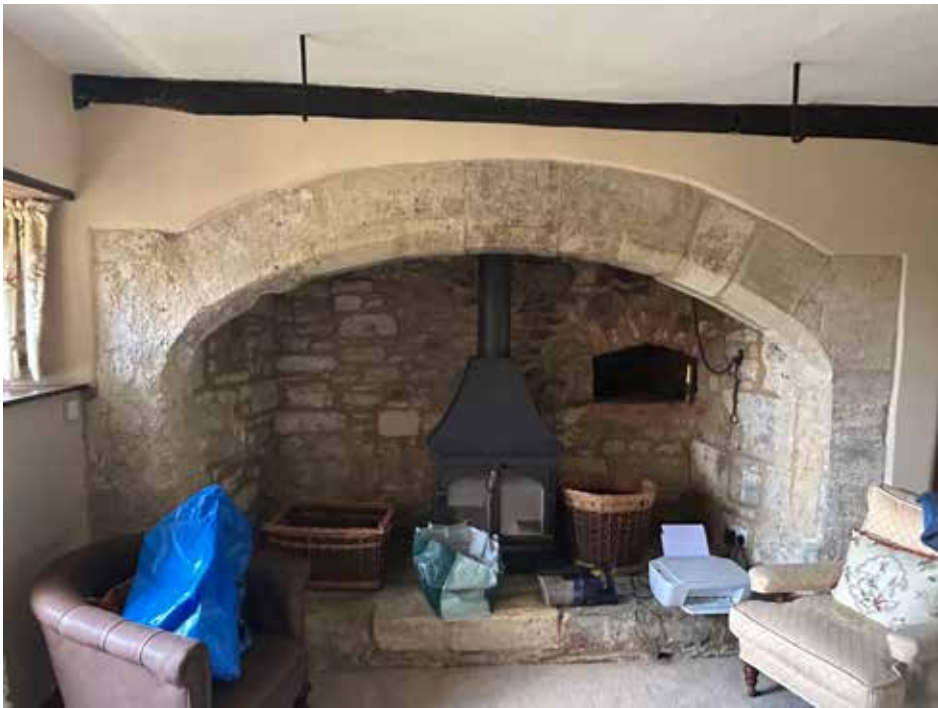
The segmental arched fireplace in the old Kitchen of the house to the west of the existing dining room.

There are two end-wall fireplaces remaining in the house from this early period of construction, contained within the old kitchen and hall. Both of these are recorded in the publication *Period House Fixtures and Fittings 1300-1900* by Linda Hall (England's Living History, Countryside Books, 2005). The fireplace in the kitchen was a distinctive type with a wide segmental stone arch, known as a 'Yorkshire Arch', spanning the opening. This type of fireplace was prevalent in Yorkshire but also in the Wiltshire and Gloucestershire area, and this feature fits with a proposed date of construction in the first half of the 1600s. A similar example can be found at Hill House Farm in Box.

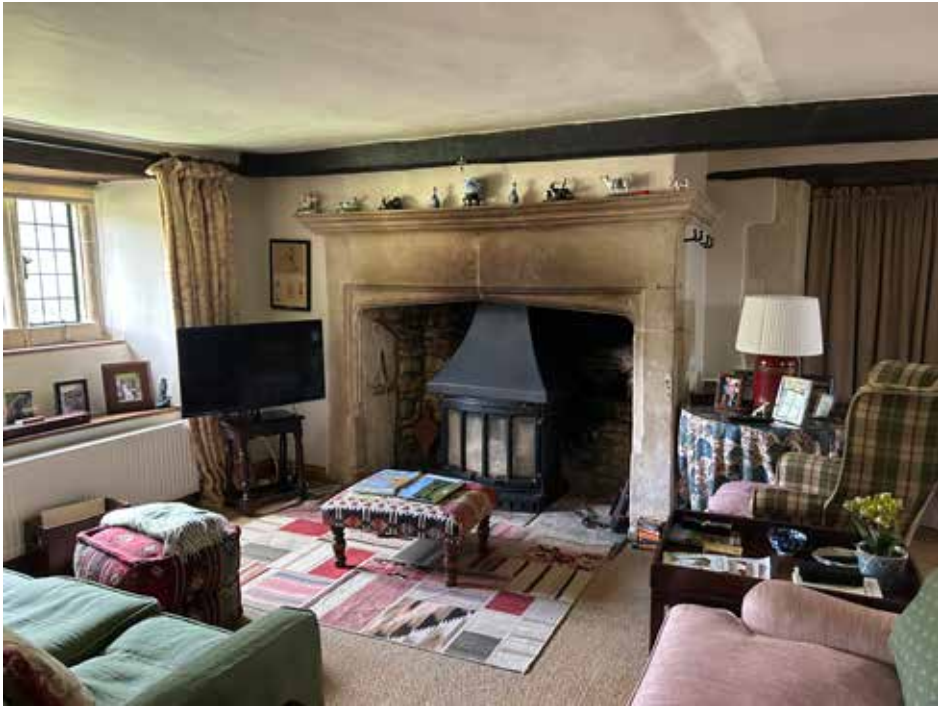
The more formal stone fireplace with depressed arch, located in the original hall to the house.

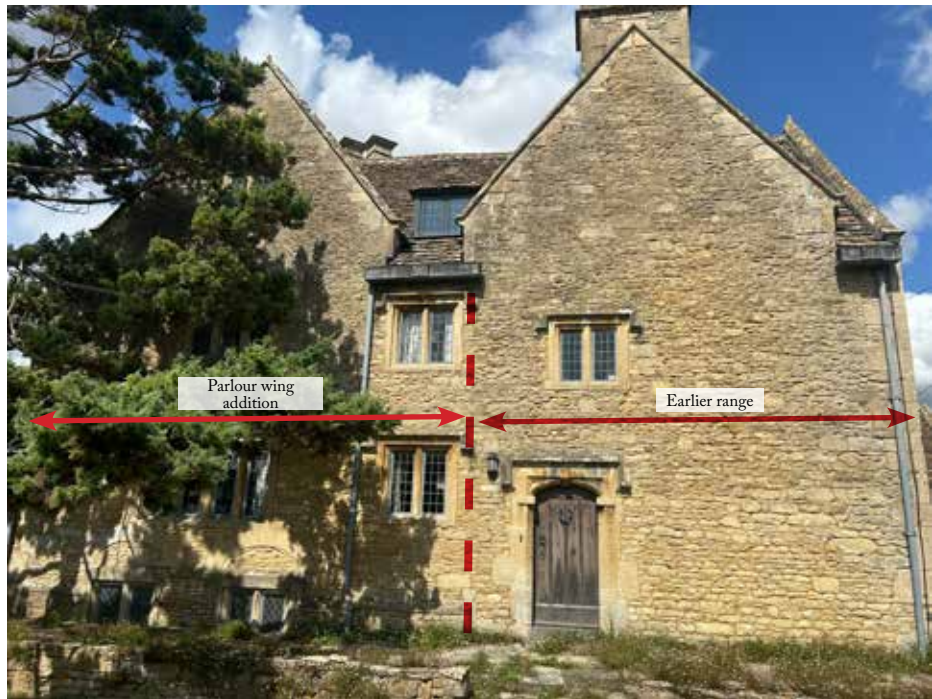
Modern photo of the south-eastern facade showing the end gable of the slightly earlier, north-eastern range to the right, and the parlour wing addition of c.1645 to the left.

At the introduction of this new wing, it seems likely that the main entrance to the house was switched to the south-eastern facade. Internally, the front door would have led into a stair-hall, leading to the existing staircase with its distinctive splat balusters. The parlour, to the left of the main entrance, would have been the finest room in the house, reserved for receiving guests. To the right of the front door would have been the hall with the old doorway retained to the north-east, with a wall dividing the space from the stairway.

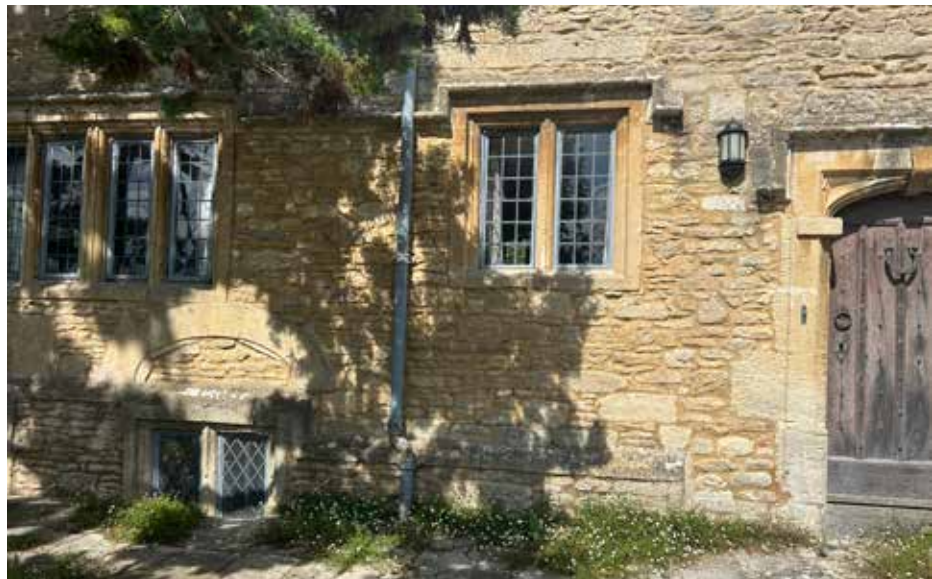
Detail of the south-eastern facade showing the plinth around the parlour wing that stops at the junction with the earlier range.

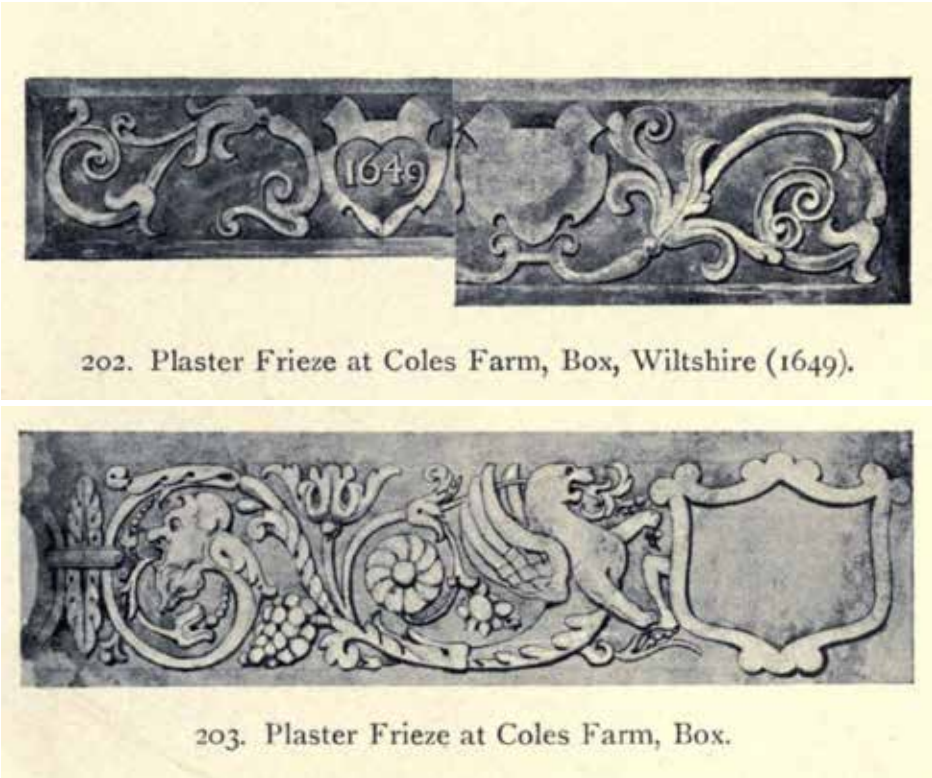
Details from Gotch's book of 1909, which contains details of the decoration of the Parlour, including part of the removed frieze, which was dated 1649.

This is supported by details in a book by John Alfred Gotch (1852-1942), published in 1909 and entitled *The growth of the English house; a short history of its architectural development from 1100 to 1800*. This includes two details from the decoration in situ at Coles. The details comprise a section of the 'plaster frieze' at Coles Farm, clearly dated 1649. The second image is a section of the existing plasterwork frieze.

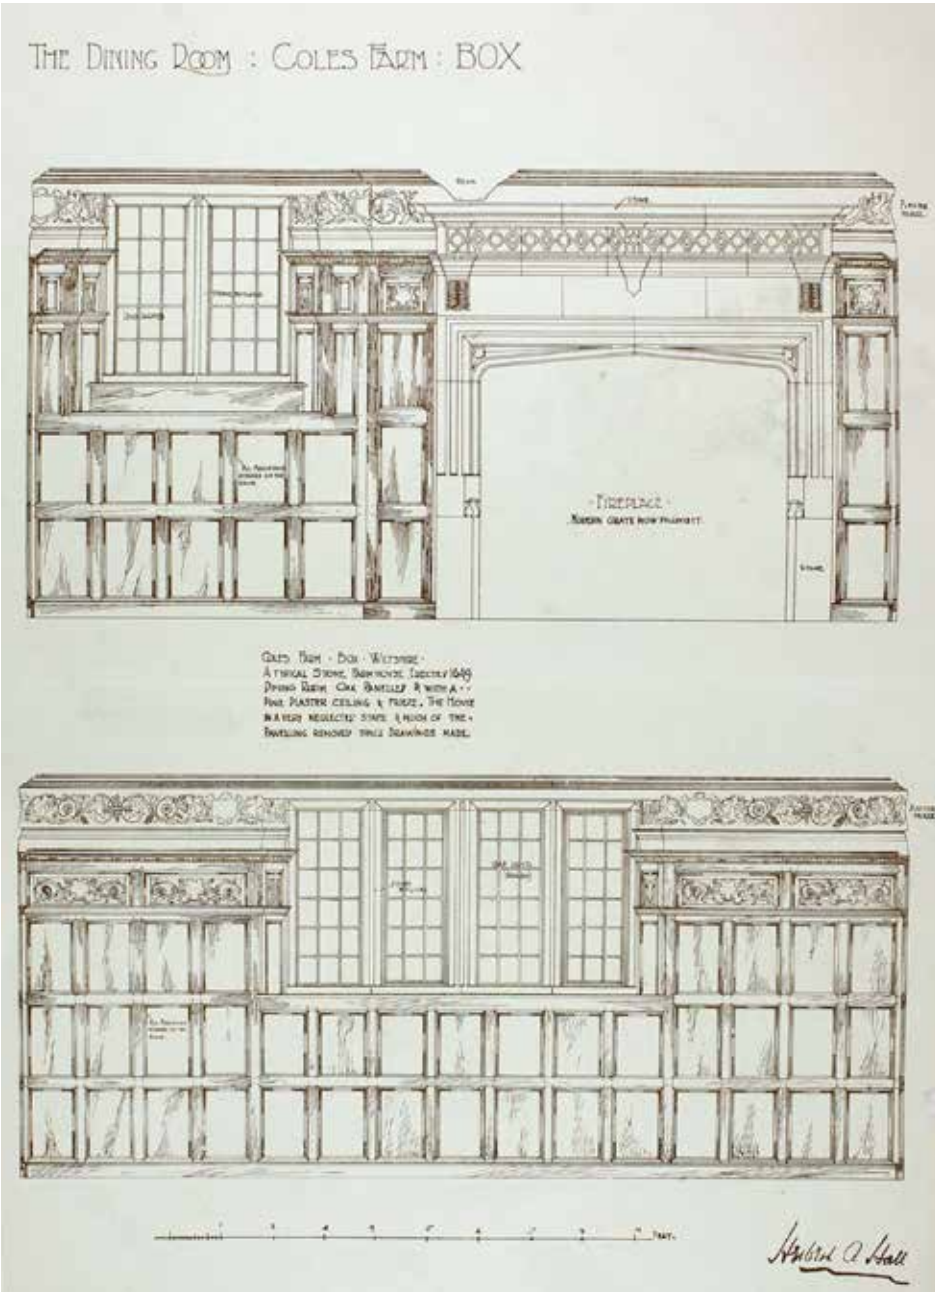
Drawings of the Dining Room (the Parlour), made by Herbert Hall in the late 1800s and published in 1903, showing the room before part of the decoration was removed.

The drawings of the parlour previously discussed were made by Herbert Hall in the late nineteenth century, and the detail he recorded suggests that the house was still in reasonable condition at that time. However, his drawings were not published until 1903 and by that time, the drawing was annotated:

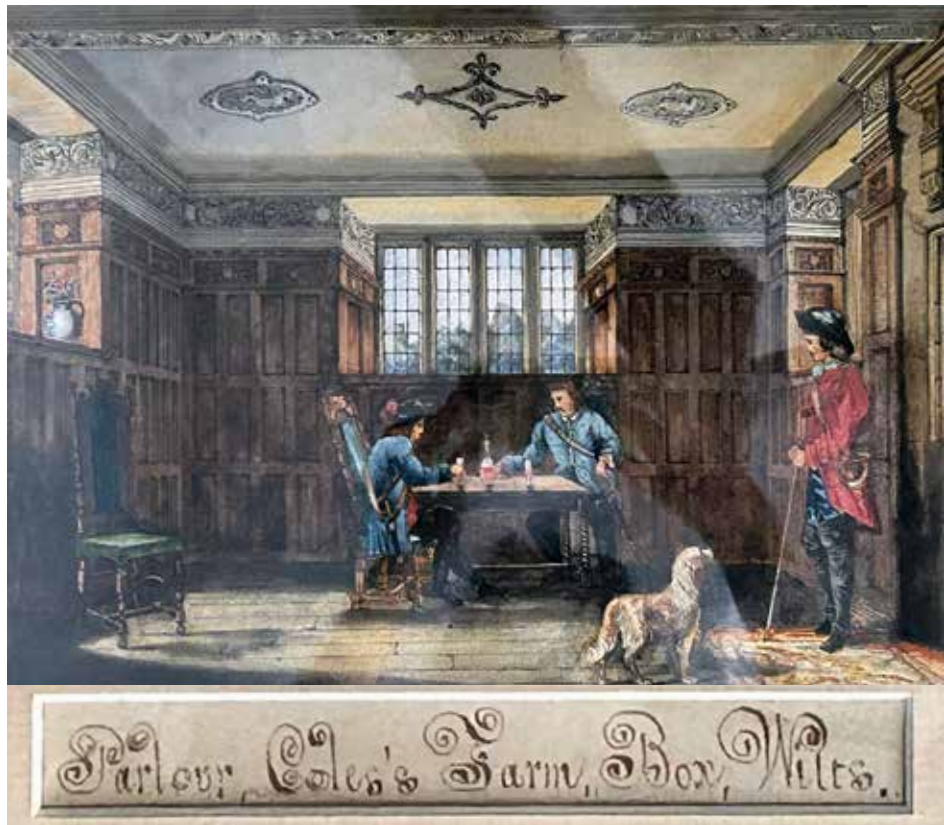
A view of the parlour, currently hanging at Coles Farm, showing the interior with its original, complete decoration. The dated panel shown in the Gotch publication appears to relate to the upper section of paneling that was later removed.

This evidence clearly dates the parlour decoration to 1649, suggesting that Webb made his additions to the existing house between 1646 and 1649, aggrandizing the property and making it suitable for a yeoman of his stature.

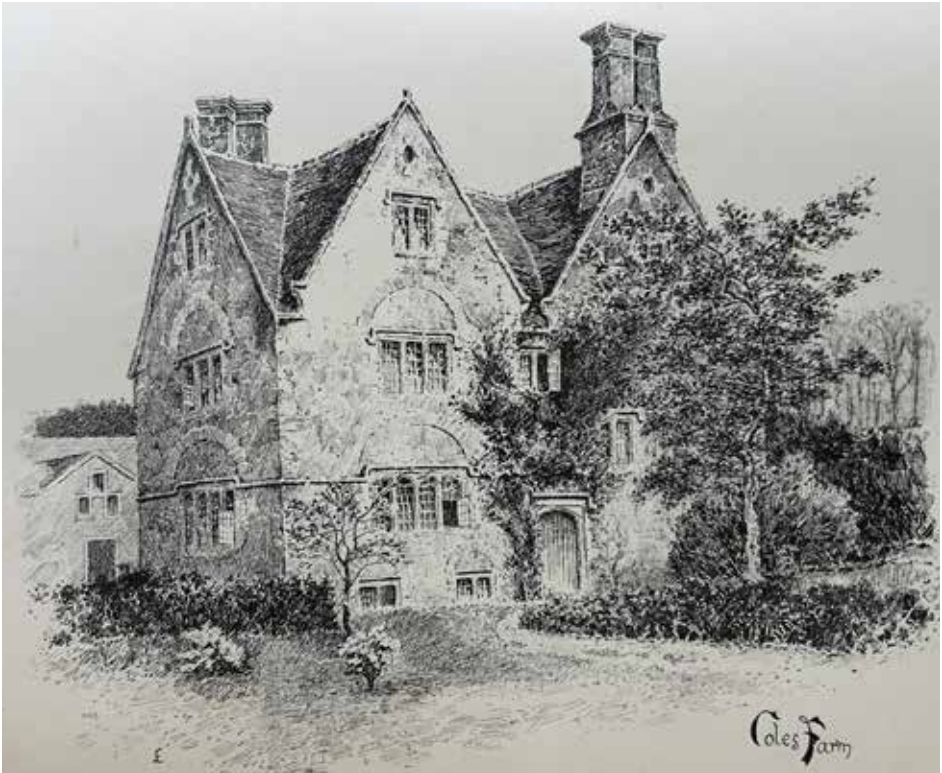
The view of the south-eastern elevation, included in S. John Elyard's publication *Some Old Wiltshire Homes* in 1894. This appears to suggest that the existing doorway was originally located at the centre of the facade on the site of an existing window.

placed centrally, on the site of the existing window opposite the staircase. Today, the door is to the right, the window to the left. The Elyard engraving shows with a 2-light mullioned window at first floor level. To the right of the view is the existing first floor window in the earlier range, set at a lower level, in its existing position. The Elyard view is relatively detailed, clearly showing the windows of the parlour range with their relieving arches. A second image is a drawing dated 1905, which appears to be less accurate. The doorway is shown in its existing position, although the window levels are wrong and the building is not wide enough.

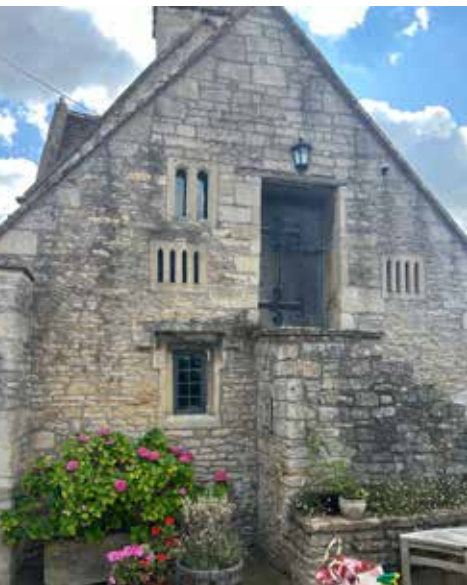
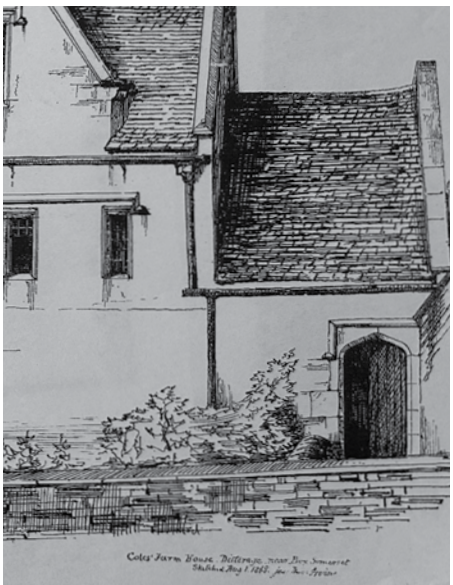
Modern view of the former agricultural building on the western end of the house (left), with steps up to the hayloft. The ground floor access to the space would originally have been via a door on the north-eastern facade, shown in the 1868 engraving (right).

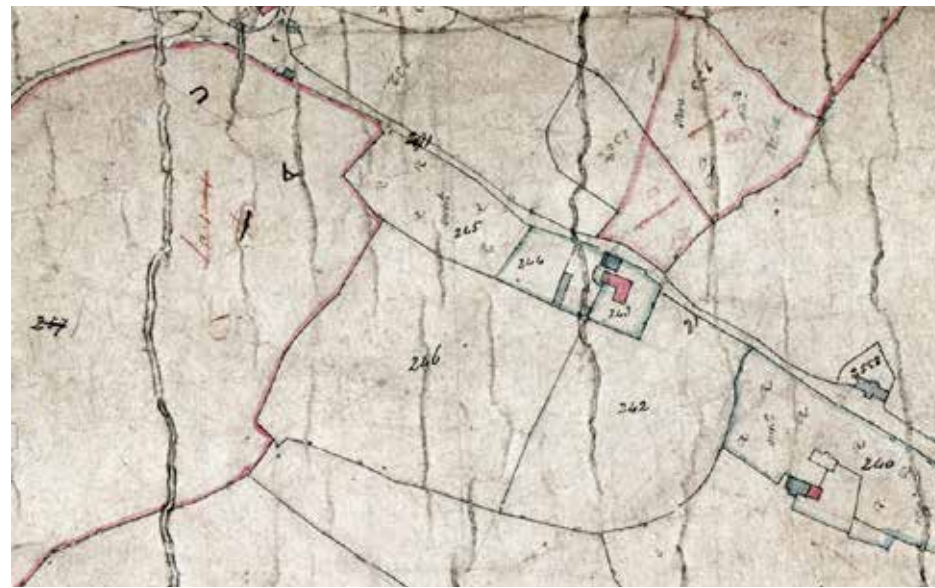
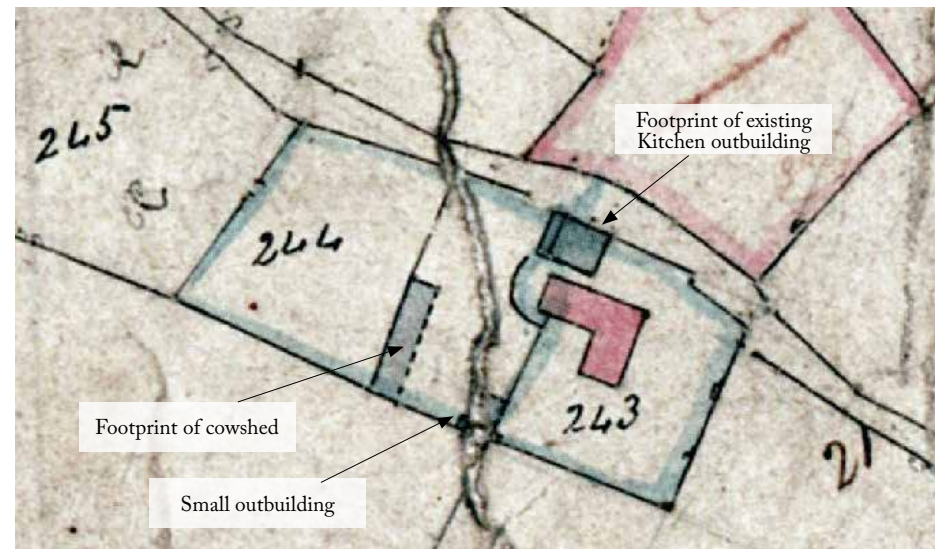
*The tithe map of 1838 showing Coles Farm (top) with a detail of the farm house and the surrounding farm buildings (above).*

The tithe map and apportionment of 1838 confirms this, showing Coles Farm in the ownership of Edward Webb, but occupied by a Thomas Rawlings, a farmer. Plot 243 is described as the 'House, Offices and Garden', with 244 as Stable and paddock. Piece 145 is shown as a 'young orchard'. There is also a plot of land (235a) on the opposite side of the road to the east, containing a large building and described as the Barn and Barton. The large plot adjoining, (235) is named as Webb's Piece.

Crucially, the map shows the broad L-shaped footprint of the main house much as today, and as it had been since the mid-late seventeenth century. Around the granary on the western elevation the curved outline of a yard

is marked, and to the north, there is a large outbuilding; this appears to be the same outbuilding on site today, that was converted to a kitchen in the late-twentieth century. There appears to be an outshot or lean-to on the western facade.

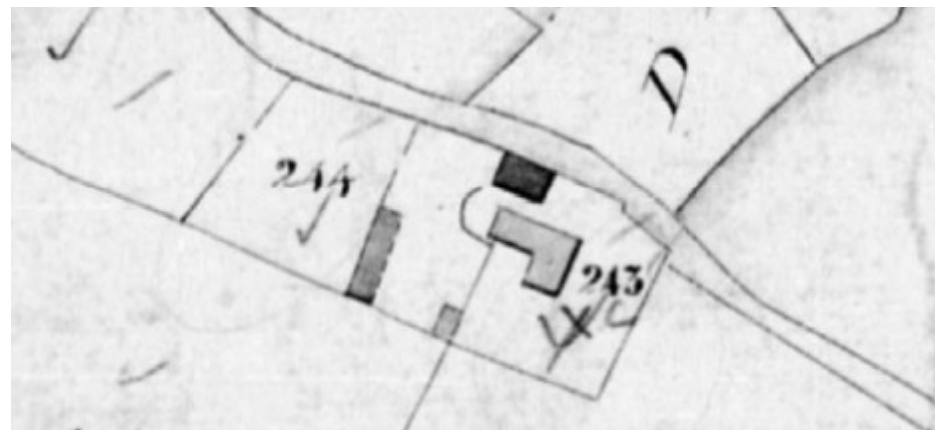
*Another version of the tithe map, also dated 1838, which more clearly shows the outbuilding to the south.*

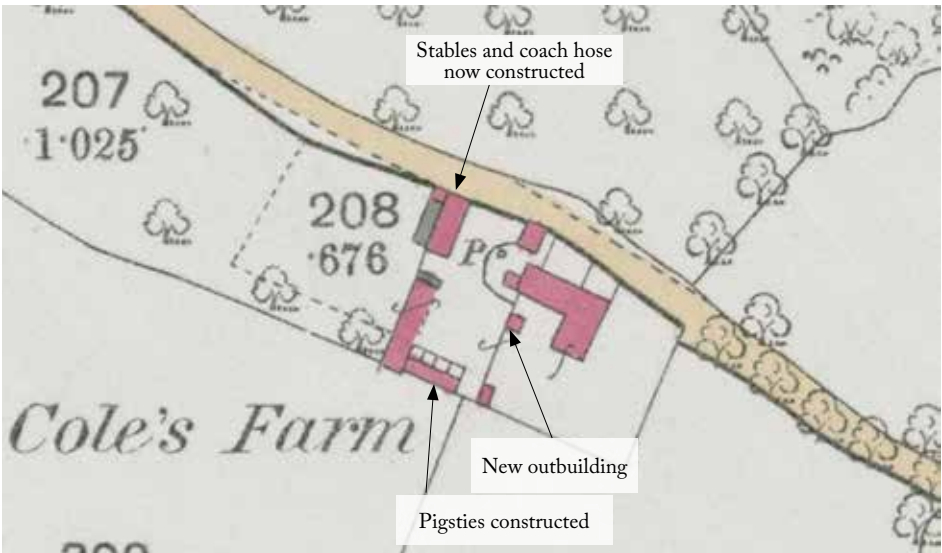
Above: The first edition Ordnance Survey map of Coles Farm from 1885, which shows the layout of the site and outbuildings in detail.

To the south-west of the house, the open-sided shed is shown, with a small outshot at its northern end. In a later nineteenth-century sales advert, this is described as an apple store at the end of the cowshed. Also shown in situ is a new range of buildings adjoining the cowshed at a right angle, running along the southern boundary of the garden. The layout with small pens to the north suggest that this was certainly a pigsty.

Perhaps most noticeably, the stables have been built in their existing location to the north-west of the main house. This clearly dates the stable building to between 1838 and 1885. The building is shown as a long range with one end to the road, and a lean-to addition on the western side. The building contains remnants of stall fittings which seem to correspond to a mid-nineteenth-century date.

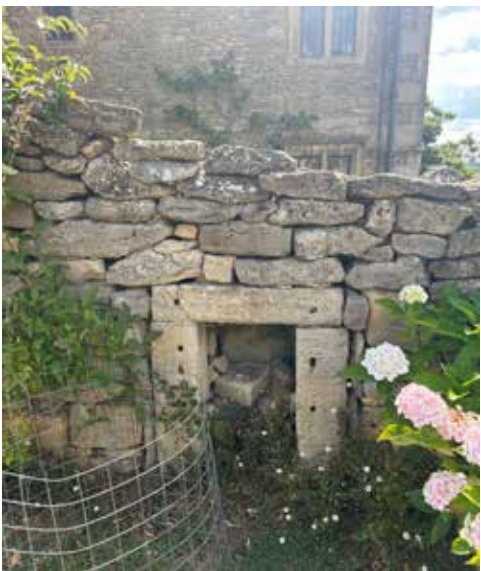
Left: One of the remnants of stone in the terrace wall running through the garden. These are possible remnants of windows from an outbuilding, that were inserted into the wall after demolition.

wall running across the garden today, there are remnants of a former building, with pieces of stonework built in. These are possibly fragments of that former building, reused within the terrace wall. These fragments may originate from that building, after it was demolished in the 1930s.

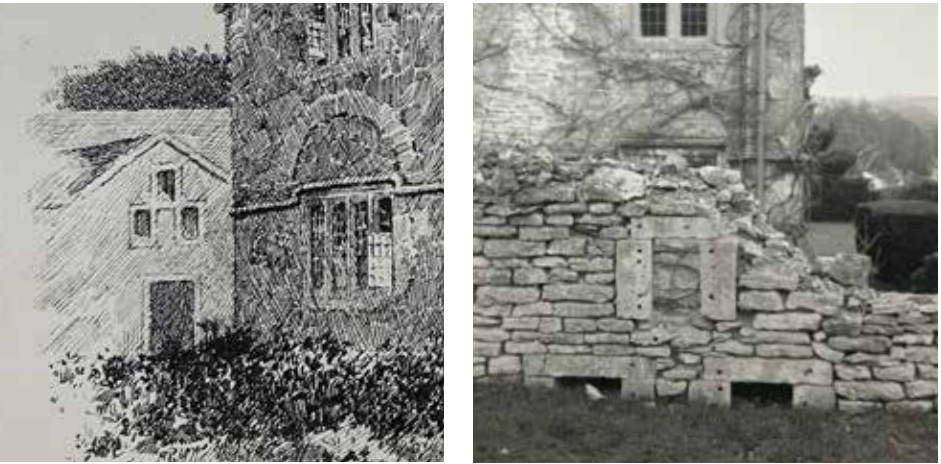
Detail of the engraving included in S. John Elyard's publication *Some Old Wiltshire Homes* in 1894 (left). This shows the gable end of a building to the rear of the parlour wing. Could the remnants of this building have been incorporated into the garden wall at Coles (right)?

The engraved view in Elyard's publication of 1894 provides a glimpse of one of the farm outbuildings. Behind the parlour wing of the house, the gable end of a building is shown with a central doorway and a distinctive arrangement of three windows above. It is unclear what the purpose of this building is. It is possibly the small building close to the house, as it seems to be the wrong angle to show the end of the stable. A 1980s

photograph of the garden wall with less foliage clearly shows a range of ex-situ stones mounted into the wall. Whilst it could simply be a coincidence, these stones are arranged in a very similar format to those shown in the engraving, and may be remnants of the building after it was demolished in the twentieth century.

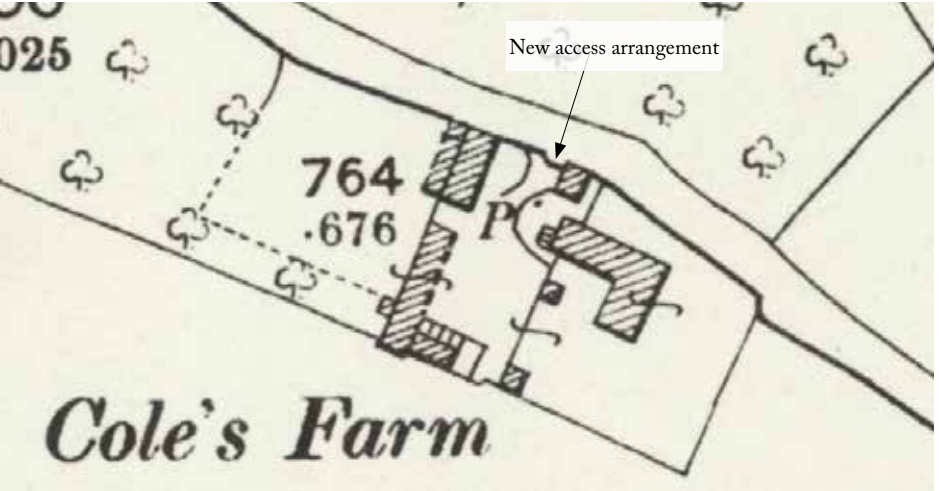
The first revision Ordnance Survey map of Coles Farm from 1899, which shows a new access layout from the road.

The next available Ordnance Survey map of 1899 shows little change to the site. However, there is now a more formal entrance shown leading from the road to the north into the central yard. An indenture document contained within the Webb archives records that in 1897, the farm was recorded as comprising the 'farm house together with garden, orchard, stable, coach-house, cowshed, pigstye and yard thereto adjoining.'
