## COLES FARM, WILTSHIRE

### HISTORICAL DEVELOPMENT

1.0 INTRODUCTION

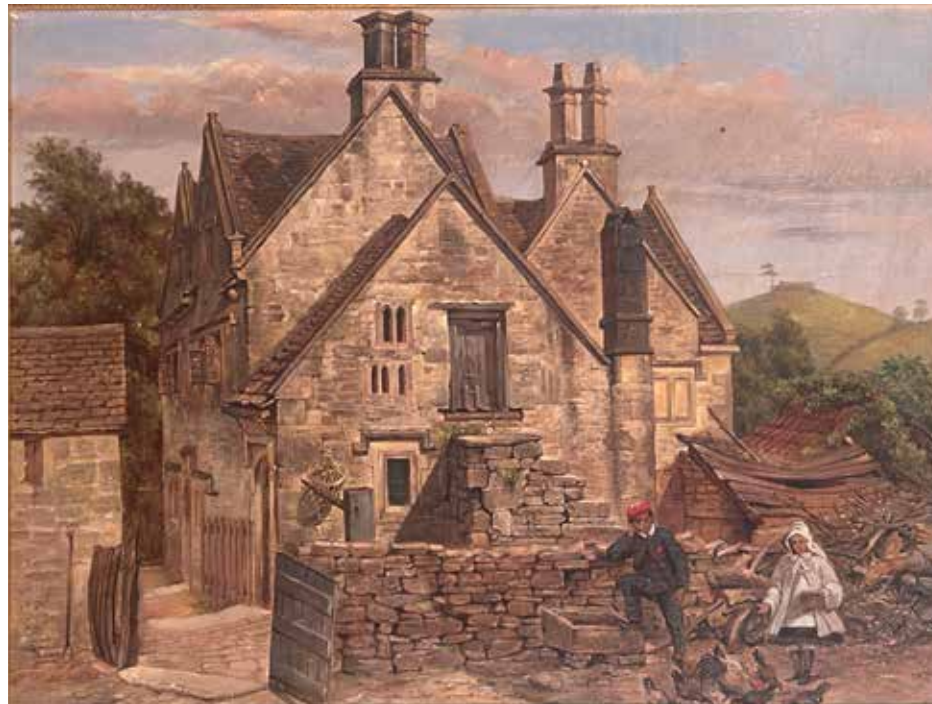
*An undated watercolour view of the western end of the house, likely dating from the turn of the twentieth century.*

A further watercolour view, still held within the house, provides further evidence of the property in a decaying state (see above and image on the document cover). The clothing worn by the figures in the view appears to fit with a date of the late 1800s/early 1900s. The view is taken from the yard to the west of the granary, and appears to show the house in a semi-derelict condition. The granary is shown much as today, but with an additional chimney set at its south-western corner.

To the far right is a building with its roof falling in - this is presumably the smaller structure close to the house shown in the 1885 and 1899 maps. The outbuilding that was to be converted into the existing Kitchen in the later twentieth century, is shown to the far left of the image. There is also a glimpse of the north-eastern elevation. This tallies with the 1868 engraving, showing the original doorway into the hall, and also the old doorway leading into the granary.

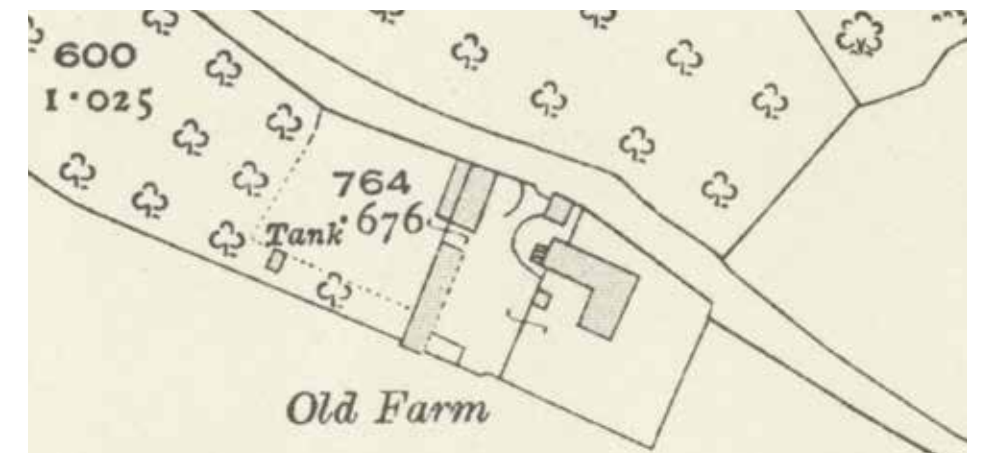
*The 1919 Ordnance Survey map of 'Old Farm', which shows that the pigsties were disused and the southern outbuilding had been demolished. A new oil tank is shown to the west.*

By the time of the 1919 Ordnance Survey map, some changes are shown on the site. The pigsty adjoining the cowshed is shown unshaded, which usually indicated that the building was disused. The building to the edge of the property boundary to the south had been entirely demolished; this all indicates that change was certainly afoot at the farm. Perhaps the most noticeable change was that the property is not recorded as Coles Farm but as 'Old Farm', perhaps a move towards creating a more romantic vision of the seventeenth-century farmhouse.

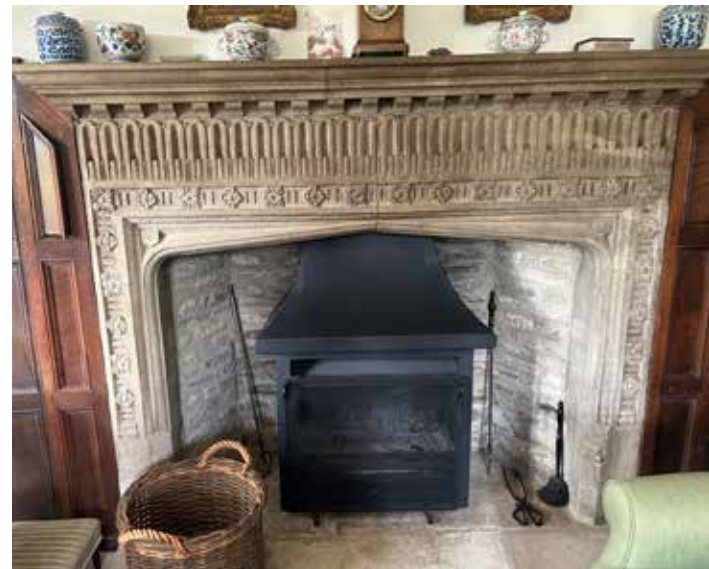
Left: The existing fire surround in the parlour. This is a modern replacement of the original that was recorded in the space in Herbert Hall's drawings of the early 20th century.

It is also thought to have been under the Moger's ownership that the fireplace in the parlour was removed and replaced with the existing replica. Local rumours recall that a wealthy American visited the family in the 1930s, admired the original fireplace and bought it to ship back to America, but there is no documentary evidence to corroborate this. Attempts have been made to track down the fireplace's location today, but to no avail. The existing fireplace is certainly a twentieth century replacement similar to the one shown in Hall's drawing but with simplified details.

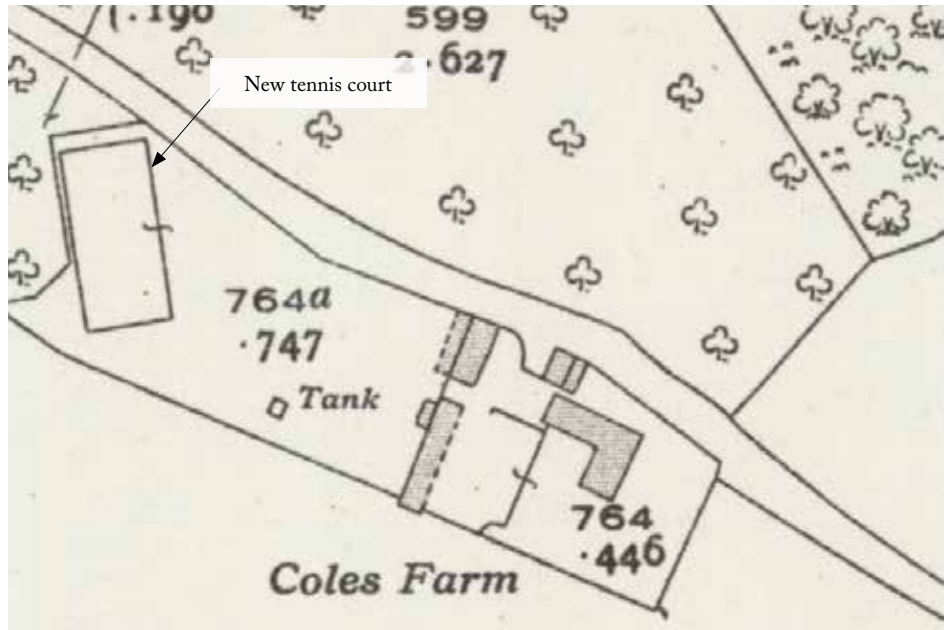
The 1936 Ordnance Survey map showing the name returned to Coles Farm and the pigsties and small outbuildings in the garden demolished.

The 1936 Ordnance survey map shows no change to the main house, but clearly shows a large tennis court created by the Mogers to the far west of the grounds (since removed) created across the site of the existing driveway.

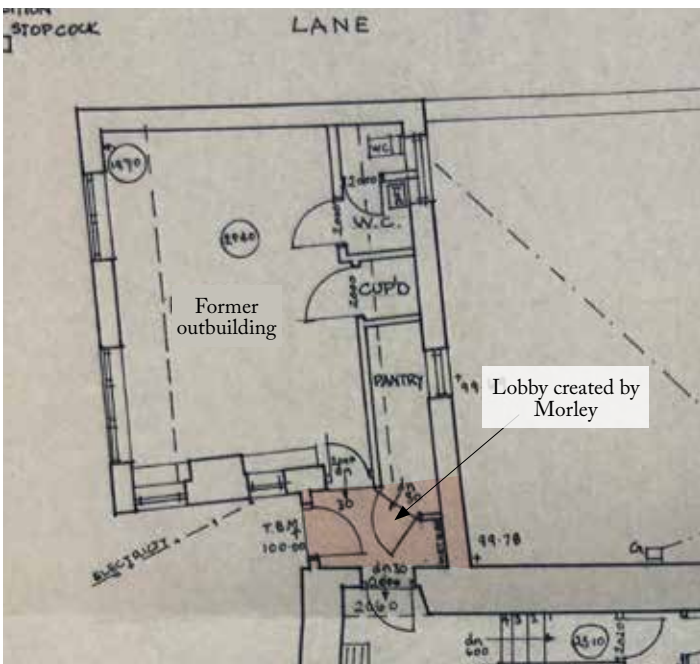
Left: 'As existing' survey drawing of 1972 showing the alterations that Robin Morley made, connecting the outbuilding to the main house via a small lobby.

An 'as existing' from 1972, just after the house had been sold by Morley, shows this lobby built, with the doorway facing westwards, onto the former yard. The small lobby led into the outbuilding, off which a cupboard and WC were set, and also a small pantry accessed from the lobby. The

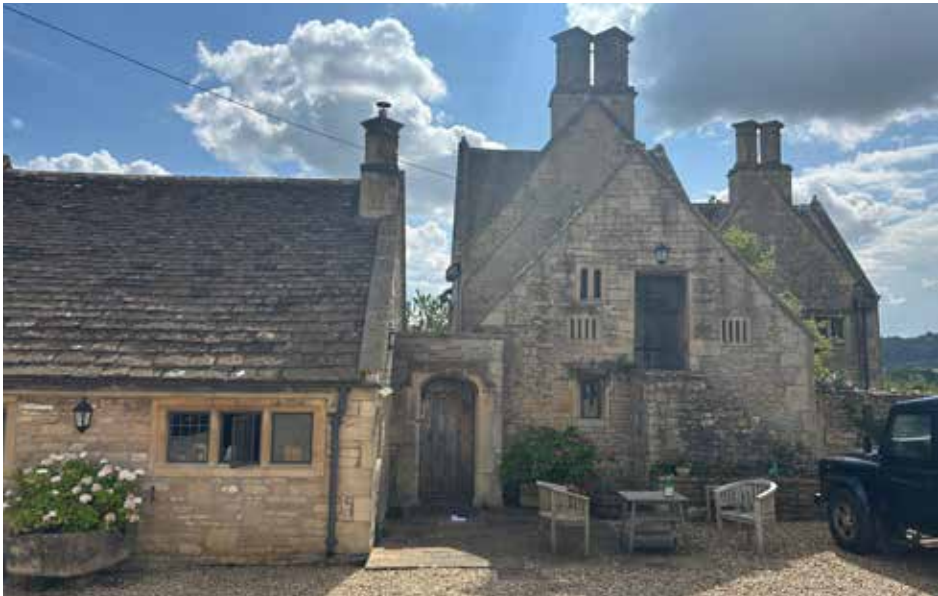
Modern view of the western side of the house, with the doorway and lobby created by Morley to link the main house and the outbuilding to the north.

The Mogers sold the property in 1950 to a Mr Robin Morley. Documentary evidence of changes made by Morley are limited, with records in Wiltshire archives relating only to a planning application for a new worker's cottage on the farm in 1947. However, one major change that the Morleys appear to have made was the creation of a small lobby to link the main house and outbuilding close to the road. A new entrance was created by closing in the gap between the outbuilding near the yard entrance and the main house. This involved creating the existing doorway onto the yard between the two buildings.

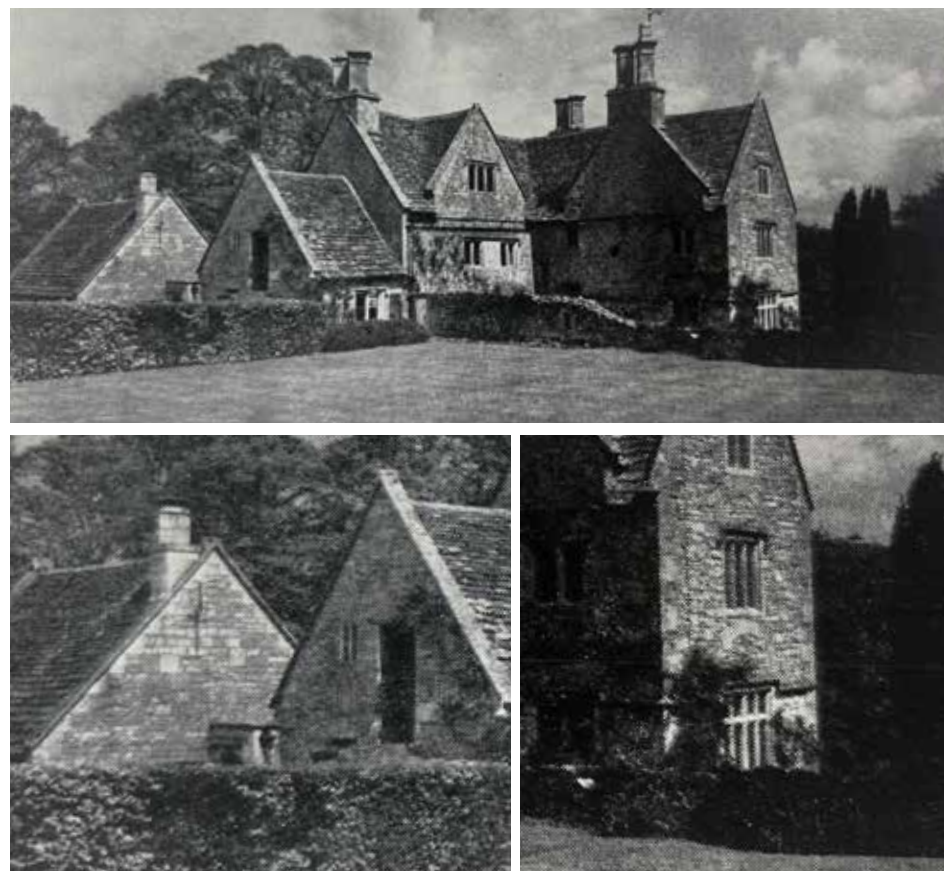
*Photograph from the 1972 sales advert (top) showing some of the changes made by Robert Morley. The photo confirms that Morley created the lobby and new door between the outbuilding and main house (see inset detail, left). It also shows that the existing window had been installed into the parlour, replacing the one shown in Herbert Hall's drawing (see inset detail, right).*

The photo also shows that by this time, Morley had replaced the window on the south-western elevation of the parlour wing. This was shown by Herbert Hall in the late nineteenth-century sketches of the rooms as a much squatter, mullioned window. Morley owned the property until July 1972 when it was auctioned for £85,000.

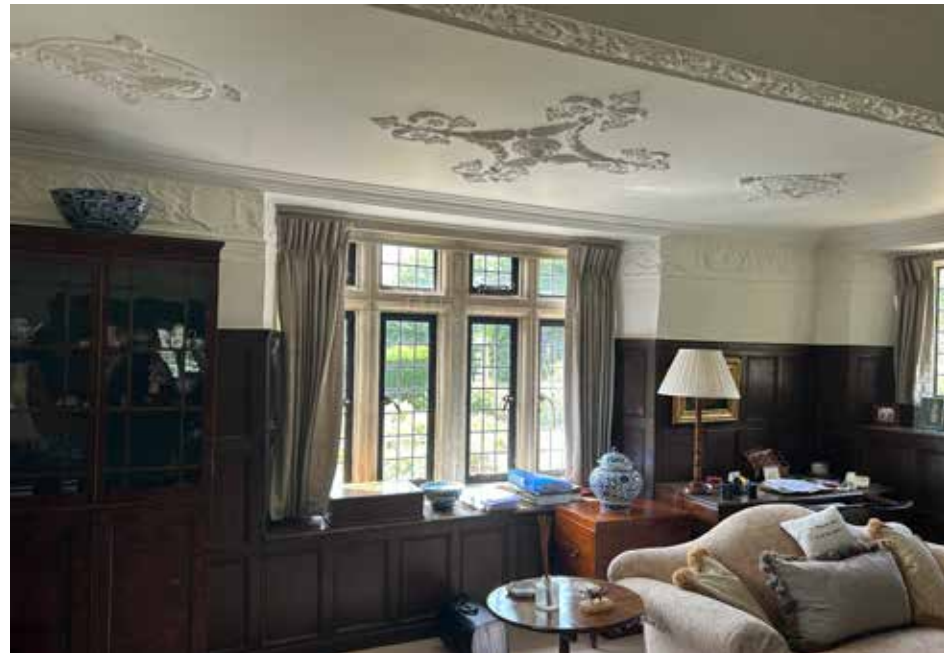
*Modern photograph of the south-western to the parlour, likely replaced by Robert Morley after 1950.*

- Some of the windows appear to have been replaced in the twentieth century, the most notable example being the enlarged parlour window that dates from the twentieth century, in a revivalist style.

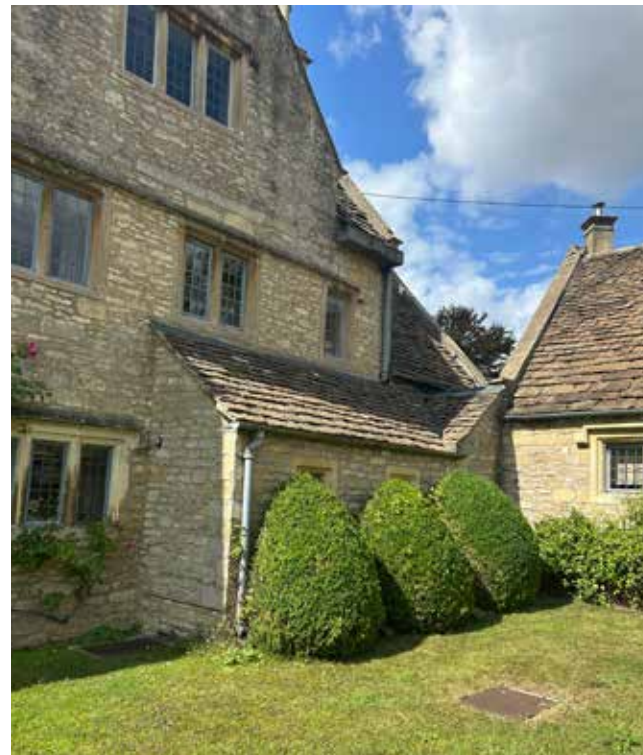
Modern view of the passage linking between the western doorway, the Kitchen and the main house, installed c.1973 by Lady Juliet.

In addition, a new passageway was built on the north-eastern side of the house to provide an access from the outbuilding through to the old kitchen and thence to the hall. A new opening was created in the old outer wall of the house to provide access from the passage into the old kitchen. The granary was maintained as a pantry but with a new subdivision to create a small lobby, with access via a set of steps to the adjoining old kitchen, by now used as a dining room. At this time, the original doorway into the granary shown on the 1868 engraving and the turn of the century watercolour was removed. Alterations to the first and second floors were relatively minimal, largely involving the installation of new bathroom fittings and cupboards. The roof guttering was replaced at this time and the lead gutter boxes feature Lady Juliet's initials and the date of 1974.

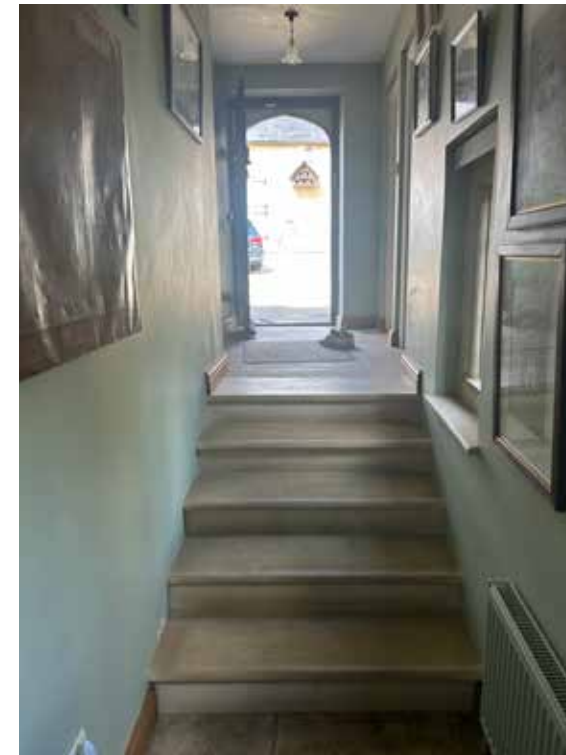
Modern interior view of the 1973 passageway leading from the western entrance door added by Morley, down to the dining room (the old kitchen).

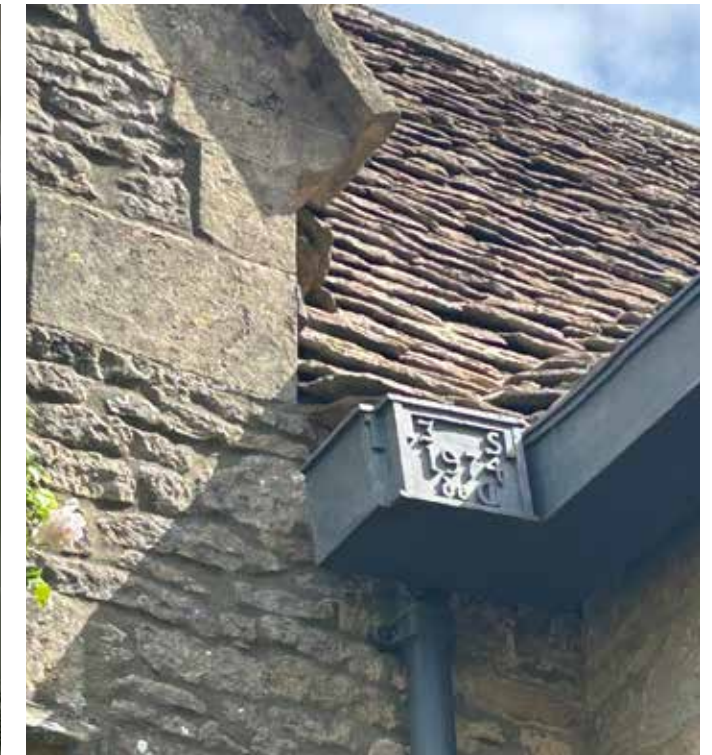
Modern photo showing one of the lead hoppers to the downpipes, installed by Lady de Chair in 1974.

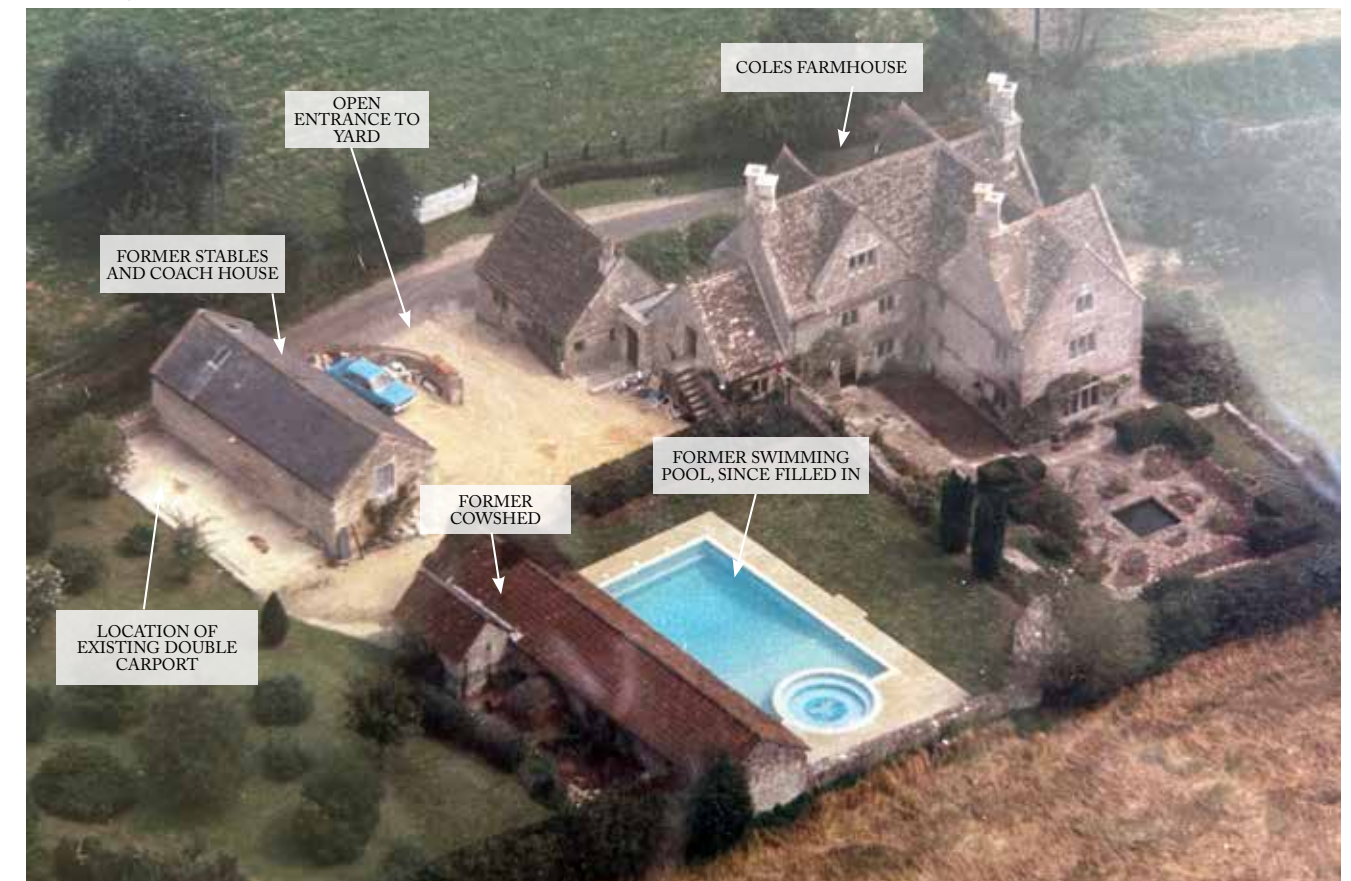
Aerial view of c.1973 showing the works in progress and the creation of the new swimming pool.

An aerial photograph from the 1970s shows the pool in situ and also the alterations being made to the entrance passage between the house and kitchen - a flat roof can still be seen. The entrance drive is also on a different layout, with an open yard to the road and a curved wall to one side of the stable. There is also a hedge and an opening for a gateway shown on the north-east boundary to the road, seemingly with no walling along the roadside.

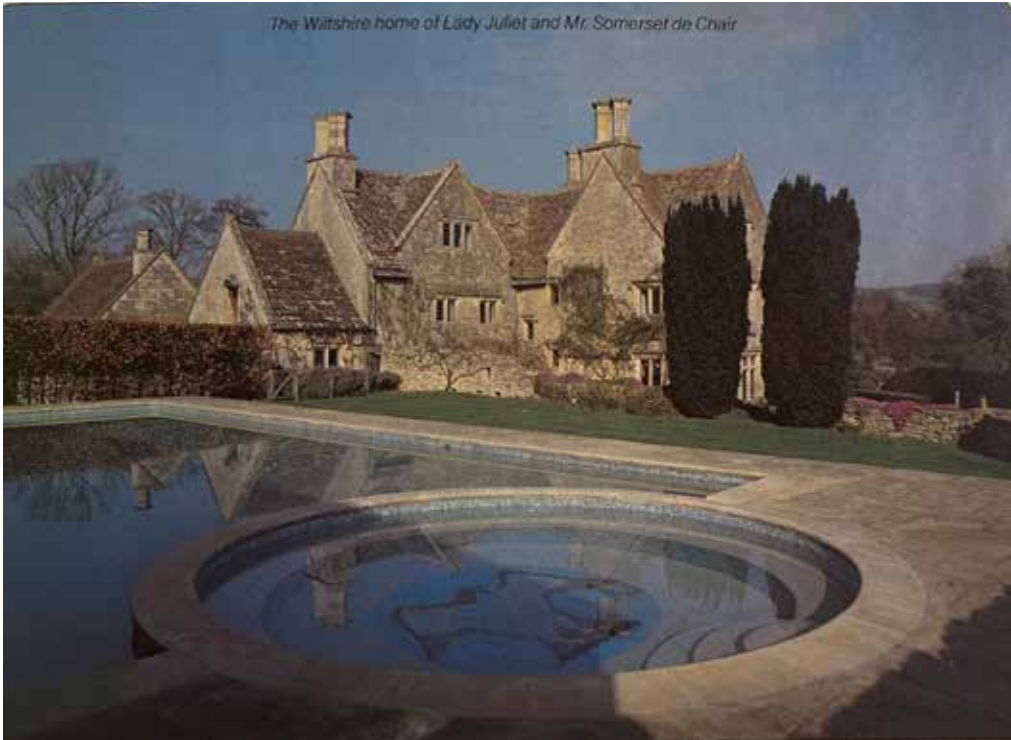
View across the gardens showing the swimming pool installed by Lady Juliet de Chair

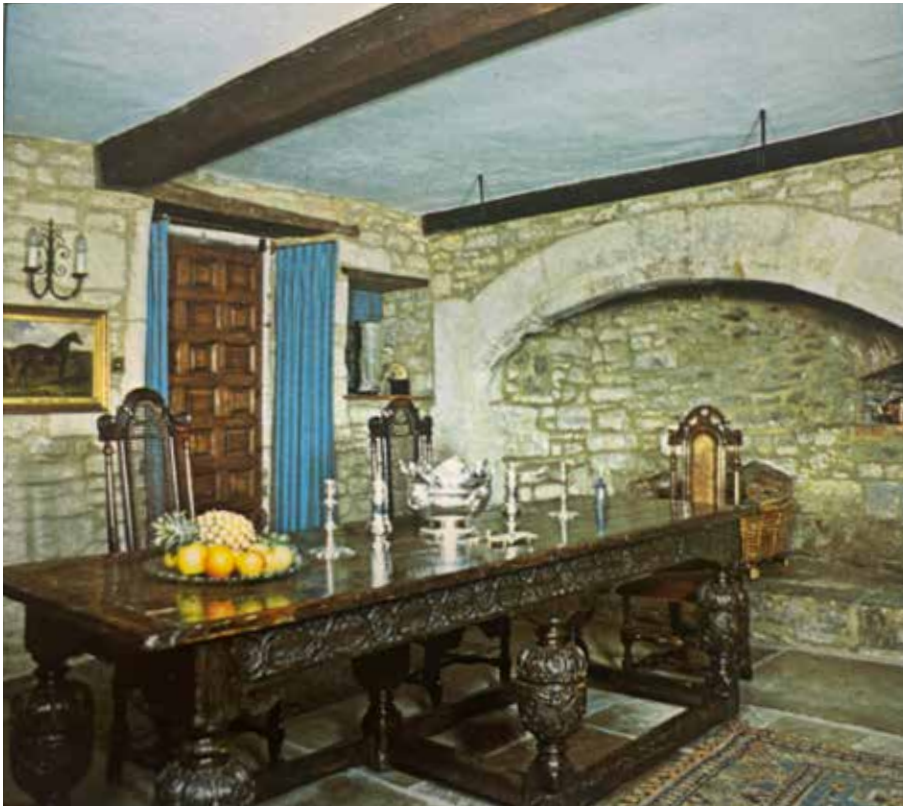
Internal view of the old kitchen, by now used as a dining room and like the hall, with stone wall left exposed.

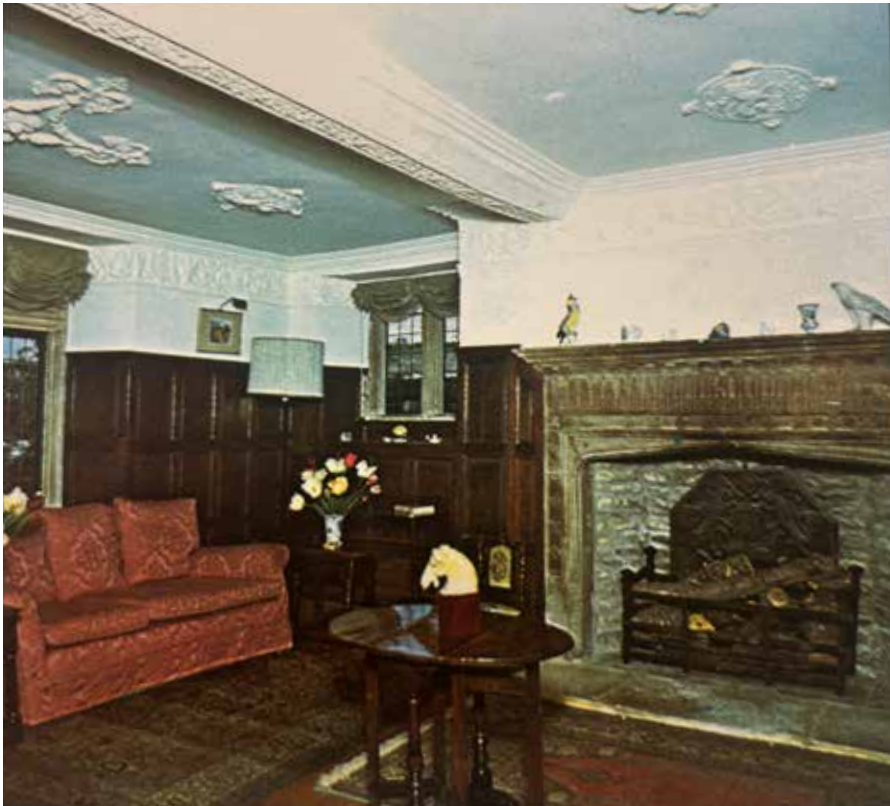
Internal view of the Parlour, now with a section of decoration removed between the panelling and the plasterwork.

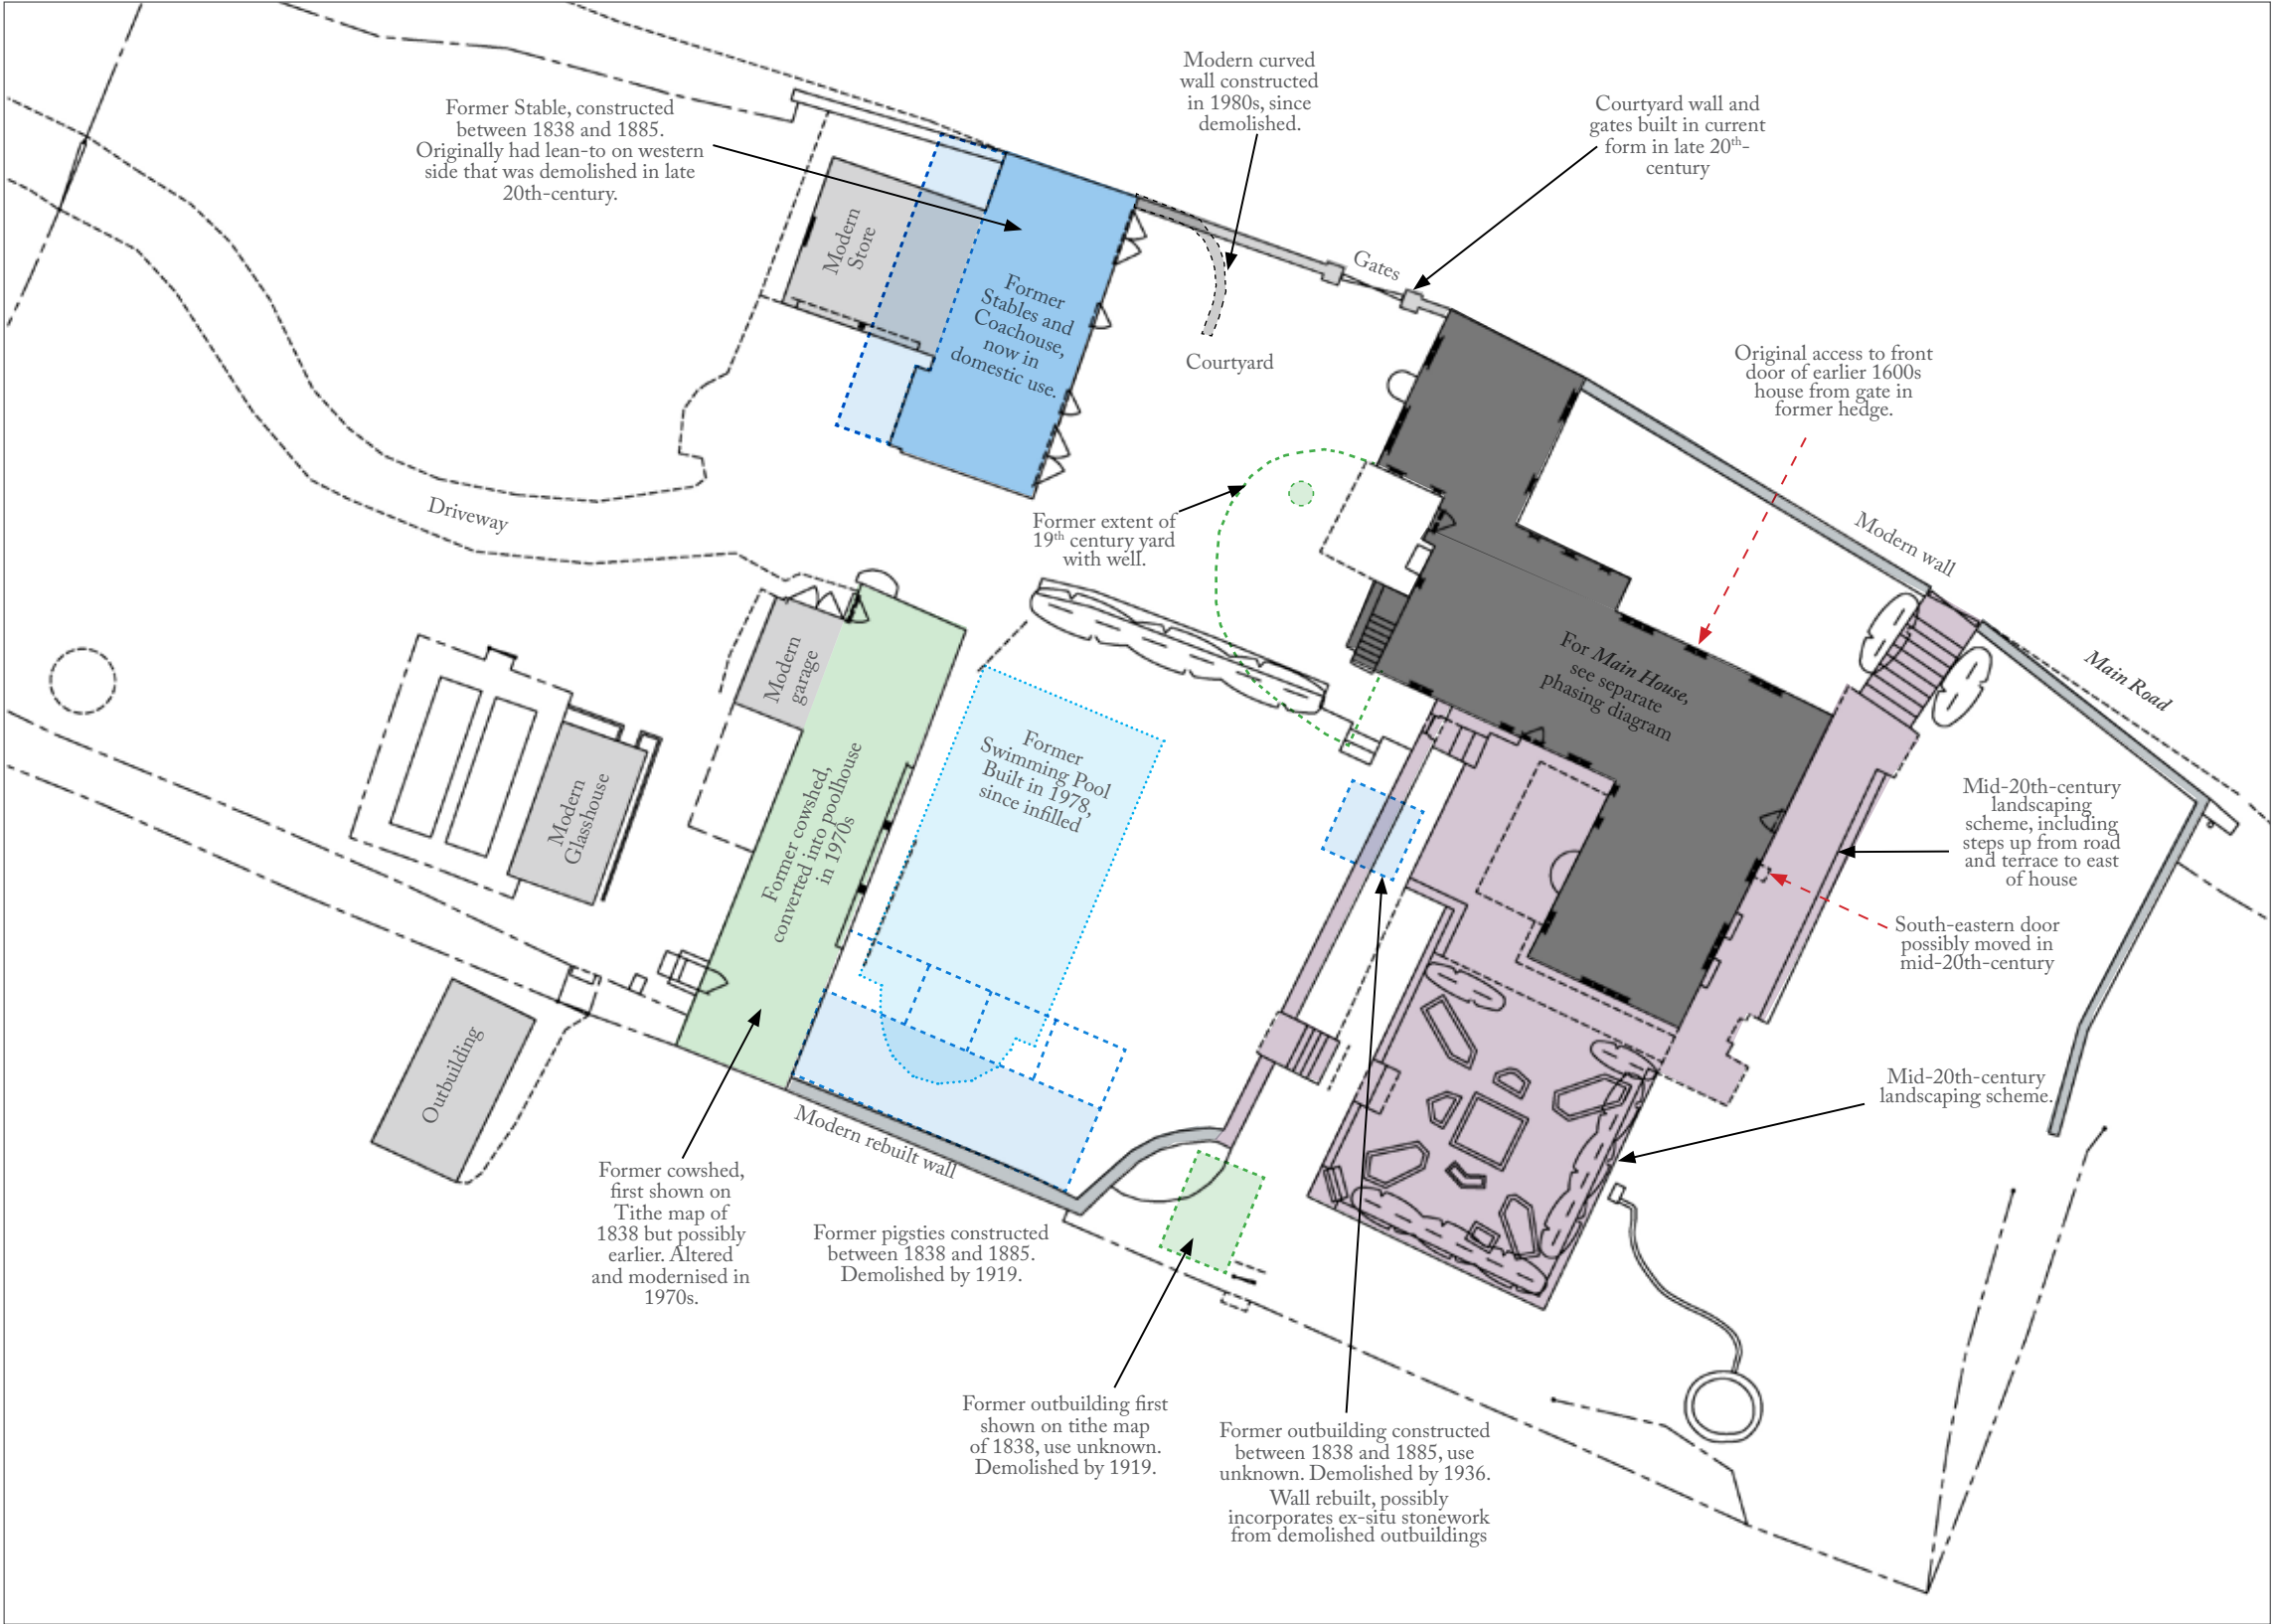
- Buildings first shown on Tithe map of 1838 (hatched lines indicate buildings since demolished)
- Buildings first shown on OS map of 1855 (hatched lines indicate buildings since demolished)
- Circa mid-20th-century landscaping scheme
- Existing modern buildings
- Swimming pool of 1978, since infilled

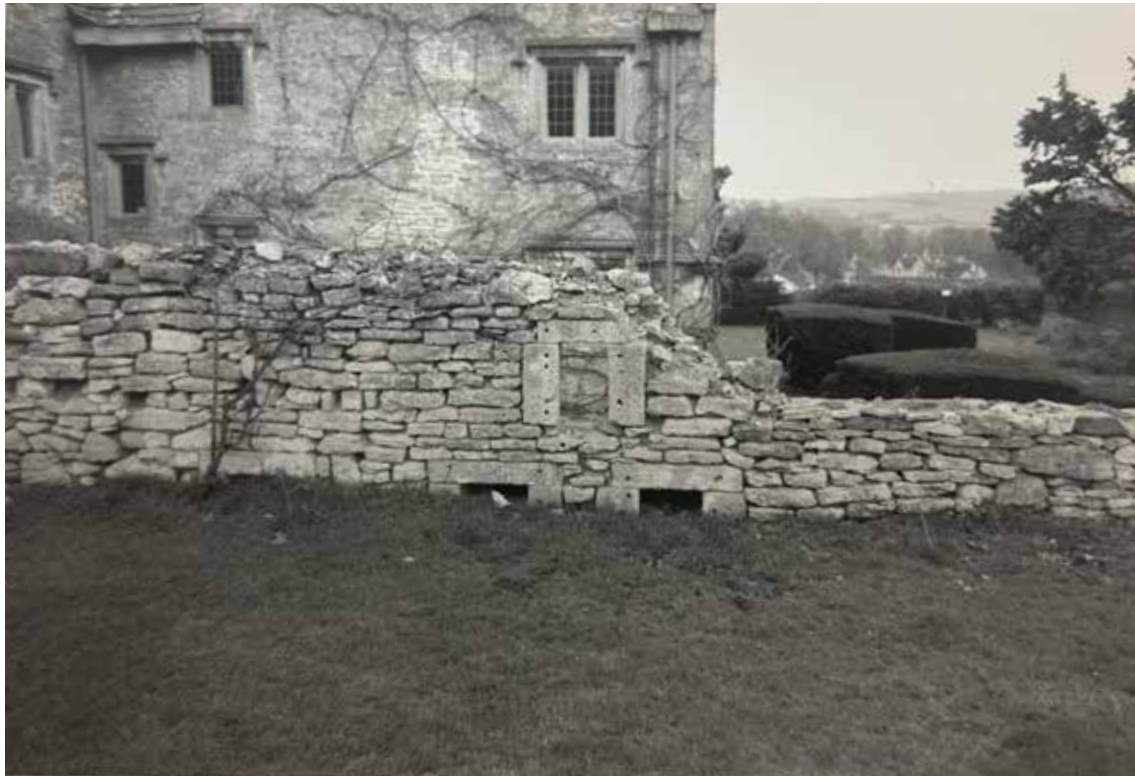
*View of the garden wall from the south-west. These stones are possibly remnants from the former outbuilding that was on the site.*

photograph of the garden wall with less foliage clearly shows a range of ex-situ stones mounted into the wall. Whilst it could simply be a coincidence, these stones are arranged in a very similar format to those shown in the engraving, and may be remnants of the building after it was demolished in the twentieth century.

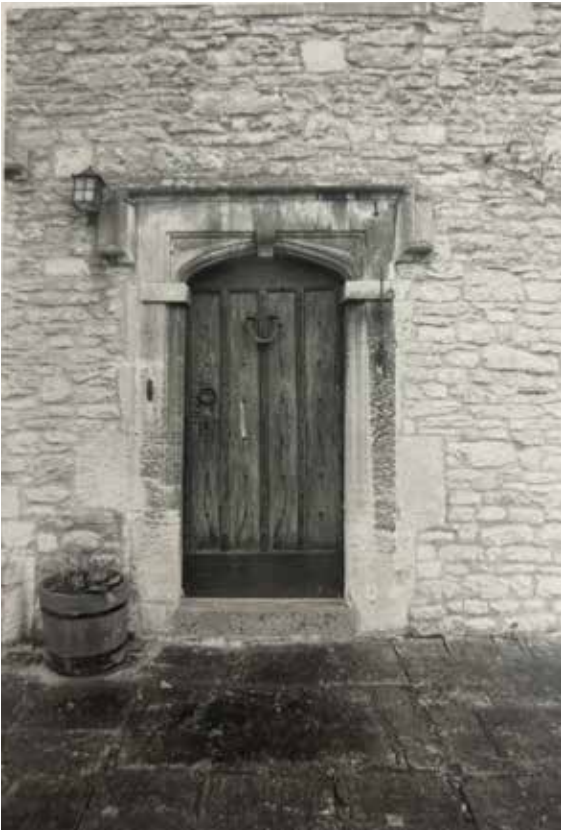
*Detail of the doorway on the south-eastern elevation, possibly moved from its original location to the west.*

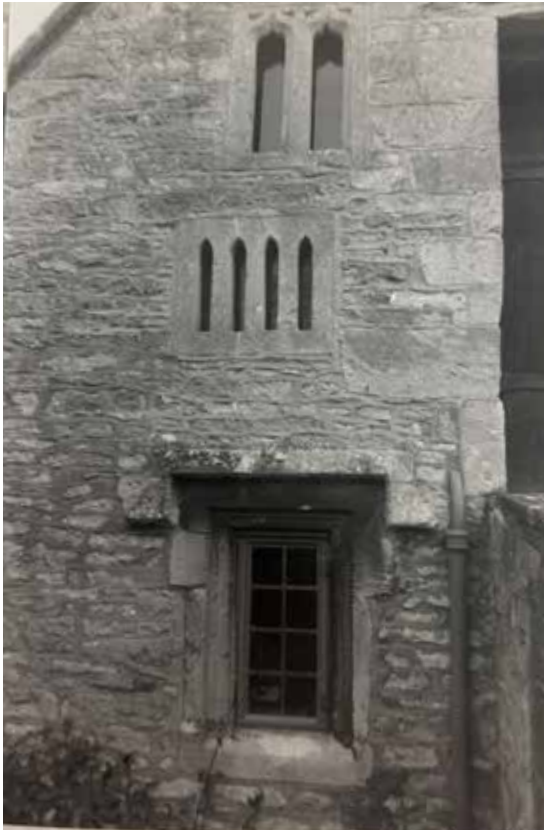
*Detail of the window openings on the former agricultural building (possibly a granary with hayloft over).*

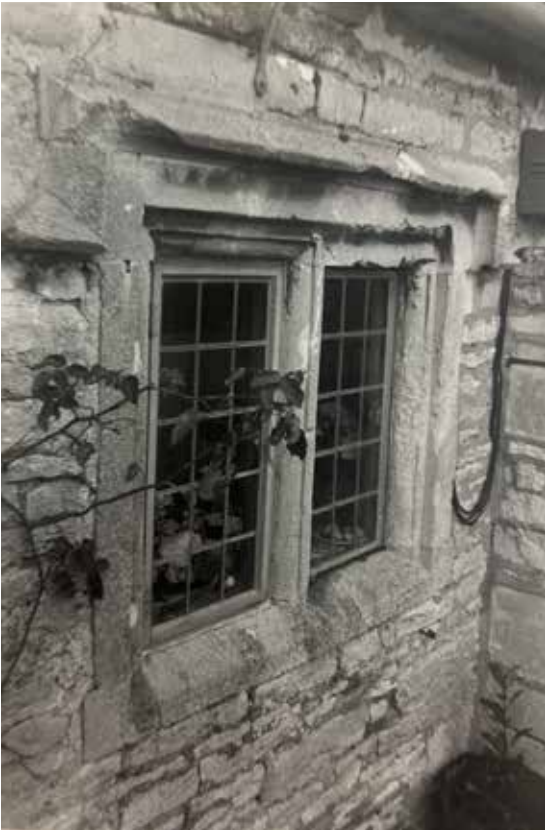
*Detail of the window at the angle of the older wing with the 1645 range.*

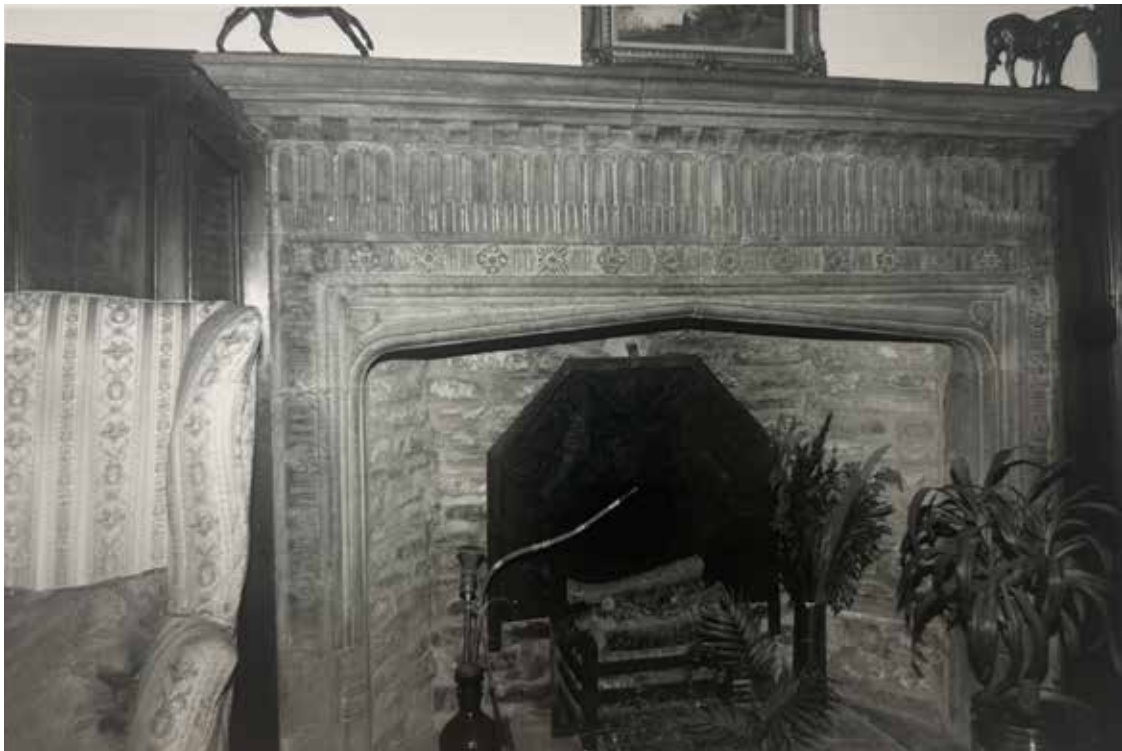
View of the modern, replacement fireplace to the parlour.

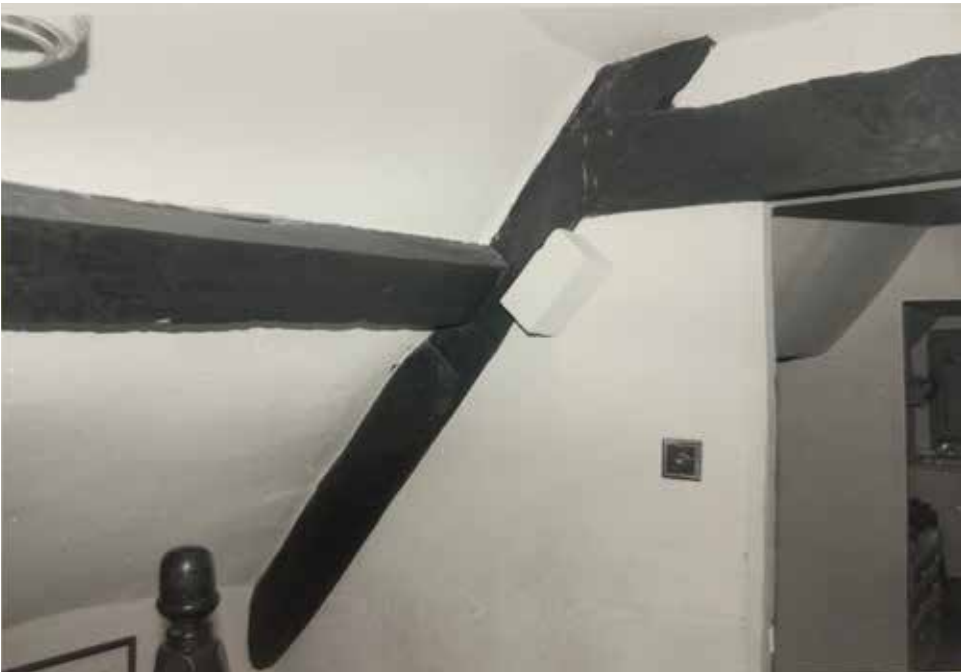
Internal view of the roof over the staircase.

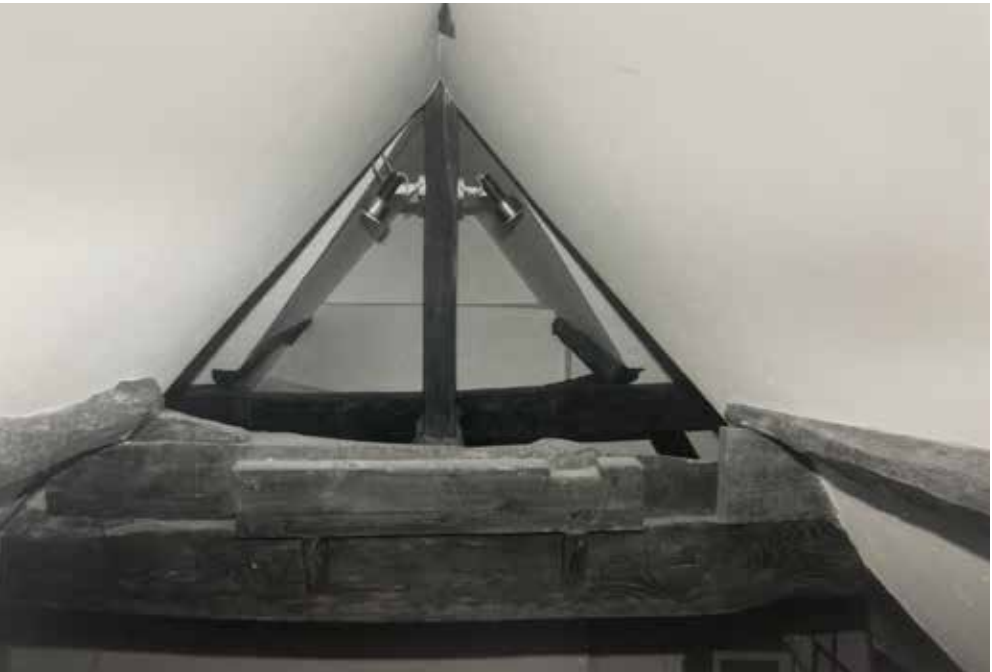
Extended collar trusses within the roof.

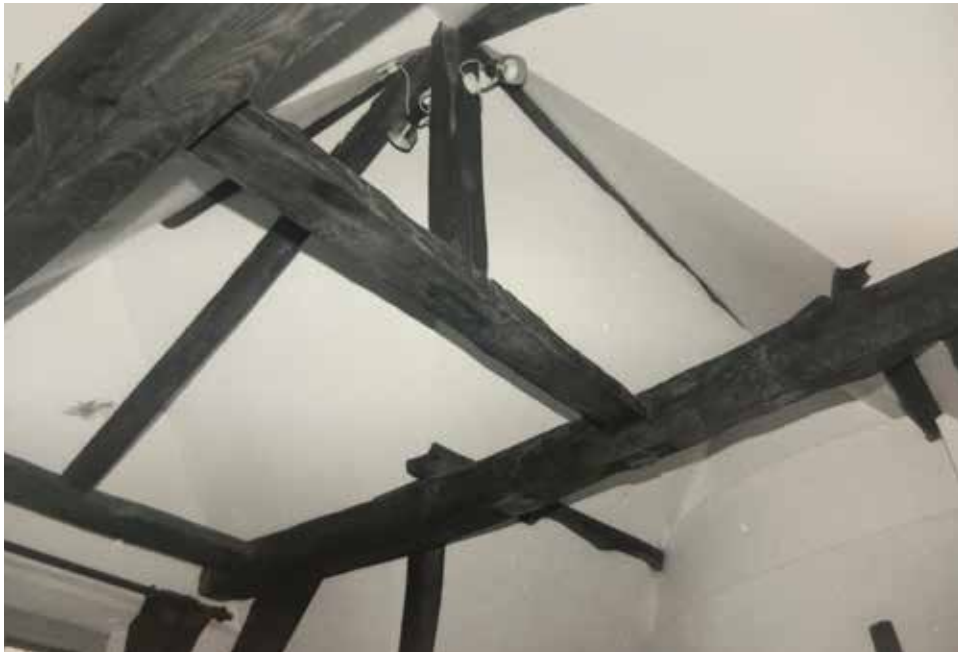
Extended collar trusses within the roof.

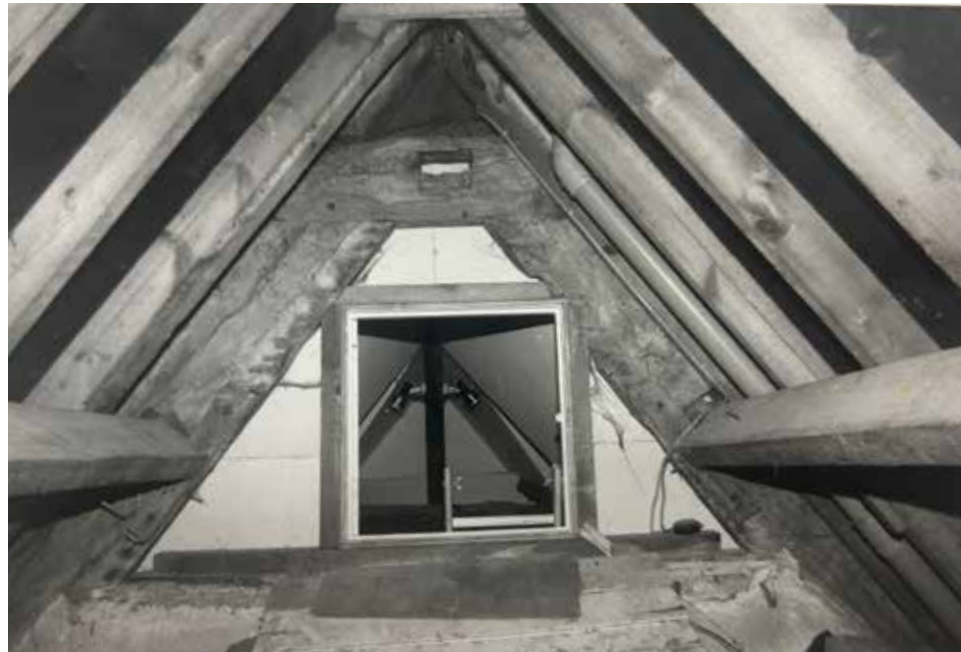
View of the roof space from the south-east.
