**Random Forge**

57 Upper South Wraxall  
Bradford on Avon  
BA15 2SE

**Design & Access Statement**

**James Grayley Architects**

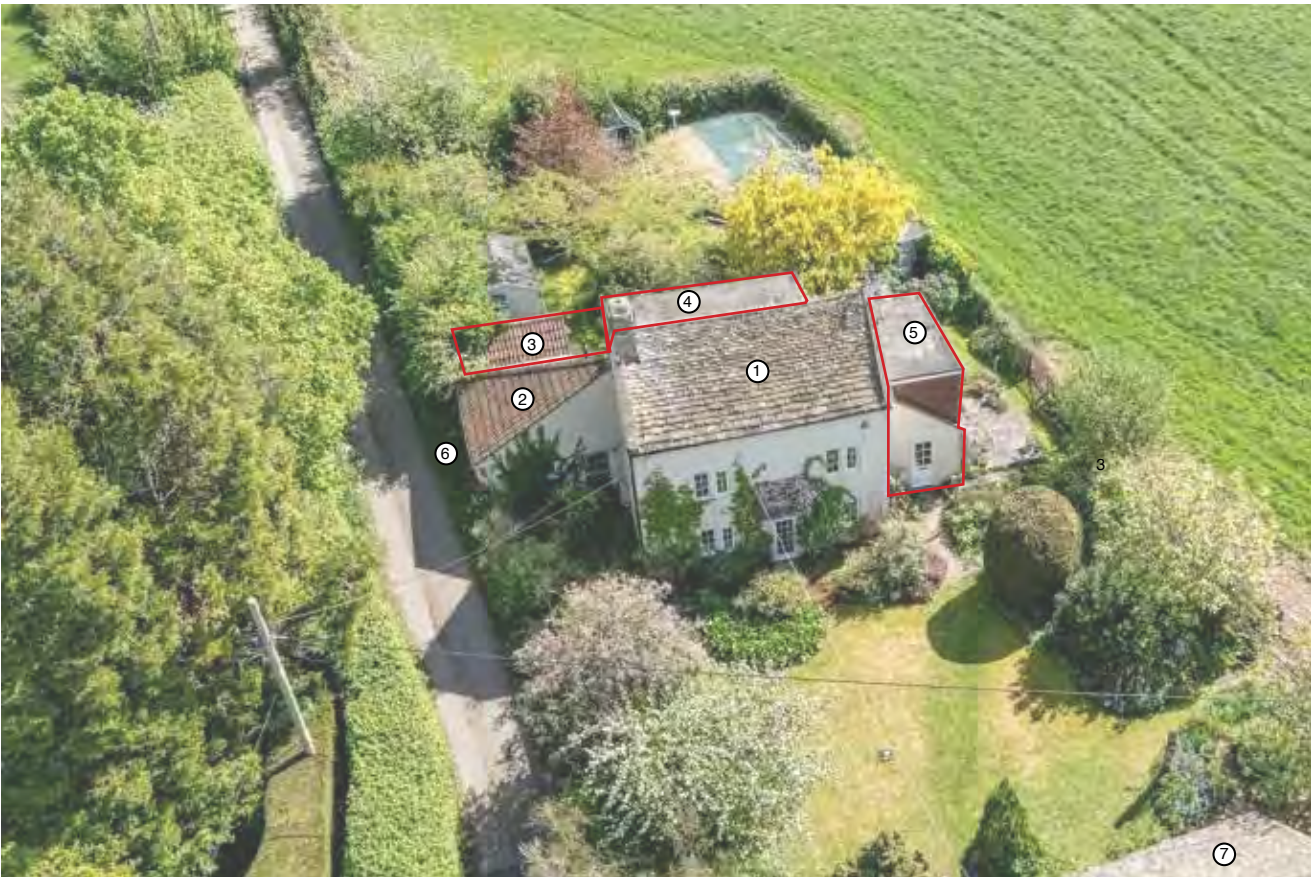
Aerial View - West

1. Original 2 bay cottage thought to date to 1612, although heavily altered including replacement roof structure and addition of second storey.
2. Single storey extension. Construction date unknown, but thought to be 18th Century. Heavily adapted and rebuilt in 20th Century.
3. Eastern extension added in 19th Century (ground floor only) to house sanitation and kitchen / scullery.
4. First floor extension to east side of the roof, with two windows to the east and 1 smaller window to the south. Extension clad with hung tiles. Exact date unclear, but shown to be earlier than 1979.
5. Southern extension added in 1979. A new utility room with bathroom and dressing room above.
6. Bay window added post-1979 to north facade.
7. Garage - Constructed 1981 on site of previous garage / car port

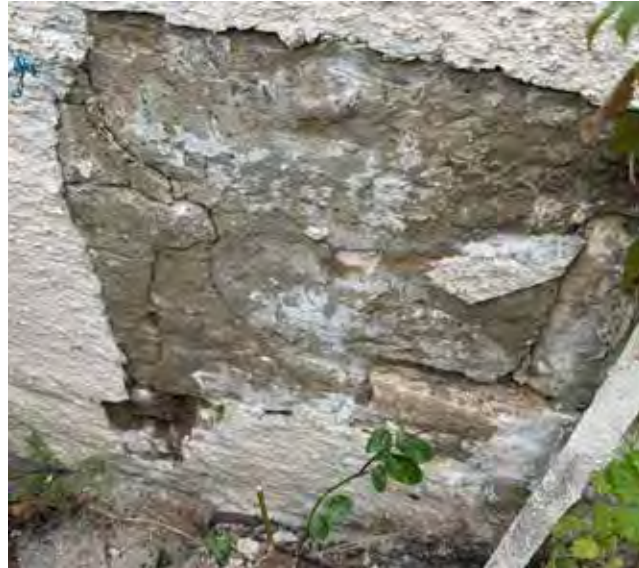
Area of stripped paint to eastern elevation revealing cementitious render beneath.

Cementitious render coats and impervious waterproofing slurry paints to the original stonework, applied previously with good intentions have contributed significantly to the decay of the building. Sample areas of paint and render have been carefully removed to assess the stonework condition, that reveal powdered stonework and mortar beneath. The areas of stonework structure that have been investigated to date require substantial replacement of the stonework and mortar due to the decay brought about by the layered build up of non-breathable renders and paints applied over many years to the property.

The waterproofing coats applied previously to the outside of the building have trapped moisture within the historic stone structure, leading to both the decay of the stonework and high levels of damp within the existing structure.

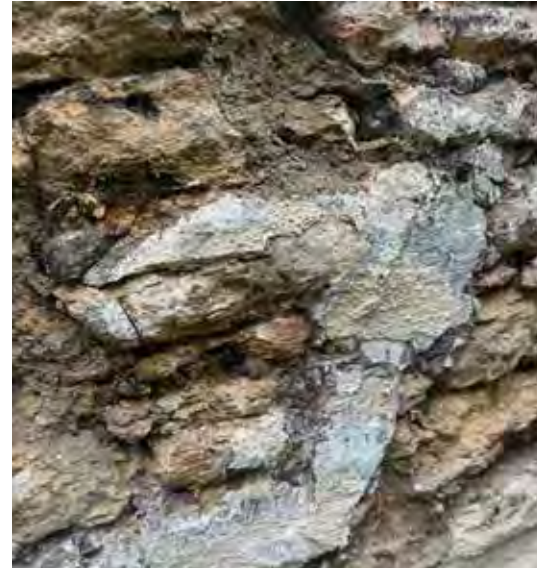
Area of removed cementitious render using hand tools to reveal powdered stonework and mortar beneath, with 70% moisture content.

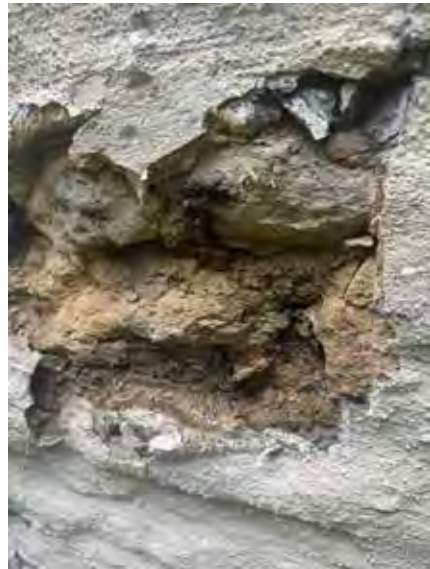
Area stripped of waterproof slurry to north elevation.

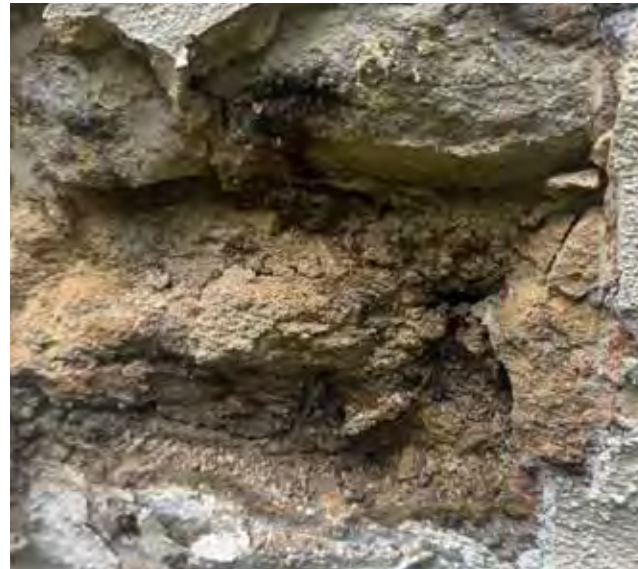
Detail showing powdered stonework beneath removed slurry to north elevation, with moisture content of 78%.

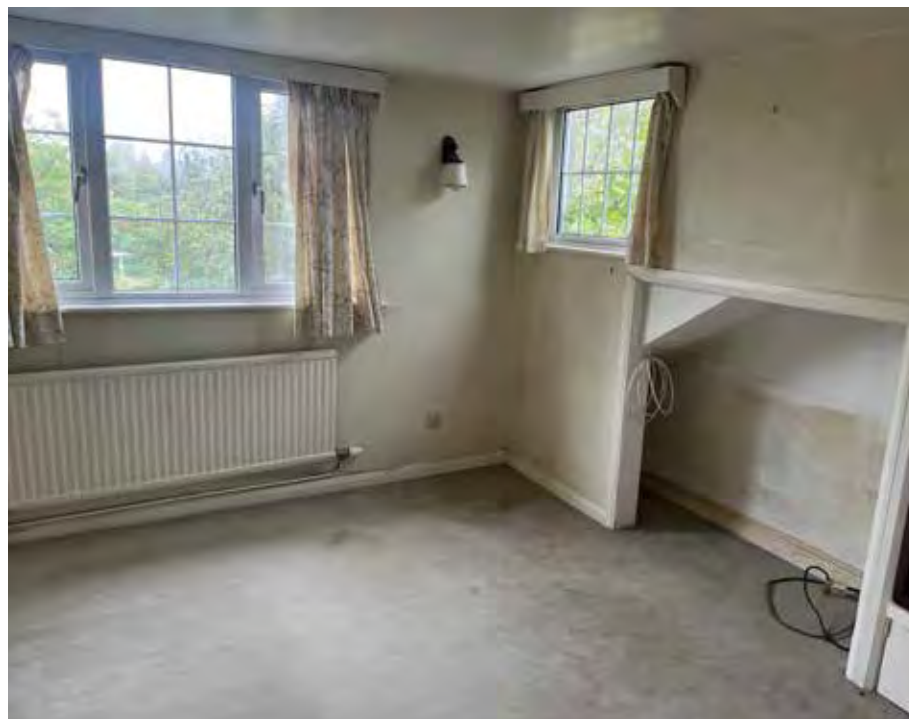
Internal view of Master Bedroom - Poor methods of construction & damp | 2025

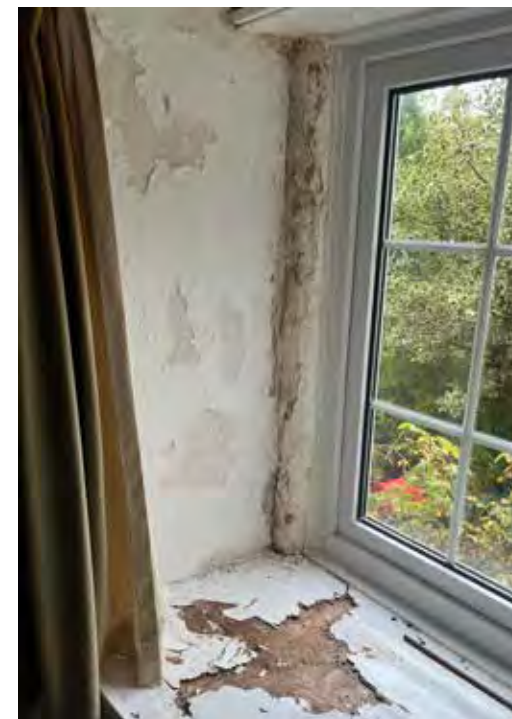
Internal view of first floor Bedroom Two - Structural movement & damp | 2025

The existing house is in a poor state of repair. The original cottage structure is suffering significant structural movement to the south-west corner, with dropped floor plates and substantial cracking to the masonry structure of the west elevation.

The first and second floor plates to the house have dropped due to structural movement within the decaying stonework, and rotting of timbers, likely caused by the external waterproofing works.

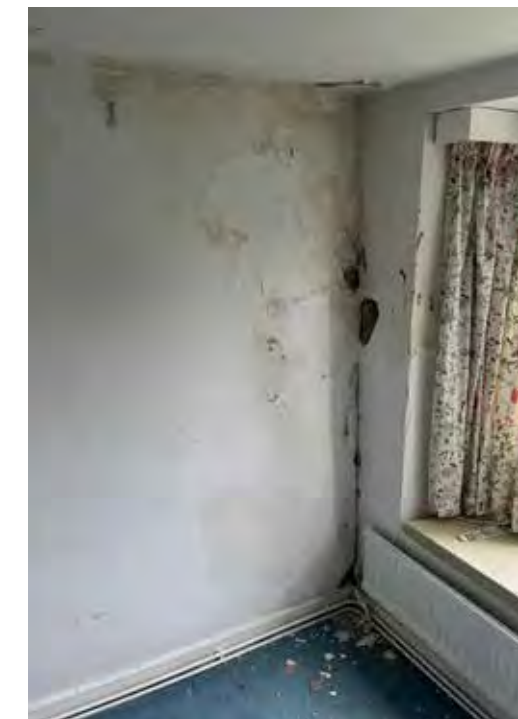
Internal view of first floor Bedroom One - Structural movement & damp | 2025

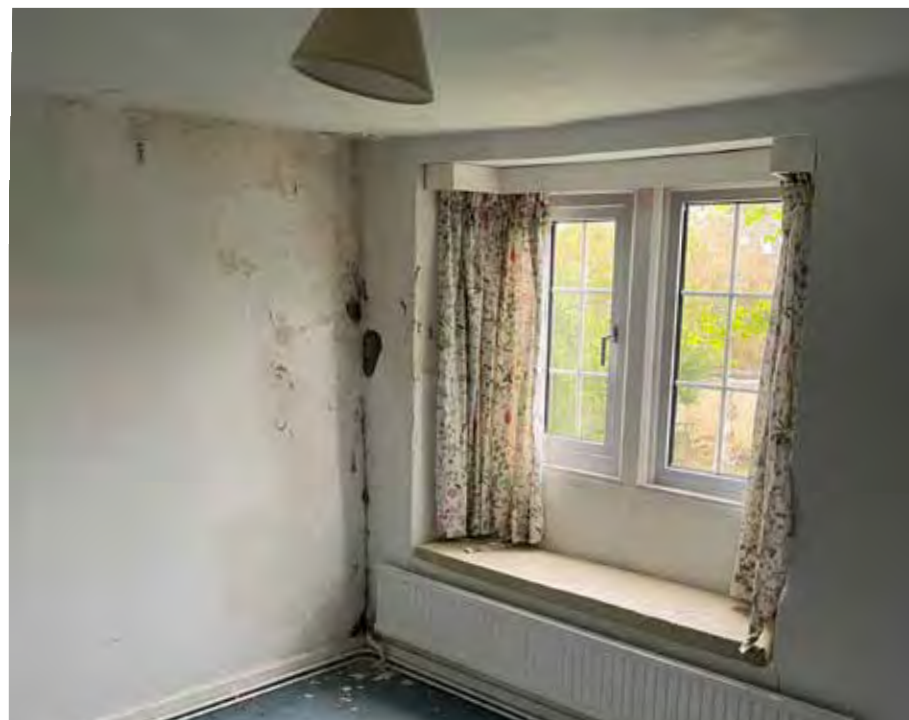
Internal view of first floor Bedroom One - Structural movement & damp | 2025

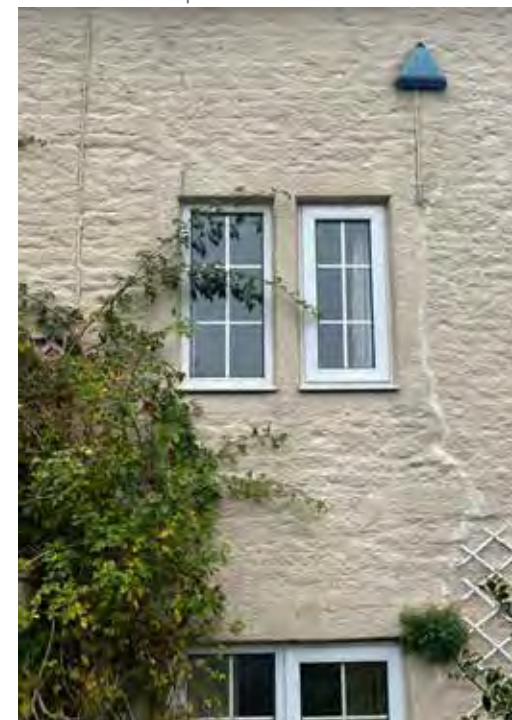
External view of front elevation - Ongoing structural movement | 2025

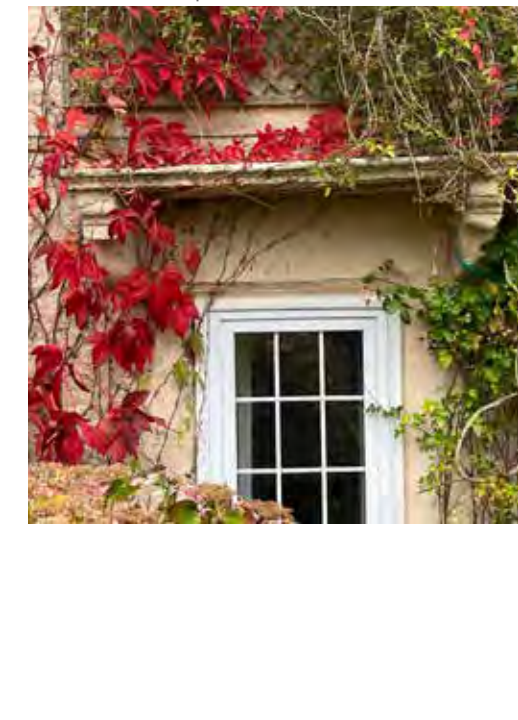
External view of front elevation - Subsidence of structure evident in door case surround | 2025

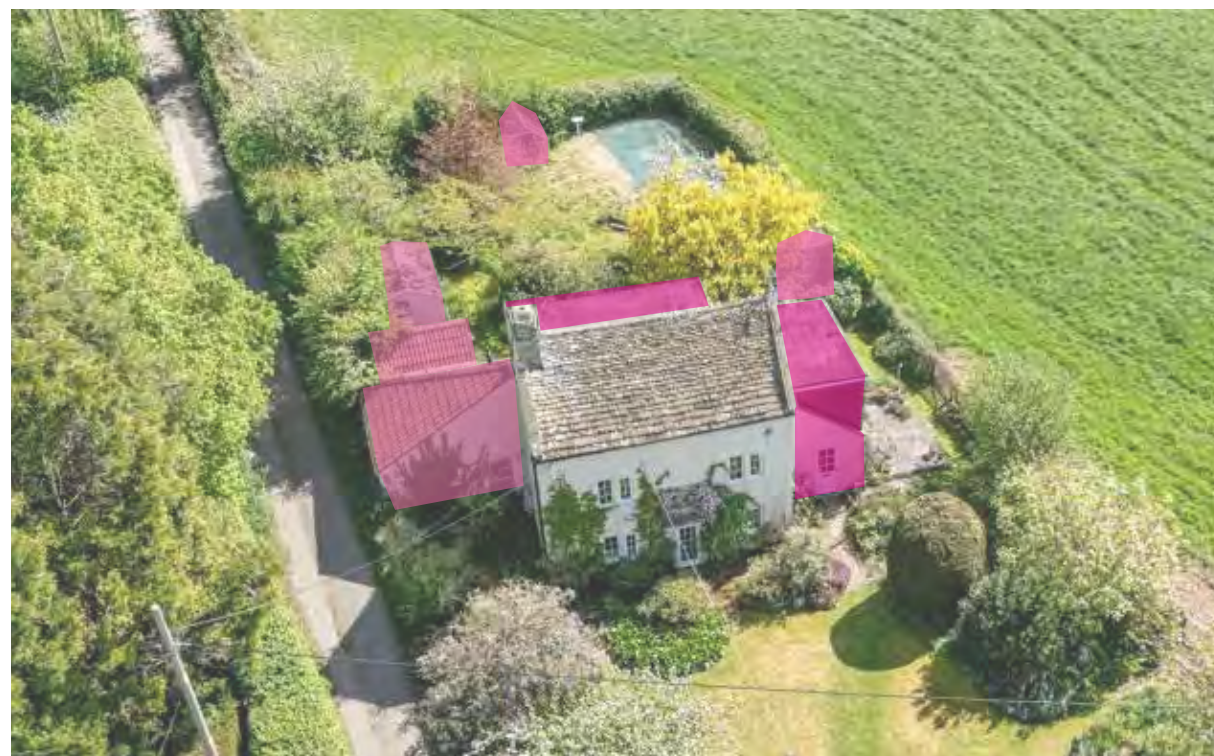
Massing & Organisation Strategy - Ad-Hoc later additions to original cottage to be removed

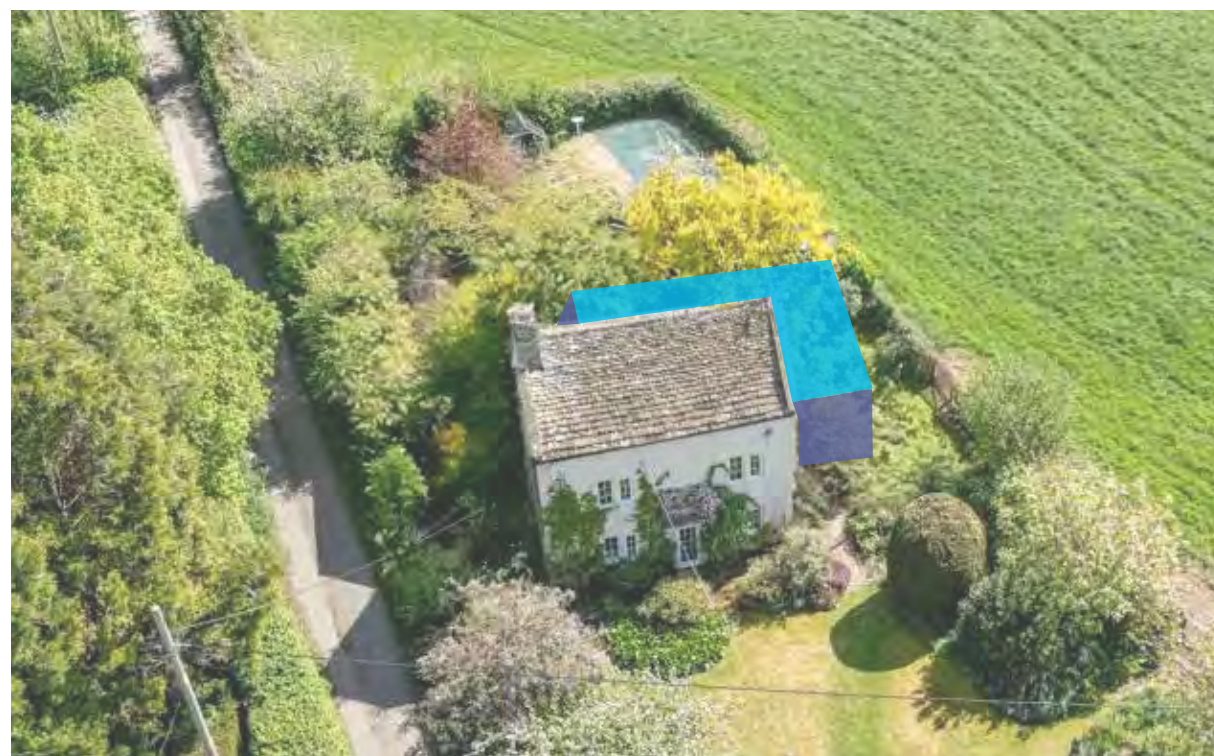
Massing & Organisation Strategy - Accommodation unified within a single volume positioned to rear of original cottage

The proposed extended form is purposefully set back behind the original cottage and moves the existing built mass away from the northern boundary with the road of Upper South Wraxall, receding the built form of the north elevation seven metres further into the site. Doing so ensures the replacement built structure reads as a secondary subservient structure to the original cottage and removing significant bulk from the glimpsed views into the site from the main road. The proposals aim to reduce the overbearing nature of this structure being located on the boundary for the wider users of the village lane, and improve amenity and privacy for the occupants of Random Forge.

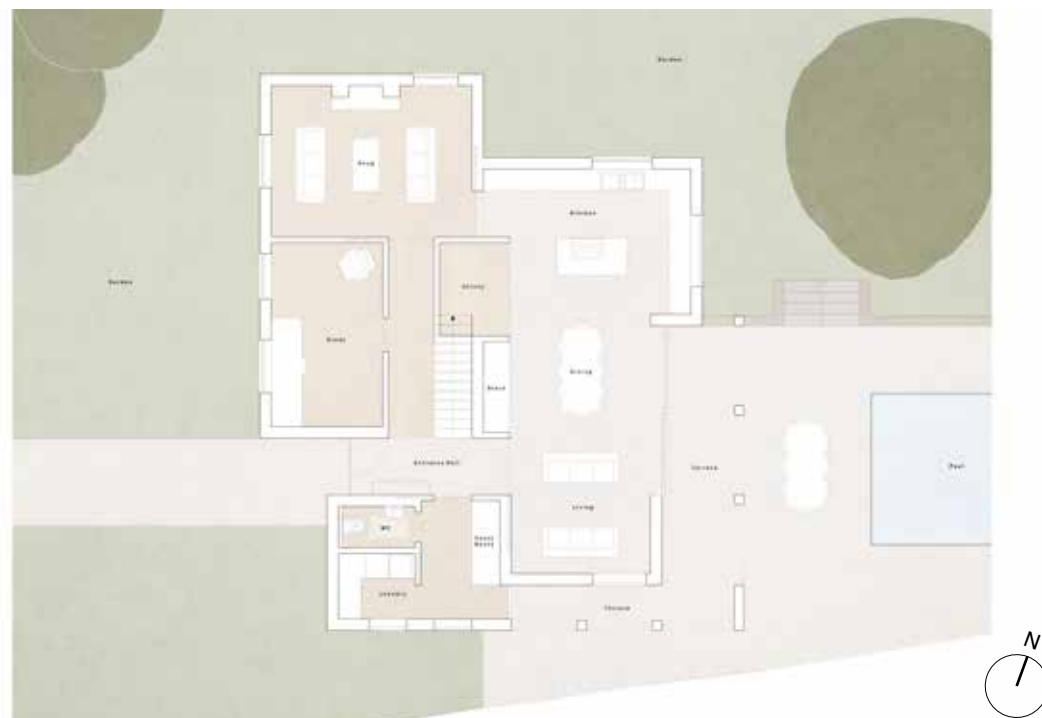
Proposed Ground Floor Plan - New extended form to south & east [rear] of original cottage

Accommodation with the ground floor of the existing house will be maintained as formal living space, with the rear extension providing additional kitchen and dining space, opening out onto the rear garden. A replacement single storey wrap around structure to the southern side of the original cottage will provide an improved entrance hallway, WC and utility space in the location of the existing. At first floor, bedrooms and a bathroom will be maintained within the original front cottage structure at first floor, with two further bedrooms and bathrooms within the replacement extension to the east. Due to the limited access and scale of the second floor accommodation in the existing cottage structure, there will be no habitable accommodation at second floor.

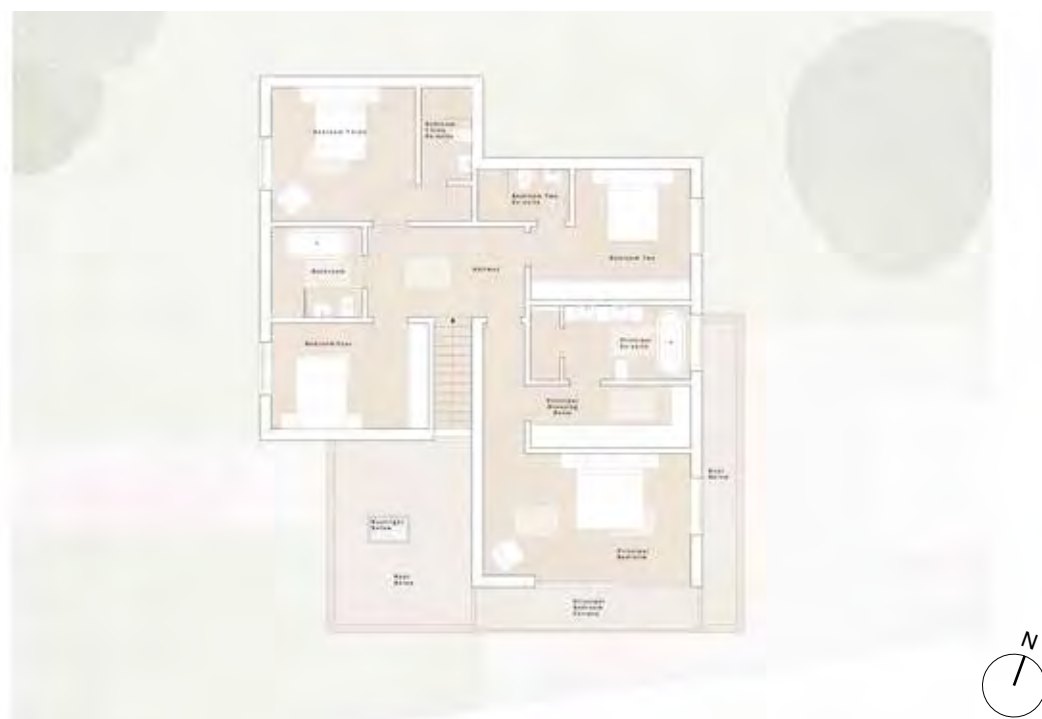
Proposed First Floor Plan - New extended form to south & east [rear] of original cottage

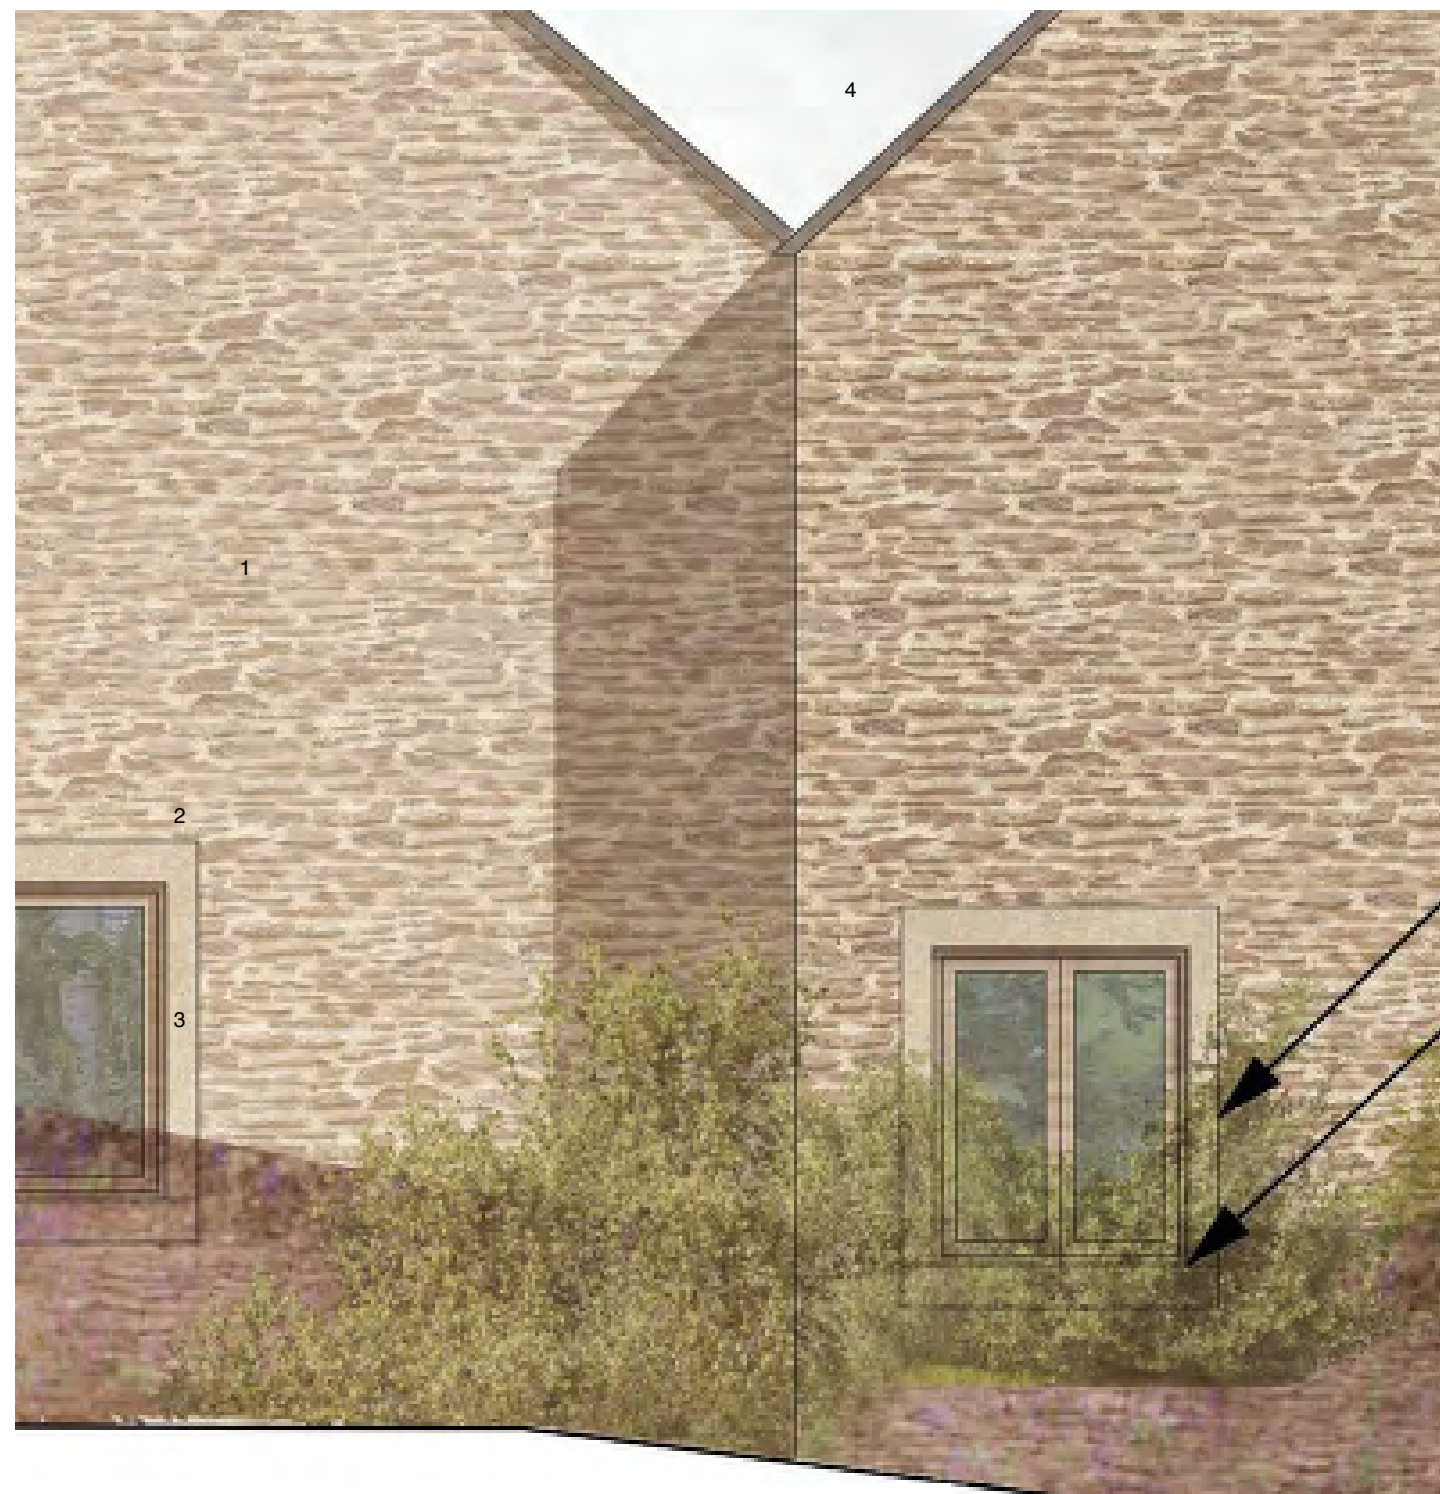
1. Coursed Wiltshire Stone wall construction with traditional lime mortar bed
2. Ashlar Stone window cases
3. Hardwood timber windows
4. Coursed Wiltshire Stone natural slate roofs, traditionally hung

The replacement extension structure will be constructed of the same material palette as the original cottage; rubble stone walls, lime mortar, coursed stone slate roofs and hardwood windows.

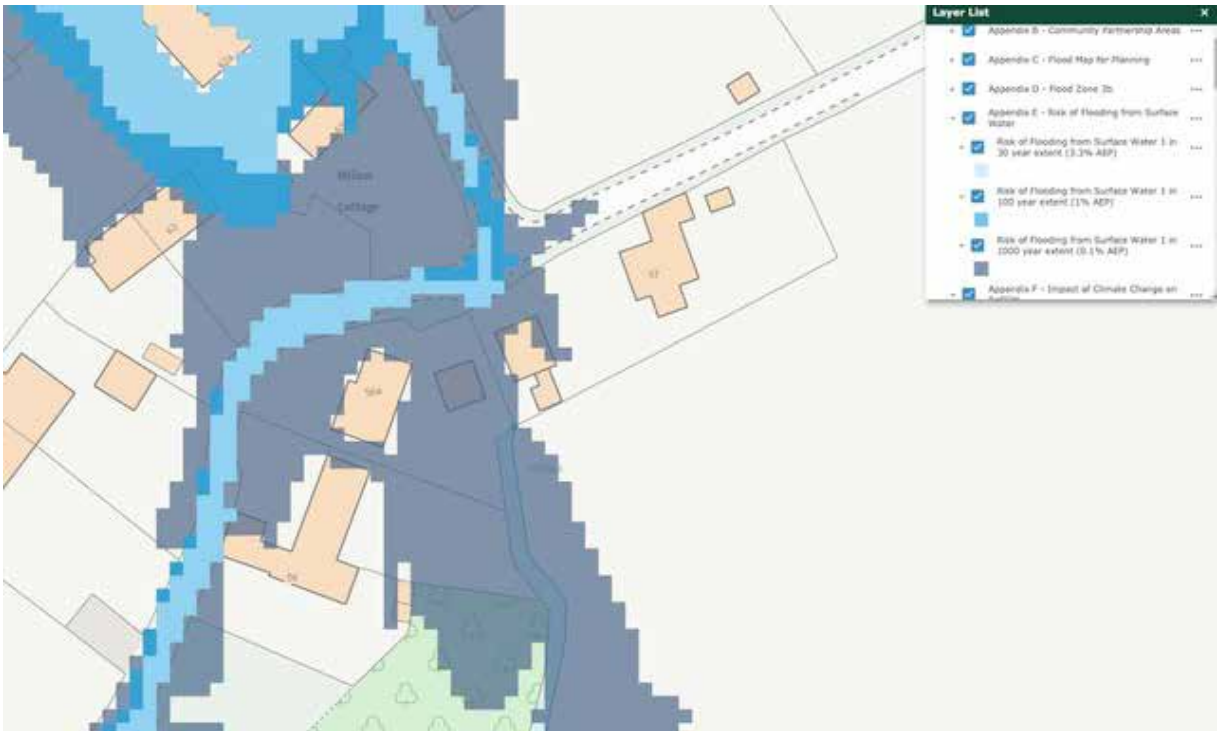
Extract form Wiltshire Council SFRA mapping.  
Dark Blue area indicates 1in1000 year surface water flooding event to existing driveway area

The existing garage is to be demolished and a replacement garage is to be constructed further south into the site, outside of the indicated surface water flooding area. The garage will be constructed with solid slab ground construction with provision for flood barriers to be installed to the doors. All electrical sockets and service installations will be installed above 1000mm above floor level to mitigate any flooding event. A new boundary wall will be constructed to the western boundary of the site adjacent to the culvert.

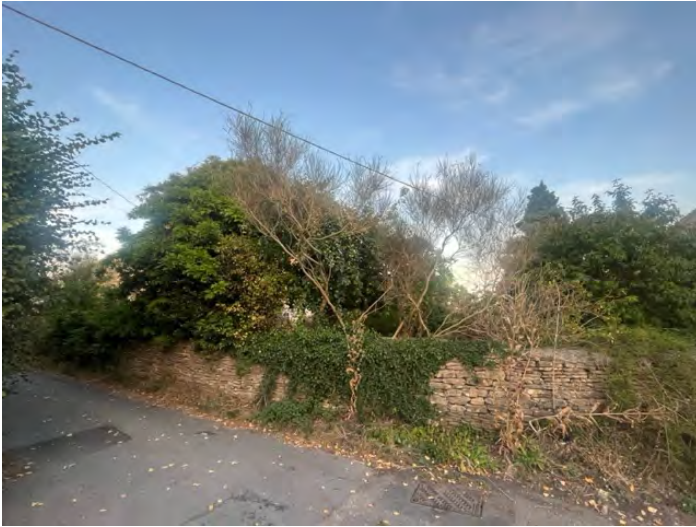
*scene of extensive arboreal wisteria covering two trees. T.294 a mature Category 'B' apple tree and T.295 a Category 'C' holly which form a positive landscape character screening and conservation feature*

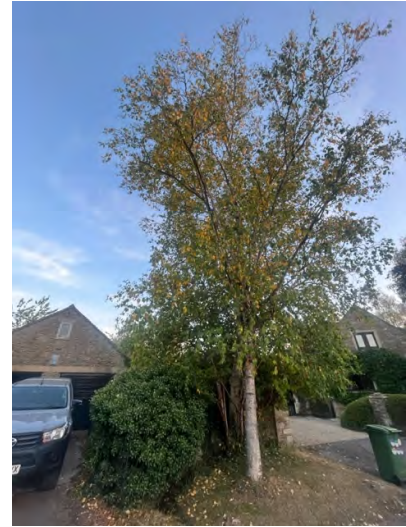
*Street*

*Off site Himalayan birch trees roadside not plotted on the site topo.*

*In close proximity to the garage which must be factored into any redevelopment of the garage*

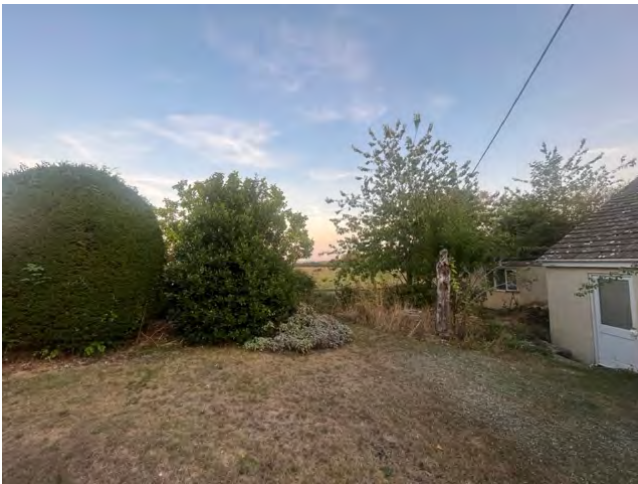
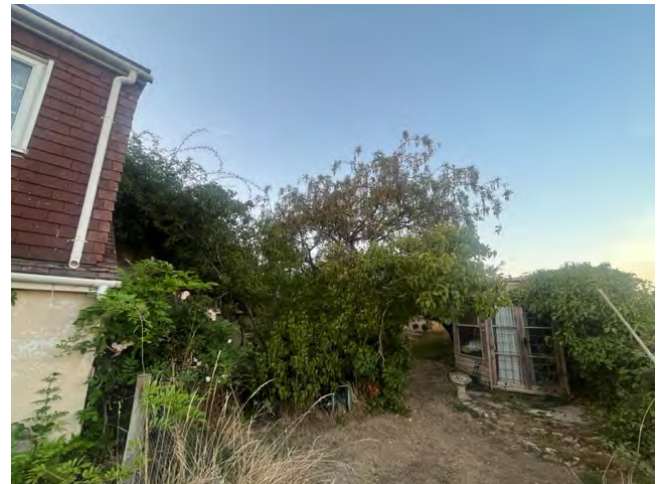
*Mature garden shrubs interspersed with average quality Category 'C' trees of localised relevance. Providing an overgrown neglected landscape cover, perhaps too close to the property to be of any sustainable suitability to the site being redeveloped or renovated*

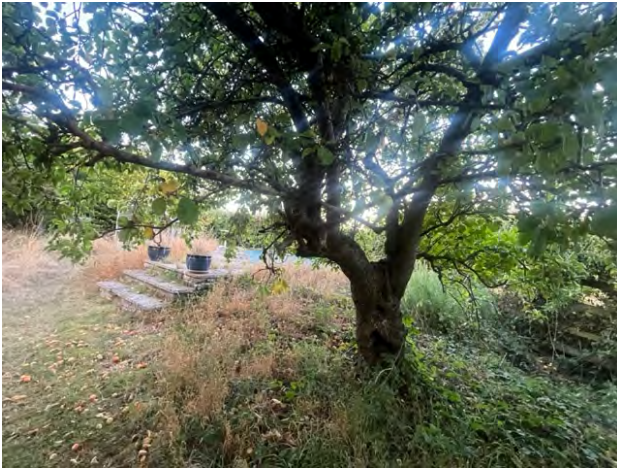
*T. 297 mature garden apple tree with positive. main stem hollowing, providing character and landscape maturity, worthy of potential retention.*

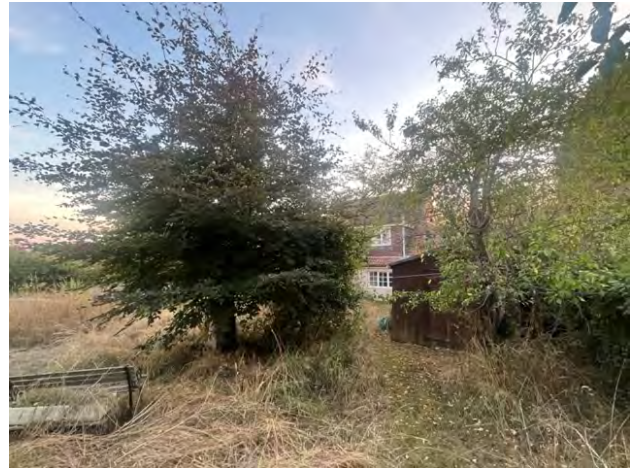
*T. 299 a 'topped' beech tree that would revert to becoming a mature tree if considered for retention within a long term garden redesign.*

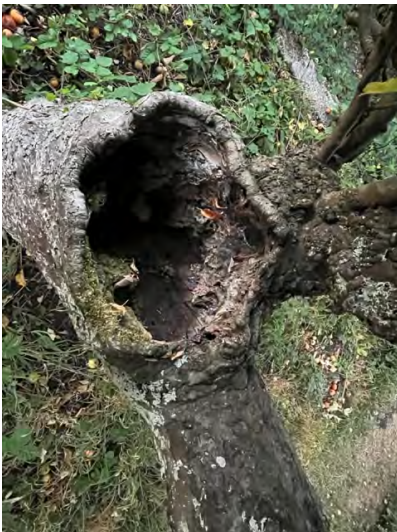
*T.297 Hollowing providing suitable habitat for nesting birds and other wildlife conservation benefits*

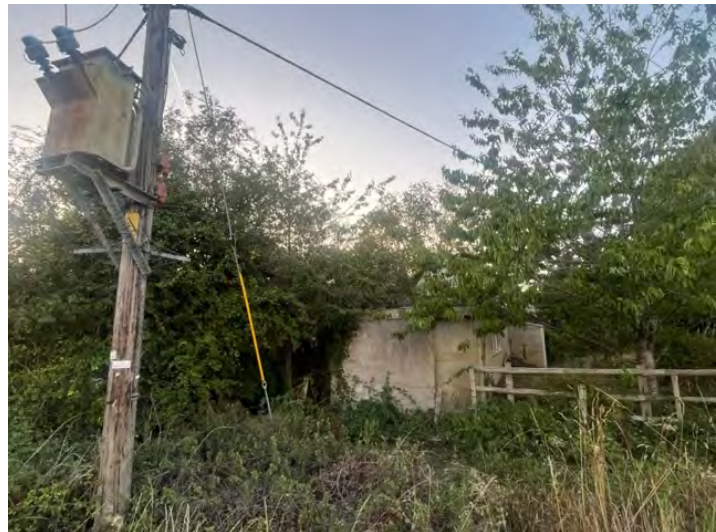
*Off site overhead 11kv transformer, to be considered when identifying sustainable landscape screening at an appropriate distance, for inevitable routine vegetation maintenance, including the over head cable itself.*  
*T. 293 wild cherry pictured here on the left hand side*

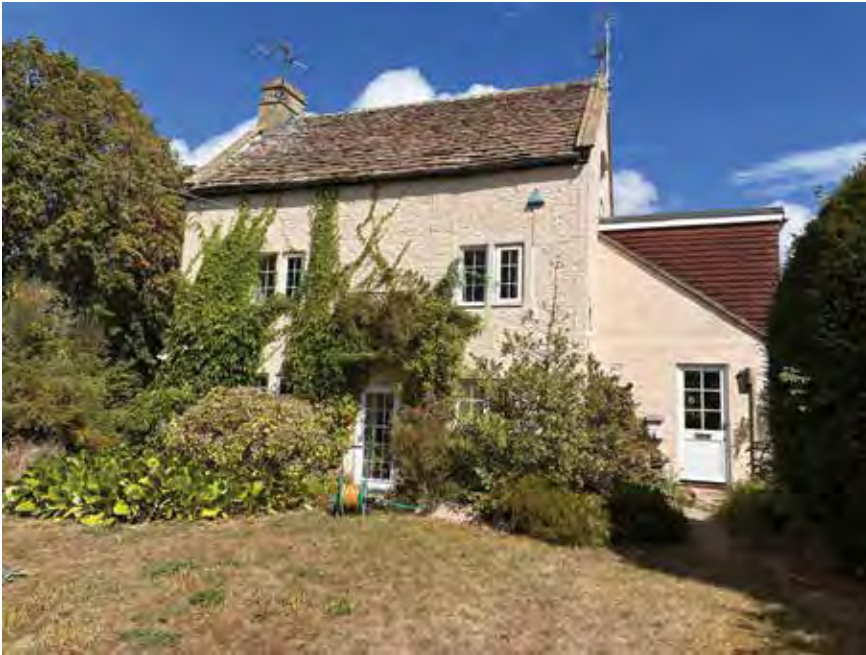
Photograph 1:

Exterior of dwelling. Principle, west elevation of dwelling

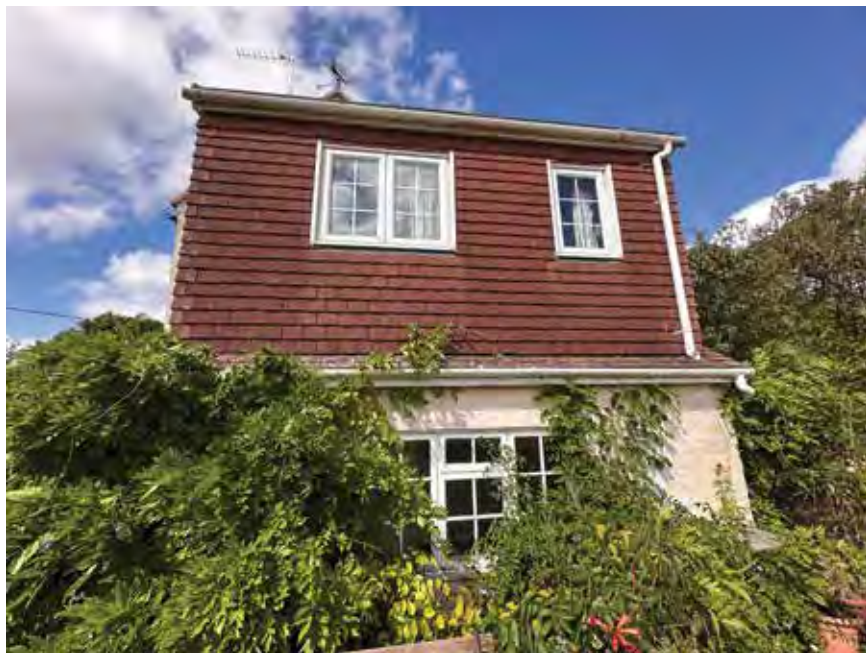
Photograph 2:

Side (southern elevation)

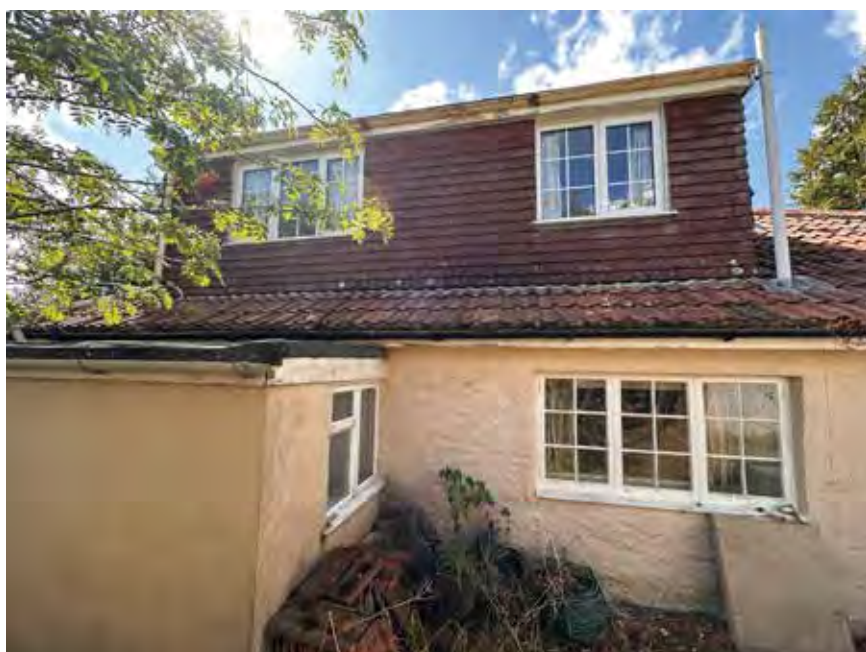
Photograph 3:

Rear (east elevation)

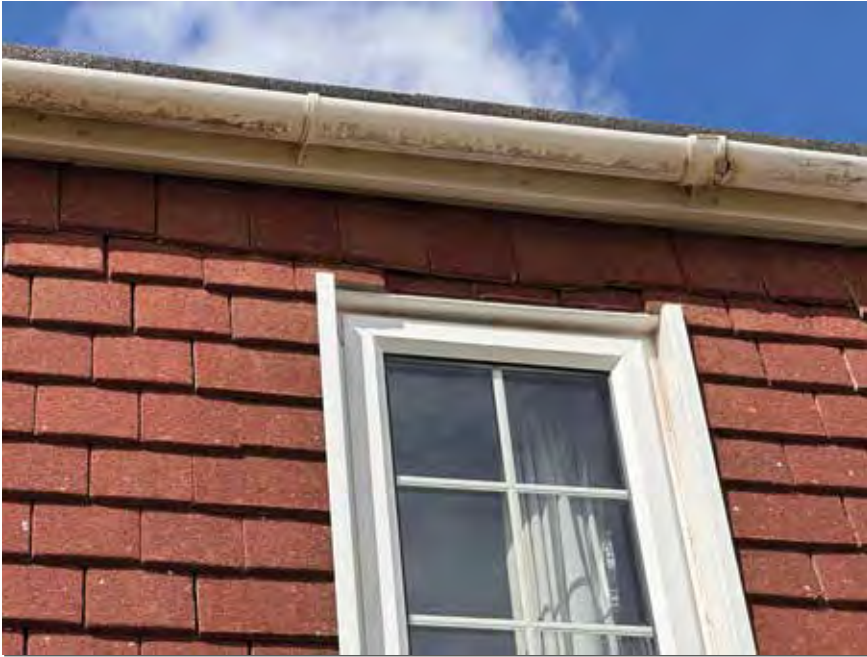
Photograph 4:

Detail showing hanging tiles on dormer window. Tiles are generally sealed but there are gaps above window.

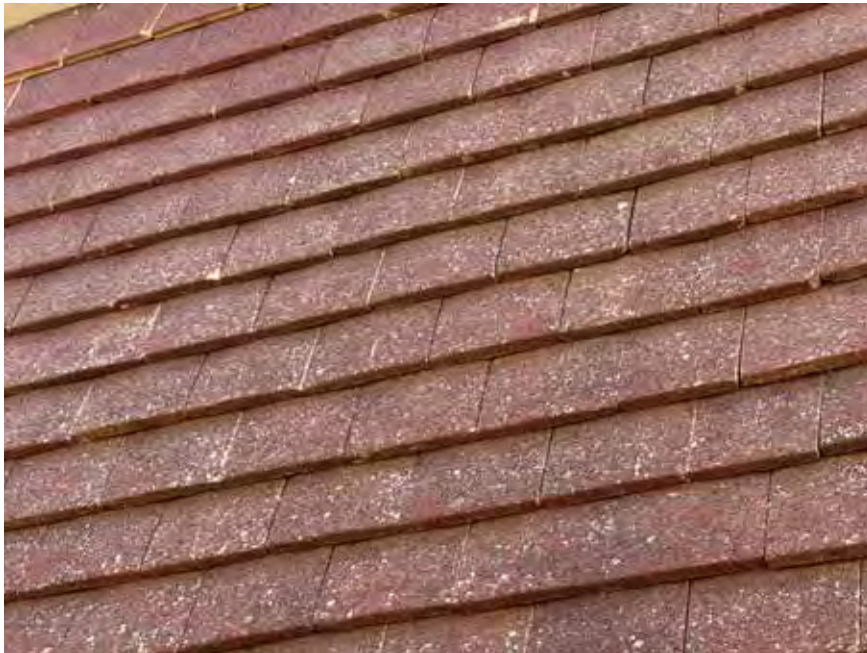
Photograph 5:

Hanging tiles on side and rear elevations are generally well-sealed

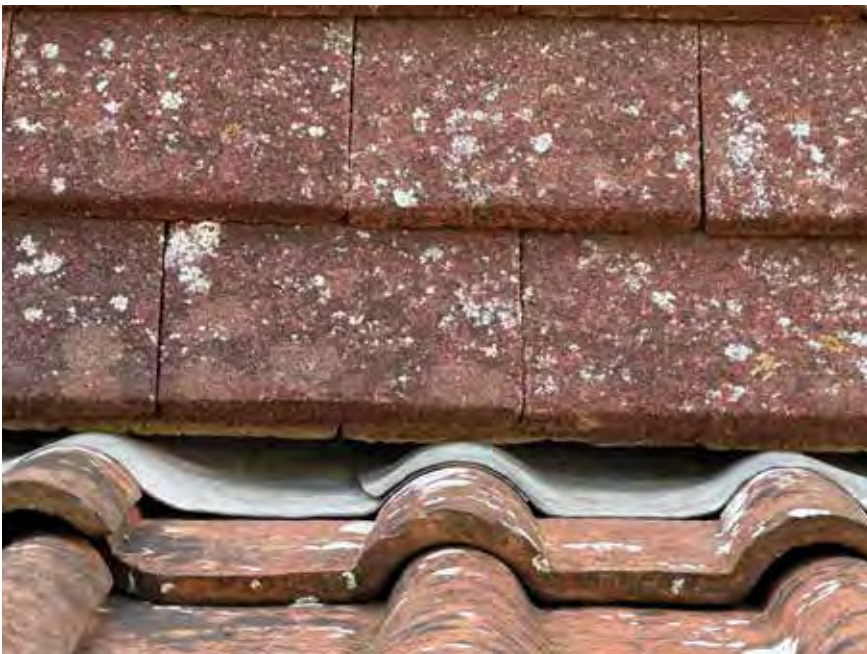
Photograph 6:

Small gaps where hanging tiles join roman tiles

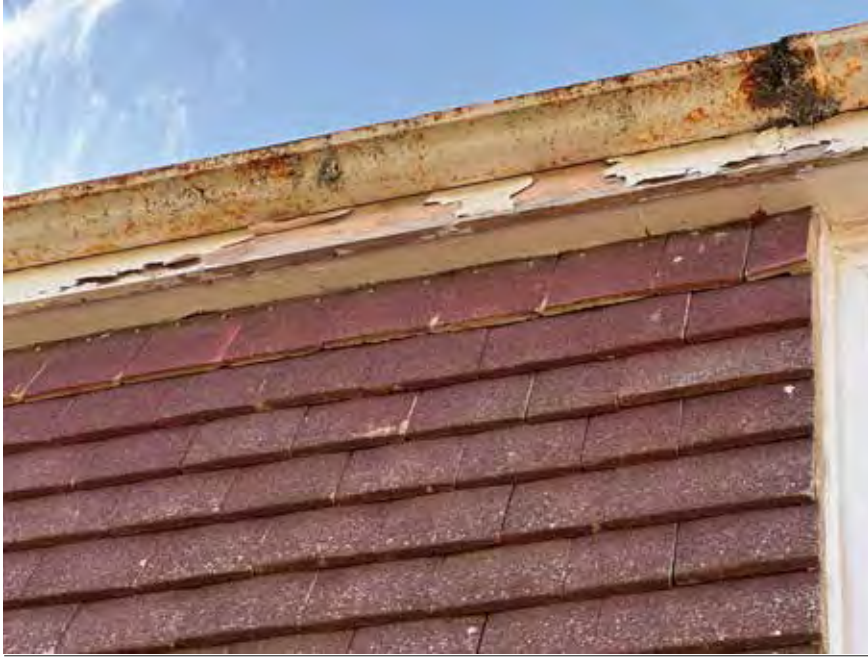
Photograph 7:

Soffits and barge boards are generally well-sealed.

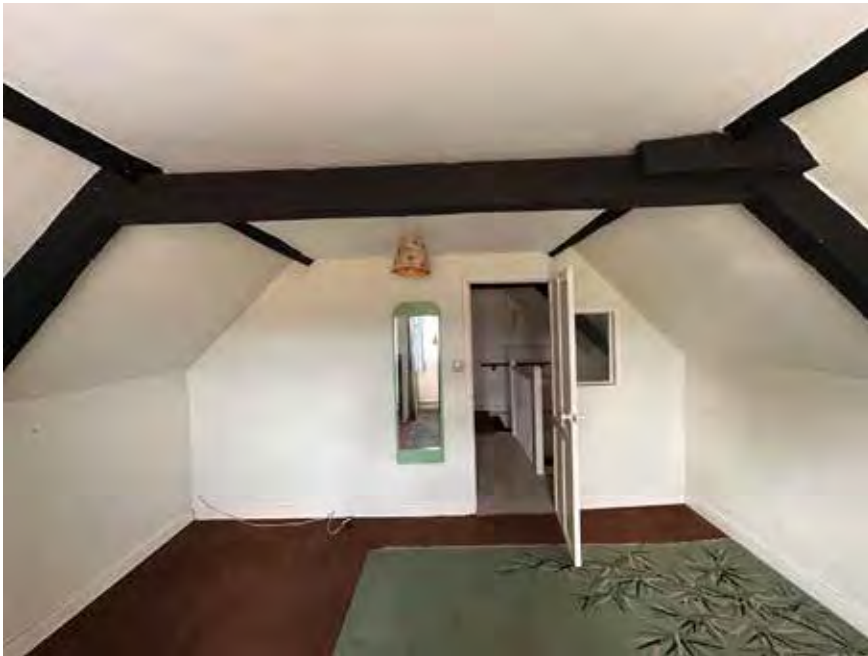
Photograph 8:

Internal attic is converted with inaccessible crawl spaces and voids above purlins.

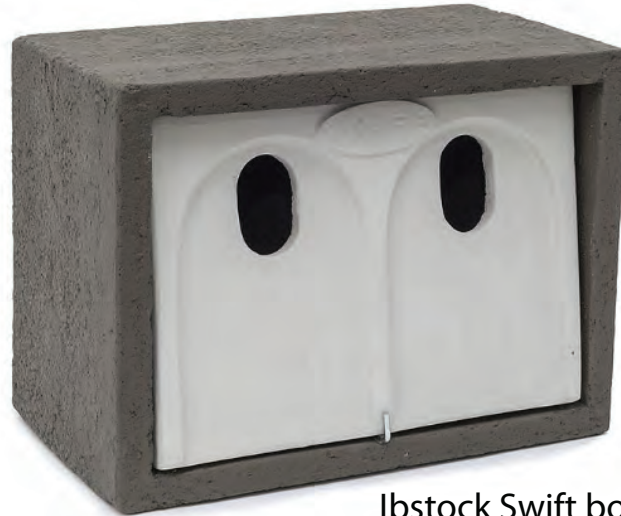
Vivara woodstone sparrow  
nest box; suitable for both  
integral fitment or surface  
mounting

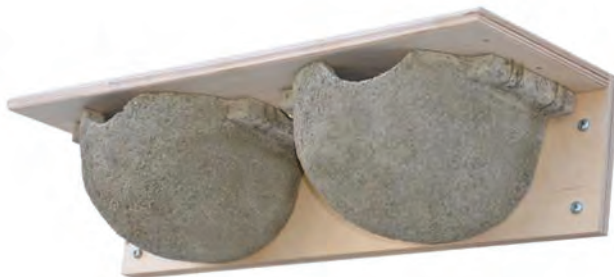
Schwegler model 9b

Schwegler house martin box model 9 b double is a suitable box for house martins and can be used to encourage the uptake of a building by this species. The boxes can be attached to the exterior walls in a sheltered position; ideally beneath the eaves. At least two sets should be placed on an averaged size house.
