# Defence Infrastructure Organisation **Bulford Service Families Accommodation Site – Bulford Camp, Sling Road**

## Historic Environment Desk-Based Assessment

January 2026

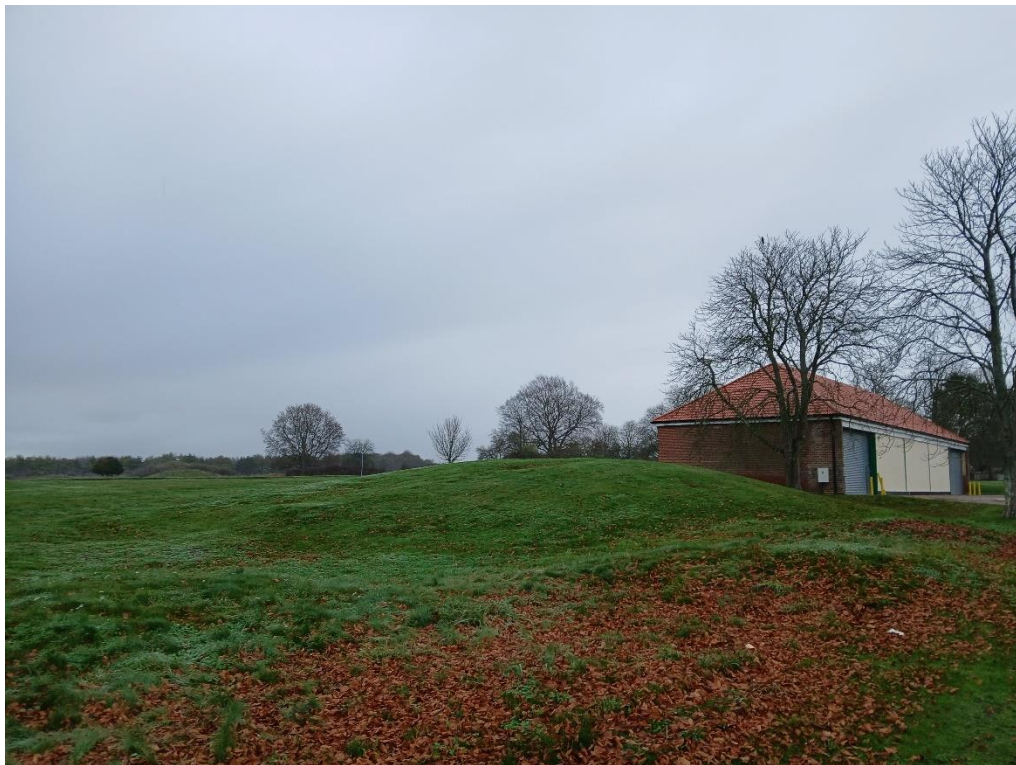
Plate 1 – north-eastern view of the Bowl barrow: one of a group of six round barrows, Sheepbridge Road, Sling Camp (**A2a**) showing the earthwork

- 6.3.1. Bowl barrow: one of a group of six round barrows, Sheepbridge Road, Sling Camp is located 30m to the east of the site and comprises the scheduled remains of a bowl barrow likely dating to the late Neolithic and early Bronze Age. The barrow includes traces of a ditch around its eastern half and has an overall diameter measuring approximately 34m. The barrow was altered by a partial excavation during the 19th century which resulted in a tail extended north-west from the barrow. It was scheduled in January 1965 (NHLE ref. 1009966, **plate 1**) (Historic England (a), n.d.).

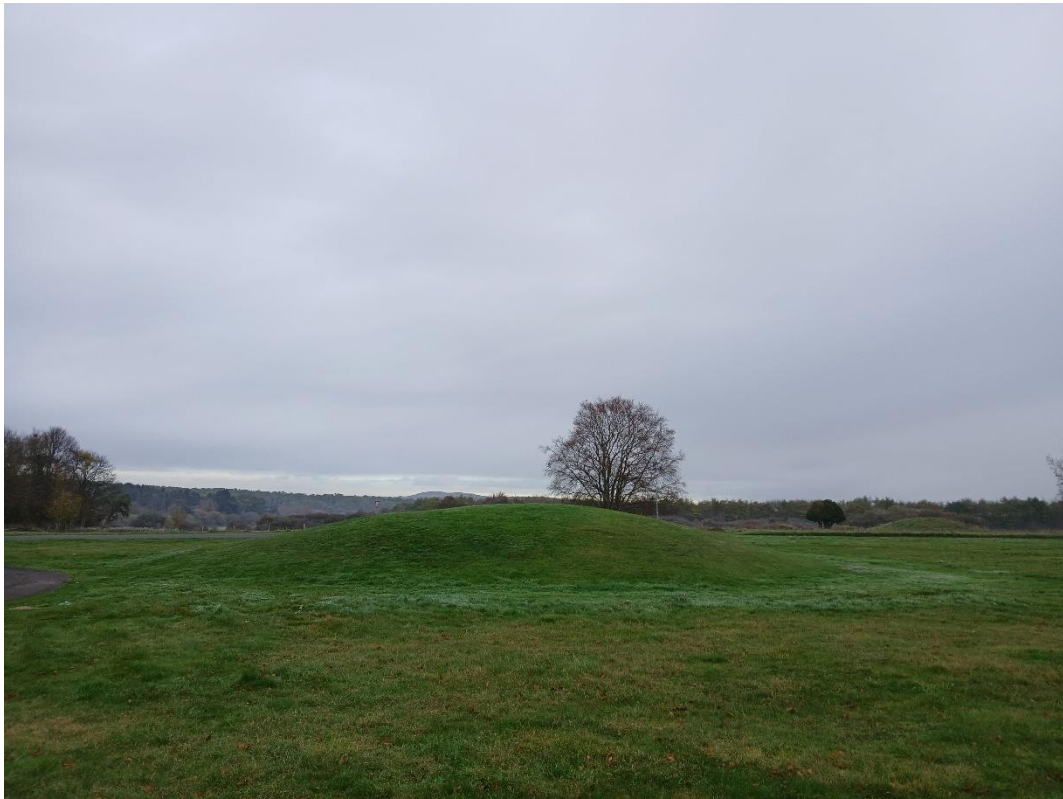
Plate 2 – north view of the Bowl barrow: one of a group of six round barrows, Sheepbridge Road, Sling Camp (**A2b**) showing the earthwork

- 6.3.2. Bowl barrow: one of a group of six round barrows, Sheepbridge Road, Sling Camp is located 57m to the north-east of the site and comprises the scheduled remains of a ditched bowl barrow likely dating to the late Neolithic and early Bronze Age. The diameter of the barrow approximately measures 34m in diameter and reaches 2.5m in height. The western section of the ditch has been destroyed by the development of Sling Road in the early 20th century. A partial excavation in the 19th century revealed primary and secondary

inhumations indicating that the designated heritage asset is a funerary monument. It was scheduled in January 1965 (NHLE ref. 1009968, **plate 2**) (Historic England (b), n.d.).

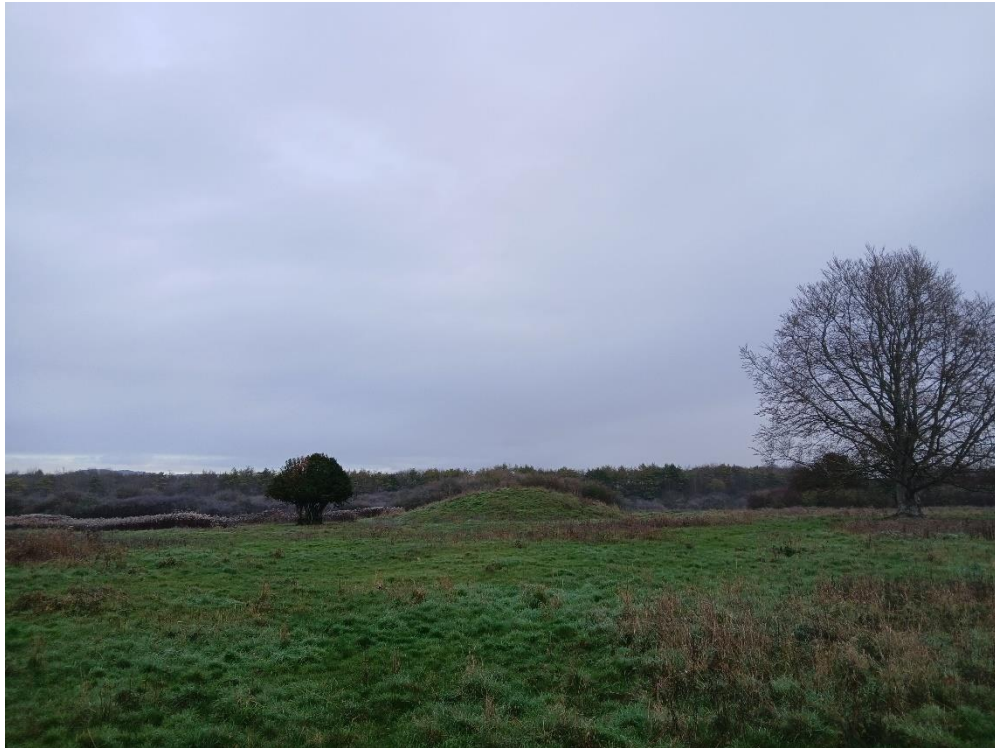
Plate 3 – north view of the Bowl barrow: one of a group of six round barrows, Sheepbridge Road, Sling Camp (**A2d**) showing the earthwork

6.3.4. Bowl barrow: one of a group of six round barrows, Sheepbridge Road, Sling Camp is located 190m to the north-east of the site and comprises the scheduled remains of a ditched bowl barrow likely dating to the late Neolithic and early Bronze Age. It has a diameter of approximately 26m and there are traces of a ditch. It was scheduled in January 1965 (NHLE ref. 1010239, **plate 3**) (Historic England (d), n.d.).

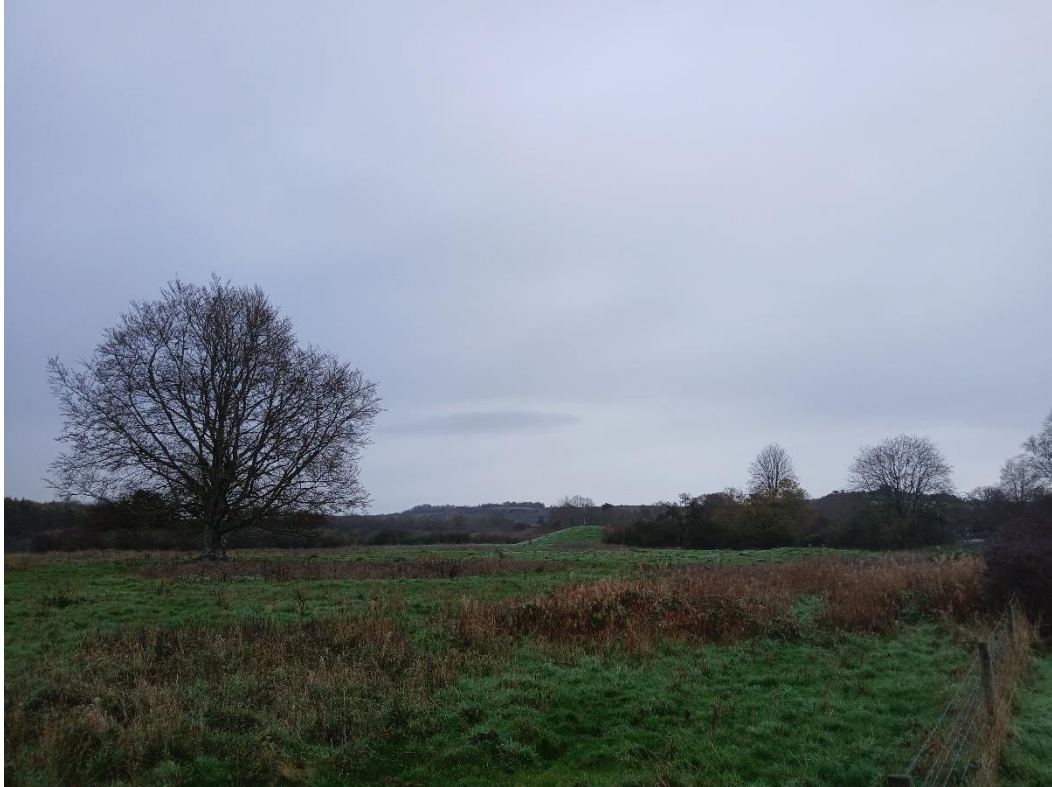
Plate 4 – north-eastern view of the Bowl barrow: one of a group of six round barrows, Sheepbridge Road, Sling Camp (**A2e**) taken from Sheepbridge Road. Part of the asset is within the grassy foreground.

- 6.3.5. Disc barrow: one of a group of six round barrows, Sheepbridge Road, Sling Camp is located 165m to the north-east of the site and comprises the scheduled remains of a disc barrow likely dating to the late Neolithic and early Bronze Age. The overall diameter of the barrow measures approximately 48m however, the outer bank is not traceable, and the southern section has been removed by the construction of Swing Road. It was scheduled in January 1965 (NHLE ref. 1010237, **plate 4**) (Historic England (e), n.d.).

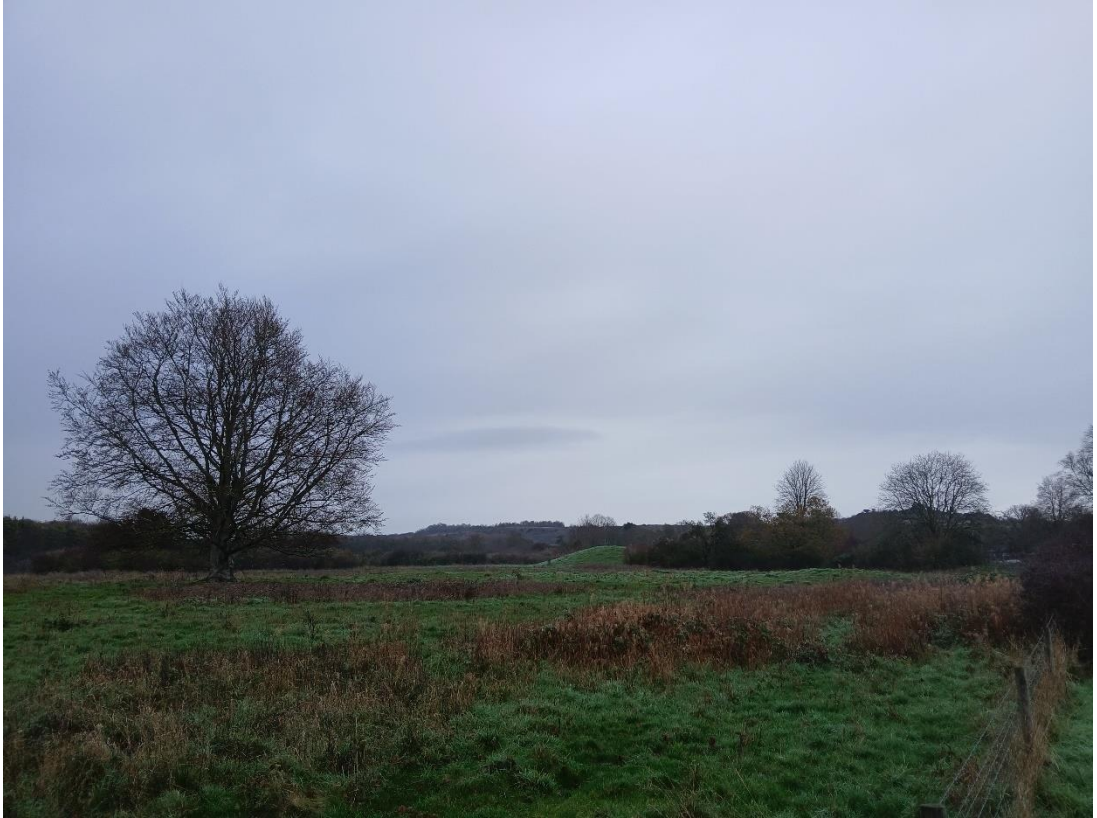
Plate 5 – north-eastern view of the Bowl barrow: one of a group of six round barrows, Sheepbridge Road, Sling Camp (**A2f**) showing the earthwork in the distance

- 6.3.6. Bowl barrow: one of a group of six round barrows, Sheepbridge Road, Sling Camp is located 275m to the north-east of the site and comprises the scheduled remains of a ditched bowl barrow likely dating to the late Neolithic and early Bronze Age. It has a diameter of approximately 43m and was partially excavated in the 19th century revealing a crouched inhumation, 10 secondary inhumations and an axe head. It was scheduled in March 1980 (NHLE ref. 1010235, **plate 5**) (Historic England (f), n.d.).

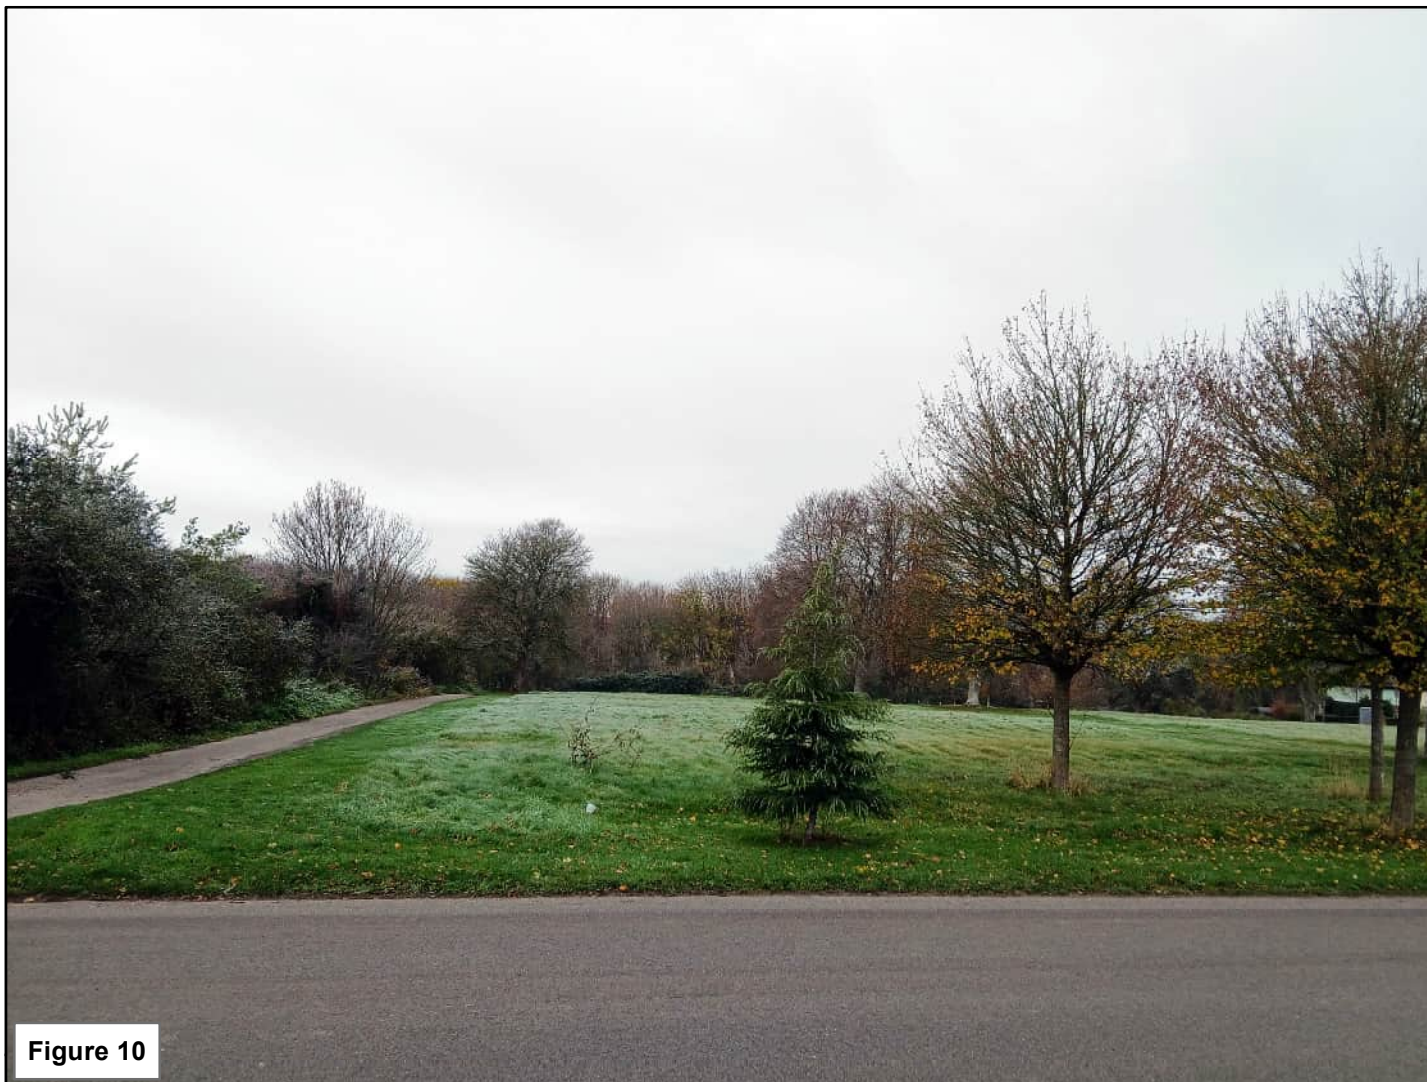
**Figure 10**

Figure 10 – West facing view of the southern and western sections of the site, taken from Sling Road in the south-eastern section of the site

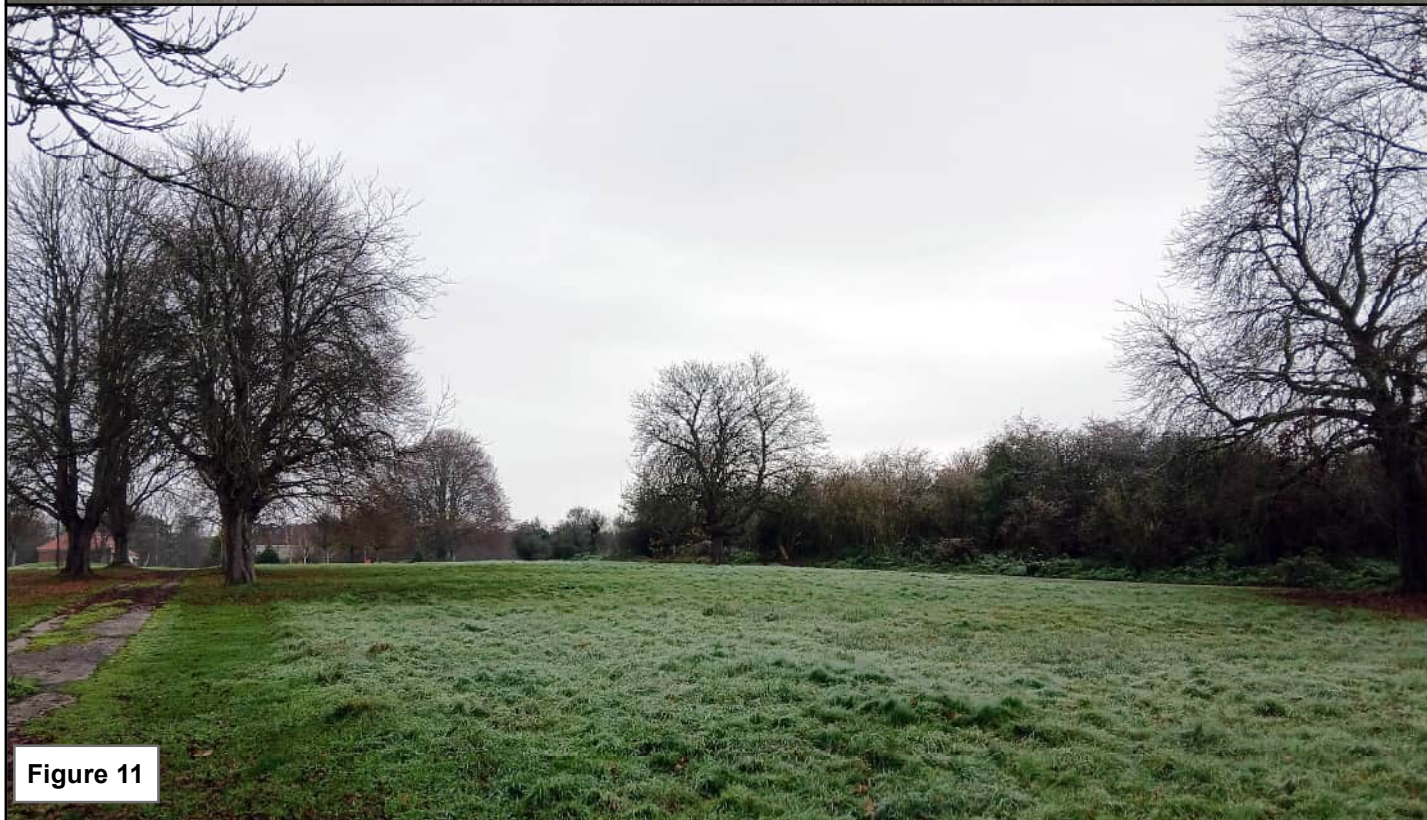
**Figure 11**

South-east facing view of the southern section of the site, taken from near the western boundary of the site

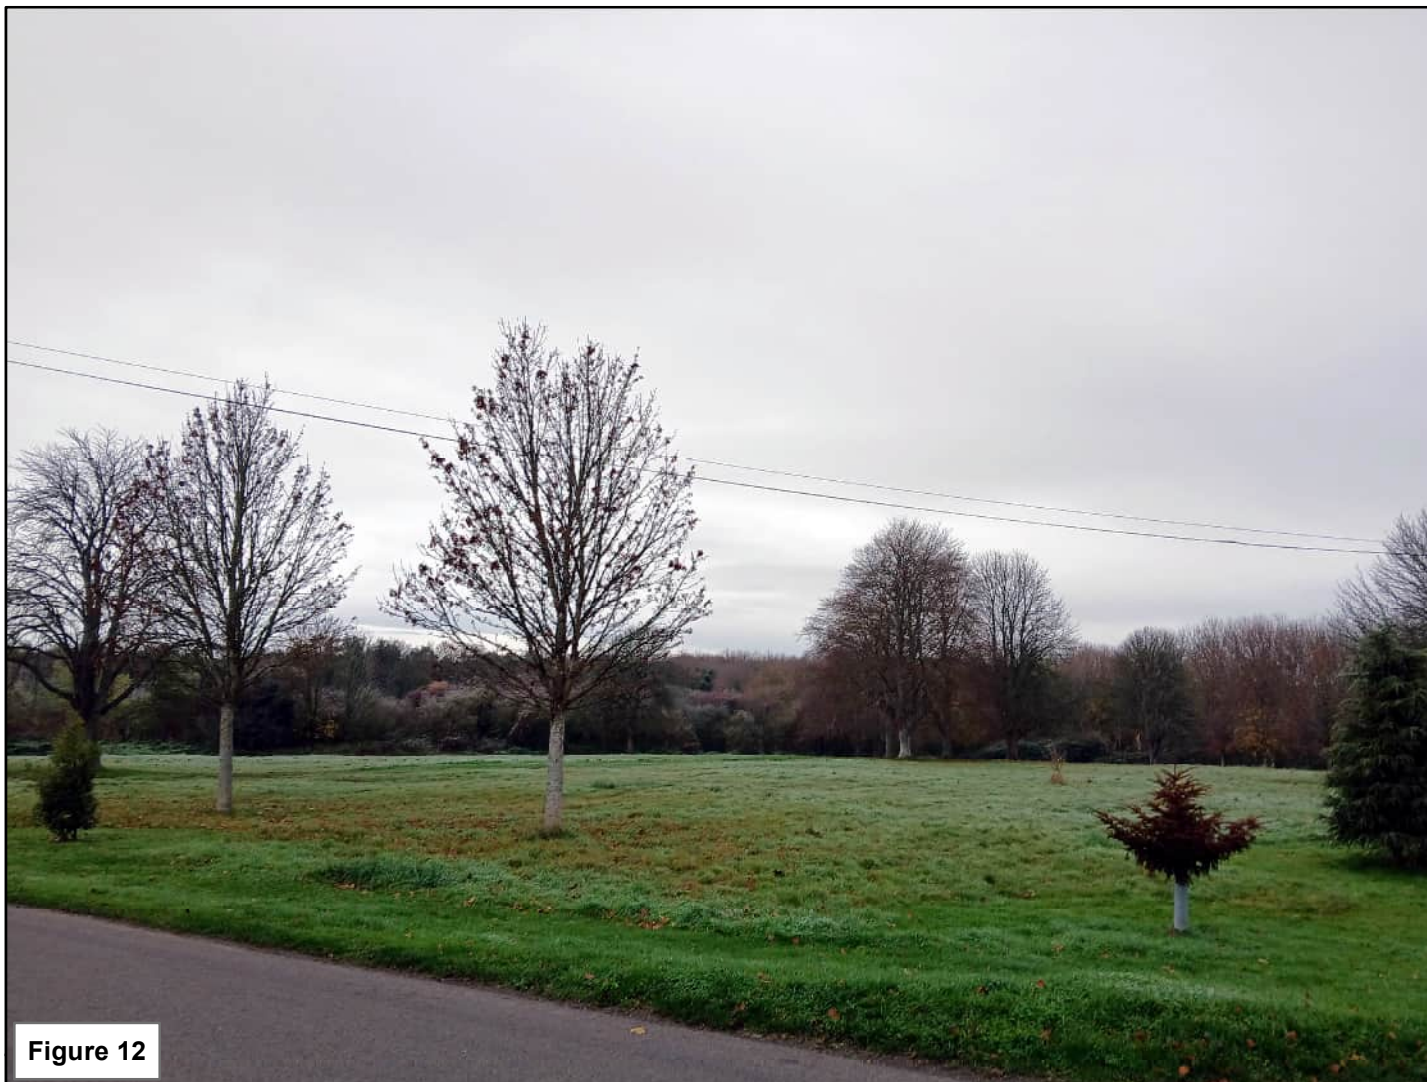
**Figure 12**

Figure 12 – South-west facing view of the site, taken from Sling Road in the north-eastern section of the site

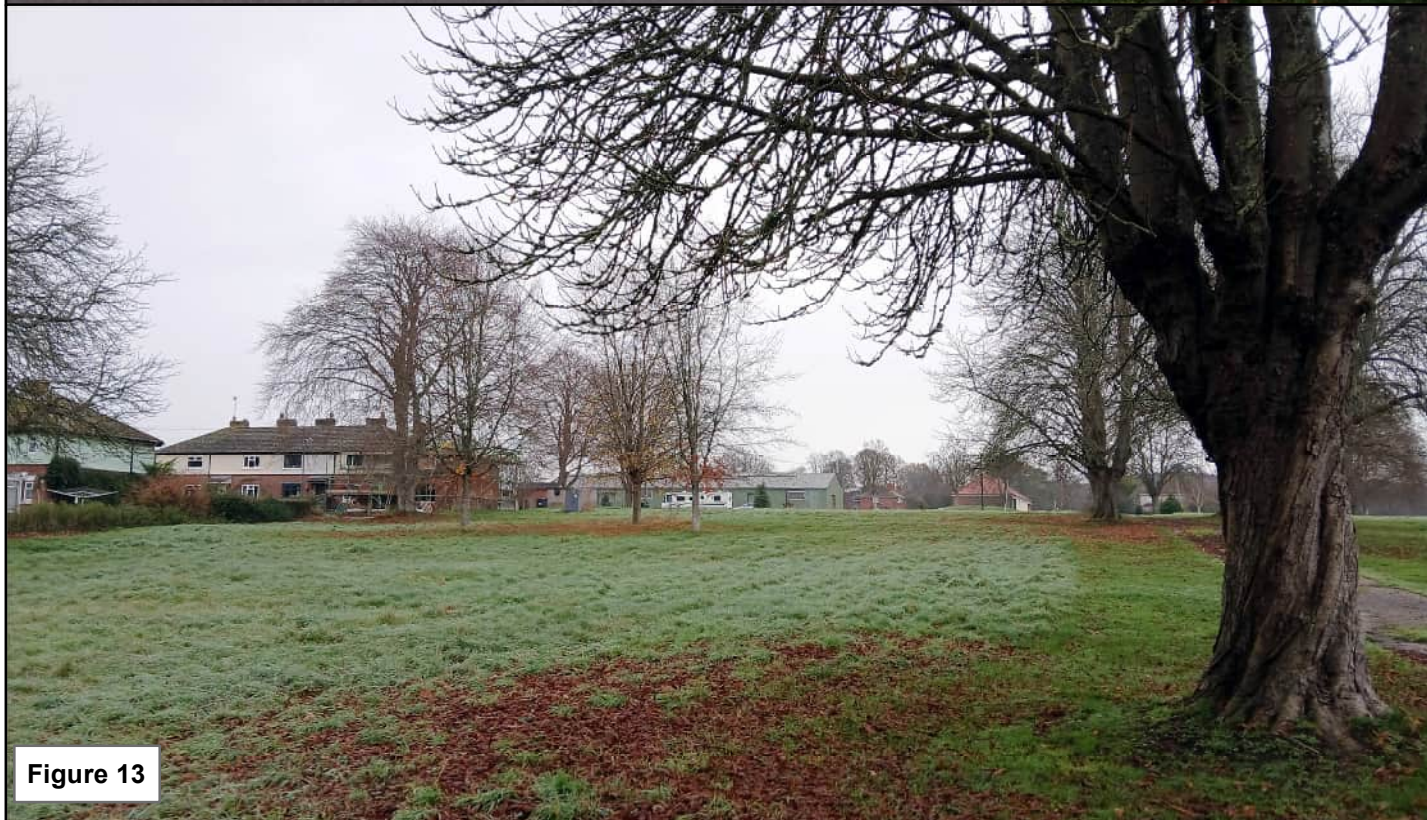
**Figure 13**

North-east facing view of the northern section of the site, taken from the unnamed road in the western extent of the site

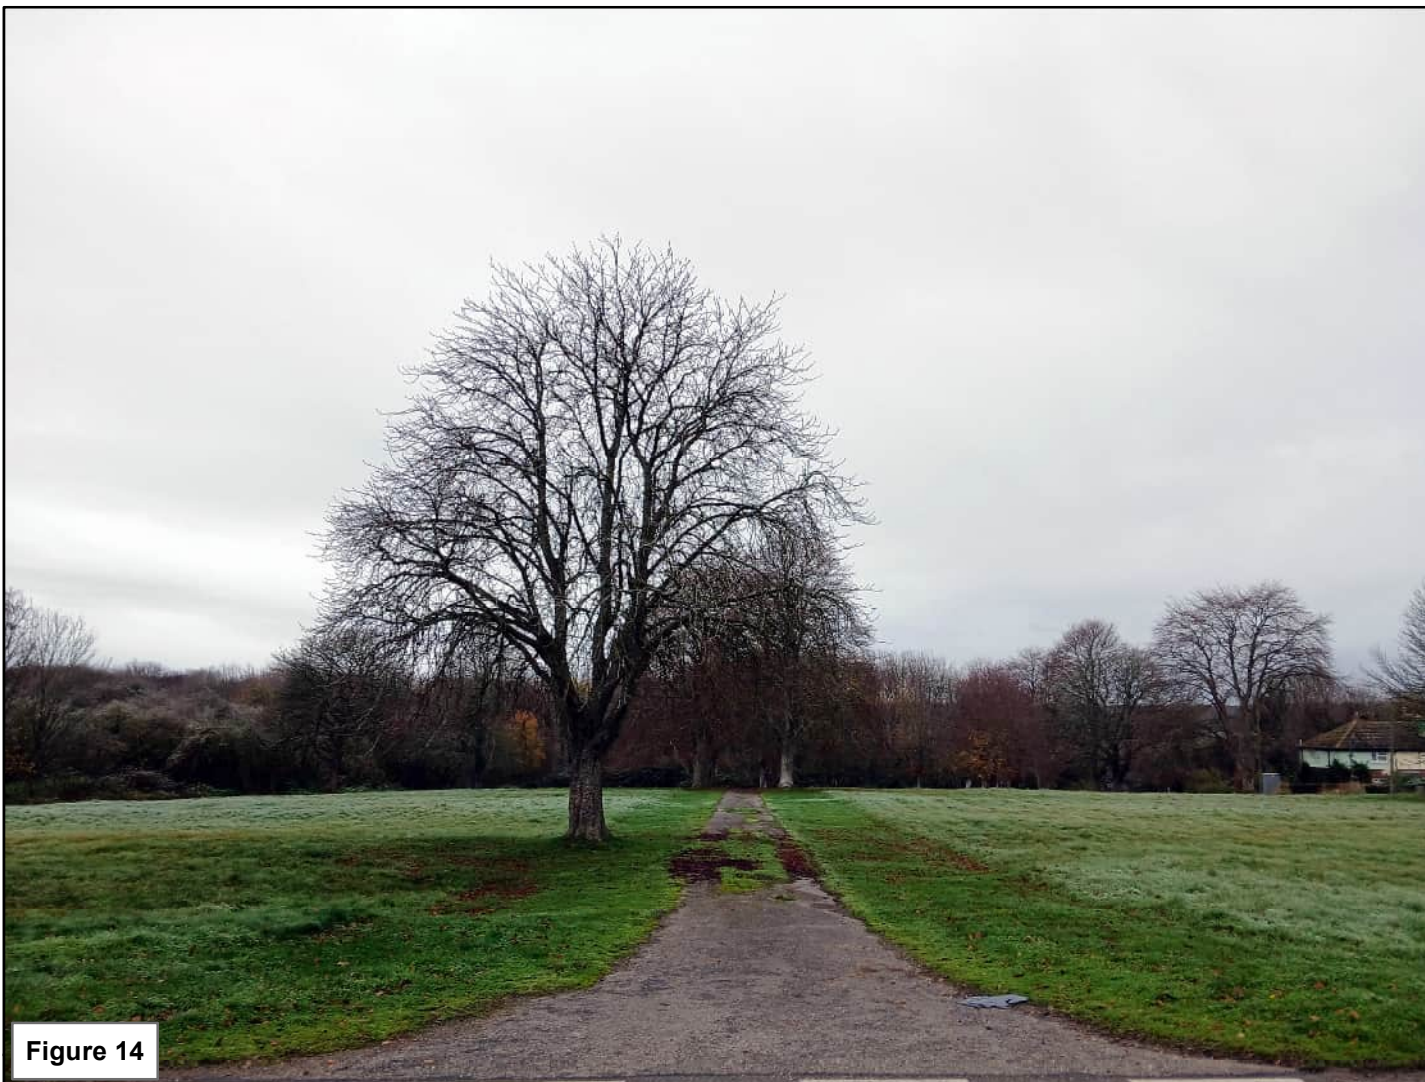
**Figure 14**

Figure 14 – West facing view of the unnamed road in central section of the site, taken from Sling Road in the east of the site

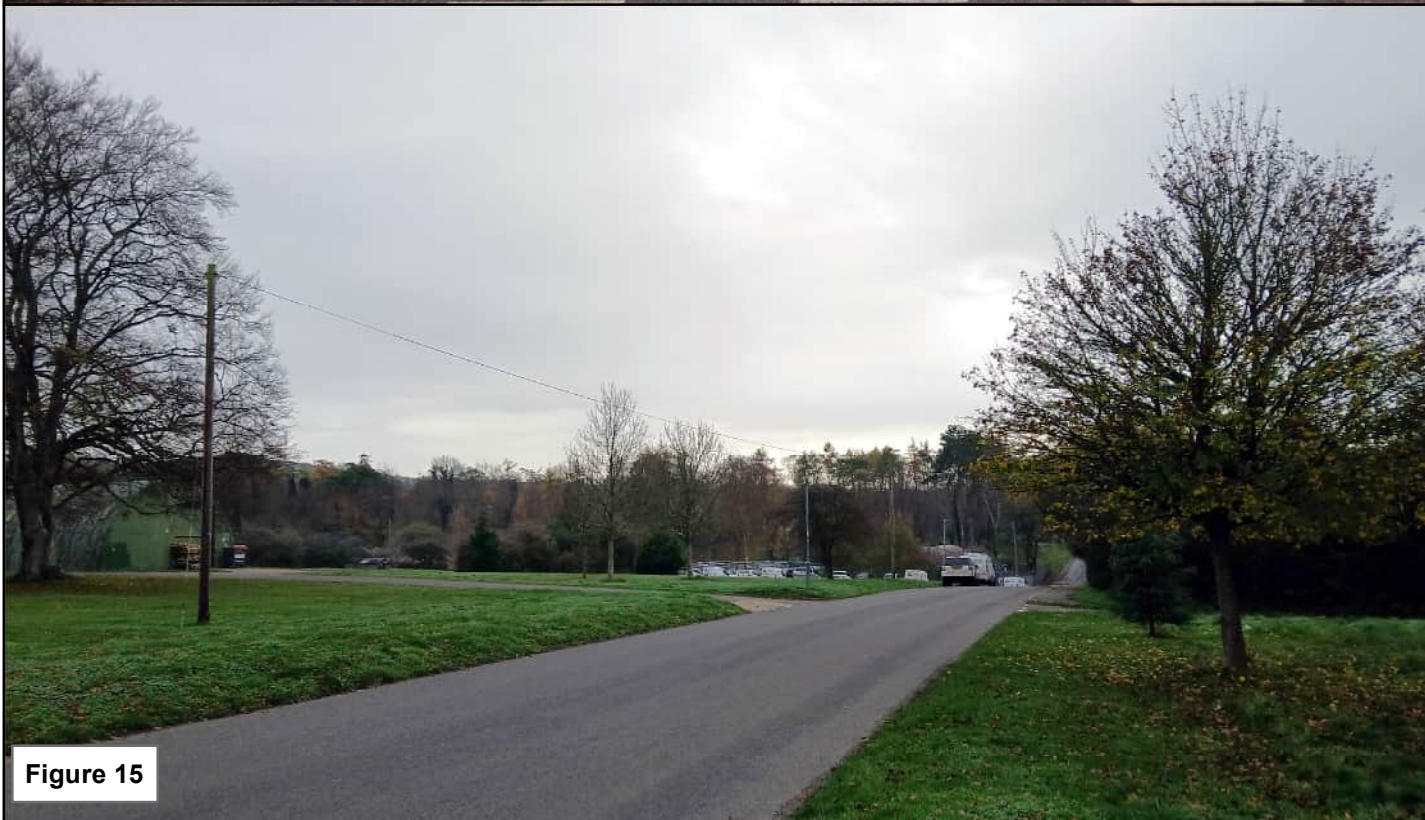
**Figure 15**

South-east facing view of Sling Road, taken from the eastern boundary of the site
